Project Number 2481

**Management
Asbestos Survey Report**

Headley Park Platoon, Bristol, BS13 7QB

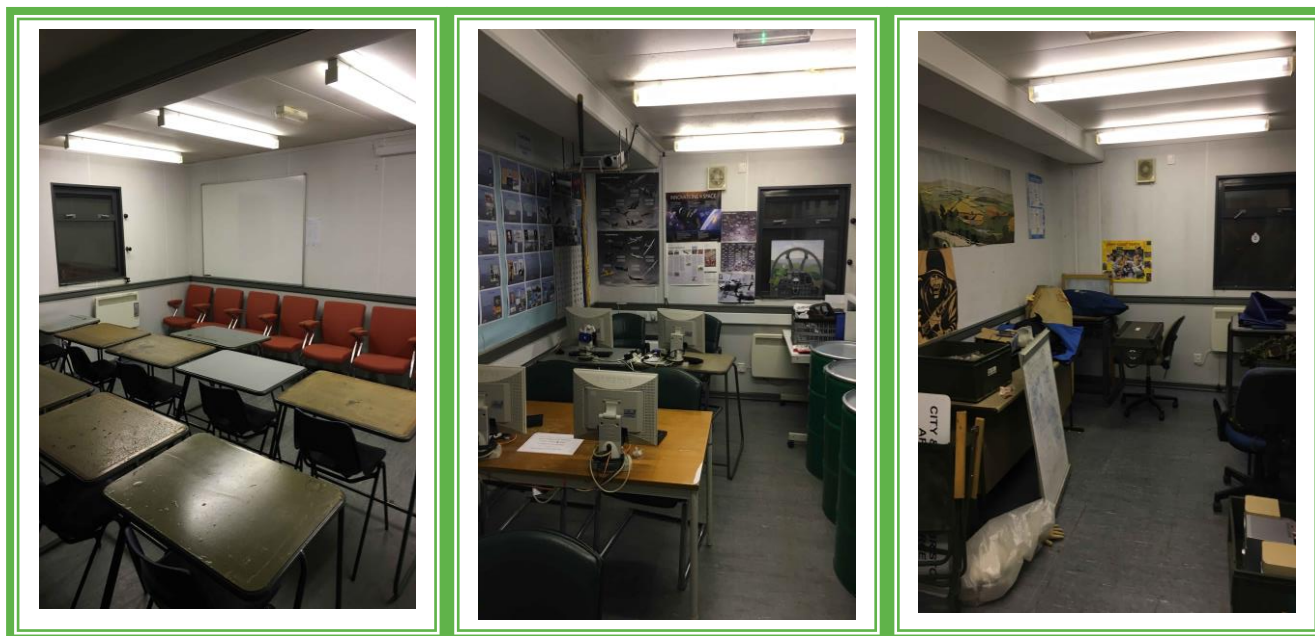
Item No: 1

Location: Classrooms 1, 2 and 3

Material Description:	Visual Inspection – No Suspect Materials Found	
Identification:	N/A	
Approx. quantity:	N/A	
Accessibility	N/A	<i>Assessment Score</i>
Product type:		N/A
Extent of Damage:		N/A
Surface Treatment:		N/A
Asbestos type:		N/A
Material Assessment Score:		N/A
Priority Assessment Score:		N/A
Action:	N/A	
Comments:	N/A

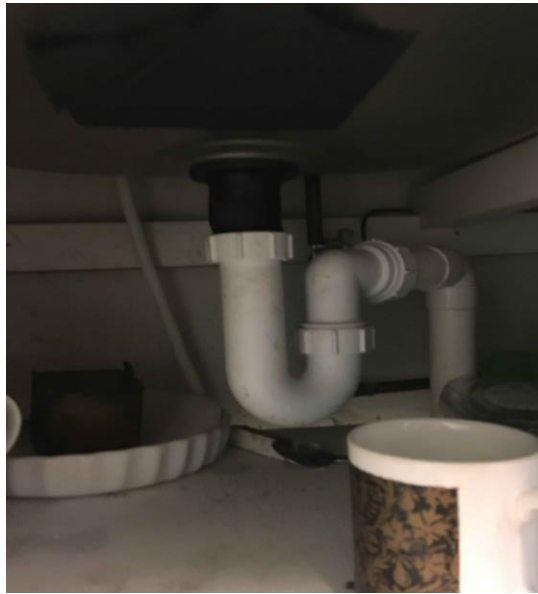
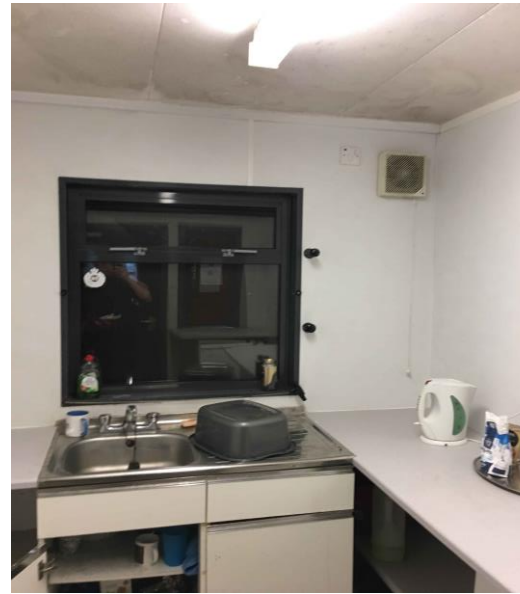
Item No: 2

Location: Kitchen

Material Description:	Sink Pad	
Identification:	Sampled – No Asbestos Detected	
Approx. quantity:	X 1	
Accessibility	N/A	<i>Assessment Score</i>
Product type:		N/A
Extent of Damage:		N/A
Surface Treatment:		N/A
Asbestos type:		N/A
Material Assessment Score:		N/A
Priority Assessment Score:		N/A
Action:	N/A	
Comments:	N/A

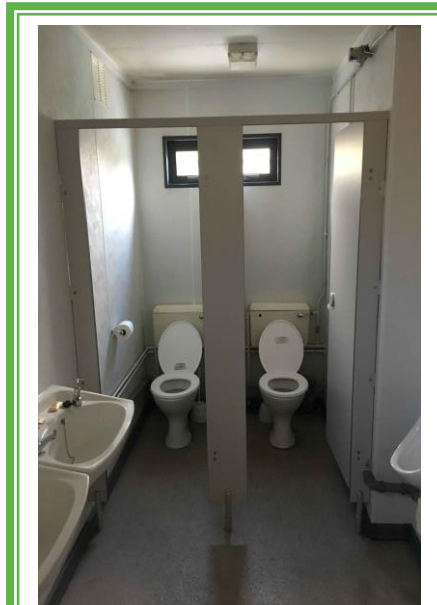
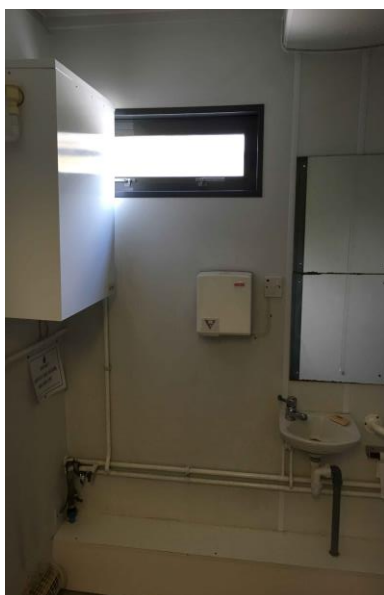
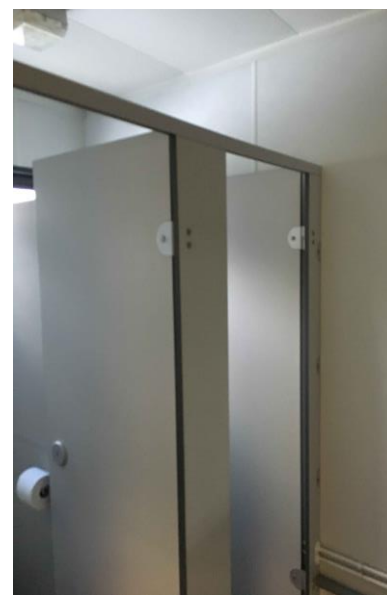
Item No: 3

Location: WC's x 3 and Circulation

Material Description:	Visual Inspection – No Suspect Materials Found	
Identification:	N/A	
Approx. quantity:	N/A	
Accessibility	N/A	<i>Assessment Score</i>
Product type:		N/A
Extent of Damage:		N/A
Surface Treatment:		N/A
Asbestos type:		N/A
Material Assessment Score:		N/A
Priority Assessment Score:		N/A
Action:	N/A	
Comments:	Modern Zip Boiler

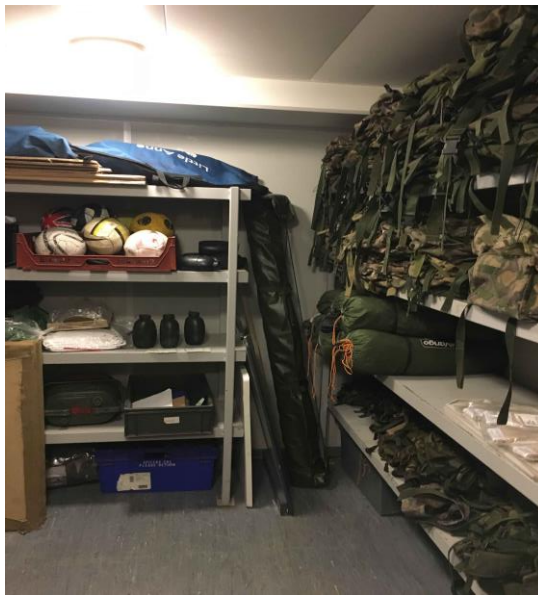
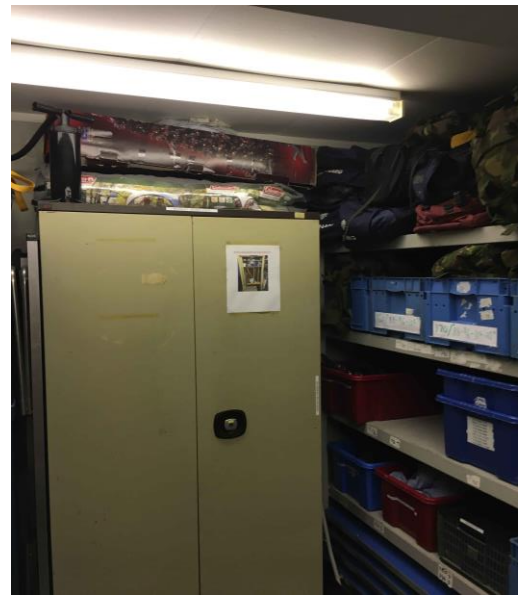
**Item No: 4****Sample No: N/A****Location: Stores x 2**

Material Description:	Visual Inspection – No Suspect Materials Found	
Identification:	N/A	
Approx. quantity:	N/A	
Accessibility	N/A	<i>Assessment Score</i>
Product type:		N/A
Extent of Damage:		N/A
Surface Treatment:		N/A
Asbestos type:		N/A
Material Assessment Score:		N/A
Priority Assessment Score:		N/A
Action:	N/A	
Comments:	N/A

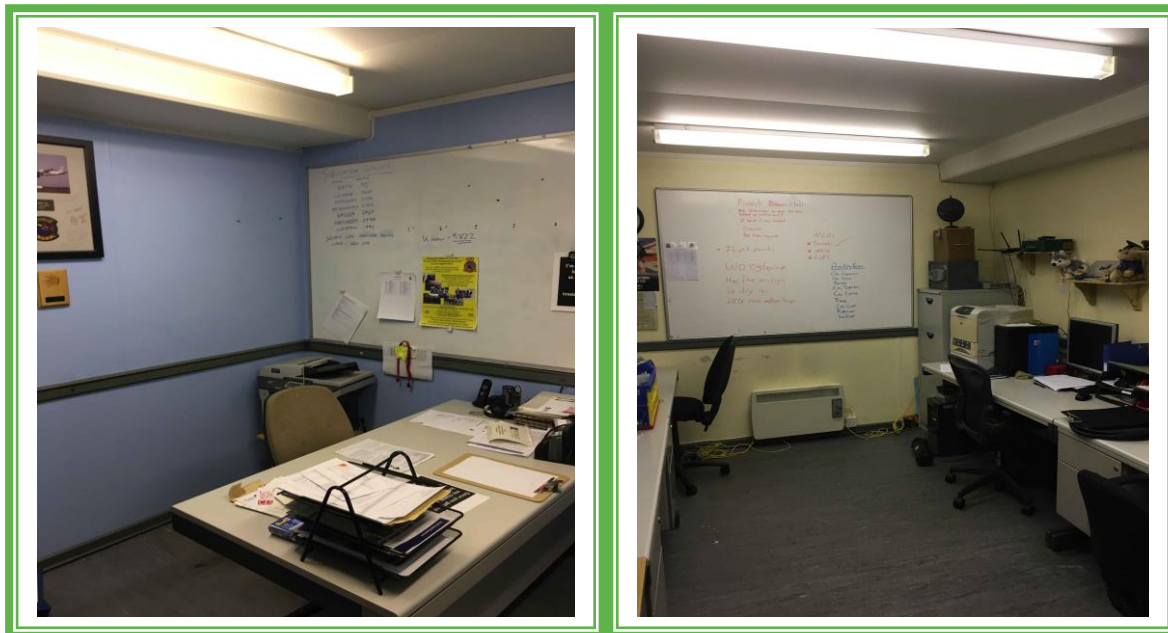
Item No: 5

Location: Offices x 2

Material Description:	Visual Inspection – No Suspect Materials Found	
Identification:	N/A	
Approx. quantity:	N/A	
Accessibility	N/A	<i>Assessment Score</i>
Product type:		N/A
Extent of Damage:		N/A
Surface Treatment:		N/A
Asbestos type:		N/A
Material Assessment Score:		N/A
Priority Assessment Score:		N/A
Action:	N/A	
Comments:	N/A

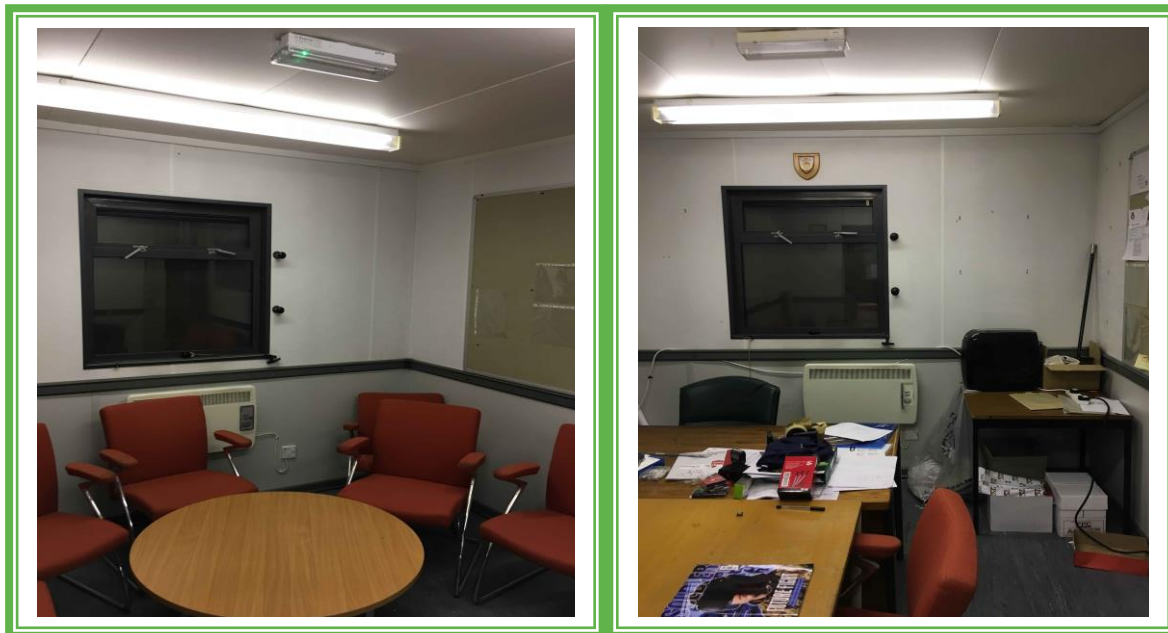
Item No: 6

Location: Meeting Room and Office

Material Description:	Visual Inspection – No Suspect Materials Found	
Identification:	N/A	
Approx. quantity:	N/A	
Accessibility	N/A	<i>Assessment Score</i>
Product type:		N/A
Extent of Damage:		N/A
Surface Treatment:		N/A
Asbestos type:		N/A
Material Assessment Score:		N/A
Priority Assessment Score:		N/A
Action:	N/A	
Comments:	N/A

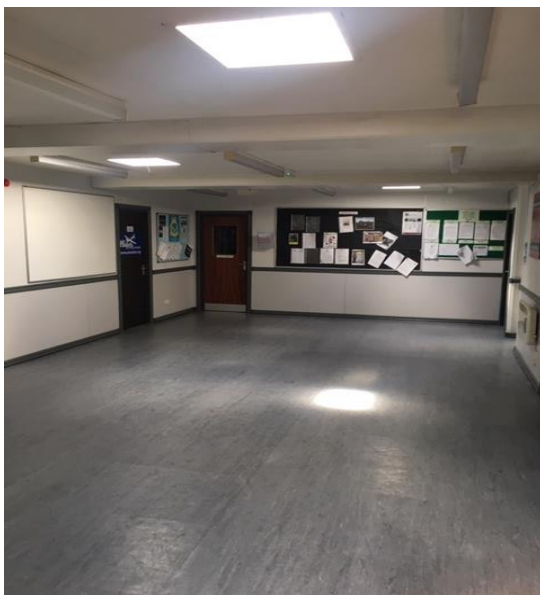
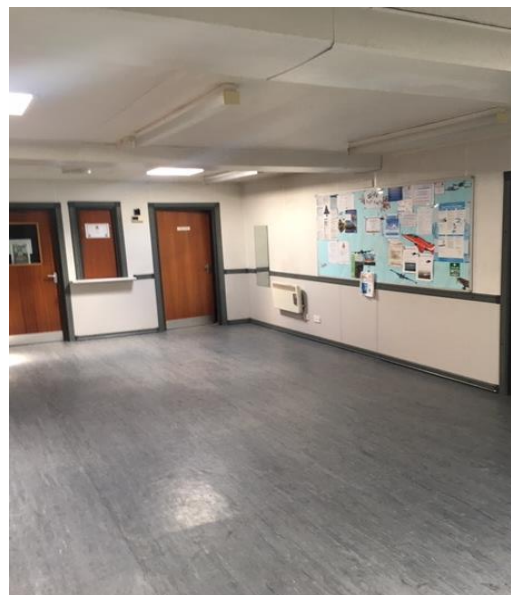
**Item No: 7****Sample No: N/A****Location: Main Hall**

Material Description:	Visual Inspection – No Suspect Materials Found	
Identification:	N/A	
Approx. quantity:	N/A	
Accessibility	N/A	<i>Assessment Score</i>
Product type:		N/A
Extent of Damage:		N/A
Surface Treatment:		N/A
Asbestos type:		N/A
Material Assessment Score:		N/A
Priority Assessment Score:		N/A
Action:	N/A	
Comments:	N/A
