ARMOUR
ANALYTICAL SERVICES

Project Number 2481

**Management
Asbestos Survey Report**

**39 Skinners, Bristol,
BS7 0XL**

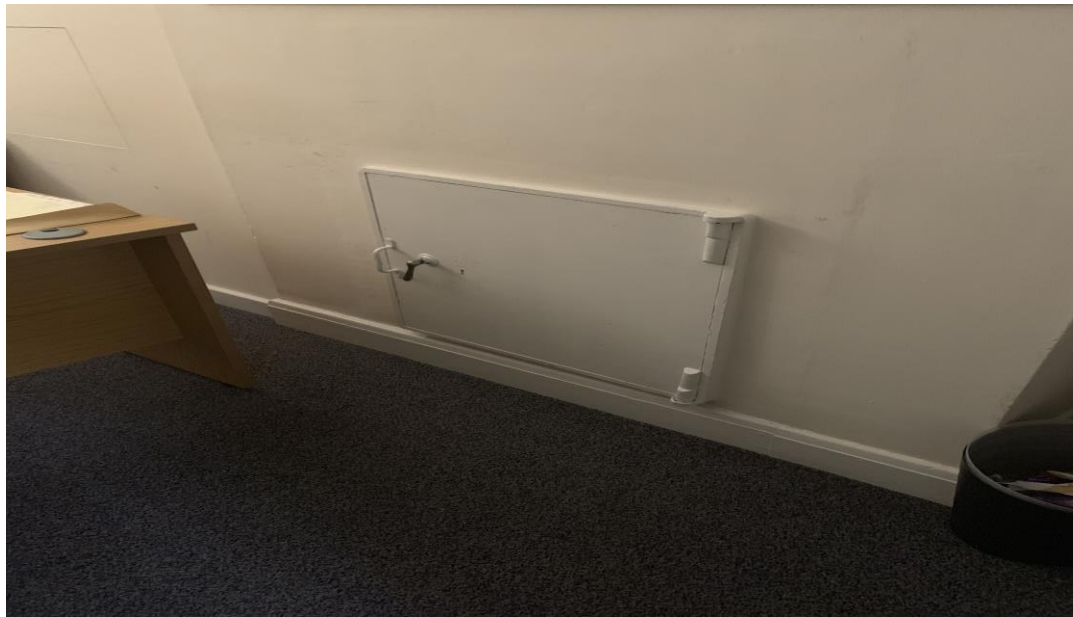
Item No: 1

Location: Ground Floor – Adjt Room

Material Description:	Safe	
Identification:	Presumed to Contain Asbestos as Per Previous Report	
Approx. quantity:	11M2	
Accessibility	High	Assessment Score
Product type:	No Access	3
Extent of Damage:	No Access	3
Surface Treatment:	No Access	3
Asbestos type:	No Access	3
Material Assessment Score:		12
Priority Assessment Score:		High
Action:	Manage	
Comments:	Unable behind the safe as it is built in

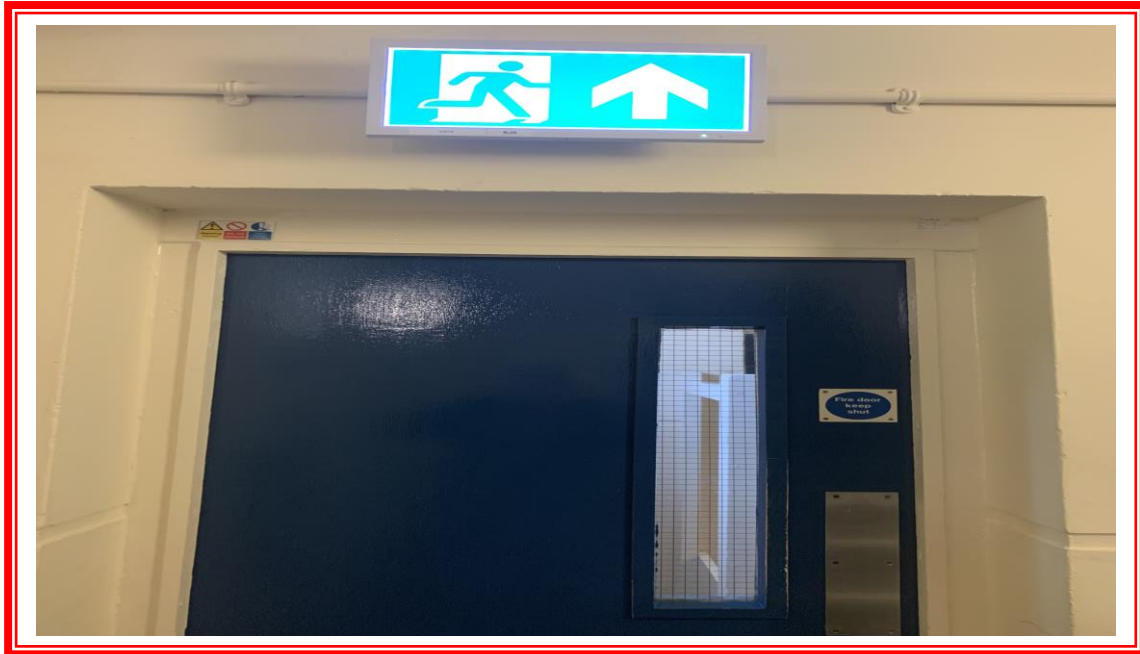
Item No: 2

Location: First Floor – Corridor

Material Description:	Asbestos Insulation Board	
Identification:	As Per Previous Sample in old report – Asbestos Detected	
Approx. quantity:	0.5M2	
Accessibility	Medium	Assessment Score
Product type:	Asbestos Insulation Board	2
Extent of Damage:	Minor	1
Surface Treatment:	Encapsulated	2
Asbestos type:	Amosite	2
Material Assessment Score:		7
Priority Assessment Score:		Medium
Action:	Manage	
Comments:	N/A

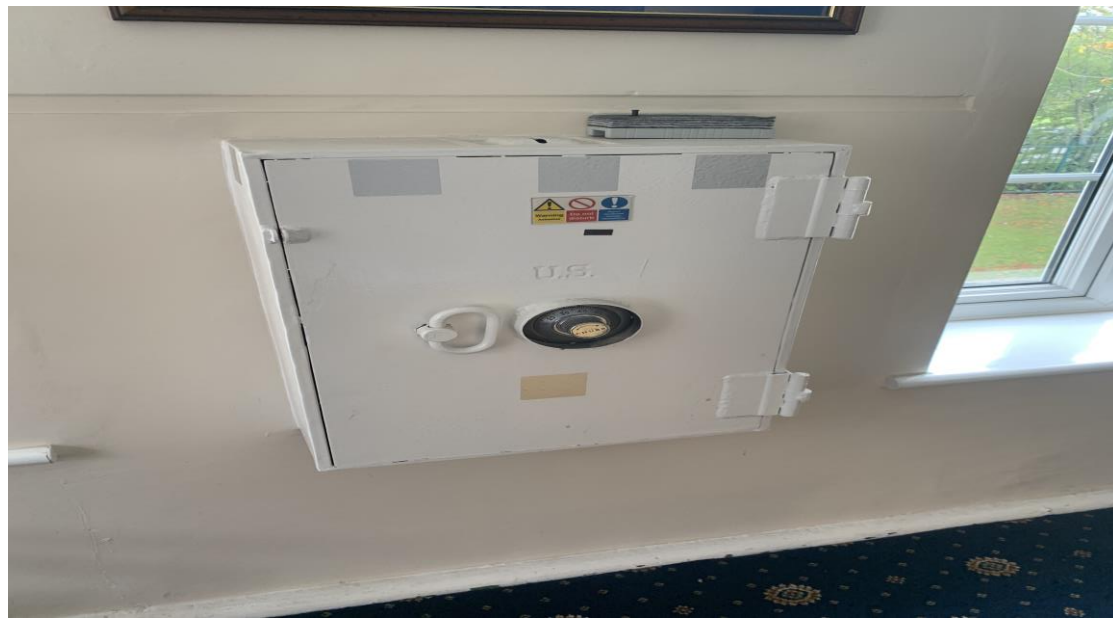
Item No: 3

Location: First Floor – Co Office

Material Description:	Safe	
Identification:	Presumed to Contain Asbestos as Per Previous Report	
Approx. quantity:	11M2	
Accessibility	High	Assessment Score
Product type:	No Access	3
Extent of Damage:	No Access	3
Surface Treatment:	No Access	3
Asbestos type:	No Access	3
Material Assessment Score:		12
Priority Assessment Score:		High
Action:	Manage	
Comments:	Unable behind the safe as it is built in

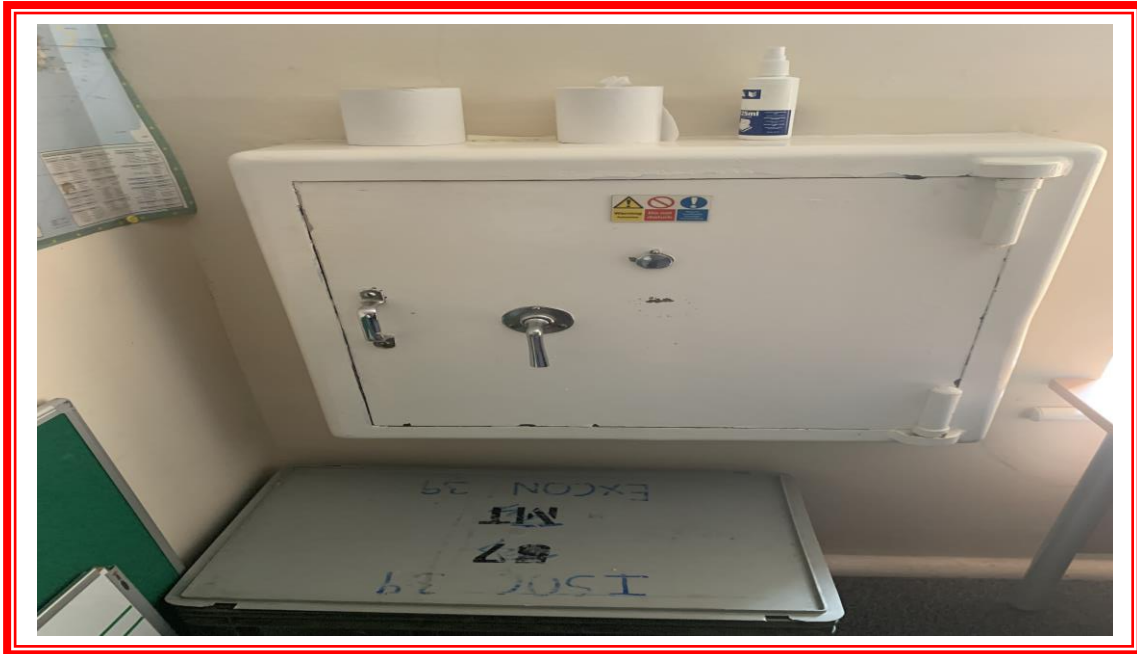
Item No: 4

Location: First Floor – RSM Office

Material Description:	Safe	
Identification:	Presumed to Contain Asbestos as Per Previous Report	
Approx. quantity:	11M2	
Accessibility	High	Assessment Score
Product type:	No Access	3
Extent of Damage:	No Access	3
Surface Treatment:	No Access	3
Asbestos type:	No Access	3
Material Assessment Score:		12
Priority Assessment Score:		High
Action:	Manage	
Comments:	Unable behind the safe as it is built in

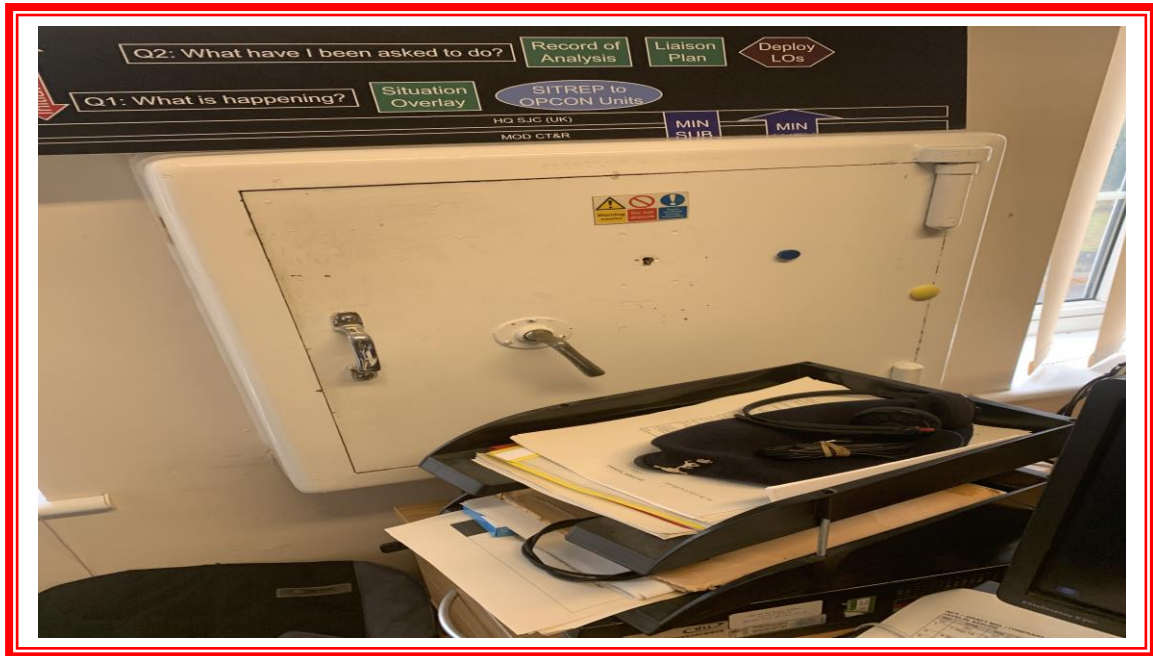
Item No: 5

Location: First Floor – Ops Office

Material Description:	Safe	
Identification:	Presumed to Contain Asbestos as Per Previous Report	
Approx. quantity:	11M2	
Accessibility	High	Assessment Score
Product type:	No Access	3
Extent of Damage:	No Access	3
Surface Treatment:	No Access	3
Asbestos type:	No Access	3
Material Assessment Score:		12
Priority Assessment Score:		High
Action:	Manage	
Comments:	Unable behind the safe as it is built in

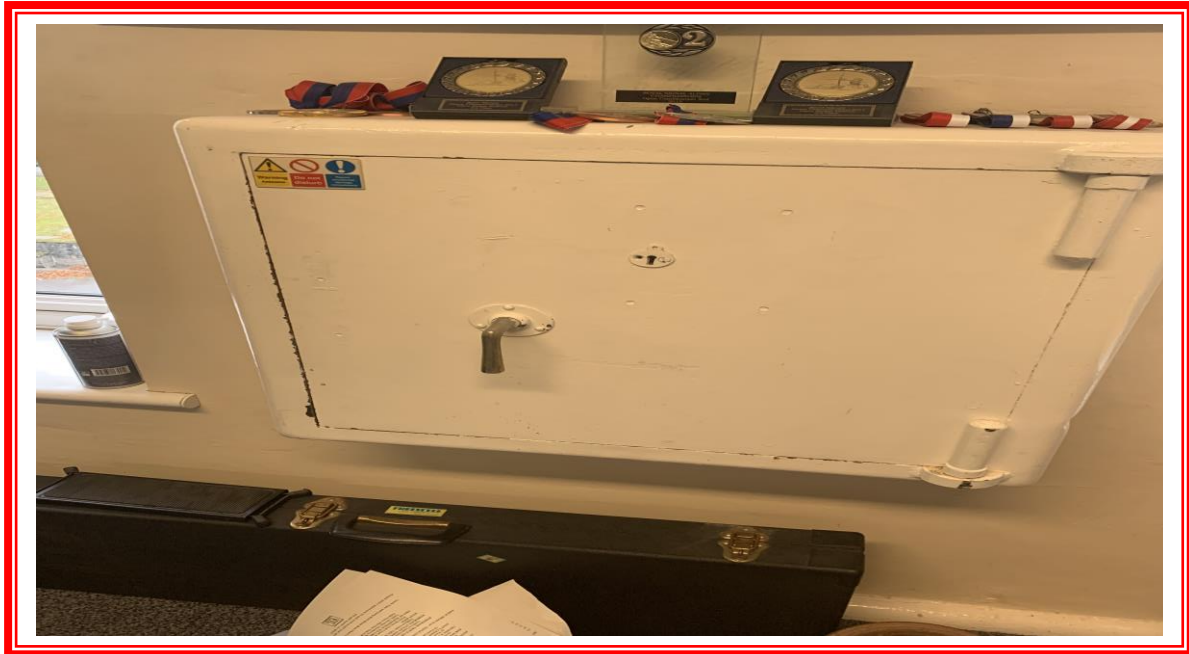
Item No: 6

Location: First Floor – RAO Office

Material Description:	Safe	
Identification:	Presumed to Contain Asbestos as Per Previous Report	
Approx. quantity:	11M2	
Accessibility	High	Assessment Score
Product type:	No Access	3
Extent of Damage:	No Access	3
Surface Treatment:	No Access	3
Asbestos type:	No Access	3
Material Assessment Score:		12
Priority Assessment Score:		High
Action:	Manage	
Comments:	Unable behind the safe as it is built in

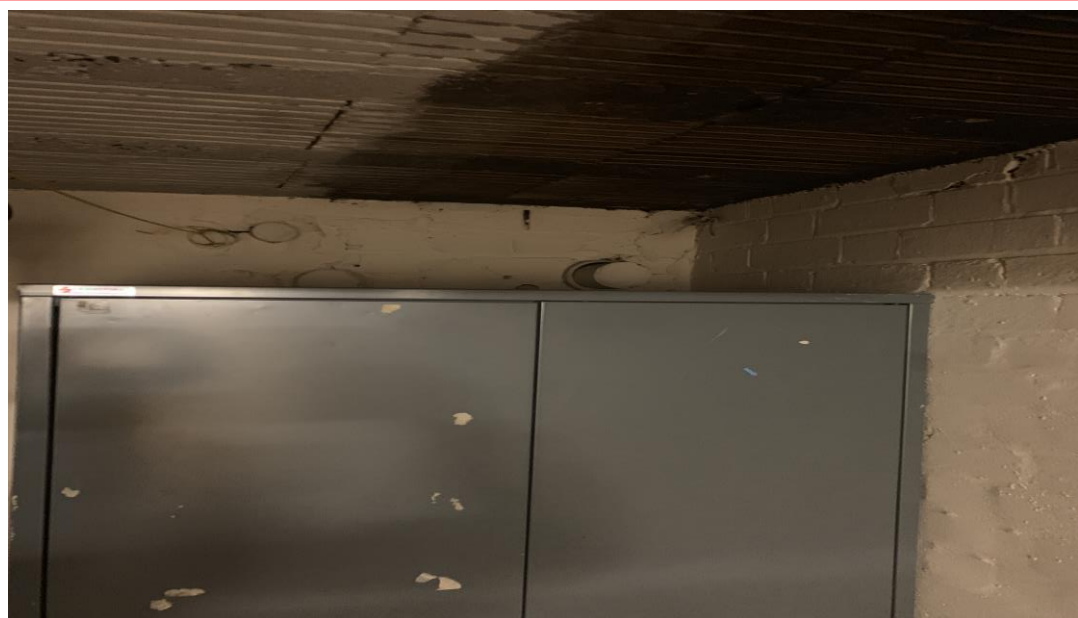
Item No: 7

Location: Ground Floor – Plant Room/Boiler

Material Description:	Pipe Work	
Identification:	Presumed to Contain Asbestos	
Approx. quantity:	Unknown	
Accessibility	High	Assessment Score
Product type:	No Access	3
Extent of Damage:	No Access	3
Surface Treatment:	No Access	3
Asbestos type:	No Access	3
Material Assessment Score:		12
Priority Assessment Score:		High
Action:	Manage	
Comments:	Plant Room has been Renewed but Unsure where the Old Pipe Leads to

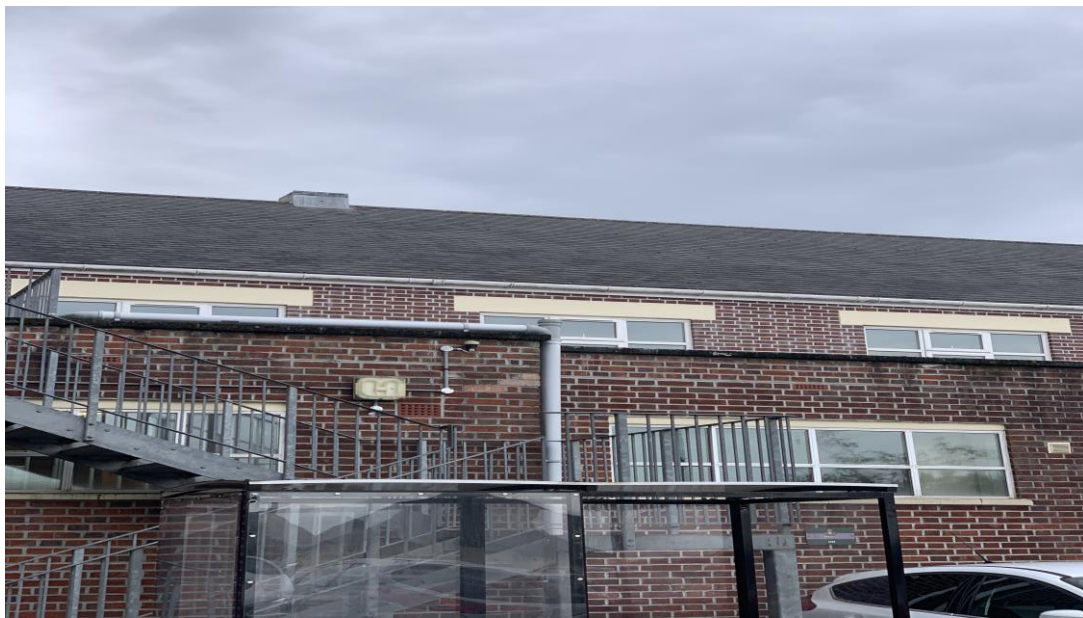
Item No: 8

Location: External - Roof

Material Description:	Slate Tiles	
Identification:	Presumed to Contain Asbestos	
Approx. quantity:	Whole Building	
Accessibility	High	Assessment Score
Product type:	No Access	3
Extent of Damage:	No Access	3
Surface Treatment:	No Access	3
Asbestos type:	No Access	3
Material Assessment Score:		12
Priority Assessment Score:		High
Action:	Manage	
Comments:	Unable to sample due to height

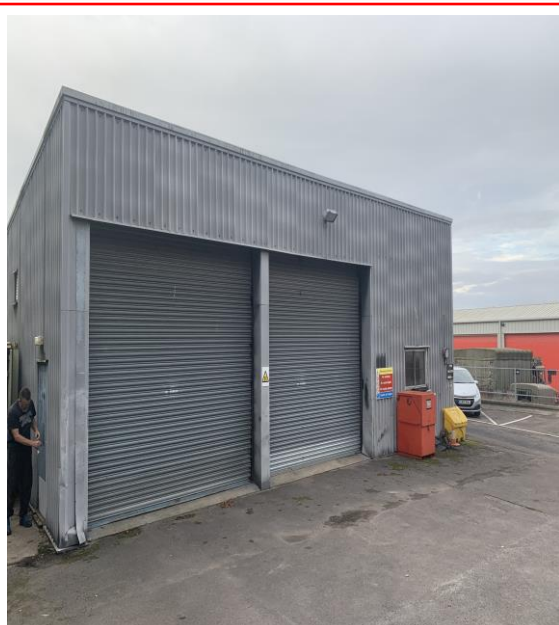
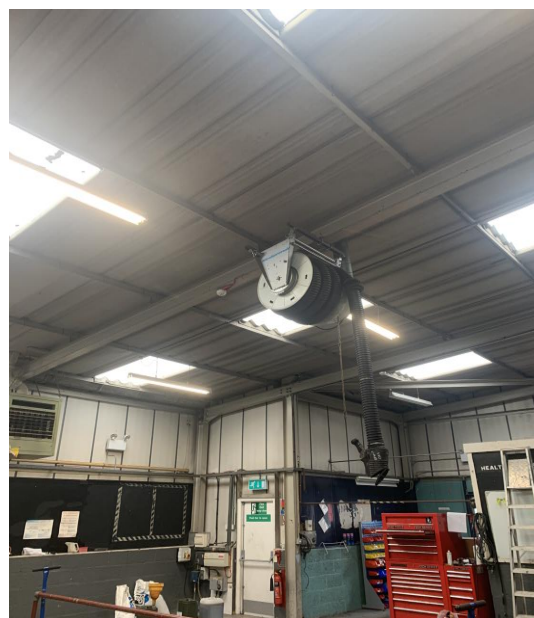
Item No: 10

Location: Workshop

Material Description:	Cement Roof and Valley	
Identification:	Presumed to Contain Asbestos	
Approx. quantity:	120M2	
Accessibility	High	Assessment Score
Product type:	No Access	3
Extent of Damage:	No Access	3
Surface Treatment:	No Access	3
Asbestos type:	No Access	3
Material Assessment Score:		12
Priority Assessment Score:		High
Action:	Manage	
Comments:	Unable to sample due to height

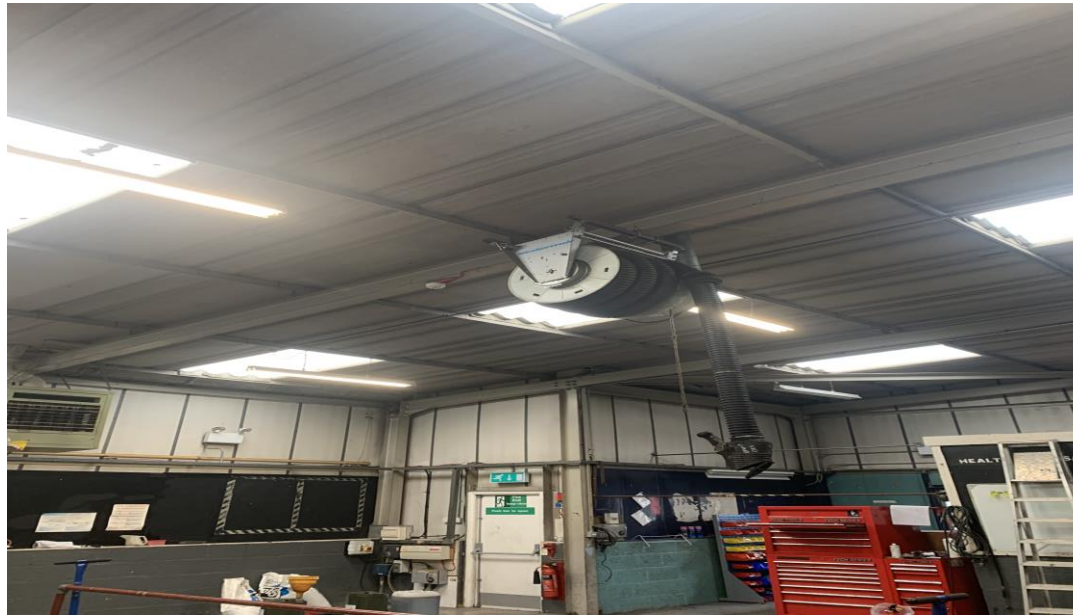
Item No: 11

Location: Workshop

Material Description:	Fuse Board/Flashguards	
Identification:	Presumed to Contain Asbestos	
Approx. quantity:	Unknown	
Accessibility	High	Assessment Score
Product type:	No Access	3
Extent of Damage:	No Access	3
Surface Treatment:	No Access	3
Asbestos type:	No Access	3
Material Assessment Score:		12
Priority Assessment Score:		High
Action:	Manage	
Comments:	No Access as Live

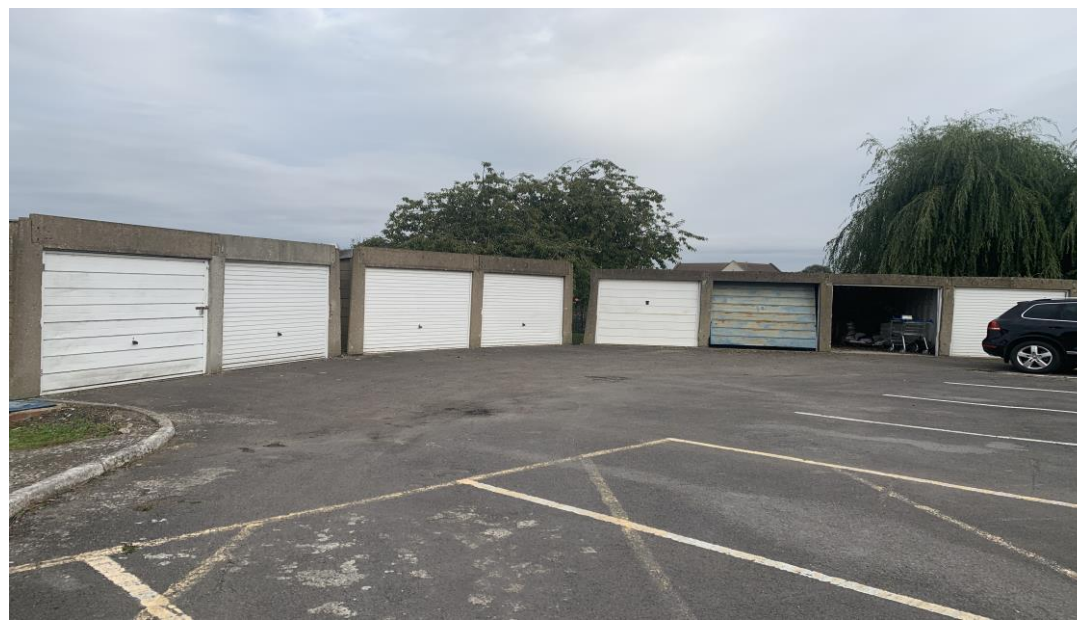
Item No: 13

Location: Garage's/Store's

Material Description:	Cement Roof Sheets	
Identification:	Strongly Presumed to Contain Asbestos	
Approx. quantity:	130M2	
Accessibility	Medium	Assessment Score
Product type:	Cement	1
Extent of Damage:	Good	0
Surface Treatment:	Unsealed	1
Asbestos type:	Chrysotile	1
Material Assessment Score:		3
Priority Assessment Score:		Negligible
Action:	Manage	
Comments:	Sampling would damage the ingratiate of the roofs

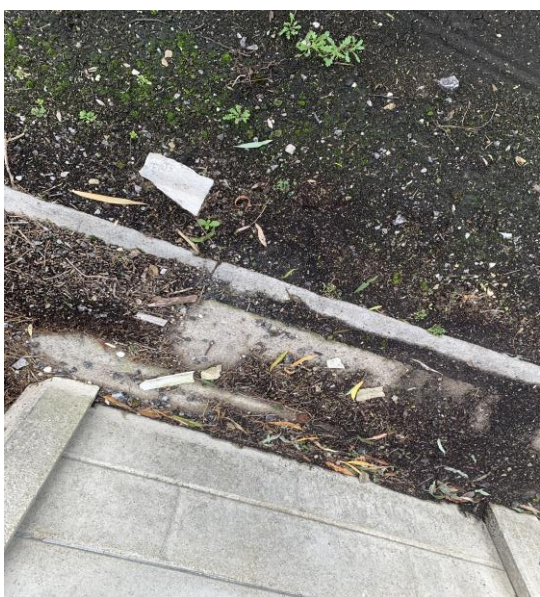
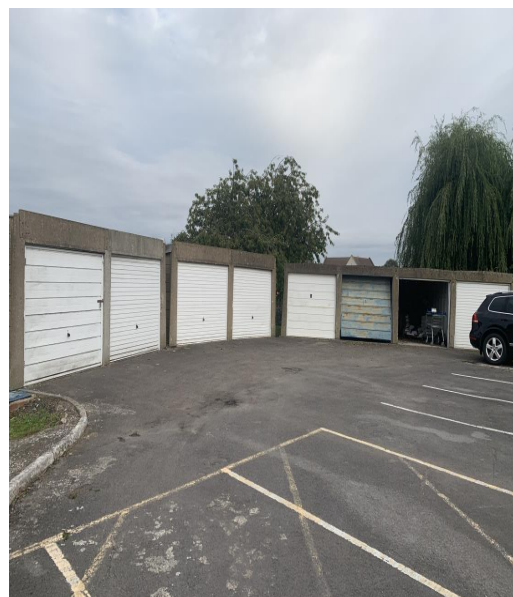
Item No: 9
Sample No: 1
Location: Garage's / Store's

Material Description:	Cement Debris	
Identification:	Sampled – No Asbestos Detected	
Approx. quantity:	130M2	
Accessibility	N/A	<i>Assessment Score</i>
Product type:	N/A	N/A
Extent of Damage:	N/A	N/A
Surface Treatment:	N/A	N/A
Asbestos type:	N/A	N/A
Material Assessment Score:		N/A
Priority Assessment Score:		N/A
Action:	N/A	
Comments:	All Roofs are Cement and Debris on the Floor

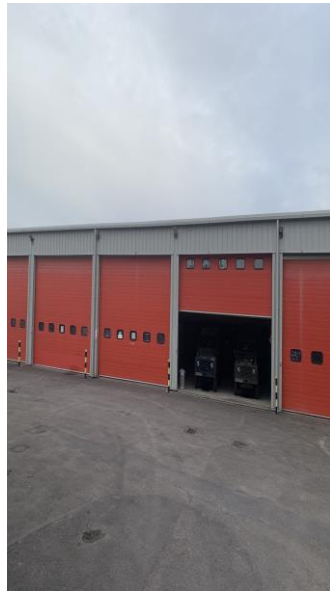
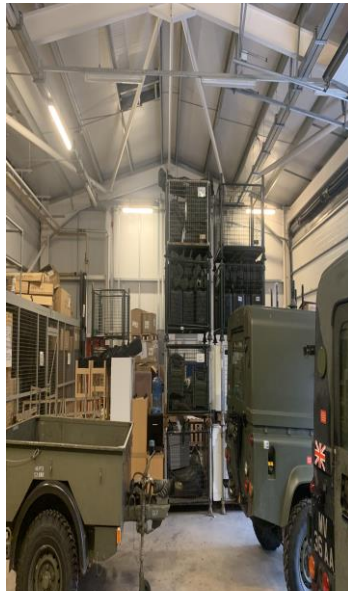
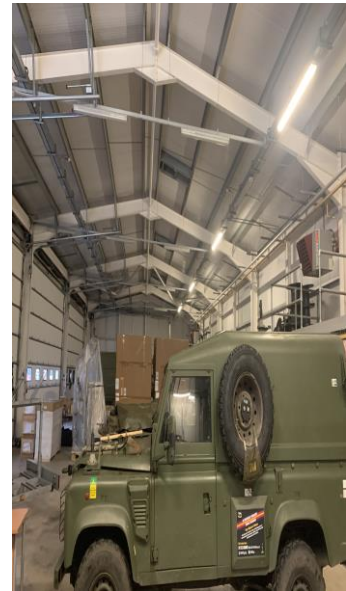
Item No: 12

Location: MOD Vehicles Storage

Material Description:	Visual Inspection – No Suspect Materials Found	
Identification:	N/A	
Approx. quantity:	N/A	
Accessibility	N/A	<i>Assessment Score</i>
Product type:	N/A	N/A
Extent of Damage:	N/A	N/A
Surface Treatment:	N/A	N/A
Asbestos type:	N/A	N/A
Material Assessment Score:		N/A
Priority Assessment Score:		N/A
Action:	N/A	
Comments:	N/A
