**Project Number 2481**

**Management  
Asbestos Survey Report**

**Uffculme Platoon, Ashley Road,  
Devon, EX15 3AY**

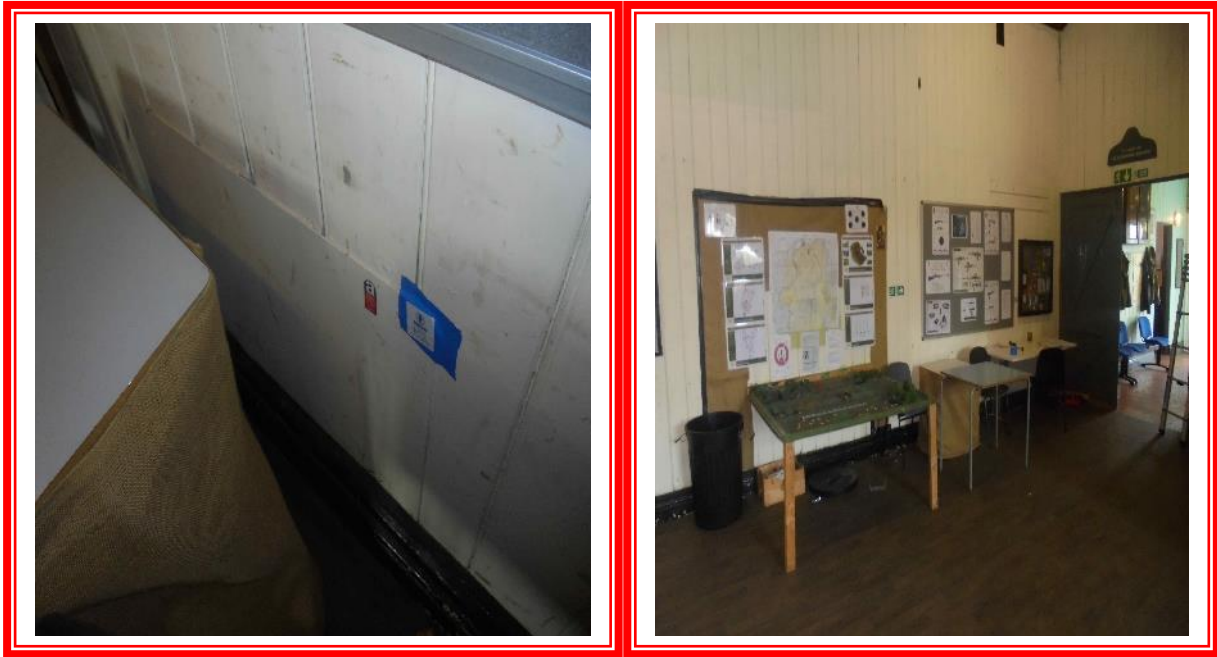
**Item No: 6**

<b>Material Description:</b>	Wall Panel	
<b>Identification:</b>	Sampled – Asbestos Detected	
<b>Approx. quantity:</b>	<1m <sup>2</sup>	
<b>Accessibility</b>	Medium	<i>Assessment Score</i>
<b>Product type:</b>	Asbestos Insulation board	2
<b>Extent of Damage:</b>	Minor	1
<b>Surface Treatment:</b>	Sealed	1
<b>Asbestos type:</b>	Chrysotile	1
<b>Material Assessment Score:</b>		5
<b>Priority Assessment Score:</b>		Low
<b>Action:</b>	Manage	
<b>Comments:</b>	Located where heater used to be situated

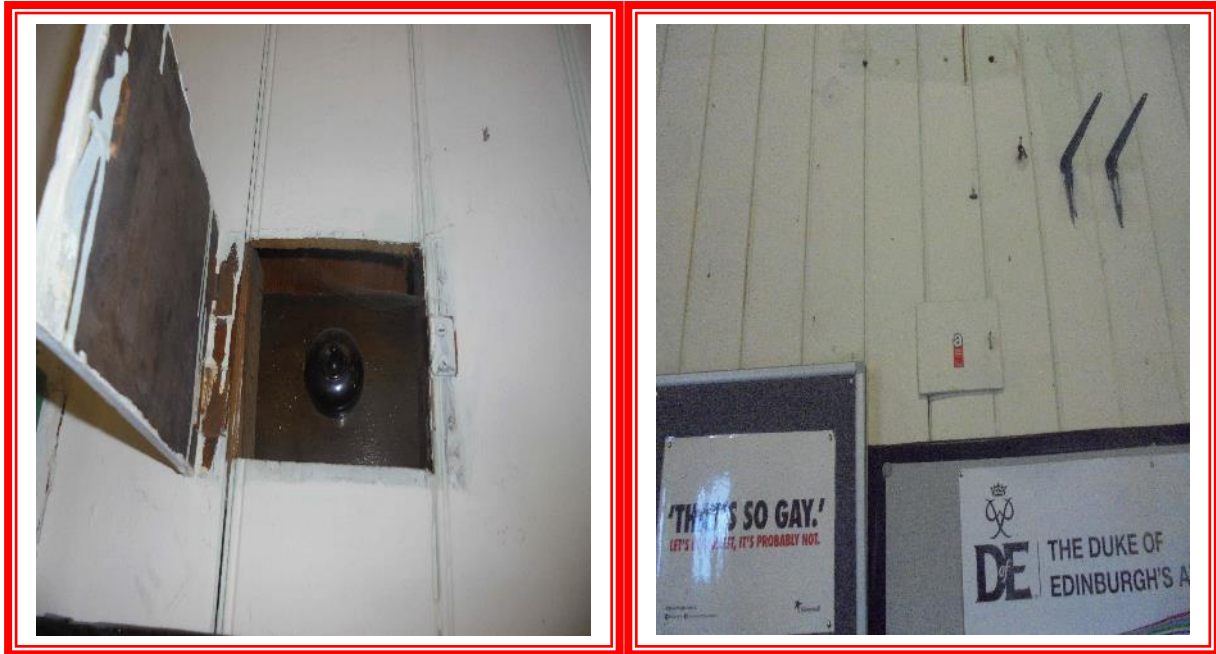
**Item No: 7**

**Item 7 - Ground Floor – Parade Hall - No Access within old light switches as presumed live**

<b>Material Description:</b>	No Access within old light switch	
<b>Identification:</b>	Presumed to Contain Asbestos	
<b>Approx. quantity:</b>	X 1 Switch	
<b>Accessibility</b>	Low	<i>Assessment Score</i>
<b>Product type:</b>	No Access	2
<b>Extent of Damage:</b>	No Access	1
<b>Surface Treatment:</b>	No Access	1
<b>Asbestos type:</b>	No Access	1
<b>Material Assessment Score:</b>		5
<b>Priority Assessment Score:</b>		Low
<b>Action:</b>	Manage	
<b>Comments:</b>	No Access within old light switch as presumed live

The presence of asbestos in these areas cannot be ascertained at this time. If any works are to be carried out in these areas in the future, then these works should be approached cautiously.

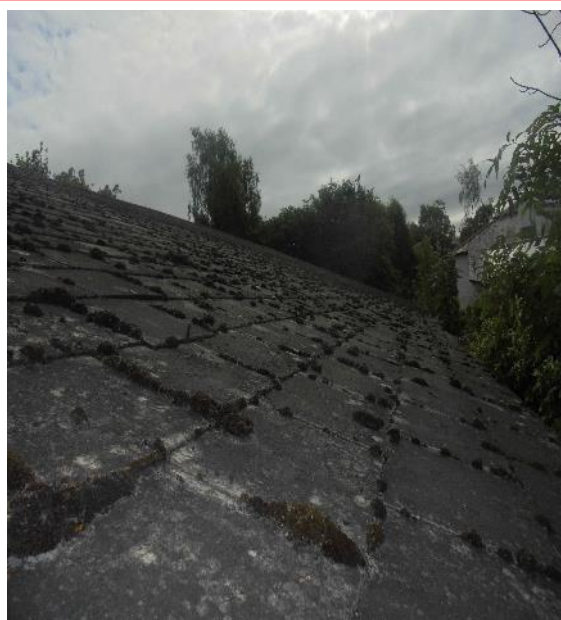
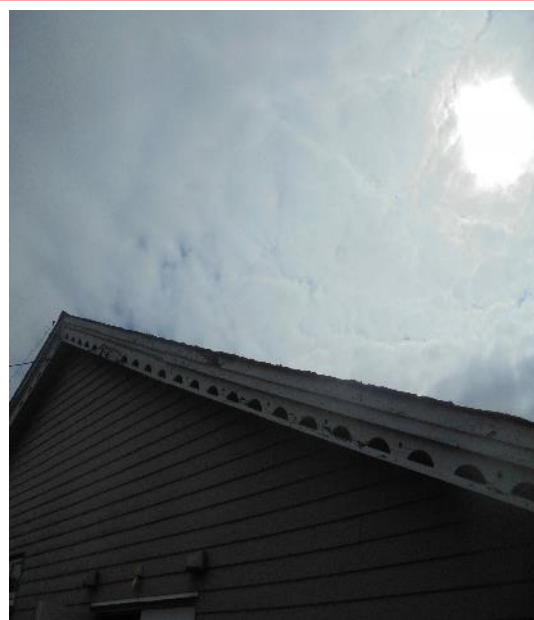
**Item No: 8****Sample No: DK/2****Location: External**

<b>Material Description:</b>	Cement Roof Tiles	
<b>Identification:</b>	Sampled – Asbestos Detected	
<b>Approx. quantity:</b>	360m <sup>2</sup>	
<b>Accessibility</b>	Low	<i>Assessment Score</i>
<b>Product type:</b>	Cement	1
<b>Extent of Damage:</b>	Minor	1
<b>Surface Treatment:</b>	Unsealed	1
<b>Asbestos type:</b>	Chrysotile	1
<b>Material Assessment Score:</b>		4
<b>Priority Assessment Score:</b>		Negligible
<b>Action:</b>	Manage	
<b>Comments:</b>	Non-asbestos modern insulation board wall cladding

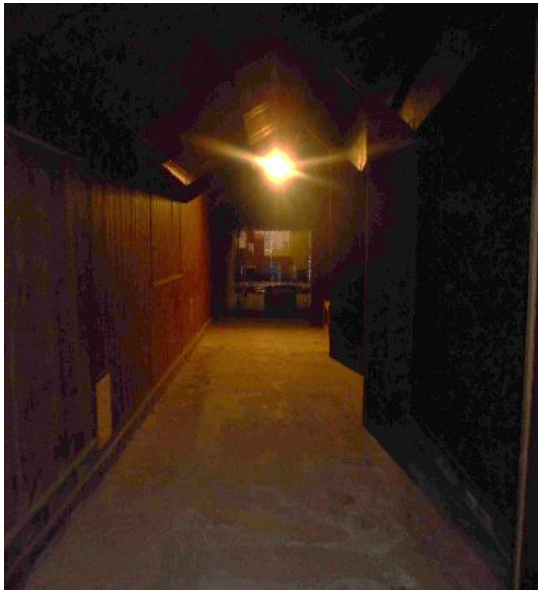
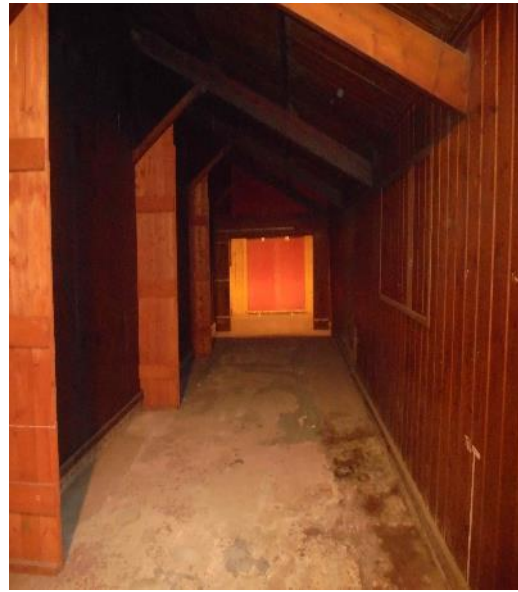
**Item No: 1**

<b>Material Description:</b>	Visual Inspection – No Suspect Materials Found	
<b>Identification:</b>	N/A	
<b>Approx. quantity:</b>	N/A	
<b>Accessibility</b>	N/A	<i>Assessment Score</i>
<b>Product type:</b>		N/A
<b>Extent of Damage:</b>		N/A
<b>Surface Treatment:</b>		N/A
<b>Asbestos type:</b>		N/A
<b>Material Assessment Score:</b>		N/A
<b>Priority Assessment Score:</b>		N/A
<b>Action:</b>	N/A	
<b>Comments:</b>	N/A

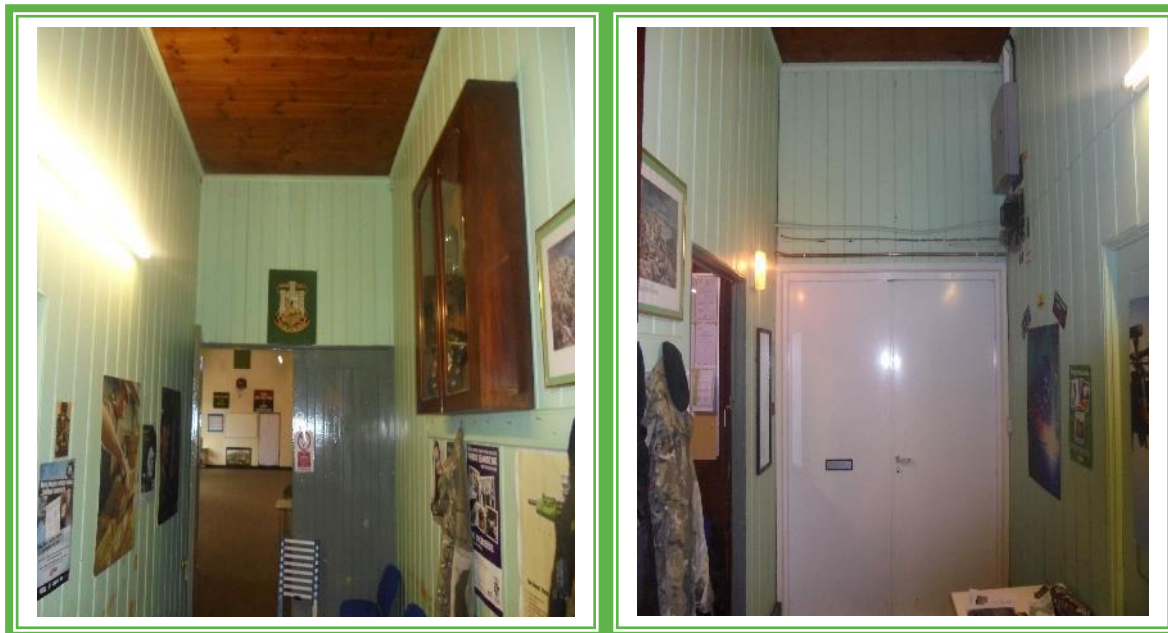
**Item No: 2**

<b>Material Description:</b>	Visual Inspection – No Suspect Materials Found	
<b>Identification:</b>	N/A	
<b>Approx. quantity:</b>	N/A	
<b>Accessibility</b>	N/A	<i>Assessment Score</i>
<b>Product type:</b>		N/A
<b>Extent of Damage:</b>		N/A
<b>Surface Treatment:</b>		N/A
<b>Asbestos type:</b>		N/A
<b>Material Assessment Score:</b>		N/A
<b>Priority Assessment Score:</b>		N/A
<b>Action:</b>	N/A	
<b>Comments:</b>	Modern Electrics

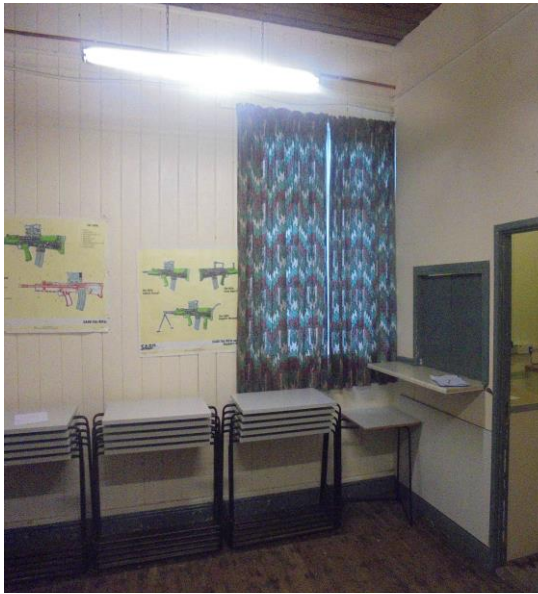
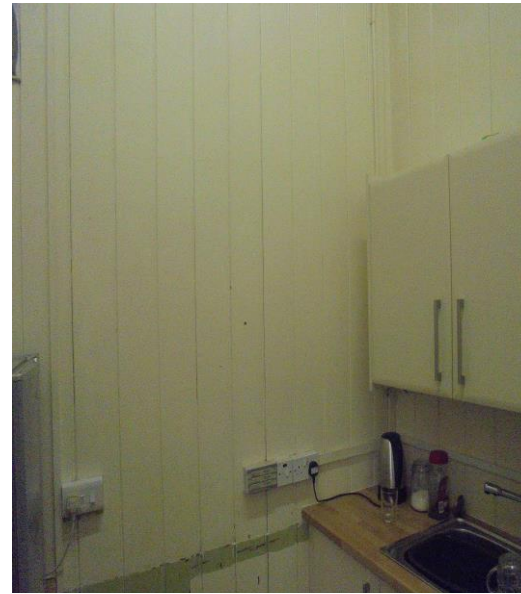
**Item No: 3**

<b>Material Description:</b>	Visual Inspection – No Suspect Materials Found	
<b>Identification:</b>	N/A	
<b>Approx. quantity:</b>	N/A	
<b>Accessibility</b>	N/A	<i>Assessment Score</i>
<b>Product type:</b>		N/A
<b>Extent of Damage:</b>		N/A
<b>Surface Treatment:</b>		N/A
<b>Asbestos type:</b>		N/A
<b>Material Assessment Score:</b>		N/A
<b>Priority Assessment Score:</b>		N/A
<b>Action:</b>	N/A	
<b>Comments:</b>	Modern sink pad, Modern Boiler

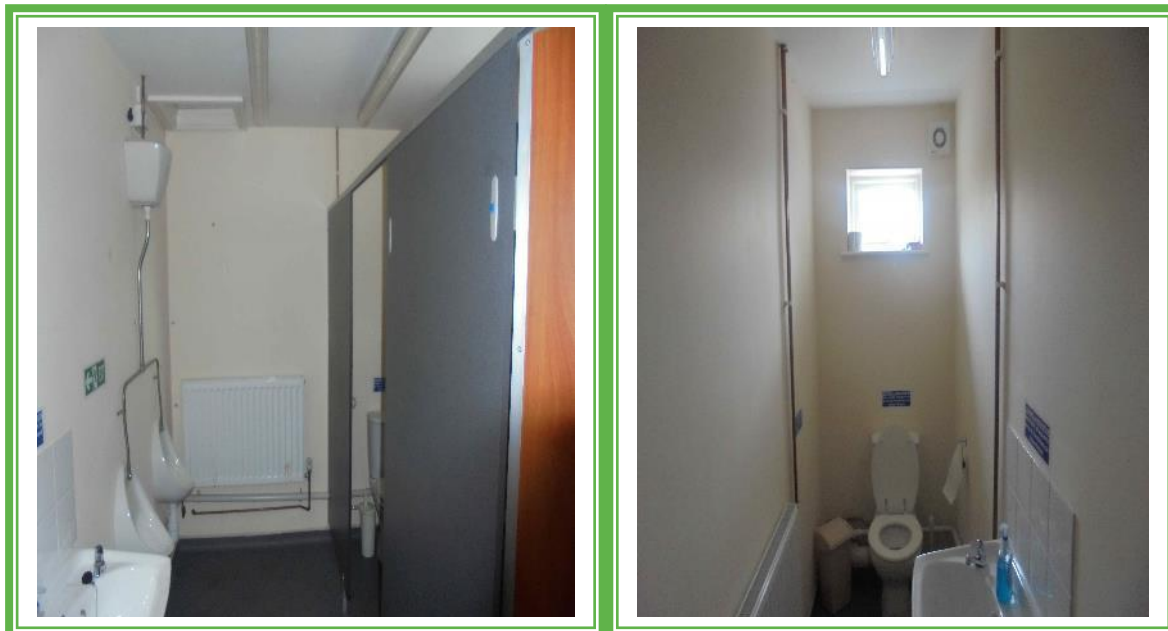
**Item No: 4**

<b>Material Description:</b>	Visual Inspection – No Suspect Materials Found	
<b>Identification:</b>	N/A	
<b>Approx. quantity:</b>	N/A	
<b>Accessibility</b>	N/A	<i>Assessment Score</i>
<b>Product type:</b>		N/A
<b>Extent of Damage:</b>		N/A
<b>Surface Treatment:</b>		N/A
<b>Asbestos type:</b>		N/A
<b>Material Assessment Score:</b>		N/A
<b>Priority Assessment Score:</b>		N/A
<b>Action:</b>	N/A	
<b>Comments:</b>	N/A

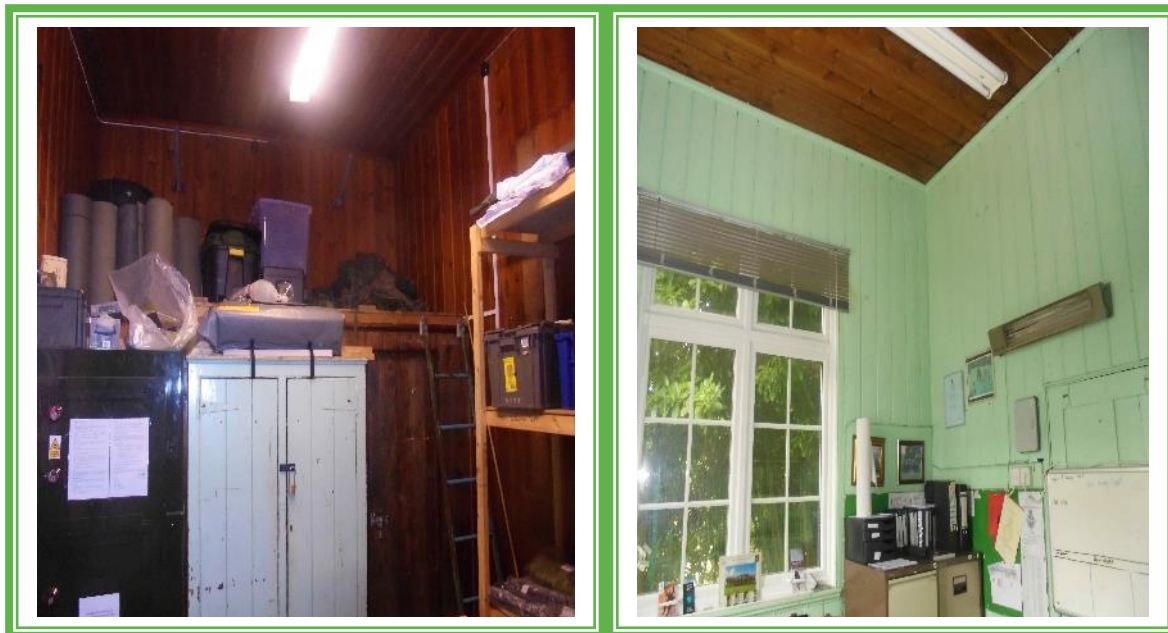
**Item No: 5**

<b>Material Description:</b>	Visual Inspection – No Suspect Materials Found	
<b>Identification:</b>	N/A	
<b>Approx. quantity:</b>	N/A	
<b>Accessibility</b>	N/A	<i>Assessment Score</i>
<b>Product type:</b>		N/A
<b>Extent of Damage:</b>		N/A
<b>Surface Treatment:</b>		N/A
<b>Asbestos type:</b>		N/A
<b>Material Assessment Score:</b>		N/A
<b>Priority Assessment Score:</b>		N/A
<b>Action:</b>	N/A	
<b>Comments:</b>	N/A
