**Project Number 2481**

**Management  
Asbestos Survey Report**

**Wyvern Barracks, Barrack Road, Exeter, Devon,  
EX2 6AE (Building 9)**

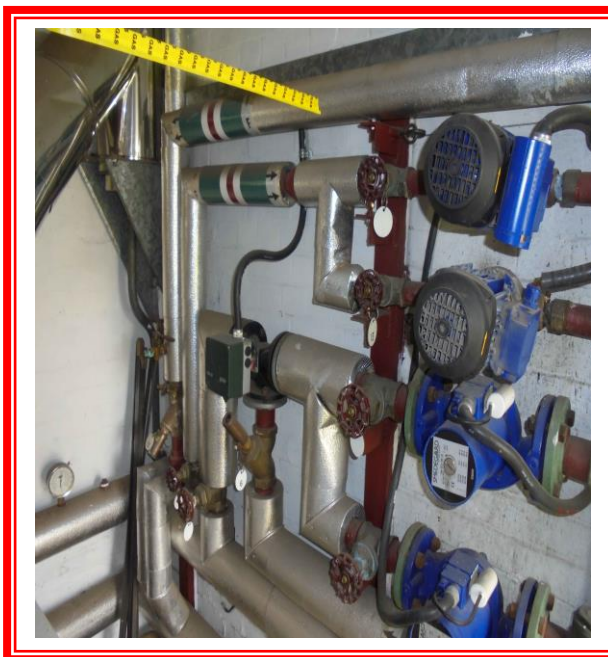
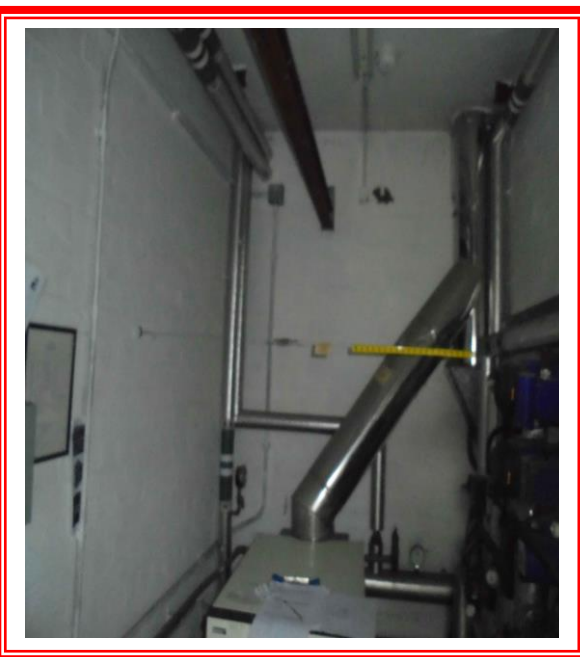
**Item No: 9**

**Location: Boiler Room**

<b>Material Description:</b>	Gaskets	
<b>Identification:</b>	Sampled – Asbestos Detected	
<b>Approx. quantity:</b>	X 7	
<b>Accessibility</b>	Low	<i>Assessment Score</i>
<b>Product type:</b>	Textiles	2
<b>Extent of Damage:</b>	Minor	1
<b>Surface Treatment:</b>	Unsealed	1
<b>Asbestos type:</b>	Chrysotile	1
<b>Material Assessment Score:</b>		5
<b>Priority Assessment Score:</b>		Low
<b>Action:</b>	Manage	
<b>Comments:</b>	Non-asbestos ideal concord cx boiler

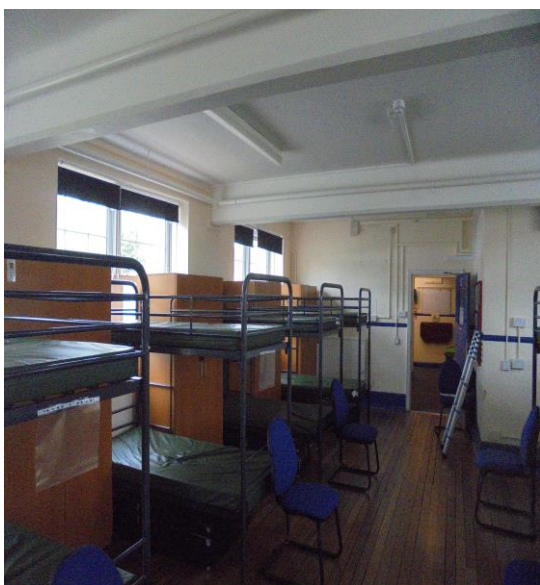
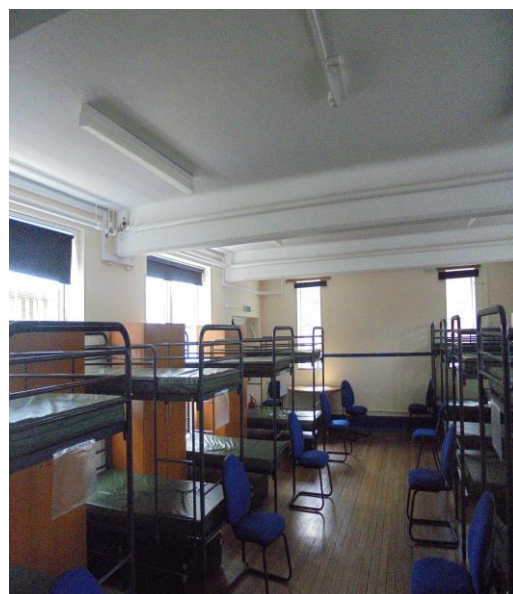
**Item No: 1**

**Location: Room 9 – Ground Floor**

<b>Material Description:</b>	Visual Inspection – No Suspect Materials Found	
<b>Identification:</b>	N/A	
<b>Approx. quantity:</b>	N/A	
<b>Accessibility</b>	N/A	<i>Assessment Score</i>
<b>Product type:</b>		N/A
<b>Extent of Damage:</b>		N/A
<b>Surface Treatment:</b>		N/A
<b>Asbestos type:</b>		N/A
<b>Material Assessment Score:</b>		N/A
<b>Priority Assessment Score:</b>		N/A
<b>Action:</b>	N/A	
<b>Comments:</b>	N/A

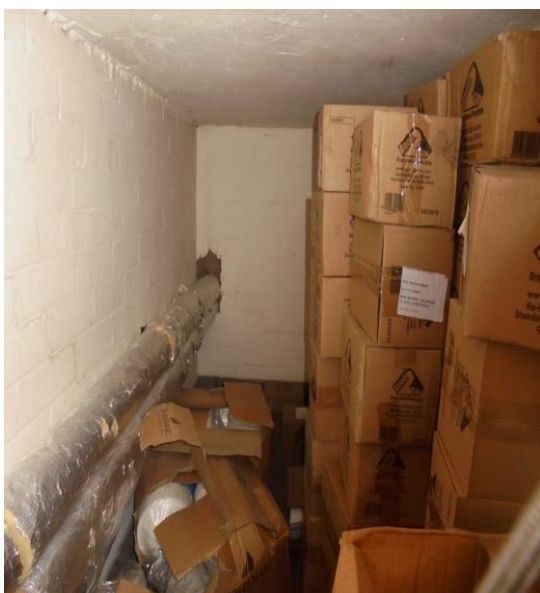
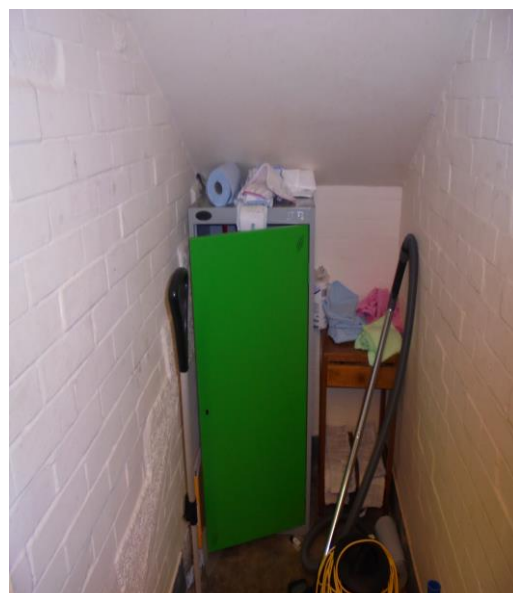
**Item No: 2**

**Location: Cupboards x 2 – Ground Floor**

<b>Material Description:</b>	Visual Inspection – No Suspect Materials Found	
<b>Identification:</b>	N/A	
<b>Approx. quantity:</b>	N/A	
<b>Accessibility</b>	N/A	<i>Assessment Score</i>
<b>Product type:</b>		N/A
<b>Extent of Damage:</b>		N/A
<b>Surface Treatment:</b>		N/A
<b>Asbestos type:</b>		N/A
<b>Material Assessment Score:</b>		N/A
<b>Priority Assessment Score:</b>		N/A
<b>Action:</b>	N/A	
<b>Comments:</b>	N/A

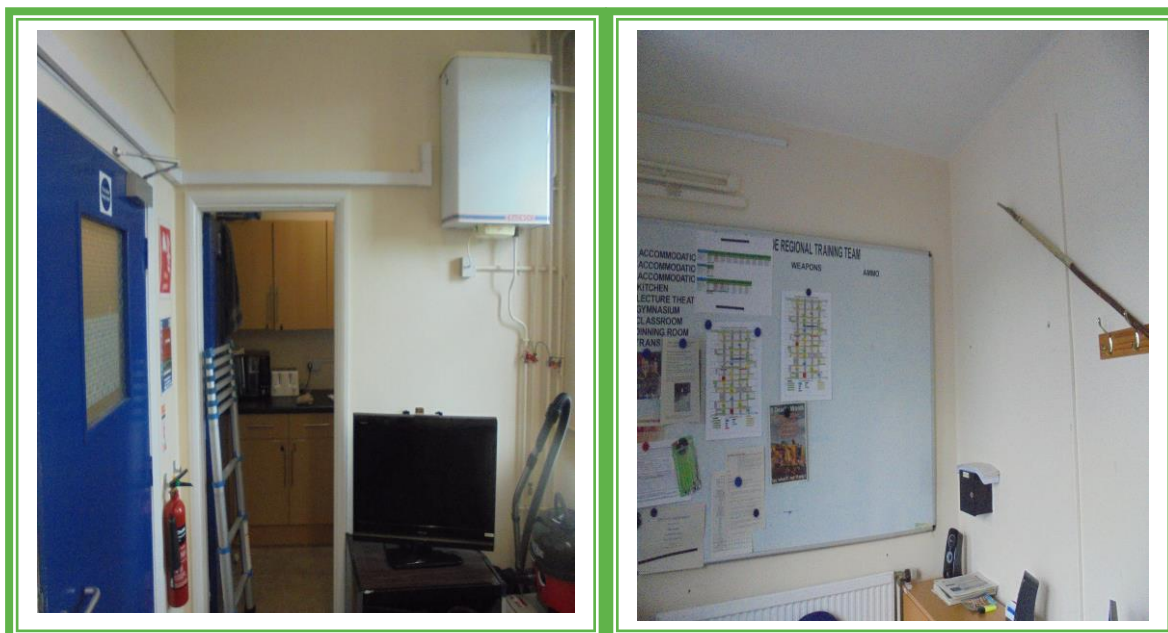
**Item No: 3**

**Location: Office, Kitchen and Common room – Ground Floor**

<b>Material Description:</b>	Visual Inspection – No Suspect Materials Found	
<b>Identification:</b>	N/A	
<b>Approx. quantity:</b>	N/A	
<b>Accessibility</b>	N/A	<i>Assessment Score</i>
<b>Product type:</b>		N/A
<b>Extent of Damage:</b>		N/A
<b>Surface Treatment:</b>		N/A
<b>Asbestos type:</b>		N/A
<b>Material Assessment Score:</b>		N/A
<b>Priority Assessment Score:</b>		N/A
<b>Action:</b>	N/A	
<b>Comments:</b>	N/A

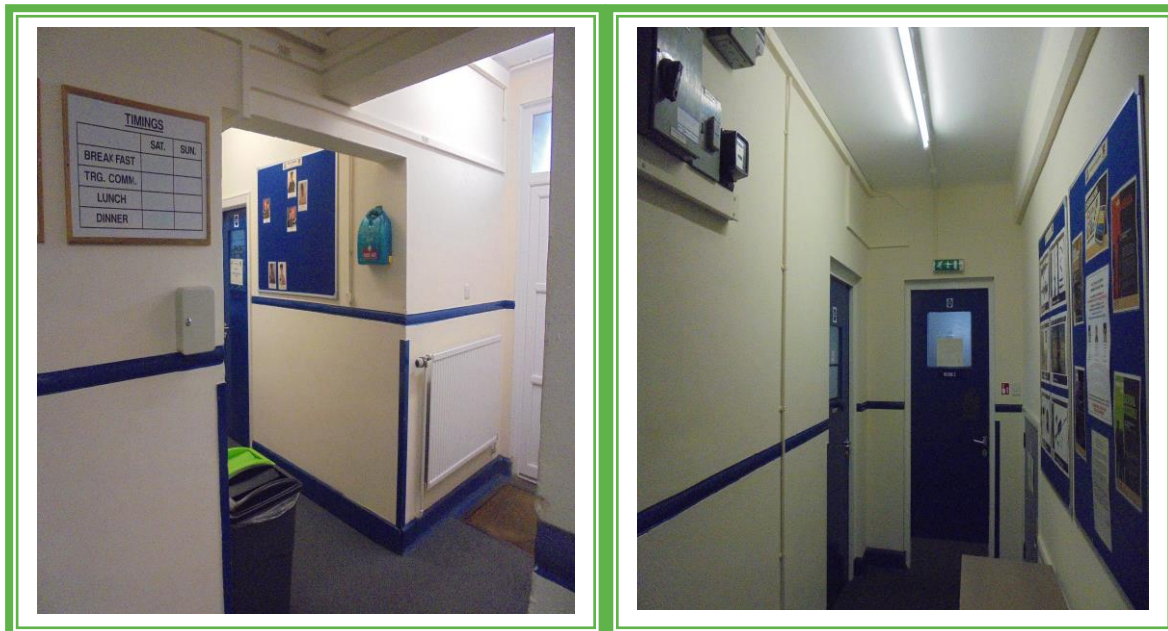
**Item No: 4**

**Location: Corridor**

<b>Material Description:</b>	Visual Inspection – No Suspect Materials Found	
<b>Identification:</b>	N/A	
<b>Approx. quantity:</b>	N/A	
<b>Accessibility</b>	N/A	<i>Assessment Score</i>
<b>Product type:</b>		N/A
<b>Extent of Damage:</b>		N/A
<b>Surface Treatment:</b>		N/A
<b>Asbestos type:</b>		N/A
<b>Material Assessment Score:</b>		N/A
<b>Priority Assessment Score:</b>		N/A
<b>Action:</b>	N/A	
<b>Comments:</b>	Non-asbestos Electrics

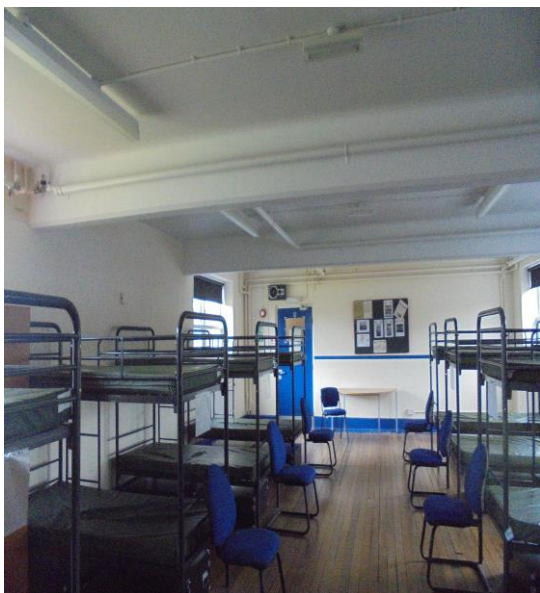
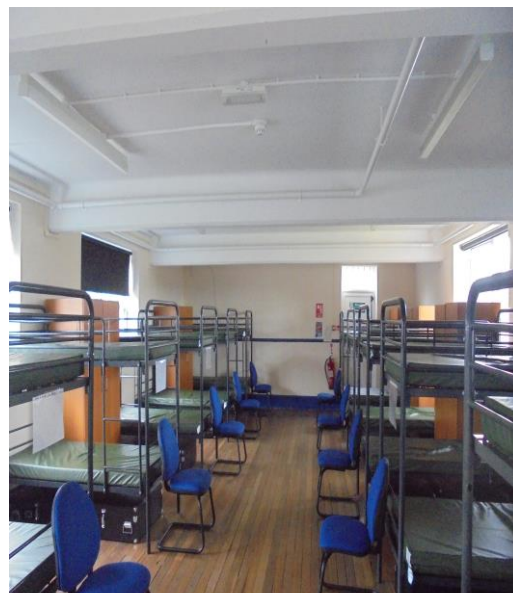
**Item No: 5**

**Location: Bedroom 1 and 2 – Ground Floor**

<b>Material Description:</b>	Visual Inspection – No Suspect Materials Found	
<b>Identification:</b>	N/A	
<b>Approx. quantity:</b>	N/A	
<b>Accessibility</b>	N/A	<i>Assessment Score</i>
<b>Product type:</b>		N/A
<b>Extent of Damage:</b>		N/A
<b>Surface Treatment:</b>		N/A
<b>Asbestos type:</b>		N/A
<b>Material Assessment Score:</b>		N/A
<b>Priority Assessment Score:</b>		N/A
<b>Action:</b>	N/A	
<b>Comments:</b>	N/A

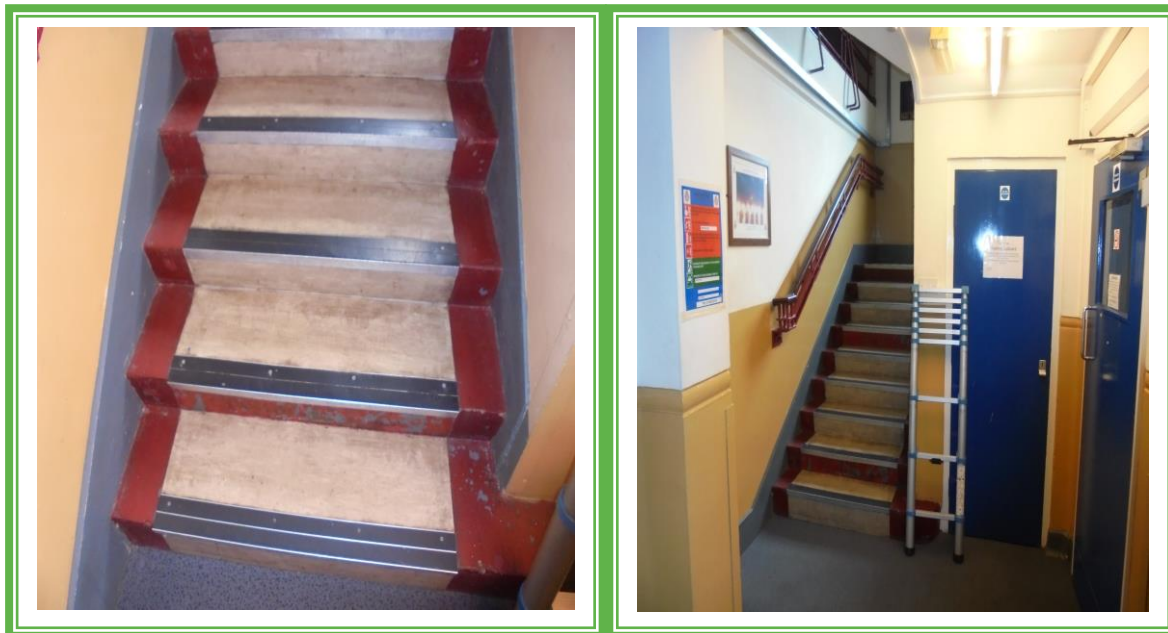
**Item No: 6**

**Location: Lobby and Stairwell**

<b>Material Description:</b>	Stair Nosing	
<b>Identification:</b>	Sampled – No Asbestos Detected	
<b>Approx. quantity:</b>	16LM	
<b>Accessibility</b>	N/A	<i>Assessment Score</i>
<b>Product type:</b>		N/A
<b>Extent of Damage:</b>		N/A
<b>Surface Treatment:</b>		N/A
<b>Asbestos type:</b>		N/A
<b>Material Assessment Score:</b>		N/A
<b>Priority Assessment Score:</b>		N/A
<b>Action:</b>	N/A	
<b>Comments:</b>	N/A

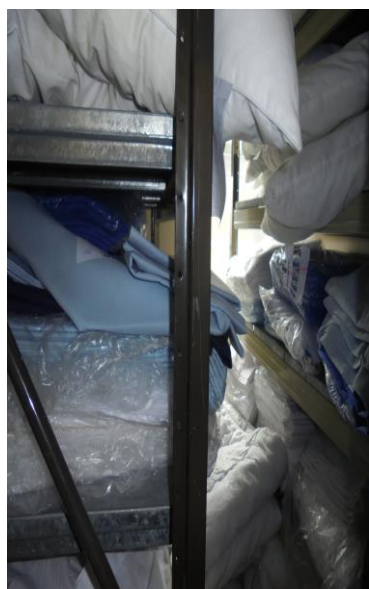
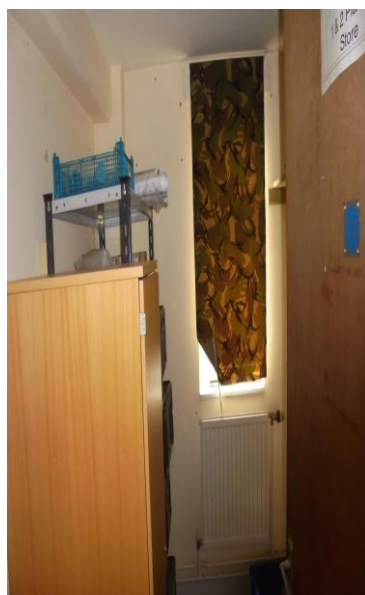
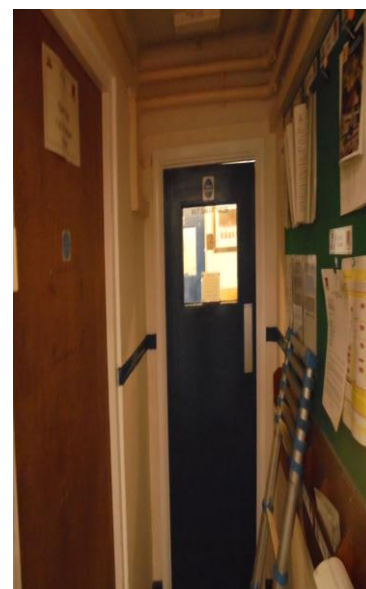
**Item No: 7****Sample No: N/A****Location: Corridor and Cupboard x2**

<b>Material Description:</b>	Visual Inspection – No Suspect Materials Found	
<b>Identification:</b>	N/A	
<b>Approx. quantity:</b>	N/A	
<b>Accessibility</b>	N/A	<i>Assessment Score</i>
<b>Product type:</b>		N/A
<b>Extent of Damage:</b>		N/A
<b>Surface Treatment:</b>		N/A
<b>Asbestos type:</b>		N/A
<b>Material Assessment Score:</b>		N/A
<b>Priority Assessment Score:</b>		N/A
<b>Action:</b>	N/A	
<b>Comments:</b>	N/A

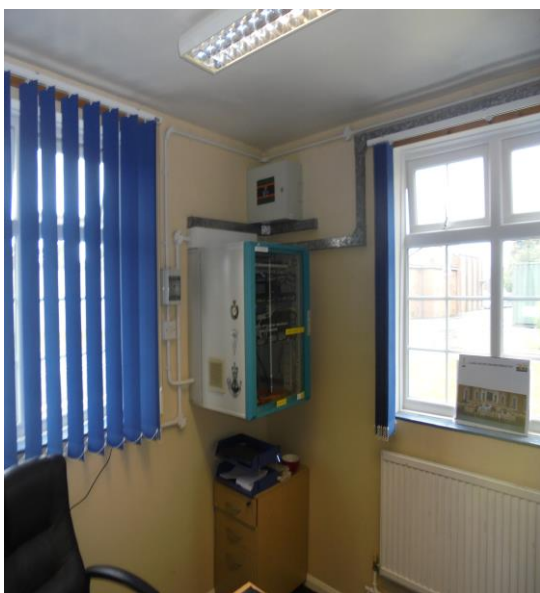
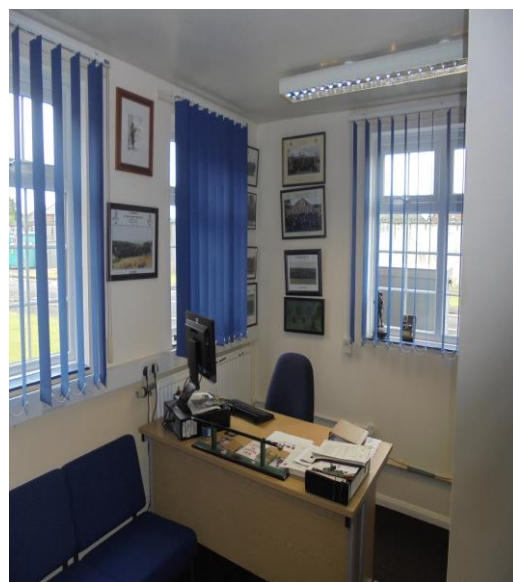
**Item No: 8****Sample No: N/A****Location: Offices x 2**

<b>Material Description:</b>	Visual Inspection – No Suspect Materials Found	
<b>Identification:</b>	N/A	
<b>Approx. quantity:</b>	N/A	
<b>Accessibility</b>	N/A	<i>Assessment Score</i>
<b>Product type:</b>		N/A
<b>Extent of Damage:</b>		N/A
<b>Surface Treatment:</b>		N/A
<b>Asbestos type:</b>		N/A
<b>Material Assessment Score:</b>		N/A
<b>Priority Assessment Score:</b>		N/A
<b>Action:</b>	N/A	
<b>Comments:</b>	N/A

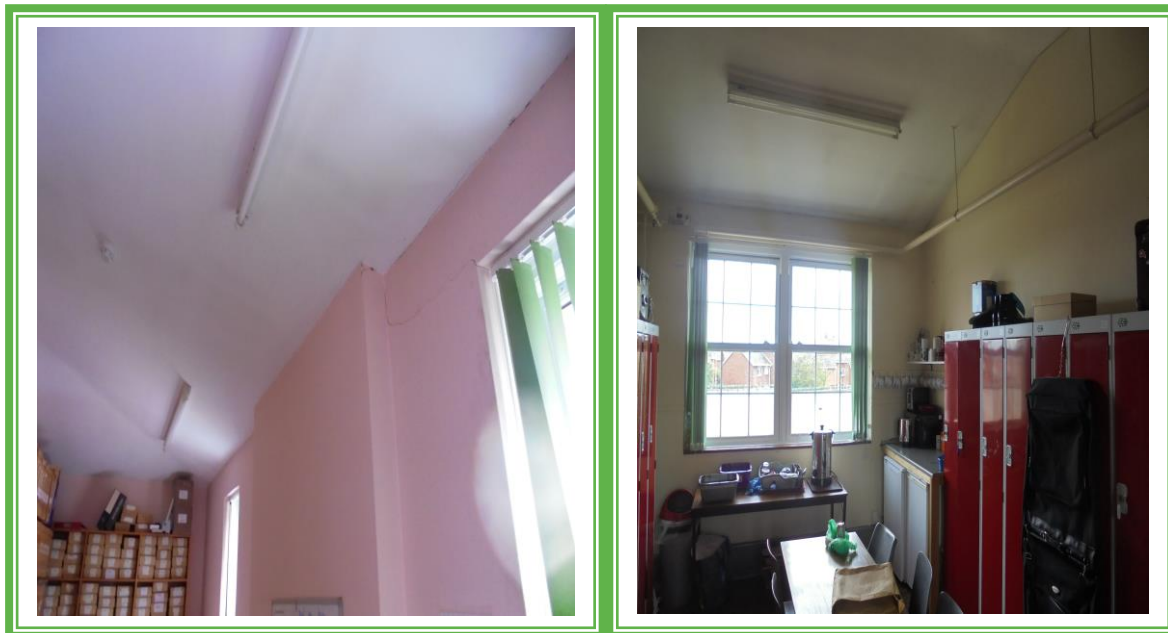
**Item No: 10**

**Location: Locker Room and Music Store**

<b>Material Description:</b>	Visual Inspection – No Suspect Materials Found	
<b>Identification:</b>	N/A	
<b>Approx. quantity:</b>	N/A	
<b>Accessibility</b>	N/A	<i>Assessment Score</i>
<b>Product type:</b>		N/A
<b>Extent of Damage:</b>		N/A
<b>Surface Treatment:</b>		N/A
<b>Asbestos type:</b>		N/A
<b>Material Assessment Score:</b>		N/A
<b>Priority Assessment Score:</b>		N/A
<b>Action:</b>	N/A	
<b>Comments:</b>	N/A

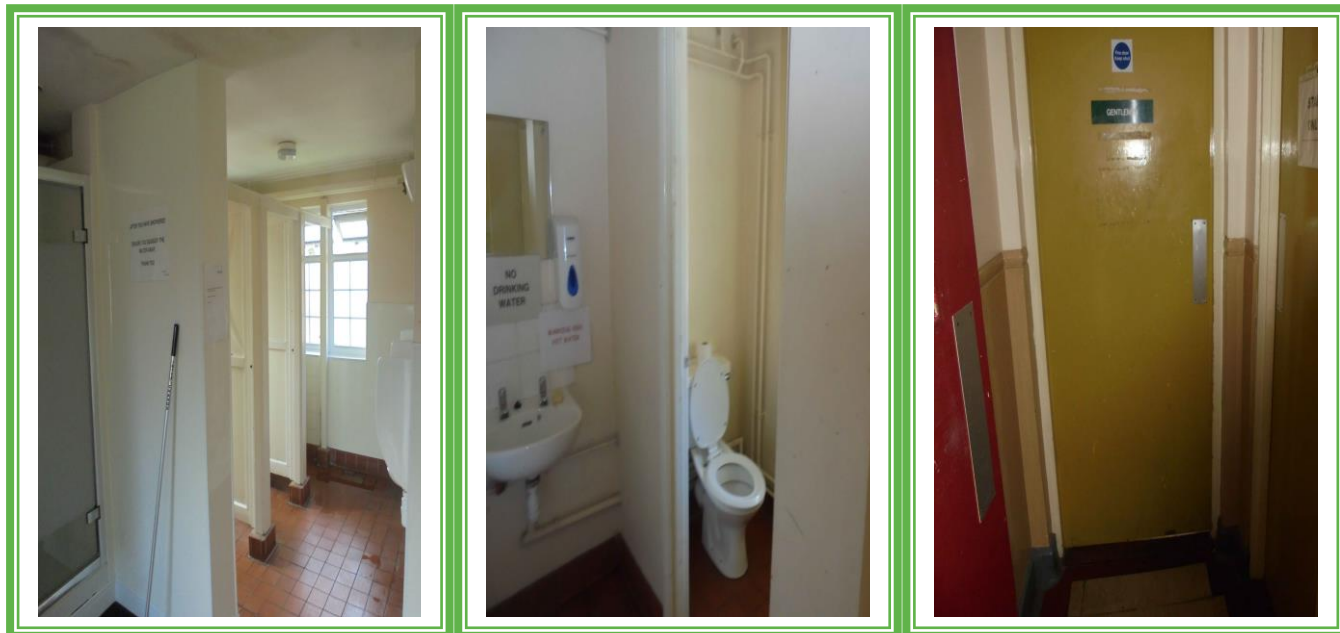
**Item No: 11**

**Location: WC, Shower Room and Lobby – First Floor**

<b>Material Description:</b>	Visual Inspection – No Suspect Materials Found	
<b>Identification:</b>	N/A	
<b>Approx. quantity:</b>	N/A	
<b>Accessibility</b>	N/A	<i>Assessment Score</i>
<b>Product type:</b>		N/A
<b>Extent of Damage:</b>		N/A
<b>Surface Treatment:</b>		N/A
<b>Asbestos type:</b>		N/A
<b>Material Assessment Score:</b>		N/A
<b>Priority Assessment Score:</b>		N/A
<b>Action:</b>	N/A	
<b>Comments:</b>	Metal wall panels between Wc's

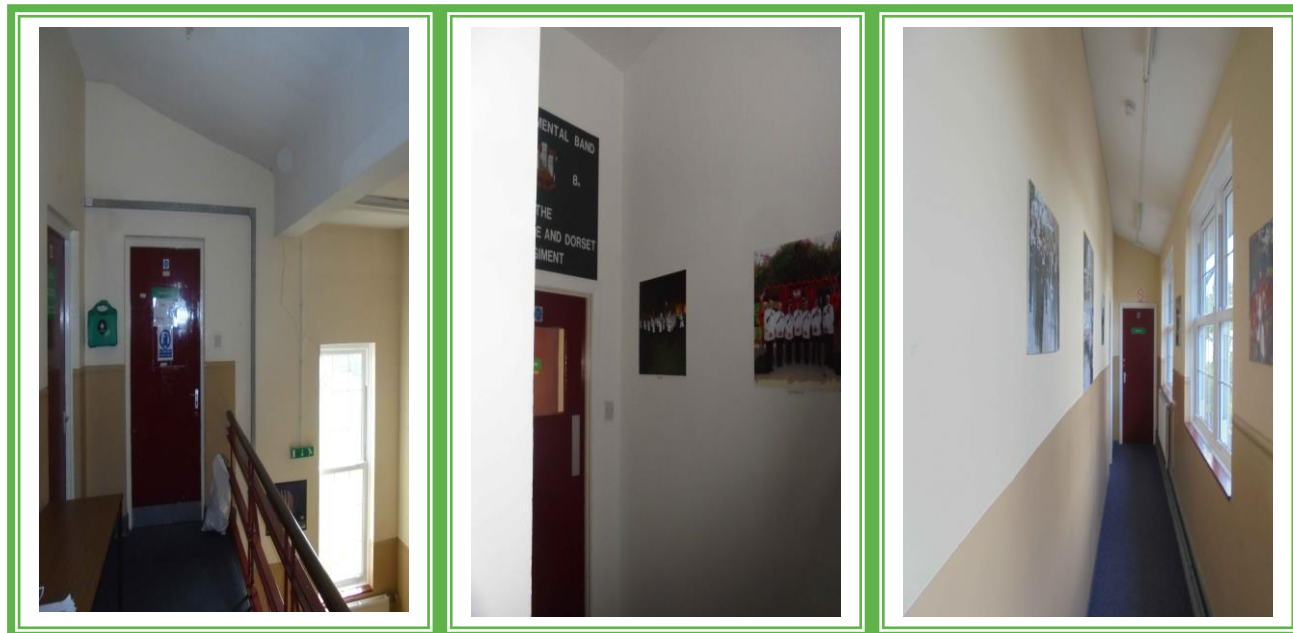
**Item No: 12****Sample No: N/A****Location: Landing, Circulation x 2 – First Floor**

<b>Material Description:</b>	Visual Inspection – No Suspect Materials Found	
<b>Identification:</b>	N/A	
<b>Approx. quantity:</b>	N/A	
<b>Accessibility</b>	N/A	<i>Assessment Score</i>
<b>Product type:</b>		N/A
<b>Extent of Damage:</b>		N/A
<b>Surface Treatment:</b>		N/A
<b>Asbestos type:</b>		N/A
<b>Material Assessment Score:</b>		N/A
<b>Priority Assessment Score:</b>		N/A
<b>Action:</b>	N/A	
<b>Comments:</b>	No access into loft space due to height

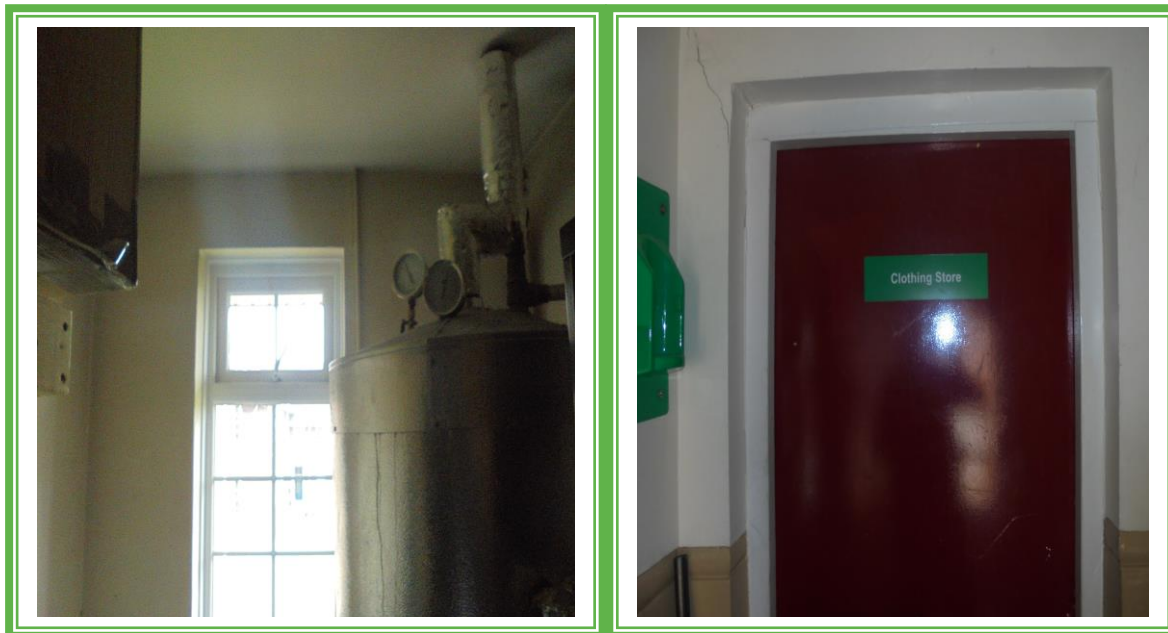
**Item No: 13**

**Location: Store and Clothing Store**

<b>Material Description:</b>	Visual Inspection – No Suspect Materials Found	
<b>Identification:</b>	N/A	
<b>Approx. quantity:</b>	N/A	
<b>Accessibility</b>	N/A	<i>Assessment Score</i>
<b>Product type:</b>		N/A
<b>Extent of Damage:</b>		N/A
<b>Surface Treatment:</b>		N/A
<b>Asbestos type:</b>		N/A
<b>Material Assessment Score:</b>		N/A
<b>Priority Assessment Score:</b>		N/A
<b>Action:</b>	N/A	
<b>Comments:</b>	Non-asbestos water heater

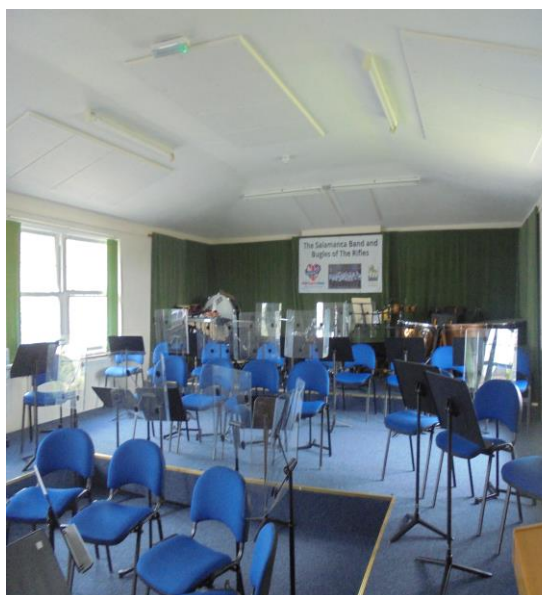
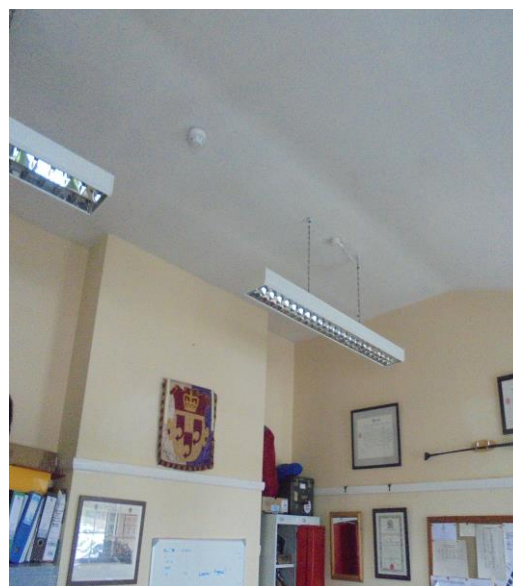
**Item No: 14**

**Location: Practice Room and Office**

<b>Material Description:</b>	Visual Inspection – No Suspect Materials Found	
<b>Identification:</b>	N/A	
<b>Approx. quantity:</b>	N/A	
<b>Accessibility</b>	N/A	<i>Assessment Score</i>
<b>Product type:</b>		N/A
<b>Extent of Damage:</b>		N/A
<b>Surface Treatment:</b>		N/A
<b>Asbestos type:</b>		N/A
<b>Material Assessment Score:</b>		N/A
<b>Priority Assessment Score:</b>		N/A
<b>Action:</b>	N/A	
<b>Comments:</b>	N/A

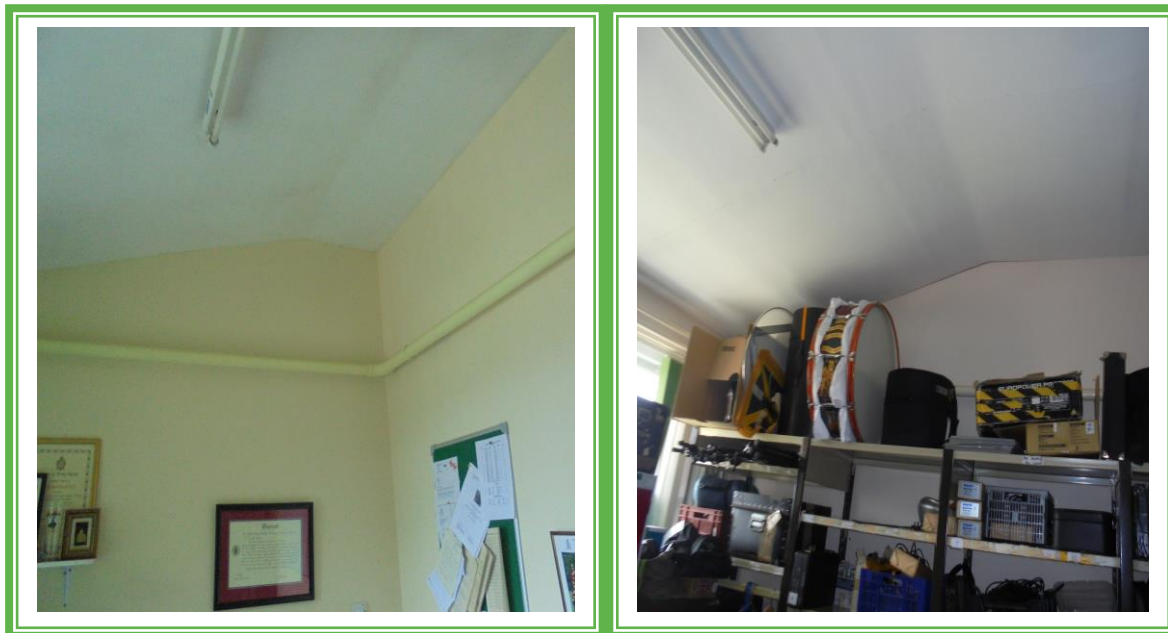
**Item No: 15**

**Location: Offices x 2 and Store**

<b>Material Description:</b>	Visual Inspection – No Suspect Materials Found	
<b>Identification:</b>	N/A	
<b>Approx. quantity:</b>	N/A	
<b>Accessibility</b>	N/A	<i>Assessment Score</i>
<b>Product type:</b>		N/A
<b>Extent of Damage:</b>		N/A
<b>Surface Treatment:</b>		N/A
<b>Asbestos type:</b>		N/A
<b>Material Assessment Score:</b>		N/A
<b>Priority Assessment Score:</b>		N/A
<b>Action:</b>	N/A	
<b>Comments:</b>	N/A
