Project Number A-00518 (3700)

**Re-Inspection
Asbestos Survey Report**

**6th Battalion
Gloucestershire
GL4 3BD**

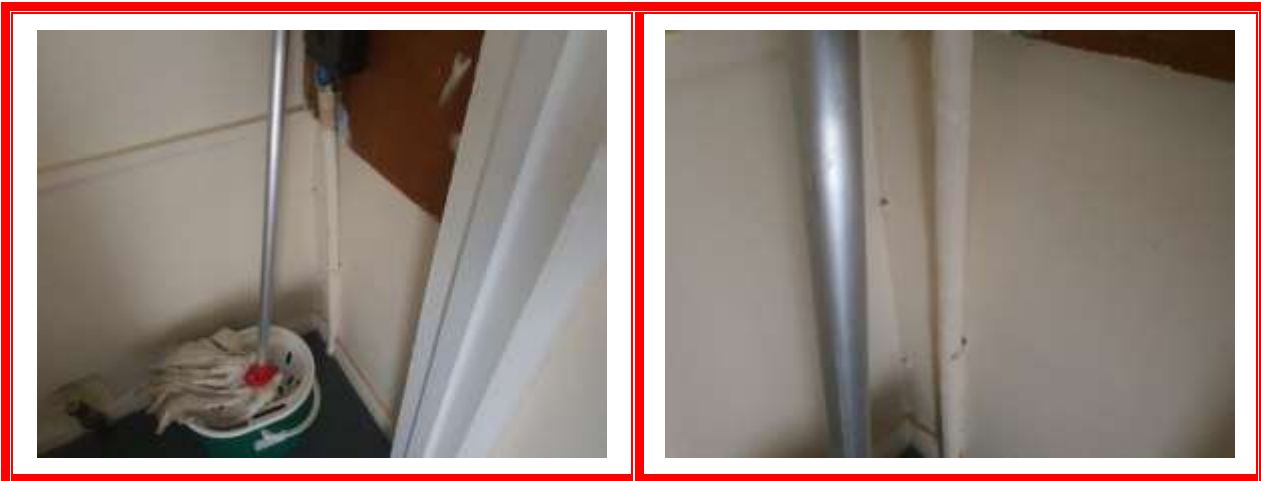
Item No:	1	Sample No:	N/A
Location:	Ground Floor - House 4 - Lobby and Cupboard 001

Material Description:	Wrap to Mains Cable - Bituminous Product	
Identification:	Presumed to Contain Asbestos	
Approx. quantity:	1 LM	
Accessibility	Difficult	Assessment Score
Product type:	Bitumen	1
Extent of Damage:	Major damage	3
Surface Treatment:	Unsealed Insulation	3
Asbestos type:	Chrysotile	1
Material Assessment Score:		8
Priority Assessment Score:		Medium
Action:	Manage	
Comments:	Not possible to sample as live

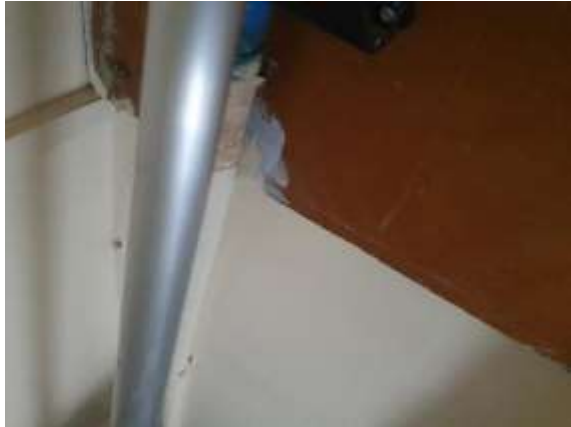
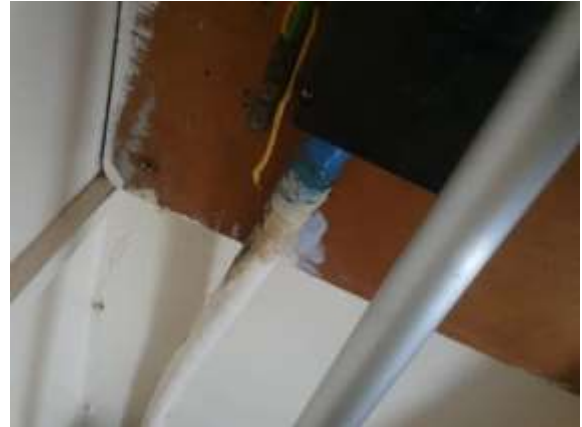
Location: Ground Floor - House 3 - Lobby and Cupboard 002

Material Description:	Wrap to Mains Cable - Bituminous Product	
Identification:	Presumed to Contain Asbestos	
Approx. quantity:	1 LM	
Accessibility	Difficult	<i>Assessment Score</i>
Product type:	Bitumen	1
Extent of Damage:	Major damage	3
Surface Treatment:	Unsealed Insulation	3
Asbestos type:	Chrysotile	1
Material Assessment Score:		8
Priority Assessment Score:		Medium
Action:	Manage	
Comments:	Not possible to sample as live

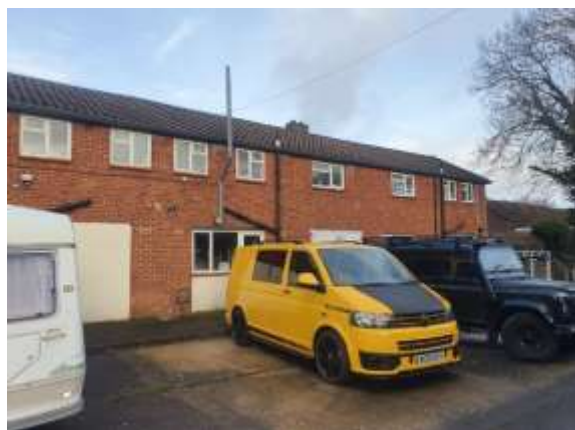
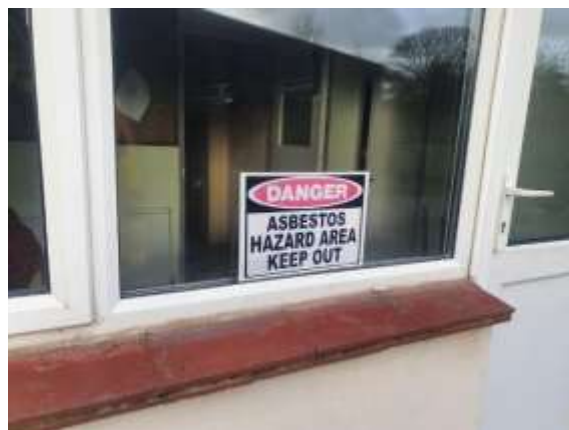
Location: Ground Floor - Houses 1 and 2 003

Material Description:	Asbestos Air Contamination - Insulation	
Identification:	Strongly Presumed to Contain Asbestos	
Approx. quantity:	Unknown	
Accessibility	Difficult	Assessment Score
Product type:	Pipe Insulation	3
Extent of Damage:	Major damage	3
Surface Treatment:	Unsealed Pipe Lagging	3
Asbestos type:	Amosite, Chrysotile, Crocidolite	3
Material Assessment Score:		12
Priority Assessment Score:		High
Action:	Manage	
Comments:	No access within houses 1 and 2 due to identified asbestos air contamination following pipe lagging removal

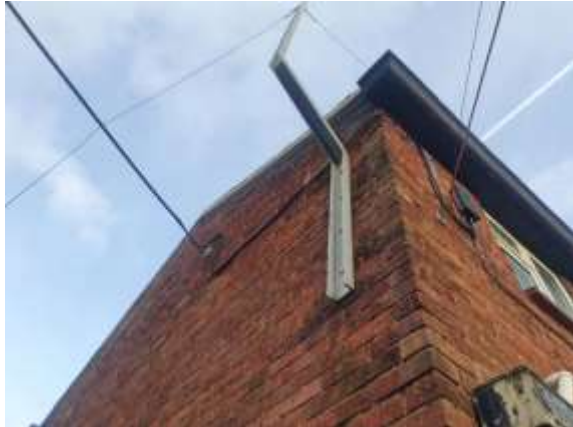
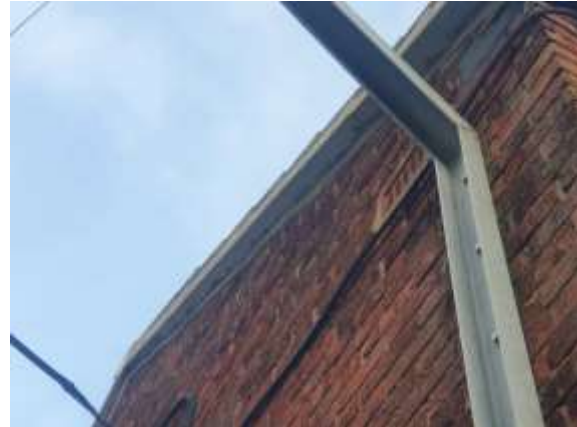
Location: External - House 3 - Lobby and Cupboard 004

Material Description:	Under cloaking - Cement Product	
Identification:	Strongly Presumed to Contain Asbestos	
Approx. quantity:	8 LM	
Accessibility	Difficult	<i>Assessment Score</i>
Product type:	Cement	1
Extent of Damage:	Slight / minor damage	1
Surface Treatment:	Unsealed Cement	1
Asbestos type:	Chrysotile	1
Material Assessment Score:		4
Priority Assessment Score:		Negligible
Action:	Manage	
Comments:	Not possible to sample due to height

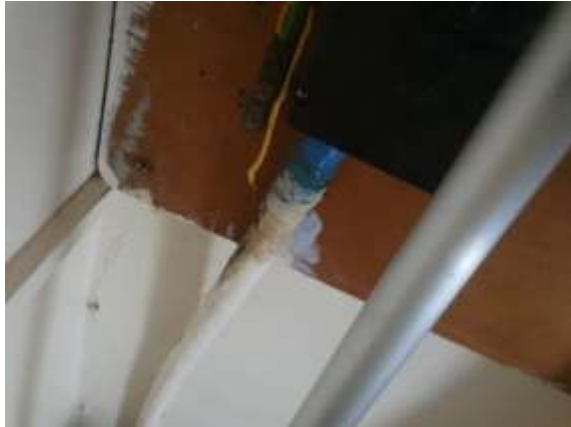
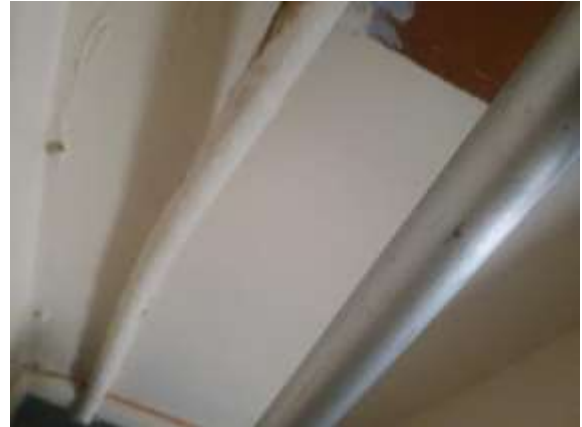
Location: Ground Floor - House 5 - Kitchen and Cupboards 005

Material Description:	Wrap to Mains Cable - Bituminous Product	
Identification:	Presumed to Contain Asbestos	
Approx. quantity:	1 LM	
Accessibility	Difficult	<i>Assessment Score</i>
Product type:	Bitumen	1
Extent of Damage:	Major damage	3
Surface Treatment:	Unsealed Insulation	3
Asbestos type:	Chrysotile	1
Material Assessment Score:		8
Priority Assessment Score:		Medium
Action:	Manage	
Comments:	Not possible to sample as live

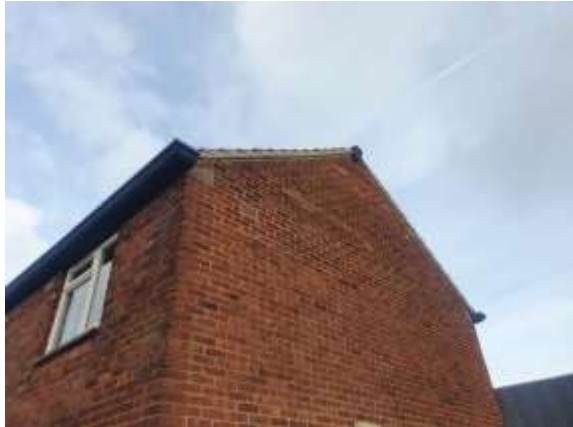
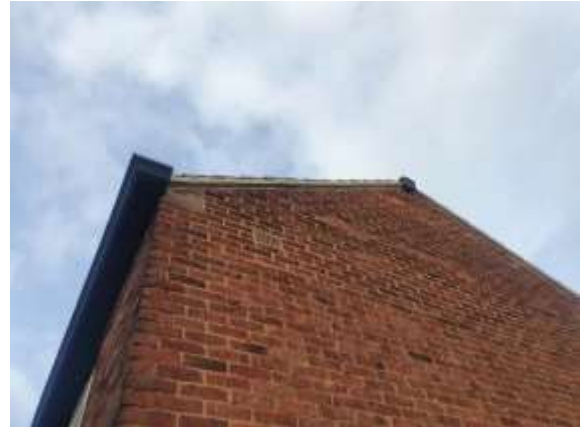
Location: External - Houses 5 and 8 006

Material Description:	Under cloaking - Cement Product	
Identification:	Strongly Presumed to Contain Asbestos	
Approx. quantity:	16 LM	
Accessibility	Difficult	<i>Assessment Score</i>
Product type:	Cement	1
Extent of Damage:	Slight / minor damage	1
Surface Treatment:	Unsealed Cement	1
Asbestos type:	Chrysotile	1
Material Assessment Score:		4
Priority Assessment Score:		Negligible
Action:	Manage	
Comments:	Not possible to sample due to height

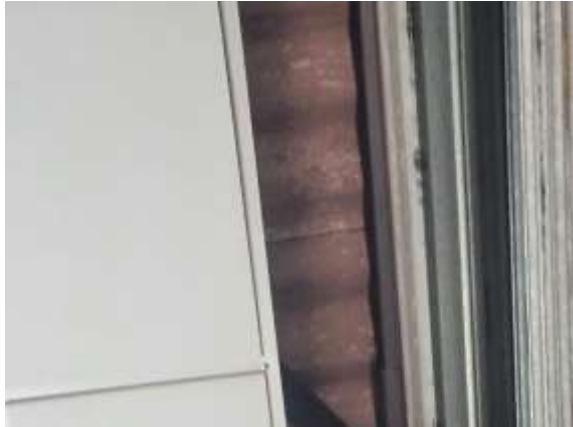
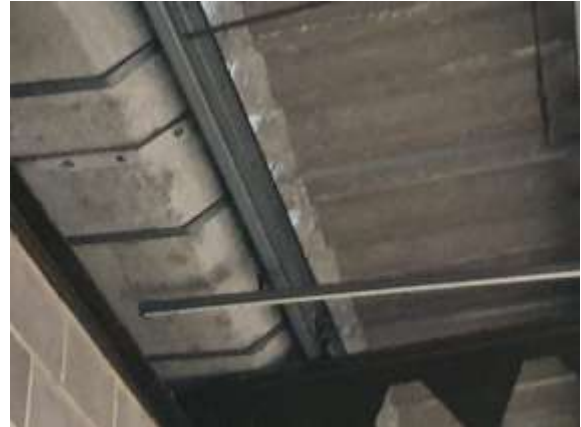
Location: External - Garages 1-5 008

Material Description:	Roof and Guttering - Cement Product	
Identification:	Strongly Presumed to Contain Asbestos	
Approx. quantity:	540 m ²	
Accessibility	Difficult	<i>Assessment Score</i>
Product type:	Cement	1
Extent of Damage:	Slight / minor damage	1
Surface Treatment:	Unsealed Cement	1
Asbestos type:	Chrysotile	1
Material Assessment Score:		4
Priority Assessment Score:		Negligible
Action:	Manage	
Comments:	Not possible to sample due to height

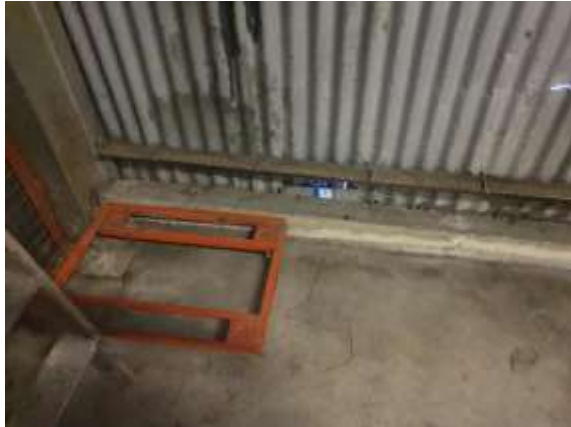
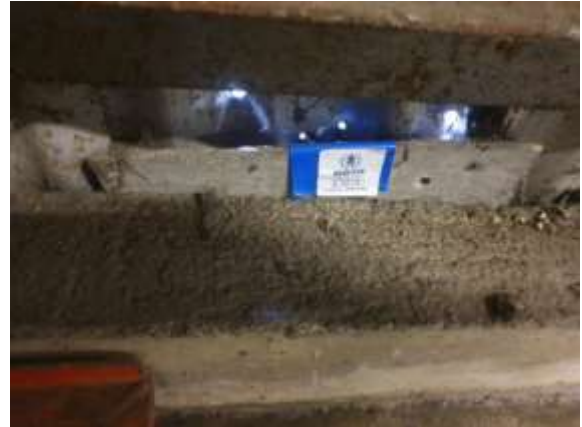
Location: Ground Floor - Garage - Drill Hall 009

Material Description:	Cement Panel Packer - Cement Product	
Identification:	Previously Sampled - Asbestos Detected	
Approx. quantity:	<1 m ²	
Accessibility	Medium	<i>Assessment Score</i>
Product type:	Cement	1
Extent of Damage:	Moderate damage	2
Surface Treatment:	Unsealed Cement	1
Asbestos type:	Chrysotile, Crocidolite	3
Material Assessment Score:		7
Priority Assessment Score:		Medium
Action:	Remove	
Comments:	Previously sampled ref: Armour 11/11/19 sample DK/3. Limited access throughout garages due to stored items and cages - other packers may be present

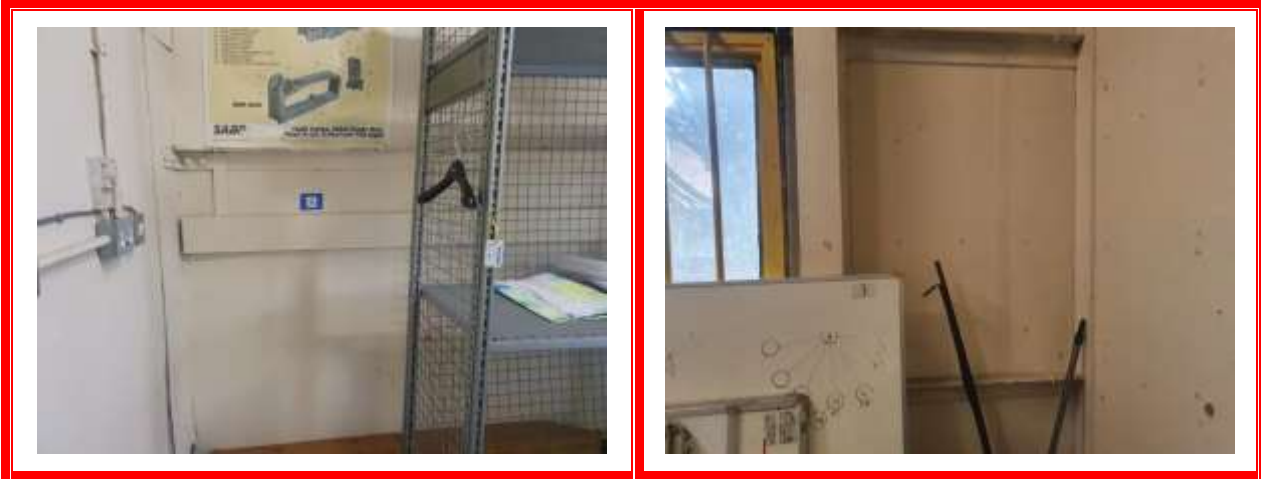
Item No:	10	Sample No:	N/A
Location:	Ground Floor - Garage - Office - Off Drill Hall Garage 010

Material Description:	Fibreboard Wall Panels - Paper Product	
Identification:	Previously Sampled - Asbestos Detected	
Approx. quantity:	24 m ²	
Accessibility	Easy	Assessment Score
Product type:	Cement	1
Extent of Damage:	Slight / minor damage	1
Surface Treatment:	Paper	1
Asbestos type:	Chrysotile	1
Material Assessment Score:		4
Priority Assessment Score:		Negligible
Action:	Encapsulate	
Comments:	Previously sampled ref: Armour 11/11/19 sample DK/5.

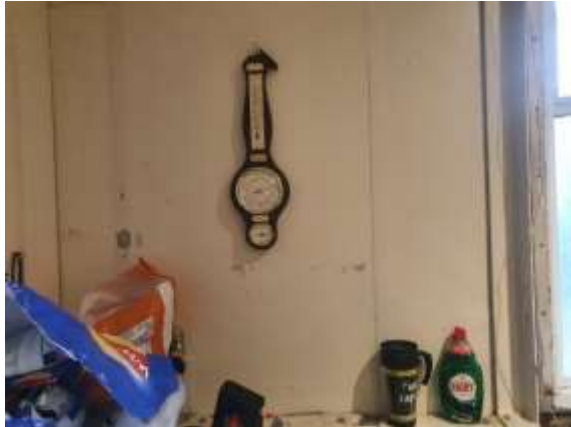
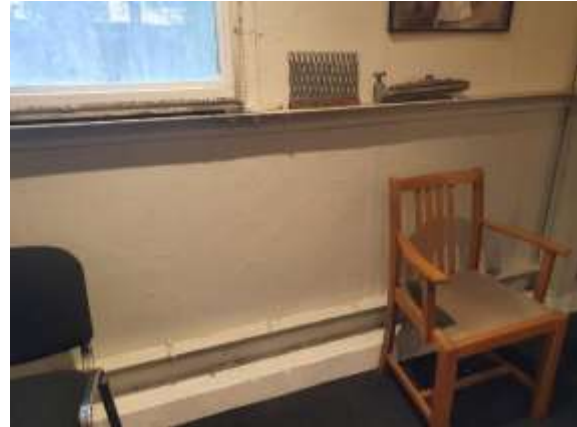
Location: Ground Floor - Garage - Bar/Mess 011

Material Description:	Fibreboard Wall Panels - Paper Product	
Identification:	Previously Sampled - Asbestos Detected	
Approx. quantity:	14 m ²	
Accessibility	Easy	Assessment Score
Product type:	Paper	2
Extent of Damage:	Moderate damage	2
Surface Treatment:	Paper	1
Asbestos type:	Chrysotile	1
Material Assessment Score:		6
Priority Assessment Score:		Low
Action:	Encapsulate	
Comments:	Previously sampled ref: Armour 11/11/19 sample DK/5.

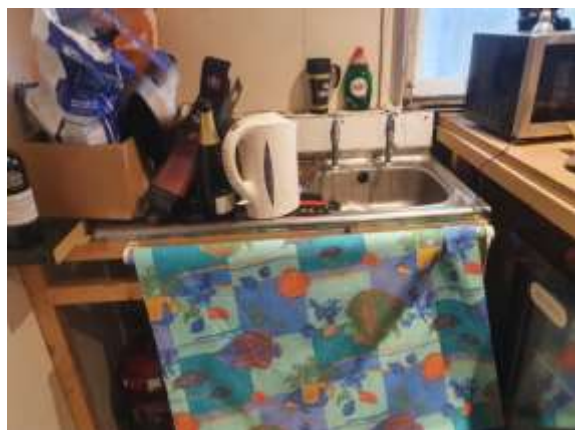
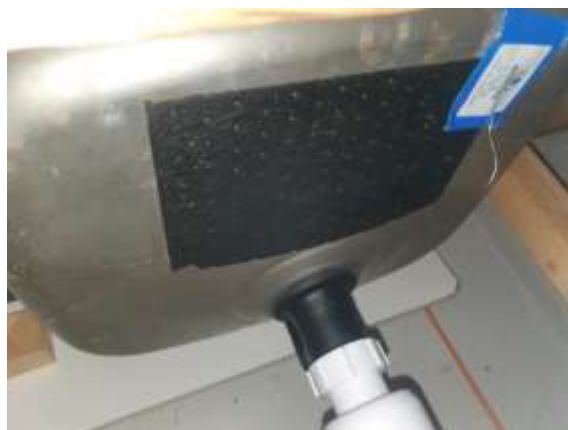
Location: Ground Floor - Garage - Bar/Mess 012

Material Description:	Sink Pad - Bituminous Product	
Identification:	Previously Sampled - Asbestos Detected	
Approx. quantity:	1 no	
Accessibility	Medium	Assessment Score
Product type:	Paper	2
Extent of Damage:	Slight / minor damage	1
Surface Treatment:	Non-friable	0
Asbestos type:	Chrysotile	1
Material Assessment Score:		4
Priority Assessment Score:		Negligible
Action:	Manage	
Comments:	Previously sampled ref: Armour 11/11/19 sample DK/6

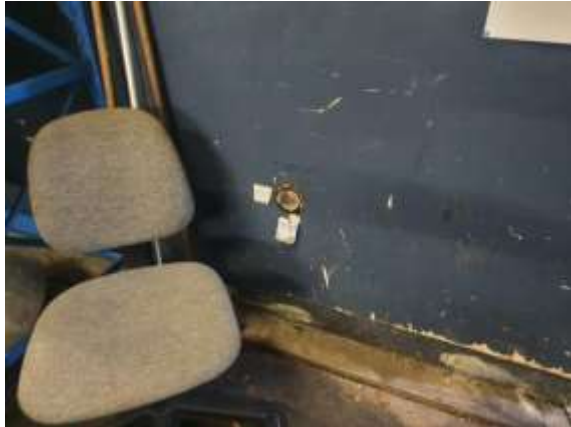
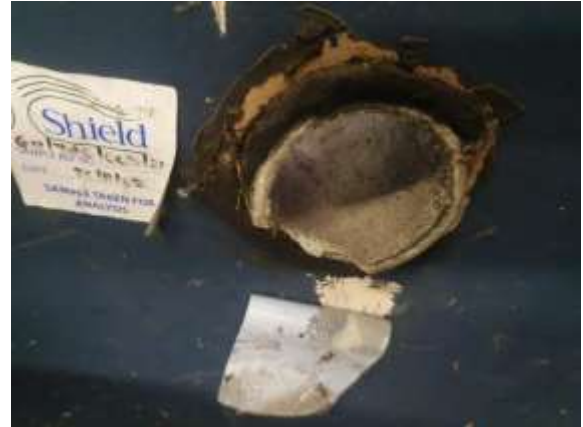
Location: Ground Floor - Service Garage 013

Material Description:	Cement Panel Packer - Cement Product	
Identification:	Previously Sampled - Asbestos Detected	
Approx. quantity:	<1 LM	
Accessibility	Medium	Assessment Score
Product type:	Cement	1
Extent of Damage:	Moderate damage	2
Surface Treatment:	Unsealed Cement	1
Asbestos type:	Chrysotile	1
Material Assessment Score:		5
Priority Assessment Score:		Low
Action:	Encapsulate	
Comments:	Previously sampled ref: Armour 11/11/19 sample DK/8

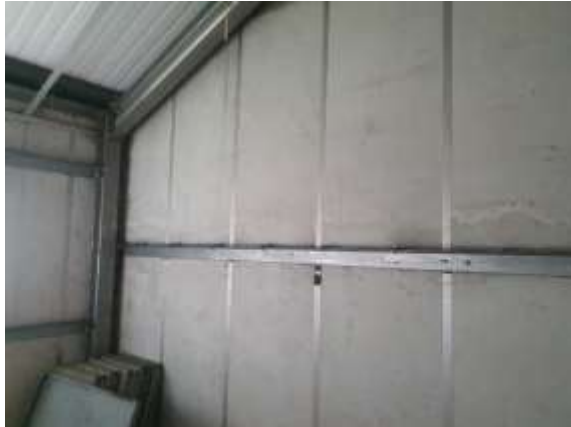
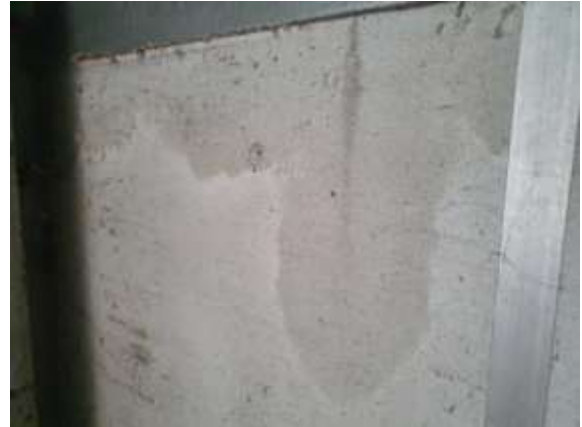
Location: Ground Floor - Garage - Stores x 2 014

Material Description:	Fiberboard Wall Panels - Paper Product	
Identification:	Previously Sampled - Asbestos Detected	
Approx. quantity:	24 m ²	
Accessibility	Easy	<i>Assessment Score</i>
Product type:	Paper	2
Extent of Damage:	Slight / minor damage	1
Surface Treatment:	Paper	1
Asbestos type:	Chrysotile	1
Material Assessment Score:		5
Priority Assessment Score:		Low
Action:	Encapsulate	
Comments:	Previously sampled ref: Armour 11/11/19 sample DK/5

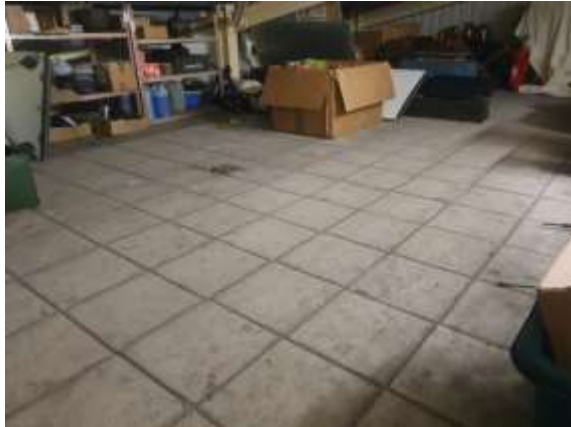
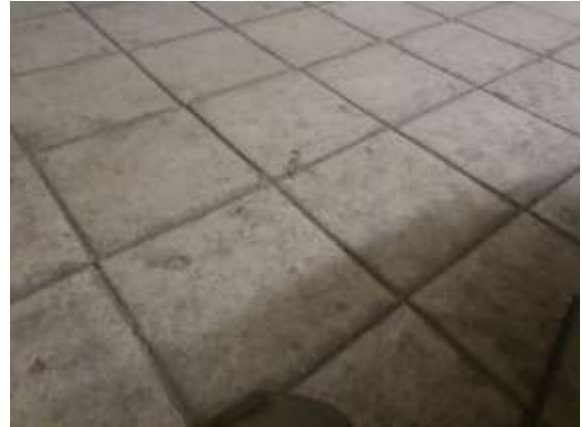
Location: First Floor - Main Building - Stores - Mezzanine 015

Material Description:	Promenade Floor Tiles - Cement Product	
Identification:	Previously Sampled - Asbestos Detected	
Approx. quantity:	72 m ²	
Accessibility	Easy	<i>Assessment Score</i>
Product type:	Paper	2
Extent of Damage:	Moderate damage	2
Surface Treatment:	Unsealed Cement	1
Asbestos type:	Chrysotile	1
Material Assessment Score:		6
Priority Assessment Score:		Low
Action:	Manage	
Comments:	Previously sampled ref: Armour 11/11/19 sample DK/12

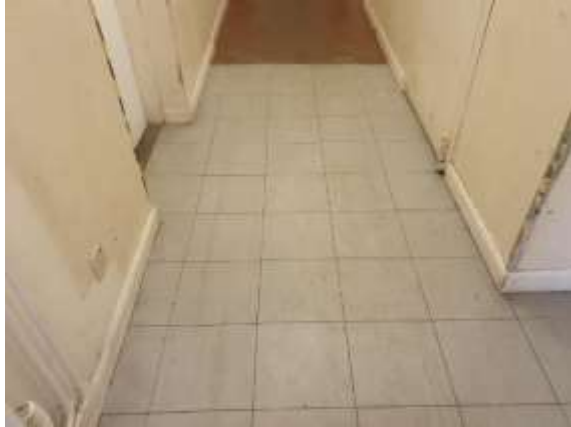
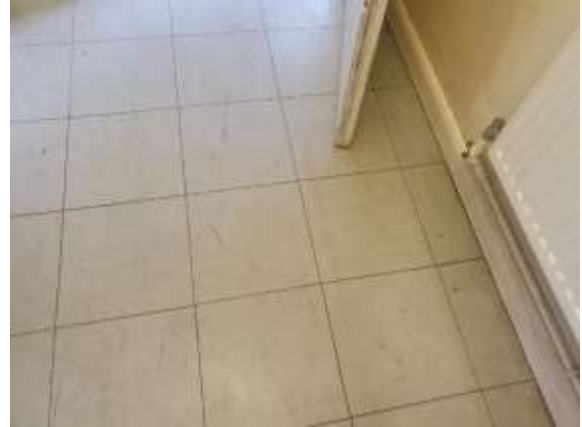
Location: Ground Floor - Main Building - Stores - Lobby and Cupboard 016

Material Description:	Cream and Grey Floor Tiles - Vinyl Products	
Identification:	Previously Sampled - Asbestos Detected	
Approx. quantity:	8 m ²	
Accessibility	Easy	Assessment Score
Product type:	Paper	2
Extent of Damage:	Moderate damage	2
Surface Treatment:	Non-friable	0
Asbestos type:	Chrysotile	1
Material Assessment Score:		5
Priority Assessment Score:		Low
Action:	Manage	
Comments:	Previously sampled ref: Armour 11/11/19 sample DK/13

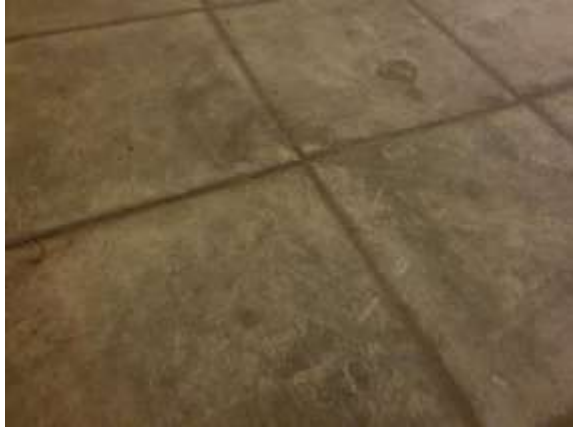
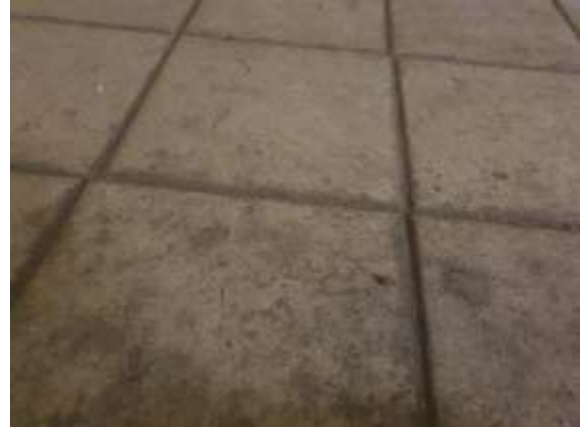
Location: First Floor - Main Building - Stores - Store G1098 and Mezzanine 017

Material Description:	Promenade Tiles - Cement Product	
Identification:	Previously Sampled - Asbestos Detected	
Approx. quantity:	75 m ²	
Accessibility	Easy	<i>Assessment Score</i>
Product type:	Cement	1
Extent of Damage:	Moderate damage	2
Surface Treatment:	Unsealed Cement	1
Asbestos type:	Chrysotile	1
Material Assessment Score:		5
Priority Assessment Score:		Low
Action:	Manage	
Comments:	Previously sampled ref: Armour 11/11/19 sample DK/12

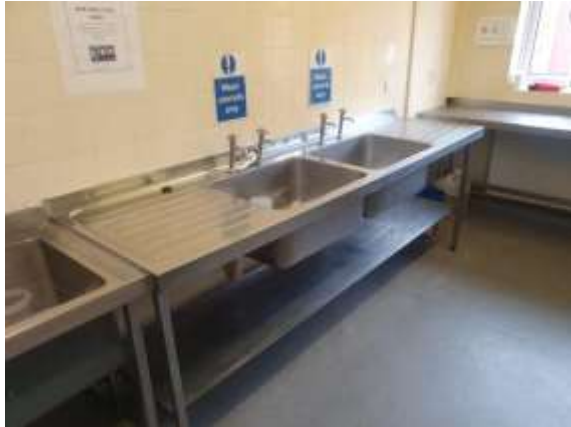
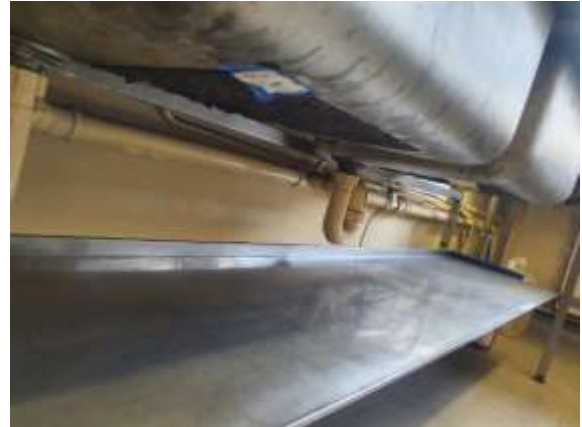
Location: Ground Floor - Main Building - Stores - Kitchen 018

Material Description:	Sink Pad - Bituminous Product	
Identification:	Previously Sampled - Asbestos Detected	
Approx. quantity:	4 no	
Accessibility	Medium	<i>Assessment Score</i>
Product type:	Bitumen	1
Extent of Damage:	Moderate damage	2
Surface Treatment:	Non-friable	0
Asbestos type:	Chrysotile	1
Material Assessment Score:		4
Priority Assessment Score:		Negligible
Action:	Manage	
Comments:	Previously sampled ref: Armour 11/11/19 sample DK/14

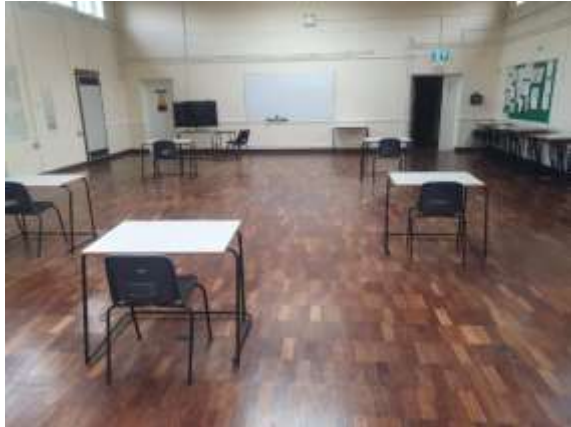
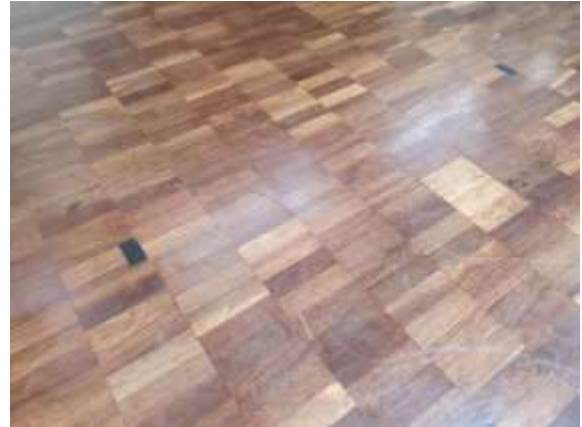
Location: Ground Floor - Main Building - Drill Hall 019

Material Description:	Adhesive under Parquet Flooring - Bituminous Product	
Identification:	Previously Sampled - Asbestos Detected	
Approx. quantity:	180 m ²	
Accessibility	Difficult	Assessment Score
Product type:	Bitumen	1
Extent of Damage:	Slight / minor damage	1
Surface Treatment:	Non-friable	0
Asbestos type:	Chrysotile	1
Material Assessment Score:		3
Priority Assessment Score:		Negligible
Action:	Manage	
Comments:	Previously sampled ref: Armour 11/11/19 sample DK/15

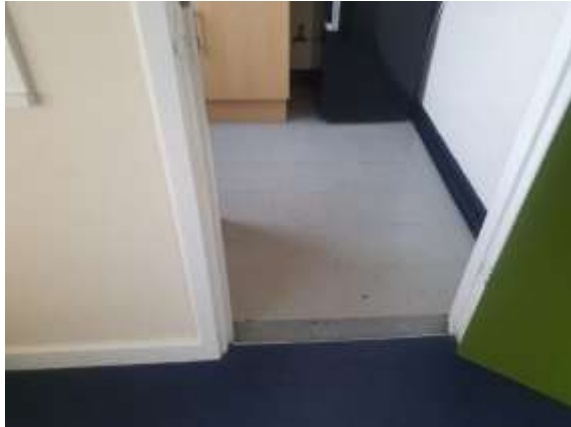
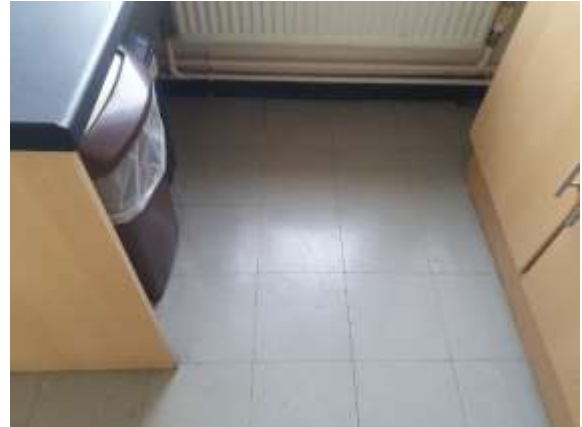
Location: First Floor - Main Building - Kitchen 020

Material Description:	Floor Tiles and Adhesive - Vinyl Products	
Identification:	Previously Sampled - Asbestos Detected	
Approx. quantity:	4 m ²	
Accessibility	Easy	<i>Assessment Score</i>
Product type:	Vinyl	1
Extent of Damage:	Slight / minor damage	1
Surface Treatment:	Non-friable	0
Asbestos type:	Chrysotile	1
Material Assessment Score:		3
Priority Assessment Score:		Negligible
Action:	Manage	
Comments:	Previously sampled ref: Armour 11/11/19 sample DK/16

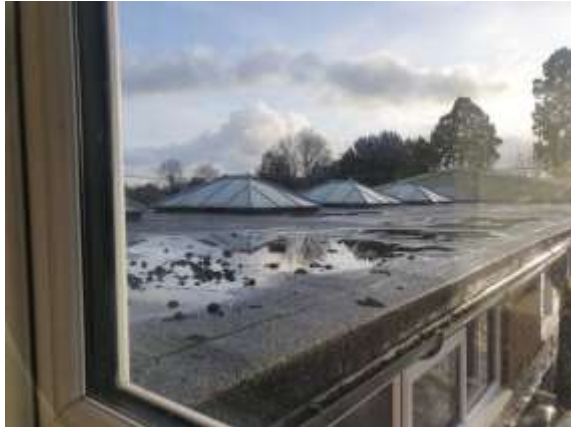
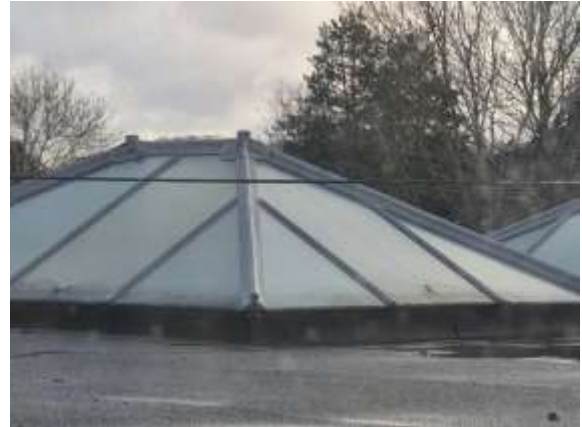
Location: External - Main Building - Drill Hall Roof 021

Material Description:	Rope Seals to Skylights - Gaskets (rope/woven)	
Identification:	Strongly Presumed to Contain Asbestos	
Approx. quantity:	4 no	
Accessibility	Difficult	<i>Assessment Score</i>
Product type:	Rope	2
Extent of Damage:	Slight / minor damage	1
Surface Treatment:	Woven Material	1
Asbestos type:	Chrysotile	1
Material Assessment Score:		5
Priority Assessment Score:		Low
Action:	Manage	
Comments:	No safe access to sample

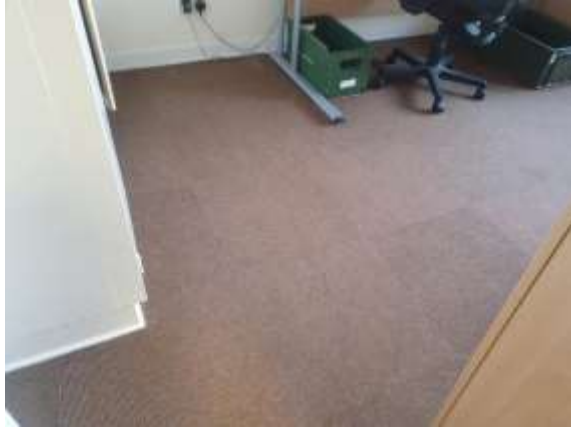
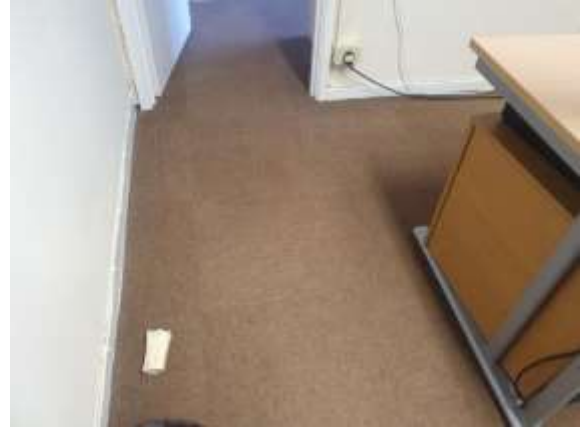
Location: First Floor - Main Building - Admin Office F4 and Office 022

Material Description:	Floor Tiles and Adhesive - Vinyl Products	
Identification:	Previously Sampled - Asbestos Detected	
Approx. quantity:	24 m ²	
Accessibility	Easy	<i>Assessment Score</i>
Product type:	Vinyl	1
Extent of Damage:	Slight / minor damage	1
Surface Treatment:	Non-friable	0
Asbestos type:	Chrysotile	1
Material Assessment Score:		3
Priority Assessment Score:		Negligible
Action:	Manage	
Comments:	Previously sampled ref: Armour 11/11/19 sample DK/17. Under carpet

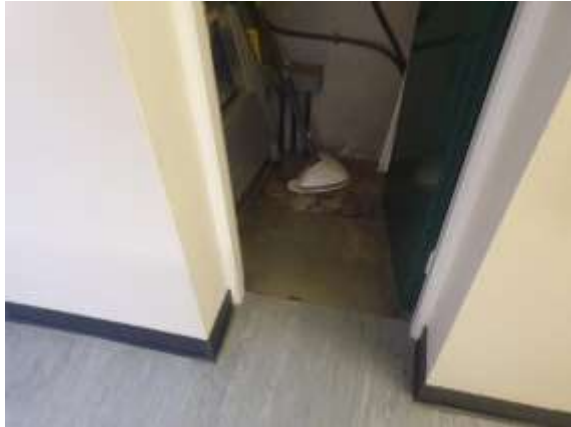
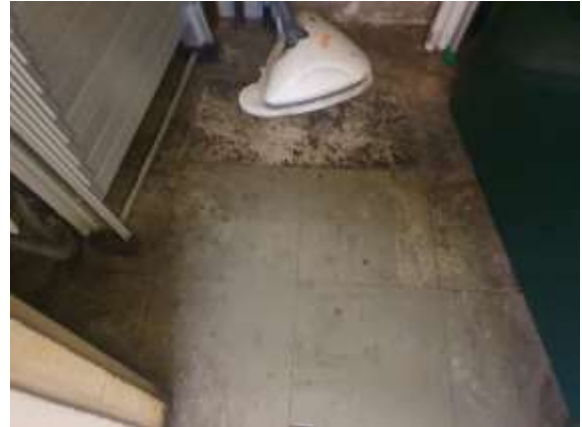
Location: First Floor - Main Building - F12 Cleaners Cupboard 023

Material Description:	Floor Tiles and Adhesive - Vinyl Products	
Identification:	Previously Sampled - Asbestos Detected	
Approx. quantity:	1 m ²	
Accessibility	Easy	<i>Assessment Score</i>
Product type:	Vinyl	1
Extent of Damage:	Moderate damage	2
Surface Treatment:	Non-friable	0
Asbestos type:	Chrysotile	1
Material Assessment Score:		4
Priority Assessment Score:		Negligible
Action:	Manage	
Comments:	Previously sampled ref: Armour 11/11/19 sample DK/20

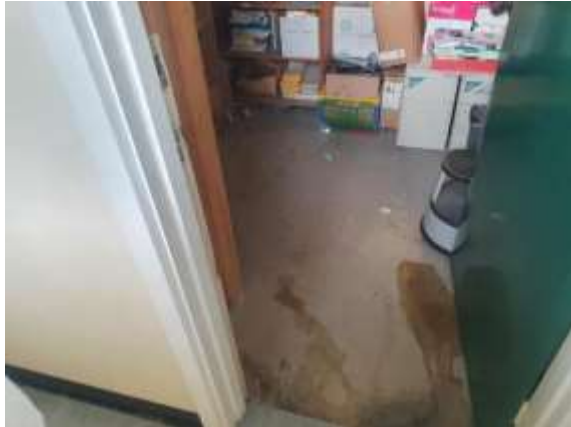
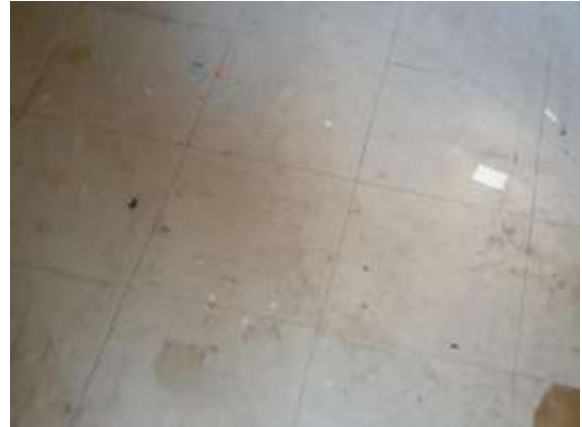
Location: First Floor - Main Building - F17 Store 024

Material Description:	Floor Tiles and Adhesive - Vinyl Products	
Identification:	Previously Sampled - Asbestos Detected	
Approx. quantity:	4 m ²	
Accessibility	Easy	<i>Assessment Score</i>
Product type:	Vinyl	1
Extent of Damage:	Slight / minor damage	1
Surface Treatment:	Non-friable	0
Asbestos type:	Chrysotile	1
Material Assessment Score:		3
Priority Assessment Score:		Negligible
Action:	Manage	
Comments:	Previously sampled ref: Armour 11/11/19 sample DK/16

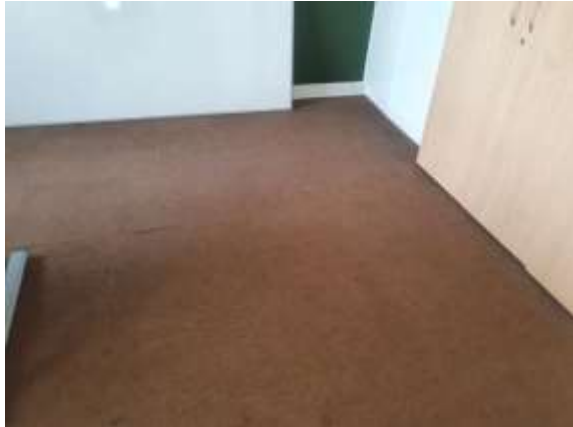
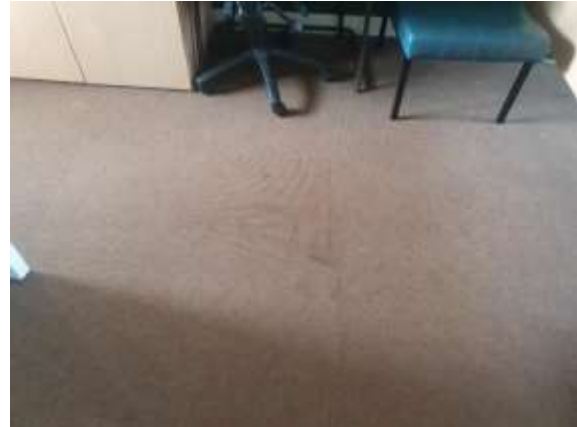
Location: First Floor - Main Building - PSI Office 025

Material Description:	Floor Tiles and Adhesive - Vinyl Products	
Identification:	Previously Sampled - Asbestos Detected	
Approx. quantity:	20 m ²	
Accessibility	Difficult	<i>Assessment Score</i>
Product type:	Vinyl	1
Extent of Damage:	Slight / minor damage	1
Surface Treatment:	Non-friable	0
Asbestos type:	Chrysotile	1
Material Assessment Score:		3
Priority Assessment Score:		Negligible
Action:	Manage	
Comments:	Previously sampled ref: Armour 11/11/19 sample DK/20. Under carpet.

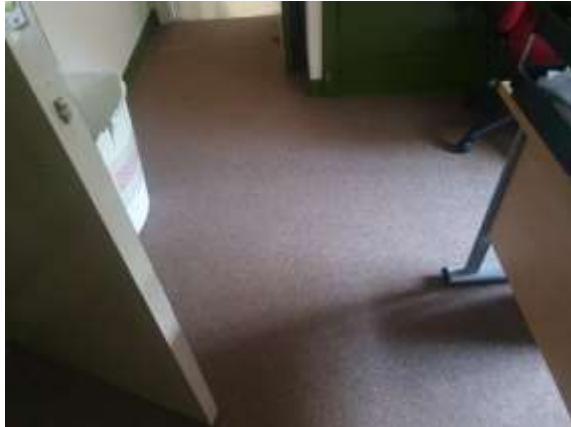
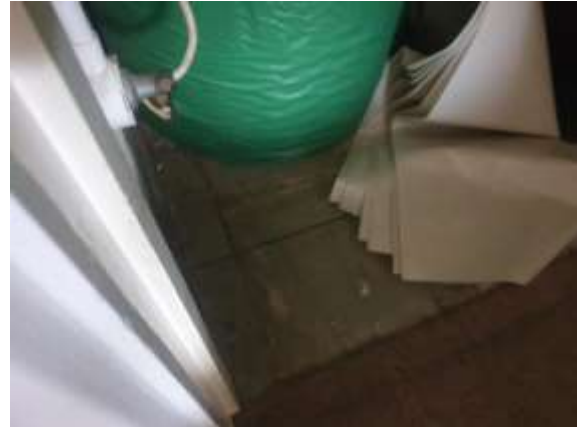
Location: First Floor - Main Building - Office F6 and Cupboard 026

Material Description:	Floor Tiles and Adhesive - Vinyl Products	
Identification:	Previously Sampled - Asbestos Detected	
Approx. quantity:	14 m ²	
Accessibility	Medium	<i>Assessment Score</i>
Product type:	Vinyl	1
Extent of Damage:	Slight / minor damage	1
Surface Treatment:	Non-friable	0
Asbestos type:	Chrysotile	1
Material Assessment Score:		3
Priority Assessment Score:		Negligible
Action:	Manage	
Comments:	Previously sampled ref: Armour 11/11/19 sample DK/20. Under carpet in office

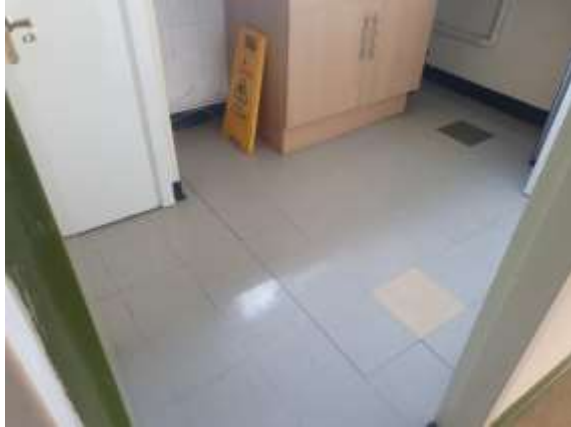
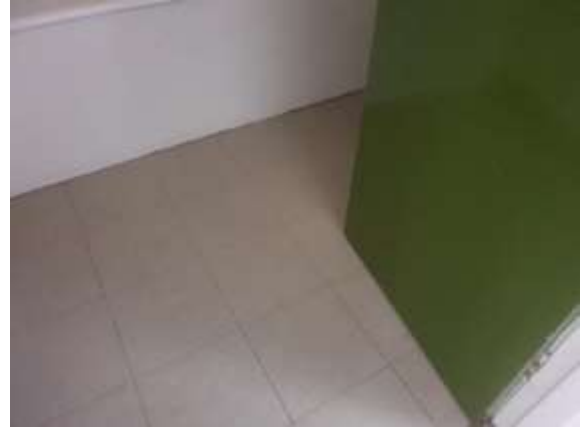
Location: First Floor - Main Building - Kitchen, Cupboard and WC
027

Material Description:	Floor Tiles and Adhesive - Vinyl Products	
Identification:	Previously Sampled - Asbestos Detected	
Approx. quantity:	8 m ²	
Accessibility	Easy	<i>Assessment Score</i>
Product type:	Vinyl	1
Extent of Damage:	Slight / minor damage	1
Surface Treatment:	Non-friable	0
Asbestos type:	Chrysotile	1
Material Assessment Score:		3
Priority Assessment Score:		Negligible
Action:	Manage	
Comments:	Previously sampled ref: Armour 11/11/19 sample DK/22

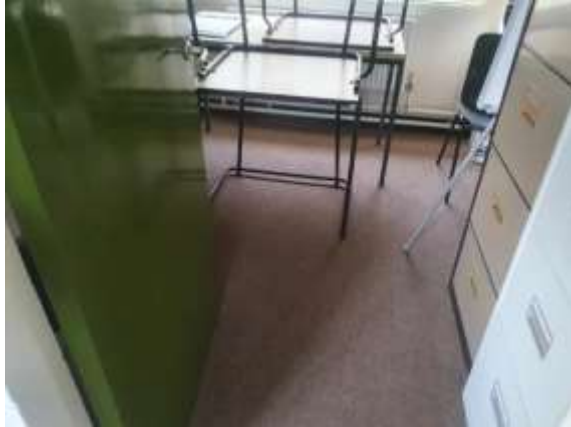
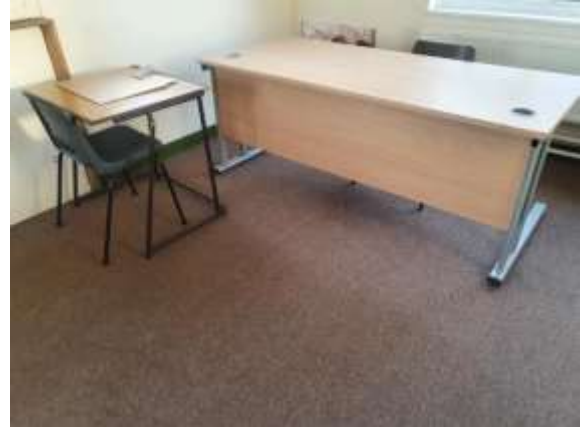
Location: First Floor - Main Building - Office F7 and Classroom F10 028

Material Description:	Floor Tiles and Adhesive - Vinyl Products	
Identification:	Previously Sampled - Asbestos Detected	
Approx. quantity:	25 m ²	
Accessibility	Difficult	Assessment Score
Product type:	Vinyl	1
Extent of Damage:	Slight / minor damage	1
Surface Treatment:	Non-friable	0
Asbestos type:	Chrysotile	1
Material Assessment Score:		3
Priority Assessment Score:		Negligible
Action:	Manage	
Comments:	Previously sampled ref: Armour 11/11/19 sample DK/21. Under carpet

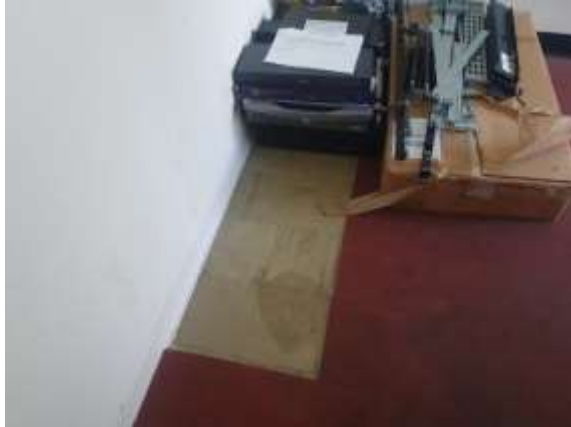
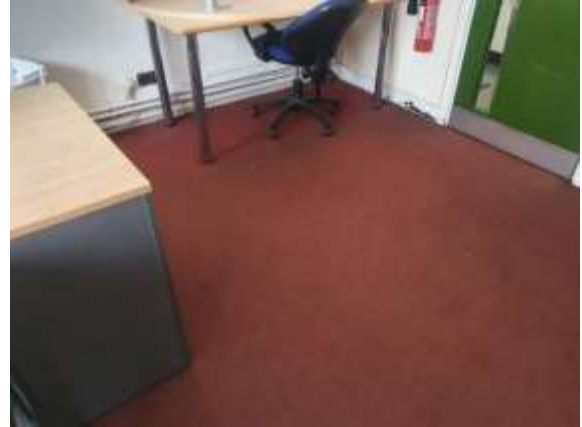
Location: Ground Floor - Main Building - IT Suite and Server Room 029

Material Description:	Floor Tiles and Adhesive - Vinyl Products	
Identification:	Previously Sampled - Asbestos Detected	
Approx. quantity:	35 m ²	
Accessibility	Difficult	Assessment Score
Product type:	Vinyl	1
Extent of Damage:	Slight / minor damage	1
Surface Treatment:	Non-friable	0
Asbestos type:	Chrysotile	1
Material Assessment Score:		3
Priority Assessment Score:		Negligible
Action:	Manage	
Comments:	Previously sampled ref: Armour 11/11/19 sample DK/23. Under carpet

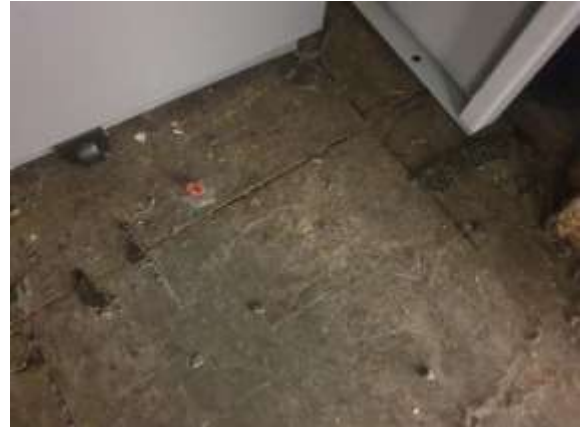
Location: Ground Floor - Main Building - Cupboard 030

Material Description:	Floor Tiles and Adhesive and Debris - Vinyl Products	
Identification:	Previously Sampled - Asbestos Detected	
Approx. quantity:	1 m ²	
Accessibility	Difficult	<i>Assessment Score</i>
Product type:	Vinyl	1
Extent of Damage:	Major damage	3
Surface Treatment:	Non-friable	0
Asbestos type:	Chrysotile	1
Material Assessment Score:		5
Priority Assessment Score:		Low
Action:	Remove	
Comments:	Previously sampled ref: Armour 11/11/19 sample DK/23. Remove Debris and manage tiles

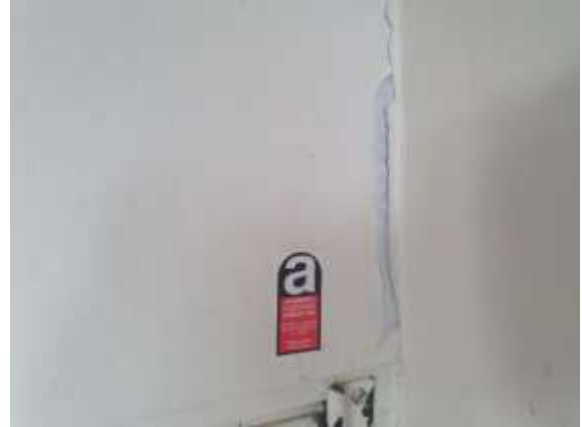
Location: Ground Floor - Main Building - Lobby (Side Entrance)
031

Material Description:	Wall and Door Panels - Insulating Board	
Identification:	Previously Sampled - Asbestos Detected	
Approx. quantity:	5 m ²	
Accessibility	Easy	Assessment Score
Product type:	Asbestos Insulating Board	2
Extent of Damage:	Slight / minor damage	1
Surface Treatment:	Unsealed AIB	2
Asbestos type:	Amosite	2
Material Assessment Score:		7
Priority Assessment Score:		Medium
Action:	Encapsulate	
Comments:	Previously sampled ref: Armour 11/11/19 sample DK/24. Encapsulate or remove and restrict access to cupboard

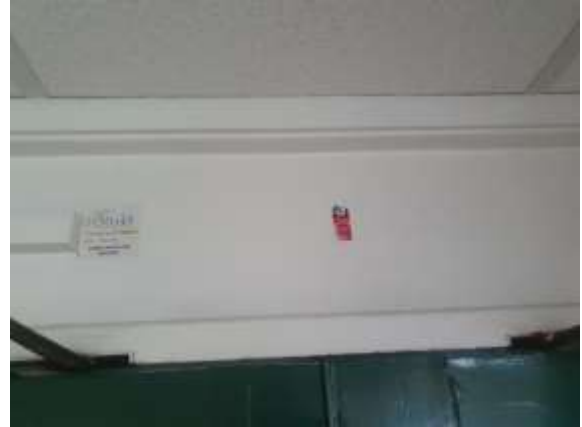
Location: Ground Floor - Main Building - Lobby (Side Entrance)
032

Material Description:	Door Header Panel - Insulating Board	
Identification:	Previously Sampled - Asbestos Detected	
Approx. quantity:	1 m ²	
Accessibility	Difficult	Assessment Score
Product type:	Asbestos Insulating Board	2
Extent of Damage:	Slight / minor damage	1
Surface Treatment:	Encapsulated AIB	1
Asbestos type:	Amosite	2
Material Assessment Score:		6
Priority Assessment Score:		Low
Action:	Manage	
Comments:	Previously sampled ref: Armour 11/11/19 sample DK/24

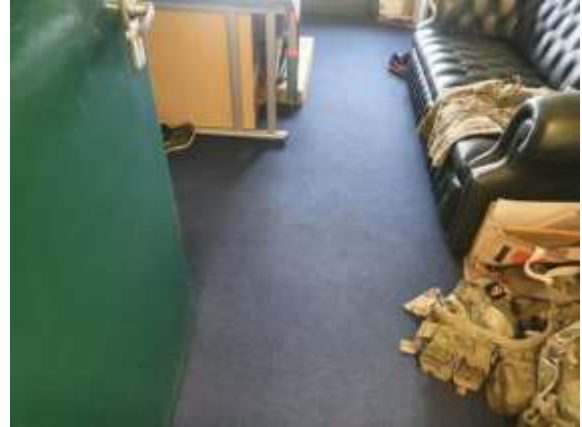
Material Description:	Floor Tiles and Adhesive and Debris - Vinyl Products	
Identification:	Previously Sampled - Asbestos Detected	
Approx. quantity:	32 m ²	
Accessibility	Difficult	Assessment Score
Product type:	Vinyl	1
Extent of Damage:	Slight / minor damage	1
Surface Treatment:	Non-friable	0
Asbestos type:	Chrysotile	1
Material Assessment Score:		3
Priority Assessment Score:		Negligible
Action:	Manage	
Comments:	Previously sampled ref: Armour 11/11/19 sample DK/23. Under carpet

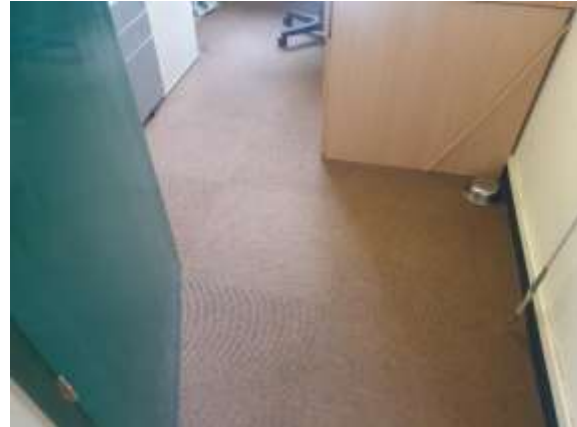
Material Description:	Floor Tiles and Adhesive and Debris - Vinyl Products	
Identification:	Previously Sampled - Asbestos Detected	
Approx. quantity:	24 m ²	
Accessibility	Difficult	<i>Assessment Score</i>
Product type:	Vinyl	1
Extent of Damage:	Slight / minor damage	1
Surface Treatment:	Non-friable	0
Asbestos type:	Chrysotile	1
Material Assessment Score:		3
Priority Assessment Score:		Negligible
Action:	Manage	
Comments:	Previously sampled ref: Armour 11/11/19 sample DK/23. Under carpet

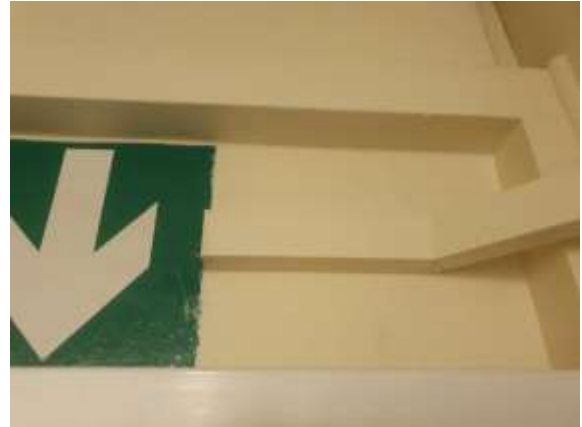
Material Description:	Door Header Panel - Insulating Board	
Identification:	Previously Sampled - Asbestos Detected	
Approx. quantity:	1 m ²	
Accessibility	Difficult	<i>Assessment Score</i>
Product type:	Asbestos Insulating Board	2
Extent of Damage:	Slight / minor damage	1
Surface Treatment:	Encapsulated AIB	1
Asbestos type:	Amosite	2
Material Assessment Score:		6
Priority Assessment Score:		Low
Action:	Manage	
Comments:	Previously sampled ref: Armour 11/11/19 sample DK/24

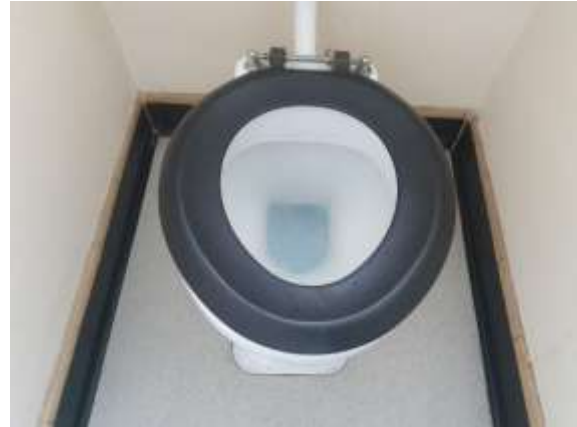
Material Description:	Toilet Seat - PVC / Reinforced Plastics	
Identification:	Presumed to Contain Asbestos	
Approx. quantity:	1 no	
Accessibility	Easy	<i>Assessment Score</i>
Product type:	Bakelite	1
Extent of Damage:	Slight / minor damage	1
Surface Treatment:	Non-friable	0
Asbestos type:	Chrysotile	1
Material Assessment Score:		3
Priority Assessment Score:		Negligible
Action:	Manage	
Comments:	Not possible to sample as may damage integrity of the seat

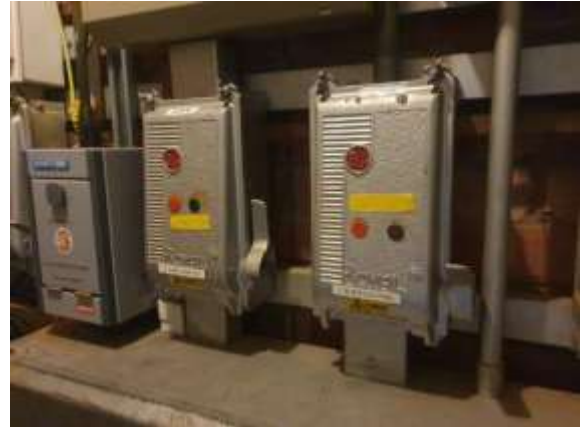
Material Description:	Electrical Panels - Gaskets (rope/woven)	
Identification:	Strongly Presumed to Contain Asbestos	
Approx. quantity:	16 no	
Accessibility	Difficult	<i>Assessment Score</i>
Product type:	Bakelite	1
Extent of Damage:	Slight / minor damage	1
Surface Treatment:	Woven Material	1
Asbestos type:	Chrysotile	1
Material Assessment Score:		4
Priority Assessment Score:		Negligible
Action:	Manage	
Comments:	No access within electrical panels as live

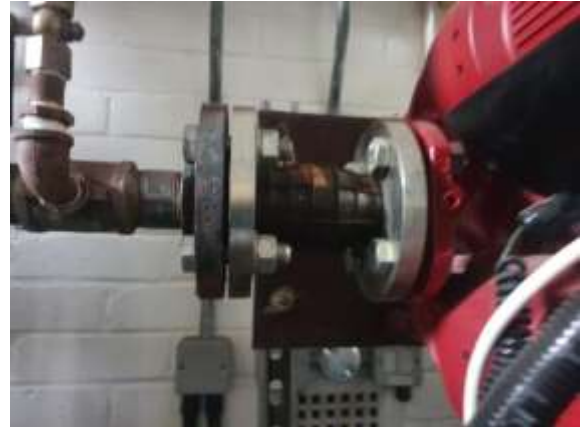
Material Description:	Gaskets - Gaskets (compressed)	
Identification:	Presumed to Contain Asbestos	
Approx. quantity:	4 no	
Accessibility	Difficult	<i>Assessment Score</i>
Product type:	Rope	2
Extent of Damage:	Slight / minor damage	1
Surface Treatment:	Woven Material	1
Asbestos type:	Chrysotile	1
Material Assessment Score:		5
Priority Assessment Score:		Low
Action:	Manage	
Comments:	Gaskets are too tight within flanges to sample

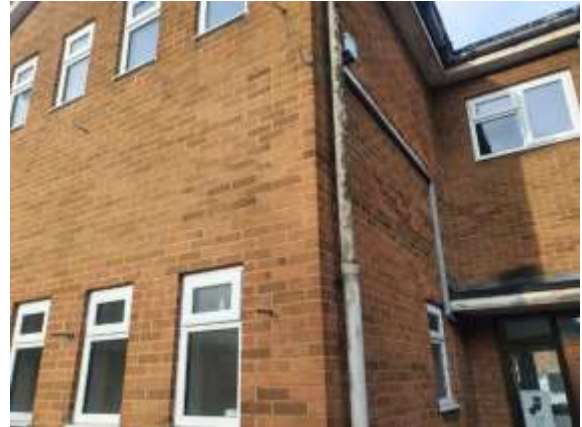
Material Description:	Downpipes - Cement Product	
Identification:	Previously Sampled - Asbestos Detected	
Approx. quantity:	11 no	
Accessibility	Medium	<i>Assessment Score</i>
Product type:	Cement	1
Extent of Damage:	Moderate damage	2
Surface Treatment:	Unsealed Cement	1
Asbestos type:	Amosite, Chrysotile	2
Material Assessment Score:		6
Priority Assessment Score:		Low
Action:	Manage	
Comments:	Previously sampled ref: Armour 11/11/19 sample DK/25. 11no, approx. 60LM

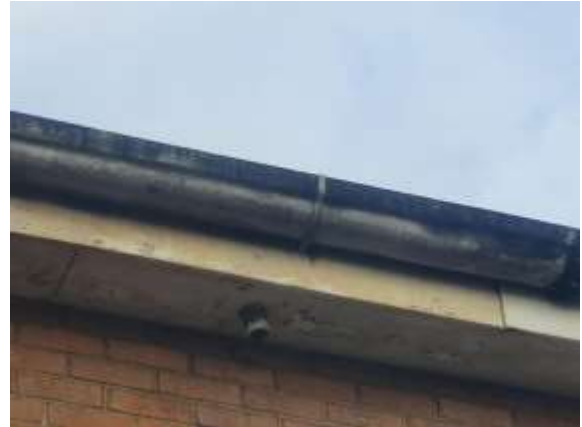
Material Description:	Guttering - Cement Product	
Identification:	Previously Sampled - Asbestos Detected	
Approx. quantity:	126 LM	
Accessibility	Difficult	<i>Assessment Score</i>
Product type:	Cement	1
Extent of Damage:	Slight / minor damage	1
Surface Treatment:	Unsealed Cement	1
Asbestos type:	Amosite, Chrysotile	2
Material Assessment Score:		5
Priority Assessment Score:		Low
Action:	Manage	
Comments:	Previously sampled ref: Armour 11/11/19 sample DK/25. 4 Sections, 126LM
