Project Number A-00518 (3700)

**Re-Inspection
Asbestos Survey Report**

**6th Battalion
Gloucestershire
GL4 3BD**

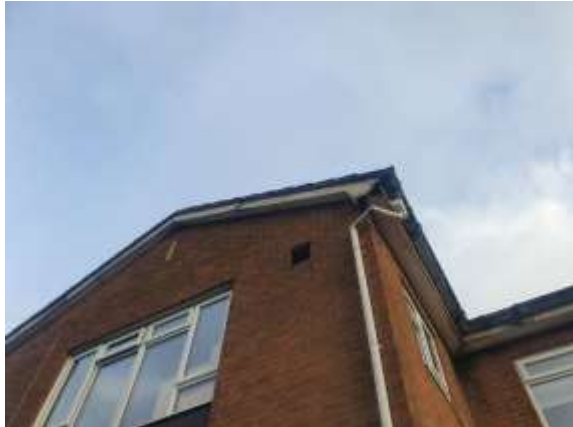
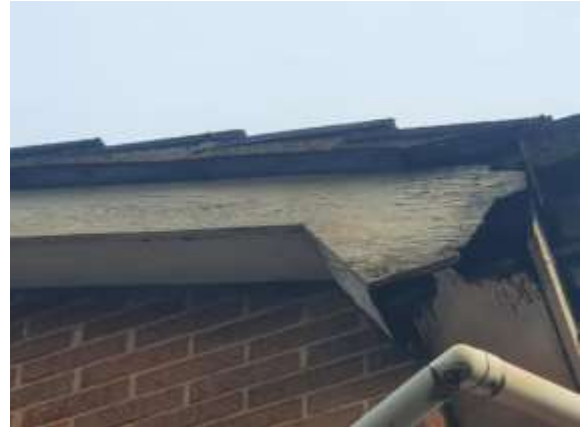
Material Description:	Under cloaking - Cement Product	
Identification:	Strongly Presumed to Contain Asbestos	
Approx. quantity:	34 LM	
Accessibility	Difficult	<i>Assessment Score</i>
Product type:	Cement	1
Extent of Damage:	Slight / minor damage	1
Surface Treatment:	Unsealed Cement	1
Asbestos type:	Chrysotile	1
Material Assessment Score:		4
Priority Assessment Score:		Negligible
Action:	Manage	
Comments:	4 sections of under cloaking, 34LM

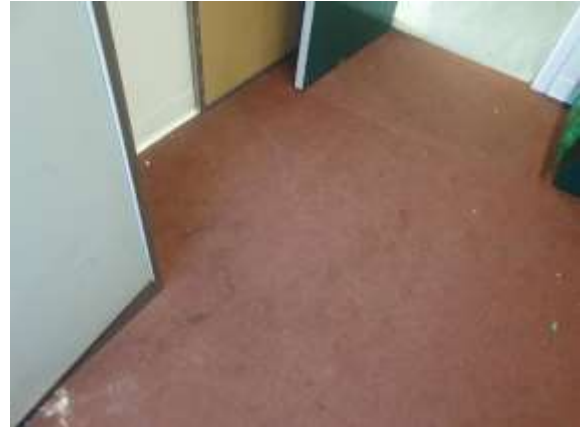
Material Description:	Floor Tiles and Adhesive and Debris - Vinyl Products	
Identification:	Previously Sampled - Asbestos Detected	
Approx. quantity:	10 m ²	
Accessibility	Difficult	<i>Assessment Score</i>
Product type:	Vinyl	1
Extent of Damage:	Slight / minor damage	1
Surface Treatment:	Non-friable	0
Asbestos type:	Chrysotile	1
Material Assessment Score:		3
Priority Assessment Score:		Negligible
Action:	Manage	
Comments:	Previously sampled ref: Armour 11/11/19 sample DK/23. Under carpet

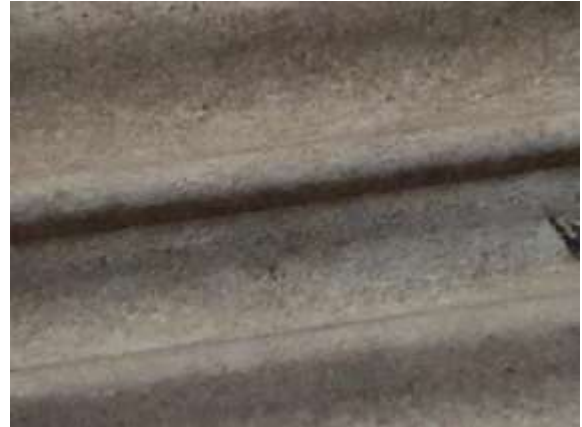
Material Description:	Profiled Cement Roof - Cement Product	
Identification:	Presumed to Contain Asbestos	
Approx. quantity:	12 m ²	
Accessibility	Difficult	<i>Assessment Score</i>
Product type:	Cement	1
Extent of Damage:	Major damage	3
Surface Treatment:	Unsealed Insulation	3
Asbestos type:	Chrysotile	1
Material Assessment Score:		8
Priority Assessment Score:		Medium
Action:	Manage	
Comments:	N/A

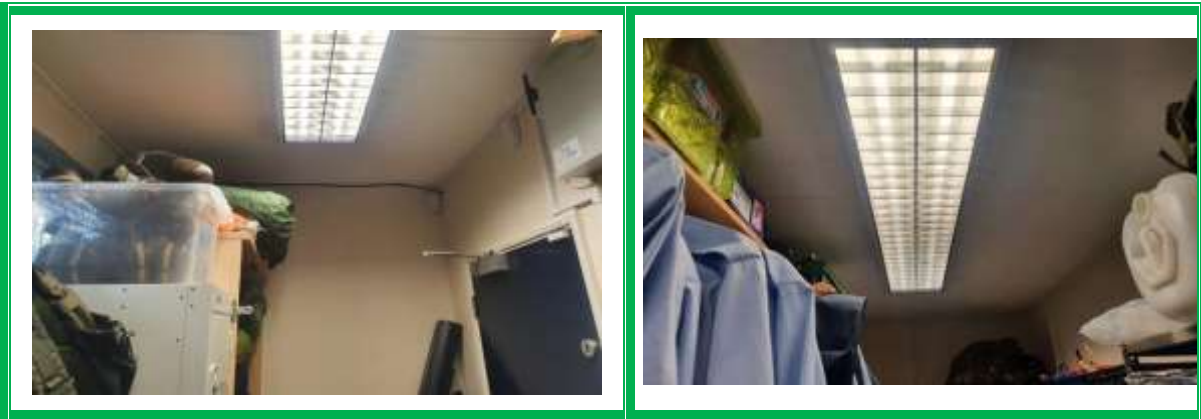
Material Description:	No Suspect Materials Found	
Identification:	N/A	
Approx. quantity:	N/A	
Accessibility	N/A	<i>Assessment Score</i>
Product type:	N/A	N/A
Extent of Damage:	N/A	N/A
Surface Treatment:	N/A	N/A
Asbestos type:	N/A	N/A
Material Assessment Score:		N/A
Priority Assessment Score:		N/A
Action:	N/A	
Comments:	Previously a no access area. Now accessed and no asbestos found
