Project Number 3700

**Re-Inspection
Asbestos Survey Report**

**232 Port Squadron
Bodmin
Cornwall
PL31 1DX**

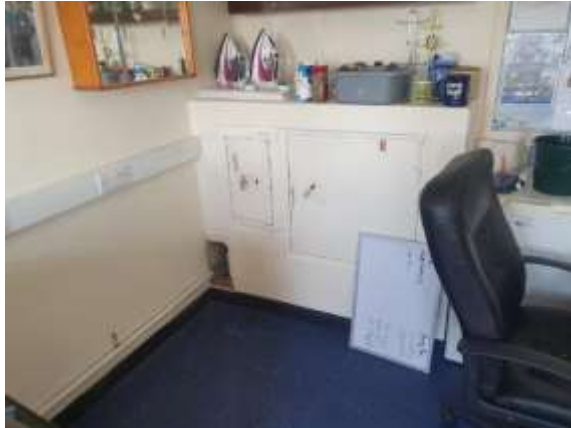
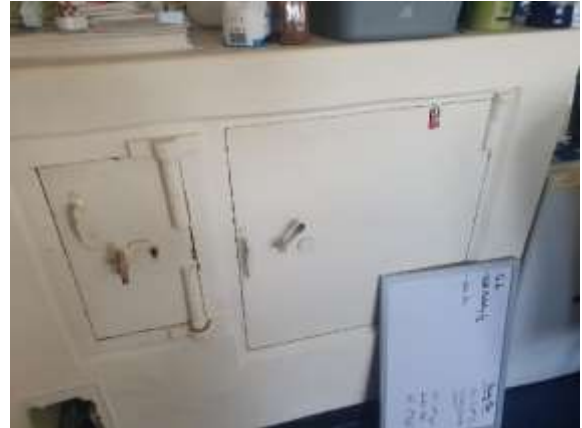
Item No:	1	Sample No:	N/A
Location:	Second Floor - ATC Office 001

Material Description:	Safe - Insulating Board	
Identification:	Presumed to Contain Asbestos	
Approx. quantity:	1 no	
Accessibility	Difficult	Assessment Score
Product type:	Asbestos Insulating Board	2
Extent of Damage:	Major damage	3
Surface Treatment:	Unsealed Insulation	3
Asbestos type:	Amosite, Chrysotile	2
Material Assessment Score:		10
Priority Assessment Score:		High
Action:	Manage	
Comments:	No access within safe casings without damaging safe

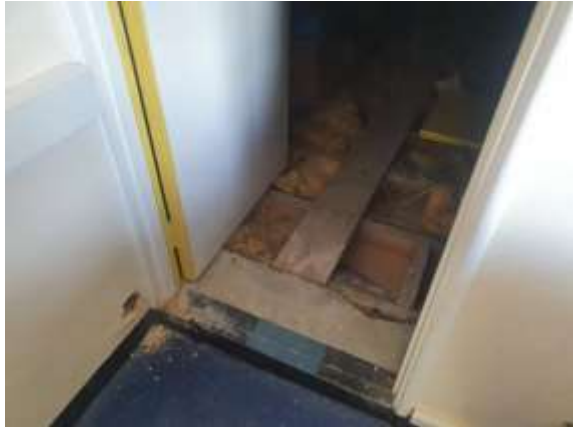
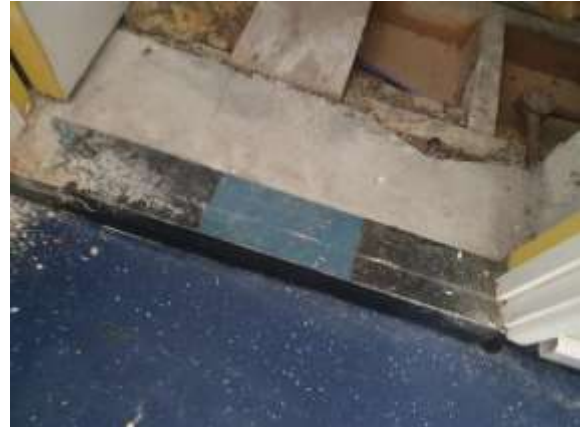
Location: Second Floor - Loft Space 003

Material Description:	Floor Tiles and Stair Nosing - Vinyl Products	
Identification:	Strongly Presumed to Contain Asbestos	
Approx. quantity:	1 LM	
Accessibility	Easy	<i>Assessment Score</i>
Product type:	Vinyl	1
Extent of Damage:	Slight / minor damage	1
Surface Treatment:	Non-friable	0
Asbestos type:	Chrysotile	1
Material Assessment Score:		3
Priority Assessment Score:		Negligible
Action:	Manage	
Comments:	Limited access within loft space. Non asbestos material to underside of roof

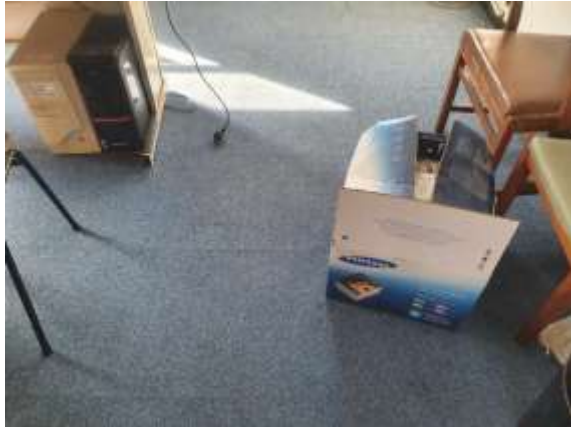
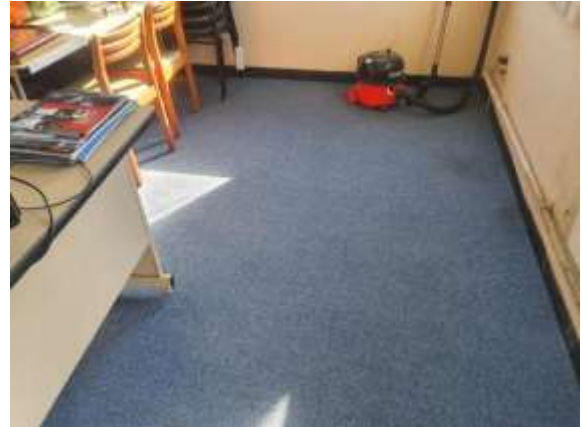
Location: Second Floor - ATC Training Room 004

Material Description:	Floor Tiles - Vinyl Products	
Identification:	Previously Sampled - Asbestos Detected	
Approx. quantity:	20 m ²	
Accessibility	Difficult	<i>Assessment Score</i>
Product type:	Vinyl	1
Extent of Damage:	Slight / minor damage	1
Surface Treatment:	Non-friable	0
Asbestos type:	Chrysotile	1
Material Assessment Score:		3
Priority Assessment Score:		Negligible
Action:	Manage	
Comments:	Previously sampled ref: REF96. Under carpet

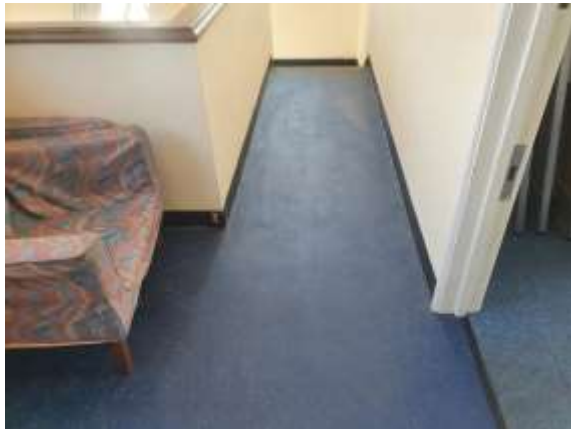
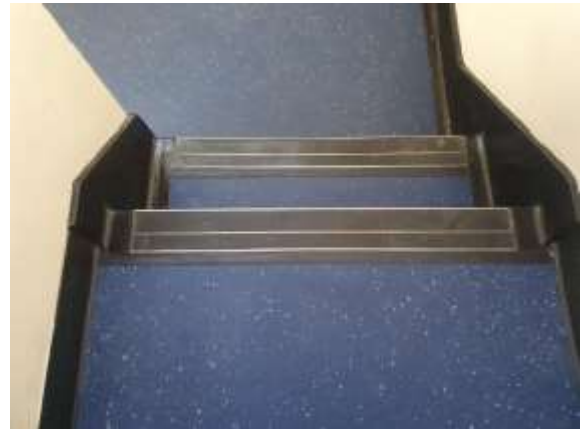
Location: Second Floor - Lobby and Stairs 005

Material Description:	Floor Tiles and Stair Nosing - Vinyl Products	
Identification:	Presumed to Contain Asbestos	
Approx. quantity:	18 m ²	
Accessibility	Easy	<i>Assessment Score</i>
Product type:	Vinyl	1
Extent of Damage:	Major damage	3
Surface Treatment:	Unsealed Insulation	3
Asbestos type:	Chrysotile	1
Material Assessment Score:		8
Priority Assessment Score:		Medium
Action:	Manage	
Comments:	Under vinyl flooring

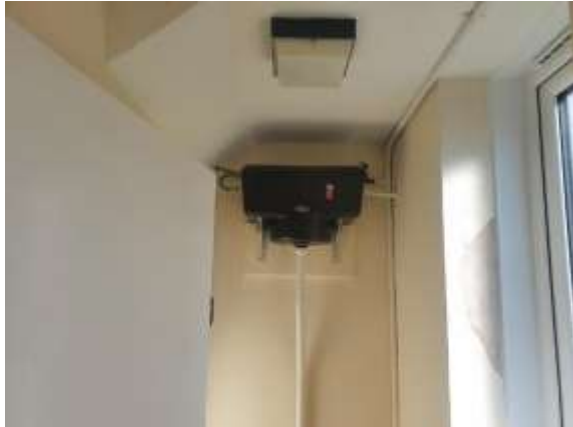
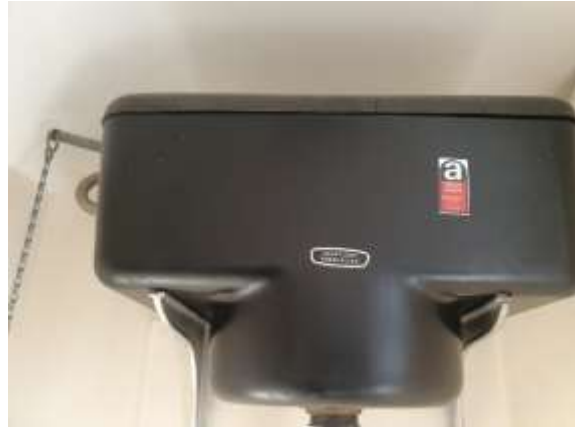
Location: Fifth Floor - Ladies WC 006

Material Description:	Toilet Cistern - PVC / Reinforced Plastics	
Identification:	Presumed to Contain Asbestos	
Approx. quantity:	1 no	
Accessibility	Difficult	<i>Assessment Score</i>
Product type:	Bakelite	1
Extent of Damage:	Major damage	3
Surface Treatment:	Unsealed Insulation	3
Asbestos type:	Amosite	2
Material Assessment Score:		9
Priority Assessment Score:		N/A
Action:	Manage	
Comments:	N/A

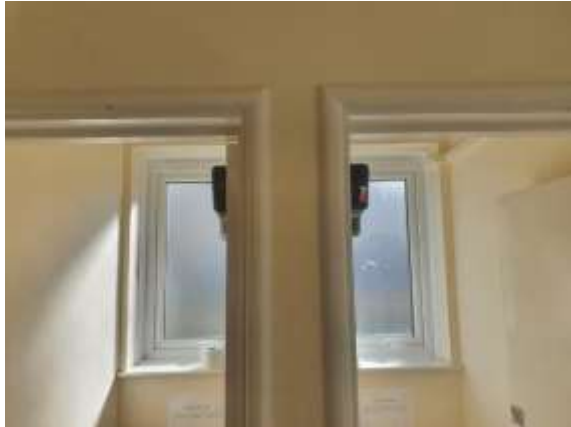
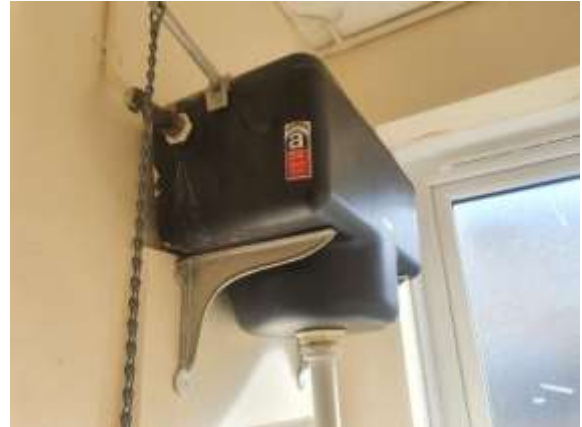
Location: First Floor - Mens WC 007

Material Description:	Toilet Cistern - PVC / Reinforced Plastics	
Identification:	Presumed to Contain Asbestos	
Approx. quantity:	2 no	
Accessibility	Difficult	<i>Assessment Score</i>
Product type:	Bakelite	1
Extent of Damage:	Major damage	3
Surface Treatment:	Unsealed Insulation	3
Asbestos type:	Amosite	2
Material Assessment Score:		9
Priority Assessment Score:		N/A
Action:	Manage	
Comments:	N/A

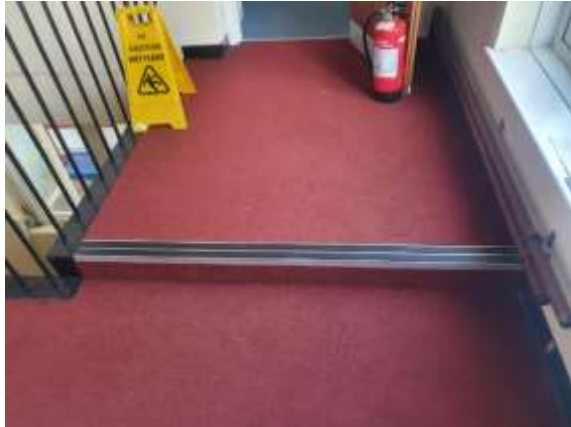
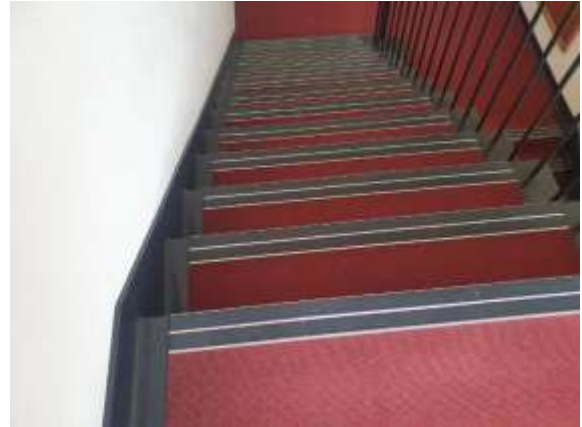
Location: First Floor - Stairwell 009

Material Description:	Floor Tiles - Vinyl Products	
Identification:	Strongly Presumed to Contain Asbestos	
Approx. quantity:	7 m ²	
Accessibility	Difficult	<i>Assessment Score</i>
Product type:	Vinyl	1
Extent of Damage:	Slight / minor damage	1
Surface Treatment:	Non-friable	0
Asbestos type:	Chrysotile	1
Material Assessment Score:		3
Priority Assessment Score:		Negligible
Action:	Manage	
Comments:	Under carpet

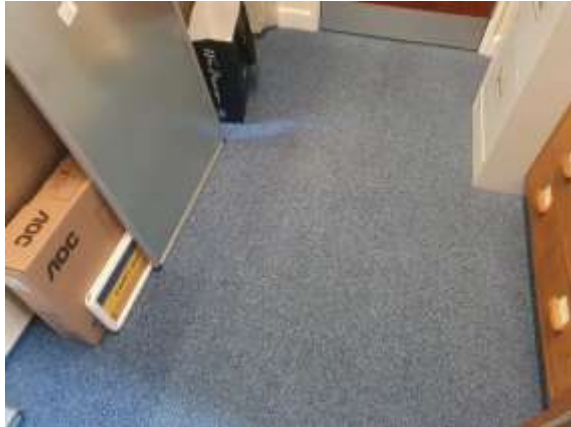
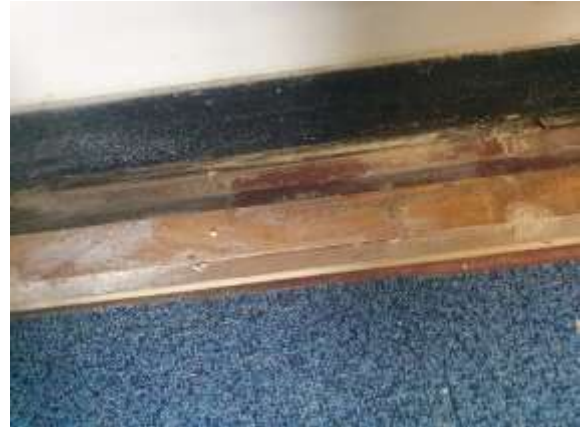
Location: First Floor - ACT QM Office 010

Material Description:	Within Boxing along Back Wall - No Access Gained	
Identification:	Presumed to Contain Asbestos	
Approx. quantity:	6 LM	
Accessibility	Difficult	<i>Assessment Score</i>
Product type:	Pipe Insulation	3
Extent of Damage:	Major damage	3
Surface Treatment:	Unsealed Insulation	3
Asbestos type:	Amosite, Chrysotile, Crocidolite	3
Material Assessment Score:		12
Priority Assessment Score:		High
Action:	Further Investigation Needed	
Comments:	No access within boxing without irreparable damage

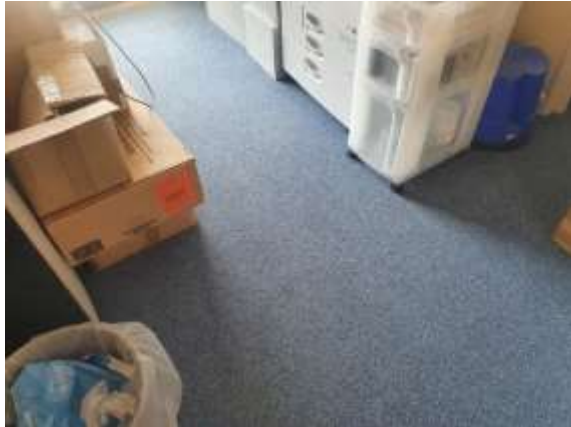
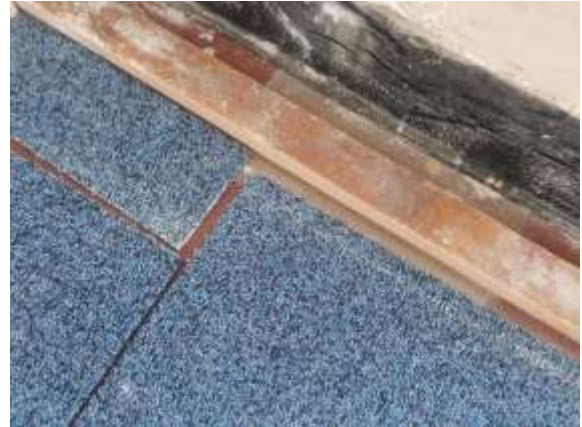
Location: First Floor - ACF Stationary Room 011

Material Description:	Floor Tiles - Vinyl Products	
Identification:	Previously Sampled - Asbestos Detected	
Approx. quantity:	22 m ²	
Accessibility	Difficult	<i>Assessment Score</i>
Product type:	Vinyl	1
Extent of Damage:	Slight / minor damage	1
Surface Treatment:	Non-friable	0
Asbestos type:	Chrysotile	1
Material Assessment Score:		3
Priority Assessment Score:		Negligible
Action:	Manage	
Comments:	Previously sampled ref: REF16. Under carpet

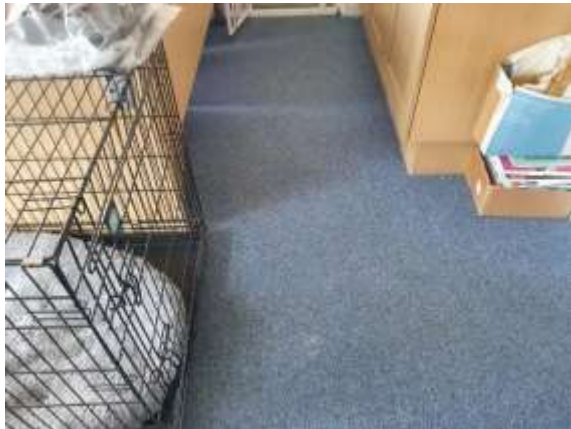
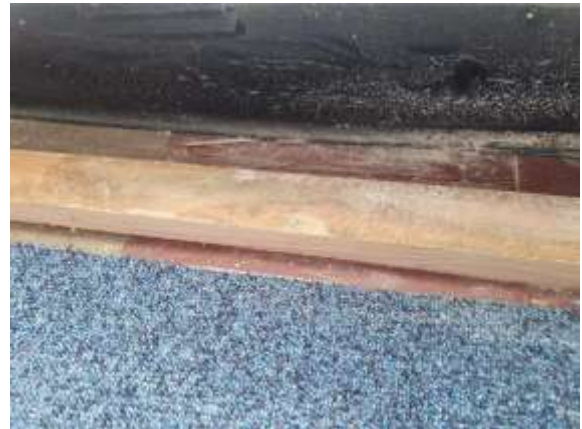
Location: First Floor - ACF AO Office 012

Material Description:	Floor Tiles - Vinyl Products	
Identification:	Presumed to Contain Asbestos	
Approx. quantity:	29 m ²	
Accessibility	Difficult	<i>Assessment Score</i>
Product type:	Vinyl	1
Extent of Damage:	Major damage	3
Surface Treatment:	Unsealed Insulation	3
Asbestos type:	Chrysotile	1
Material Assessment Score:		8
Priority Assessment Score:		Medium
Action:	Manage	
Comments:	Under carpet

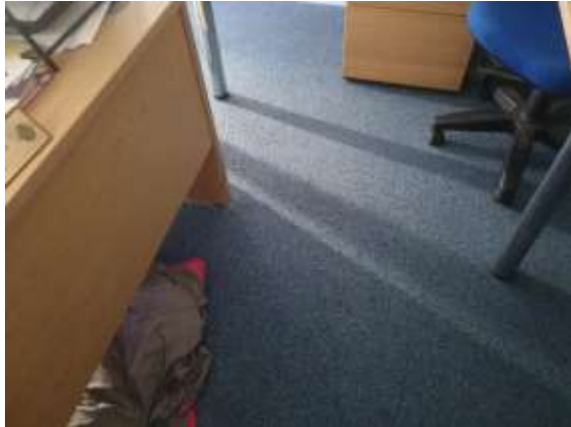
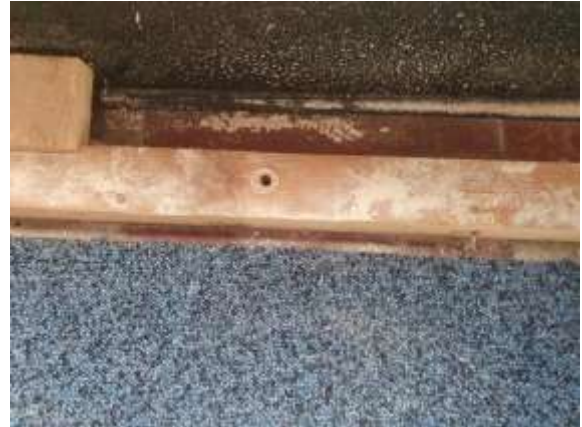
Location: First Floor - ACF AO Office 013

Material Description:	Within Boxing along Back Wall - No Access Gained	
Identification:	Presumed to Contain Asbestos	
Approx. quantity:	6 LM	
Accessibility	Difficult	<i>Assessment Score</i>
Product type:	Pipe Insulation	3
Extent of Damage:	Major damage	3
Surface Treatment:	Unsealed Insulation	3
Asbestos type:	Amosite, Chrysotile, Crocidolite	3
Material Assessment Score:		12
Priority Assessment Score:		High
Action:	Further Investigation Needed	
Comments:	No access within boxing without irreparable damage

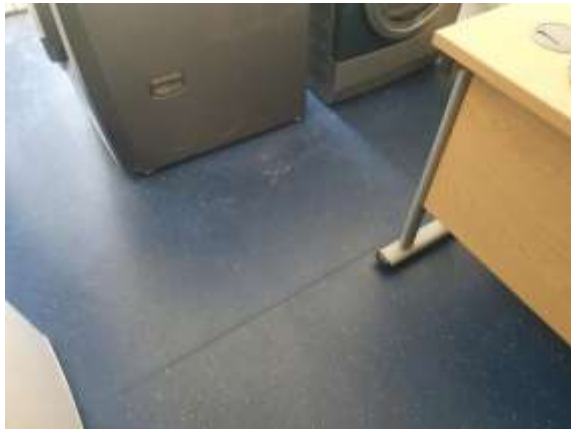
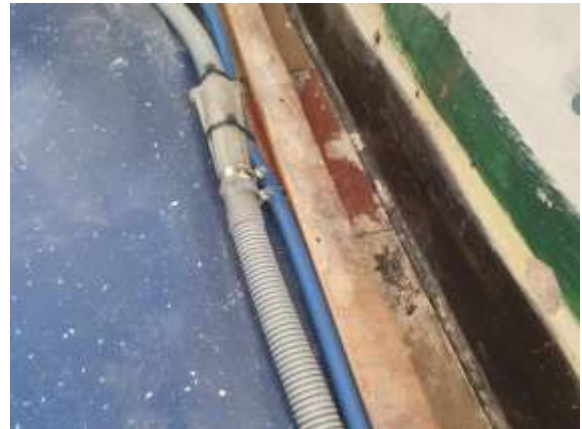
Location: First Floor - ACF AO Office 014

Material Description:	Floor Tiles - Vinyl Products	
Identification:	Strongly Presumed to Contain Asbestos	
Approx. quantity:	10 m ²	
Accessibility	Difficult	<i>Assessment Score</i>
Product type:	Vinyl	1
Extent of Damage:	Slight / minor damage	1
Surface Treatment:	Non-friable	0
Asbestos type:	Chrysotile	1
Material Assessment Score:		3
Priority Assessment Score:		Negligible
Action:	Manage	
Comments:	Under vinyl

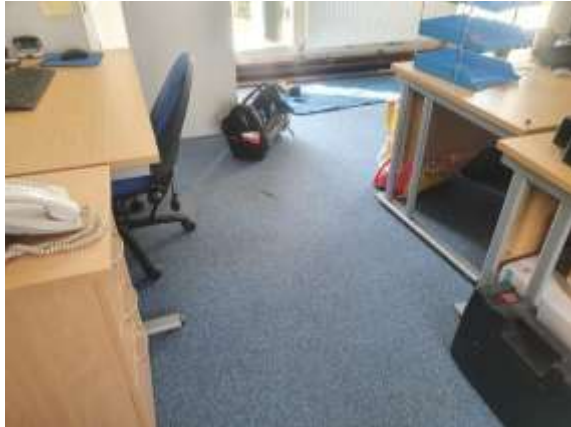
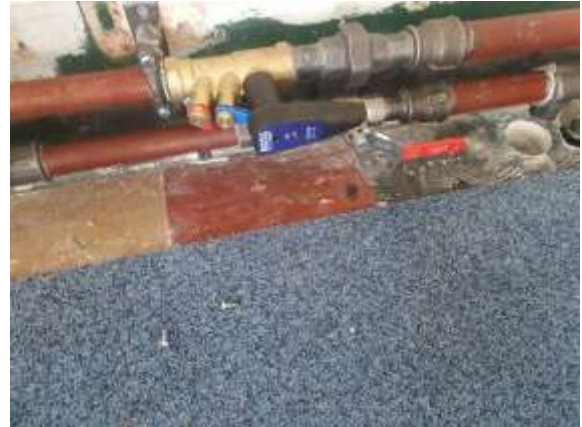
Location: First Floor - ACF Rest Room 015

Material Description:	Floor Tiles - Vinyl Products	
Identification:	Previously Sampled - Asbestos Detected	
Approx. quantity:	43 m ²	
Accessibility	Difficult	<i>Assessment Score</i>
Product type:	Vinyl	1
Extent of Damage:	Slight / minor damage	1
Surface Treatment:	Non-friable	0
Asbestos type:	Chrysotile	1
Material Assessment Score:		3
Priority Assessment Score:		Negligible
Action:	Manage	
Comments:	Previously sampled ref: REF16. Under carpet

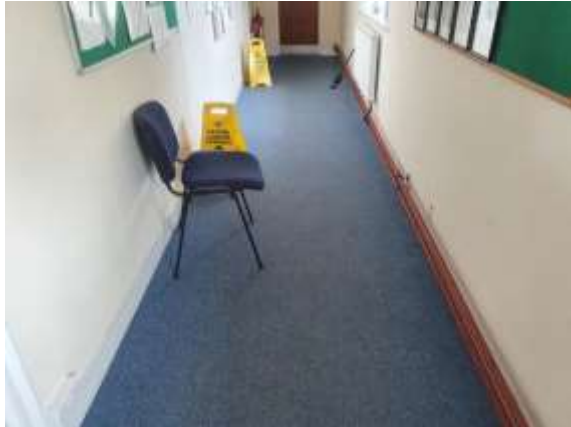
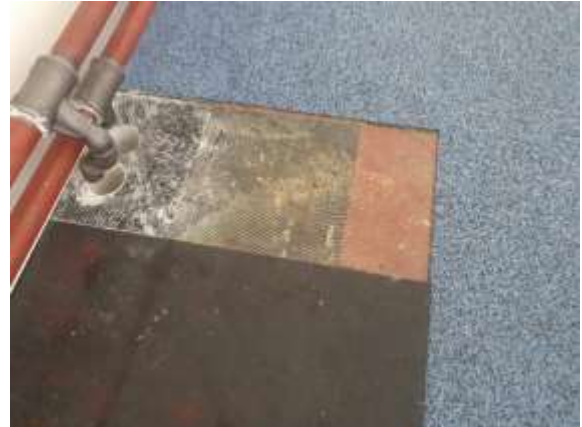
Location: First Floor - Zone 2 Corridor 016

Material Description:	Floor Tiles - Vinyl Products	
Identification:	Strongly Presumed to Contain Asbestos	
Approx. quantity:	24 m ²	
Accessibility	Difficult	<i>Assessment Score</i>
Product type:	Vinyl	1
Extent of Damage:	Slight / minor damage	1
Surface Treatment:	Non-friable	0
Asbestos type:	Chrysotile	1
Material Assessment Score:		3
Priority Assessment Score:		Negligible
Action:	Manage	
Comments:	Under carpet

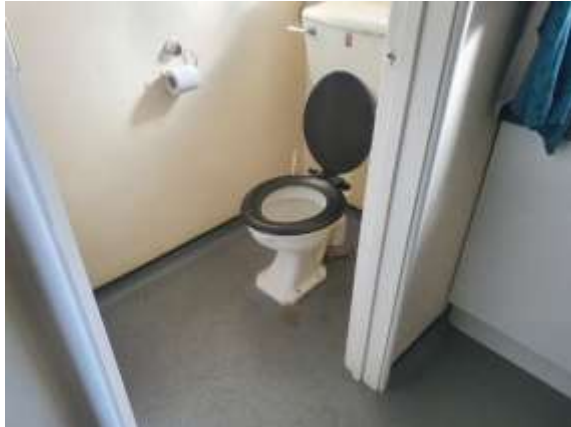
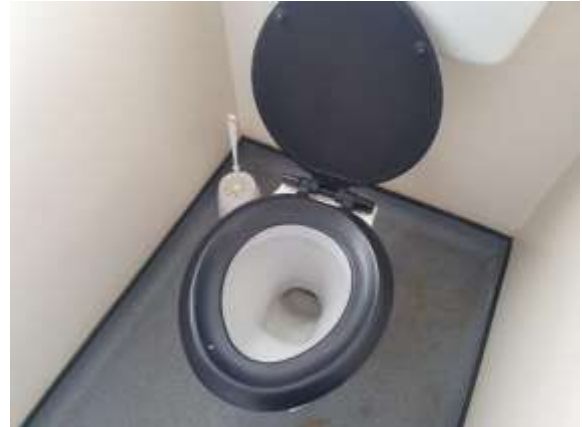
Location: Ground Floor - Mens WC 019

Material Description:	Toilet Seat - PVC / Reinforced Plastics	
Identification:	Presumed to Contain Asbestos	
Approx. quantity:	1 no	
Accessibility	Easy	<i>Assessment Score</i>
Product type:	Bakelite	1
Extent of Damage:	Major damage	3
Surface Treatment:	Unsealed Insulation	3
Asbestos type:	Chrysotile	1
Material Assessment Score:		8
Priority Assessment Score:		Medium
Action:	Manage	
Comments:	N/A

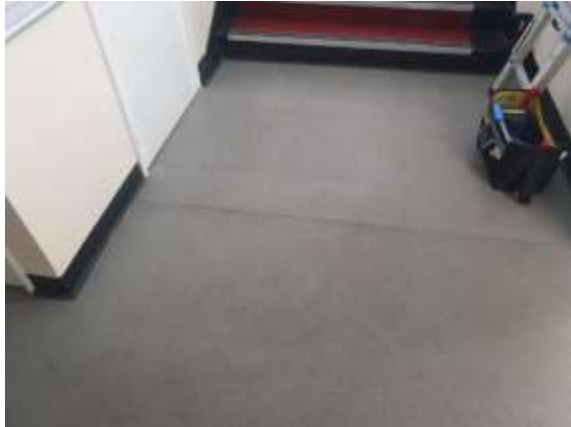
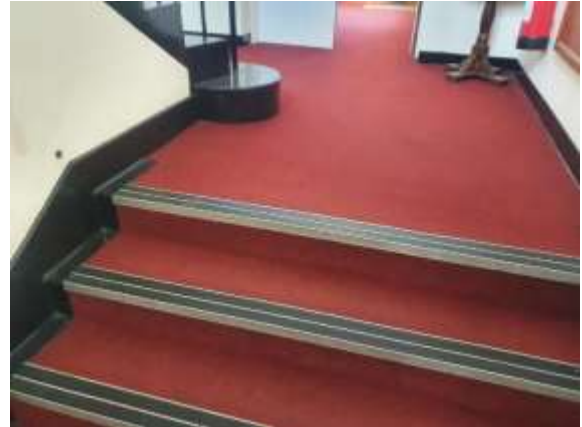
Location: Ground Floor - Corridor 023

Material Description:	Floor Tiles - Vinyl Products	
Identification:	Strongly Presumed to Contain Asbestos	
Approx. quantity:	7 m ²	
Accessibility	Difficult	<i>Assessment Score</i>
Product type:	Vinyl	1
Extent of Damage:	Slight / minor damage	1
Surface Treatment:	Non-friable	0
Asbestos type:	Chrysotile	1
Material Assessment Score:		3
Priority Assessment Score:		Negligible
Action:	Manage	
Comments:	Under vinyl and carpet

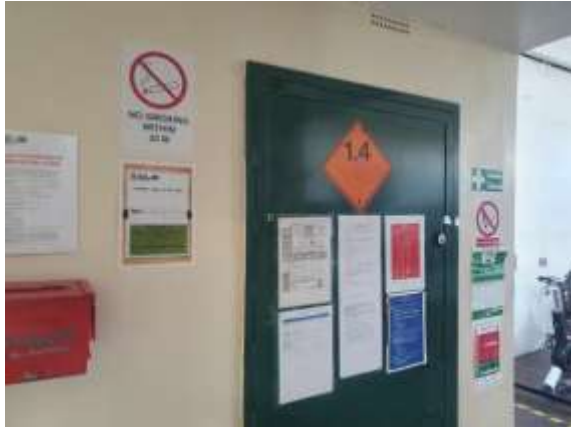
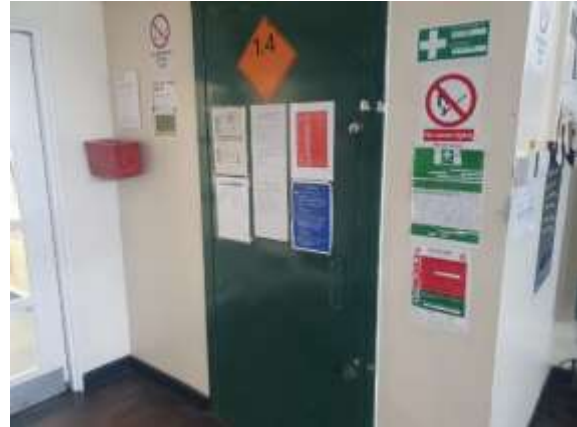
Location: First Floor - Ammo Store 024

Material Description:	All - No Access Gained	
Identification:	Presumed to Contain Asbestos	
Approx. quantity:	1 no	
Accessibility	Difficult	<i>Assessment Score</i>
Product type:	Pipe Insulation	3
Extent of Damage:	Major damage	3
Surface Treatment:	Unsealed Insulation	3
Asbestos type:	Amosite, Chrysotile, Crocidolite	3
Material Assessment Score:		12
Priority Assessment Score:		High
Action:	Further Investigation Needed	
Comments:	No access within locked store. The operative with access was not on site during the survey

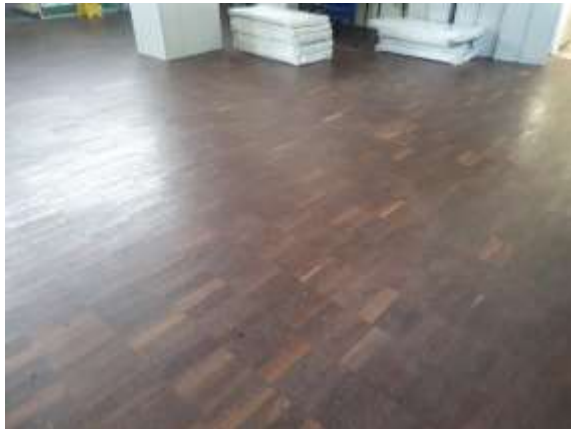
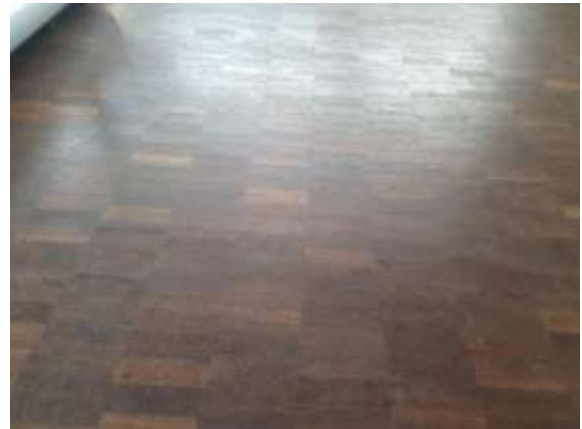
Location: Ground Floor - Drill Hall 025

Material Description:	Adhesive under Parquet Flooring - Bituminous Product	
Identification:	Presumed to Contain Asbestos	
Approx. quantity:	70 m ²	
Accessibility	Difficult	<i>Assessment Score</i>
Product type:	Bitumen	1
Extent of Damage:	Slight / minor damage	1
Surface Treatment:	Non-friable	0
Asbestos type:	Chrysotile	1
Material Assessment Score:		3
Priority Assessment Score:		Negligible
Action:	Manage	
Comments:	N/A

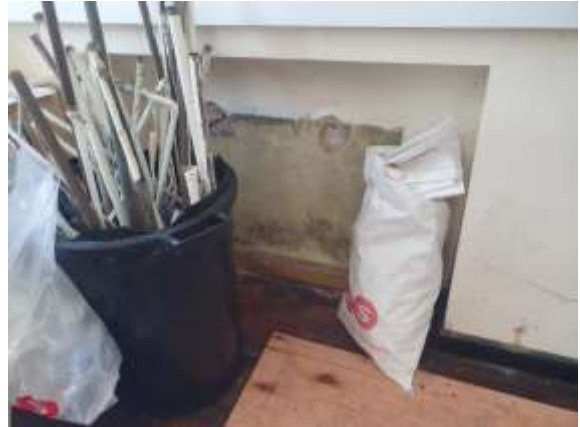
Location: Ground Floor - Drill Hall/Gym 026

Material Description:	Storage Heater - Insulating Board	
Identification:	Presumed to Contain Asbestos	
Approx. quantity:	1 no	
Accessibility	Difficult	<i>Assessment Score</i>
Product type:	Asbestos Insulating Board	2
Extent of Damage:	Slight / minor damage	1
Surface Treatment:	Non-friable	0
Asbestos type:	Amosite, Chrysotile	2
Material Assessment Score:		5
Priority Assessment Score:		Low
Action:	Manage	
Comments:	No access within live heaters

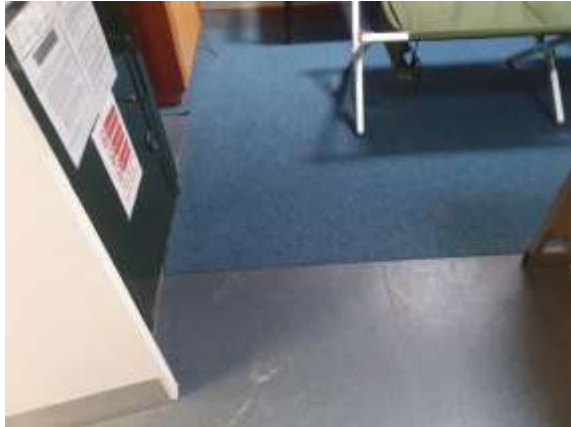
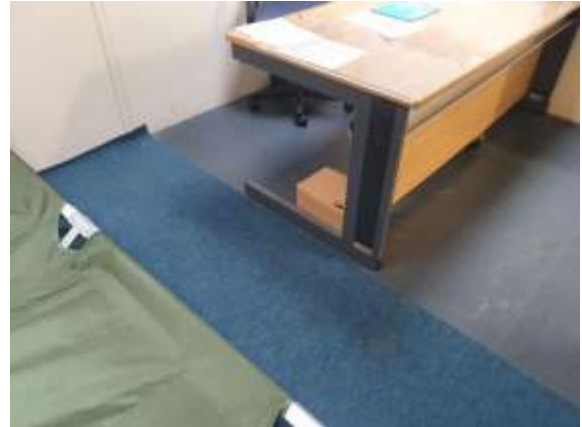
Location: Ground Floor - SC Room 027

Material Description:	Floor Tiles - Vinyl Products	
Identification:	Strongly Presumed to Contain Asbestos	
Approx. quantity:	20 m ²	
Accessibility	Difficult	<i>Assessment Score</i>
Product type:	Vinyl	1
Extent of Damage:	Slight / minor damage	1
Surface Treatment:	Non-friable	0
Asbestos type:	Chrysotile	1
Material Assessment Score:		3
Priority Assessment Score:		Negligible
Action:	Manage	
Comments:	Under carpet and vinyl

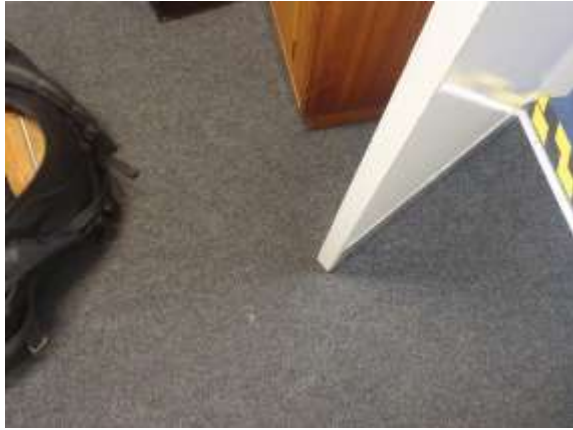
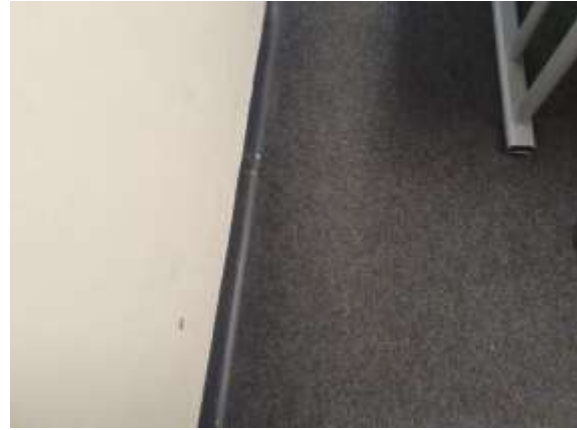
Location: Ground Floor - OC Office 028

Material Description:	Floor Tiles - Vinyl Products	
Identification:	Strongly Presumed to Contain Asbestos	
Approx. quantity:	24 m ²	
Accessibility	Difficult	<i>Assessment Score</i>
Product type:	Vinyl	1
Extent of Damage:	Slight / minor damage	1
Surface Treatment:	Non-friable	0
Asbestos type:	Chrysotile	1
Material Assessment Score:		3
Priority Assessment Score:		Negligible
Action:	Manage	
Comments:	Under carpet

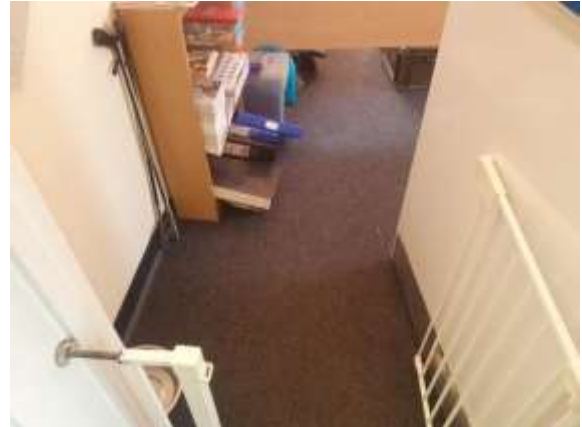
Location: Ground Floor - PASO and OPS Office 029

Material Description:	Floor Tiles - Vinyl Products	
Identification:	Strongly Presumed to Contain Asbestos	
Approx. quantity:	45 m ²	
Accessibility	Difficult	<i>Assessment Score</i>
Product type:	Vinyl	1
Extent of Damage:	Slight / minor damage	1
Surface Treatment:	Non-friable	0
Asbestos type:	Chrysotile	1
Material Assessment Score:		3
Priority Assessment Score:		Negligible
Action:	Manage	
Comments:	Under carpet

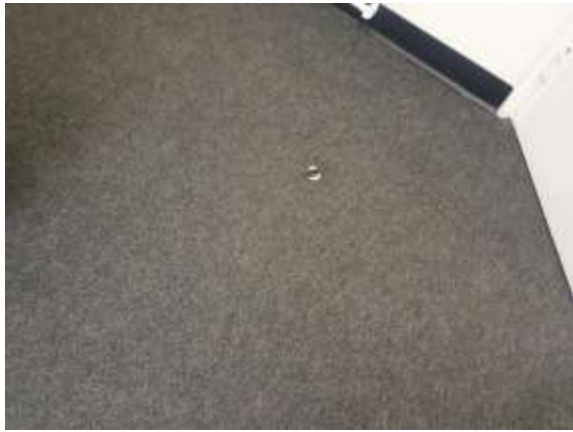
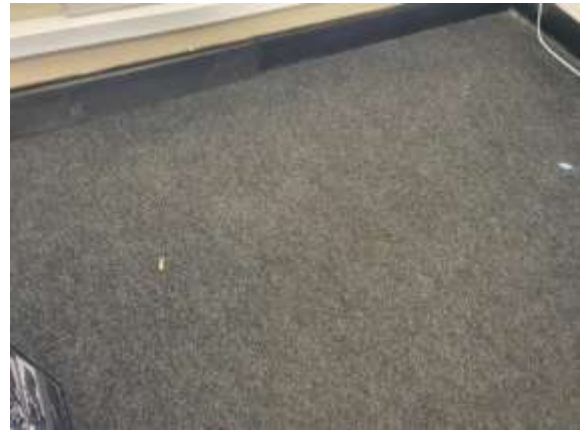
Location: Ground Floor - Server Room 031

Material Description:	Floor Tiles - Vinyl Products	
Identification:	Presumed to Contain Asbestos	
Approx. quantity:	18 m ²	
Accessibility	Difficult	<i>Assessment Score</i>
Product type:	Vinyl	1
Extent of Damage:	Slight / minor damage	1
Surface Treatment:	Non-friable	0
Asbestos type:	Chrysotile	1
Material Assessment Score:		3
Priority Assessment Score:		Negligible
Action:	Manage	
Comments:	Under carpet

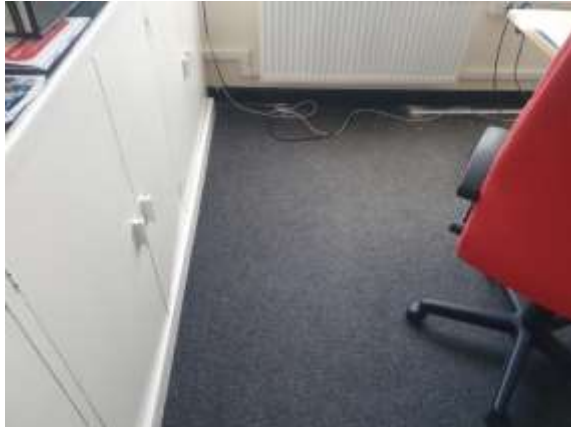
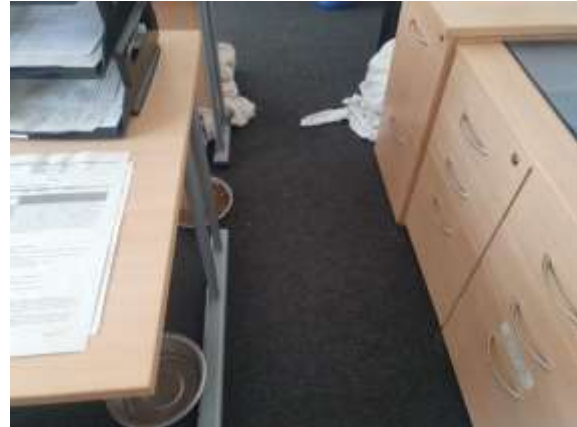
Location: Ground Floor - Troop Office 032

Material Description:	Floor Tiles - Vinyl Products	
Identification:	Presumed to Contain Asbestos	
Approx. quantity:	18 m ²	
Accessibility	Difficult	<i>Assessment Score</i>
Product type:	Vinyl	1
Extent of Damage:	Slight / minor damage	1
Surface Treatment:	Non-friable	0
Asbestos type:	Chrysotile	1
Material Assessment Score:		3
Priority Assessment Score:		Negligible
Action:	Manage	
Comments:	Under carpet

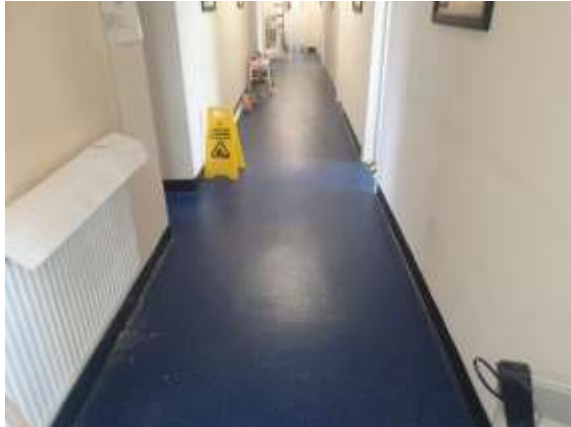
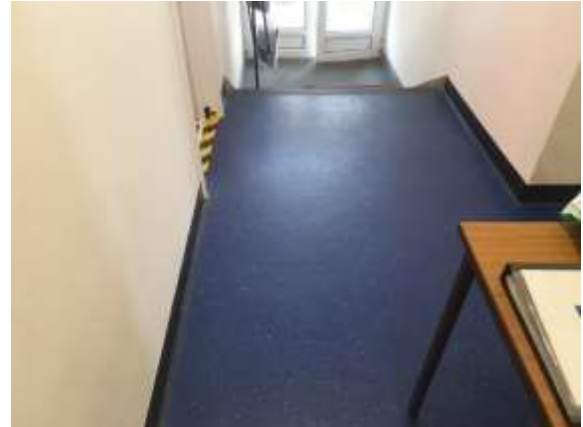
Location: Ground Floor - Hallway 033

Material Description:	Floor Tiles - Vinyl Products	
Identification:	Presumed to Contain Asbestos	
Approx. quantity:	20 m ²	
Accessibility	Difficult	<i>Assessment Score</i>
Product type:	Vinyl	1
Extent of Damage:	Slight / minor damage	1
Surface Treatment:	Non-friable	0
Asbestos type:	Chrysotile	1
Material Assessment Score:		3
Priority Assessment Score:		Negligible
Action:	Manage	
Comments:	Under vinyl

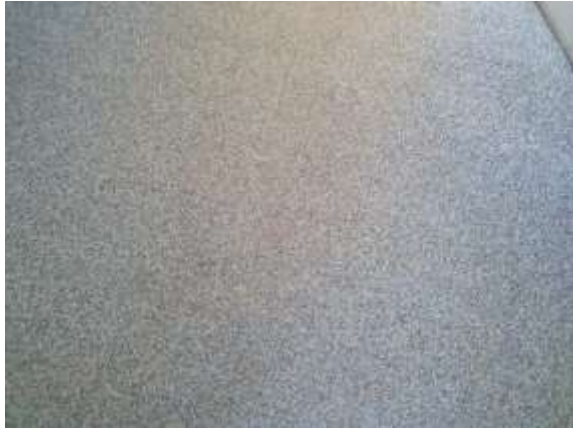
Location: Ground Floor - Stationary Office 034

Material Description:	Floor Tiles - Vinyl Products	
Identification:	Presumed to Contain Asbestos	
Approx. quantity:	15 m ²	
Accessibility	Difficult	<i>Assessment Score</i>
Product type:	Vinyl	1
Extent of Damage:	Slight / minor damage	1
Surface Treatment:	Non-friable	0
Asbestos type:	Chrysotile	1
Material Assessment Score:		3
Priority Assessment Score:		Negligible
Action:	Manage	
Comments:	Under carpet

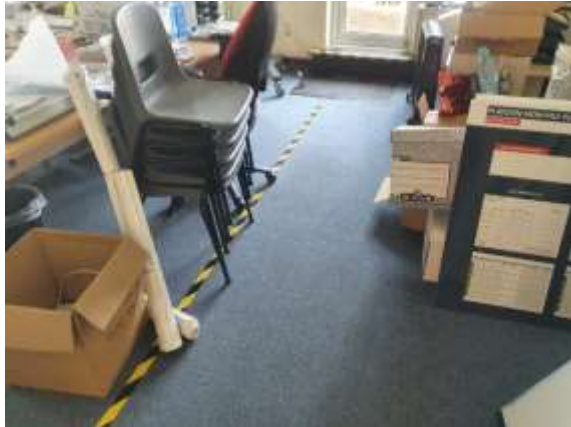
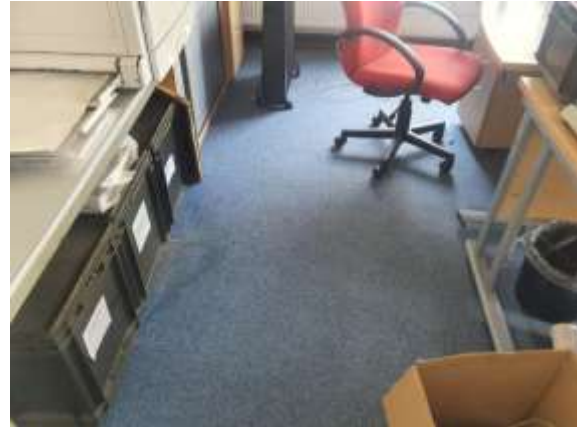
Location: Ground Floor - AO Office 035

Material Description:	Floor Tiles - Vinyl Products	
Identification:	Presumed to Contain Asbestos	
Approx. quantity:	43 m ²	
Accessibility	Difficult	<i>Assessment Score</i>
Product type:	Vinyl	1
Extent of Damage:	Slight / minor damage	1
Surface Treatment:	Non-friable	0
Asbestos type:	Chrysotile	1
Material Assessment Score:		3
Priority Assessment Score:		Negligible
Action:	Manage	
Comments:	Under carpet

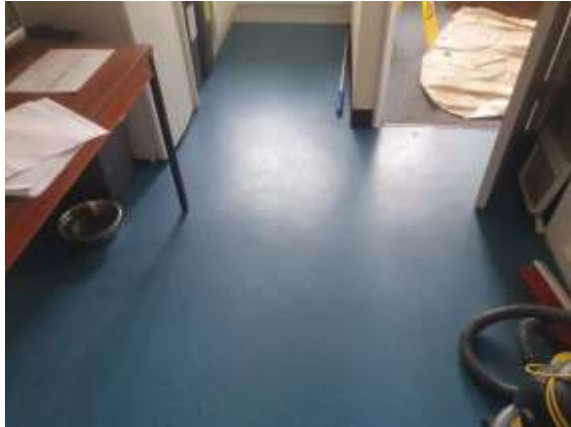
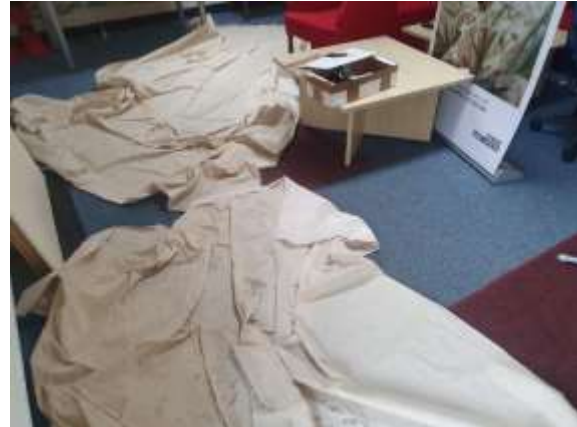
Location: Ground Floor - Rest Room and RRTT 036

Material Description:	Floor Tiles - Vinyl Products	
Identification:	Presumed to Contain Asbestos	
Approx. quantity:	70 m ²	
Accessibility	Difficult	<i>Assessment Score</i>
Product type:	Vinyl	1
Extent of Damage:	Slight / minor damage	1
Surface Treatment:	Non-friable	0
Asbestos type:	Chrysotile	1
Material Assessment Score:		3
Priority Assessment Score:		Negligible
Action:	Manage	
Comments:	Under carpet

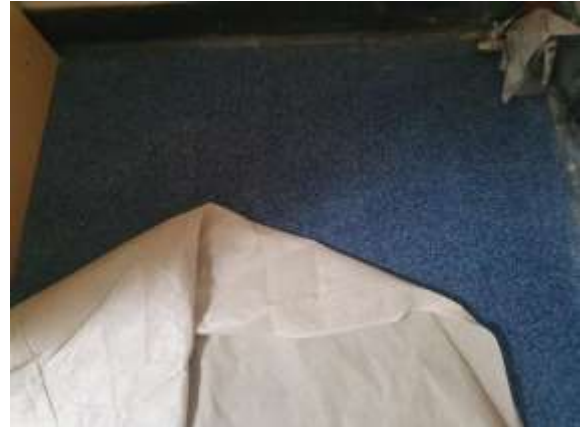
Location: Ground Floor - RRTT Office 037

Material Description:	Floor Tiles - Vinyl Products	
Identification:	Presumed to Contain Asbestos	
Approx. quantity:	15 m ²	
Accessibility	Difficult	<i>Assessment Score</i>
Product type:	Vinyl	1
Extent of Damage:	Slight / minor damage	1
Surface Treatment:	Non-friable	0
Asbestos type:	Chrysotile	1
Material Assessment Score:		3
Priority Assessment Score:		Negligible
Action:	Manage	
Comments:	Under carpet

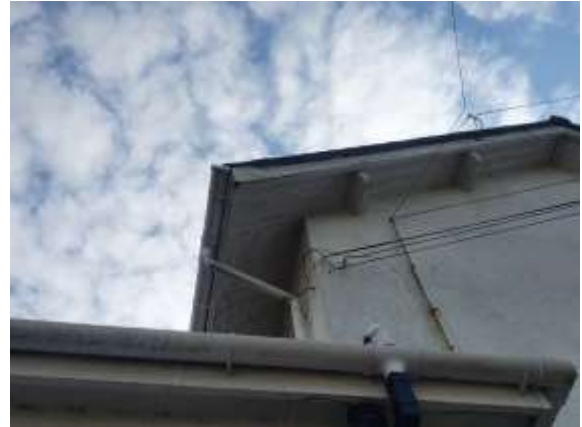
Location: External - Roof - Front Elevation 038

Material Description:	Undercloaking - Cement Product	
Identification:	Presumed to Contain Asbestos	
Approx. quantity:	16 LM	
Accessibility	Difficult	<i>Assessment Score</i>
Product type:	Cement	1
Extent of Damage:	Slight / minor damage	1
Surface Treatment:	Non-friable	0
Asbestos type:	Chrysotile	1
Material Assessment Score:		3
Priority Assessment Score:		Negligible
Action:	Manage	
Comments:	Unable to sample due to height

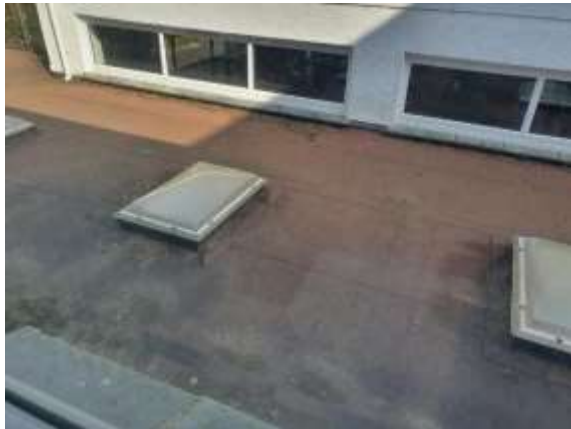
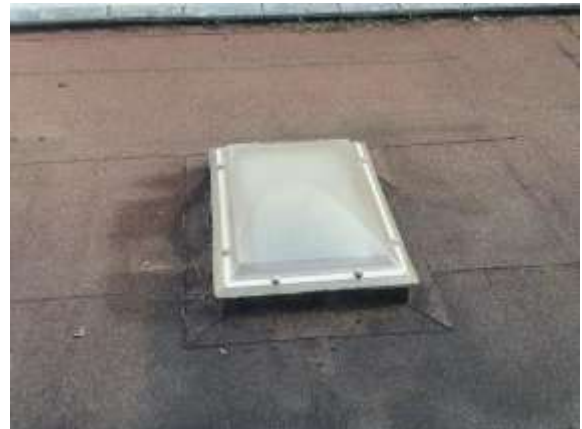
Location: External - Roof - Lights in Flat Roof 039

Material Description:	Roof Lights - Gaskets (rope/woven)	
Identification:	Previously Sampled - Asbestos Detected	
Approx. quantity:	6 no	
Accessibility	Difficult	<i>Assessment Score</i>
Product type:	Cement	1
Extent of Damage:	Moderate damage	2
Surface Treatment:	Woven Material	1
Asbestos type:	Chrysotile	1
Material Assessment Score:		5
Priority Assessment Score:		Low
Action:	Manage	
Comments:	Previously sampled ref: Sample REF111

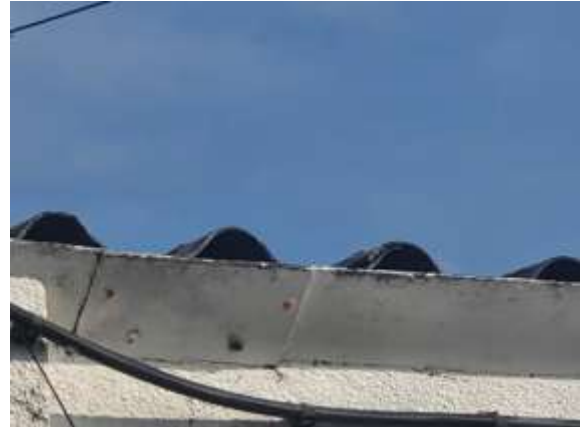
Location: External - External 040

Material Description:	Profiled Roof and Downpipes - Cement Product	
Identification:	Strongly Presumed to Contain Asbestos	
Approx. quantity:	12 LM	
Accessibility	Medium	<i>Assessment Score</i>
Product type:	Cement	1
Extent of Damage:	Slight / minor damage	1
Surface Treatment:	Unsealed Cement	1
Asbestos type:	Chrysotile	1
Material Assessment Score:		4
Priority Assessment Score:		Negligible
Action:	Manage	
Comments:	N/A

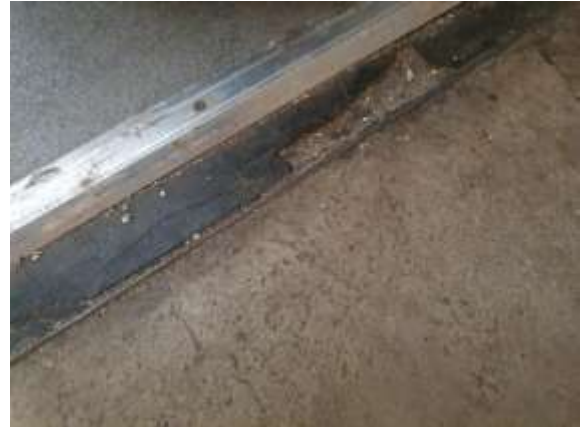
Location: Ground Floor - Stairwell to Boiler Room 042

Material Description:	Floor Tiles - Vinyl Products	
Identification:	Strongly Presumed to Contain Asbestos	
Approx. quantity:	1 LM	
Accessibility	Easy	<i>Assessment Score</i>
Product type:	Vinyl	1
Extent of Damage:	Moderate damage	2
Surface Treatment:	Non-friable	0
Asbestos type:	Chrysotile	1
Material Assessment Score:		4
Priority Assessment Score:		Negligible
Action:	Manage	
Comments:	Located by door

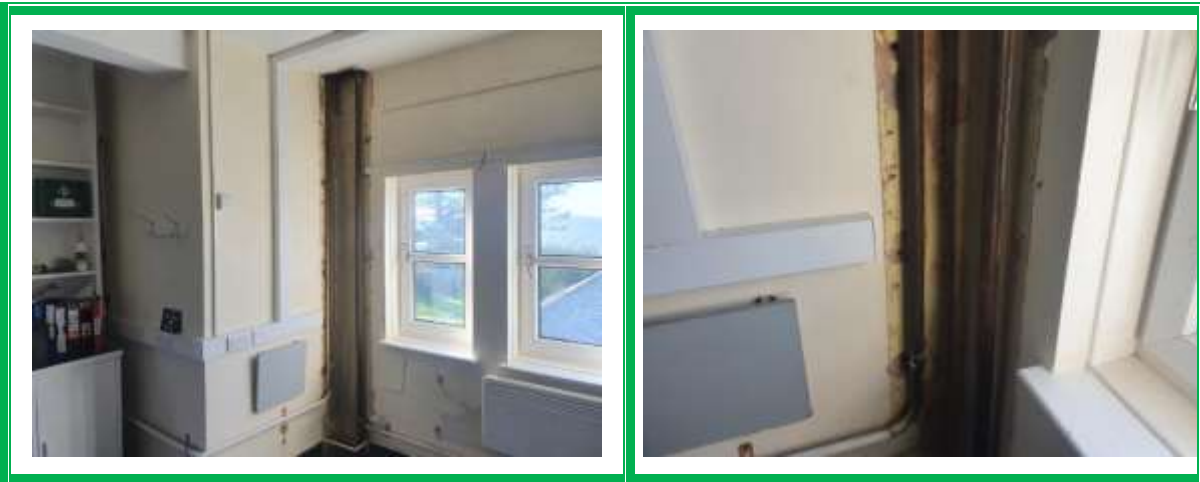
Item No:	2	Sample No:	N/A
Location:	Second Floor - ATC Office 002

Material Description:	No Suspect Materials Found	
Identification:	N/A	
Approx. quantity:	N/A	
Accessibility	N/A	<i>Assessment Score</i>
Product type:	N/A	N/A
Extent of Damage:	N/A	N/A
Surface Treatment:	N/A	N/A
Asbestos type:	N/A	N/A
Material Assessment Score:		N/A
Priority Assessment Score:		N/A
Action:	N/A	
Comments:	Boxing removed

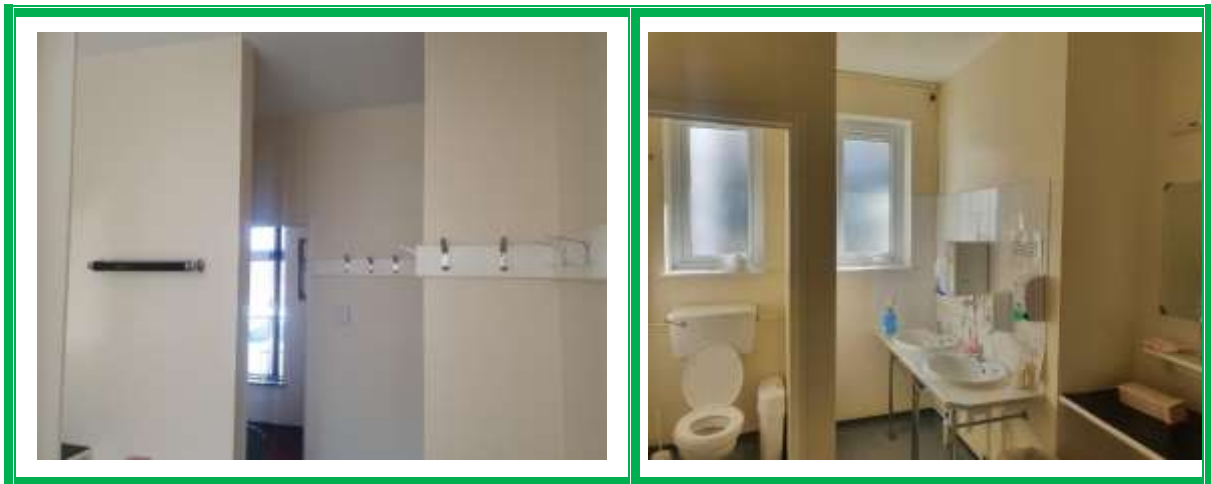
Item No: 17 **Sample No:** N/A

Material Description:	No Suspect Materials Found	
Identification:	N/A	
Approx. quantity:	N/A	
Accessibility	N/A	<i>Assessment Score</i>
Product type:	N/A	N/A
Extent of Damage:	N/A	N/A
Surface Treatment:	N/A	N/A
Asbestos type:	N/A	N/A
Material Assessment Score:		N/A
Priority Assessment Score:		N/A
Action:	N/A	
Comments:	Boiler removed

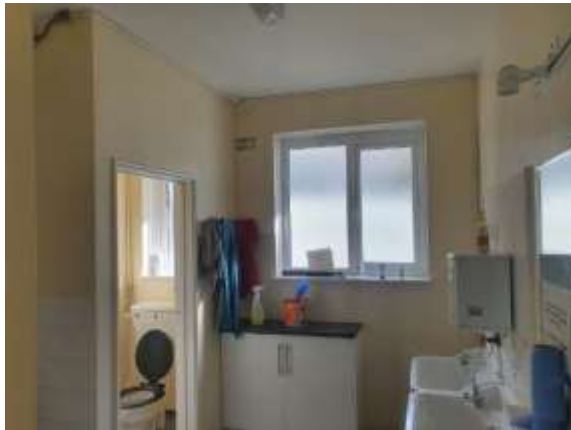
Item No: 18

Material Description:	No Suspect Materials Found	
Identification:	N/A	
Approx. quantity:	N/A	
Accessibility	N/A	<i>Assessment Score</i>
Product type:	N/A	N/A
Extent of Damage:	N/A	N/A
Surface Treatment:	N/A	N/A
Asbestos type:	N/A	N/A
Material Assessment Score:		N/A
Priority Assessment Score:		N/A
Action:	N/A	
Comments:	Boiler removed

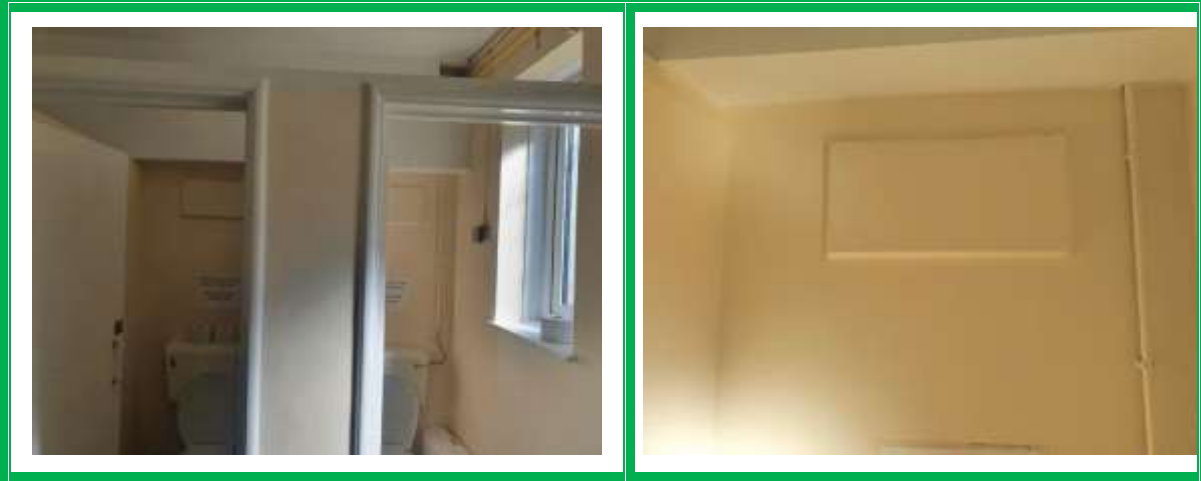
Material Description:	No Suspect Materials Found	
Identification:	N/A	
Approx. quantity:	N/A	
Accessibility	N/A	<i>Assessment Score</i>
Product type:	N/A	N/A
Extent of Damage:	N/A	N/A
Surface Treatment:	N/A	N/A
Asbestos type:	N/A	N/A
Material Assessment Score:		N/A
Priority Assessment Score:		N/A
Action:	N/A	
Comments:	Cistern removed

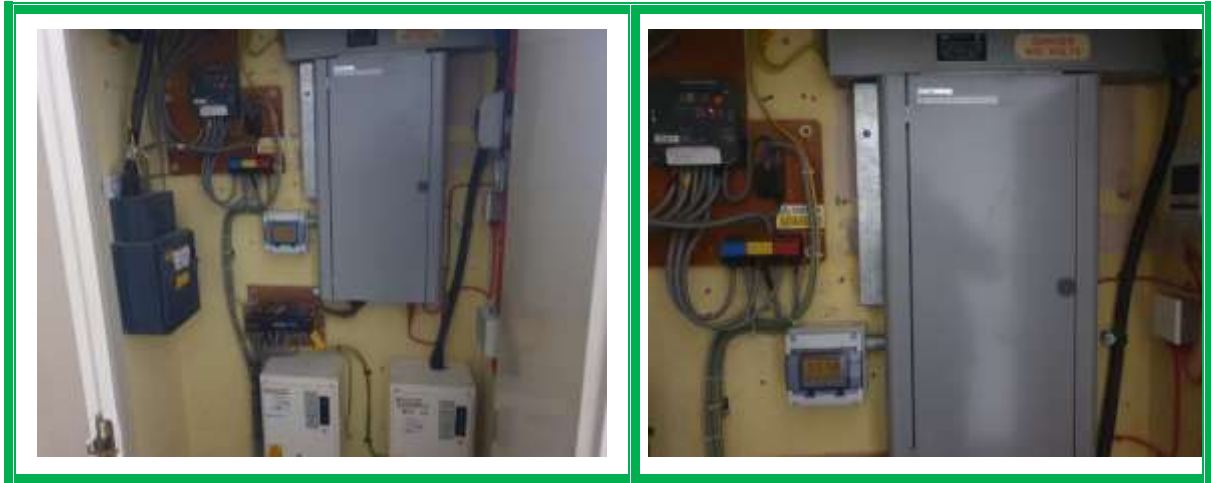
Material Description:	No Suspect Materials Found	
Identification:	N/A	
Approx. quantity:	N/A	
Accessibility	N/A	<i>Assessment Score</i>
Product type:	N/A	N/A
Extent of Damage:	N/A	N/A
Surface Treatment:	N/A	N/A
Asbestos type:	N/A	N/A
Material Assessment Score:		N/A
Priority Assessment Score:		N/A
Action:	N/A	
Comments:	Previously a no access area. Now accessed and no asbestos found. Modern electrics. No tiles under lino flooring

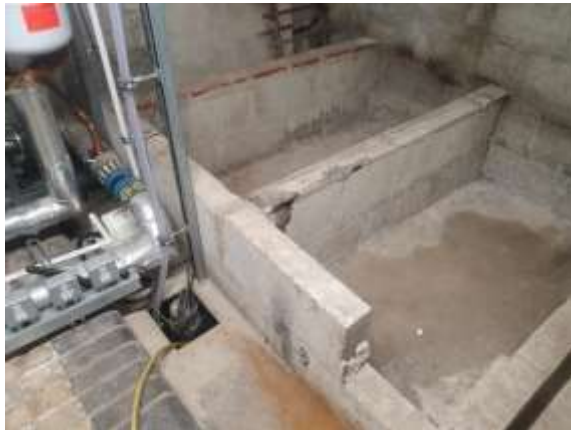
Item No: 22

Material Description:	Remains of Bitumen where Tank used to sit - Bituminous Product	
Identification:	Sampled - No Asbestos Found	
Approx. quantity:	N/A	
Accessibility	N/A	<i>Assessment Score</i>
Product type:	N/A	N/A
Extent of Damage:	N/A	N/A
Surface Treatment:	N/A	N/A
Asbestos type:	N/A	N/A
Material Assessment Score:		N/A
Priority Assessment Score:		N/A
Action:	N/A	
Comments:	Modern boilers and pipework. Non asbestos slate packers visible within hole in wall
