Project Number 3700

**Re-Inspection
Asbestos Survey Report**

**232 Port Squadron
Bodmin
Cornwall
PL31 1DX**

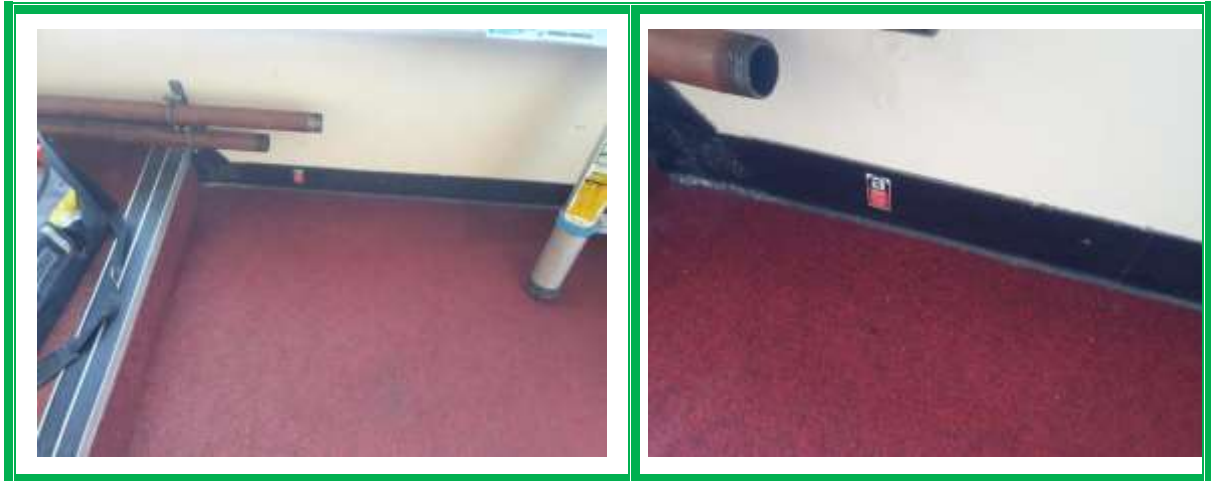
Material Description:	Skirting Boards - PVC / Reinforced Plastics	
Identification:	Sampled - No Asbestos Found	
Approx. quantity:	N/A	
Accessibility	N/A	<i>Assessment Score</i>
Product type:	N/A	N/A
Extent of Damage:	N/A	N/A
Surface Treatment:	N/A	N/A
Asbestos type:	N/A	N/A
Material Assessment Score:		N/A
Priority Assessment Score:		N/A
Action:	N/A	
Comments:	Treat as uniform to skirting boards throughout building
