ARMOUR
ANALYTICAL SERVICES

Project Number 2481

**Management
Asbestos Survey Report**

**2152 North Bristol Squadron, Filton, Bristol,
BS7 0SL**

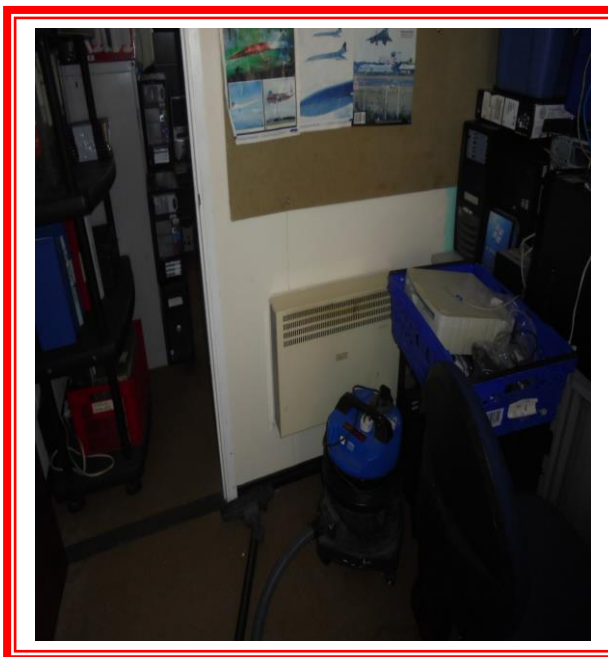
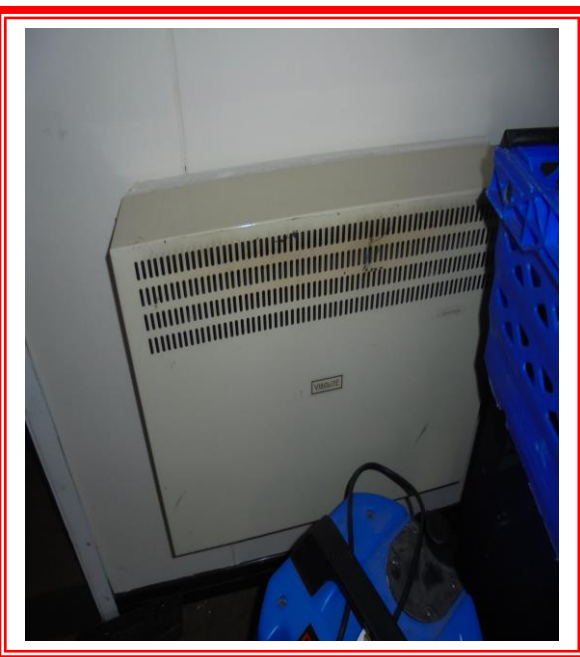
Item No: 4

Item 4 – Concorde Building – Office – Components within Heater – Unable to sample as presumed live

Material Description:	Components within Heater	
Identification:	Presumed to Contain Asbestos	
Approx. quantity:	X 1 Heater	
Accessibility	Low	<i>Assessment Score</i>
Product type:	No Access	2
Extent of Damage:	No Access	2
Surface Treatment:	No Access	2
Asbestos type:	No Access	2
Material Assessment Score:		8
Priority Assessment Score:		Medium
Action:	Manage	
Comments:	No access to inspect as presumed live

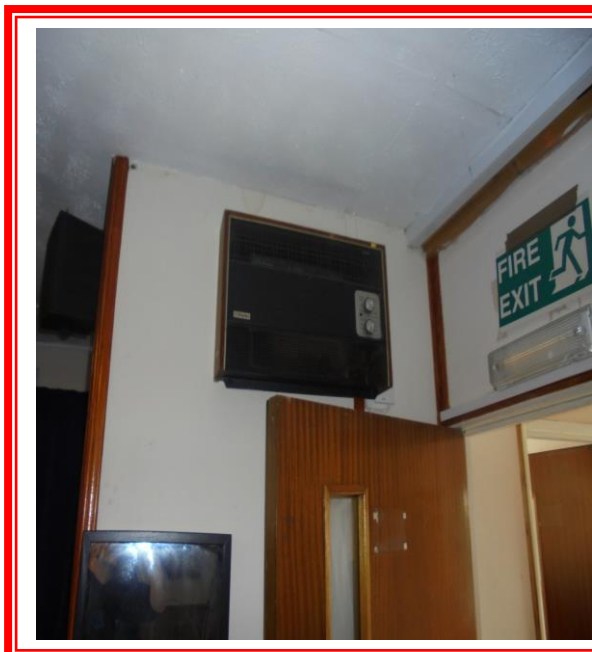
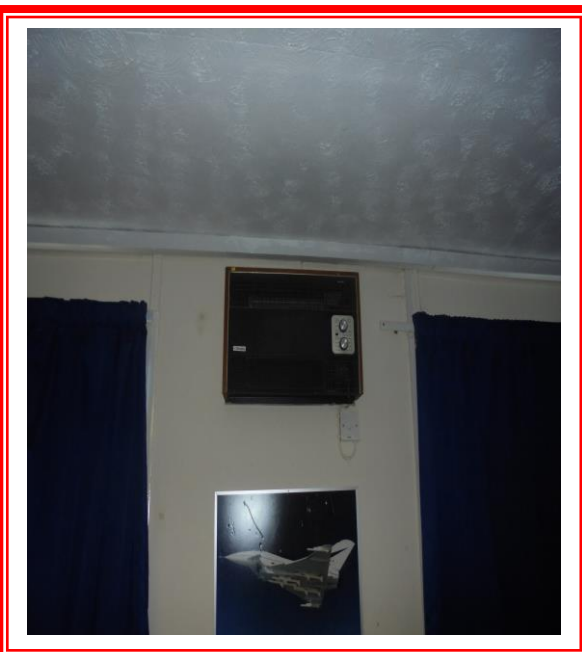
Item No: 12

Item 12 – Cadet Mess – Old Dimplex Heater - Unable to sample as presumed live

Material Description:	Old Dimplex Heater	
Identification:	Presumed to Contain Asbestos	
Approx. quantity:	X 2 Heater's	
Accessibility	Low	<i>Assessment Score</i>
Product type:	No Access	2
Extent of Damage:	No Access	2
Surface Treatment:	No Access	2
Asbestos type:	No Access	2
Material Assessment Score:		8
Priority Assessment Score:		Medium
Action:	Manage	
Comments:	No access to inspect as presumed live

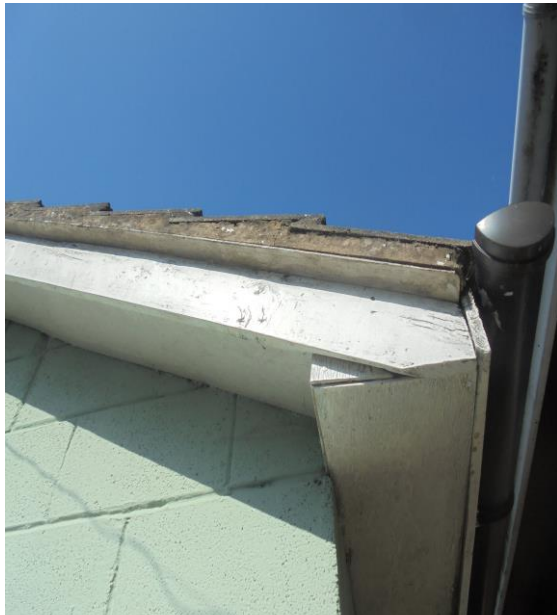
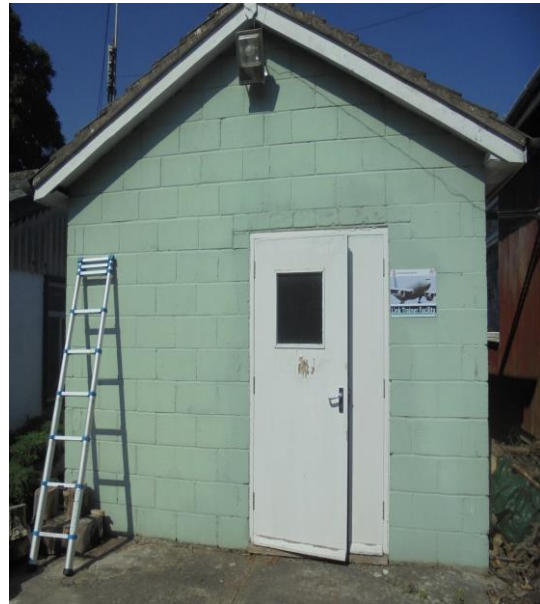
Item No: 13

Material Description:	Cement Undercloaking	
Identification:	Sampled – Asbestos Detected	
Approx. quantity:	8LM	
Accessibility	Low	Assessment Score
Product type:	Cement	1
Extent of Damage:	Minor	1
Surface Treatment:	Unsealed	1
Asbestos type:	Chrysotile	1
Material Assessment Score:		4
Priority Assessment Score:		Negligible
Action:	Manage	
Comments:	N/A

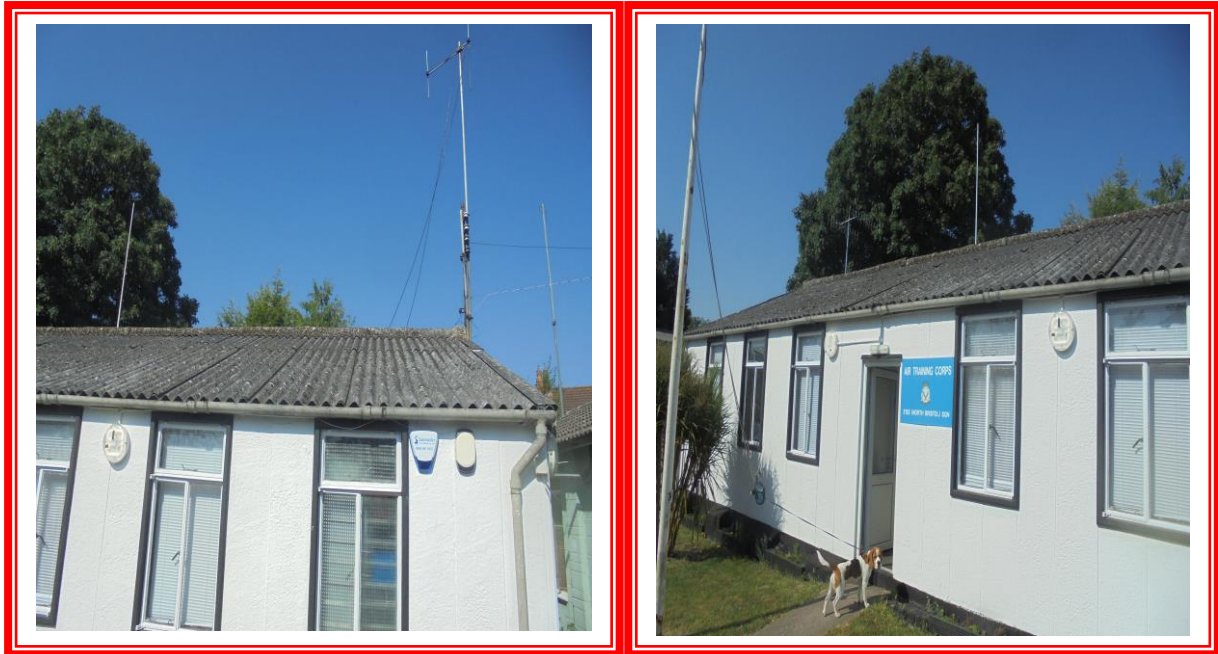
**Item No: 15****Sample No: 6****Location: External – Admin Building**

Material Description:	Profiled Cement Roof	
Identification:	Sampled – Asbestos Detected	
Approx. quantity:	100M2	
Accessibility	Low	<i>Assessment Score</i>
Product type:	Cement	1
Extent of Damage:	Minor	1
Surface Treatment:	Unsealed	1
Asbestos type:	Chrysotile/Crocidolite	3
Material Assessment Score:		6
Priority Assessment Score:		Low
Action:	Manage	
Comments:	N/A

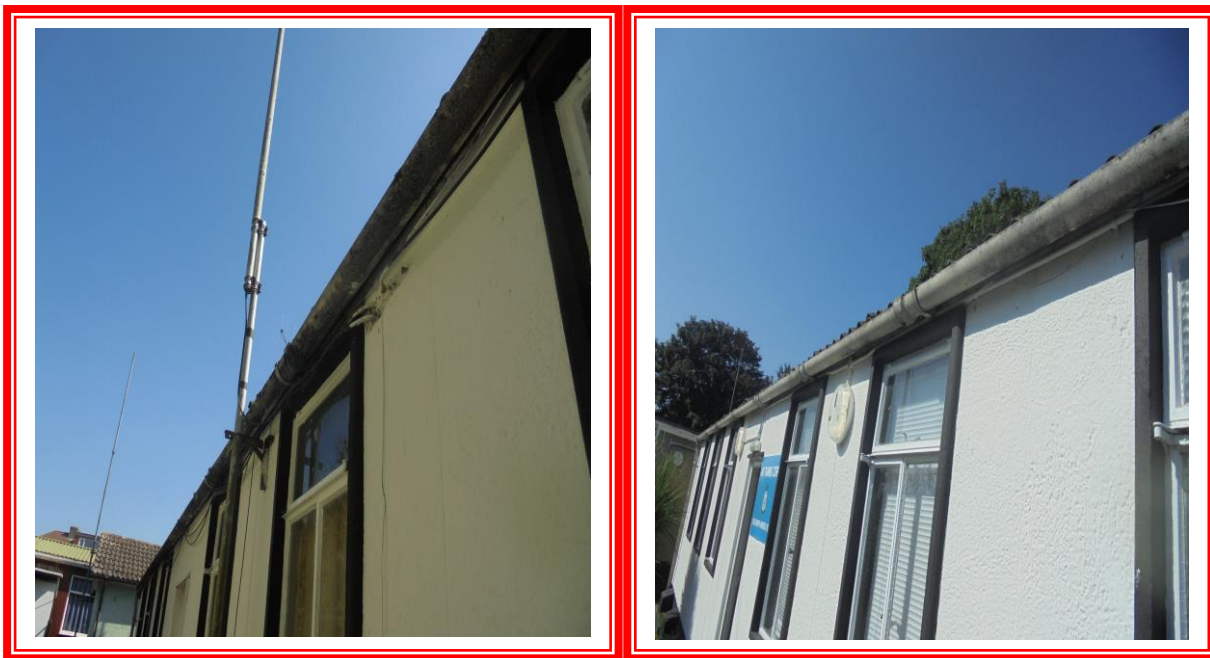
**Item No: 16****Sample No: N/A****Location: External – Admin Building**

Material Description:	Cement Guttering	
Identification:	As Per Sample 7– Asbestos Detected	
Approx. quantity:	28LM	
Accessibility	Low	<i>Assessment Score</i>
Product type:	Cement	1
Extent of Damage:	Minor	1
Surface Treatment:	Unsealed	1
Asbestos type:	Chrysotile	1
Material Assessment Score:		4
Priority Assessment Score:		Negligible
Action:	Manage	
Comments:	N/A

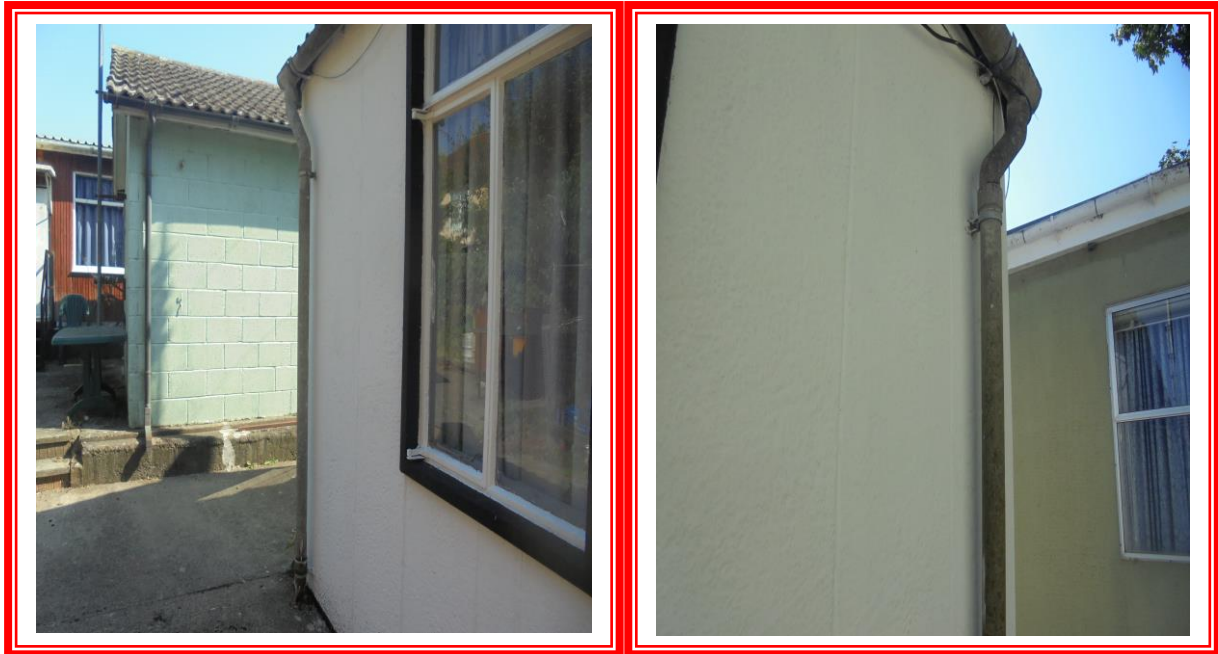
**Item No: 17****Sample No: 7****Location: External – Admin Building**

Material Description:	Cement Downpipes	
Identification:	Sampled – Asbestos Detected	
Approx. quantity:	X 4 (12LM in Total)	
Accessibility	Medium	<i>Assessment Score</i>
Product type:	Cement	1
Extent of Damage:	Minor	1
Surface Treatment:	Unsealed	1
Asbestos type:	Chrysotile	1
Material Assessment Score:		4
Priority Assessment Score:		Negligible
Action:	Manage	
Comments:	N/A

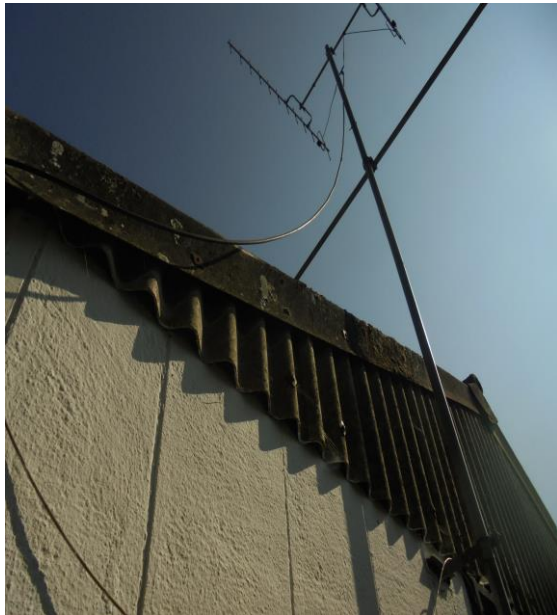
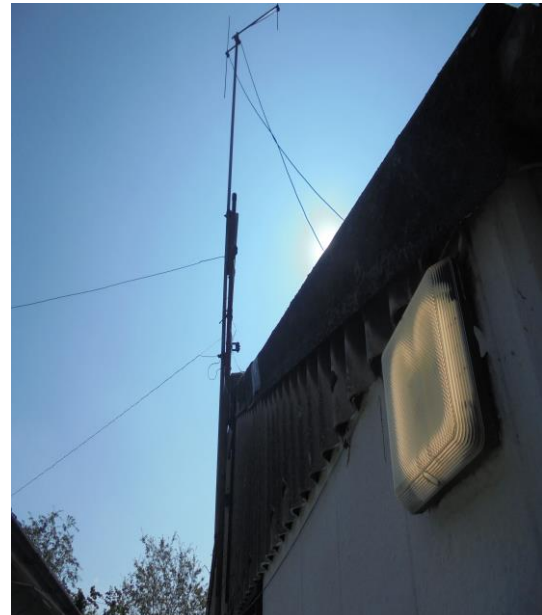
**Item No: 18****Sample No: 8****Location: External – Admin Building**

Material Description:	Cement Roof Edging	
Identification:	Sampled – Asbestos Detected	
Approx. quantity:	14LM	
Accessibility	Low	<i>Assessment Score</i>
Product type:	Cement	1
Extent of Damage:	Minor	1
Surface Treatment:	Unsealed	1
Asbestos type:	Chrysotile	1
Material Assessment Score:		4
Priority Assessment Score:		Negligible
Action:	Manage	
Comments:	N/A

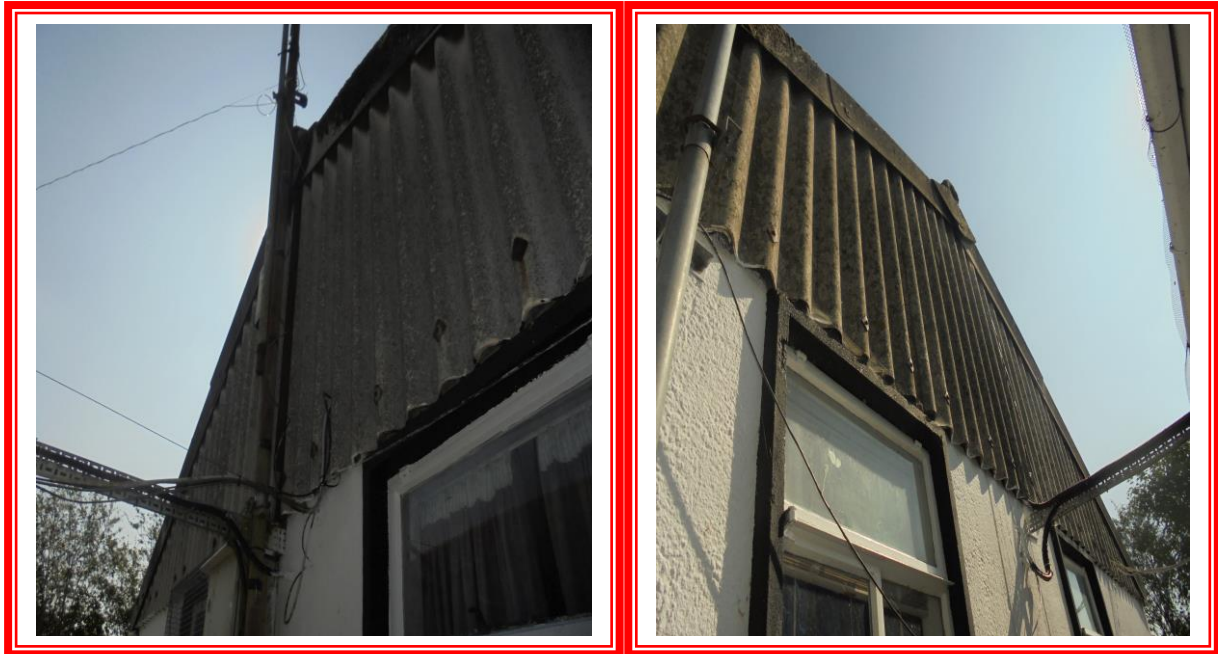
**Item No: 19****Sample No: N/A****Location: External – Admin Building**

Material Description:	Profiled Cement Wall Cladding	
Identification:	As Sample 6 – Asbestos Detected	
Approx. quantity:	20M2	
Accessibility	Low	<i>Assessment Score</i>
Product type:	Cement	1
Extent of Damage:	Minor	1
Surface Treatment:	Unsealed	1
Asbestos type:	Chrysotile	1
Material Assessment Score:		4
Priority Assessment Score:		Negligible
Action:	Manage	
Comments:	N/A

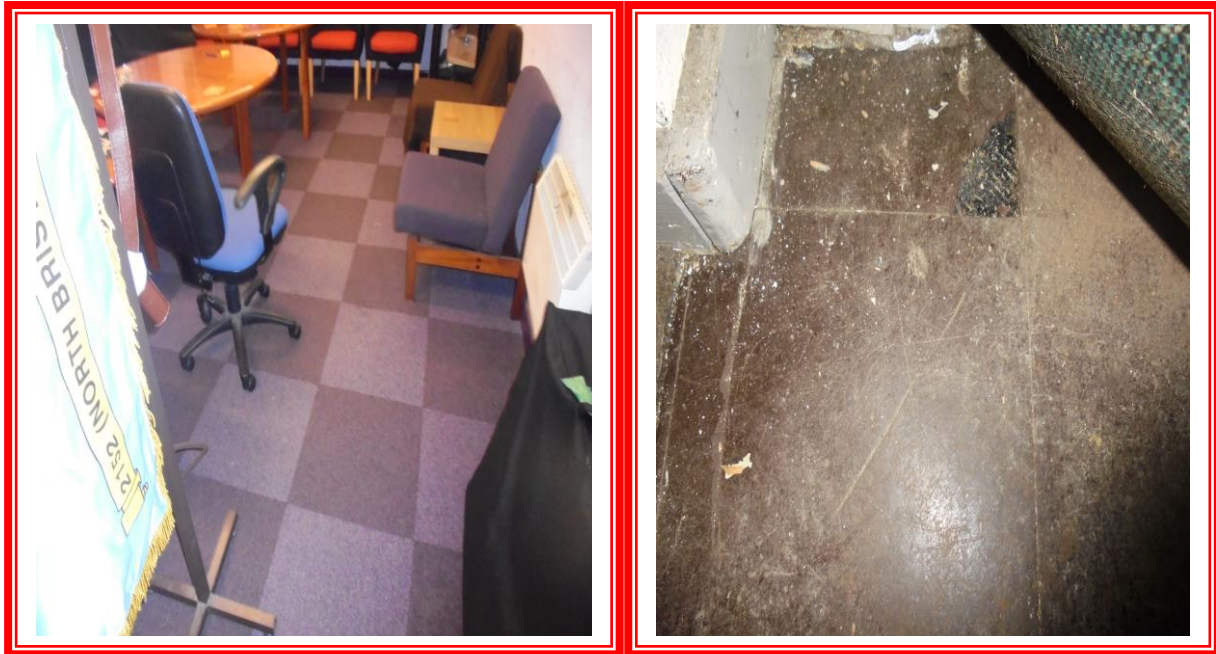
Item No: 20

Material Description:	Floor Tiles and Adhesive Under Carpet	
Identification:	Sampled – Asbestos Detected	
Approx. quantity:	40M2	
Accessibility	Low	<i>Assessment Score</i>
Product type:	Composite	1
Extent of Damage:	Minor	1
Surface Treatment:	Non-Friable	0
Asbestos type:	Chrysotile	1
Material Assessment Score:		3
Priority Assessment Score:		Negligible
Action:	Manage	
Comments:	Non-Asbestos fibreboard ceiling above suspended ceilings

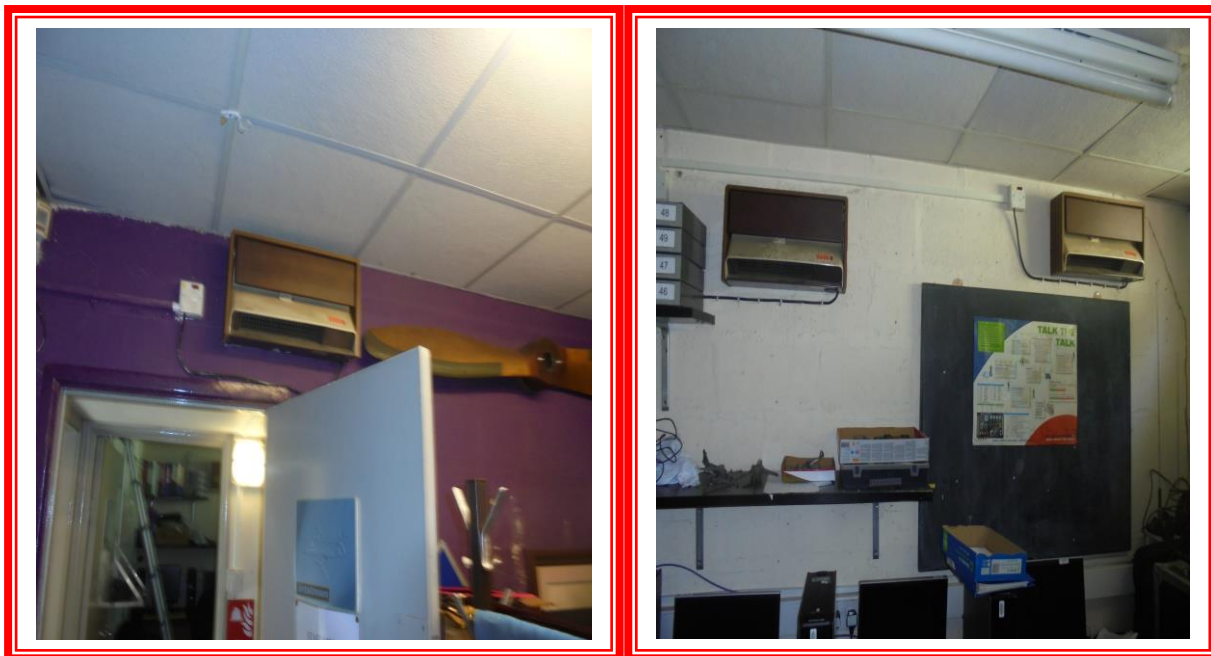
Item No: 21

Item 21 - Admin Block – Comms Room and Mess Room – Heaters - Unable to sample as presumed live

Material Description:	Components within Heaters	
Identification:	Presumed to Contain Asbestos	
Approx. quantity:	X 3 Heaters	
Accessibility	Low	<i>Assessment Score</i>
Product type:	No Access	2
Extent of Damage:	No Access	2
Surface Treatment:	No Access	2
Asbestos type:	No Access	2
Material Assessment Score:		8
Priority Assessment Score:		Medium
Action:	Manage	
Comments:	Unable to sample as presumed live

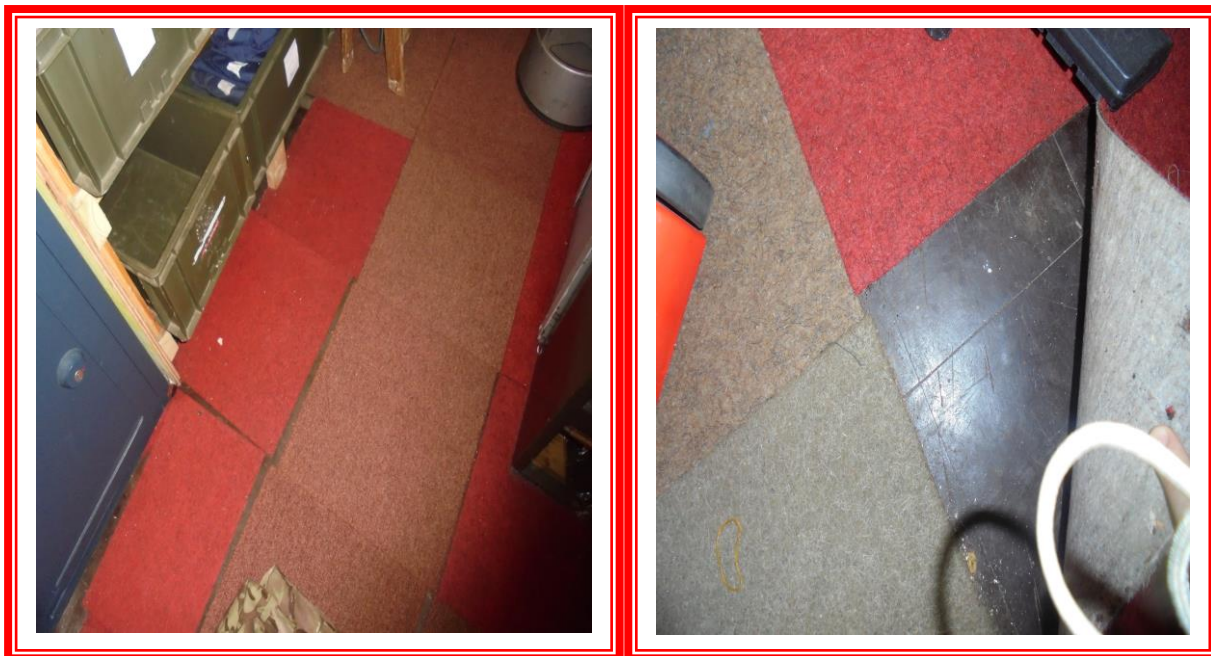
Item No: 22

Material Description:	Floor Tiles and Adhesive Under Carpet	
Identification:	As Per Sample 9 – Asbestos Detected	
Approx. quantity:	24M2	
Accessibility	Low	<i>Assessment Score</i>
Product type:	Composite	1
Extent of Damage:	Minor	1
Surface Treatment:	Non-Friable	0
Asbestos type:	Chrysotile	1
Material Assessment Score:		3
Priority Assessment Score:		Negligible
Action:	Manage	
Comments:	N/A

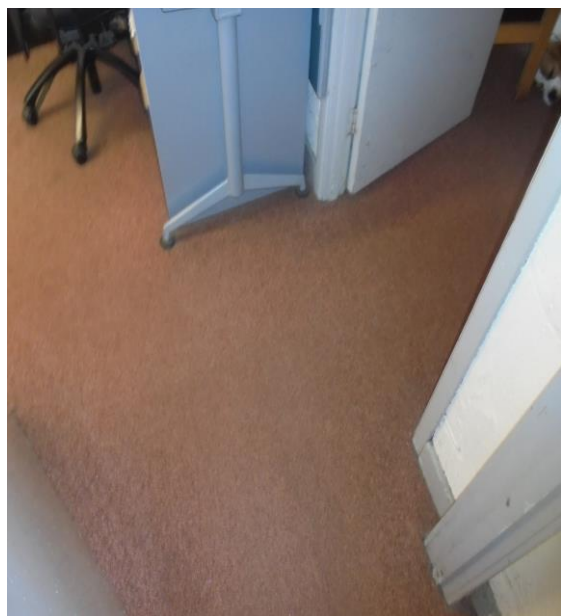
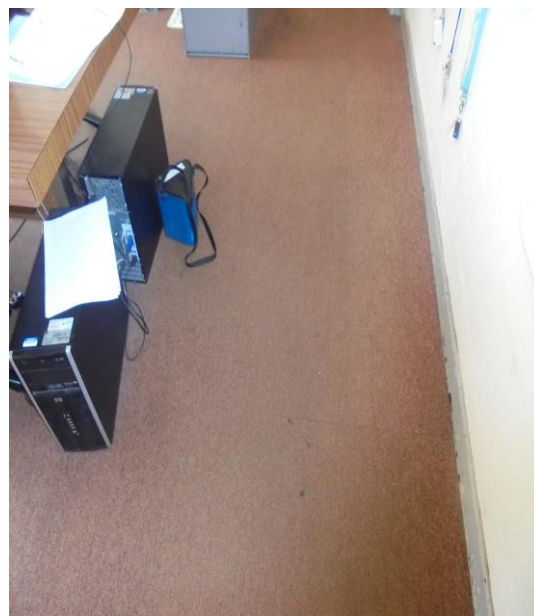
**Item No: 23****Sample No: N/A****Location: Admin Building – Offices x 3**

Material Description:	Floor Tiles and Adhesive Under Carpet	
Identification:	As Per Sample 9 – Asbestos Detected	
Approx. quantity:	40M2	
Accessibility	Low	<i>Assessment Score</i>
Product type:	Composite	1
Extent of Damage:	Minor	1
Surface Treatment:	Non-Friable	0
Asbestos type:	Chrysotile	1
Material Assessment Score:		3
Priority Assessment Score:		Negligible
Action:	Manage	
Comments:	Non-Asbestos Fiberboard wall panels and ceiling above suspended ceiling

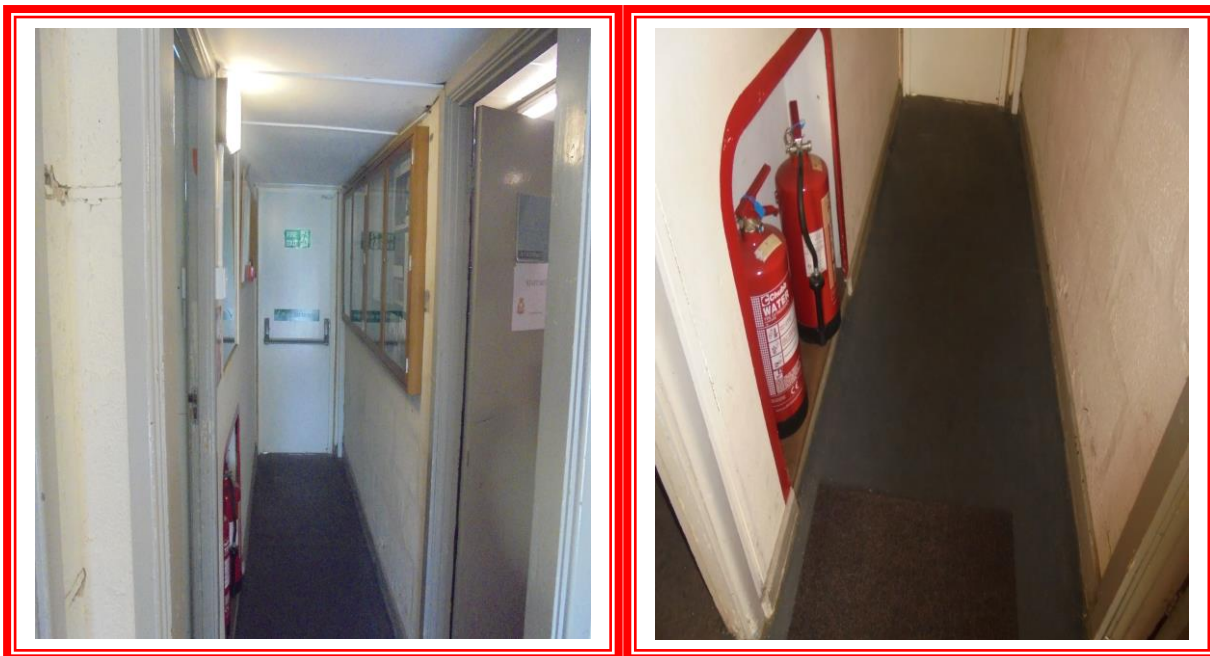
**Item No: 25****Sample No: N/A****Location: Admin Building – Corridor**

Material Description:	Floor Tiles and Adhesive Under Lino	
Identification:	Presumed to Contain Asbestos	
Approx. quantity:	7M2	
Accessibility	Low	<i>Assessment Score</i>
Product type:	No Access	1
Extent of Damage:	No Access	1
Surface Treatment:	No Access	0
Asbestos type:	No Access	1
Material Assessment Score:		3
Priority Assessment Score:		Negligible
Action:	Manage	
Comments:	No access under the lino but presumed to be the same tiles as the rest of the building

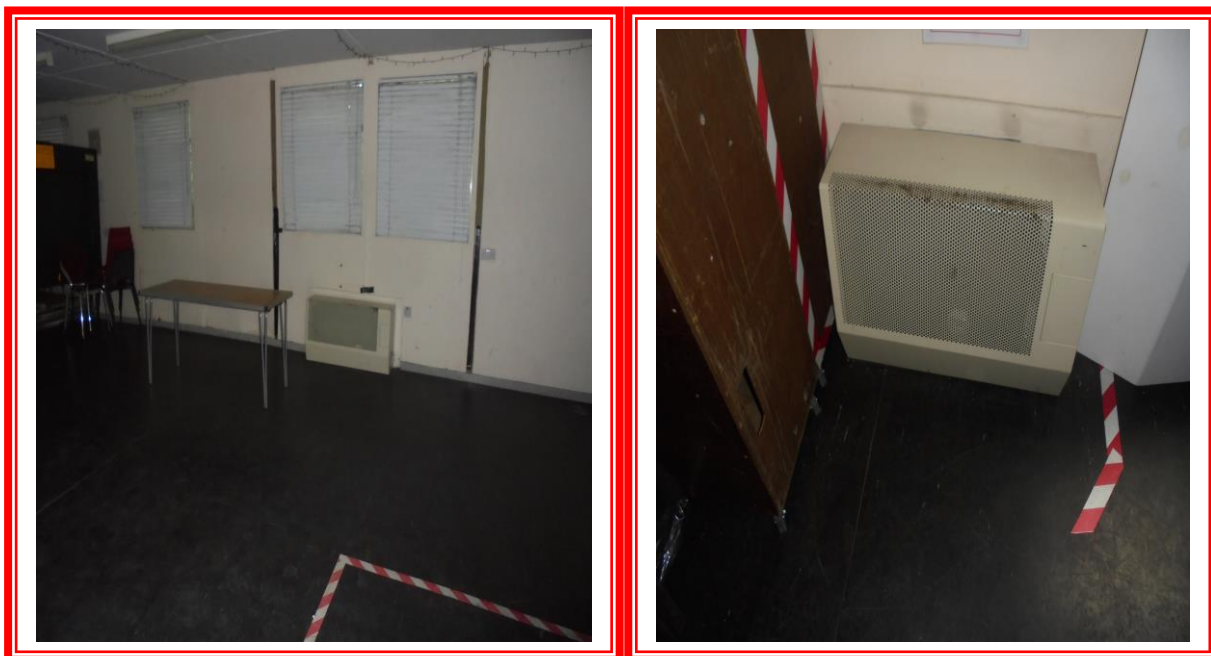
**Item No: 37****Sample No: N/A****Location: Beluga Parade Hall - Hall**

Item 37 – Beluga Parade Hall – Hall – Heaters - Unable to sample as presumed live

Material Description:	Components within Heater	
Identification:	Presumed to Contain Asbestos	
Approx. quantity:	X 3 Heaters	
Accessibility	Low	<i>Assessment Score</i>
Product type:	No Access	2
Extent of Damage:	No Access	2
Surface Treatment:	No Access	2
Asbestos type:	No Access	2
Material Assessment Score:		8
Priority Assessment Score:		Medium
Action:	Manage	
Comments:	N/A

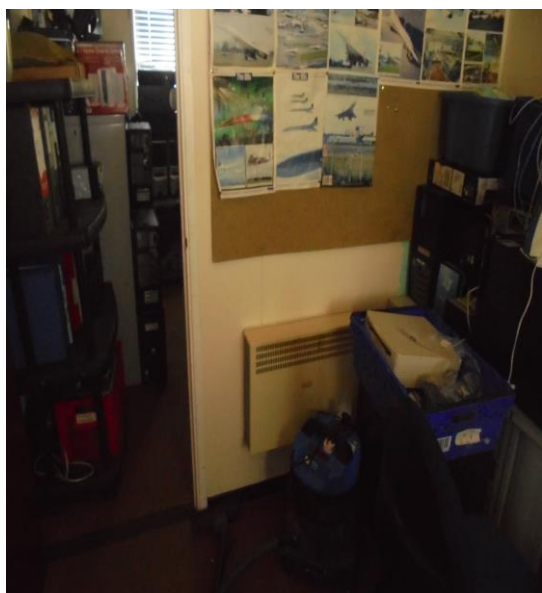
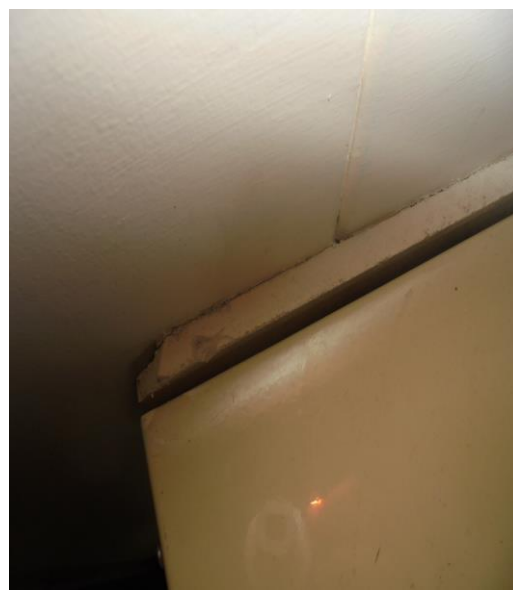
Item No: 3

Material Description:	Panel Behind Heater	
Identification:	Sampled – No Asbestos Detected	
Approx. quantity:	<1M2	
Accessibility	N/A	<i>Assessment Score</i>
Product type:		N/A
Extent of Damage:		N/A
Surface Treatment:		N/A
Asbestos type:		N/A
Material Assessment Score:		N/A
Priority Assessment Score:		N/A
Action:	N/A	
Comments:	N/A

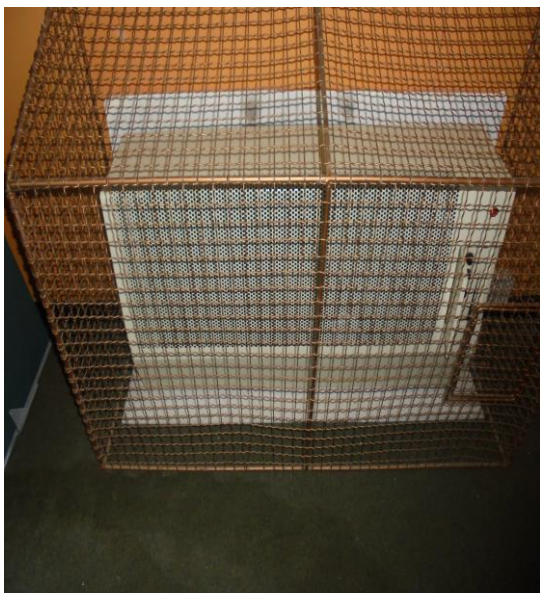
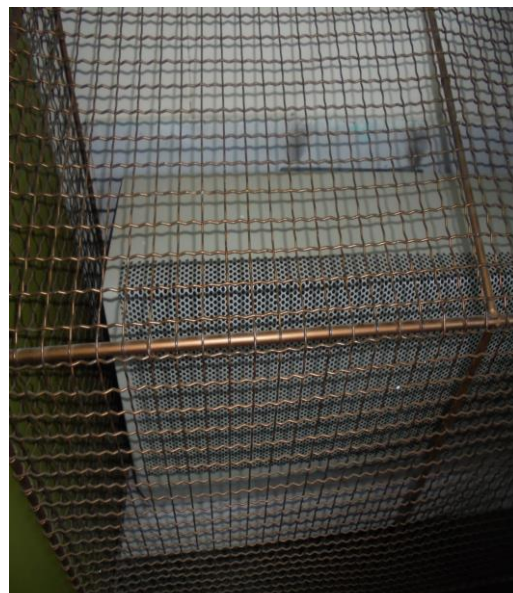
Item No: 6

Material Description:	Panels behind and below heater	
Identification:	Sampled – No Asbestos Detected	
Approx. quantity:	X 2 Heaters	
Accessibility	N/A	<i>Assessment Score</i>
Product type:		N/A
Extent of Damage:		N/A
Surface Treatment:		N/A
Asbestos type:		N/A
Material Assessment Score:		N/A
Priority Assessment Score:		N/A
Action:	N/A	
Comments:	Non-Asbestos Heaters

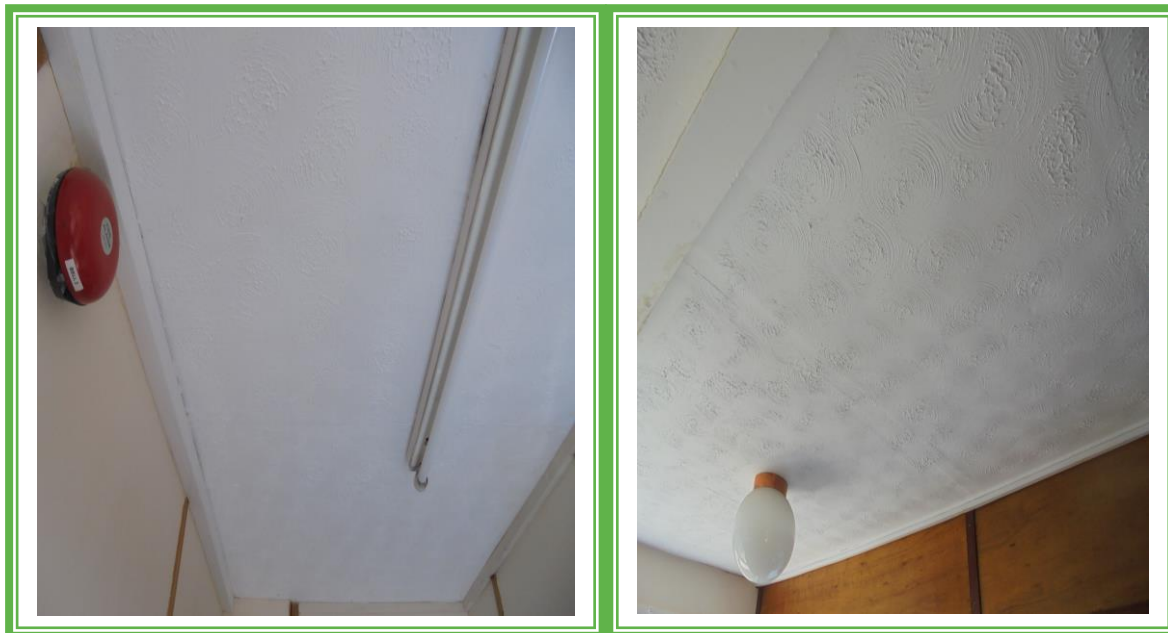
Item No: 8

Material Description:	Textured Coating to Ceilings	
Identification:	Sampled – No Asbestos Detected	
Approx. quantity:	16M2	
Accessibility	N/A	<i>Assessment Score</i>
Product type:		N/A
Extent of Damage:		N/A
Surface Treatment:		N/A
Asbestos type:		N/A
Material Assessment Score:		N/A
Priority Assessment Score:		N/A
Action:	N/A	
Comments:	Modern electrics in lounge cupboard

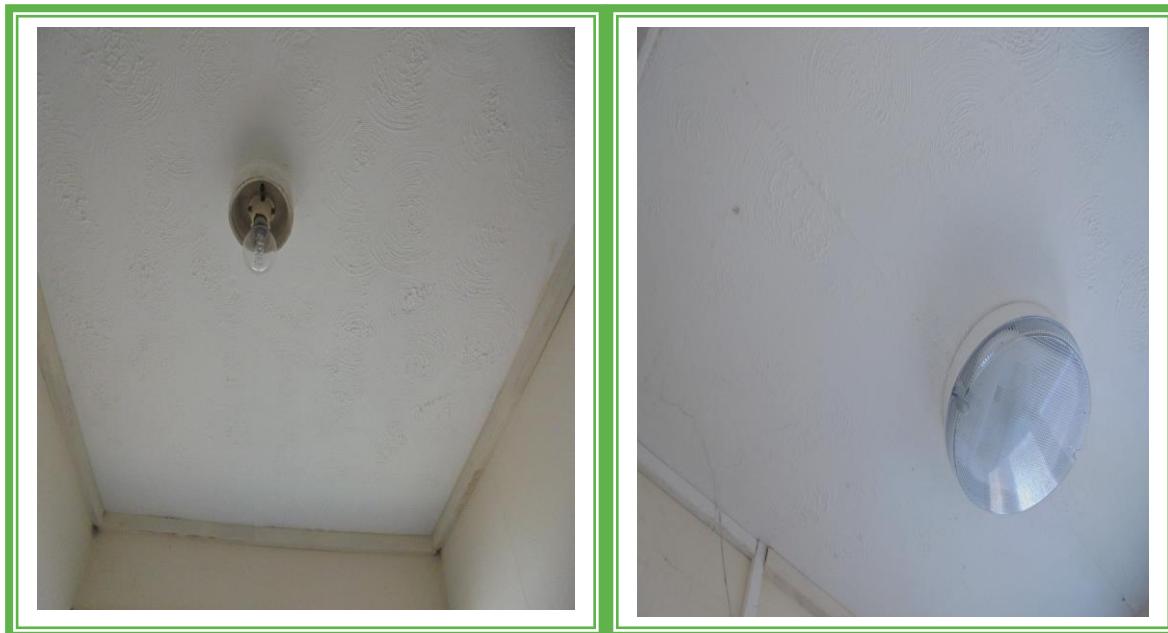
**Item No: 9****Sample No: N/A****Location: Cadets Mess – WC's x 2**

Material Description:	Textured Coating to Ceilings	
Identification:	As Per Sample – DK/3 – No Asbestos Detected	
Approx. quantity:	4M2	
Accessibility	N/A	<i>Assessment Score</i>
Product type:		N/A
Extent of Damage:		N/A
Surface Treatment:		N/A
Asbestos type:		N/A
Material Assessment Score:		N/A
Priority Assessment Score:		N/A
Action:	N/A	
Comments:	N/A

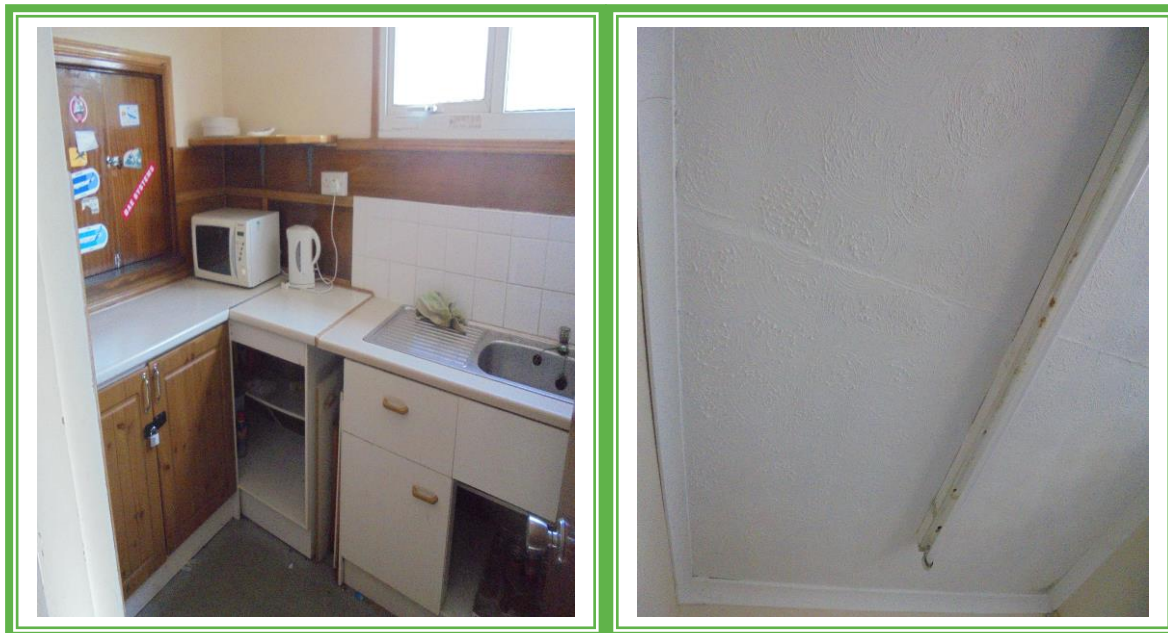
Item No: 10

Material Description:	Textured Coating to Ceilings	
Identification:	As Per Sample – DK/3 – No Asbestos Detected	
Approx. quantity:	4M2	
Accessibility	N/A	<i>Assessment Score</i>
Product type:		N/A
Extent of Damage:		N/A
Surface Treatment:		N/A
Asbestos type:		N/A
Material Assessment Score:		N/A
Priority Assessment Score:		N/A
Action:	N/A	
Comments:	Modern Sink Pad

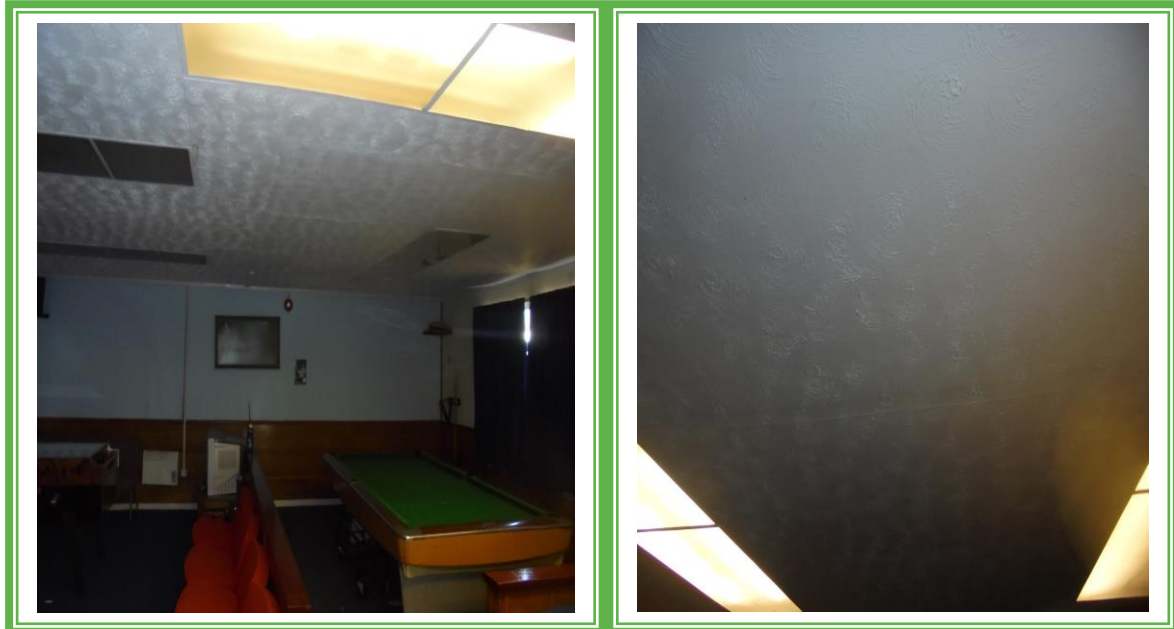
Item No: 11

Material Description:	Textured Coating to Ceiling	
Identification:	Sampled – No Asbestos Detected	
Approx. quantity:	70M2	
Accessibility	N/A	<i>Assessment Score</i>
Product type:		N/A
Extent of Damage:		N/A
Surface Treatment:		N/A
Asbestos type:		N/A
Material Assessment Score:		N/A
Priority Assessment Score:		N/A
Action:	N/A	
Comments:	N/A

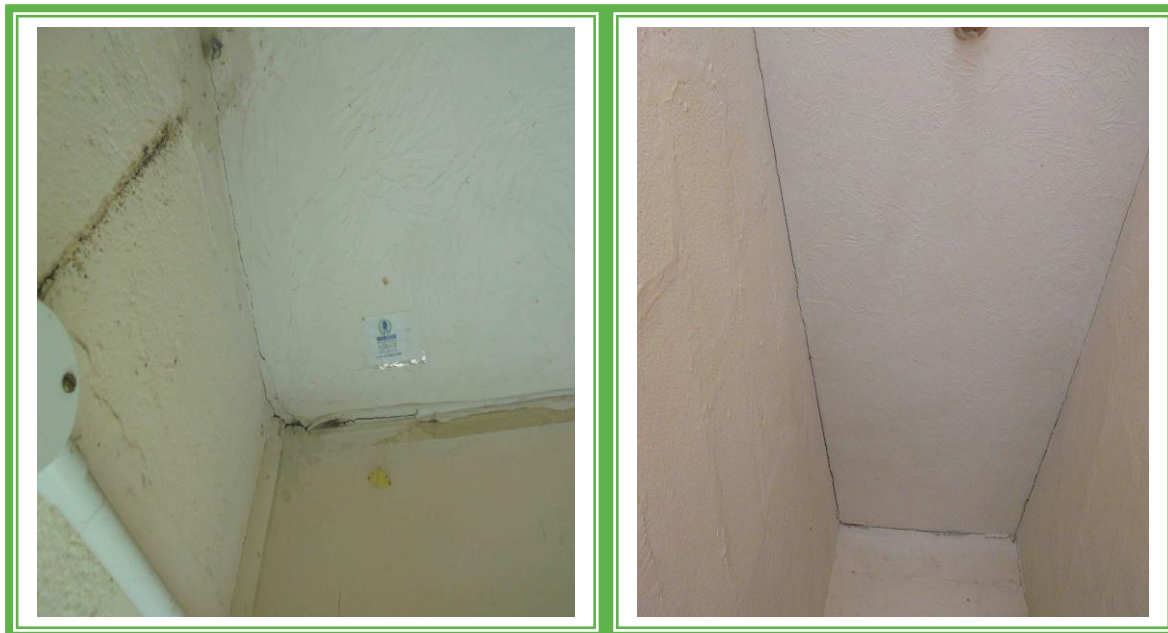
**Item No: 24****Sample No: 10****Location: Admin Building – Corridor**

Material Description:	Textured Coating to Ceiling	
Identification:	Sampled – No Asbestos Detected	
Approx. quantity:	4M2	
Accessibility	N/A	<i>Assessment Score</i>
Product type:		N/A
Extent of Damage:		N/A
Surface Treatment:		N/A
Asbestos type:		N/A
Material Assessment Score:		N/A
Priority Assessment Score:		N/A
Action:	N/A	
Comments:	N/A

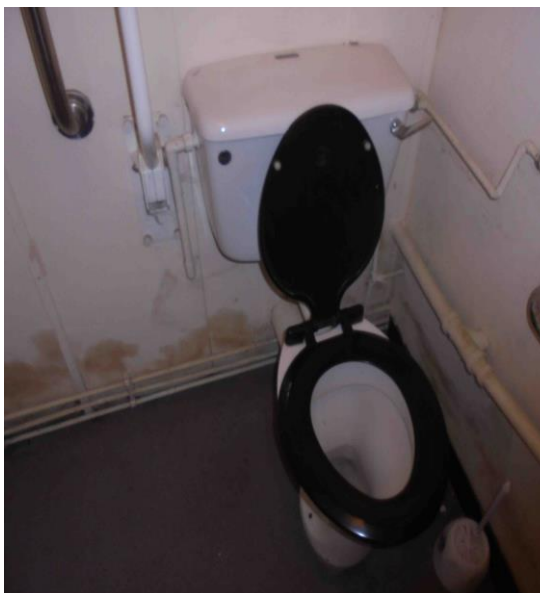
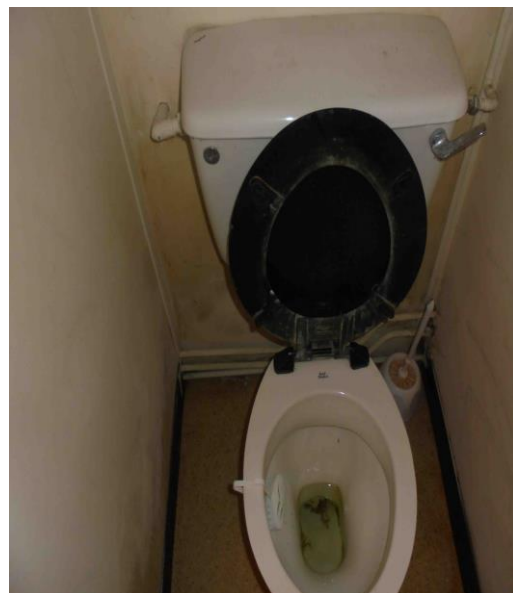
**Item No: 30****Sample No: 11****Location: Portbury Building – WC's x 3**

Material Description:	Toilet Seats	
Identification:	Sampled – No Asbestos Detected	
Approx. quantity:	X 3 Seats	
Accessibility	N/A	<i>Assessment Score</i>
Product type:		N/A
Extent of Damage:		N/A
Surface Treatment:		N/A
Asbestos type:		N/A
Material Assessment Score:		N/A
Priority Assessment Score:		N/A
Action:	N/A	
Comments:	N/A

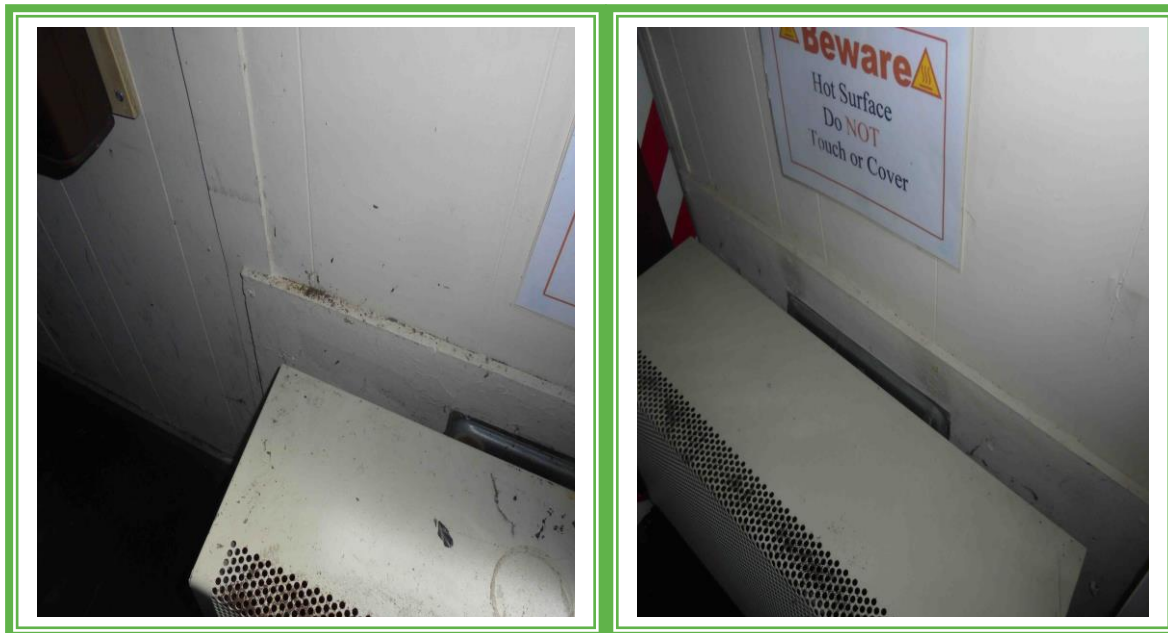
Item No: 36

Material Description:	Panels Behind Heaters	
Identification:	Sampled – No Asbestos Detected	
Approx. quantity:	2-3M2	
Accessibility	N/A	<i>Assessment Score</i>
Product type:		N/A
Extent of Damage:		N/A
Surface Treatment:		N/A
Asbestos type:		N/A
Material Assessment Score:		N/A
Priority Assessment Score:		N/A
Action:	N/A	
Comments:	N/A
