ARMOUR
ANALYTICAL SERVICES

Project Number 2481

**Management
Asbestos Survey Report**

Wellington Platoon, Somerset, TA21 8AX

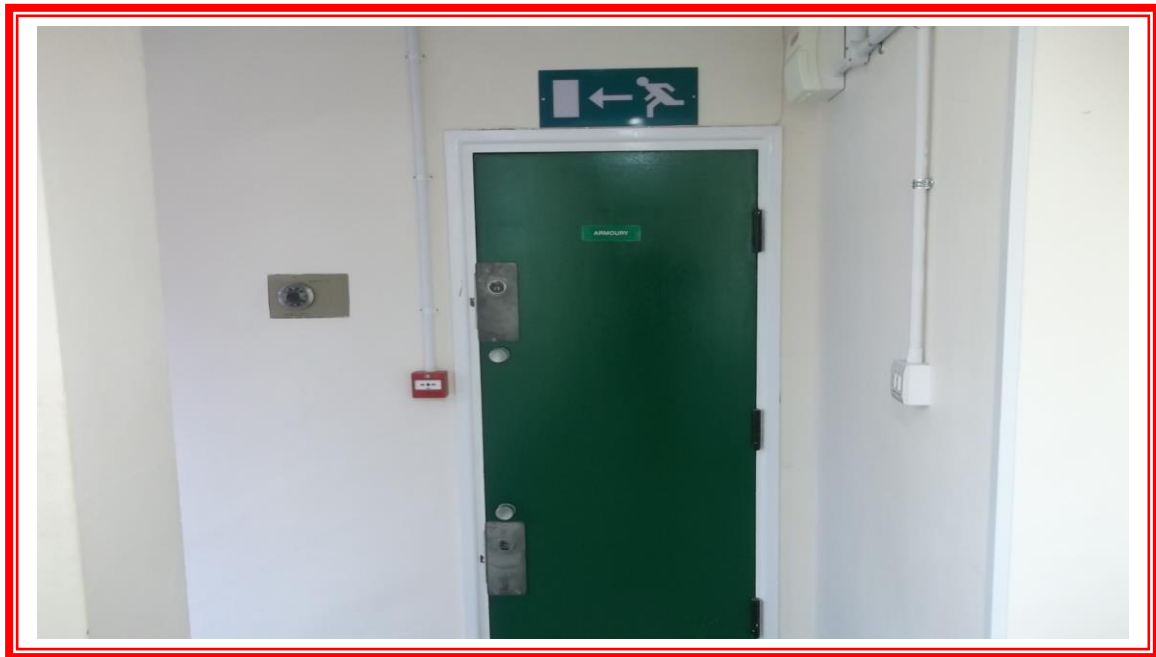
Item No: 4

Item 4 – First Floor - Armoury – Presumed to Contain Asbestos – No Access due to Locked Armoury

Material Description:	No Access	
Identification:	Presumed to Contain Asbestos	
Approx. quantity:	Unknown	
Accessibility	Low	Assessment Score
Product type:	No Access	2
Extent of Damage:	No Access	3
Surface Treatment:	No Access	2
Asbestos type:	No Access	2
Material Assessment Score:		9
Priority Assessment Score:		Medium
Action:	Further Investigation Required	
Comments:	No Access Granted to Locked Armoury

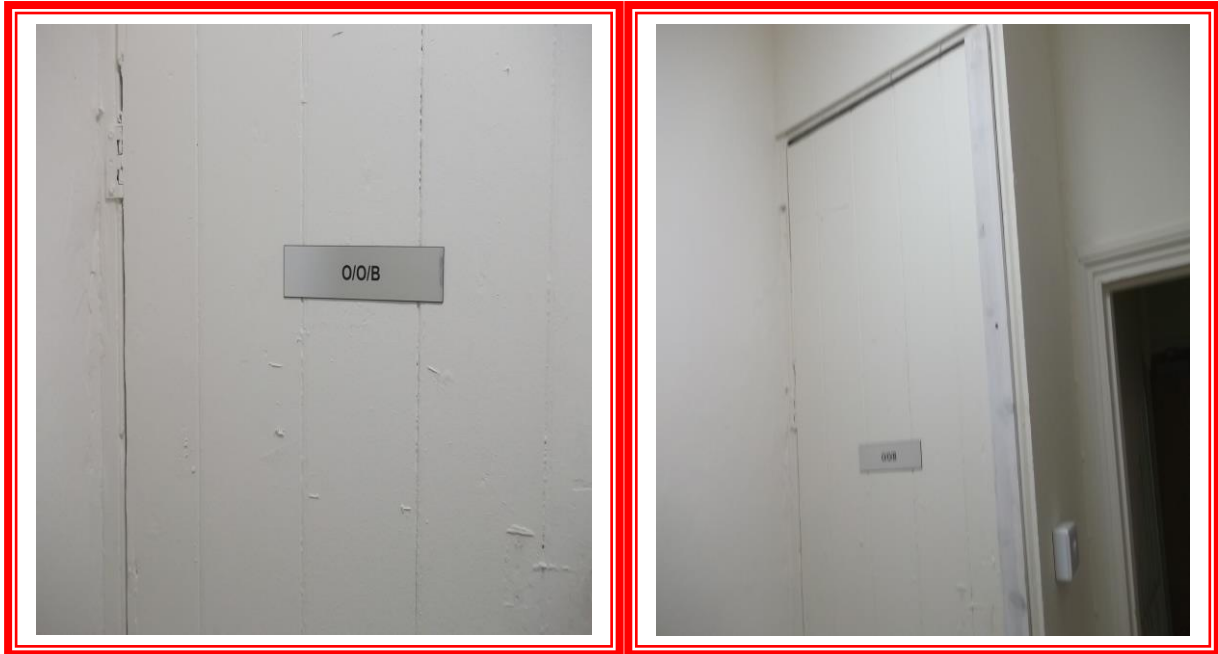
Item No: 9

Item 9 – First Floor – Attic Area – Presumed to Contain Asbestos – No Access for Safety Reasons

Material Description:	No Access	
Identification:	Presumed to Contain Asbestos	
Approx. quantity:	Unknown	
Accessibility	Low	Assessment Score
Product type:	No Access	2
Extent of Damage:	No Access	2
Surface Treatment:	No Access	2
Asbestos type:	No Access	2
Material Assessment Score:		8
Priority Assessment Score:		Medium
Action:	Further Investigation Required	
Comments:	"Out of Bounds – OOB" – Door Screwed Shut for Safety Reasons – no Access to Inspect.

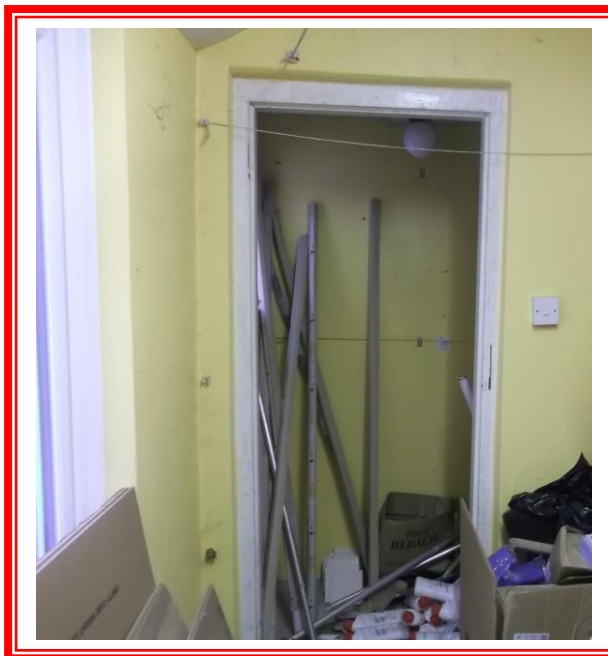
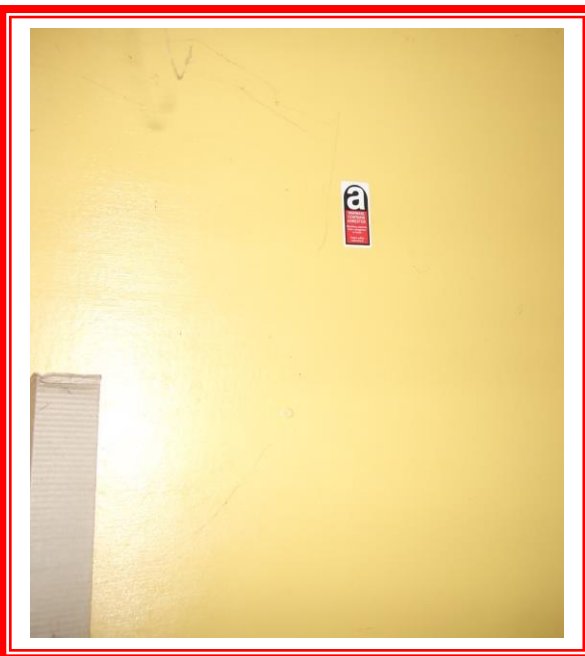
Item No: 12

Sample Number	Sample Type	Location	Analysis
GR001	Insulation Board to Wall	Ground Floor – Store	Chrysotile
GR002	Sink Pad to Sink	Ground Floor – HQ Store	N.A.D.I.S

Material Description:	Insulating Board	
Identification:	Sampled – Asbestos Detected	
Approx. quantity:	7M2	
Accessibility	Low	Assessment Score
Product type:	Insulating Board	2
Extent of Damage:	Major	3
Surface Treatment:	Sealed	1
Asbestos type:	Chrysotile	1
Material Assessment Score:		7
Priority Assessment Score:		Medium
Action:	Remove	
Comments:	Overclad – Poor Condition

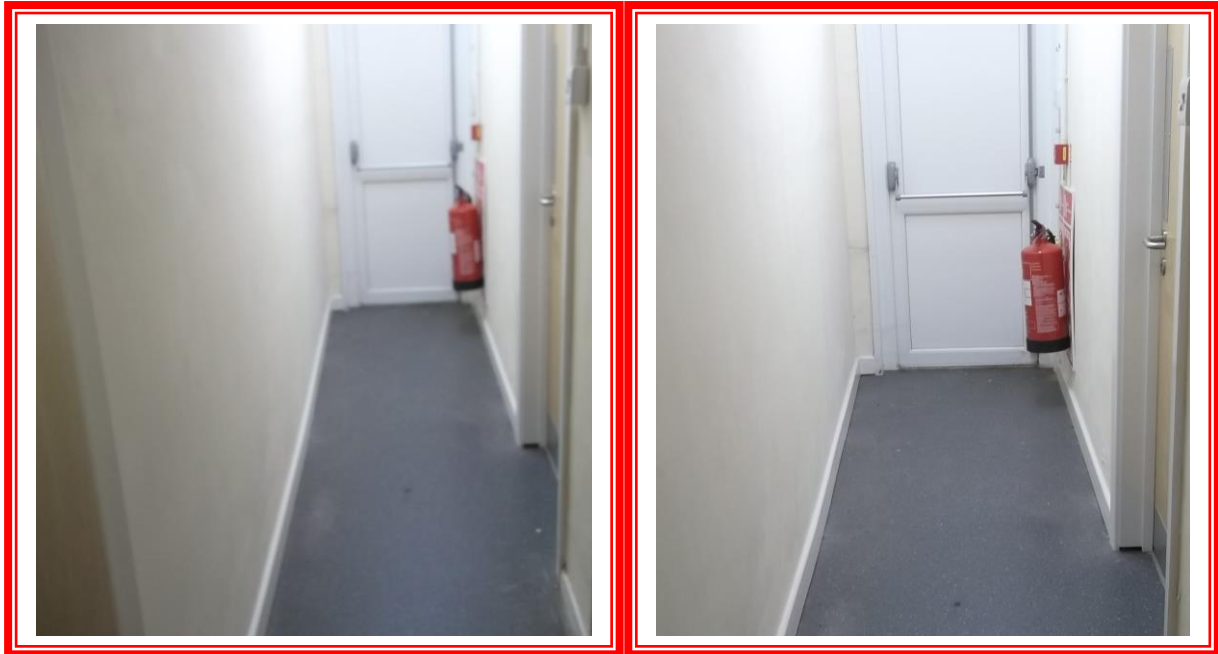
Item No: 13

Item 13 – Ground Floor - Hallway and CAA Office – Floor Tiles under Carpets – Strongly Presumed to Contain Asbestos – Unable to Lift Carpet to Inspect

Material Description:	Floor Tiles Under Carpets (Hallway)	
Identification:	Strongly Presumed to Contain Asbestos	
Approx. quantity:	2M2	
Accessibility	Low	<i>Assessment Score</i>
Product type:	Vinyl	1
Extent of Damage:	Unknown	3
Surface Treatment:	No-Friable	0
Asbestos type:	Chrysotile	1
Material Assessment Score:		5
Priority Assessment Score:		Low
Action:	Manage	
Comments:	Information That Floors Under Carpet Have Floor Tiles, Unable to Lift Carpet to Inspect or Sample

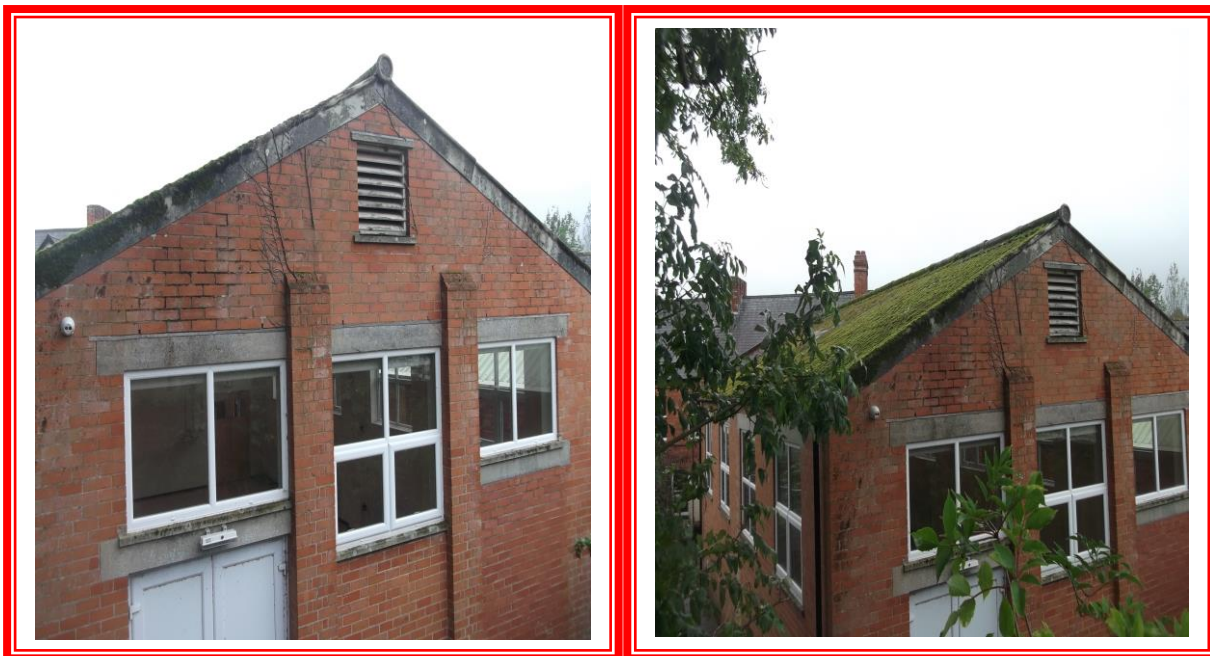
Item No: 17

Item 17 – Ground Floor - External – Roof to Drill Hall – Strongly Presumed to Contain Asbestos – No Safe Access

Material Description:	Profiled Cement Roof Sheets	
Identification:	Strongly Presumed to Contain Asbestos	
Approx. quantity:	225M2	
Accessibility	Low	Assessment Score
Product type:	Cement	1
Extent of Damage:	Major	3
Surface Treatment:	Unsealed Cement	1
Asbestos type:	Chrysotile	1
Material Assessment Score:		6
Priority Assessment Score:		Low
Action:	Manage	
Comments:	To Roof of Drill Hall Only, Unable to Sample as no Safe Means of Access.

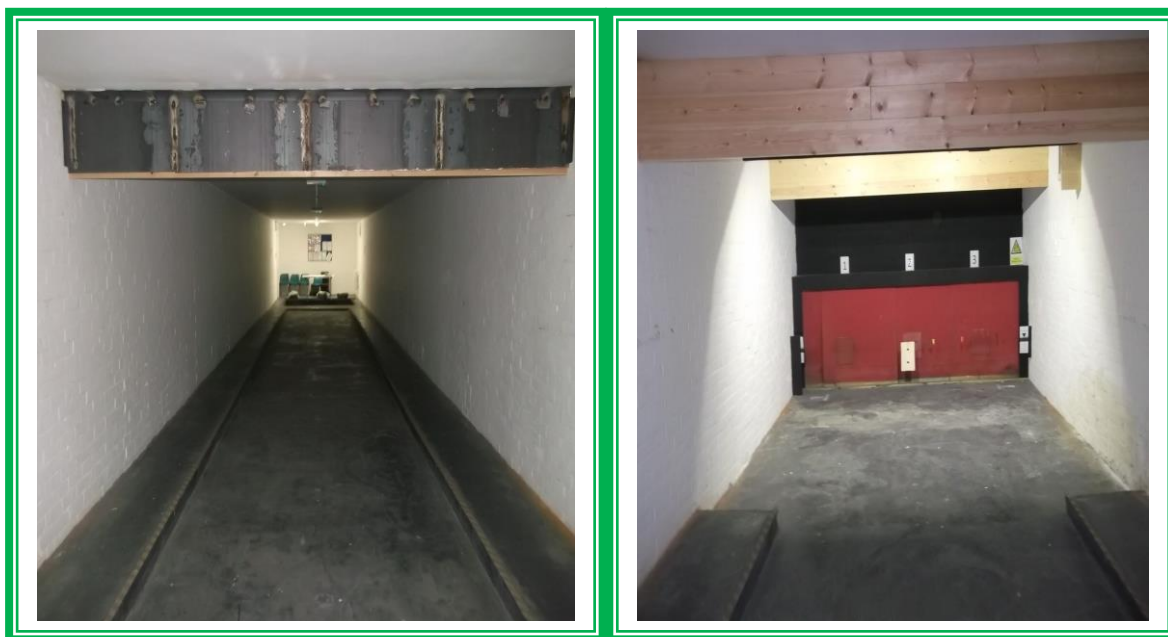
Item No: 1

Material Description:	Visual Inspection – No Suspect Materials Found	
Identification:	N/A	
Approx. quantity:	N/A	
Accessibility	High	<i>Assessment Score</i>
Product type:	N/A	N/A
Extent of Damage:	N/A	N/A
Surface Treatment:	N/A	N/A
Asbestos type:	N/A	N/A
Material Assessment Score:		N/A
Priority Assessment Score:		N/A
Action:	N/A	
Comments:	Modernised Throughout

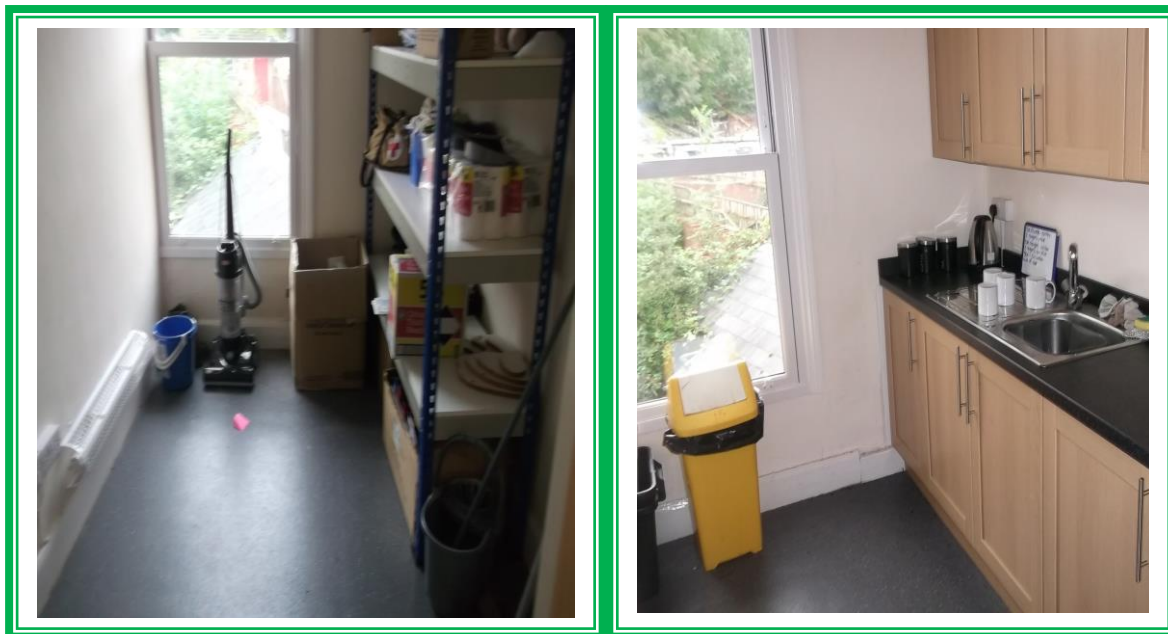
Item No: 10

Material Description:	Visual Inspection – No Suspect Materials Found	
Identification:	N/A	
Approx. quantity:	N/A	
Accessibility	N/A	<i>Assessment Score</i>
Product type:	N/A	N/A
Extent of Damage:	N/A	N/A
Surface Treatment:	N/A	N/A
Asbestos type:	N/A	N/A
Material Assessment Score:		N/A
Priority Assessment Score:		N/A
Action:	N/A	
Comments:	Fully Modern Throughout

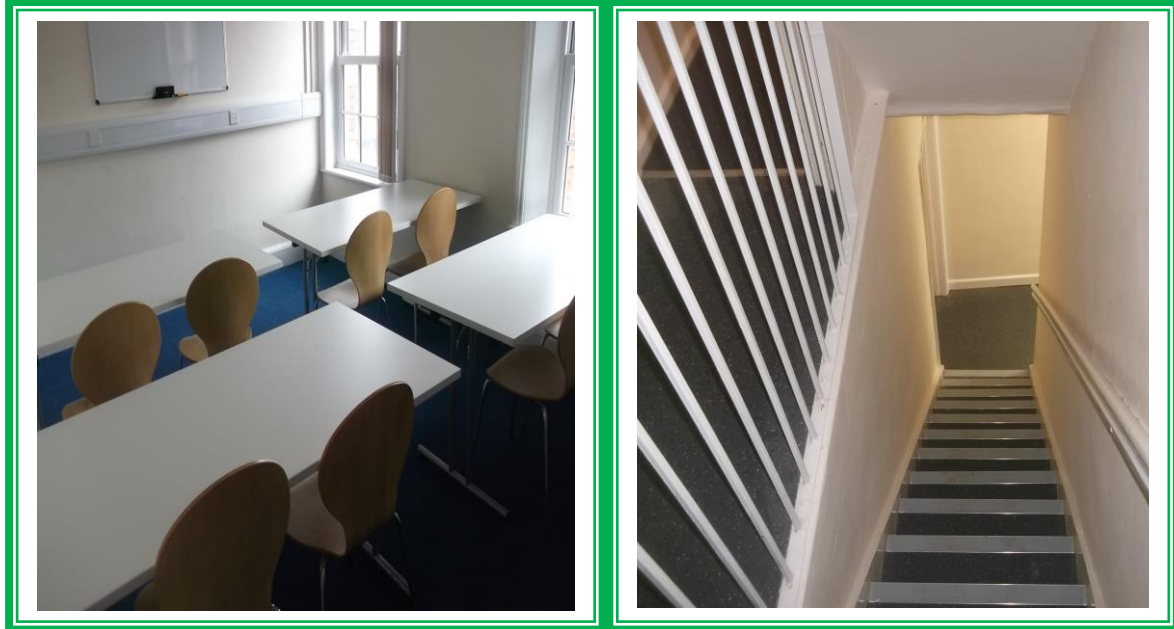
Item No: 11

Material Description:	Visual Inspection – No Suspect Materials Found	
Identification:	N/A	
Approx. quantity:	N/A	
Accessibility	N/A	<i>Assessment Score</i>
Product type:	N/A	N/A
Extent of Damage:	N/A	N/A
Surface Treatment:	N/A	N/A
Asbestos type:	N/A	N/A
Material Assessment Score:		N/A
Priority Assessment Score:		N/A
Action:	N/A	
Comments:	Fully Modernised Throughout

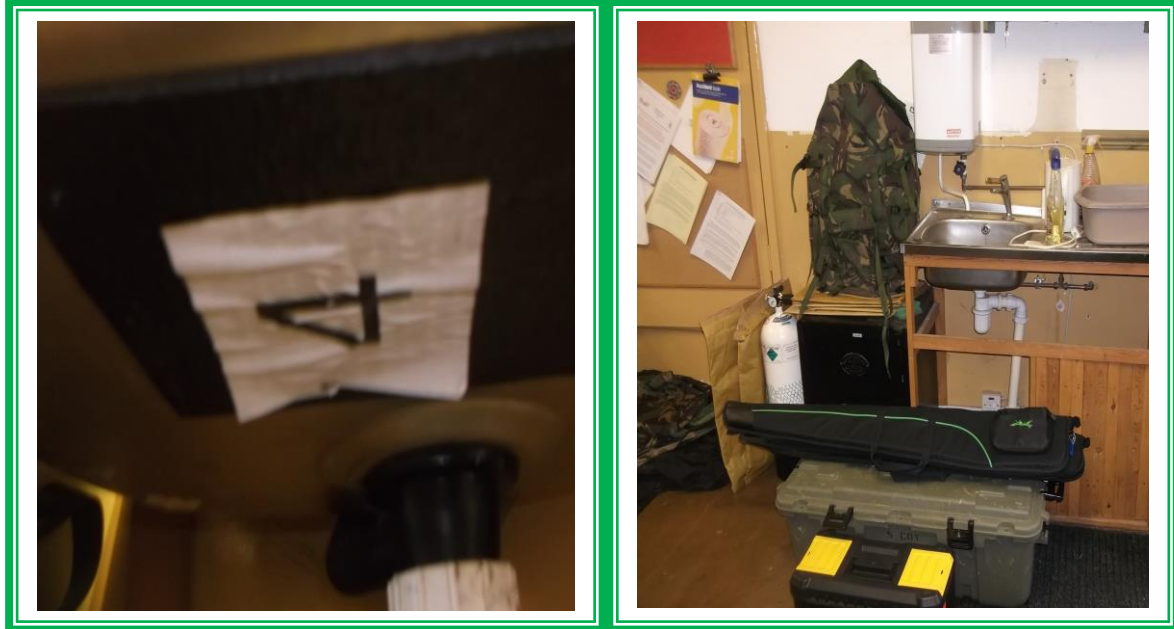
Item No: 14

Material Description:	Sink Pad to Sink	
Identification:	Sampled – No Asbestos Detected	
Approx. quantity:	1NR	
Accessibility	N/A	<i>Assessment Score</i>
Product type:	N/A	N/A
Extent of Damage:	N/A	N/A
Surface Treatment:	N/A	N/A
Asbestos type:	N/A	N/A
Material Assessment Score:		N/A
Priority Assessment Score:		N/A
Action:	N/A	
Comments:	Safe in Room Also Checked, No Rope Seal.

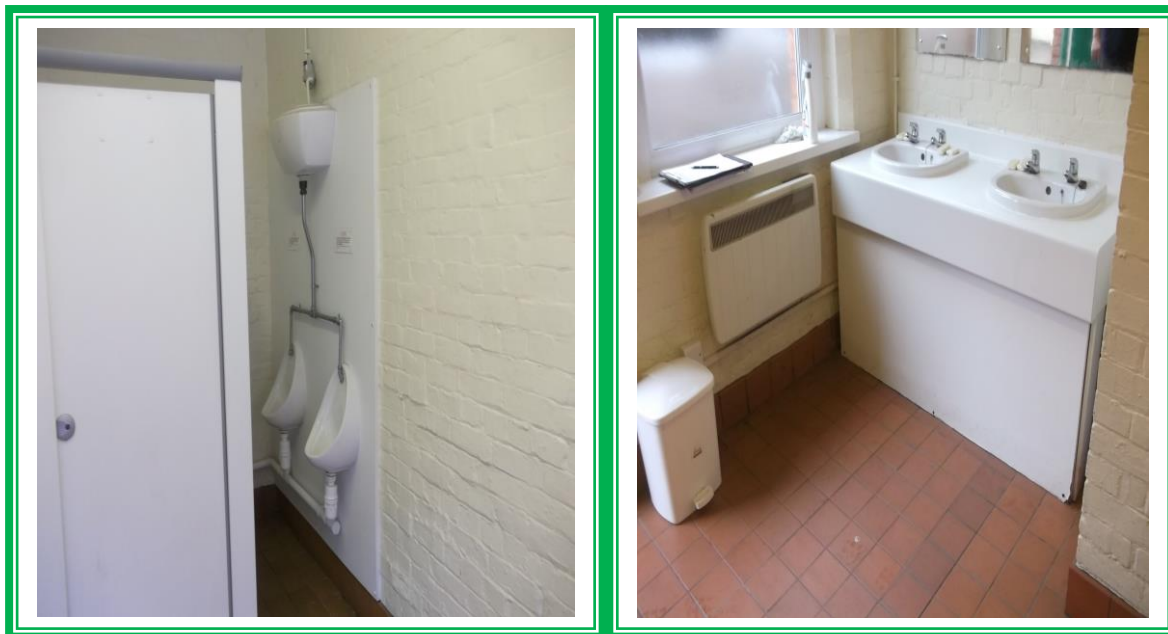
Item No: 15

Material Description:	Visual Inspection – No Suspect Materials Found	
Identification:	N/A	
Approx. quantity:	N/A	
Accessibility	N/A	<i>Assessment Score</i>
Product type:	N/A	N/A
Extent of Damage:	N/A	N/A
Surface Treatment:	N/A	N/A
Asbestos type:	N/A	N/A
Material Assessment Score:		N/A
Priority Assessment Score:		N/A
Action:	N/A	
Comments:	Red Ceramic Non-Asbestos Floor Tiles
