ASBESTOS DEMOLITION SURVEY REPORT

**Milford Road
Yeovil
Somerset
BA21 4QL**

26th July 2019

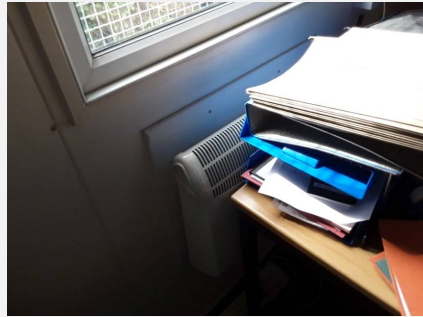
| Incident Reference | Sample Number | Level | Material Location | | | | Quantity | |
|---|--|---|---|---|---|---|---|---|
| 1 | AK002535 | Ground Floor | Units 1 & 2 Admin 001 | | | | 1 m ² | |

| Incident Reference | Sample Number | Level | Material Location | | | | Quantity | |
|---|--|---|---|---|---|---|---|---|
| N/A | N/A | N/A | N/A | N/A | N/A | N/A | No Action | |

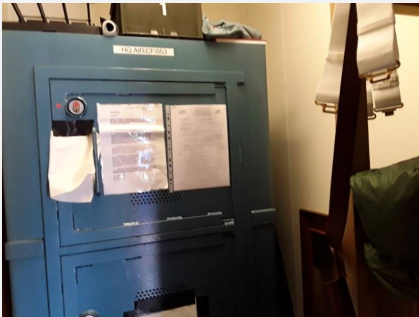
| Incident Reference | Sample Number | Level | Material Location | | | | Quantity | |
|---|---|---|---|---|---|---|---|---|
| 3 | No sample taken | Ground Floor | Units 1 & 2 Store 003 | | | | Throughout | |

| Incident Reference | Sample Number | Level | Material Location | | | | Quantity | |
|---|---|---|---|---|---|---|---|---|
| NAD | Area inspected. No suspect materials found. | | N/A | | | | No Asbestos Detected | |

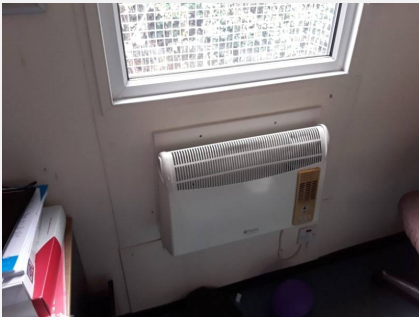
| Incident Reference | Sample Number | Level | Material Location | | | | Quantity | |
|---|--|---|---|---|---|---|---|---|
| 5 | As AK002535 | Ground Floor | Units 1 & 2 Office 005 | | | | 1 m² | |

| Incident Reference | Sample Number | Level | Material Location | | | | Quantity | |
|---|--|---|---|---|---|---|---|---|
| N/A | N/A | N/A | N/A | N/A | N/A | N/A | No Action | |

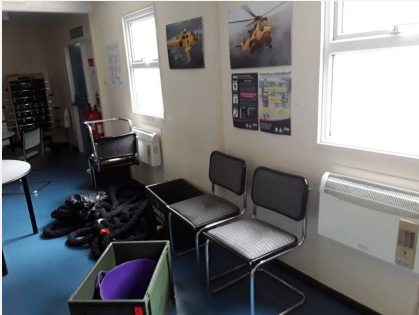
| Incident Reference | Sample Number | Level | Material Location | | | | Quantity | |
|---|---|---|---|---|---|---|---|---|
| 7 | As AK002535 | Ground Floor | Units 1 & 2 Dining Room 007 | | | | 2 m² | |

| Incident Reference | Sample Number | Level | Material Location | | | | Quantity | |
|---|---|---|---|---|---|---|---|---|
| N/A | N/A | N/A | N/A | N/A | N/A | N/A | No Action | |

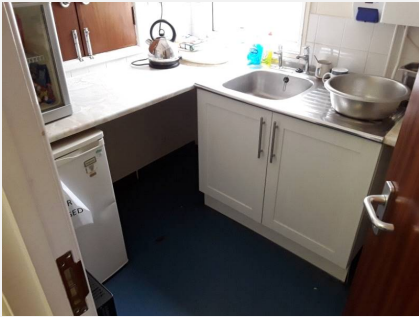
| Incident Reference | Sample Number | Level | Material Location | | | | Quantity | |
|---|---|---|---|---|---|---|---|---|
| 8 | No sample taken | Ground Floor | Units 1 & 2 Canteen 008 | | | | Throughout | |

| Incident Reference | Sample Number | Level | Material Location | | | | Quantity | |
|---|---|---|---|---|---|---|---|---|
| NAD | Area inspected. No suspect materials found. | | N/A | | | | No Asbestos Detected | |

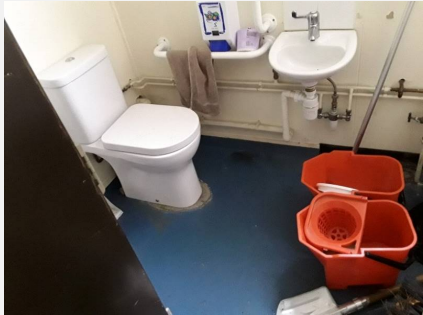
| Incident Reference | Sample Number | Level | Material Location | | | | Quantity | |
|---|---|---|---|---|---|---|---|---|
| 9 | No sample taken | Ground Floor | Units 1 & 2 Disabled WC 009 | | | | Throughout | |

| Incident Reference | Sample Number | Level | Material Location | | | | Quantity | |
|---|---|---|---|---|---|---|---|---|
| NAD | Area inspected. No suspect materials found. | | N/A | | | | No Asbestos Detected | |

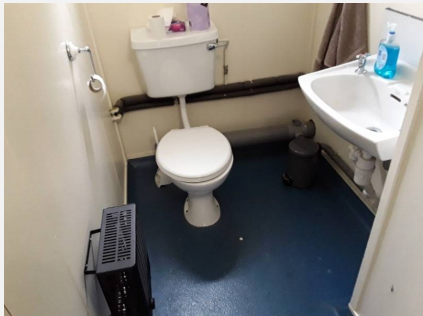
| Incident Reference | Sample Number | Level | Material Location | | | | Quantity | |
|---|---|---|---|---|---|---|---|---|
| 10 | No sample taken | Ground Floor | Units 1 & 2 Female WC 010 | | | | Throughout | |

| Incident Reference | Sample Number | Level | Material Location | | | | Quantity | |
|---|---|---|---|---|---|---|---|---|
| NAD | Area inspected. No suspect materials found. | | N/A | | | | No Asbestos Detected | |

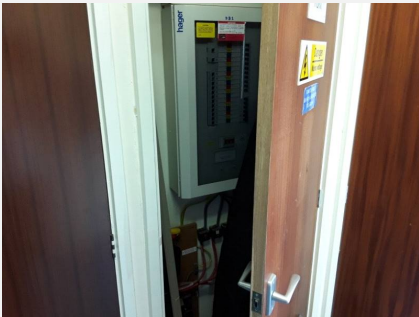
| Incident Reference | Sample Number | Level | Material Location | | | | Quantity | |
|---|---|---|---|---|---|---|---|---|
| 11 | No sample taken | Ground Floor | Units 1 & 2 Electrics 011 | | | | Throughout | |

| Incident Reference | Sample Number | Level | Material Location | | | | Quantity | |
|---|---|---|---|---|---|---|---|---|
| NAD | Area inspected. No suspect materials found. | | N/A | | | | No Asbestos Detected | |

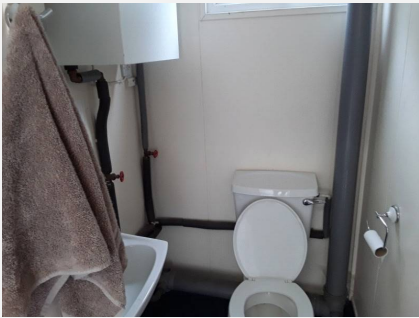
| Incident Reference | Sample Number | Level | Material Location | | | | Quantity | |
|---|---|---|---|---|---|---|---|---|
| 12 | No sample taken | Ground Floor | Units 1 & 2 Male WC 012 | | | | Throughout | |

| Incident Reference | Sample Number | Level | Material Location | | | | Quantity | |
|---|---|---|---|---|---|---|---|---|
| NAD | Area inspected. No suspect materials found. | | N/A | | | | No Asbestos Detected | |

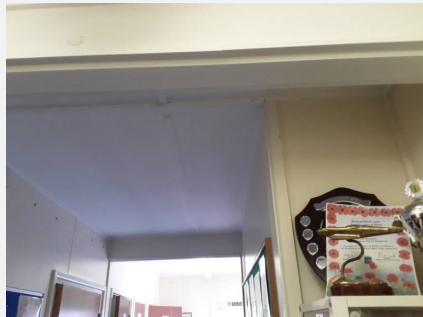
| Incident Reference | Sample Number | Level | Material Location | | | | Quantity | |
|---|---|---|---|---|---|---|---|---|
| 13 | No sample taken | Ground Floor | Units 1 & 2 Hall 013 | | | | Throughout | |

| Incident Reference | Sample Number | Level | Material Location | | | | Quantity | |
|---|---|---|---|---|---|---|---|---|
| NAD | Area inspected. No suspect materials found. | | N/A | | | | No Asbestos Detected | |

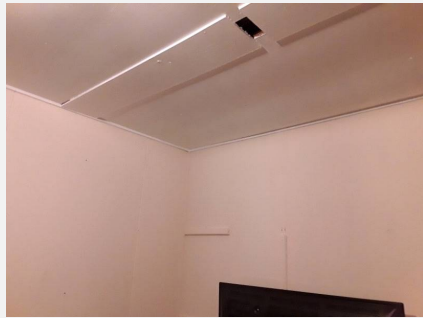
| Incident Reference | Sample Number | Level | Material Location | | | | Quantity | |
|---|---|---|---|---|---|---|---|---|
| 14 | No sample taken | Ground Floor | Units 1 & 2 Simulator 014 | | | | Throughout | |

| Incident Reference | Sample Number | Level | Material Location | | | | Quantity | |
|---|---|---|---|---|---|---|---|---|
| NAD | Area inspected. No suspect materials found. | | N/A | | | | No Asbestos Detected | |

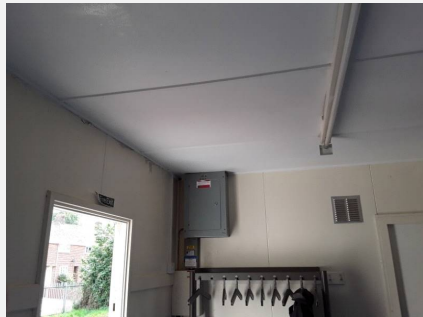
| Incident Reference | Sample Number | Level | Material Location | | | | Quantity | |
|---|---|---|---|---|---|---|---|---|
| 15 | No sample taken | Ground Floor | Units 1 & 2 Lobby 015 | | | | Throughout | |

| Incident Reference | Sample Number | Level | Material Location | | | | Quantity | |
|---|---|---|---|---|---|---|---|---|
| NAD | Area inspected. No suspect materials found. | | N/A | | | | No Asbestos Detected | |

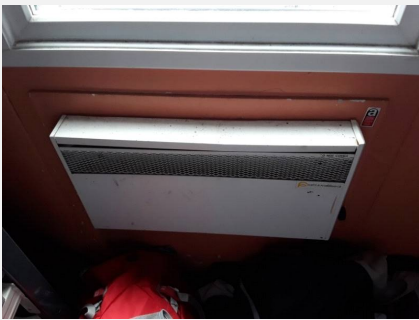
| Incident Reference | Sample Number | Level | Material Location | | | | Quantity | |
|---|---|---|---|---|---|---|---|--|
| 17 | As AK002536 | Ground Floor | Units 1 & 2 Kit Store 017 | | | | 1 m ² | |

| Incident Reference | Sample Number | Level | Material Location | | | | Quantity | |
|---|---|---|---|---|---|---|---|--|
| N/A | N/A | N/A | N/A | N/A | N/A | N/A | No Action | Modern "supalux" boards to all locations - incorrectly labelled as asbestos - to prove that all are similar composite sampling into AK002536 was conducted |
