Project Number 3700

Re-Inspection
Asbestos Survey Report - Revised

St Blazey Platoon
Cornwall
PL24 2NF

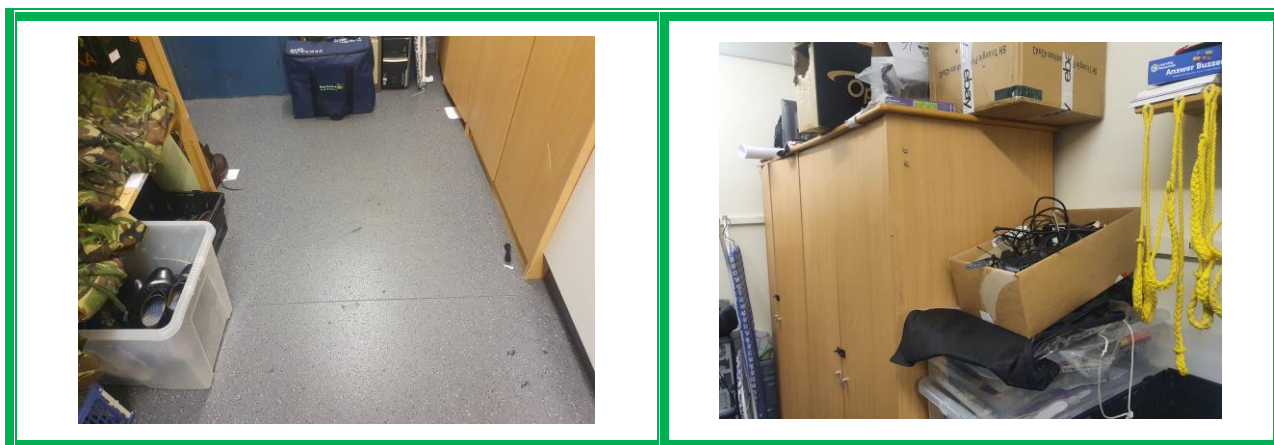
Item No:	1	Sample No:	N/A
Location:	Ground Floor – Ground Floor ATC Store - 001

Material Description:	No Suspect Materials Found	
Identification:	N/A	
Approx. quantity:	N/A	
Accessibility	N/A	Assessment Score
Product type:	N/A	N/A
Extent of Damage:	N/A	N/A
Surface Treatment:	N/A	N/A
Asbestos type:	N/A	N/A
Material Assessment Score:		N/A
Priority Assessment Score:		N/A
Action:	N/A	
Comments:	<p>Previously a no access area. Now accessed and no asbestos found.</p> <p>Plasterboard/blockwork walls, lino flooring, modern ceiling tiles.</p>
