Project Number 2481

**Management
Asbestos Survey Report**

The Lord Sandhurst Hall, Jersey, JE3 8FJ

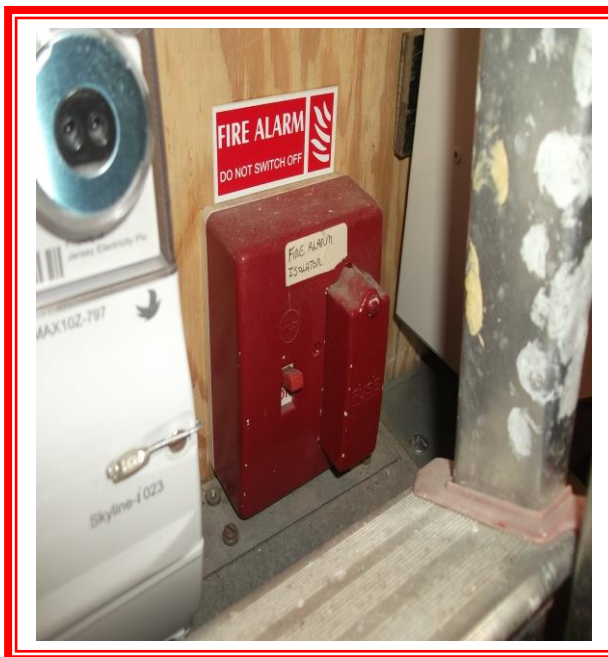
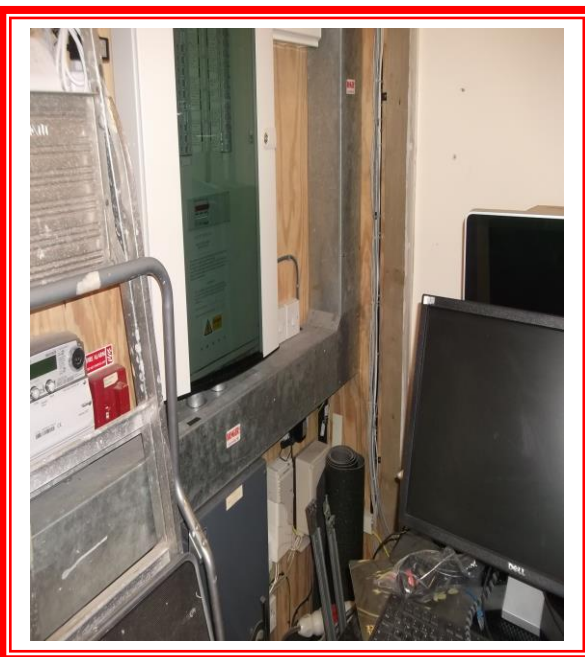
Item No: 8
Sample No: N/A
**Location: Ground Floor – Electrical and Services
Cupboard**

Item 8 – Ground Floor – Electrical and Services Cupboard – Flash guard to Old Fuse – Strongly Presumed

Material Description:	Flash Guard to Old Fuses	
Identification:	Strongly Presumed to Contain Asbestos	
Approx. quantity:	X 1	
Accessibility	High	Assessment Score
Product type:	Textile	1
Extent of Damage:	Unknown	3
Surface Treatment:	Sealed	0
Asbestos type:	Chrysotile	1
Material Assessment Score:		5
Priority Assessment Score:		Low
Action:	Manage	
Comments:	Unable to sample as live

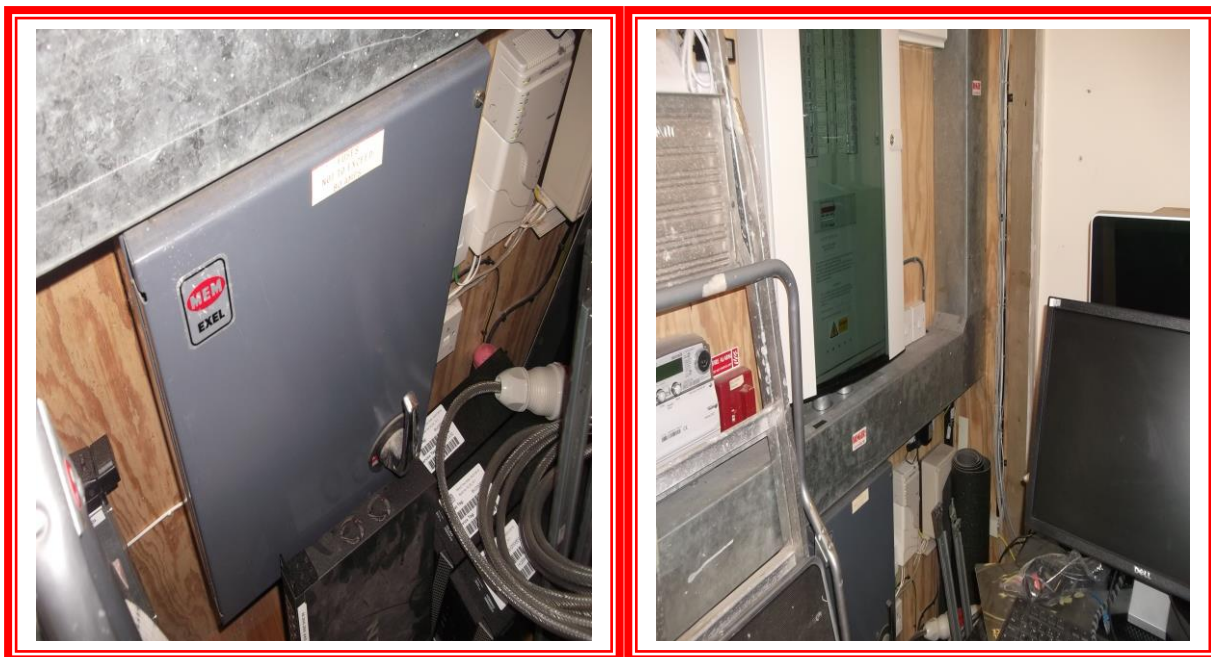
Item No: 9
Sample No: N/A
**Location: Ground Floor – Electrical and Services
Cupboard**

Item 9 – Ground Floor – Electrical and Services Cupboard – Textiles within Fuse Box – – Strongly Presumed

Material Description:	Textiles Within Fuse Box	
Identification:	Strongly Presumed to Contain Asbestos	
Approx. quantity:	X 1	
Accessibility	High	Assessment Score
Product type:	Textile	1
Extent of Damage:	Unknown	3
Surface Treatment:	Sealed	0
Asbestos type:	Chrysotile	1
Material Assessment Score:		5
Priority Assessment Score:		Low
Action:	Manage	
Comments:	Unable to sample as live

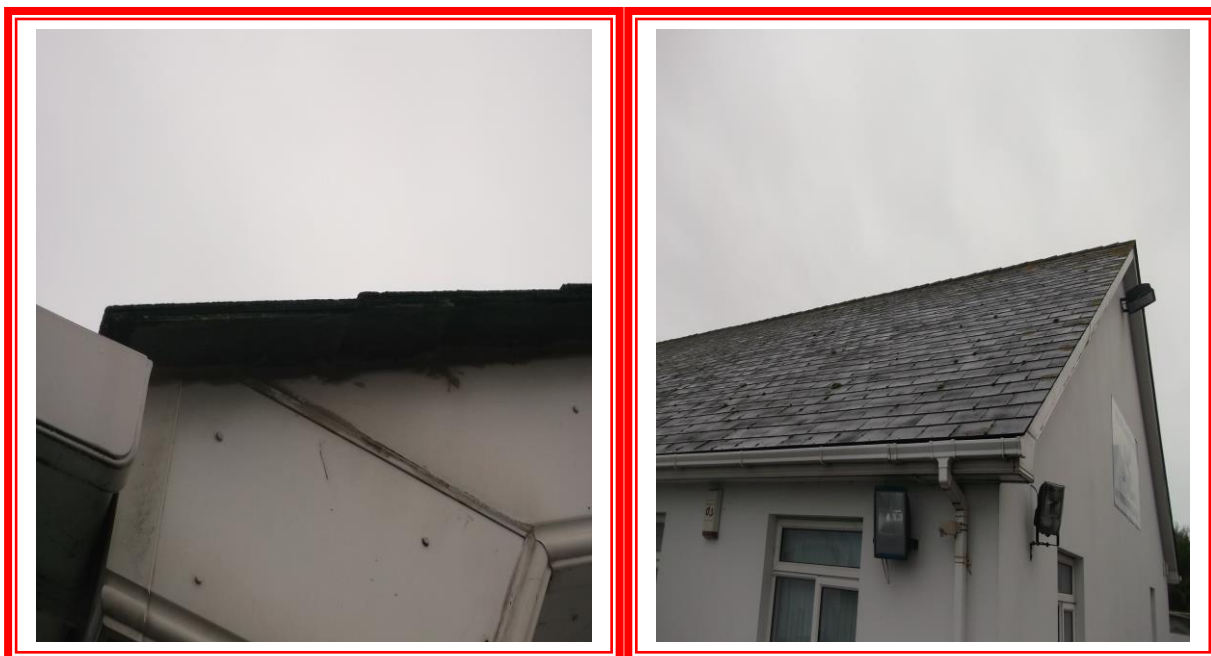
Item No: 17
Sample No: GR001
Location: Main Cadet HQ Building – Externals

Sample Number	Sample Type	Location	Analysis
GR001	Roof Tiles to Roof	Main Cadet HQ Building – Externals	Chrysotile

Material Description:	Roof Tiles to Roof	
Identification:	Sampled – Asbestos Detected	
Approx. quantity:	300M2	
Accessibility	Low	<i>Assessment Score</i>
Product type:	Composite	1
Extent of Damage:	Good	0
Surface Treatment:	Non-Friable	0
Asbestos type:	Chrysotile	1
Material Assessment Score:		2
Priority Assessment Score:		Negligible
Action:	Manage	
Comments:	N/A

Sample No.	Sample Ref.	Location	Asbestos Detected	Asbestos Type
GR001	BS593356	Main Cadet HQ Building - Externals - Roof Tiles to Roof	Yes	Chrysotile

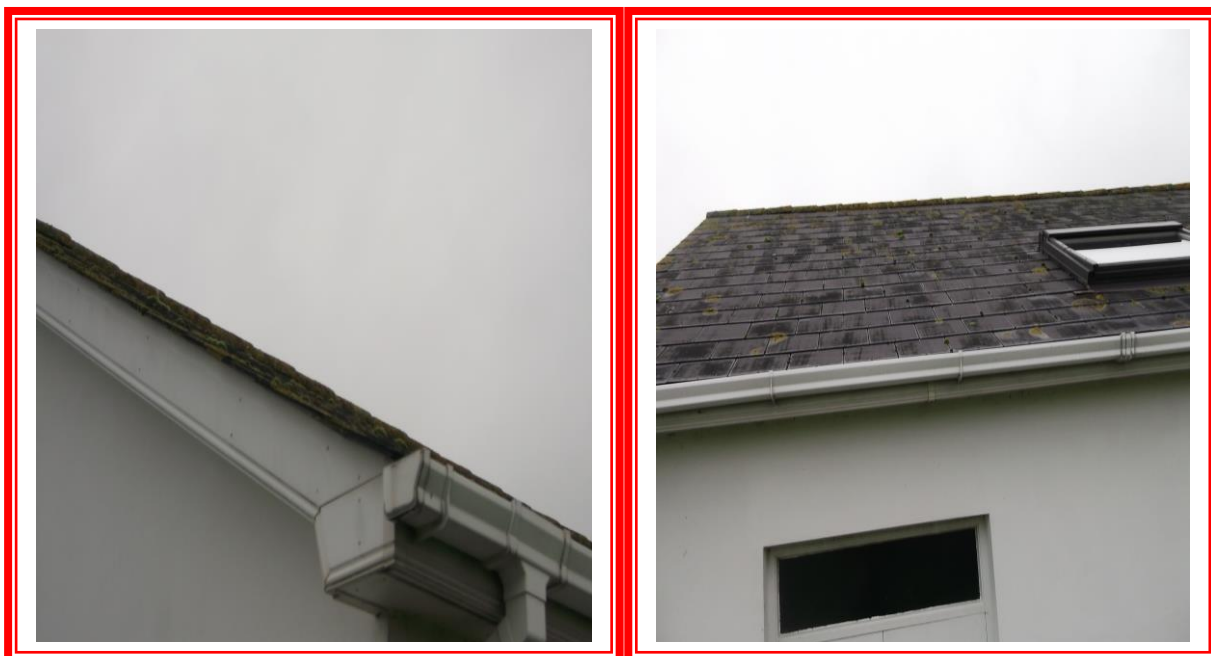
Item No: 20
Sample No: N/A
Location: Garage Shower Block – Externals

Material Description:	Roof Tiles to Roof	
Identification:	As Per sample GR001 – Asbestos Detected	
Approx. quantity:	50M2	
Accessibility	Low	<i>Assessment Score</i>
Product type:	Composite	1
Extent of Damage:	Good	0
Surface Treatment:	Non-Friable	0
Asbestos type:	Chrysotile	1
Material Assessment Score:		2
Priority Assessment Score:		Negligible
Action:	Manage	
Comments:	Manage in accordance with CAR 2012

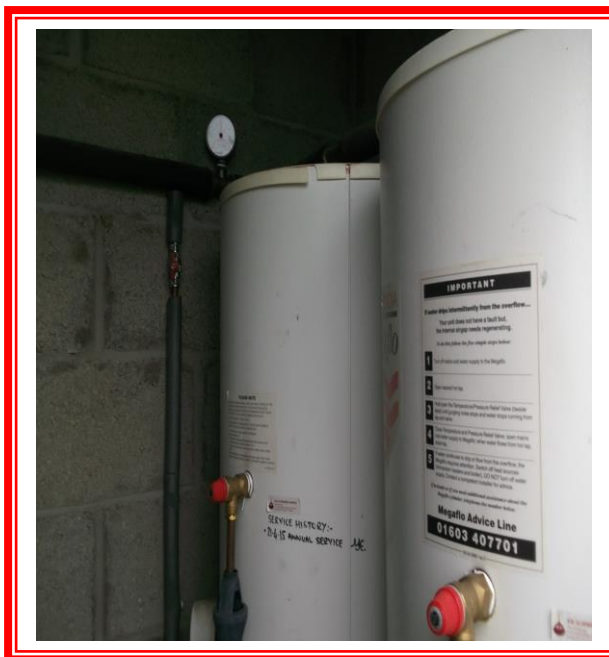
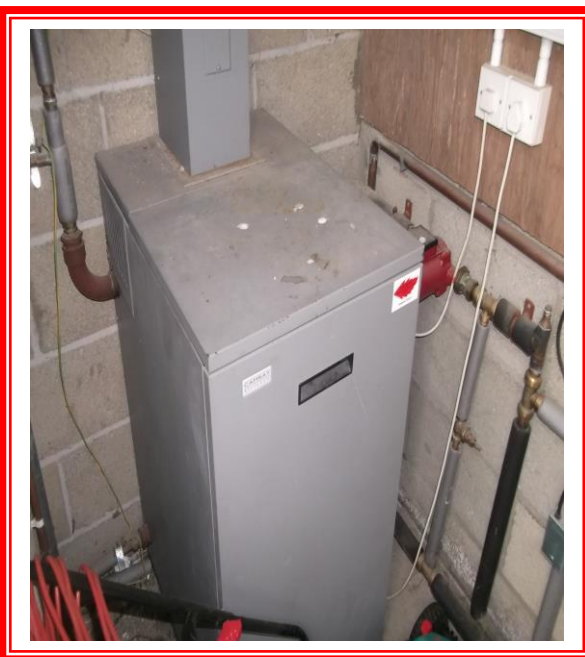
Item No: 21
Sample No: N/A
Location: Garage Shower Block – Ground Floor – Boiler Room

Item 21 - Garage Shower Block - Ground Floor – Boiler Room – Textile Products to Boiler (Grey) – No access to sample as live

Material Description:	Textile Products to Boiler (Grey)	
Identification:	Presumed to Contain Asbestos	
Approx. quantity:	X 1	
Accessibility	Low	Assessment Score
Product type:	Textiles	1
Extent of Damage:	Unknown	3
Surface Treatment:	Sealed	0
Asbestos type:	Chrysotile	1
Material Assessment Score:		5
Priority Assessment Score:		Low
Action:	Manage	
Comments:	Unable to sample as live

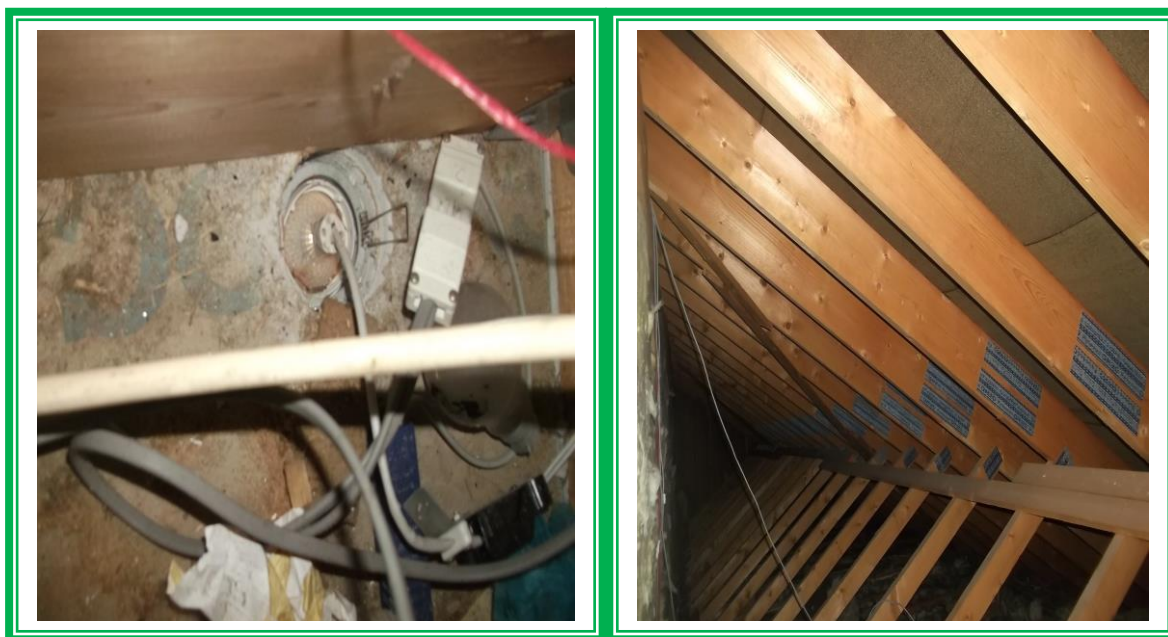
Item No: 1
Sample No: N/A
Location: First Floor – Attic Space/Eaves

Material Description:	Visual Inspection – No Suspect Materials Found	
Identification:	N/A	
Approx. quantity:	N/A	
Accessibility	High	<i>Assessment Score</i>
Product type:	N/A	N/A
Extent of Damage:	N/A	N/A
Surface Treatment:	N/A	N/A
Asbestos type:	N/A	N/A
Material Assessment Score:		N/A
Priority Assessment Score:		N/A
Action:	N/A	
Comments:	N/A

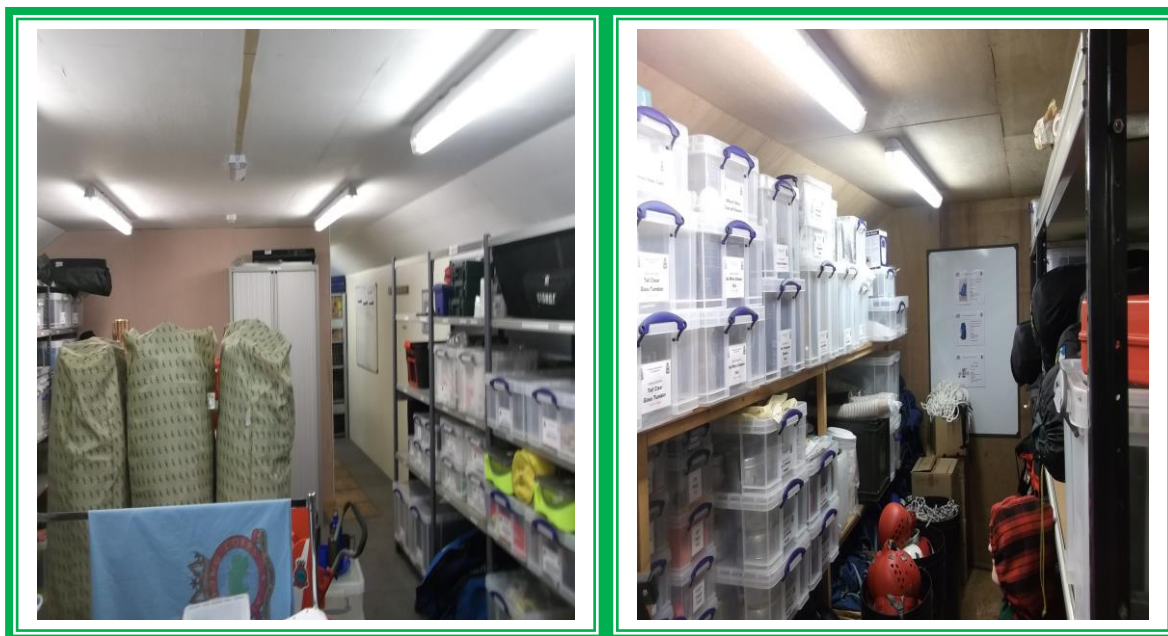
Item No: 2
Sample No: N/A
Location: First Floor – Stores Area

Material Description:	Visual Inspection – No Suspect Materials Found	
Identification:	N/A	
Approx. quantity:	N/A	
Accessibility	N/A	<i>Assessment Score</i>
Product type:	N/A	N/A
Extent of Damage:	N/A	N/A
Surface Treatment:	N/A	N/A
Asbestos type:	N/A	N/A
Material Assessment Score:		N/A
Priority Assessment Score:		N/A
Action:	N/A	
Comments:	Plywood Walls, Carpet Tiles

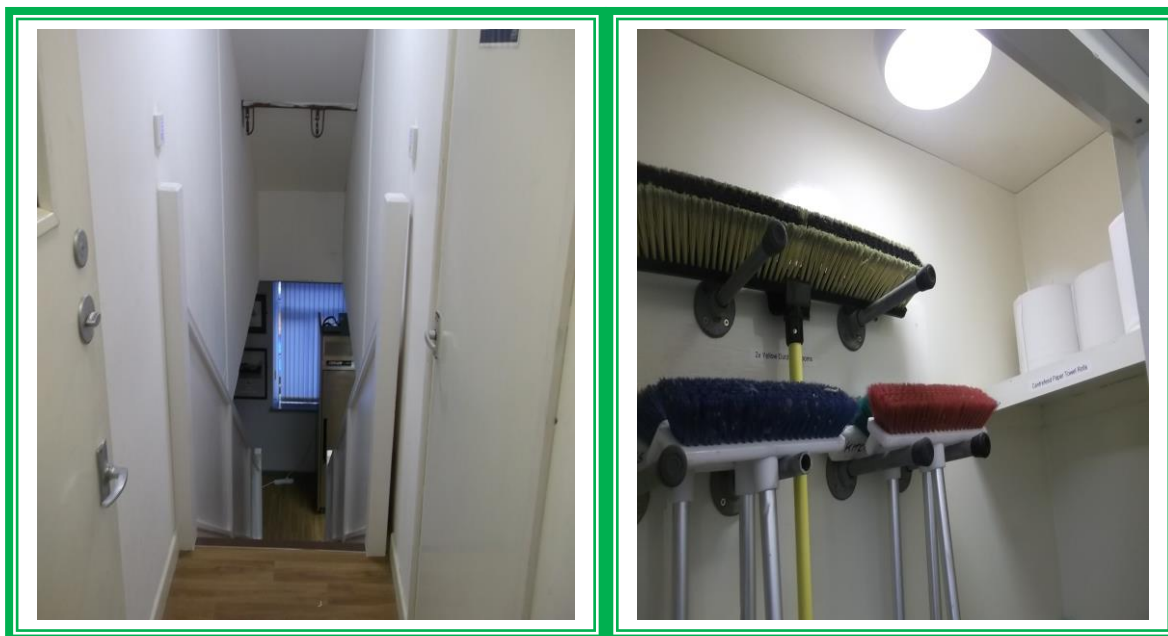
Item No: 3
Sample No: N/A
Location: First Floor – Stairwell and Cleaning Cupboard

Material Description:	Visual Inspection – No Suspect Materials Found	
Identification:	N/A	
Approx. quantity:	N/A	
Accessibility	N/A	<i>Assessment Score</i>
Product type:	N/A	N/A
Extent of Damage:	N/A	N/A
Surface Treatment:	N/A	N/A
Asbestos type:	N/A	N/A
Material Assessment Score:		N/A
Priority Assessment Score:		N/A
Action:	N/A	
Comments:	N/A

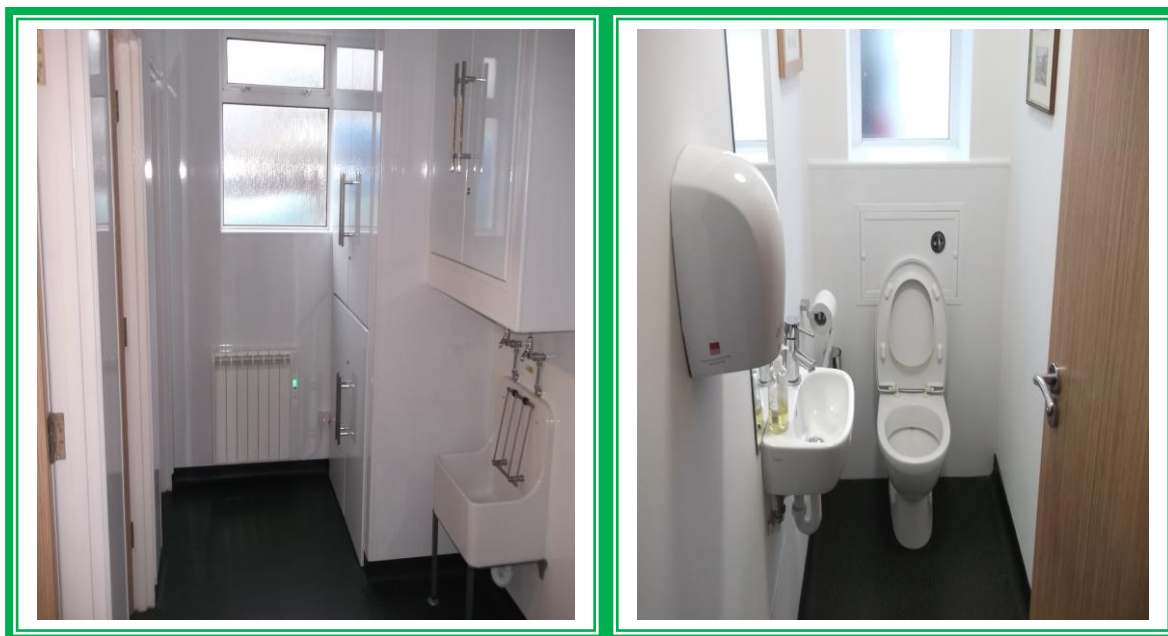
Item No: 4
Sample No: N/A
Location: Ground Floor – Toilets x 3 and Corridor

Material Description:	Visual Inspection – No Suspect Materials Found	
Identification:	N/A	
Approx. quantity:	N/A	
Accessibility	N/A	<i>Assessment Score</i>
Product type:	N/A	N/A
Extent of Damage:	N/A	N/A
Surface Treatment:	N/A	N/A
Asbestos type:	N/A	N/A
Material Assessment Score:		N/A
Priority Assessment Score:		N/A
Action:	N/A	
Comments:	Fully modern fitted toilets, modern water tank and pipework within cupboard in corridor

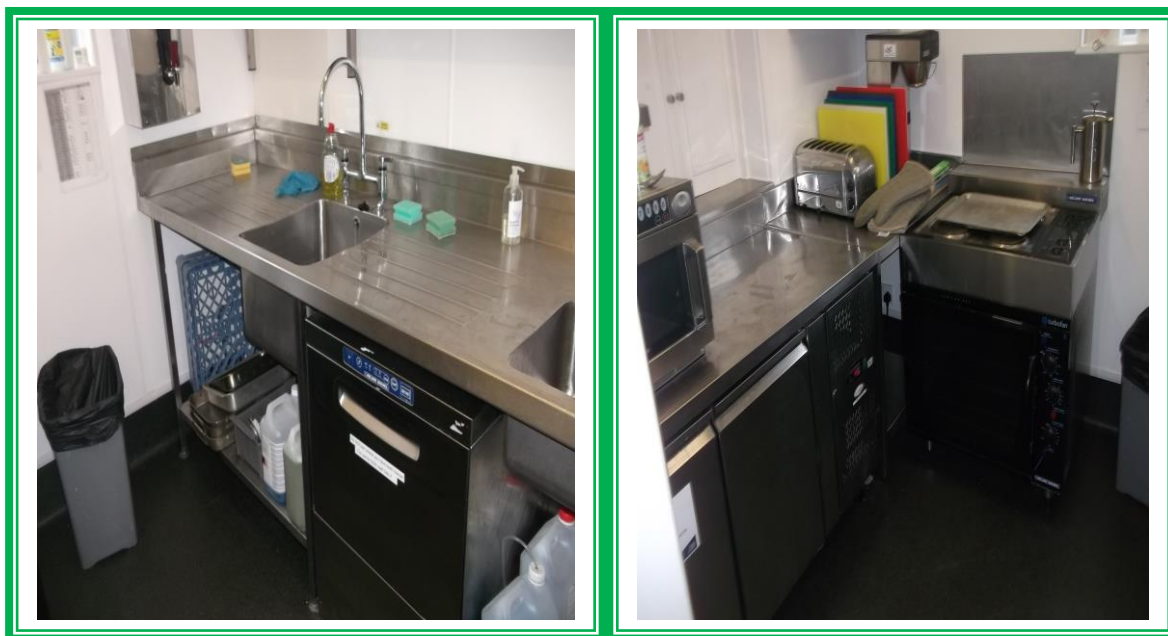
Item No: 5
Sample No: N/A
Location: Ground Floor – Kitchen

Material Description:	Visual Inspection – No Suspect Materials Found	
Identification:	N/A	
Approx. quantity:	N/A	
Accessibility	N/A	<i>Assessment Score</i>
Product type:	N/A	N/A
Extent of Damage:	N/A	N/A
Surface Treatment:	N/A	N/A
Asbestos type:	N/A	N/A
Material Assessment Score:		N/A
Priority Assessment Score:		N/A
Action:	N/A	
Comments:	Fully Fitted, modernized kitchen

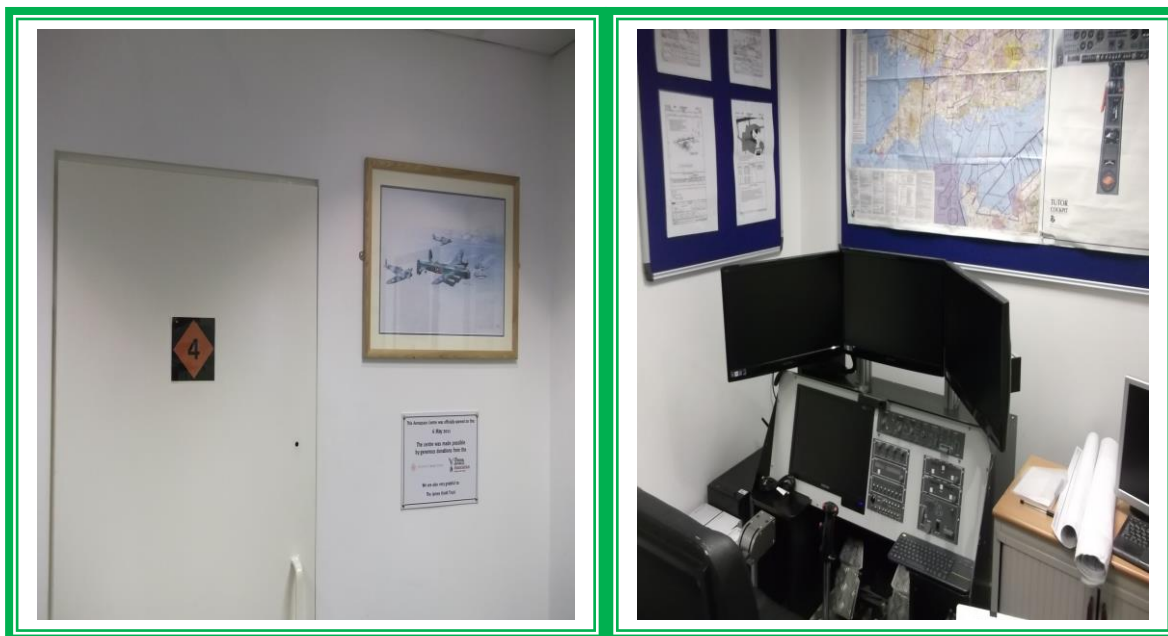
Item No: 6
Sample No: N/A
Location: Ground Floor – Aerospace Centre and Armoury

Material Description:	Visual Inspection – No Suspect Materials Found	
Identification:	N/A	
Approx. quantity:	N/A	
Accessibility	N/A	<i>Assessment Score</i>
Product type:	N/A	N/A
Extent of Damage:	N/A	N/A
Surface Treatment:	N/A	N/A
Asbestos type:	N/A	N/A
Material Assessment Score:		N/A
Priority Assessment Score:		N/A
Action:	N/A	
Comments:	Modern Throughout

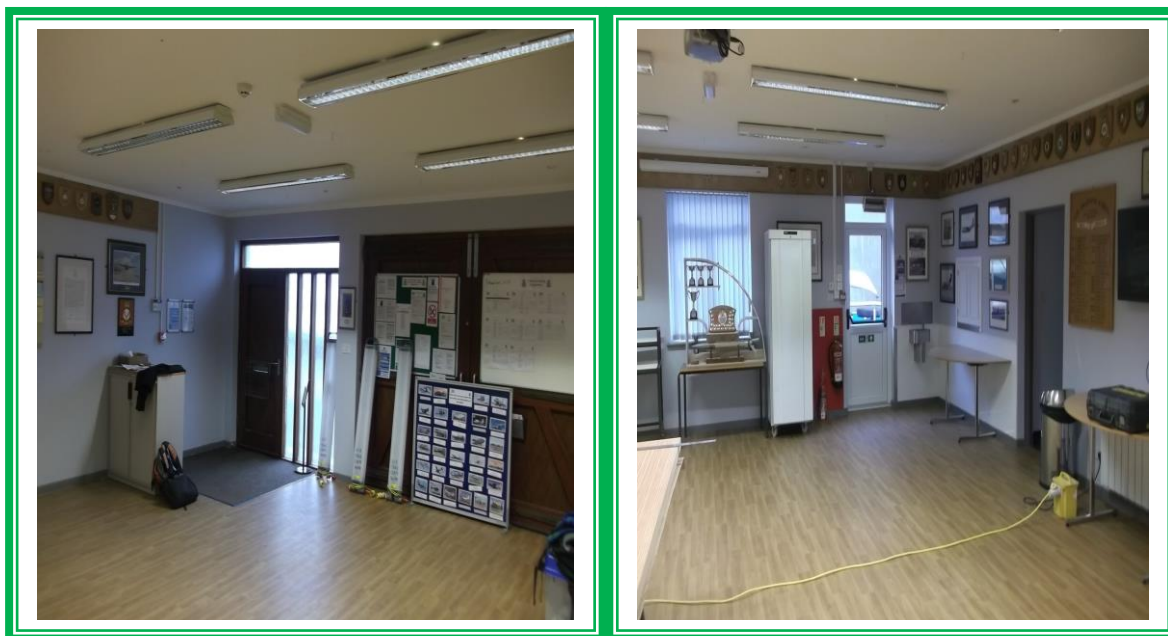
Item No: 7
Sample No: N/A
Location: Ground Floor – Main Hall/Drill Hall

Material Description:	Visual Inspection – No Suspect Materials Found	
Identification:	N/A	
Approx. quantity:	N/A	
Accessibility	N/A	<i>Assessment Score</i>
Product type:	N/A	N/A
Extent of Damage:	N/A	N/A
Surface Treatment:	N/A	N/A
Asbestos type:	N/A	N/A
Material Assessment Score:		N/A
Priority Assessment Score:		N/A
Action:	N/A	
Comments:	Fully modernized, 1990's heaters with no asbestos products within

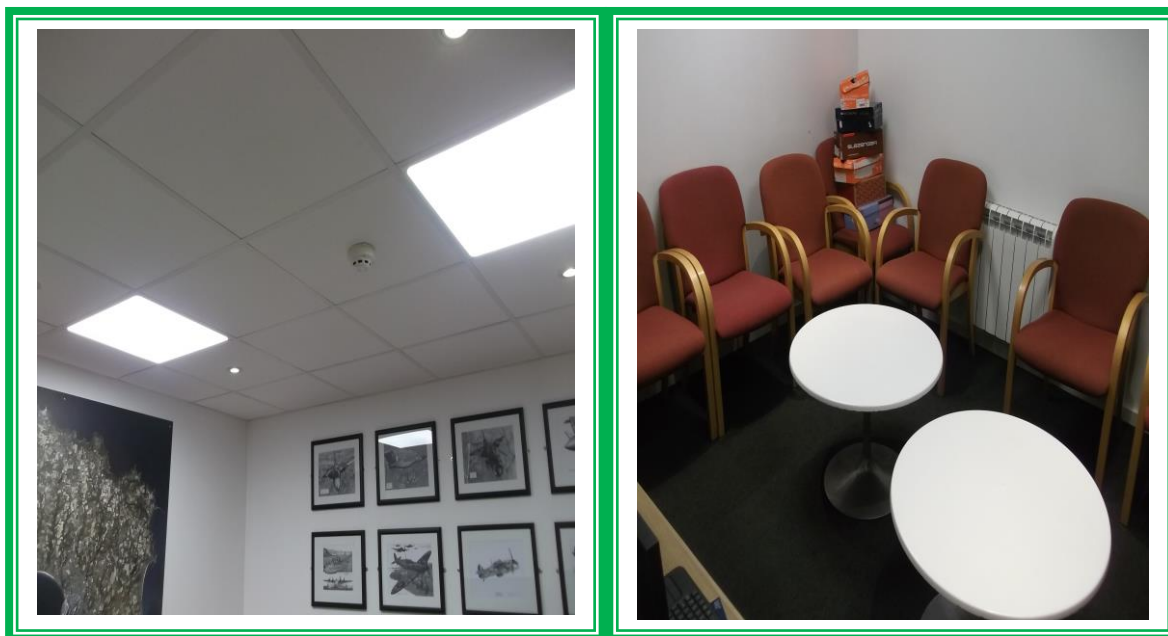
Location: Ground Floor – Meeting Room

Material Description:	Visual Inspection – No Suspect Materials Found	
Identification:	N/A	
Approx. quantity:	N/A	
Accessibility	N/A	<i>Assessment Score</i>
Product type:	N/A	N/A
Extent of Damage:	N/A	N/A
Surface Treatment:	N/A	N/A
Asbestos type:	N/A	N/A
Material Assessment Score:		N/A
Priority Assessment Score:		N/A
Action:	N/A	
Comments:	Fully modernized, modern wall heater mounted on wall

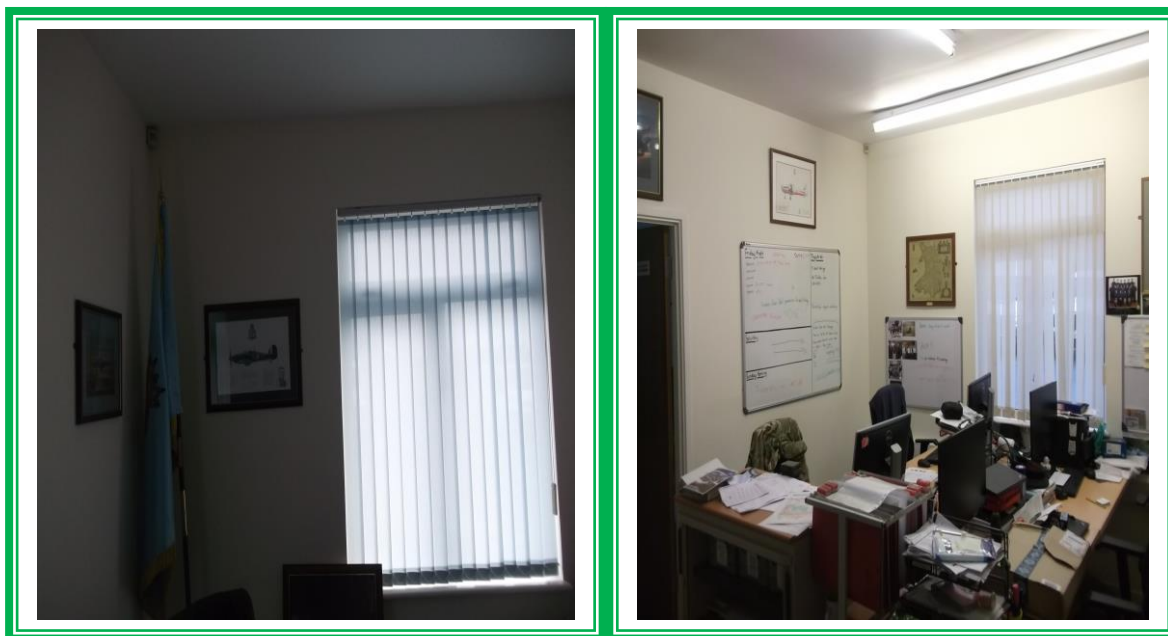
Item No: 11
Sample No: N/A
Location: Ground Floor – Offices

Material Description:	Visual Inspection – No Suspect Materials Found	
Identification:	N/A	
Approx. quantity:	N/A	
Accessibility	N/A	<i>Assessment Score</i>
Product type:	N/A	N/A
Extent of Damage:	N/A	N/A
Surface Treatment:	N/A	N/A
Asbestos type:	N/A	N/A
Material Assessment Score:		N/A
Priority Assessment Score:		N/A
Action:	N/A	
Comments:	Modern wall heaters and furnishings

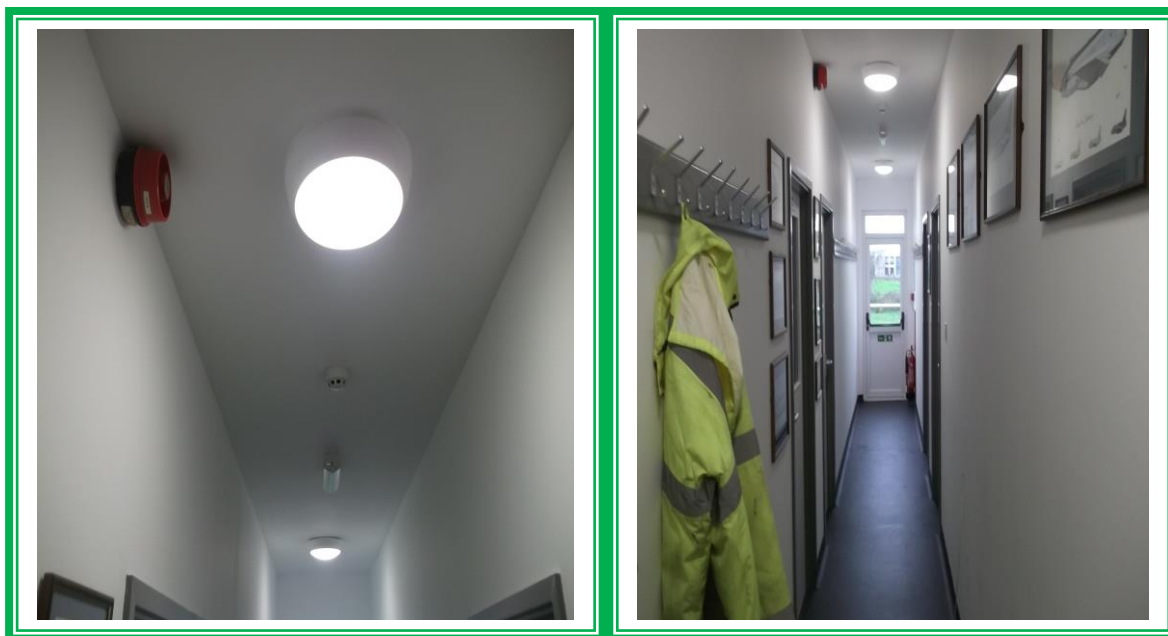
Item No: 12
Sample No: N/A
Location: Ground Floor – Corridor Near Training Rooms

Material Description:	Visual Inspection – No Suspect Materials Found	
Identification:	N/A	
Approx. quantity:	N/A	
Accessibility	N/A	<i>Assessment Score</i>
Product type:	N/A	N/A
Extent of Damage:	N/A	N/A
Surface Treatment:	N/A	N/A
Asbestos type:	N/A	N/A
Material Assessment Score:		N/A
Priority Assessment Score:		N/A
Action:	N/A	
Comments:	Fitted Modern Lino Flooring

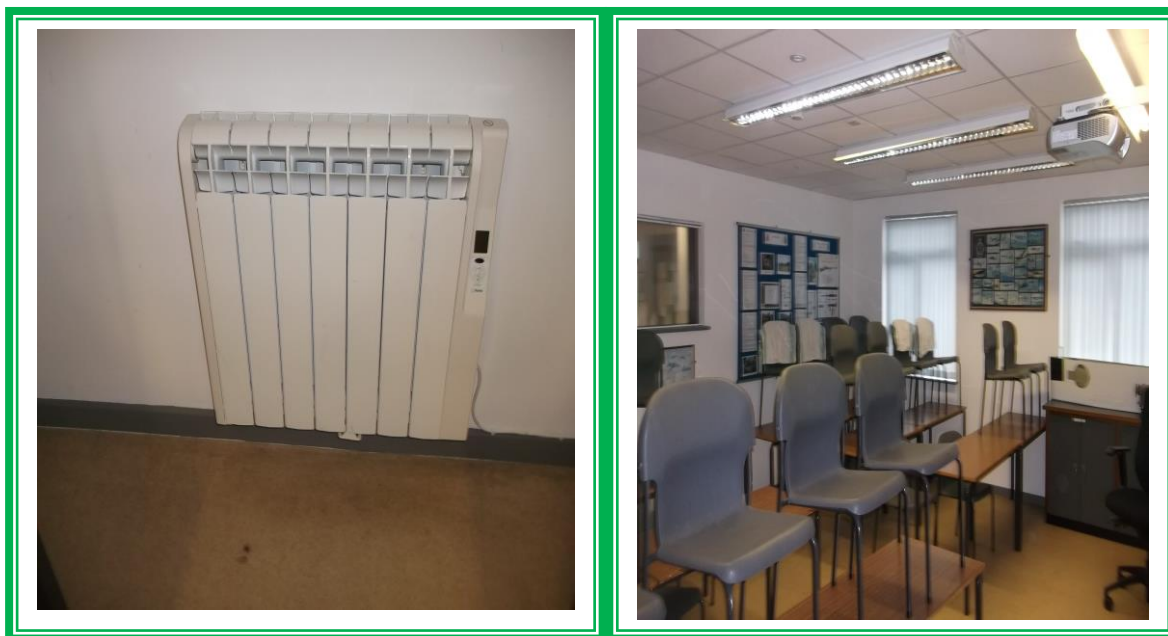
Item No: 13
Sample No: N/A
Location: Ground Floor – Senior Cadet Training Room

Material Description:	Visual Inspection – No Suspect Materials Found	
Identification:	N/A	
Approx. quantity:	N/A	
Accessibility	N/A	<i>Assessment Score</i>
Product type:	N/A	N/A
Extent of Damage:	N/A	N/A
Surface Treatment:	N/A	N/A
Asbestos type:	N/A	N/A
Material Assessment Score:		N/A
Priority Assessment Score:		N/A
Action:	N/A	
Comments:	Modern Wall Heater

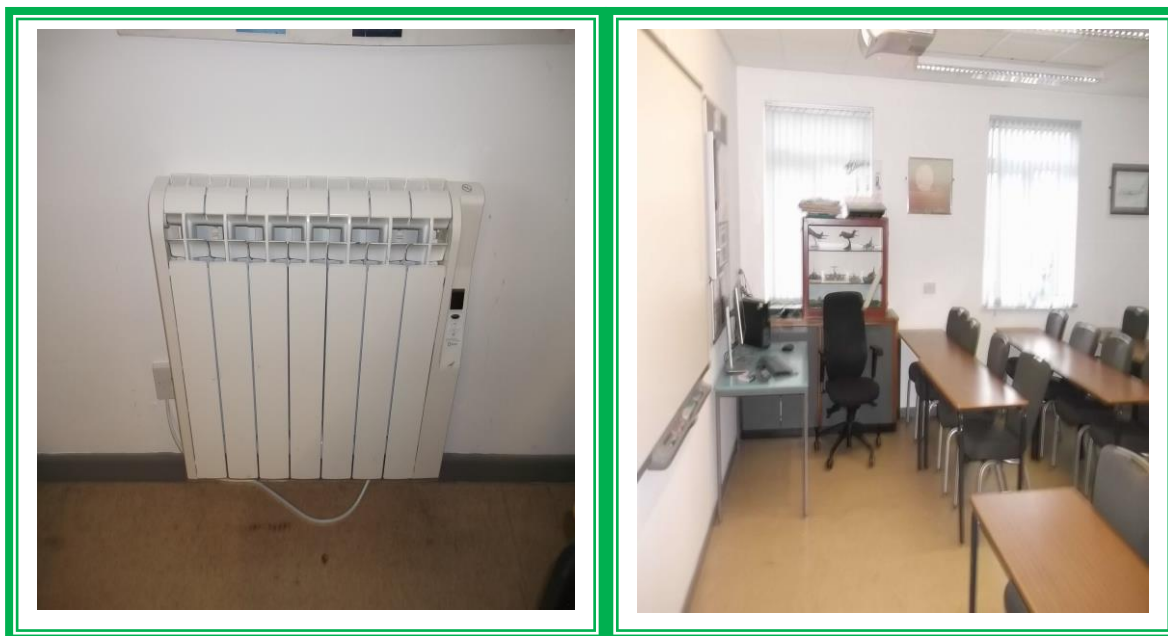
Item No: 14
Sample No: N/A
Location: Ground floor – Leading Cadet Training Room

Material Description:	Visual Inspection – No Suspect Materials Found	
Identification:	N/A	
Approx. quantity:	N/A	
Accessibility	N/A	<i>Assessment Score</i>
Product type:	N/A	N/A
Extent of Damage:	N/A	N/A
Surface Treatment:	N/A	N/A
Asbestos type:	N/A	N/A
Material Assessment Score:		N/A
Priority Assessment Score:		N/A
Action:	N/A	
Comments:	Modern wall heater

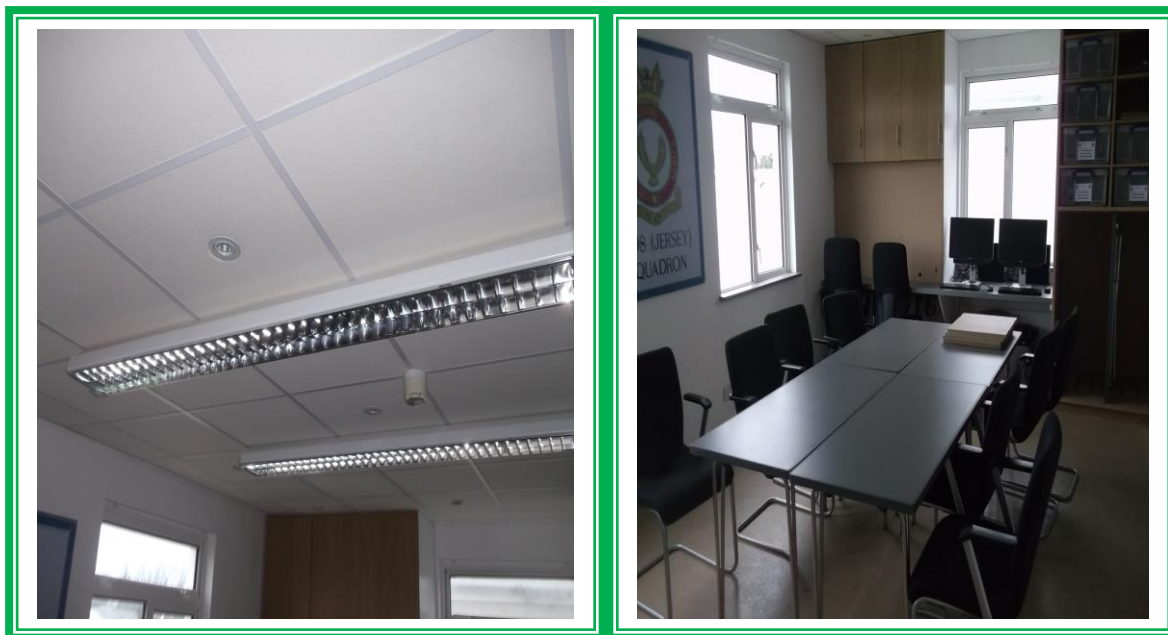
Item No: 15
Sample No: N/A
Location: Ground Floor – Staff Cadet and Radio Training Room

Material Description:	Visual Inspection – No Suspect Materials Found	
Identification:	N/A	
Approx. quantity:	N/A	
Accessibility	N/A	Assessment Score
Product type:	N/A	N/A
Extent of Damage:	N/A	N/A
Surface Treatment:	N/A	N/A
Asbestos type:	N/A	N/A
Material Assessment Score:		N/A
Priority Assessment Score:		N/A
Action:	N/A	
Comments:	Modern throughout, heavy duty modern lino fitted to floor

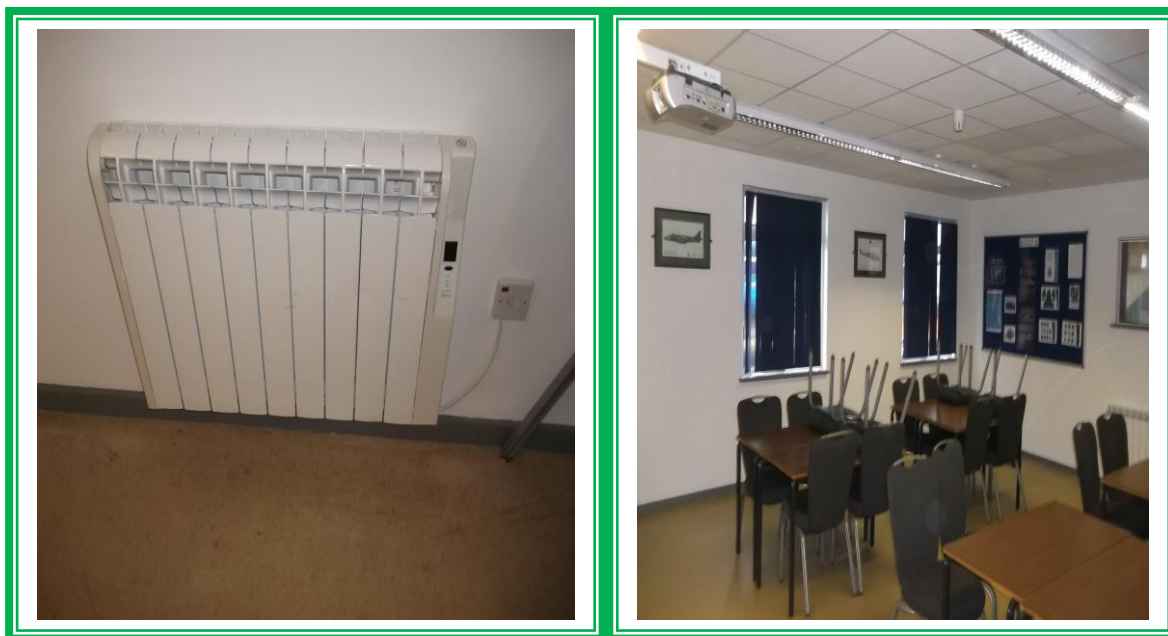
Item No: 16
Sample No: N/A
Location: Ground floor – First Class Cadet Training Room

Material Description:	Visual Inspection – No Suspect Materials Found	
Identification:	N/A	
Approx. quantity:	N/A	
Accessibility	N/A	<i>Assessment Score</i>
Product type:	N/A	N/A
Extent of Damage:	N/A	N/A
Surface Treatment:	N/A	N/A
Asbestos type:	N/A	N/A
Material Assessment Score:		N/A
Priority Assessment Score:		N/A
Action:	N/A	
Comments:	Modern wall heater

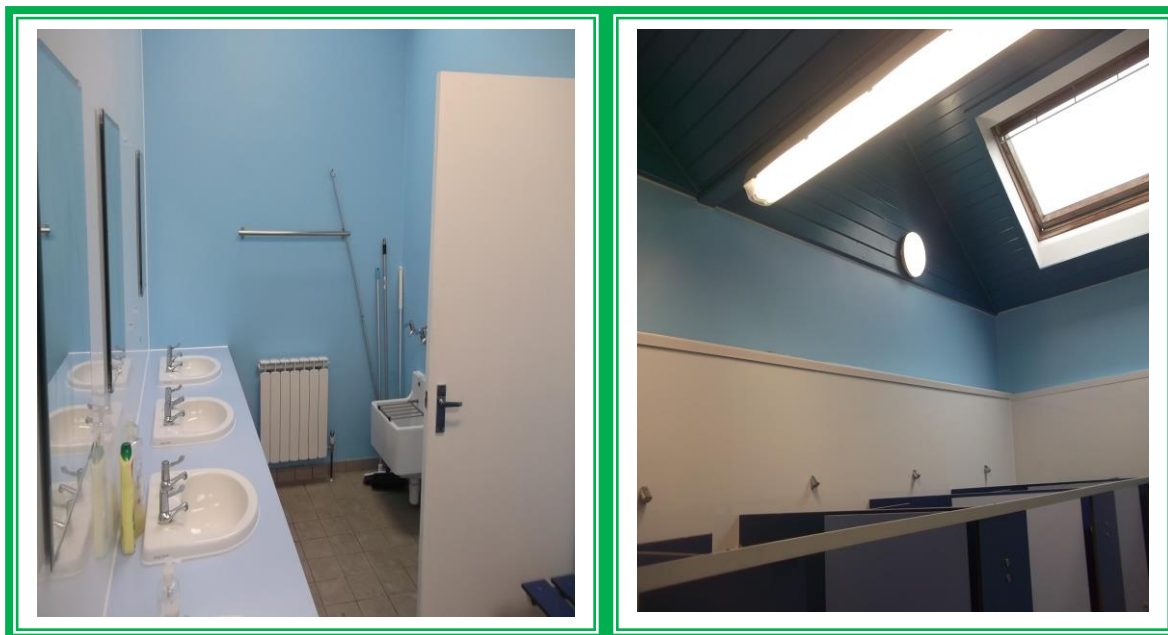
Item No: 18
Sample No: N/A
**Location: Garage Shower Block – Ground Floor –
Showers and Toilets**

Material Description:	Visual Inspection – No Suspect Materials Found	
Identification:	N/A	
Approx. quantity:	N/A	
Accessibility	N/A	Assessment Score
Product type:	N/A	N/A
Extent of Damage:	N/A	N/A
Surface Treatment:	N/A	N/A
Asbestos type:	N/A	N/A
Material Assessment Score:		N/A
Priority Assessment Score:		N/A
Action:	N/A	
Comments:	Modern Throughout

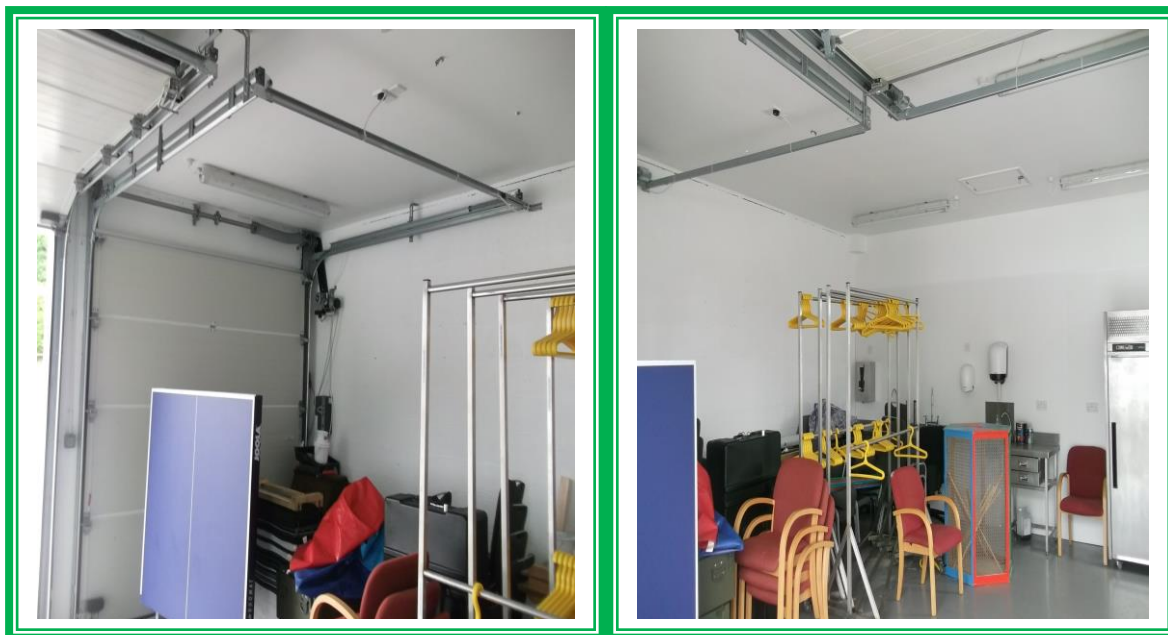
Location: Garage Shower Block – Ground Floor – Main Garage Area

Material Description:	Visual Inspection – No Suspect Materials Found	
Identification:	N/A	
Approx. quantity:	N/A	
Accessibility	N/A	Assessment Score
Product type:	N/A	N/A
Extent of Damage:	N/A	N/A
Surface Treatment:	N/A	N/A
Asbestos type:	N/A	N/A
Material Assessment Score:		N/A
Priority Assessment Score:		N/A
Action:	N/A	
Comments:	Fully modernized new ceiling in 2018
