Project Number 2481

**Management
Asbestos Survey Report**

**Wyvern Barracks, Barrack Road, Exeter, Devon,
EX2 6AE (Building 7)**

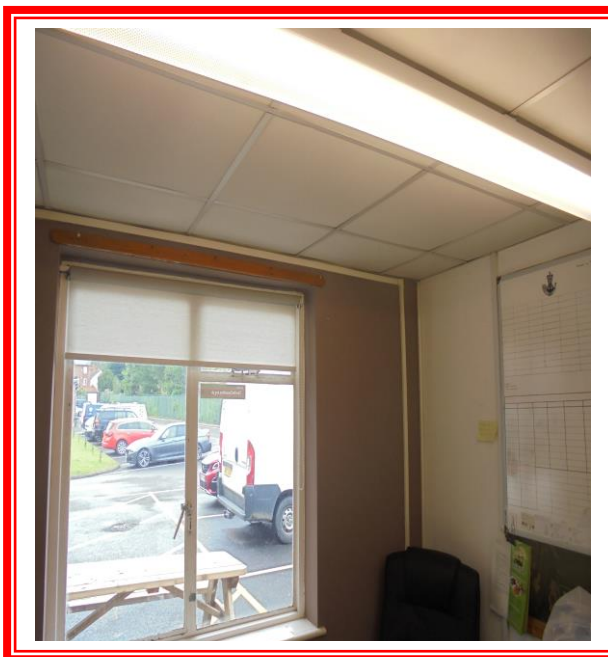
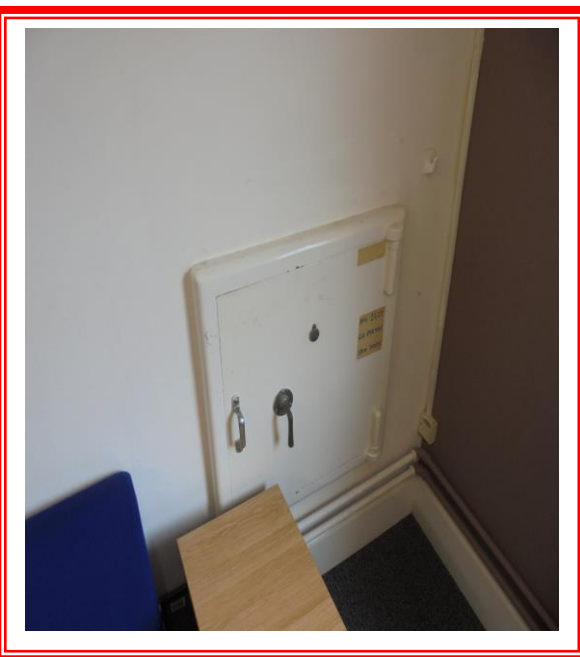
Location: Office G70

Material Description:	No access within safe casings	
Identification:	Presumed to Contain Asbestos	
Approx. quantity:	X 1 Safe	
Accessibility	Low	<i>Assessment Score</i>
Product type:	No Access	2
Extent of Damage:	No Access	2
Surface Treatment:	No Access	2
Asbestos type:	No Access	2
Material Assessment Score:		8
Priority Assessment Score:		Medium
Action:	Manage	
Comments:	No access without irreparable damage

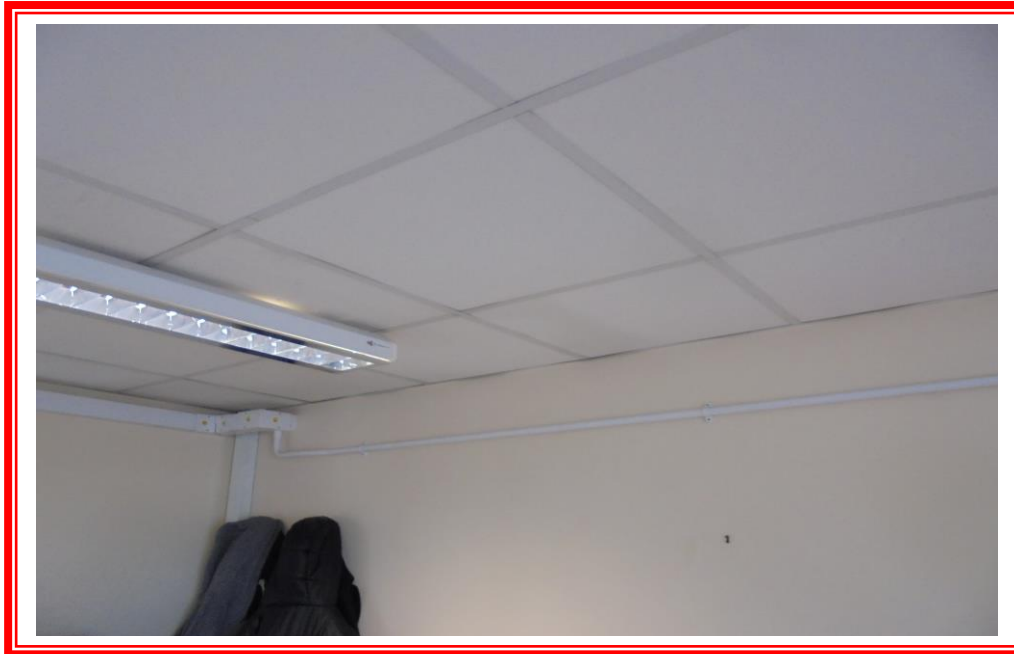
**Item No: 34****Sample No: N/A****Location: Office – F24**

Material Description:	No access within safe casings	
Identification:	Presumed to Contain Asbestos	
Approx. quantity:	X 1 Safe	
Accessibility	Low	<i>Assessment Score</i>
Product type:	No Access	2
Extent of Damage:	No Access	2
Surface Treatment:	No Access	2
Asbestos type:	No Access	2
Material Assessment Score:		8
Priority Assessment Score:		Medium
Action:	Manage	
Comments:	No photo of safe was possible on request of the room occupant

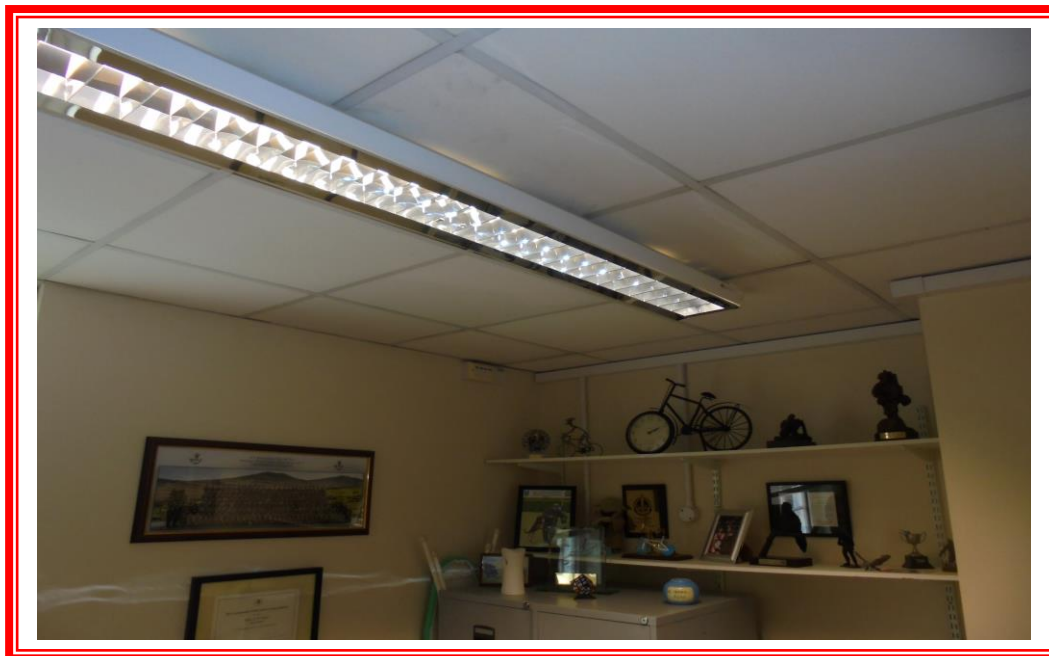
Location: Office F23

Material Description:	No access within safe casings	
Identification:	Presumed to Contain Asbestos	
Approx. quantity:	X 1 Safe	
Accessibility	Low	<i>Assessment Score</i>
Product type:	No Access	2
Extent of Damage:	No Access	2
Surface Treatment:	No Access	2
Asbestos type:	No Access	2
Material Assessment Score:		8
Priority Assessment Score:		Medium
Action:	Manage	
Comments:	No photo of safe was possible on request of the room occupant

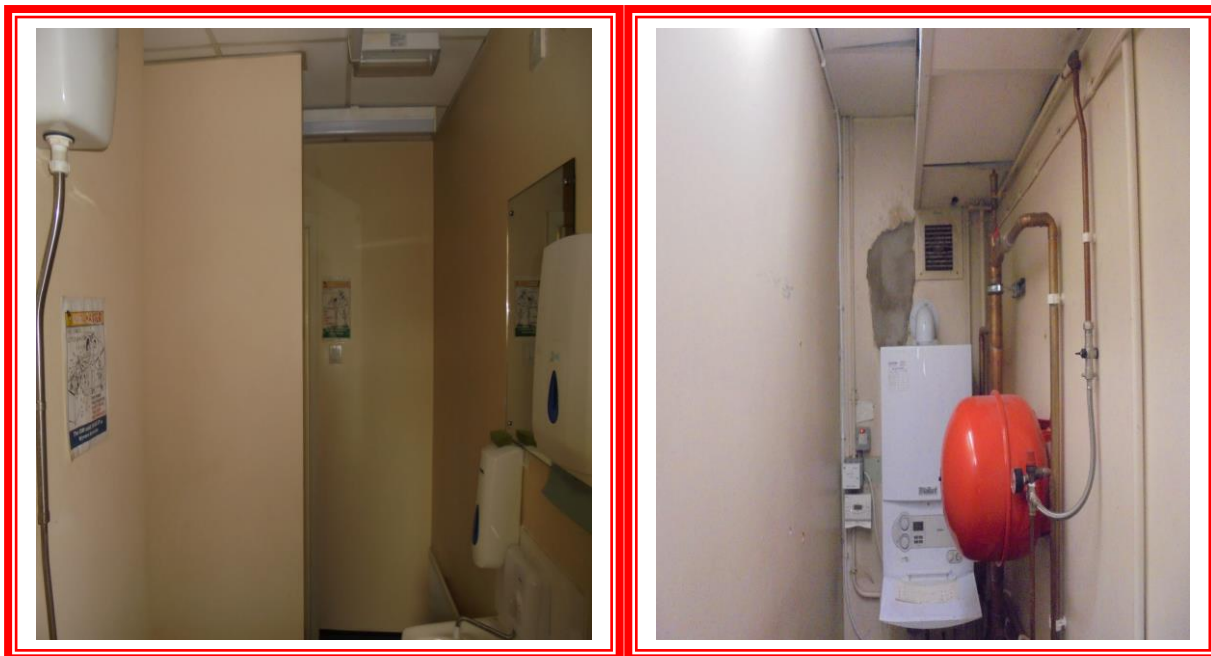
**Item No: 48****Sample No: N/A****Location: G08**

Material Description:	Gaskets	
Identification:	Presumed to Contain Asbestos	
Approx. quantity:	X 2 Gaskets	
Accessibility	Low	<i>Assessment Score</i>
Product type:	Textiles	2
Extent of Damage:	Minor	1
Surface Treatment:	Unsealed	1
Asbestos type:	Chrysotile	1
Material Assessment Score:		5
Priority Assessment Score:		Low
Action:	Manage	
Comments:	Located in room G08. No access to sample gaskets as they were too inset within flanges

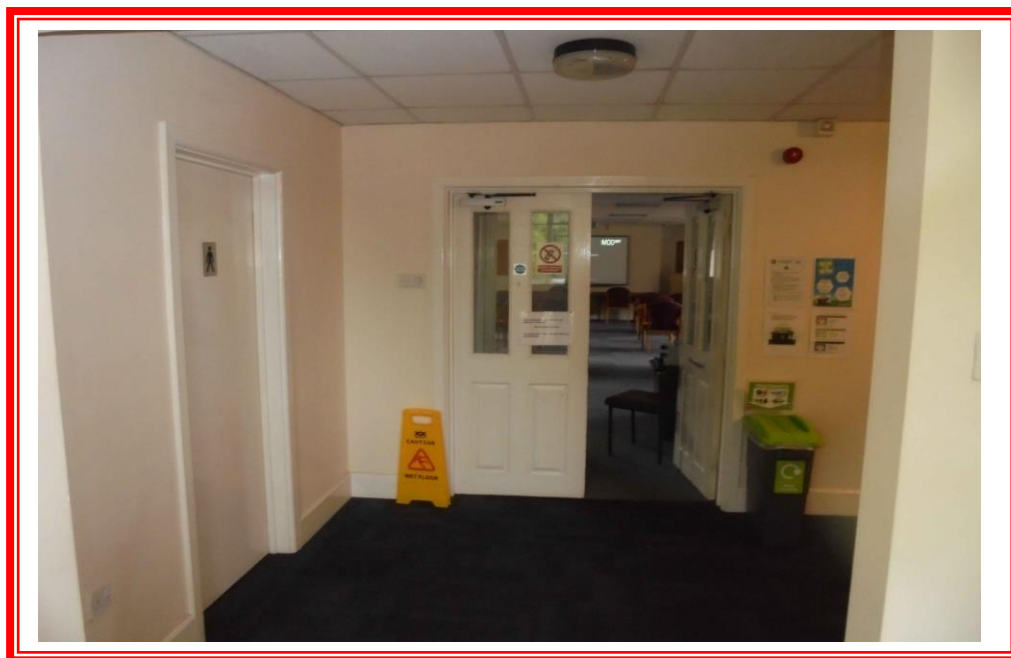
Material Description:	No access with Rooms	
Identification:	Presumed to Contain Asbestos	
Approx. quantity:	Unknown	
Accessibility	Low	<i>Assessment Score</i>
Product type:	No Access	3
Extent of Damage:	No Access	3
Surface Treatment:	No Access	3
Asbestos type:	No Access	3
Material Assessment Score:		12
Priority Assessment Score:		High
Action:	Further Investigation Required	
Comments:	Temporarily locked and then in constant use for remainder of survey. Occupants using the rooms would not allow access.

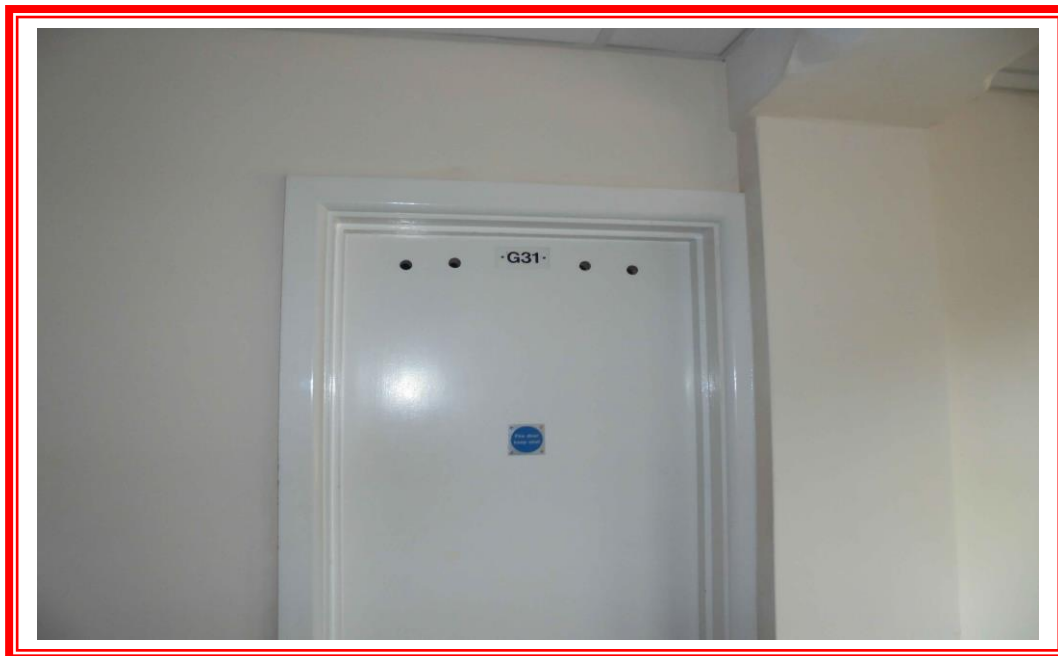
Material Description:	No access with Room	
Identification:	Presumed to Contain Asbestos	
Approx. quantity:	Unknown	
Accessibility	Low	<i>Assessment Score</i>
Product type:	No Access	3
Extent of Damage:	No Access	3
Surface Treatment:	No Access	3
Asbestos type:	No Access	3
Material Assessment Score:		12
Priority Assessment Score:		High
Action:	Further Investigation Required	
Comments:	Locked throughout the survey. Checked with Andy Palmer and with the guard room but they did not know where the key was kept.

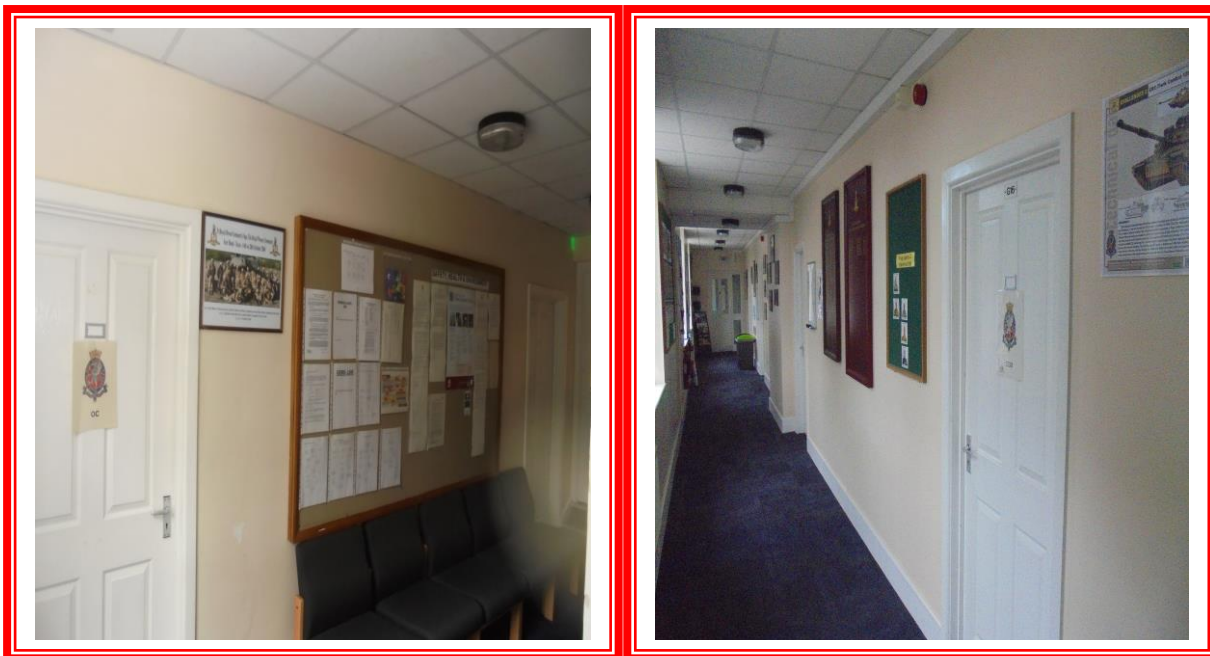
Material Description:	No access with Rooms	
Identification:	Presumed to Contain Asbestos	
Approx. quantity:	X 4 Rooms	
Accessibility	Low	<i>Assessment Score</i>
Product type:	No Access	3
Extent of Damage:	No Access	3
Surface Treatment:	No Access	3
Asbestos type:	No Access	3
Material Assessment Score:		12
Priority Assessment Score:		High
Action:	Further Investigation Required	
Comments:	Rooms constantly locked. Andy Palmer instructed that the keys were held with the Yeomanry but none of the Yeomanry operatives were present during the survey. Several attempts were made to access the rooms during the survey.

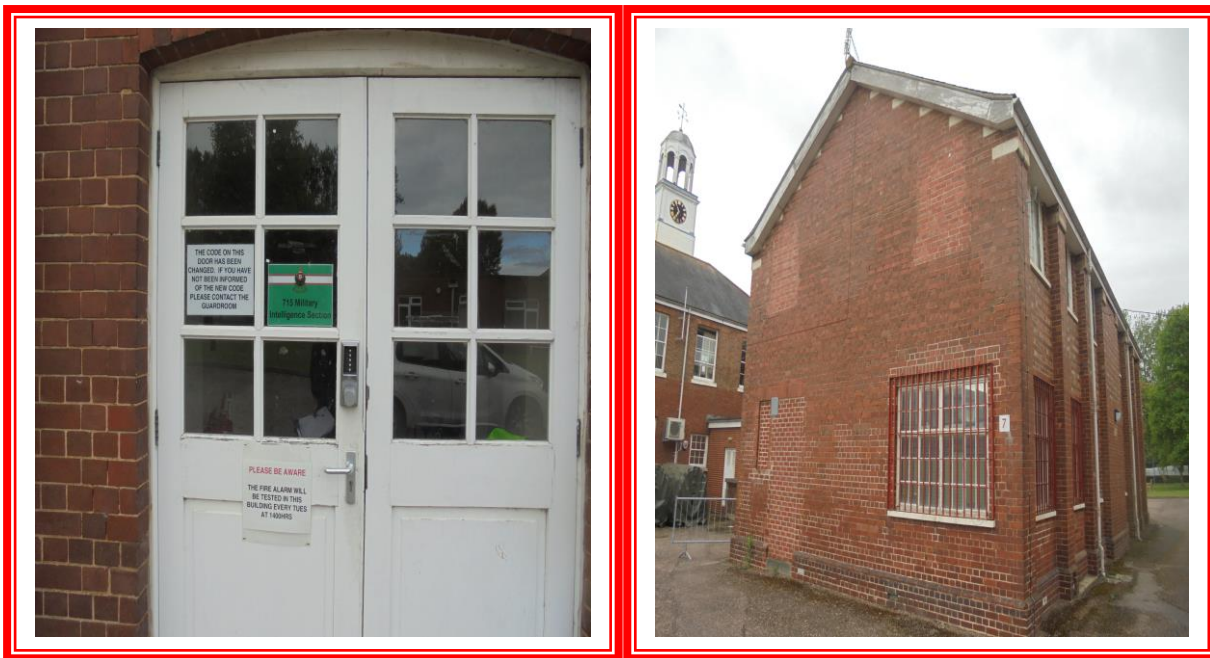
Material Description:	Access was not permitted to Area	
Identification:	Presumed to Contain Asbestos	
Approx. quantity:	Several Rooms	
Accessibility	Low	<i>Assessment Score</i>
Product type:	No Access	3
Extent of Damage:	No Access	3
Surface Treatment:	No Access	3
Asbestos type:	No Access	3
Material Assessment Score:		12
Priority Assessment Score:		High
Action:	Further Investigation Required	
Comments:	Access was not permitted to section as instructed by site contact (Andy Palmer)

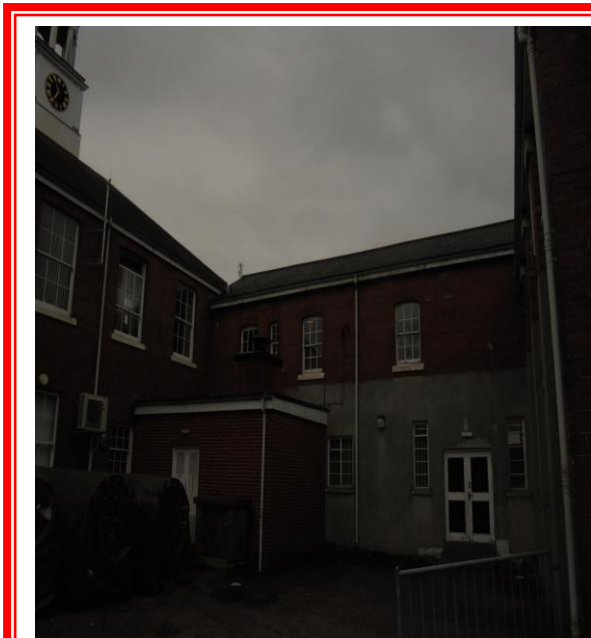
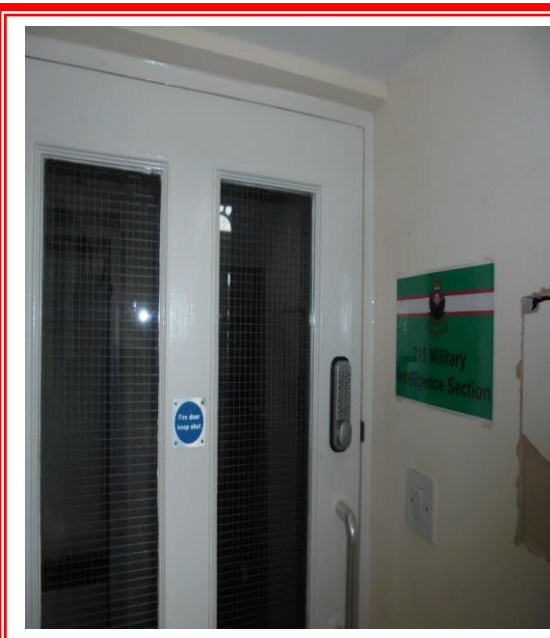
Material Description:	Access was not permitted	
Identification:	Presumed to Contain Asbestos	
Approx. quantity:	X 7 Rooms	
Accessibility	Low	<i>Assessment Score</i>
Product type:	No Access	3
Extent of Damage:	No Access	3
Surface Treatment:	No Access	3
Asbestos type:	No Access	3
Material Assessment Score:		12
Priority Assessment Score:		High
Action:	Further Investigation Required	
Comments:	Access was not permitted to section as instructed by site contact (Andy Palmer)

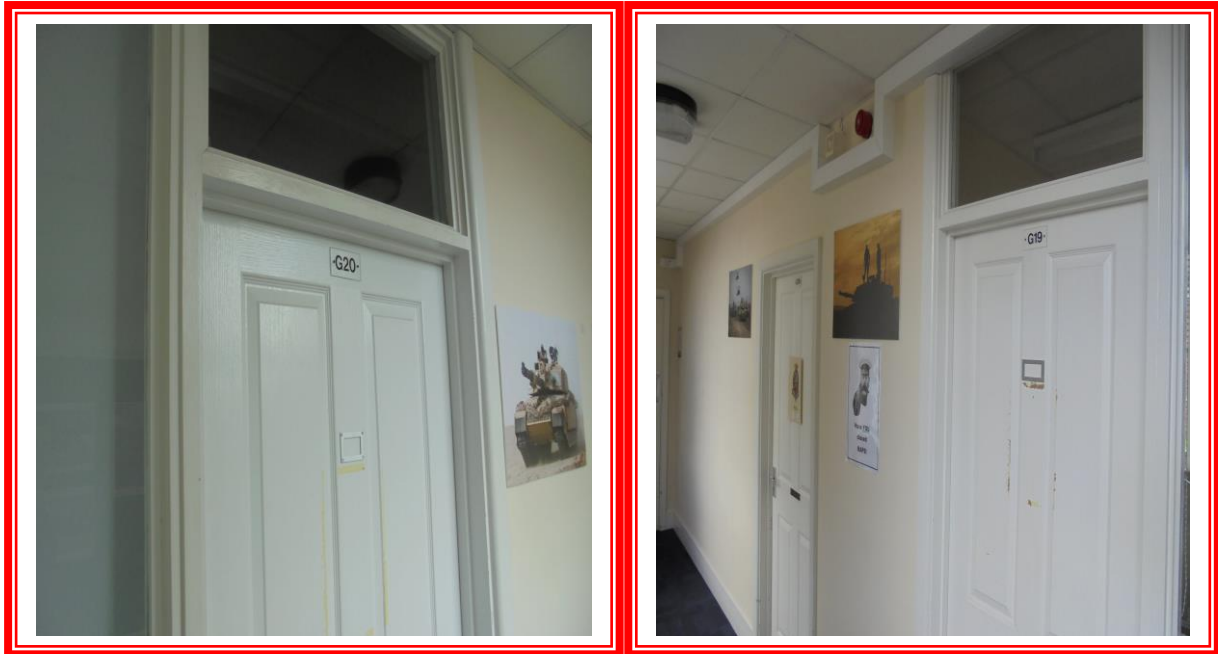
Material Description:	No access with locked rooms	
Identification:	Presumed to Contain Asbestos	
Approx. quantity:	X 3 Rooms	
Accessibility	Low	<i>Assessment Score</i>
Product type:	No Access	3
Extent of Damage:	No Access	2
Surface Treatment:	No Access	3
Asbestos type:	No Access	3
Material Assessment Score:		11
Priority Assessment Score:		High
Action:	Further Investigation Required	
Comments:	Rooms constantly locked and site contact (Andy Palmer) did not have access and did not know where keys were kept

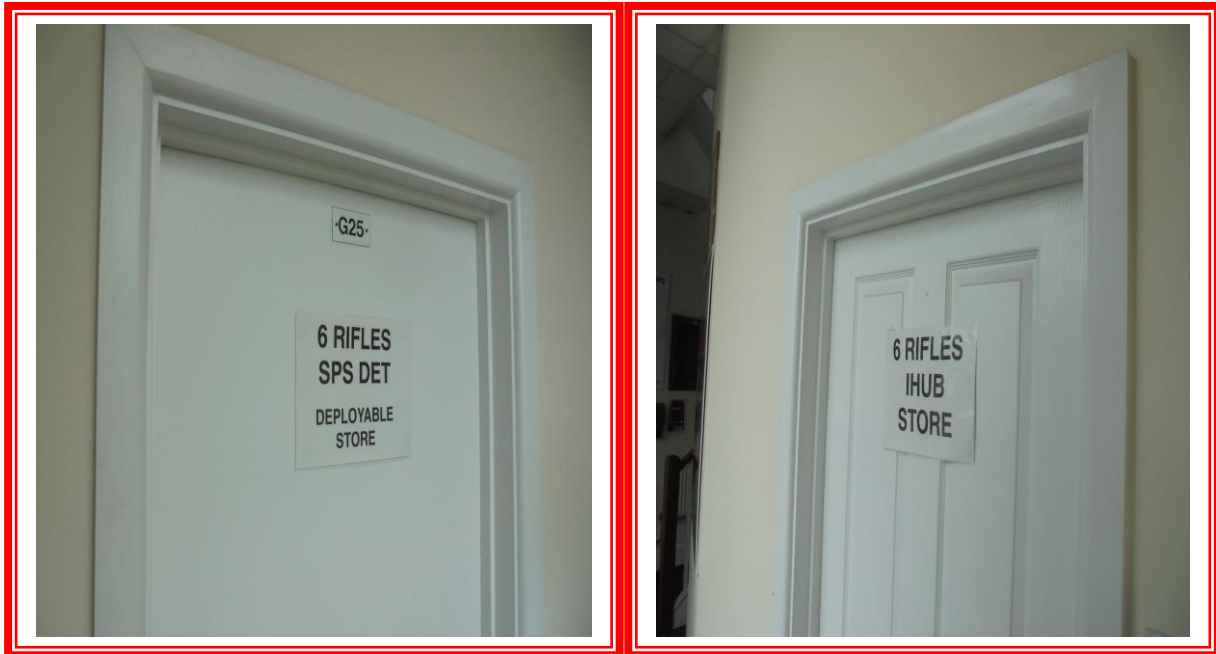
Material Description:	No access with locked rooms	
Identification:	Presumed to Contain Asbestos	
Approx. quantity:	X 2 Rooms	
Accessibility	Low	<i>Assessment Score</i>
Product type:	No Access	3
Extent of Damage:	No Access	3
Surface Treatment:	No Access	3
Asbestos type:	No Access	3
Material Assessment Score:		12
Priority Assessment Score:		High
Action:	Further Investigation Required	
Comments:	Could not located owner of keys. Site contact (Andy Palmer) did not have access

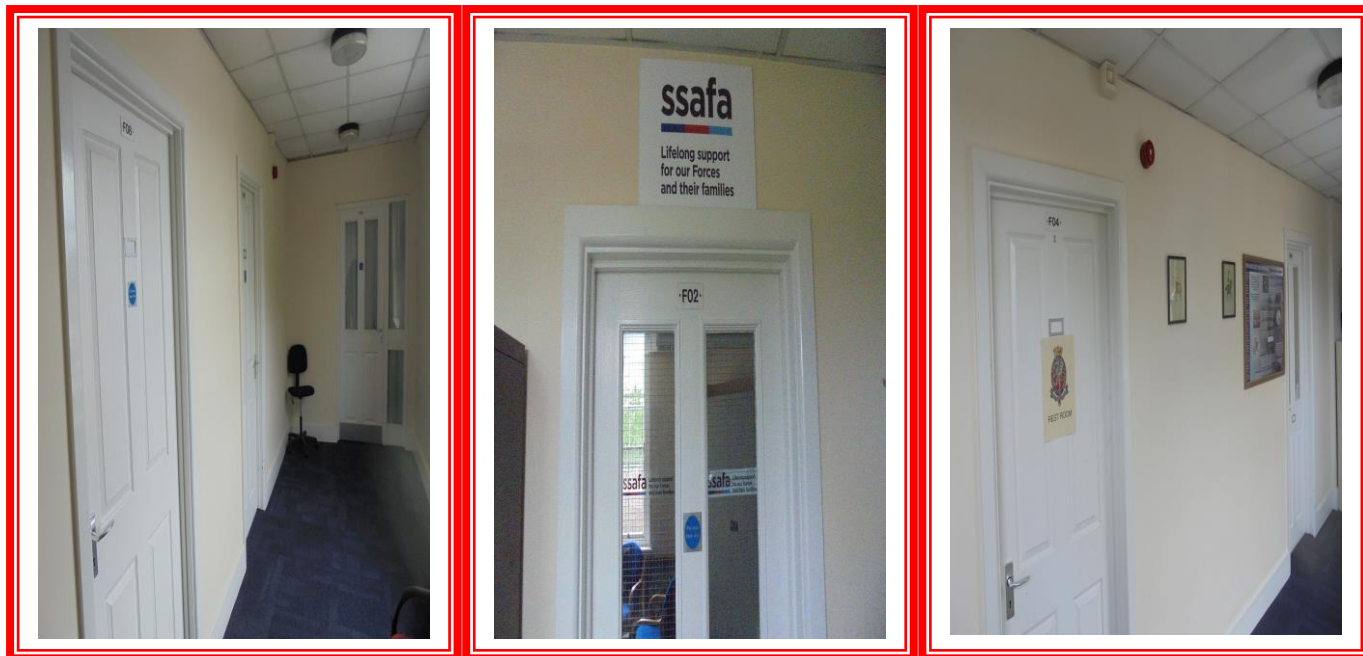
Material Description:	No access with locked rooms	
Identification:	Presumed to Contain Asbestos	
Approx. quantity:	X 6 Rooms	
Accessibility	Low	<i>Assessment Score</i>
Product type:	No Access	3
Extent of Damage:	No Access	3
Surface Treatment:	No Access	3
Asbestos type:	No Access	3
Material Assessment Score:		12
Priority Assessment Score:		High
Action:	Further Investigation Required	
Comments:	Rooms constantly locked. Andy Palmer instructed that the keys were held with the Yeomanry but none of the Yeomanry operatives were present during the survey. Several attempts were made to access the rooms during the survey.

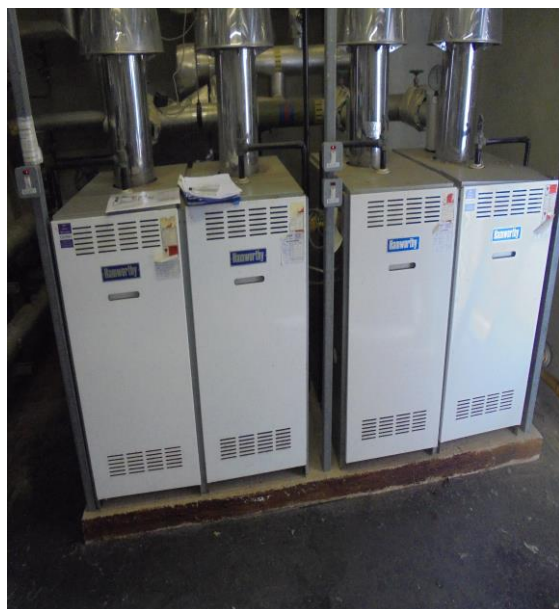
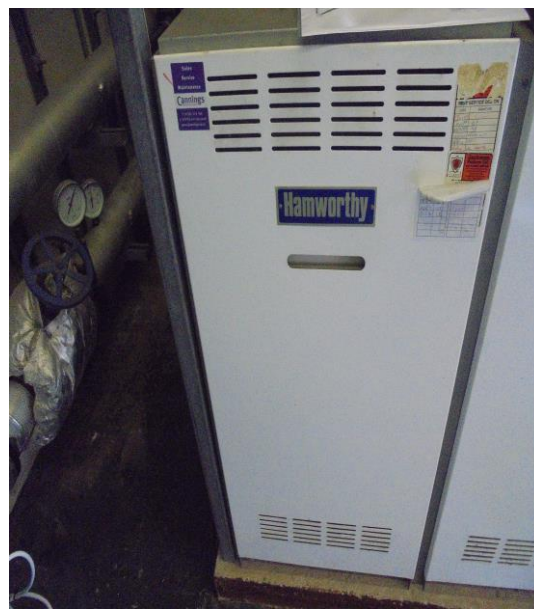
Material Description:	No access with Hamworthy Boilers	
Identification:	Presumed to Contain Asbestos	
Approx. quantity:	X 4 Boilers	
Accessibility	Low	<i>Assessment Score</i>
Product type:	No Access	2
Extent of Damage:	No Access	2
Surface Treatment:	No Access	2
Asbestos type:	No Access	2
Material Assessment Score:		8
Priority Assessment Score:		Medium
Action:	Manage	
Comments:	No access within boilers as live

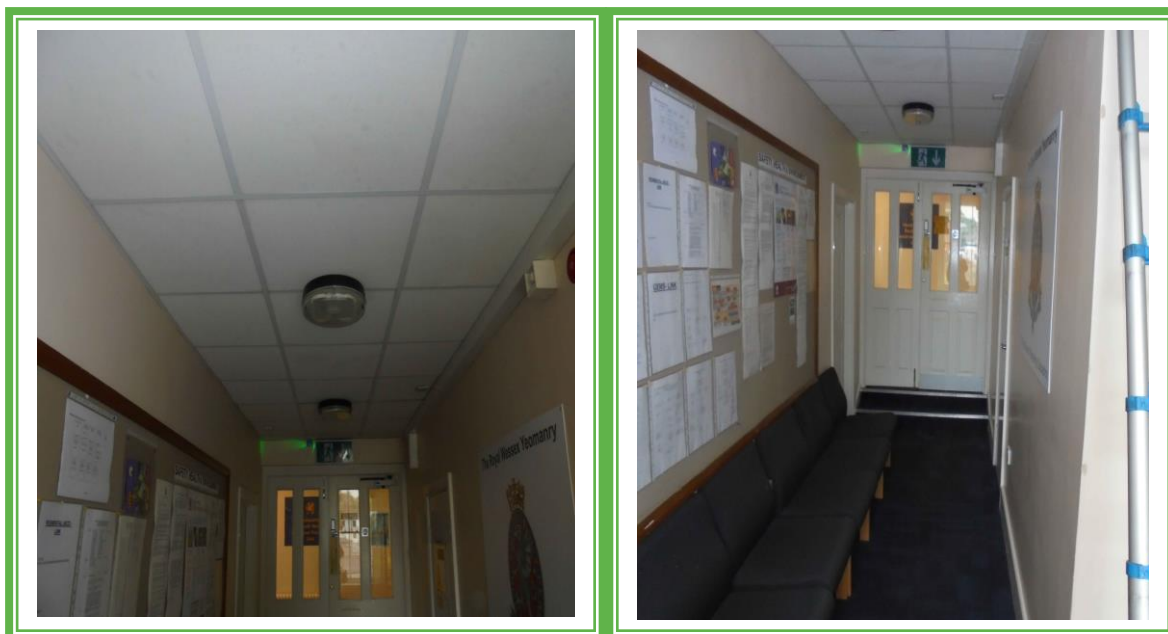
Material Description:	Insulation Board Ceiling Tiles	
Identification:	Samples – No Asbestos Detected	
Approx. quantity:	200M2+ (Throughout Building)	
Accessibility	N/A	<i>Assessment Score</i>
Product type:		N/A
Extent of Damage:		N/A
Surface Treatment:		N/A
Asbestos type:		N/A
Material Assessment Score:		N/A
Priority Assessment Score:		N/A
Action:	N/A	
Comments:	Limited access into ceiling voids due to services and insulation blocking access

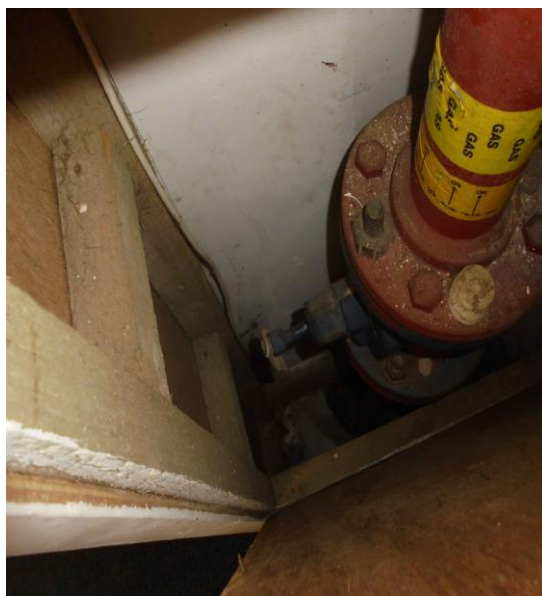
Material Description:	Gaskets	
Identification:	Sampled – No Asbestos Detected	
Approx. quantity:	X 2	
Accessibility	N/A	<i>Assessment Score</i>
Product type:		N/A
Extent of Damage:		N/A
Surface Treatment:		N/A
Asbestos type:		N/A
Material Assessment Score:		N/A
Priority Assessment Score:		N/A
Action:	N/A	
Comments:	Located within boxing. Modern stair nosing to stairs

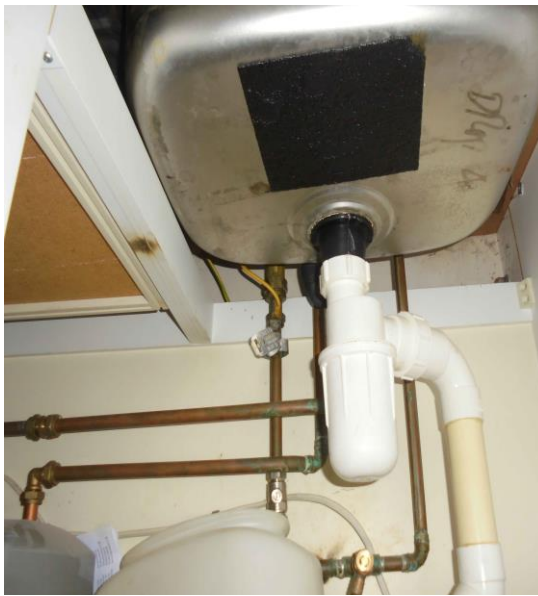
Material Description:	Sink Pad	
Identification:	Sampled – No Asbestos Detected	
Approx. quantity:	1 x Sink	
Accessibility	N/A	<i>Assessment Score</i>
Product type:		N/A
Extent of Damage:		N/A
Surface Treatment:		N/A
Asbestos type:		N/A
Material Assessment Score:		N/A
Priority Assessment Score:		N/A
Action:	N/A	
Comments:	N/A

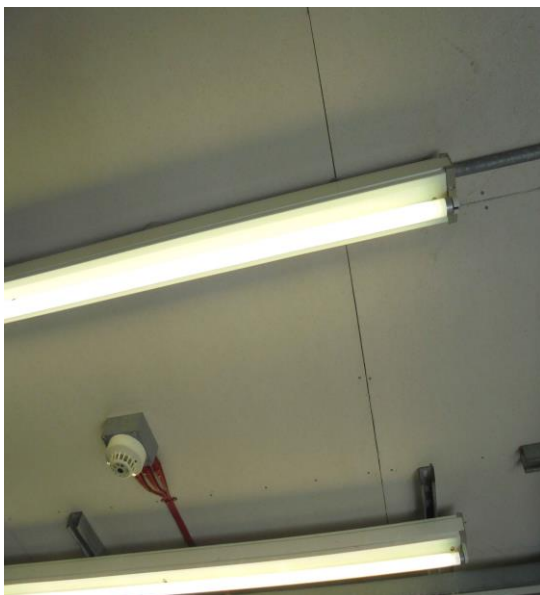
Material Description:	Insulation Board Ceiling Tiles	
Identification:	Sampled – No Asbestos Detected	
Approx. quantity:	12M2	
Accessibility	N/A	<i>Assessment Score</i>
Product type:		N/A
Extent of Damage:		N/A
Surface Treatment:		N/A
Asbestos type:		N/A
Material Assessment Score:		N/A
Priority Assessment Score:		N/A
Action:	N/A	
Comments:	N/A

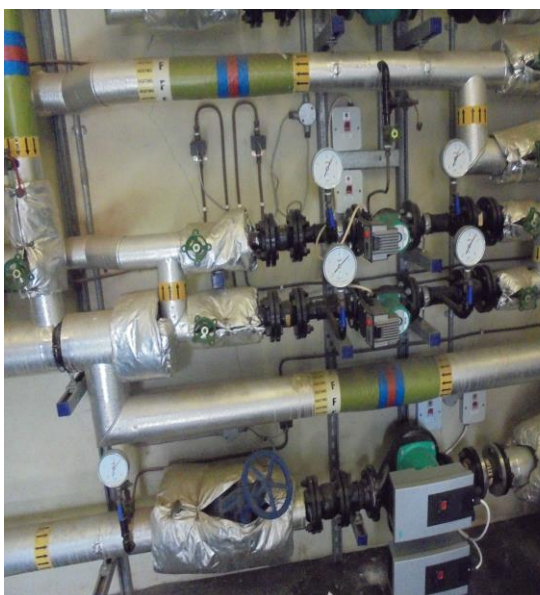
Material Description:	Gaskets	
Identification:	Sampled – No Asbestos Detected	
Approx. quantity:	30+ Gaskets	
Accessibility	N/A	<i>Assessment Score</i>
Product type:		N/A
Extent of Damage:		N/A
Surface Treatment:		N/A
Asbestos type:		N/A
Material Assessment Score:		N/A
Priority Assessment Score:		N/A
Action:	N/A	
Comments:	N/A
