Project Number A-00708 (3700)

**Re-Inspection
Asbestos Survey Report**

**125 Cheltenham
Horse fair Street
Gloucestershire
GL53 8JU**

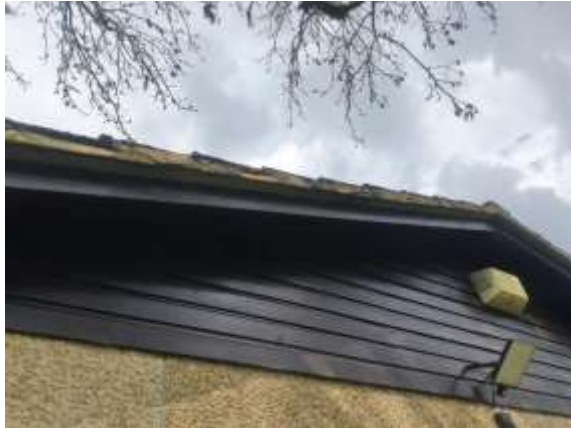
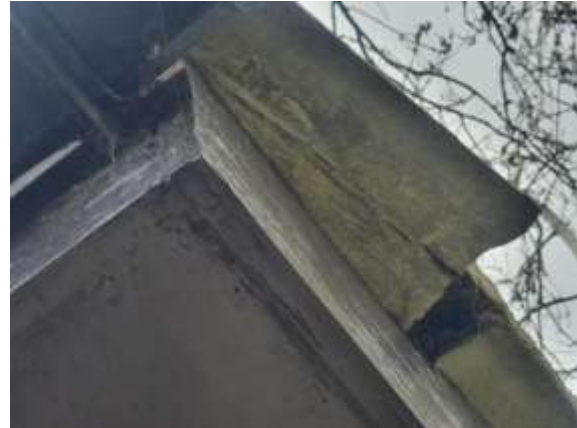
Item No:	1	Sample No:	N/A
Location:	External - Roof 001

Material Description:	Cement Under cloaking - Cement Product	
Identification:	Previously Sampled - Asbestos Detected	
Approx. quantity:	14 LM	
Accessibility	Difficult	Assessment Score
Product type:	Cement	1
Extent of Damage:	Slight / minor damage	1
Surface Treatment:	Unsealed Cement	1
Asbestos type:	Chrysotile	1
Material Assessment Score:		4
Priority Assessment Score:		Negligible
Action:	Manage	
Comments:	Section of under cloaking is loose. Previously sampled ref: Armour 17/7/19 Sample 4

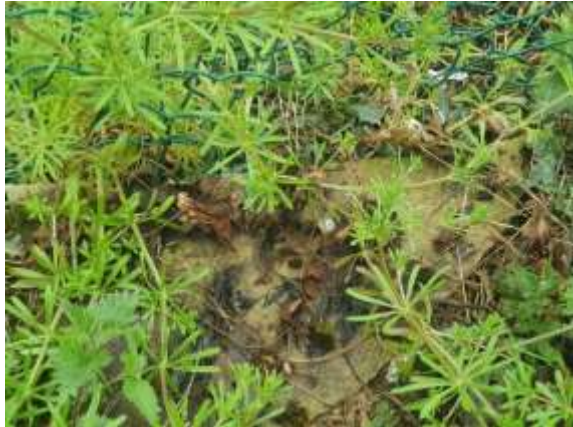
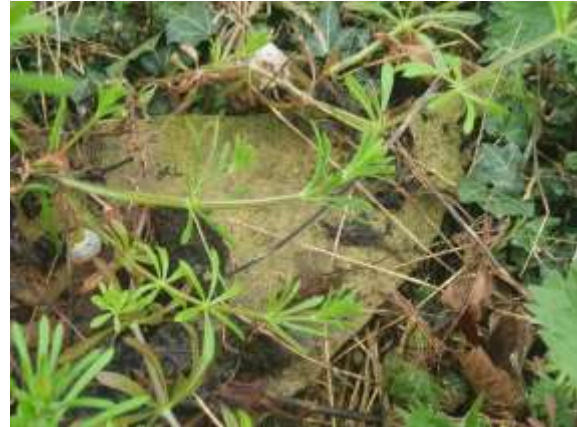
Location: External - Floor 001

Material Description:	Cement Debris - Cement Product	
Identification:	Previously Sampled - Asbestos Detected	
Approx. quantity:	<1 m ²	
Accessibility	Difficult	<i>Assessment Score</i>
Product type:	Cement	1
Extent of Damage:	Moderate damage	2
Surface Treatment:	Unsealed Cement	1
Asbestos type:	Chrysotile	1
Material Assessment Score:		5
Priority Assessment Score:		Low
Action:	Remove	
Comments:	Previously sampled ref: Armour 17/7/19 Sample 5. Debris is likely from the old roof material.
