Project Number A-00528 (3700)

**Re-Inspection
Asbestos Survey Report**

**Dorset House
Clifton
Bristol
BS8 3NA**

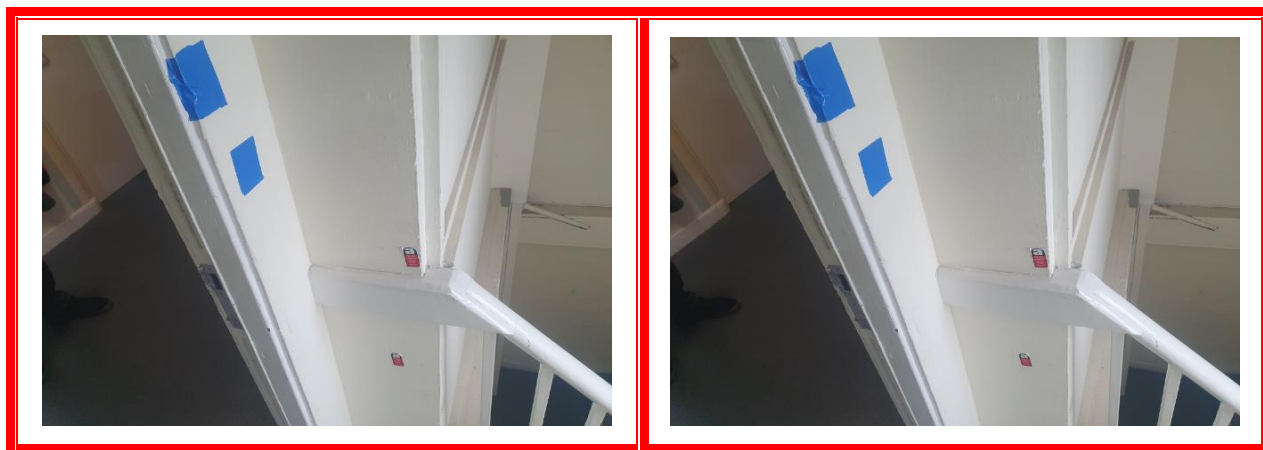
Item No:	1	Sample No:	N/A
Location:	Third Floor - Stairwell 001

Material Description:	Panels - Insulating Board	
Identification:	Previously Sampled - Asbestos Detected	
Approx. quantity:	14 m ²	
Accessibility	Easy	<i>Assessment Score</i>
Product type:	Asbestos Insulating Board	2
Extent of Damage:	Slight / minor damage	1
Surface Treatment:	Encapsulated AIB	1
Asbestos type:	Amosite, Chrysotile	2
Material Assessment Score:		6
Priority Assessment Score:		Low
Action:	Manage	
Comments:	Areas have been encapsulated

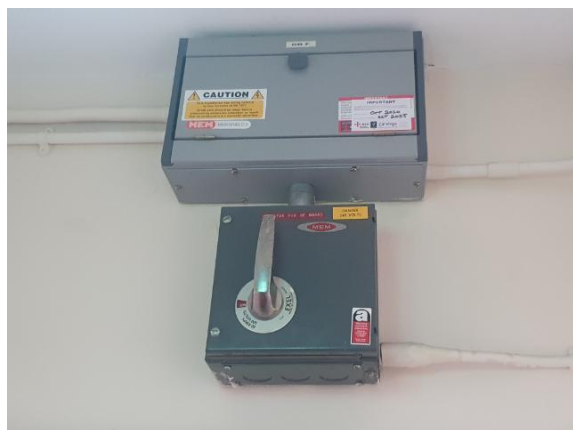
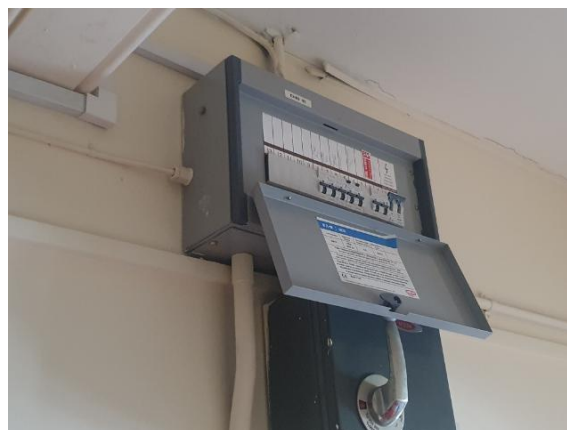
Location: Third Floor - Circulation corridor 002

Material Description:	Electrical services - No Access Gained	
Identification:	Strongly Presumed to Contain Asbestos	
Approx. quantity:	2 no	
Accessibility	Difficult	<i>Assessment Score</i>
Product type:	Friable Debris	3
Extent of Damage:	Good	0
Surface Treatment:	Woven Material	1
Asbestos type:	Presumed	3
Material Assessment Score:		7
Priority Assessment Score:		Medium
Action:	Manage	
Comments:	Unable to sample due to electrical services being live

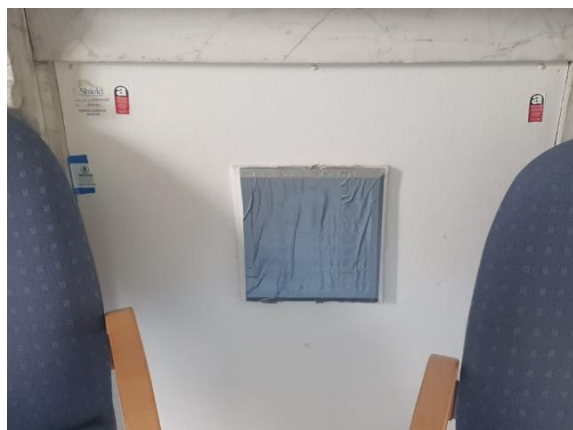
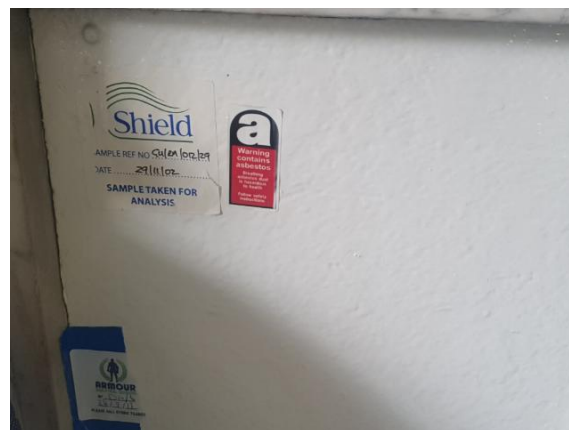
Location: Second Floor - Administration office 003

Material Description:	Fire place - Insulating Board	
Identification:	Previously Sampled - Asbestos Detected	
Approx. quantity:	1 m ²	
Accessibility	Easy	Assessment Score
Product type:	Asbestos Insulating Board	2
Extent of Damage:	Good	0
Surface Treatment:	Encapsulated AIB	1
Asbestos type:	Amosite	2
Material Assessment Score:		5
Priority Assessment Score:		Low
Action:	Manage	
Comments:	small amounts of damage and vent is sealed edges have also been encapsulated

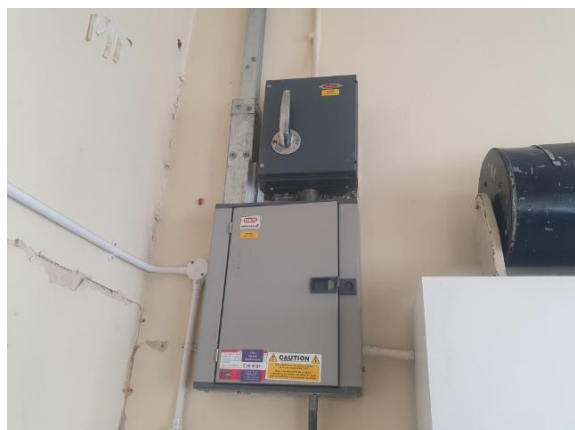
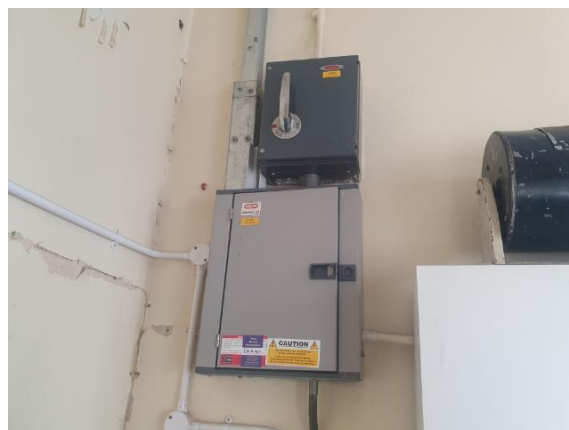
Location: Second Floor - Circulation corridor 004

Material Description:	Electric boards - No Access Gained	
Identification:	Strongly Presumed to Contain Asbestos	
Approx. quantity:	1 no	
Accessibility	Difficult	<i>Assessment Score</i>
Product type:	Rope	2
Extent of Damage:	Good	0
Surface Treatment:	Woven Material	1
Asbestos type:	Presumed	3
Material Assessment Score:		6
Priority Assessment Score:		Low
Action:	Manage	
Comments:	No access into electrical services as services are live

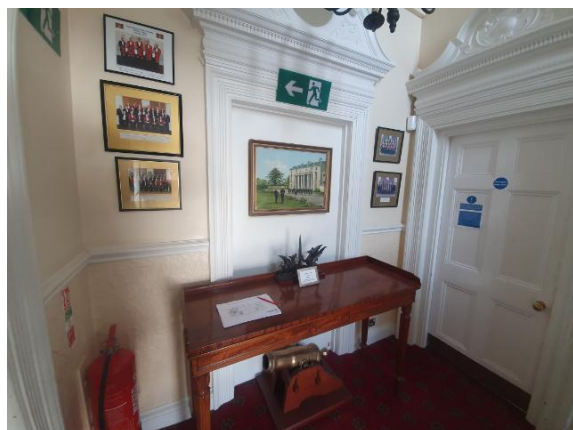
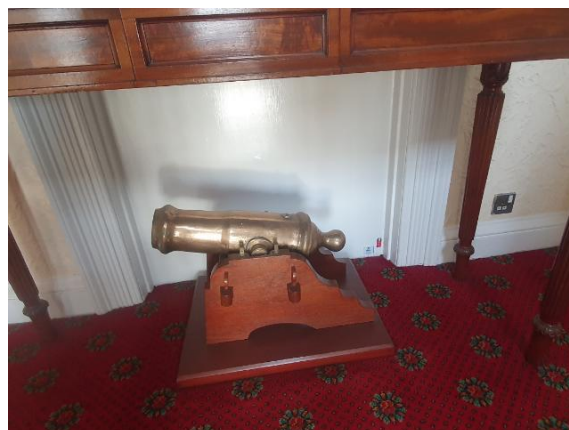
Location: First Floor - Stairwell 007

Material Description:	Door panel - Insulating Board	
Identification:	Previously Sampled - Asbestos Detected	
Approx. quantity:	2 m ²	
Accessibility	Easy	Assessment Score
Product type:	Asbestos Insulating Board	2
Extent of Damage:	Good	0
Surface Treatment:	Encapsulated AIB	1
Asbestos type:	Amosite	2
Material Assessment Score:		5
Priority Assessment Score:		Low
Action:	Manage	
Comments:	Door infill panel were a door once was

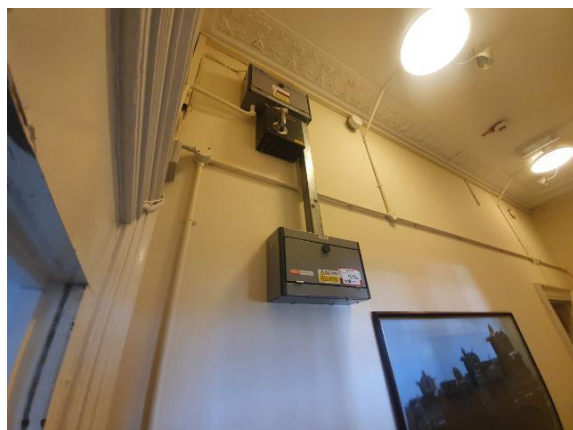
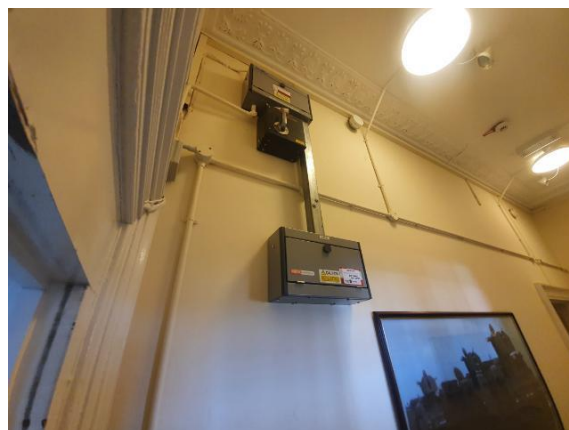
Location: First Floor - Stairwell 008

Material Description:	Electric boards - No Access Gained	
Identification:	Strongly Presumed to Contain Asbestos	
Approx. quantity:	1 no	
Accessibility	Difficult	<i>Assessment Score</i>
Product type:	Rope	2
Extent of Damage:	Good	0
Surface Treatment:	Woven Material	1
Asbestos type:	Presumed	3
Material Assessment Score:		6
Priority Assessment Score:		Low
Action:	Manage	
Comments:	No access into electricity services as electric is live

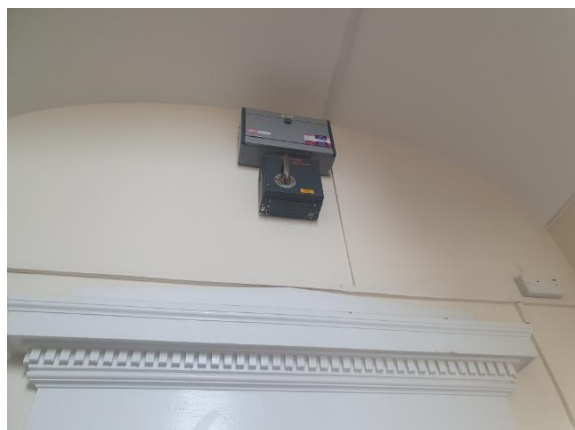
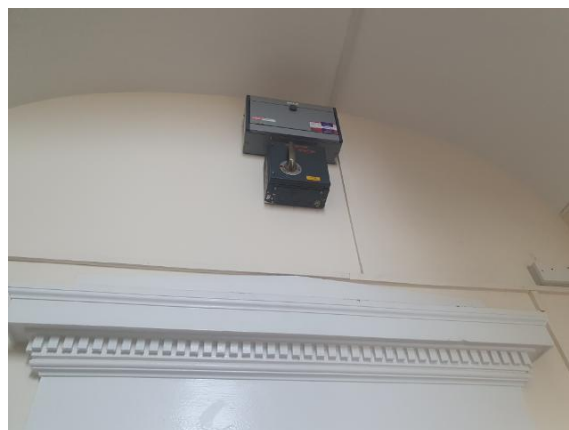
Location: Ground Floor - Corridor 011

Material Description:	Electric boards - No Access Gained	
Identification:	Strongly Presumed to Contain Asbestos	
Approx. quantity:	1 no	
Accessibility	Difficult	<i>Assessment Score</i>
Product type:	Rope	2
Extent of Damage:	Good	0
Surface Treatment:	Woven Material	1
Asbestos type:	Presumed	3
Material Assessment Score:		6
Priority Assessment Score:		Low
Action:	Manage	
Comments:	No access into electricity services as they are live

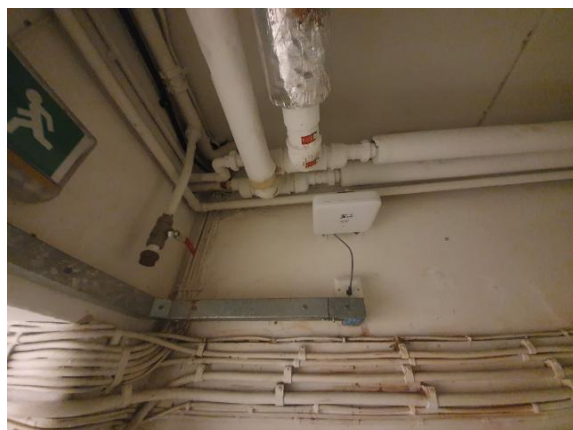
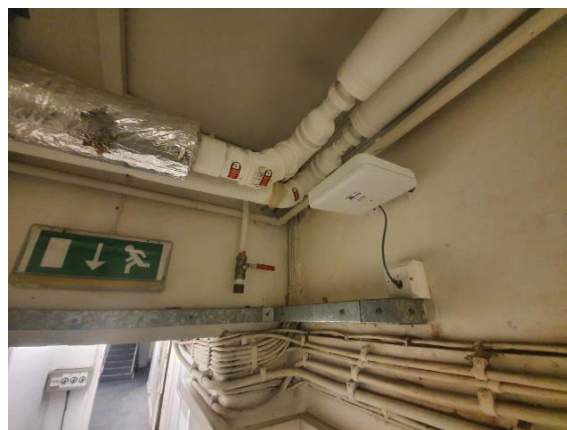
Location: Basement - Corridor 012

Material Description:	Pipework - Insulation	
Identification:	Previously Sampled - Asbestos Detected	
Approx. quantity:	25 LM	
Accessibility	Easy	<i>Assessment Score</i>
Product type:	Pipe Insulation	3
Extent of Damage:	Good	0
Surface Treatment:	Encapsulated Insulation	2
Asbestos type:	Amosite	2
Material Assessment Score:		7
Priority Assessment Score:		Medium
Action:	Manage	
Comments:	Pipes were sampled on last visit. The pipes have been encapsulated

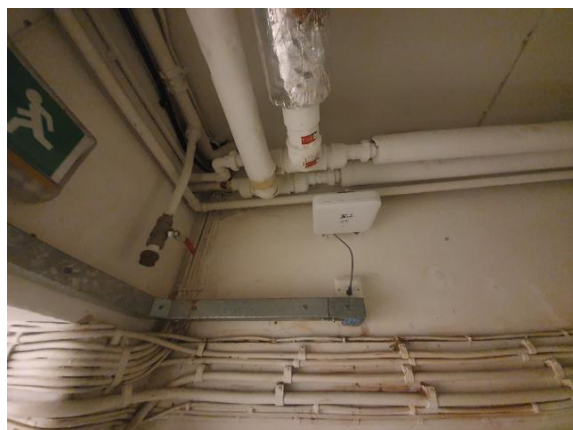
Location: Basement - Corridor 013

Material Description:	Electric boards - No Access Gained	
Identification:	Strongly Presumed to Contain Asbestos	
Approx. quantity:	20 no	
Accessibility	Difficult	<i>Assessment Score</i>
Product type:	Rope	2
Extent of Damage:	Good	0
Surface Treatment:	Woven Material	1
Asbestos type:	Presumed	3
Material Assessment Score:		6
Priority Assessment Score:		Low
Action:	Manage	
Comments:	No access into electricity services as services are live

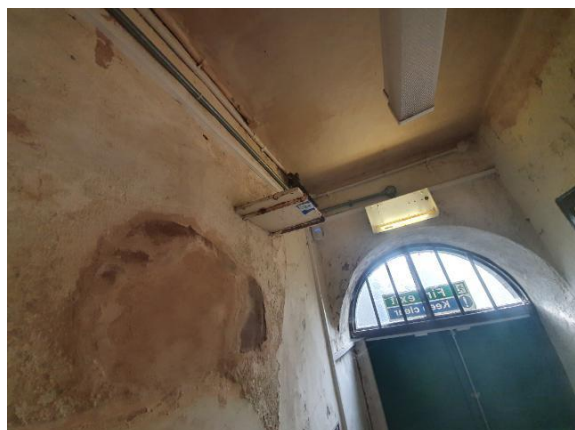
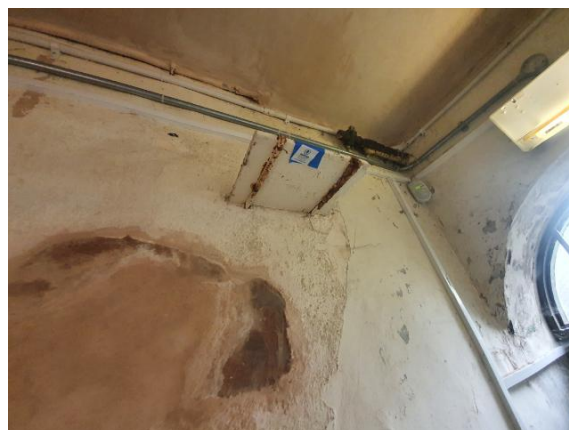
Location: Basement - Corridor 014

Material Description:	Gas shelf - Insulating Board	
Identification:	Previously Sampled - Asbestos Detected	
Approx. quantity:	1 m ²	
Accessibility	Medium	Assessment Score
Product type:	Asbestos Insulating Board	2
Extent of Damage:	Good	0
Surface Treatment:	Encapsulated AIB	1
Asbestos type:	Amosite	2
Material Assessment Score:		5
Priority Assessment Score:		Low
Action:	Manage	
Comments:	1 x panel where gas meter was

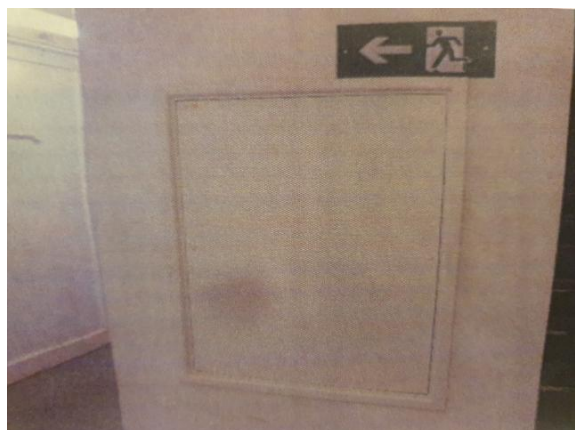
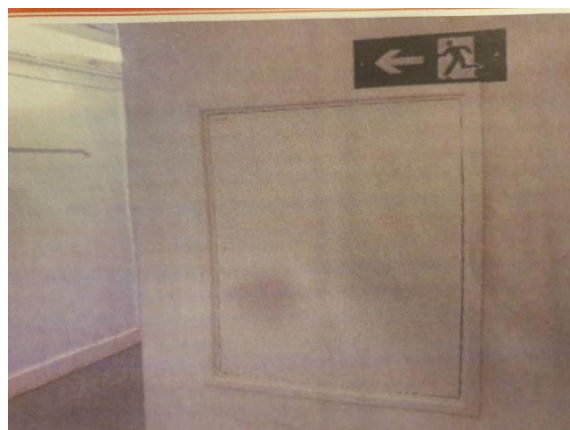
Location: Basement - Lift 015

Material Description:	Lift - No Access Gained	
Identification:	Strongly Presumed to Contain Asbestos	
Approx. quantity:	1 no	
Accessibility	Medium	<i>Assessment Score</i>
Product type:	Friable Debris	3
Extent of Damage:	Good	0
Surface Treatment:	Encapsulated AIB	1
Asbestos type:	Presumed	3
Material Assessment Score:		7
Priority Assessment Score:		Medium
Action:	Manage	
Comments:	No access as lift is live

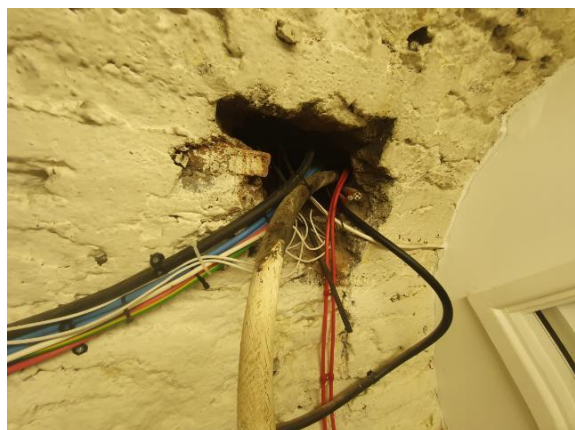
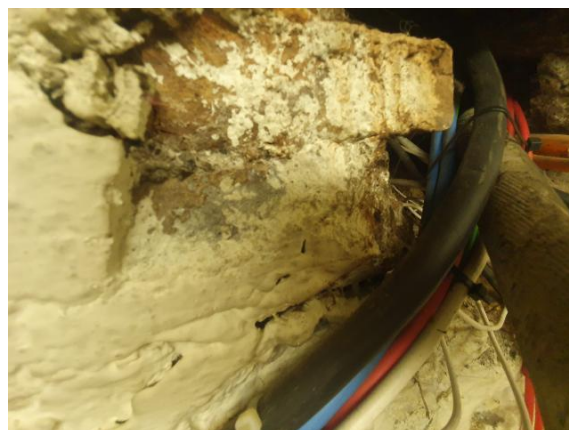
Location: Sub-Basement - Corridor 017

Material Description:	Void - No Access Gained	
Identification:	Strongly Presumed to Contain Asbestos	
Approx. quantity:	Unknow	
Accessibility	Difficult	<i>Assessment Score</i>
Product type:	Asbestos Insulating Board	2
Extent of Damage:	Good	0
Surface Treatment:	Unsealed AIB	2
Asbestos type:	Presumed	3
Material Assessment Score:		7
Priority Assessment Score:		Medium
Action:	Manage	
Comments:	A boarded product within void

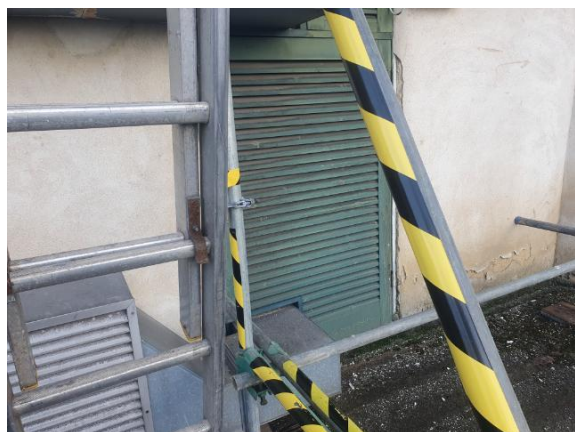
Location: Sub-Basement - Boiler room 018

Material Description:	Door panel - Insulating Board	
Identification:	Previously Sampled - Asbestos Detected	
Approx. quantity:	1 m ²	
Accessibility	Medium	Assessment Score
Product type:	Asbestos Insulating Board	2
Extent of Damage:	Slight / minor damage	1
Surface Treatment:	Encapsulated AIB	1
Asbestos type:	Amosite	2
Material Assessment Score:		6
Priority Assessment Score:		Low
Action:	Manage	
Comments:	A boarded product above door in boiler room

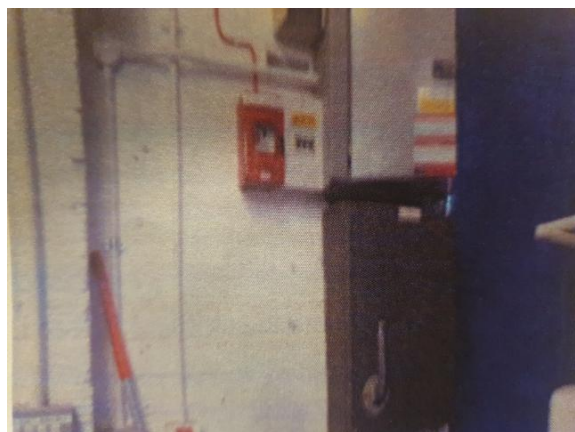
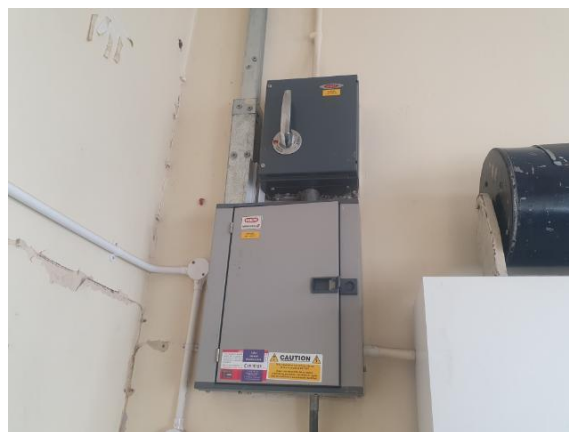
Location: Sub-Basement - Gym 019

Material Description:	Electrical Boards - No Access Gained	
Identification:	Strongly Presumed to Contain Asbestos	
Approx. quantity:	1 no	
Accessibility	Difficult	<i>Assessment Score</i>
Product type:	Rope	2
Extent of Damage:	Good	0
Surface Treatment:	Woven Material	1
Asbestos type:	Presumed	3
Material Assessment Score:		6
Priority Assessment Score:		Low
Action:	Manage	
Comments:	Electrical boxes are live and no access

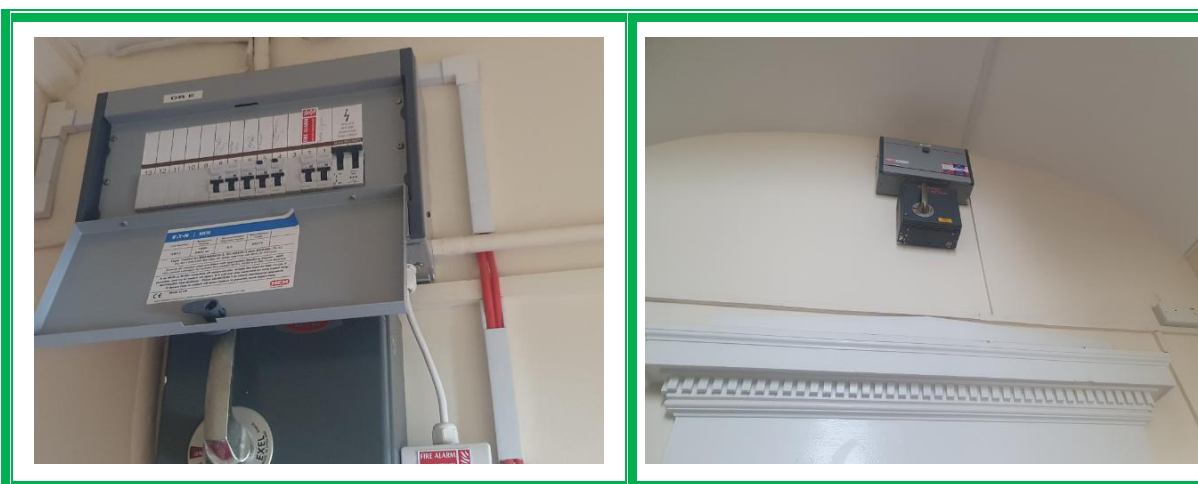
Item No:	5	Sample No:	N/A
Location:	Second Floor - Corridor 005

Material Description:	No Suspect Materials Found	
Identification:	N/A	
Approx. quantity:	N/A	
Accessibility	N/A	<i>Assessment Score</i>
Product type:	N/A	N/A
Extent of Damage:	N/A	N/A
Surface Treatment:	N/A	N/A
Asbestos type:	N/A	N/A
Material Assessment Score:		N/A
Priority Assessment Score:		N/A
Action:	N/A	
Comments:	N/A

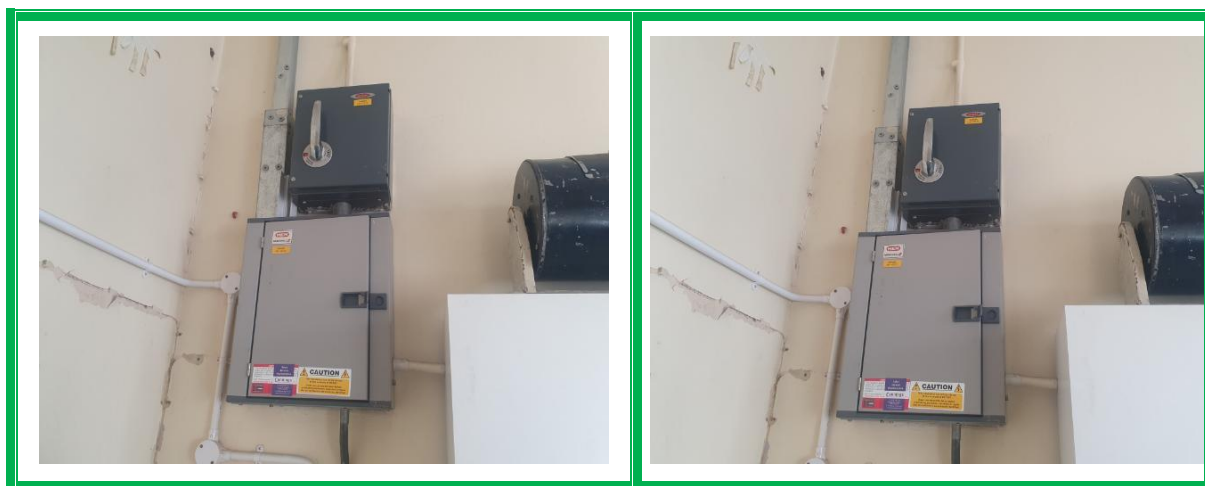
Location: First Floor - Bar Store 006

Material Description:	No Suspect Materials Found	
Identification:	N/A	
Approx. quantity:	N/A	
Accessibility	N/A	<i>Assessment Score</i>
Product type:	N/A	N/A
Extent of Damage:	N/A	N/A
Surface Treatment:	N/A	N/A
Asbestos type:	N/A	N/A
Material Assessment Score:		N/A
Priority Assessment Score:		N/A
Action:	N/A	
Comments:	The bar area electrical services were installed and tested in 2018

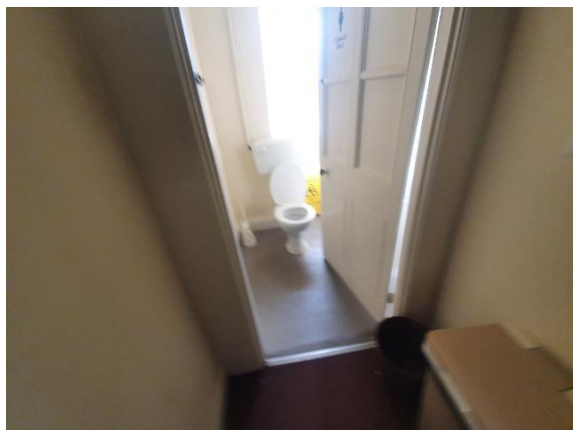
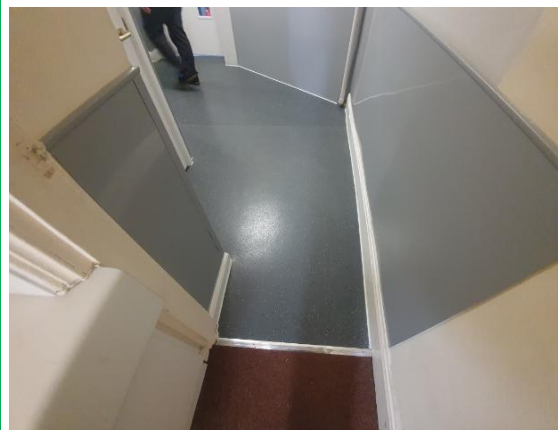
Location: Ground Floor - Men's Wc and lobby 009

Material Description:	No Suspect Materials Found	
Identification:	N/A	
Approx. quantity:	N/A	
Accessibility	N/A	<i>Assessment Score</i>
Product type:	N/A	N/A
Extent of Damage:	N/A	N/A
Surface Treatment:	N/A	N/A
Asbestos type:	N/A	N/A
Material Assessment Score:		N/A
Priority Assessment Score:		N/A
Action:	N/A	
Comments:	This area has recently be renovated

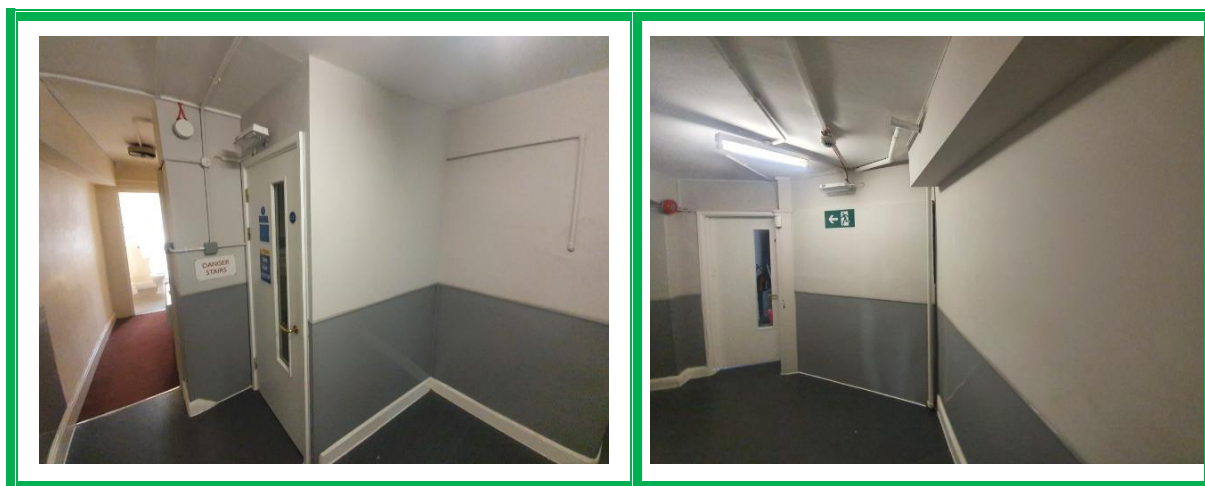
Location: Ground Floor - Corridor 010

Material Description:	No Suspect Materials Found	
Identification:	N/A	
Approx. quantity:	N/A	
Accessibility	N/A	<i>Assessment Score</i>
Product type:	N/A	N/A
Extent of Damage:	N/A	N/A
Surface Treatment:	N/A	N/A
Asbestos type:	N/A	N/A
Material Assessment Score:		N/A
Priority Assessment Score:		N/A
Action:	N/A	
Comments:	This area has recently been renovated

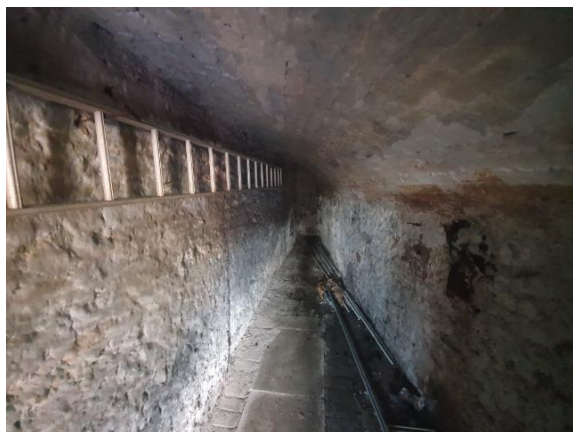
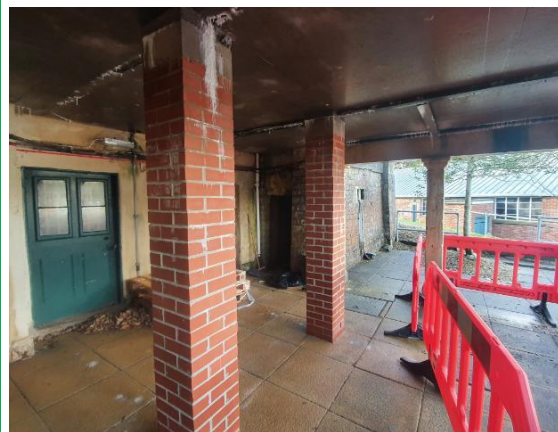
Location: External - Outside 016

Material Description:	No Suspect Materials Found	
Identification:	N/A	
Approx. quantity:	N/A	
Accessibility	N/A	<i>Assessment Score</i>
Product type:	N/A	N/A
Extent of Damage:	N/A	N/A
Surface Treatment:	N/A	N/A
Asbestos type:	N/A	N/A
Material Assessment Score:		N/A
Priority Assessment Score:		N/A
Action:	N/A	
Comments:	N/A
