**Project Number A-01022 (3700)**

**Re-Inspection  
Asbestos Survey Report**

**Brislington Platoon Centre  
Bristol  
BS4 3JZ**

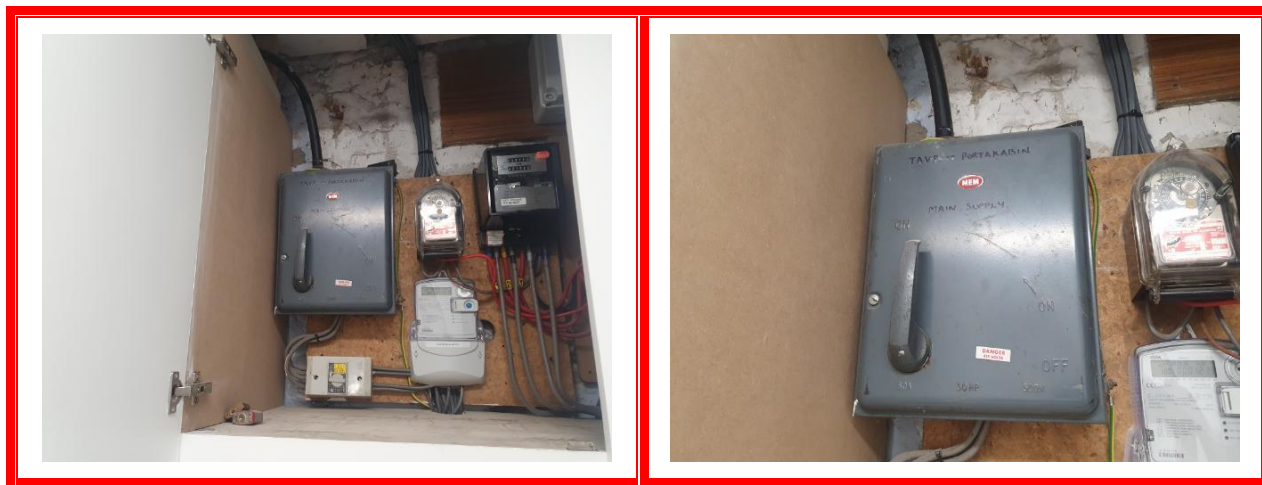
<b>Item No:</b>	<b>1</b>	<b>Sample No:</b>	<b>N/A</b>
<b>Location:</b>	Ground Floor - Office 001

<b>Material Description:</b>	Old Electrical Panel within Cupboard - Woven Product	
<b>Identification:</b>	Presumed to Contain Asbestos	
<b>Approx. quantity:</b>	1 no	
<b>Accessibility</b>	Difficult	Assessment Score
<b>Product type:</b>	Rope	2
<b>Extent of Damage:</b>	Major damage	3
<b>Surface Treatment:</b>	Unsealed Insulation	3
<b>Asbestos type:</b>	Chrysotile	1
<b>Material Assessment Score:</b>		9
<b>Priority Assessment Score:</b>		N/A
<b>Action:</b>	Manage	
<b>Comments:</b>	No access as live

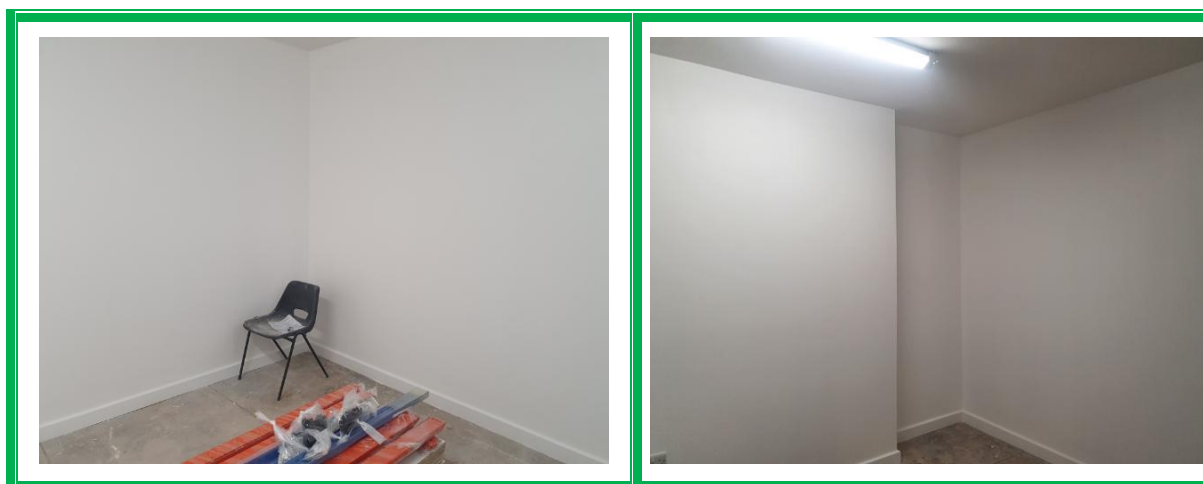
<b>Item No:</b>	<b>2</b>	<b>Sample No:</b>	<b>N/A</b>
<b>Location:</b>	Ground Floor - Ammunitions Store 002

<b>Material Description:</b>	No Suspect Materials Found	
<b>Identification:</b>	N/A	
<b>Approx. quantity:</b>	N/A	
<b>Accessibility</b>	N/A	<i>Assessment Score</i>
<b>Product type:</b>	N/A	N/A
<b>Extent of Damage:</b>	N/A	N/A
<b>Surface Treatment:</b>	N/A	N/A
<b>Asbestos type:</b>	N/A	N/A
<b>Material Assessment Score:</b>		N/A
<b>Priority Assessment Score:</b>		N/A
<b>Action:</b>	N/A	
<b>Comments:</b>	Room has been refurbished

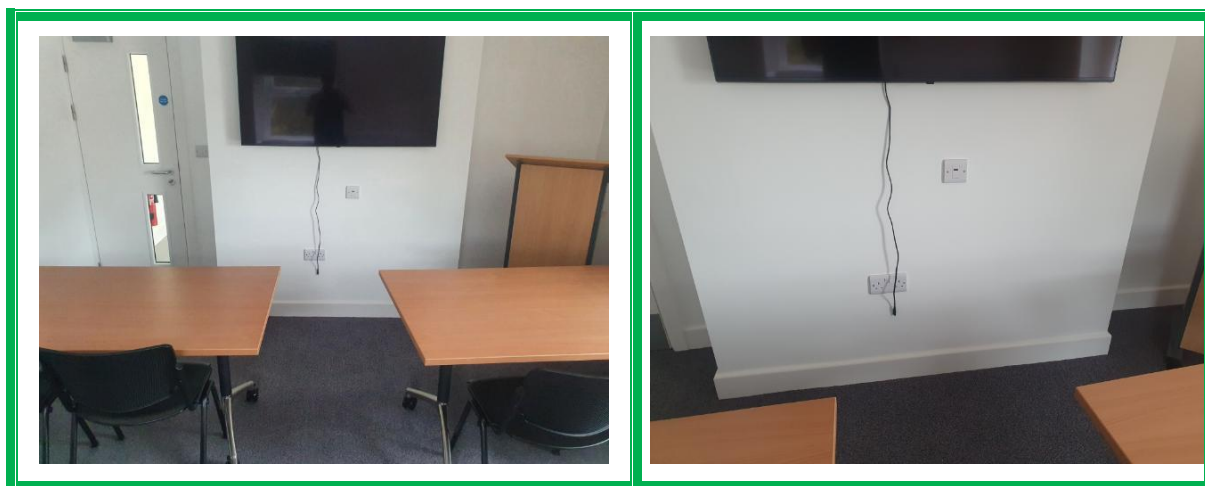
**Location:** First Floor - Classroom 003

<b>Material Description:</b>	No Suspect Materials Found	
<b>Identification:</b>	N/A	
<b>Approx. quantity:</b>	N/A	
<b>Accessibility</b>	N/A	<i>Assessment Score</i>
<b>Product type:</b>	N/A	N/A
<b>Extent of Damage:</b>	N/A	N/A
<b>Surface Treatment:</b>	N/A	N/A
<b>Asbestos type:</b>	N/A	N/A
<b>Material Assessment Score:</b>		N/A
<b>Priority Assessment Score:</b>		N/A
<b>Action:</b>	N/A	
<b>Comments:</b>	Safe removed during a refurbishment

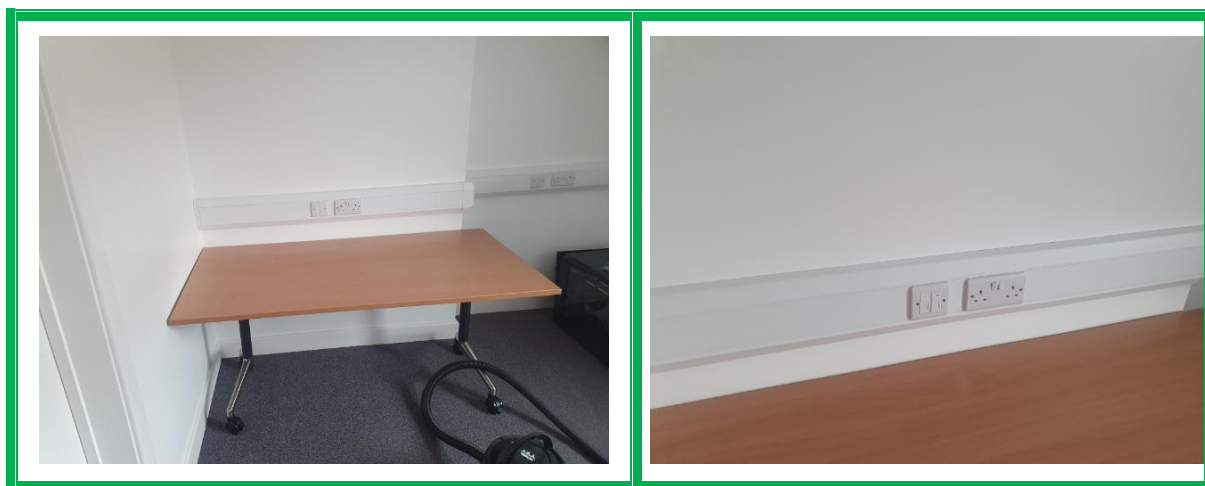
**Location:** First Floor - Office 004

<b>Material Description:</b>	No Suspect Materials Found	
<b>Identification:</b>	N/A	
<b>Approx. quantity:</b>	N/A	
<b>Accessibility</b>	N/A	<i>Assessment Score</i>
<b>Product type:</b>	N/A	N/A
<b>Extent of Damage:</b>	N/A	N/A
<b>Surface Treatment:</b>	N/A	N/A
<b>Asbestos type:</b>	N/A	N/A
<b>Material Assessment Score:</b>		N/A
<b>Priority Assessment Score:</b>		N/A
<b>Action:</b>	N/A	
<b>Comments:</b>	Panel in wall removed during a refurbishment

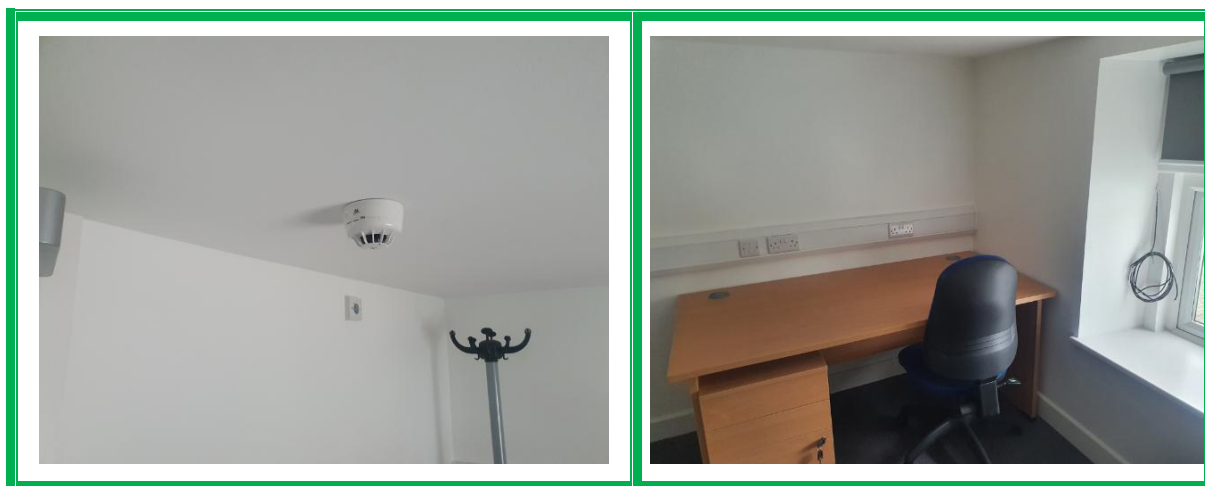
**Location:** First Floor - Office 005

<b>Material Description:</b>	No Suspect Materials Found	
<b>Identification:</b>	N/A	
<b>Approx. quantity:</b>	N/A	
<b>Accessibility</b>	N/A	<i>Assessment Score</i>
<b>Product type:</b>	N/A	N/A
<b>Extent of Damage:</b>	N/A	N/A
<b>Surface Treatment:</b>	N/A	N/A
<b>Asbestos type:</b>	N/A	N/A
<b>Material Assessment Score:</b>		N/A
<b>Priority Assessment Score:</b>		N/A
<b>Action:</b>	N/A	
<b>Comments:</b>	Cement panel has been removed during a refurbishment

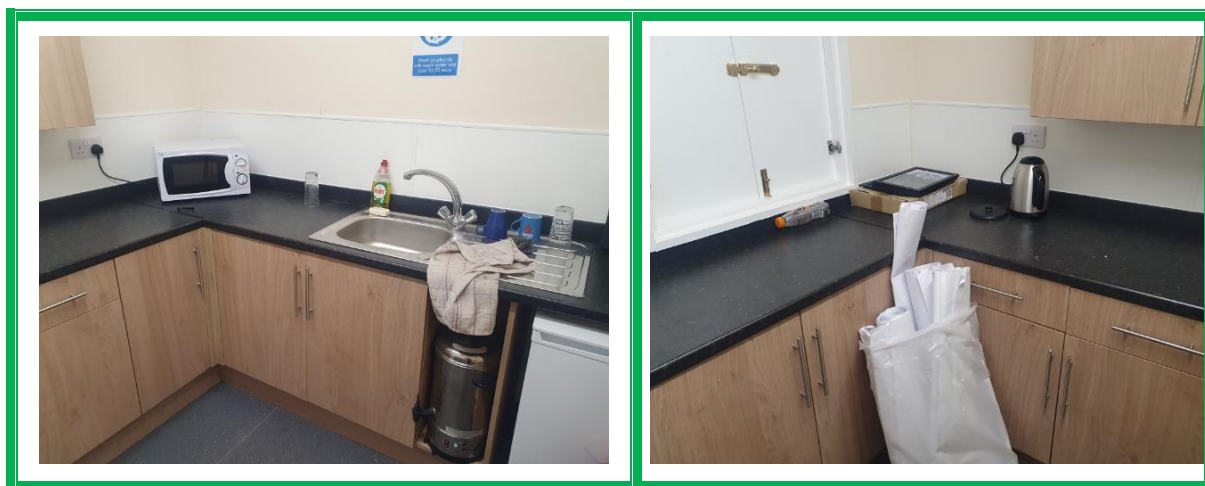
**Location:** Ground Floor - Portacabin - Kitchen 006

<b>Material Description:</b>	No Suspect Materials Found	
<b>Identification:</b>	N/A	
<b>Approx. quantity:</b>	N/A	
<b>Accessibility</b>	N/A	<i>Assessment Score</i>
<b>Product type:</b>	N/A	N/A
<b>Extent of Damage:</b>	N/A	N/A
<b>Surface Treatment:</b>	N/A	N/A
<b>Asbestos type:</b>	N/A	N/A
<b>Material Assessment Score:</b>		N/A
<b>Priority Assessment Score:</b>		N/A
<b>Action:</b>	N/A	
<b>Comments:</b>	New kitchen recently installed.

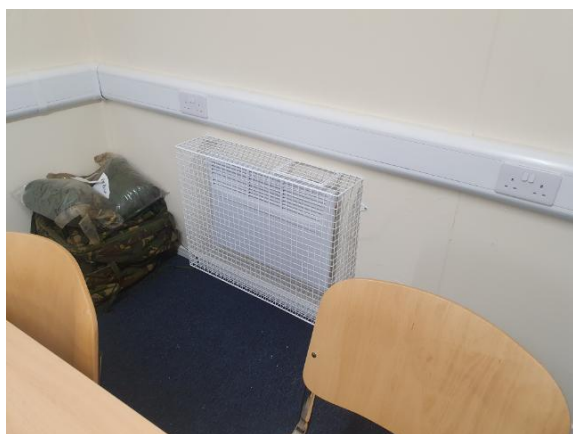
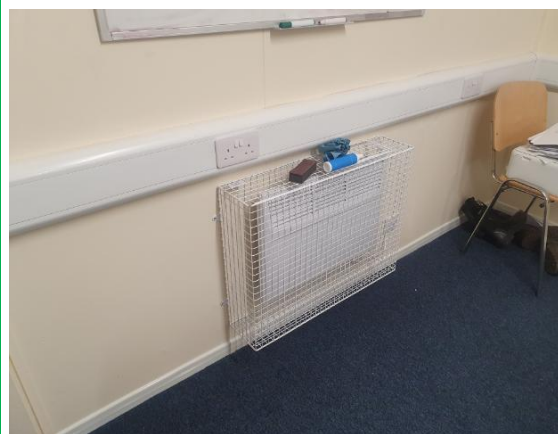
**Location:** Ground Floor - Portacabin - Classroom 007

<b>Material Description:</b>	No Suspect Materials Found	
<b>Identification:</b>	N/A	
<b>Approx. quantity:</b>	N/A	
<b>Accessibility</b>	N/A	<i>Assessment Score</i>
<b>Product type:</b>	N/A	N/A
<b>Extent of Damage:</b>	N/A	N/A
<b>Surface Treatment:</b>	N/A	N/A
<b>Asbestos type:</b>	N/A	N/A
<b>Material Assessment Score:</b>		N/A
<b>Priority Assessment Score:</b>		N/A
<b>Action:</b>	N/A	
<b>Comments:</b>	Night storage heaters replaced.
