**Project Number 2481**

**Management  
Asbestos Survey Report**

**Wyvern Barracks, Barrack Road, Exeter, Devon,  
EX2 6AE (Building 6)**

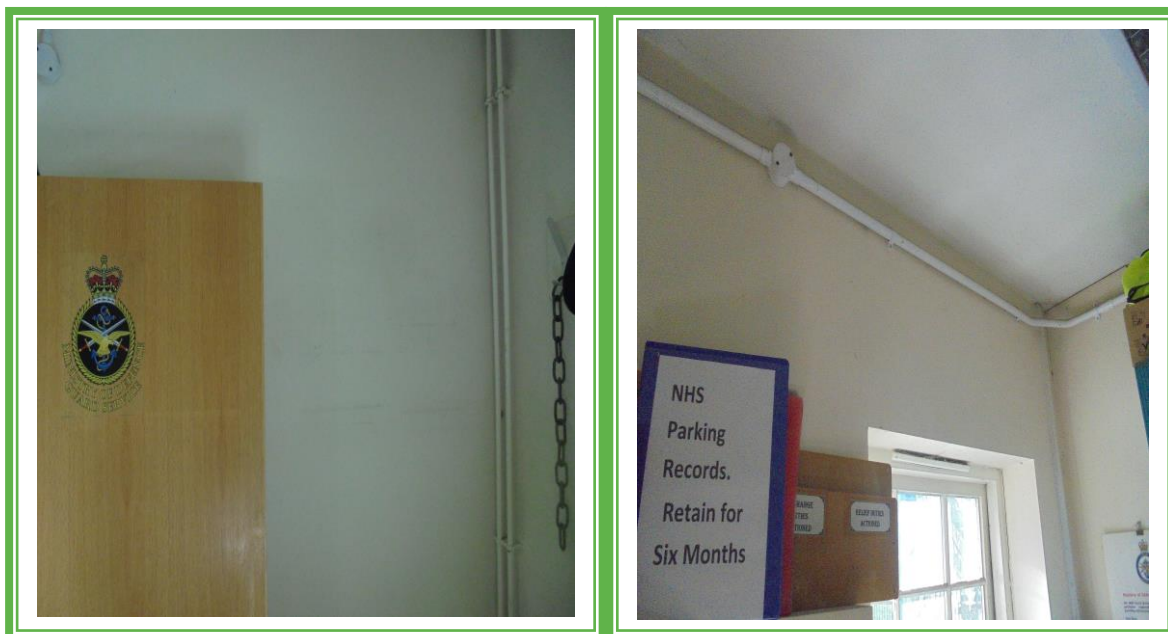
**Item No: 1**

**Location: Server Room**

<b>Material Description:</b>	Visual Inspection – No Suspect Materials Found	
<b>Identification:</b>	N/A	
<b>Approx. quantity:</b>	N/A	
<b>Accessibility</b>	N/A	<i>Assessment Score</i>
<b>Product type:</b>		N/A
<b>Extent of Damage:</b>		N/A
<b>Surface Treatment:</b>		N/A
<b>Asbestos type:</b>		N/A
<b>Material Assessment Score:</b>		N/A
<b>Priority Assessment Score:</b>		N/A
<b>Action:</b>	N/A	
<b>Comments:</b>	No access within timber boxing

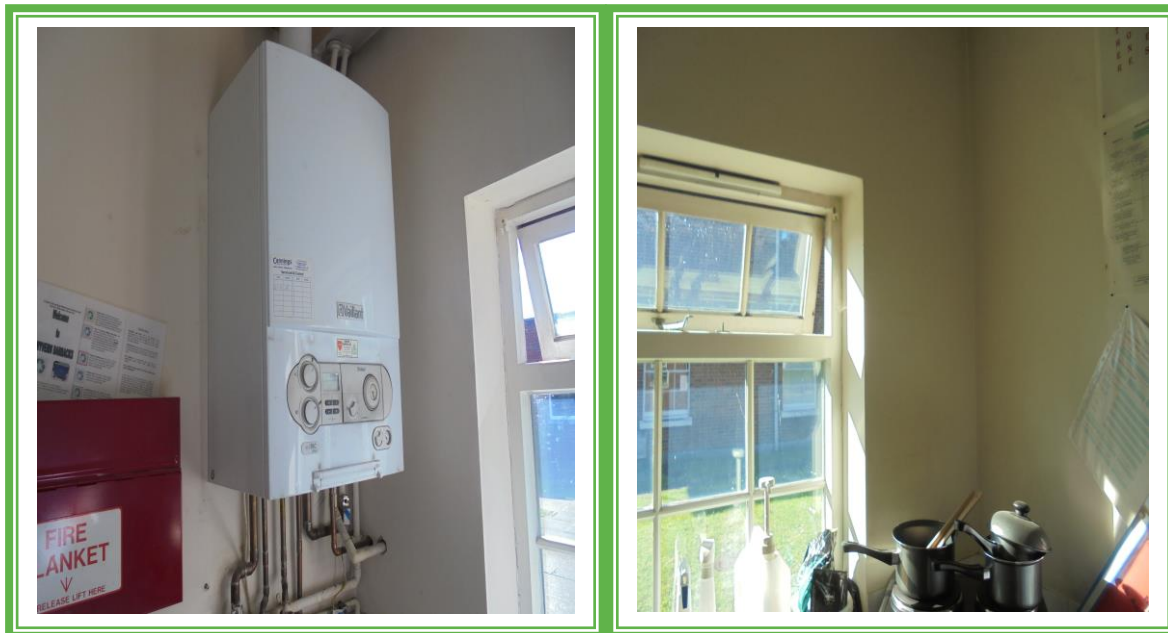
**Item No: 2**

**Location: Kitchen**

<b>Material Description:</b>	Visual Inspection – No Suspect Materials Found	
<b>Identification:</b>	N/A	
<b>Approx. quantity:</b>	N/A	
<b>Accessibility</b>	N/A	<i>Assessment Score</i>
<b>Product type:</b>		N/A
<b>Extent of Damage:</b>		N/A
<b>Surface Treatment:</b>		N/A
<b>Asbestos type:</b>		N/A
<b>Material Assessment Score:</b>		N/A
<b>Priority Assessment Score:</b>		N/A
<b>Action:</b>	N/A	
<b>Comments:</b>	Modern sink pad. Modern Valliant boiler

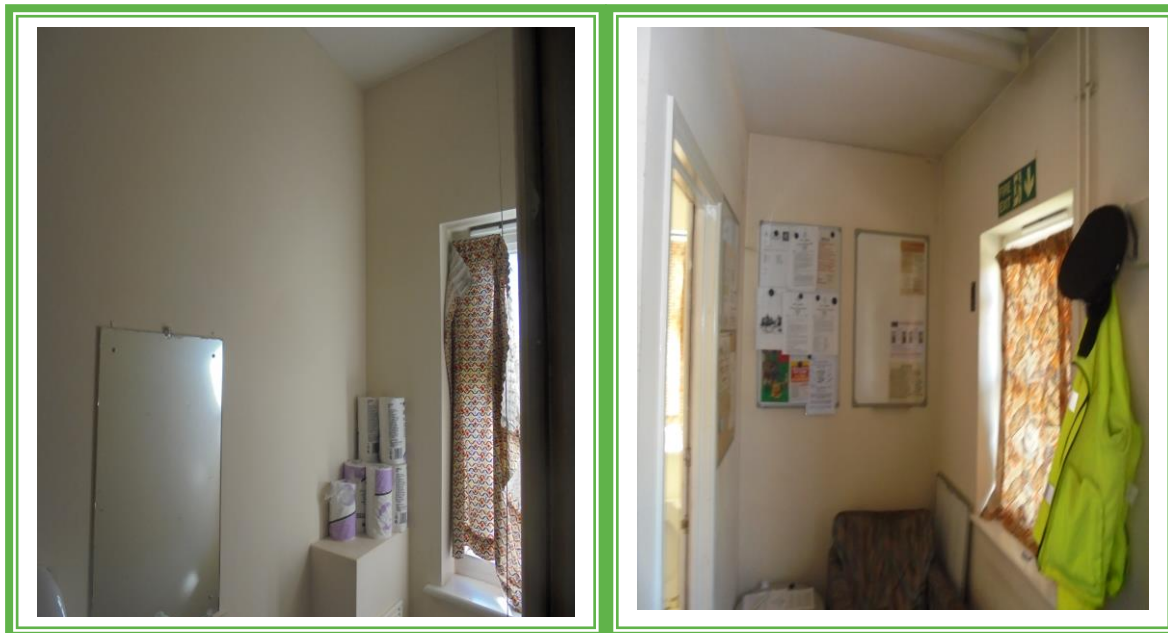
**Item No: 3****Sample No: N/A****Location: Office and WC**

<b>Material Description:</b>	Visual Inspection – No Suspect Materials Found	
<b>Identification:</b>	N/A	
<b>Approx. quantity:</b>	N/A	
<b>Accessibility</b>	N/A	<i>Assessment Score</i>
<b>Product type:</b>		N/A
<b>Extent of Damage:</b>		N/A
<b>Surface Treatment:</b>		N/A
<b>Asbestos type:</b>		N/A
<b>Material Assessment Score:</b>		N/A
<b>Priority Assessment Score:</b>		N/A
<b>Action:</b>	N/A	
<b>Comments:</b>	No access within timber boxing

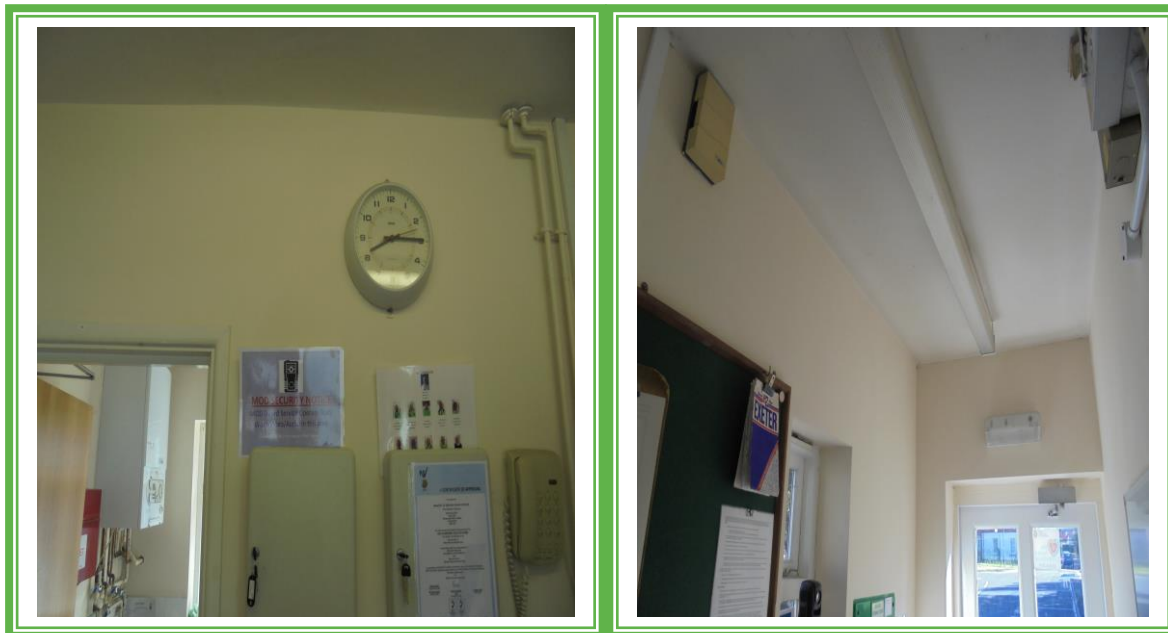
**Item No: 4****Sample No: N/A****Location: Guard Room**

<b>Material Description:</b>	Visual Inspection – No Suspect Materials Found	
<b>Identification:</b>	N/A	
<b>Approx. quantity:</b>	N/A	
<b>Accessibility</b>	N/A	<i>Assessment Score</i>
<b>Product type:</b>		N/A
<b>Extent of Damage:</b>		N/A
<b>Surface Treatment:</b>		N/A
<b>Asbestos type:</b>		N/A
<b>Material Assessment Score:</b>		N/A
<b>Priority Assessment Score:</b>		N/A
<b>Action:</b>	N/A	
<b>Comments:</b>	N/A

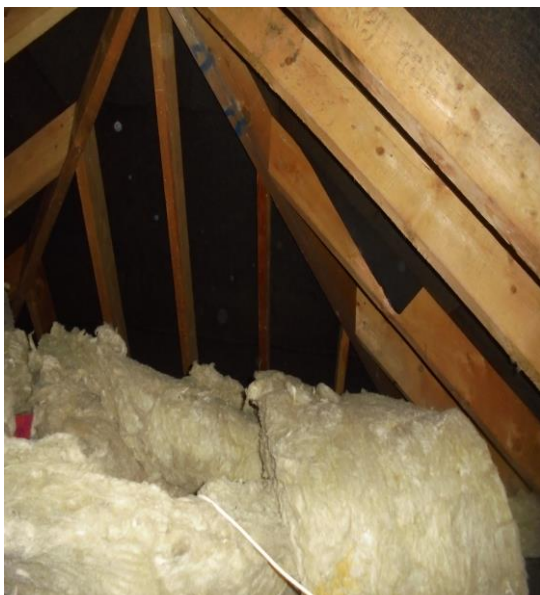
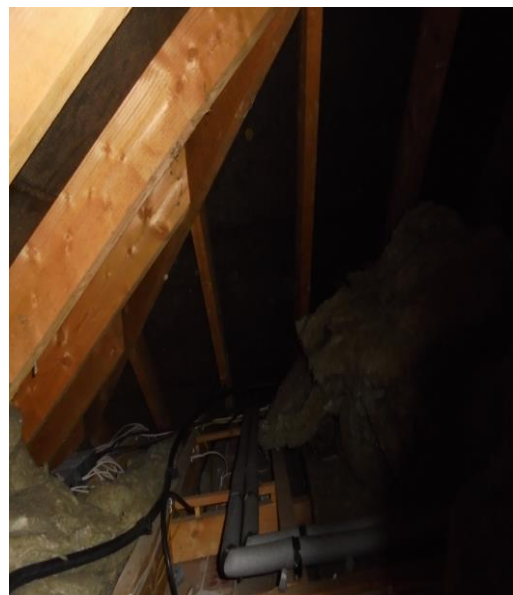
**Item No: 5****Sample No: N/A****Location: Loft Space**

<b>Material Description:</b>	Visual Inspection – No Suspect Materials Found	
<b>Identification:</b>	N/A	
<b>Approx. quantity:</b>	N/A	
<b>Accessibility</b>	N/A	<i>Assessment Score</i>
<b>Product type:</b>		N/A
<b>Extent of Damage:</b>		N/A
<b>Surface Treatment:</b>		N/A
<b>Asbestos type:</b>		N/A
<b>Material Assessment Score:</b>		N/A
<b>Priority Assessment Score:</b>		N/A
<b>Action:</b>	N/A	
<b>Comments:</b>	Limited access into loft due to size of hatch. Non-asbestos roof felt
