**Project Number A-00395 (3700)**

**Re-Inspection  
Asbestos Survey Report**

**Wessex RFCA  
Storage Hanger  
Swindon  
Wiltshire  
SN4 0QZ**

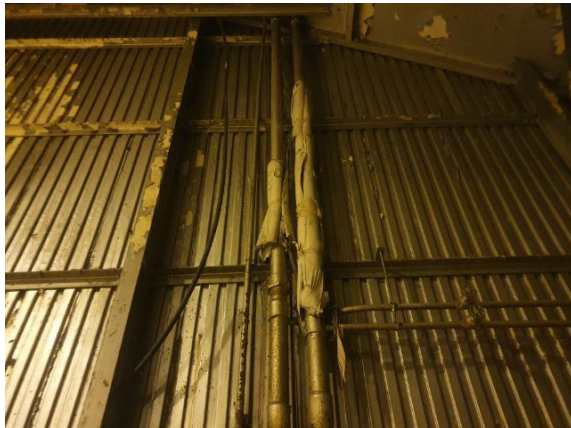
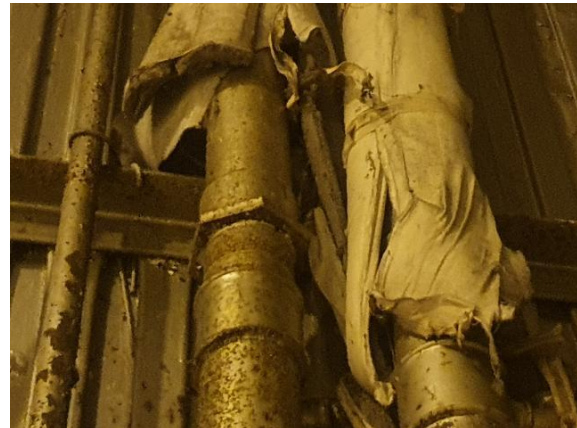
<b>Item No:</b>	<b>5</b>	<b>Sample No:</b>	<b>N/A</b>
<b>Location:</b>	Ground Floor - Main Hangar 005

<b>Material Description:</b>	Lining to Pipework - Paper Product	
<b>Identification:</b>	Previously Sampled - Asbestos Detected	
<b>Approx. quantity:</b>	4 LM	
<b>Accessibility</b>	Difficult	Assessment Score
<b>Product type:</b>	Paper	2
<b>Extent of Damage:</b>	Major damage	3
<b>Surface Treatment:</b>	Paper	1
<b>Asbestos type:</b>	Chrysotile	1
<b>Material Assessment Score:</b>		7
<b>Priority Assessment Score:</b>		Medium
<b>Action:</b>	Remove	
<b>Comments:</b>	Previously sampled ref: Armour 14/11/2019 Sample DK/5

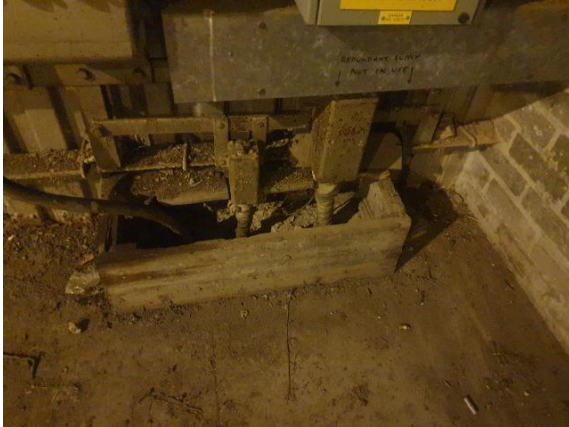
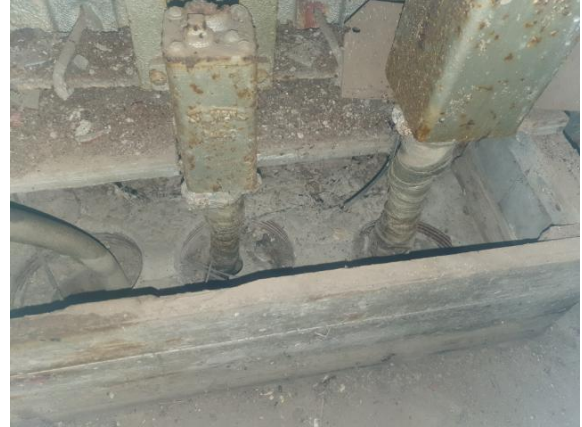
<b>Item No:</b>	<b>7</b>	<b>Sample No:</b>	<b>N/A</b>
<b>Location:</b>	Ground Floor - Main Hangar 007

<b>Material Description:</b>	Wrap to Mains Cable - Bituminous Product	
<b>Identification:</b>	Presumed to Contain Asbestos	
<b>Approx. quantity:</b>	1 LM	
<b>Accessibility</b>	Difficult	<i>Assessment Score</i>
<b>Product type:</b>	Bitumen	1
<b>Extent of Damage:</b>	Minor damage	1
<b>Surface Treatment:</b>	Non-friable	0
<b>Asbestos type:</b>	Chrysotile	1
<b>Material Assessment Score:</b>		3
<b>Priority Assessment Score:</b>		Negligible
<b>Action:</b>	Manage	
<b>Comments:</b>	Not possible to sample as presumed live

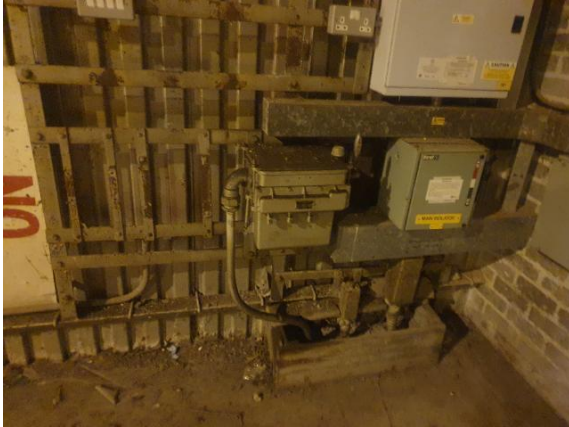
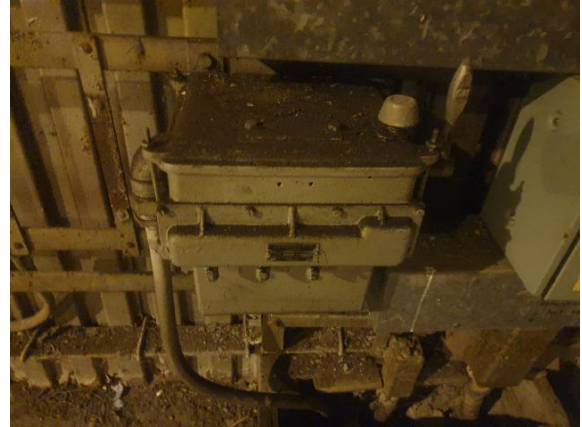
<b>Item No:</b>	<b>8</b>	<b>Sample No:</b>	<b>N/A</b>
<b>Location:</b>	Ground Floor - Main Hangar 008

<b>Material Description:</b>	Electrical Panel - Gaskets (rope/woven)	
<b>Identification:</b>	Presumed to Contain Asbestos	
<b>Approx. quantity:</b>	1 no	
<b>Accessibility</b>	Difficult	<i>Assessment Score</i>
<b>Product type:</b>	Flashguards	2
<b>Extent of Damage:</b>	Minor damage	1
<b>Surface Treatment:</b>	Woven	1
<b>Asbestos type:</b>	Chrysotile	1
<b>Material Assessment Score:</b>		5
<b>Priority Assessment Score:</b>		Low
<b>Action:</b>	Manage	
<b>Comments:</b>	No access within box as presumed live

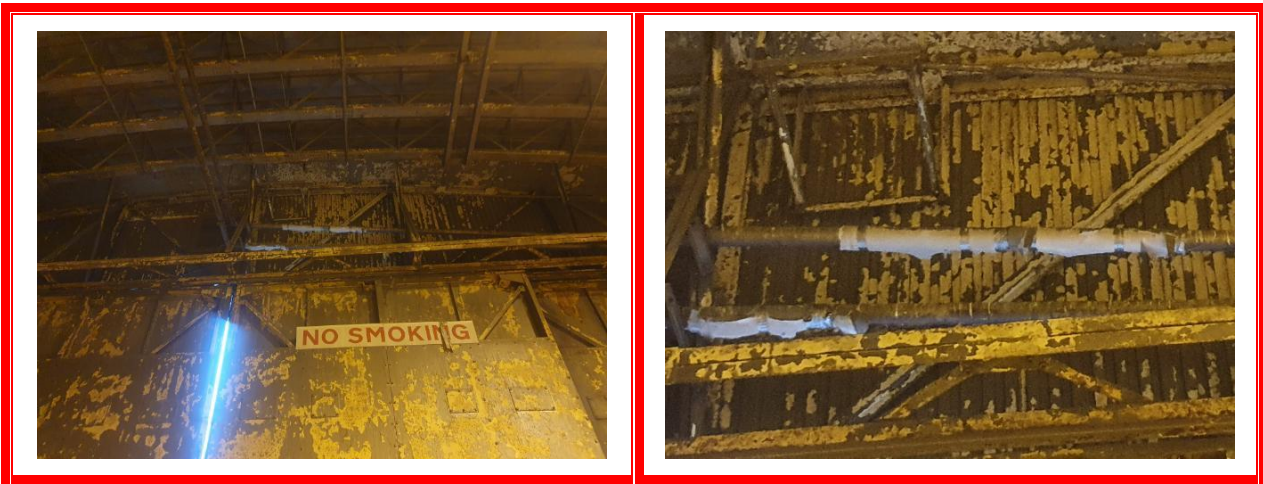
<b>Item No:</b>	<b>9</b>	<b>Sample No:</b>	<b>N/A</b>
<b>Location:</b>	Ground Floor - Main Hangar 009

<b>Material Description:</b>	Lining to Pipework - Paper Product	
<b>Identification:</b>	Previously Sampled - Asbestos Detected	
<b>Approx. quantity:</b>	7 LM	
<b>Accessibility</b>	Difficult	<i>Assessment Score</i>
<b>Product type:</b>	Paper	2
<b>Extent of Damage:</b>	Major damage	3
<b>Surface Treatment:</b>	Paper	1
<b>Asbestos type:</b>	Chrysotile	1
<b>Material Assessment Score:</b>		7
<b>Priority Assessment Score:</b>		Medium
<b>Action:</b>	Remove	
<b>Comments:</b>	Located at High level above hangar door. Previously sampled ref: Armour 14/11/2019 Sample DK/5

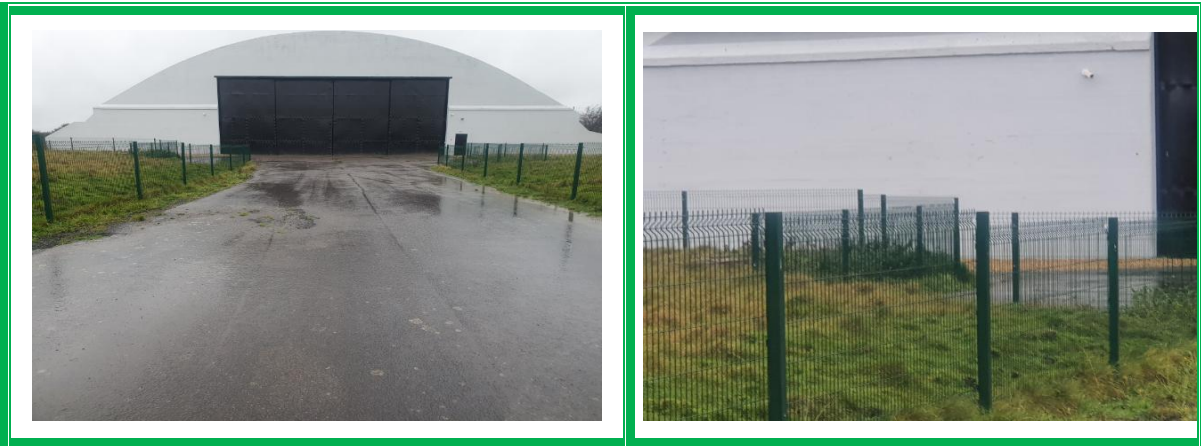
<b>Item No:</b>	<b>1</b>	<b>Sample No:</b>	<b>N/A</b>
<b>Location:</b>	Ground Floor - Tank Room 001

<b>Material Description:</b>	Gaskets	
<b>Identification:</b>	N/A	
<b>Approx. quantity:</b>	N/A	
<b>Accessibility</b>	N/A	<i>Assessment Score</i>
<b>Product type:</b>	N/A	N/A
<b>Extent of Damage:</b>	N/A	N/A
<b>Surface Treatment:</b>	N/A	N/A
<b>Asbestos type:</b>	N/A	N/A
<b>Material Assessment Score:</b>		
<b>Priority Assessment Score:</b>		
<b>Action:</b>	N/A	
<b>Comments:</b>	Building demolished and gaskets removed.

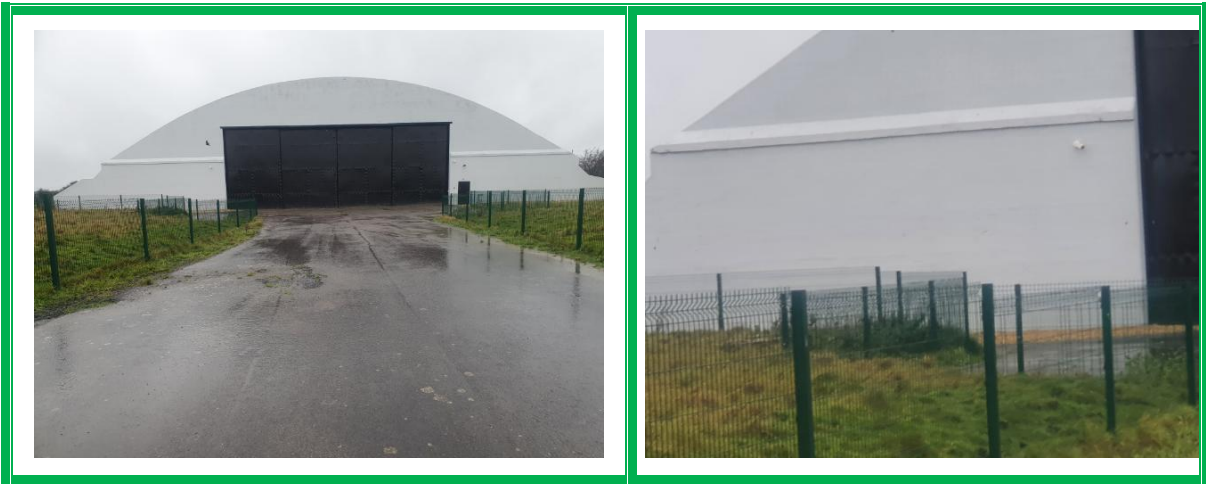
<b>Item No:</b>	<b>2</b>	<b>Sample No:</b>	<b>N/A</b>
<b>Location:</b>	Ground Floor - Boiler Room 002

<b>Material Description:</b>	Boiler Room	
<b>Identification:</b>	N/A	
<b>Approx. quantity:</b>	N/A	
<b>Accessibility</b>	N/A	<i>Assessment Score</i>
<b>Product type:</b>	N/A	N/A
<b>Extent of Damage:</b>	N/A	N/A
<b>Surface Treatment:</b>	N/A	N/A
<b>Asbestos type:</b>	N/A	N/A
<b>Material Assessment Score:</b>		
<b>Priority Assessment Score:</b>		
<b>Action:</b>	N/A	
<b>Comments:</b>	Building demolished and boiler room removed

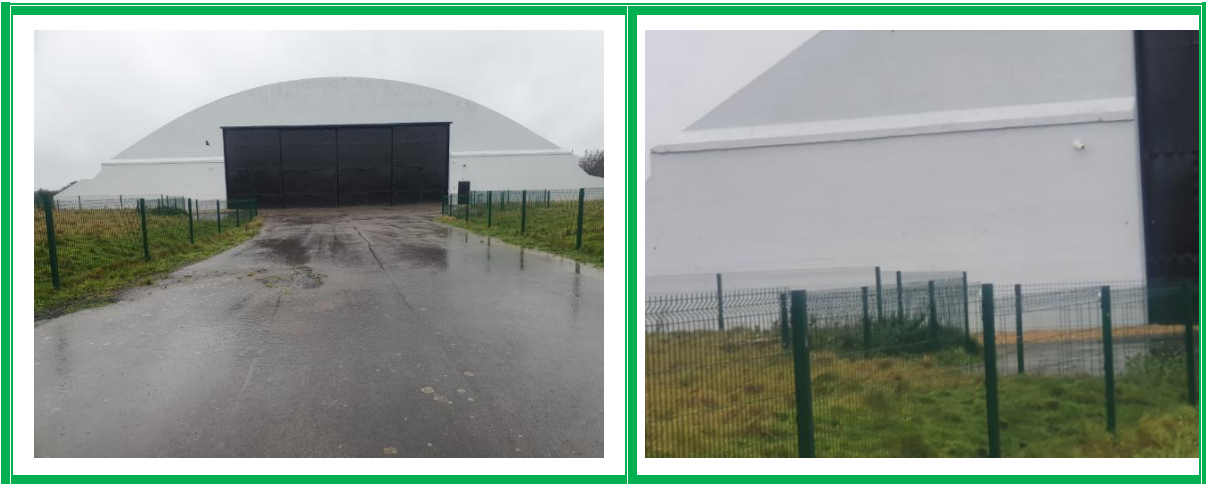
<b>Item No:</b>	<b>3</b>	<b>Sample No:</b>	<b>N/A</b>
<b>Location:</b>	External - 003

<b>Material Description:</b>	Electrical Panel	
<b>Identification:</b>	N/A	
<b>Approx. quantity:</b>	N/A	
<b>Accessibility</b>	N/A	<i>Assessment Score</i>
<b>Product type:</b>	N/A	N/A
<b>Extent of Damage:</b>	N/A	N/A
<b>Surface Treatment:</b>	N/A	N/A
<b>Asbestos type:</b>	N/A	N/A
<b>Material Assessment Score:</b>		
<b>Priority Assessment Score:</b>		
<b>Action:</b>	N/A	
<b>Comments:</b>	Building demolished and electrical panel removed

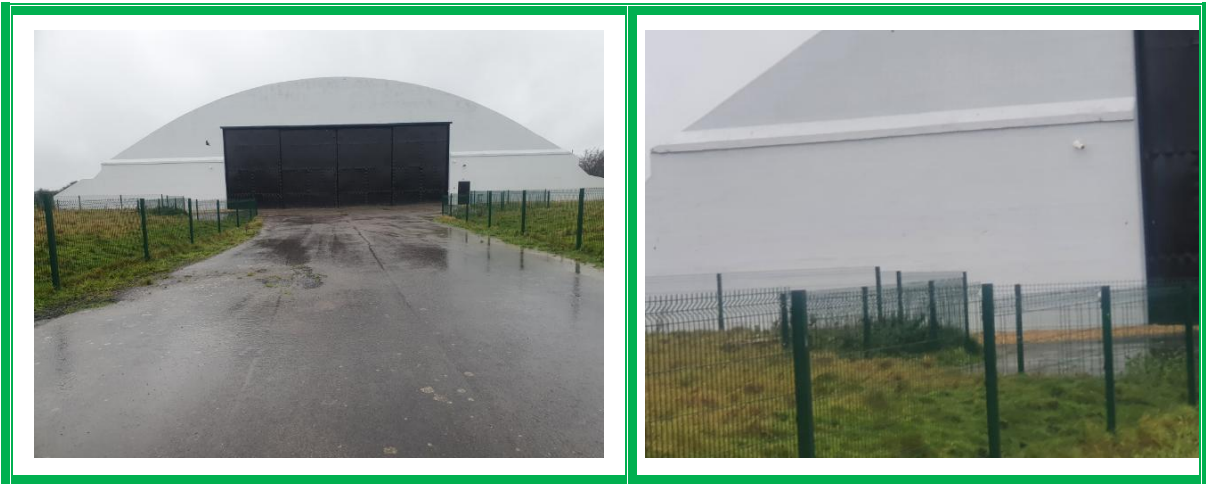
<b>Item No:</b>	<b>4</b>	<b>Sample No:</b>	<b>N/A</b>
<b>Location:</b>	External 004

<b>Material Description:</b>	Mains Cable	
<b>Identification:</b>	N/A	
<b>Approx. quantity:</b>	N/A	
<b>Accessibility</b>	N/A	<i>Assessment Score</i>
<b>Product type:</b>	N/A	N/A
<b>Extent of Damage:</b>	N/A	N/A
<b>Surface Treatment:</b>	N/A	N/A
<b>Asbestos type:</b>	N/A	N/A
<b>Material Assessment Score:</b>		
<b>Priority Assessment Score:</b>		
<b>Action:</b>	N/A	
<b>Comments:</b>	Building demolished and mains cable removed.

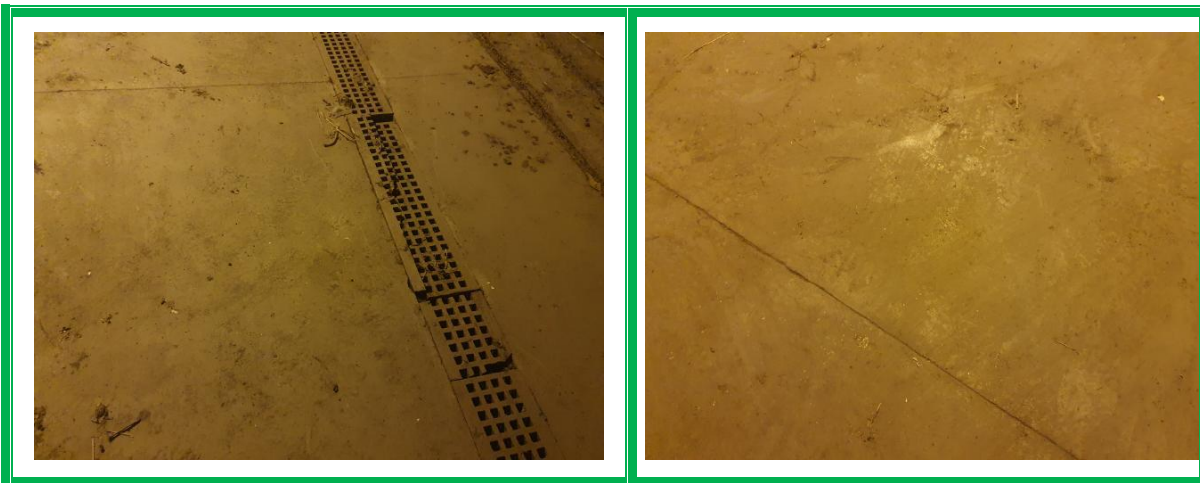
<b>Item No:</b>	<b>6</b>	<b>Sample No:</b>	<b>N/A</b>
<b>Location:</b>	Ground Floor - Main Hangar 006

<b>Material Description:</b>	Debris	
<b>Identification:</b>	N/A	
<b>Approx. quantity:</b>	N/A	
<b>Accessibility</b>	N/A	<i>Assessment Score</i>
<b>Product type:</b>	N/A	N/A
<b>Extent of Damage:</b>	N/A	N/A
<b>Surface Treatment:</b>	N/A	N/A
<b>Asbestos type:</b>	N/A	N/A
<b>Material Assessment Score:</b>		
<b>Priority Assessment Score:</b>		
<b>Action:</b>	N/A	
<b>Comments:</b>	Previously identified debris on floor could not be located. Presumed removed during refurbishment.
