Project Number A-00566 (3700)

**Re-Inspection
Asbestos Survey Report -Revised**

**Totnes Platoon
Totnes
Devon
TQ9 5XW**

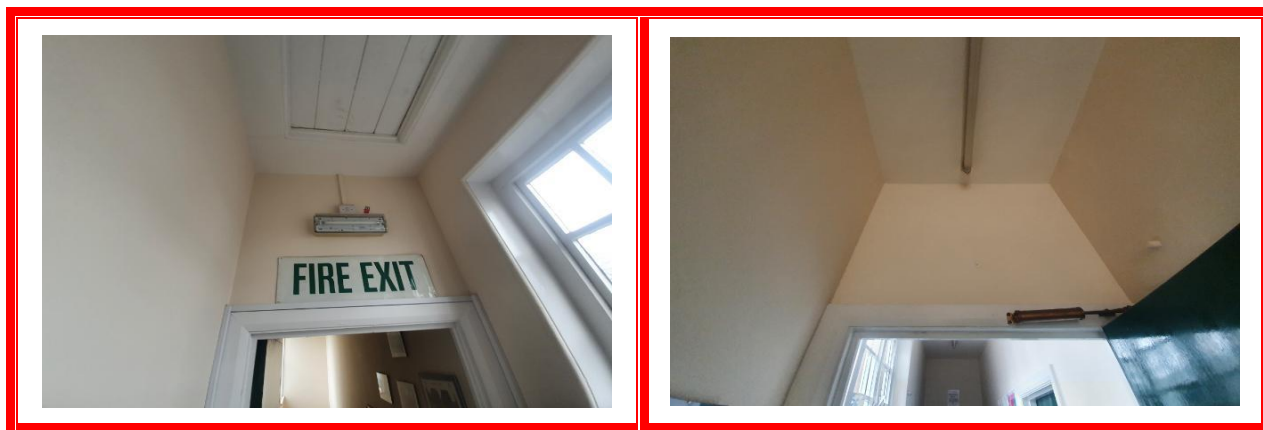
Item No:	1	Sample No:	N/A
Location:	First Floor - Corridor 001

Material Description:	Panels above Fire Exit Door - Insulating Board	
Identification:	Previously Sampled - Asbestos Detected	
Approx. quantity:	2 no	
Accessibility	Difficult	<i>Assessment Score</i>
Product type:	Asbestos Insulating Board	2
Extent of Damage:	Slight / minor damage	1
Surface Treatment:	Unsealed AIB	2
Asbestos type:	Amosite	2
Material Assessment Score:		7
Priority Assessment Score:		Medium
Action:	Encapsulate	
Comments:	Previously sampled ref: Armour 23/10/19 - Sample DK/3

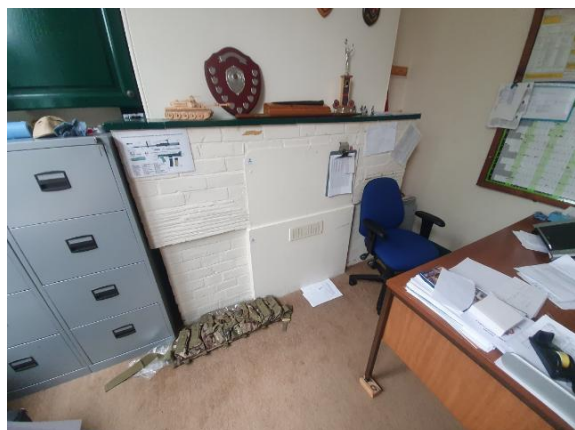
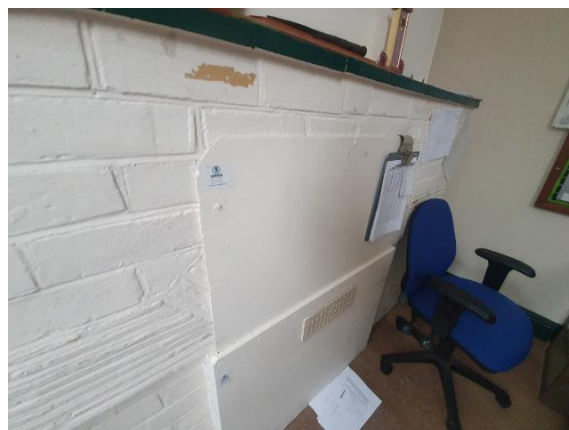
Location: Ground Floor - Office 002

Material Description:	Panel to Fireplace - Cement Product	
Identification:	Previously Sampled - Asbestos Detected	
Approx. quantity:	<1 m ²	
Accessibility	Easy	<i>Assessment Score</i>
Product type:	Cement	1
Extent of Damage:	Slight / minor damage	1
Surface Treatment:	Unsealed Cement	1
Asbestos type:	Chrysotile	1
Material Assessment Score:		4
Priority Assessment Score:		Negligible
Action:	Manage	
Comments:	Previously sampled ref: Armour 23/10/19 - Sample DK/7

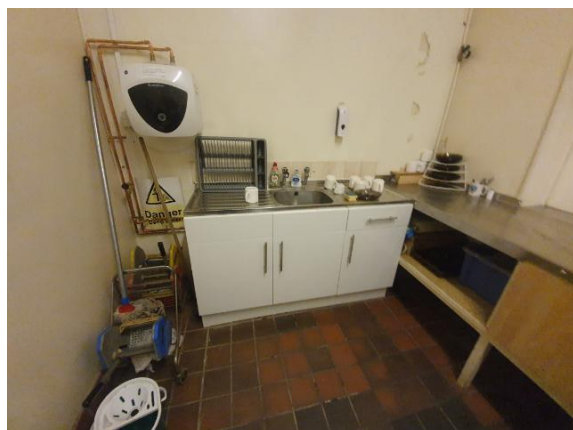
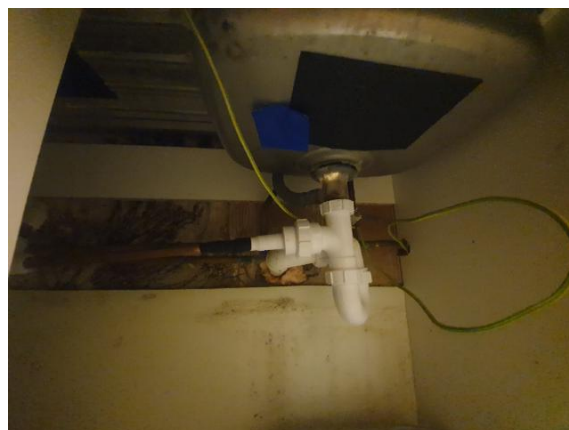
Location: Ground Floor - Kitchen 003

Material Description:	Sink Pad - Bituminous Product	
Identification:	Previously Sampled - Asbestos Detected	
Approx. quantity:	1 no	
Accessibility	Medium	Assessment Score
Product type:	Bitumen	1
Extent of Damage:	Slight / minor damage	1
Surface Treatment:	Non-friable	0
Asbestos type:	Chrysotile	1
Material Assessment Score:		3
Priority Assessment Score:		Negligible
Action:	Manage	
Comments:	Previously sampled ref: Armour 23/10/19 - Sample DK/9

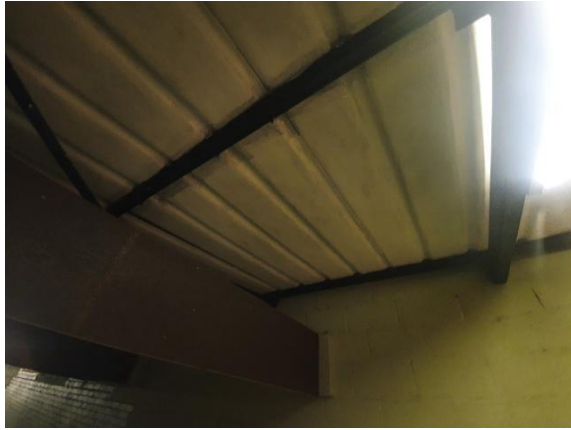
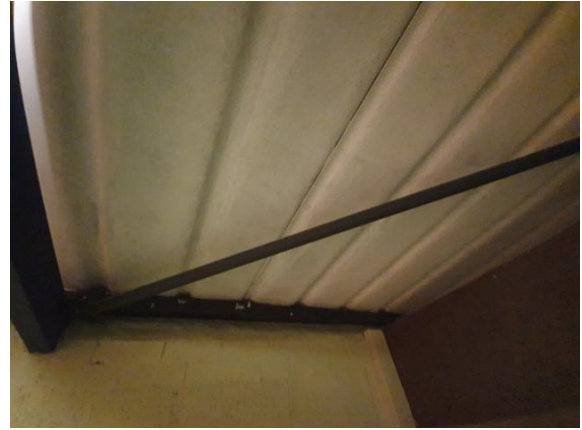
Location: First Floor - Firing Range 004

Material Description:	Profiled Roof - Cement Product	
Identification:	Previously Sampled - Asbestos Detected	
Approx. quantity:	112 m ²	
Accessibility	Difficult	<i>Assessment Score</i>
Product type:	Cement	1
Extent of Damage:	Slight / minor damage	1
Surface Treatment:	Unsealed Cement	1
Asbestos type:	Chrysotile	1
Material Assessment Score:		4
Priority Assessment Score:		Negligible
Action:	Manage	
Comments:	Previously sampled ref: Armour 23/10/19 - Sample DK/10

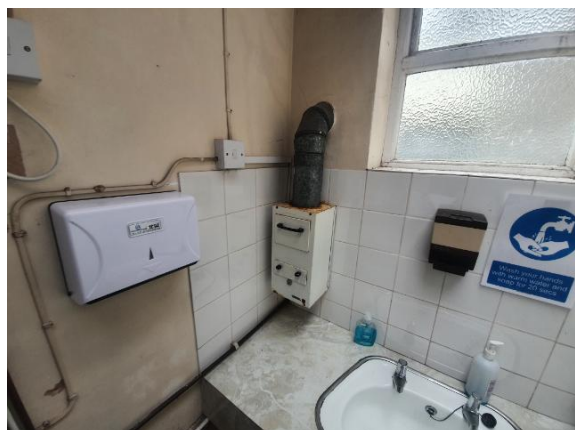
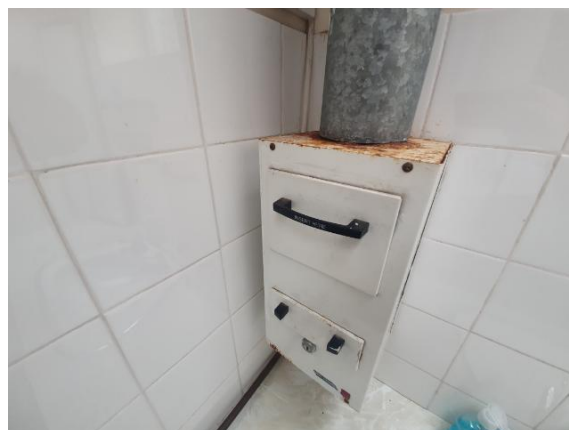
Location: Ground Floor - Ladies WC 005

Material Description:	Incinerator Unit - No Access Gained	
Identification:	Presumed to Contain Asbestos	
Approx. quantity:	1 no	
Accessibility	Difficult	<i>Assessment Score</i>
Product type:	Asbestos Insulating Board	2
Extent of Damage:	Major damage	3
Surface Treatment:	Unsealed Insulation	3
Asbestos type:	Amosite, Chrysotile	2
Material Assessment Score:		10
Priority Assessment Score:		High
Action:	Manage	
Comments:	No access within live incinerator

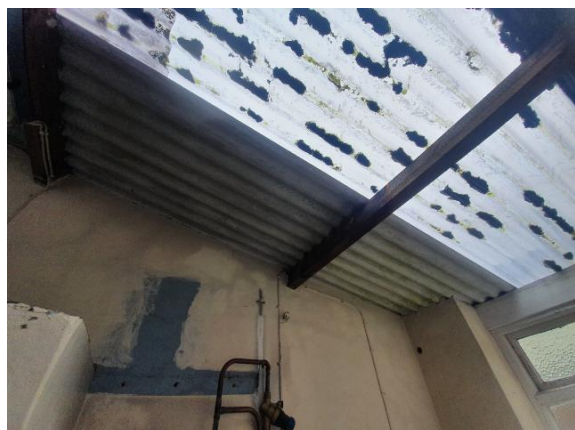
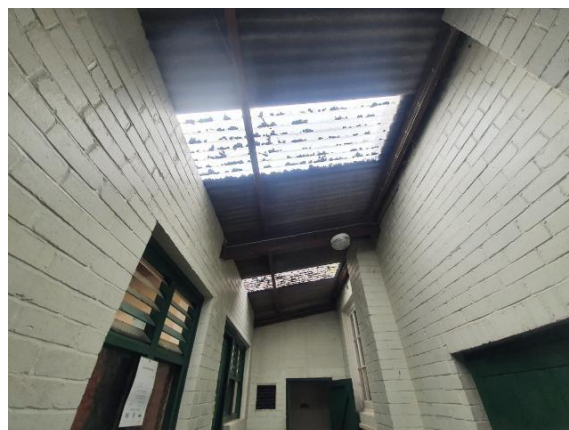
Location: Ground Floor - WC's x 2 and Corridor 006

Material Description:	Profiled Roof - Cement Product	
Identification:	Previously Sampled - Asbestos Detected	
Approx. quantity:	30 m ²	
Accessibility	Difficult	<i>Assessment Score</i>
Product type:	Cement	1
Extent of Damage:	Slight / minor damage	1
Surface Treatment:	Unsealed Cement	1
Asbestos type:	Chrysotile	1
Material Assessment Score:		4
Priority Assessment Score:		Negligible
Action:	Manage	
Comments:	Previously sampled ref: Armour 23/10/19 - Sample DK/12

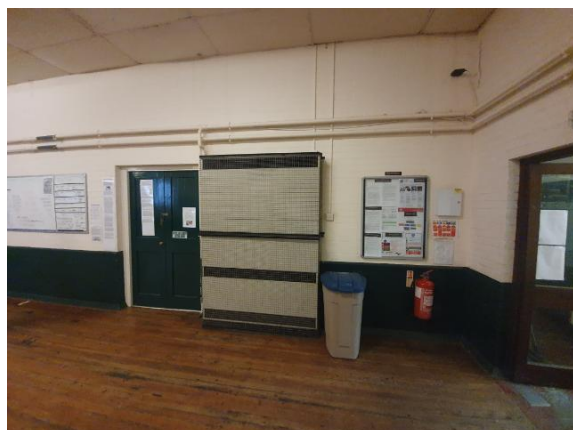
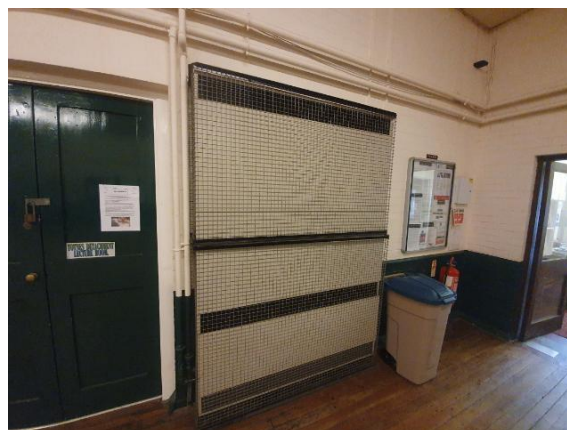
Location: Ground Floor - Drill Hall 007

Material Description:	Heaters - Insulating Board	
Identification:	Presumed to Contain Asbestos	
Approx. quantity:	4 no	
Accessibility	Difficult	<i>Assessment Score</i>
Product type:	Asbestos Insulating Board	2
Extent of Damage:	Major damage	3
Surface Treatment:	Unsealed Insulation	3
Asbestos type:	Amosite, Chrysotile	2
Material Assessment Score:		10
Priority Assessment Score:		High
Action:	Manage	
Comments:	No access within live heaters

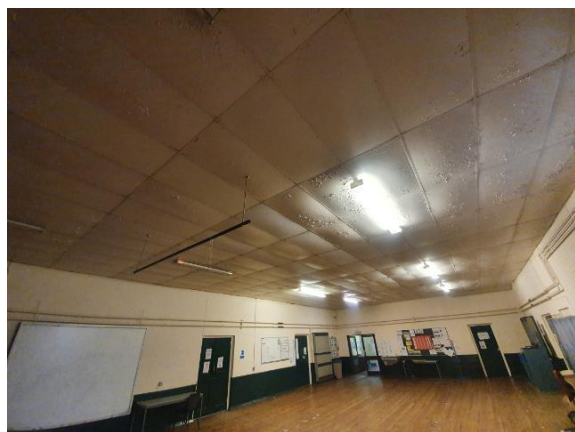
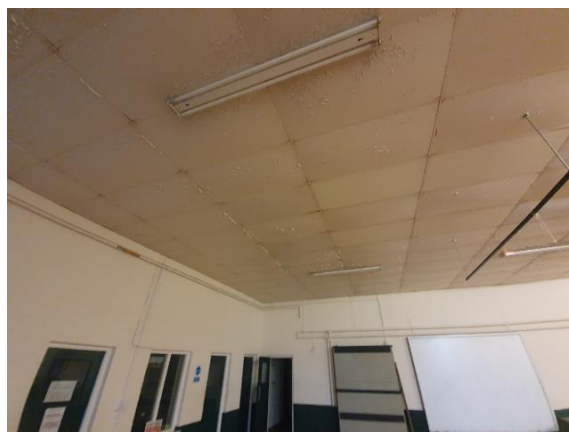
Location: Ground Floor - Drill Hall 008

Material Description:	Profiled Roof - Cement Product	
Identification:	Strongly Presumed to Contain Asbestos	
Approx. quantity:	40 m ²	
Accessibility	Difficult	<i>Assessment Score</i>
Product type:	Cement	1
Extent of Damage:	Slight / minor damage	1
Surface Treatment:	Unsealed Cement	1
Asbestos type:	Chrysotile	1
Material Assessment Score:		4
Priority Assessment Score:		Negligible
Action:	Manage	
Comments:	Above suspended ceiling

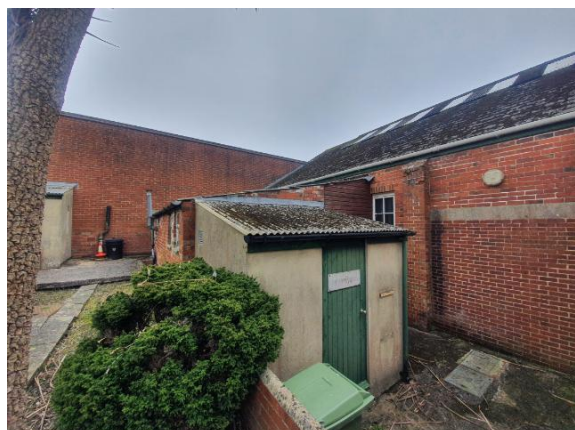
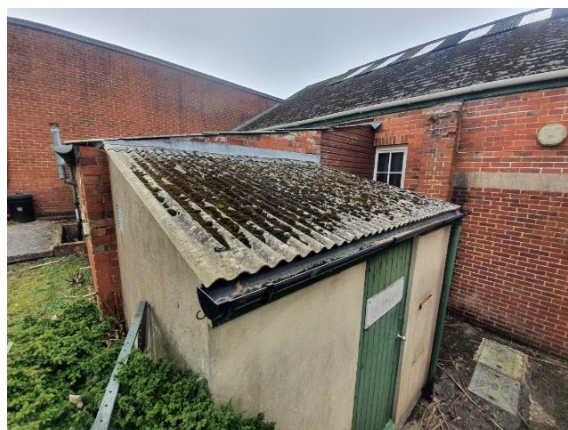
Location: External - Store 011

Material Description:	Profiled Roof - Cement Product	
Identification:	Strongly Presumed to Contain Asbestos	
Approx. quantity:	6 m ²	
Accessibility	Difficult	<i>Assessment Score</i>
Product type:	Cement	1
Extent of Damage:	Slight / minor damage	1
Surface Treatment:	Unsealed Cement	1
Asbestos type:	Chrysotile	1
Material Assessment Score:		4
Priority Assessment Score:		Negligible
Action:	Manage	
Comments:	Previously sampled ref: Armour 23/10/19 - Sample DK/12

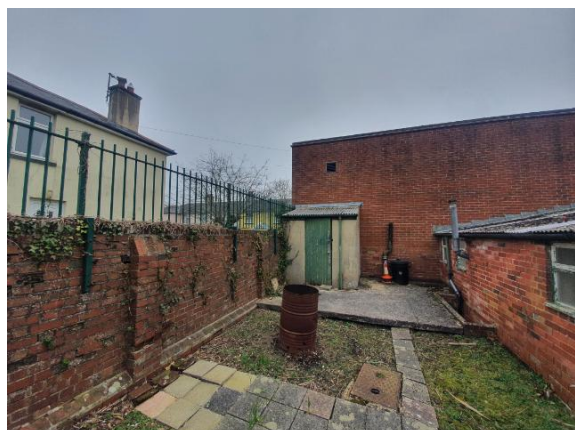
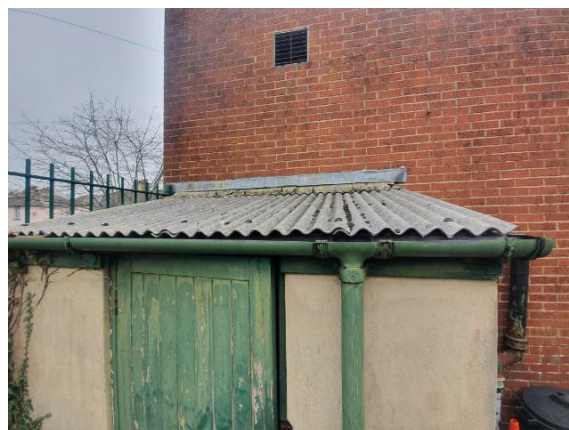
Location: External - Shed 012

Material Description:	Profiled Roof - Cement Product	
Identification:	Strongly Presumed to Contain Asbestos	
Approx. quantity:	4 m ²	
Accessibility	Difficult	<i>Assessment Score</i>
Product type:	Cement	1
Extent of Damage:	Slight / minor damage	1
Surface Treatment:	Unsealed Cement	1
Asbestos type:	Chrysotile	1
Material Assessment Score:		4
Priority Assessment Score:		Negligible
Action:	Manage	
Comments:	Previously sampled ref: Armour 23/10/19 - Sample DK/12

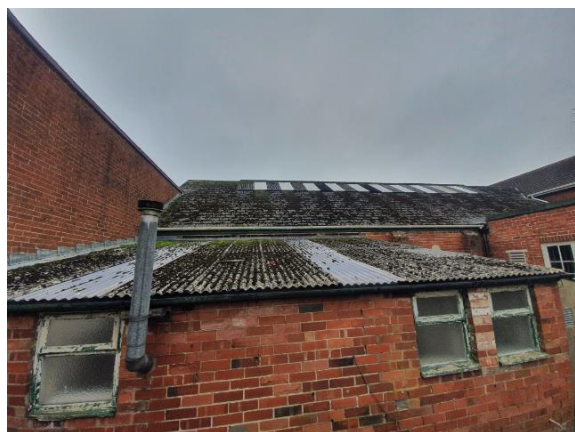
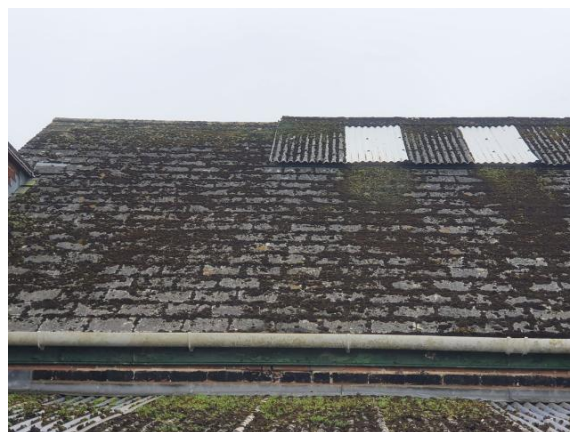
Location: External - Main Hall 013

Material Description:	Cement Tiles & Profiled Roof - Cement Product	
Identification:	Strongly Presumed to Contain Asbestos	
Approx. quantity:	110 m ²	
Accessibility	Difficult	<i>Assessment Score</i>
Product type:	Cement	1
Extent of Damage:	Slight / minor damage	1
Surface Treatment:	Unsealed Cement	1
Asbestos type:	Chrysotile	1
Material Assessment Score:		4
Priority Assessment Score:		Negligible
Action:	Manage	
Comments:	N/A

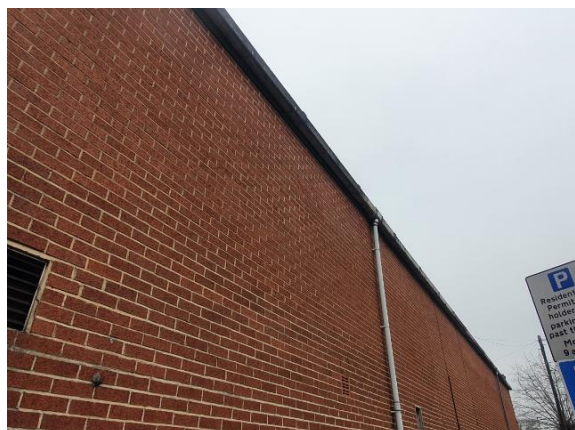
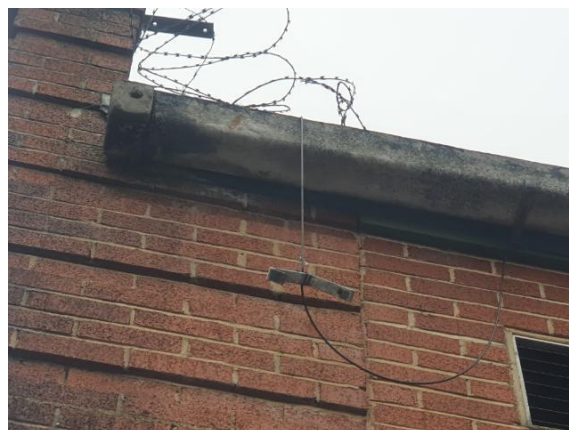
Location: External - Range 014

Material Description:	Guttering - Cement Product	
Identification:	Strongly Presumed to Contain Asbestos	
Approx. quantity:	28 LM	
Accessibility	Difficult	<i>Assessment Score</i>
Product type:	Cement	1
Extent of Damage:	Slight / minor damage	1
Surface Treatment:	Unsealed Cement	1
Asbestos type:	Chrysotile	1
Material Assessment Score:		4
Priority Assessment Score:		Negligible
Action:	Manage	
Comments:	N/A

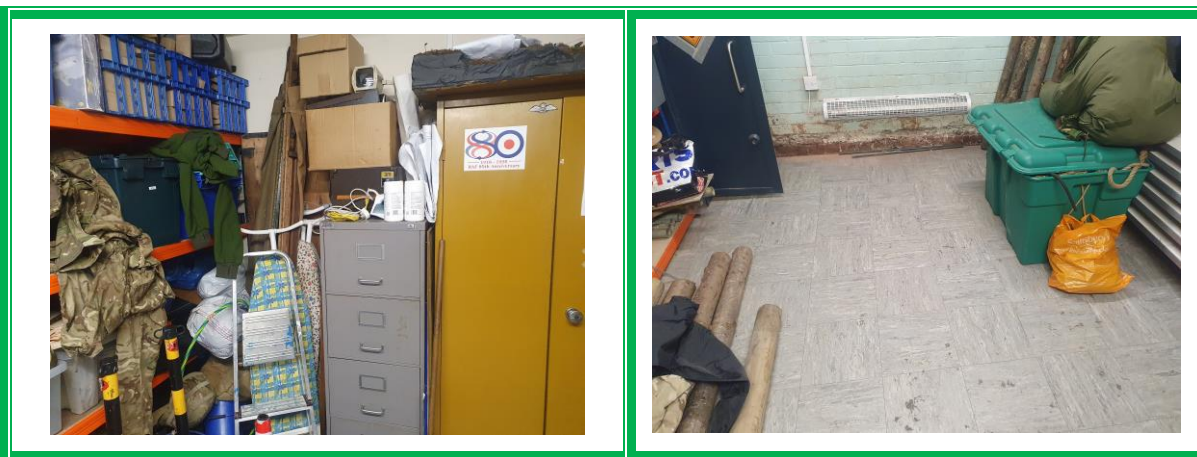
Item No:	9	Sample No:	N/A
Location:	Ground Floor - Armoury 009

Material Description:	No Asbestos Suspected	
Identification:	N/A	
Approx. quantity:	N/A	
Accessibility	N/A	<i>Assessment Score</i>
Product type:	N/A	N/A
Extent of Damage:	N/A	N/A
Surface Treatment:	N/A	N/A
Asbestos type:	N/A	N/A
Material Assessment Score:		N/A
Priority Assessment Score:		N/A
Action:	N/A	
Comments:	Previously a no access area, now accessed. No asbestos found. Non-asbestos floor tiles – sampled during management survey.

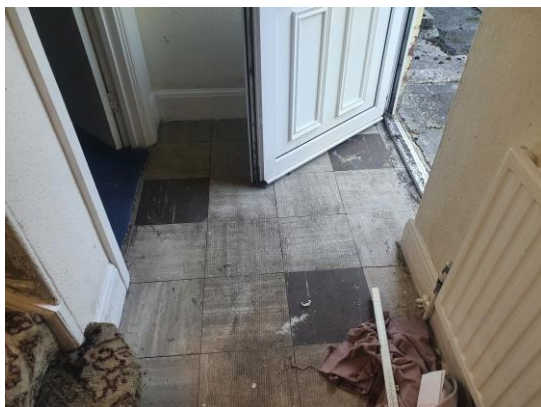
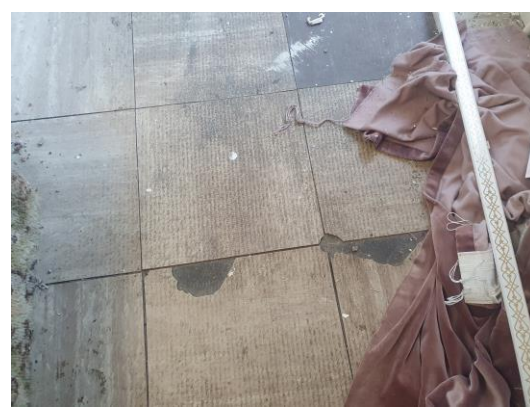
Location: Caretakers Flat – GF Lobby 015

Material Description:	Floor Tiles	
Identification:	Sampled – No Asbestos Found	
Approx. quantity:	N/A	
Accessibility	N/A	<i>Assessment Score</i>
Product type:	N/A	N/A
Extent of Damage:	N/A	N/A
Surface Treatment:	N/A	N/A
Asbestos type:	N/A	N/A
Material Assessment Score:		N/A
Priority Assessment Score:		N/A
Action:	N/A	
Comments:	Previously a no access area, now accessed. No asbestos found. Non-asbestos electrics.

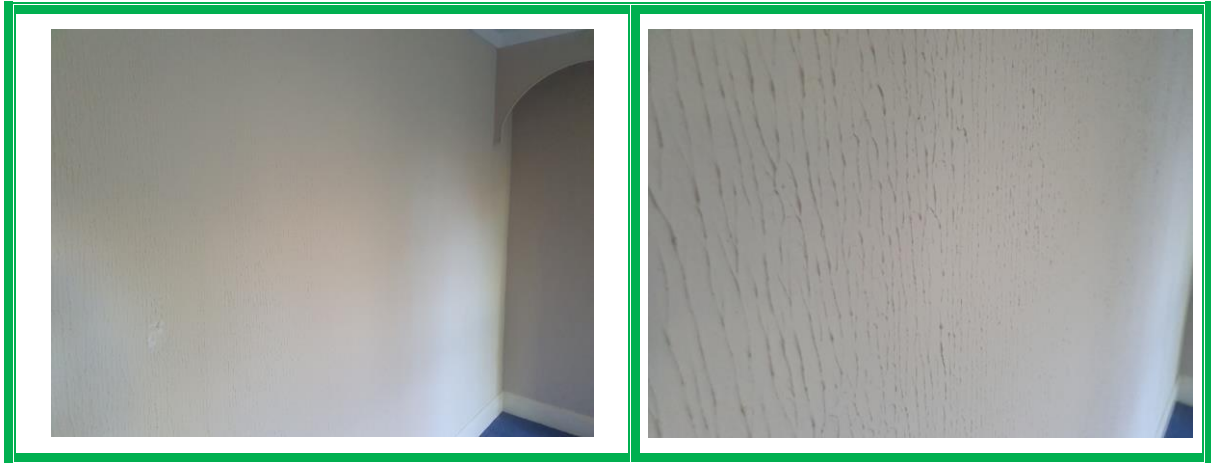
Location: Caretakers Flat – GF Lounge 016

Material Description:	Textured Coating to Walls	
Identification:	Sampled – No Asbestos Found	
Approx. quantity:	N/A	
Accessibility	N/A	<i>Assessment Score</i>
Product type:	N/A	N/A
Extent of Damage:	N/A	N/A
Surface Treatment:	N/A	N/A
Asbestos type:	N/A	N/A
Material Assessment Score:		N/A
Priority Assessment Score:		N/A
Action:	N/A	
Comments:	Previously a no access area, now accessed. No asbestos found.

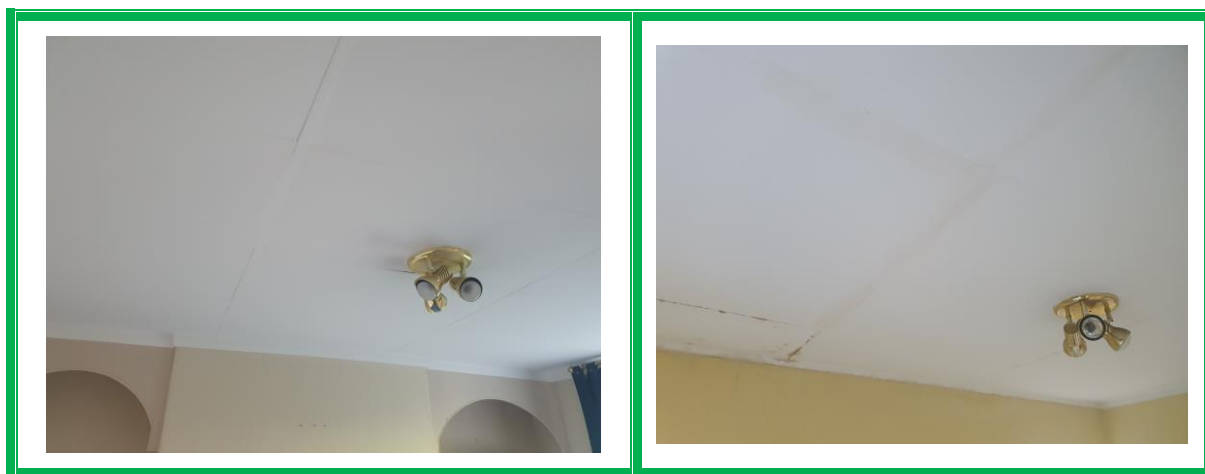
Location: Caretakers Flat – GF Living and Dining Room 017

Material Description:	Ceiling Tiles - Fibreboard	
Identification:	Sampled – No Asbestos Found	
Approx. quantity:	N/A	
Accessibility	N/A	<i>Assessment Score</i>
Product type:	N/A	N/A
Extent of Damage:	N/A	N/A
Surface Treatment:	N/A	N/A
Asbestos type:	N/A	N/A
Material Assessment Score:		N/A
Priority Assessment Score:		N/A
Action:	N/A	
Comments:	Previously a no access area, now accessed. No asbestos found.

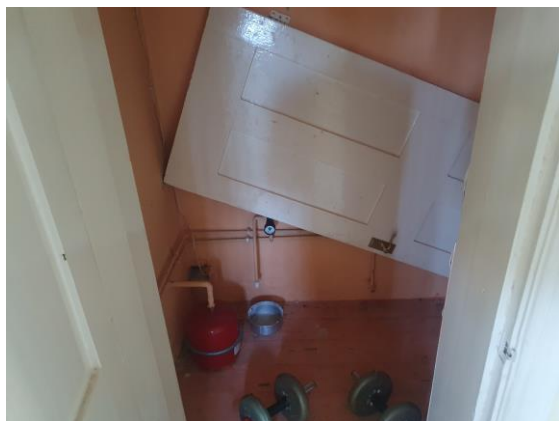
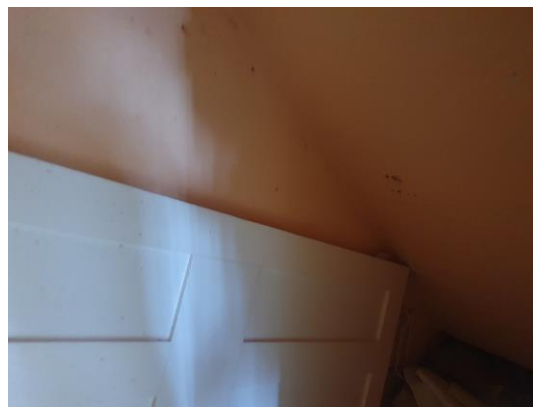
Location: Caretakers Flat – GF Cupboard 018

Material Description:	No Asbestos Suspected	
Identification:	N/A	
Approx. quantity:	N/A	
Accessibility	N/A	<i>Assessment Score</i>
Product type:	N/A	N/A
Extent of Damage:	N/A	N/A
Surface Treatment:	N/A	N/A
Asbestos type:	N/A	N/A
Material Assessment Score:		N/A
Priority Assessment Score:		N/A
Action:	N/A	
Comments:	Previously a no access area, now accessed. No asbestos found. Lathe and Plaster Ceiling.

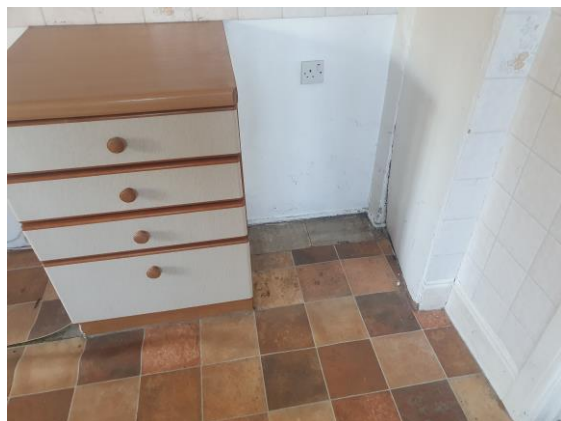
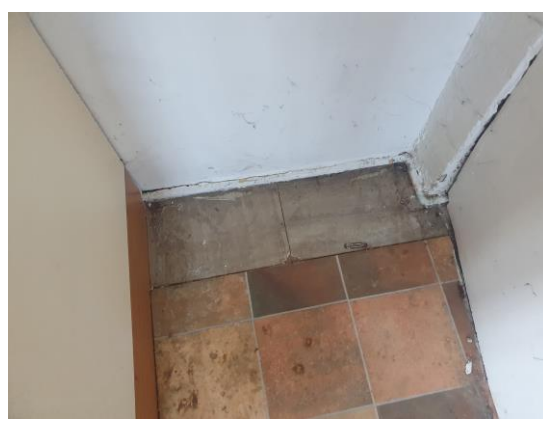
Location: Caretakers Flat – GF Kitchen 019

Material Description:	No Asbestos Suspected	
Identification:	As per Sample DK/15	
Approx. quantity:	N/A	
Accessibility	N/A	<i>Assessment Score</i>
Product type:	N/A	N/A
Extent of Damage:	N/A	N/A
Surface Treatment:	N/A	N/A
Asbestos type:	N/A	N/A
Material Assessment Score:		N/A
Priority Assessment Score:		N/A
Action:	N/A	
Comments:	Previously a no access area, now accessed. No asbestos found.

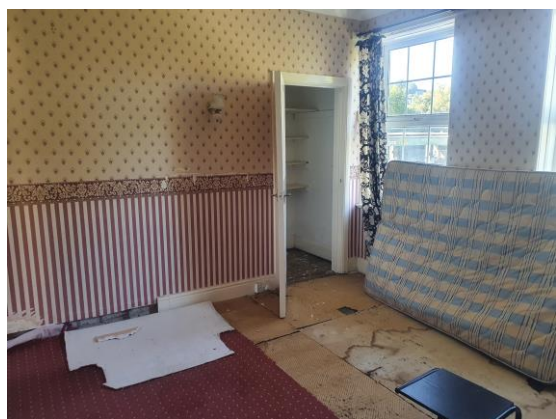
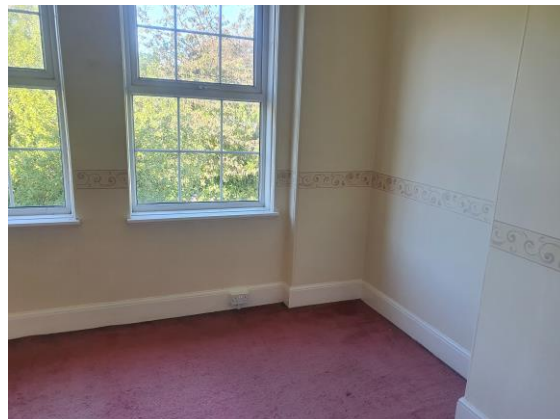
Location: Caretakers Flat – FF Bedrooms x 3 and Cupboard

Material Description:	No Asbestos Suspected	
Identification:	N/A	
Approx. quantity:	N/A	
Accessibility	N/A	<i>Assessment Score</i>
Product type:	N/A	N/A
Extent of Damage:	N/A	N/A
Surface Treatment:	N/A	N/A
Asbestos type:	N/A	N/A
Material Assessment Score:		N/A
Priority Assessment Score:		N/A
Action:	N/A	
Comments:	Previously a no access area, now accessed. Lathe, plaster, and plasterboard ceiling.

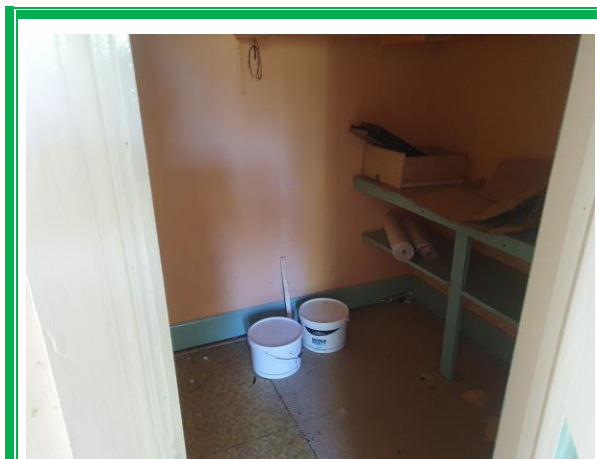
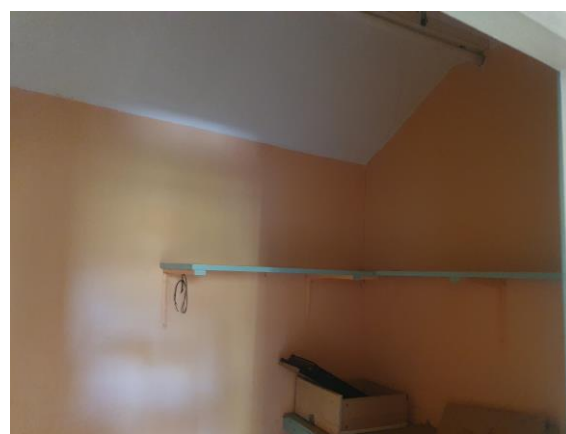
Location: Caretakers Flat – FF Cupboard

Material Description:	No Asbestos Suspected	
Identification:	N/A	
Approx. quantity:	N/A	
Accessibility	N/A	<i>Assessment Score</i>
Product type:	N/A	N/A
Extent of Damage:	N/A	N/A
Surface Treatment:	N/A	N/A
Asbestos type:	N/A	N/A
Material Assessment Score:		N/A
Priority Assessment Score:		N/A
Action:	N/A	
Comments:	Previously a no access area, now accessed. Non-asbestos lino.

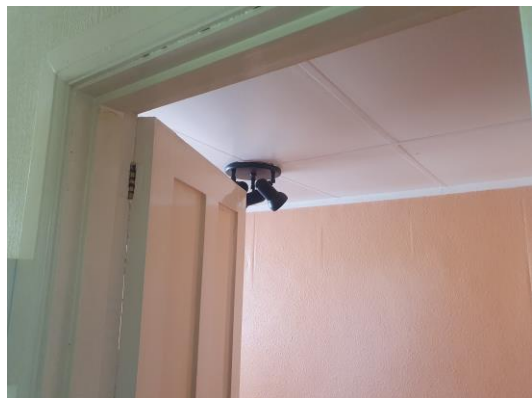
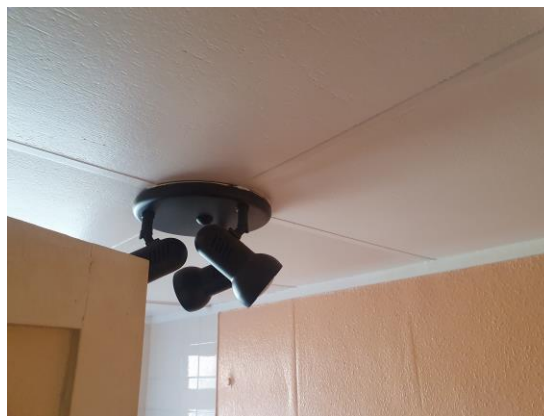
Location: Caretakers Flat – FF Bathroom

Material Description:	No Asbestos Suspected	
Identification:	As per Sample DK/17	
Approx. quantity:	N/A	
Accessibility	N/A	<i>Assessment Score</i>
Product type:	N/A	N/A
Extent of Damage:	N/A	N/A
Surface Treatment:	N/A	N/A
Asbestos type:	N/A	N/A
Material Assessment Score:		N/A
Priority Assessment Score:		N/A
Action:	N/A	
Comments:	Previously a no access area, now accessed. Lathe, plaster, and plasterboard ceiling.

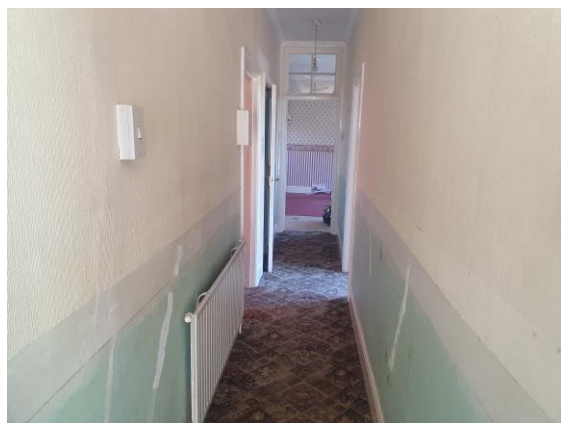
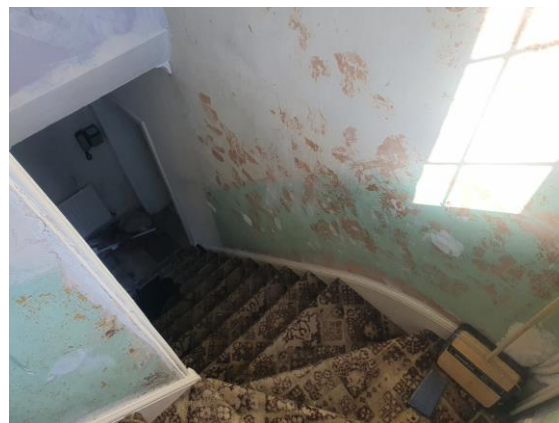
Location: Caretakers Flat – FF Corridor and Stairwell

Material Description:	No Asbestos Suspected	
Identification:	N/A	
Approx. quantity:	N/A	
Accessibility	N/A	<i>Assessment Score</i>
Product type:	N/A	N/A
Extent of Damage:	N/A	N/A
Surface Treatment:	N/A	N/A
Asbestos type:	N/A	N/A
Material Assessment Score:		N/A
Priority Assessment Score:		N/A
Action:	N/A	
Comments:	Previously a no access area, now accessed. No asbestos suspected.

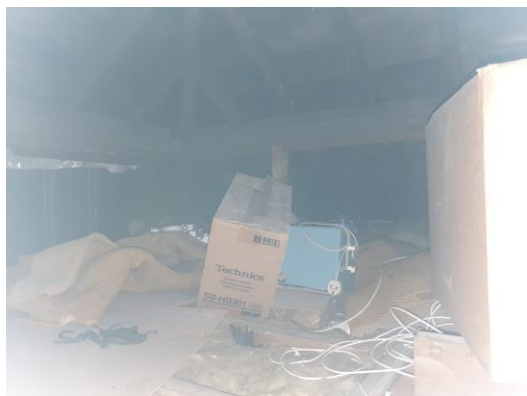
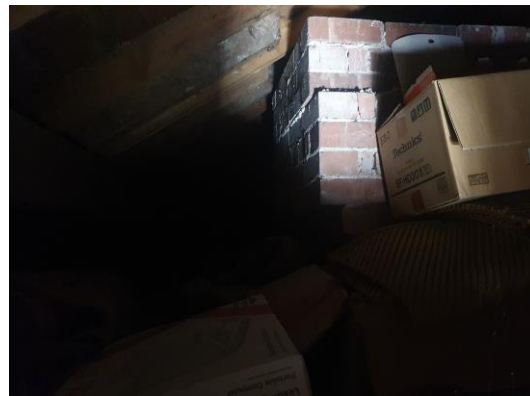
Location: Caretakers Flat – Loft Space

Material Description:	No Asbestos Suspected	
Identification:	N/A	
Approx. quantity:	N/A	
Accessibility	N/A	<i>Assessment Score</i>
Product type:	N/A	N/A
Extent of Damage:	N/A	N/A
Surface Treatment:	N/A	N/A
Asbestos type:	N/A	N/A
Material Assessment Score:		N/A
Priority Assessment Score:		N/A
Action:	N/A	
Comments:	Previously a no access area, limited access as no crawl boards. No asbestos suspected.
