**Project Number 2481**

**Management  
Asbestos Survey Report**

**2185 Wareham, St Martins Lane,  
Wareham, BH20 4HF**

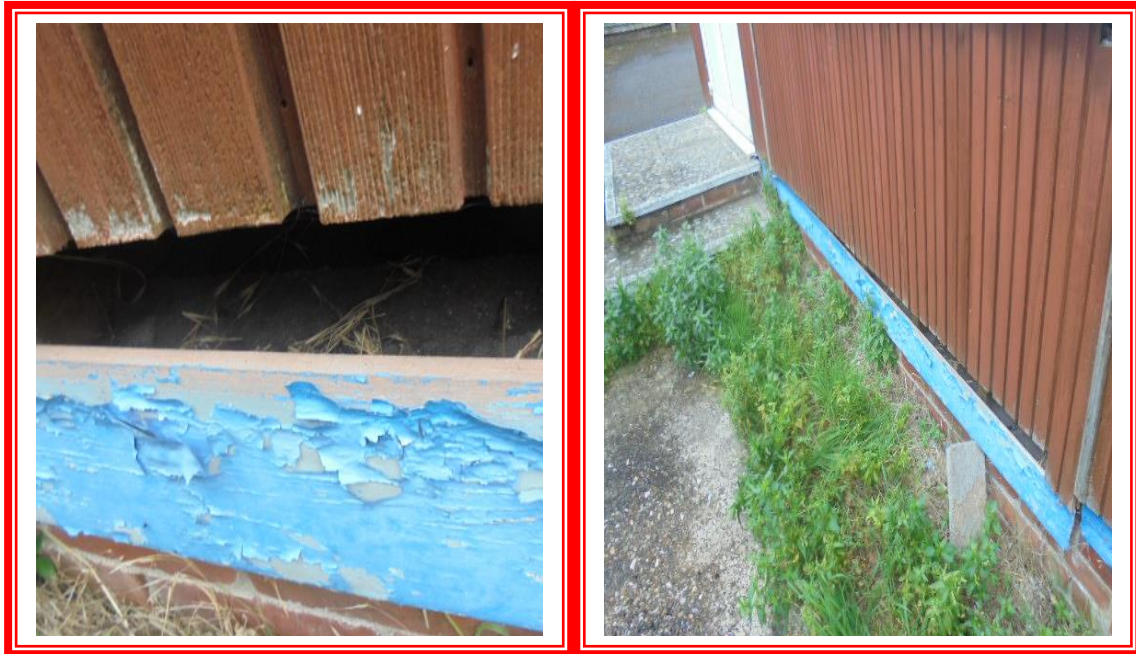
**Item No: 1**

<b>Material Description:</b>	Damp Proof Course	
<b>Identification:</b>	Sampled – Asbestos Detected	
<b>Approx. quantity:</b>	To Entire Perimeter of Building	
<b>Accessibility</b>	Low	<i>Assessment Score</i>
<b>Product type:</b>	Bitumen	1
<b>Extent of Damage:</b>	Minor	1
<b>Surface Treatment:</b>	Non-Friable	0
<b>Asbestos type:</b>	Chrysotile	1
<b>Material Assessment Score:</b>		3
<b>Priority Assessment Score:</b>		Negligible
<b>Action:</b>	Manage	
<b>Comments:</b>	N/A

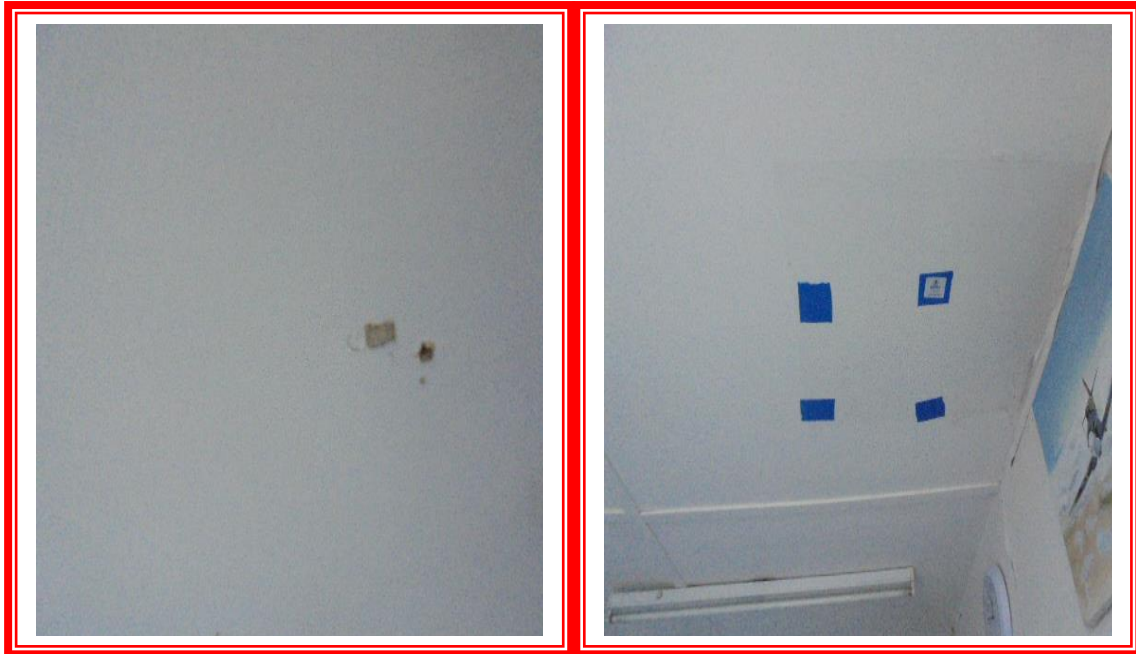
**Item No: 2****Sample No: 2****Location: Office**

<b>Material Description:</b>	Insulation Board Residue to Ceiling	
<b>Identification:</b>	Sampled – Asbestos Detected	
<b>Approx. quantity:</b>	Small Amounts	
<b>Accessibility</b>	Low	<i>Assessment Score</i>
<b>Product type:</b>	Insulation Board	2
<b>Extent of Damage:</b>	Major	3
<b>Surface Treatment:</b>	Unsealed	2
<b>Asbestos type:</b>	Chrysotile	1
<b>Material Assessment Score:</b>		8
<b>Priority Assessment Score:</b>		Medium
<b>Action:</b>	Encapsulate	
<b>Comments:</b>	Residue visible where panel was removed from ceiling. Temporarily encapsulated with tape but requires permanent encapsulation

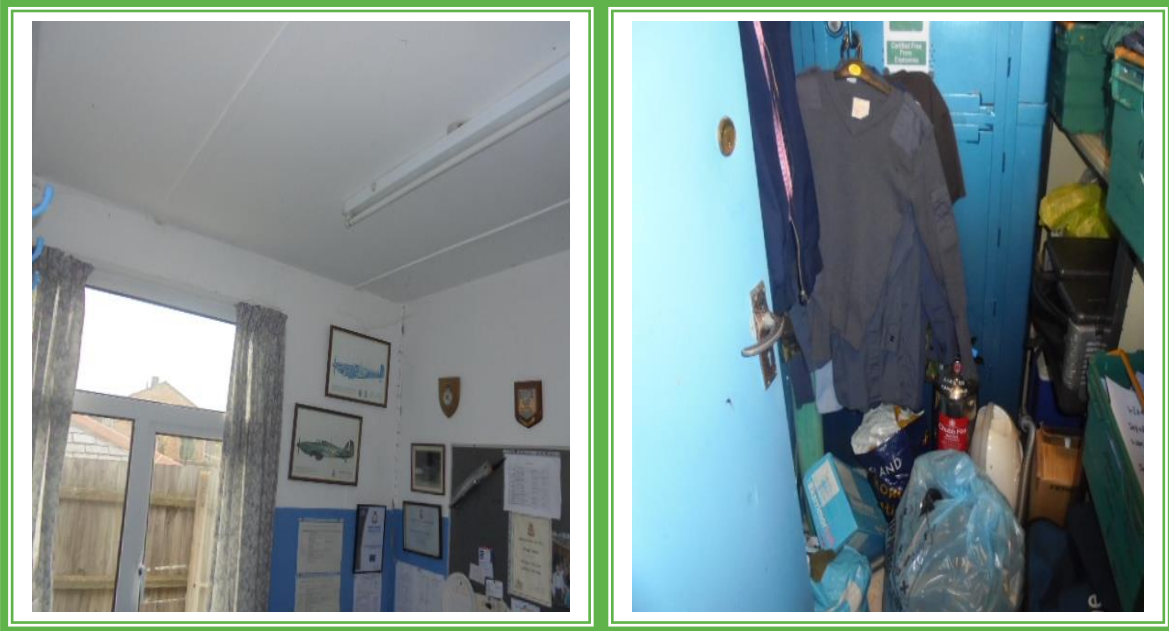
**Item No: 3**

<b>Material Description:</b>	Visual Inspection – No Suspect Materials Found	
<b>Identification:</b>	N/A	
<b>Approx. quantity:</b>	N/A	
<b>Accessibility</b>	N/A	<i>Assessment Score</i>
<b>Product type:</b>		N/A
<b>Extent of Damage:</b>		N/A
<b>Surface Treatment:</b>		N/A
<b>Asbestos type:</b>		N/A
<b>Material Assessment Score:</b>		N/A
<b>Priority Assessment Score:</b>		N/A
<b>Action:</b>	N/A	
<b>Comments:</b>	N/A

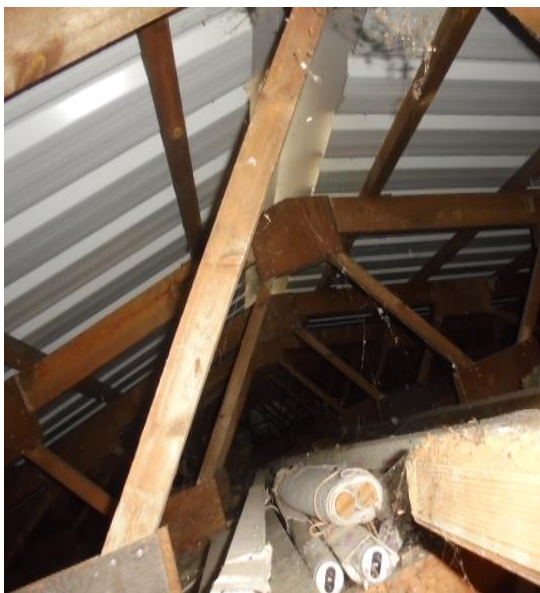
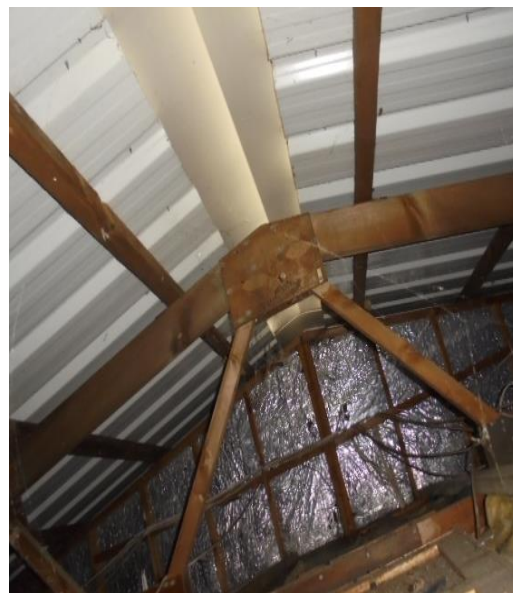
**Item No: 4**

<b>Material Description:</b>	Visual Inspection – No Suspect Materials Found	
<b>Identification:</b>	N/A	
<b>Approx. quantity:</b>	N/A	
<b>Accessibility</b>	N/A	<i>Assessment Score</i>
<b>Product type:</b>		N/A
<b>Extent of Damage:</b>		N/A
<b>Surface Treatment:</b>		N/A
<b>Asbestos type:</b>		N/A
<b>Material Assessment Score:</b>		N/A
<b>Priority Assessment Score:</b>		N/A
<b>Action:</b>	N/A	
<b>Comments:</b>	N/A

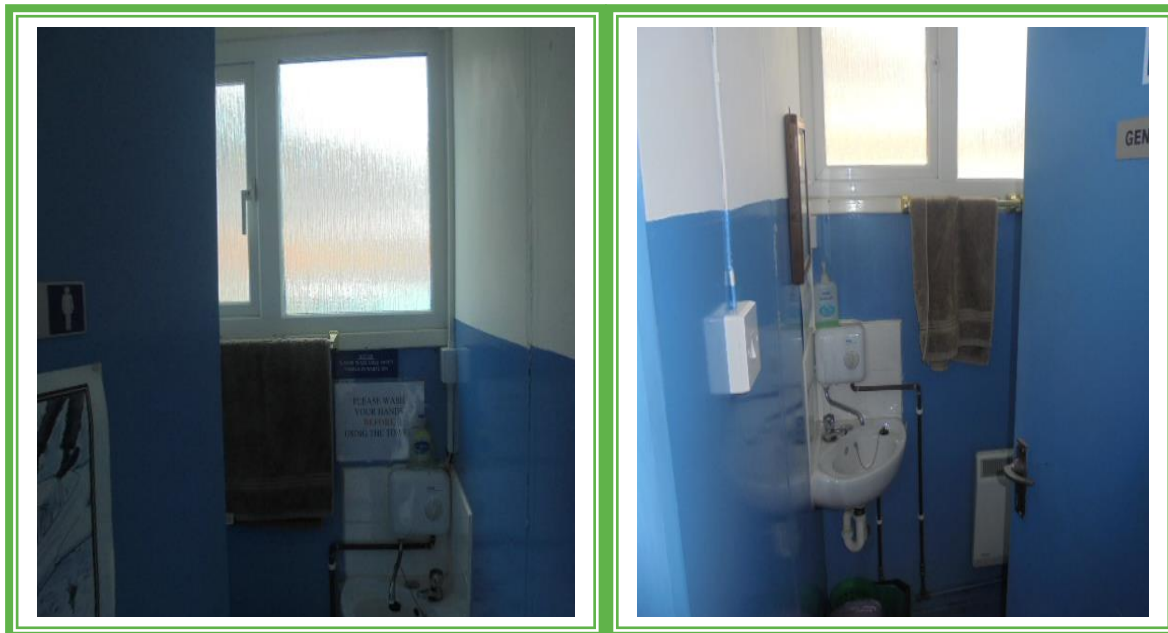
**Item No: 5**

<b>Material Description:</b>	Visual Inspection – No Suspect Materials Found	
<b>Identification:</b>	N/A	
<b>Approx. quantity:</b>	N/A	
<b>Accessibility</b>	N/A	<i>Assessment Score</i>
<b>Product type:</b>		N/A
<b>Extent of Damage:</b>		N/A
<b>Surface Treatment:</b>		N/A
<b>Asbestos type:</b>		N/A
<b>Material Assessment Score:</b>		N/A
<b>Priority Assessment Score:</b>		N/A
<b>Action:</b>	N/A	
<b>Comments:</b>	Plastic toilet seats and ceramic toilet cisterns

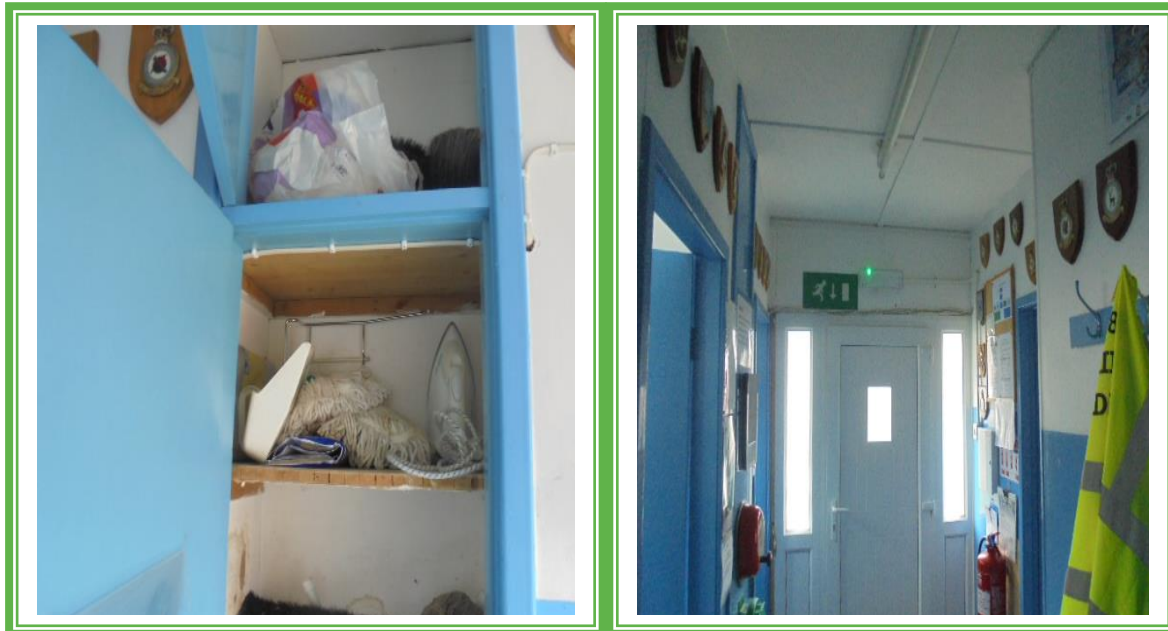
**Item No: 6**

<b>Material Description:</b>	Visual Inspection – No Suspect Materials Found	
<b>Identification:</b>	N/A	
<b>Approx. quantity:</b>	N/A	
<b>Accessibility</b>	N/A	<i>Assessment Score</i>
<b>Product type:</b>		N/A
<b>Extent of Damage:</b>		N/A
<b>Surface Treatment:</b>		N/A
<b>Asbestos type:</b>		N/A
<b>Material Assessment Score:</b>		N/A
<b>Priority Assessment Score:</b>		N/A
<b>Action:</b>	N/A	
<b>Comments:</b>	N/A

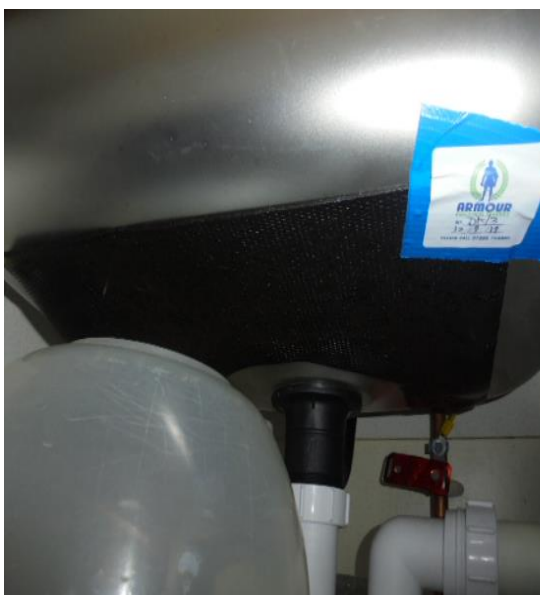
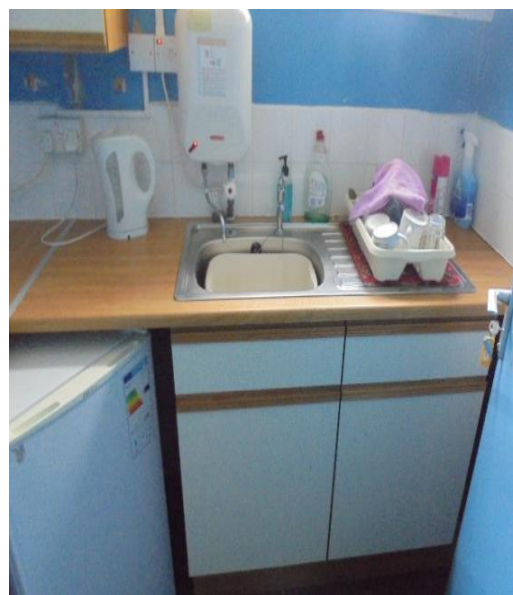
**Item No: 7**

<b>Material Description:</b>	Sink Pad	
<b>Identification:</b>	Sampled – No Asbestos Detected	
<b>Approx. quantity:</b>	1 x Sink	
<b>Accessibility</b>	N/A	<i>Assessment Score</i>
<b>Product type:</b>		N/A
<b>Extent of Damage:</b>		N/A
<b>Surface Treatment:</b>		N/A
<b>Asbestos type:</b>		N/A
<b>Material Assessment Score:</b>		N/A
<b>Priority Assessment Score:</b>		N/A
<b>Action:</b>	N/A	
<b>Comments:</b>	N/A

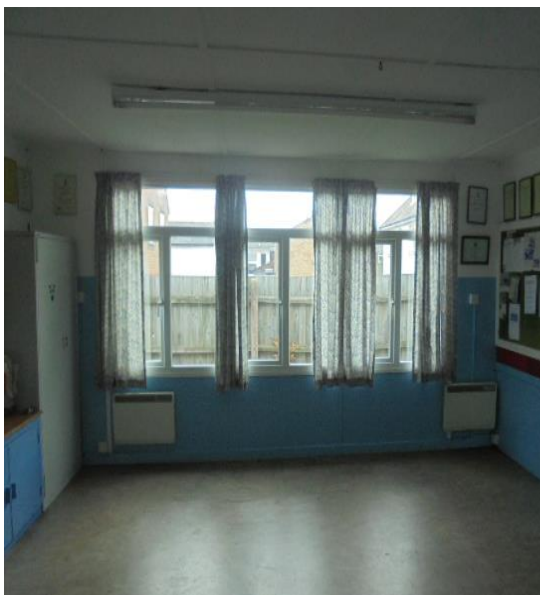
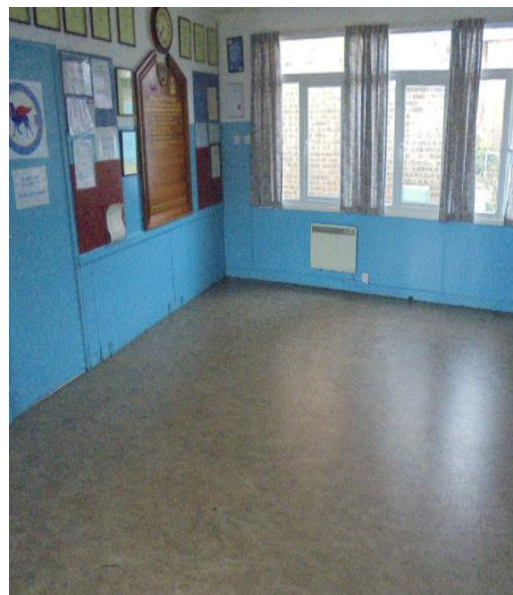
**Item No: 8****Sample No: N/A****Location: Drill Hall**

<b>Material Description:</b>	Visual Inspection – No Suspect Materials Found	
<b>Identification:</b>	N/A	
<b>Approx. quantity:</b>	N/A	
<b>Accessibility</b>	N/A	<i>Assessment Score</i>
<b>Product type:</b>		N/A
<b>Extent of Damage:</b>		N/A
<b>Surface Treatment:</b>		N/A
<b>Asbestos type:</b>		N/A
<b>Material Assessment Score:</b>		N/A
<b>Priority Assessment Score:</b>		N/A
<b>Action:</b>	N/A	
<b>Comments:</b>	N/A

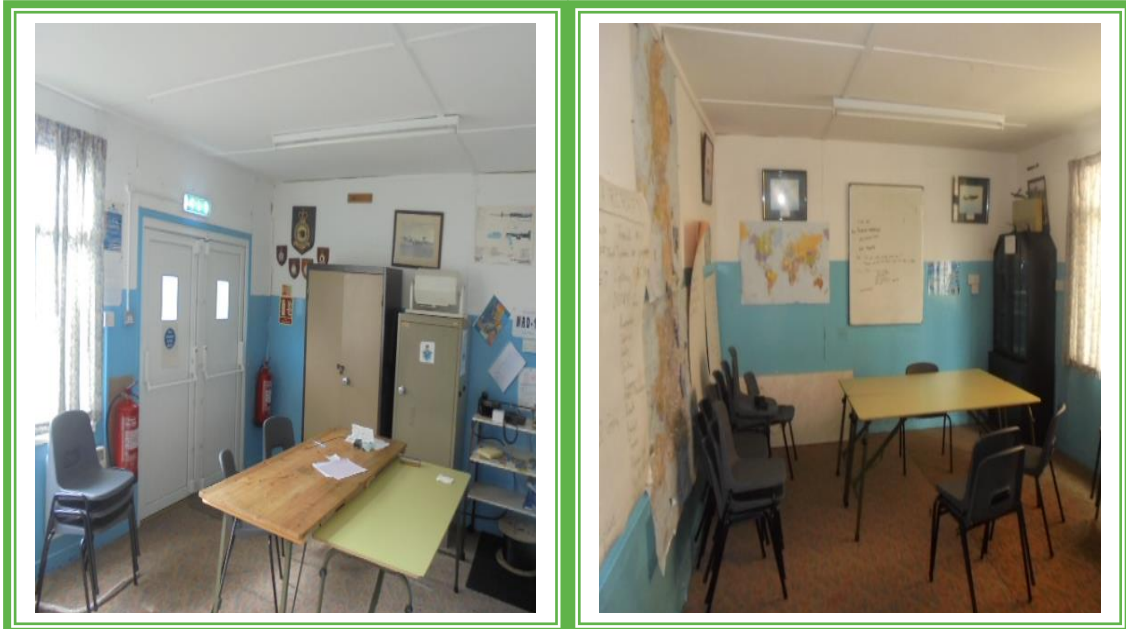
**Item No: 9****Sample No: N/A****Location: Classrooms x 2**

<b>Material Description:</b>	Visual Inspection – No Suspect Materials Found	
<b>Identification:</b>	N/A	
<b>Approx. quantity:</b>	N/A	
<b>Accessibility</b>	N/A	<i>Assessment Score</i>
<b>Product type:</b>		N/A
<b>Extent of Damage:</b>		N/A
<b>Surface Treatment:</b>		N/A
<b>Asbestos type:</b>		N/A
<b>Material Assessment Score:</b>		N/A
<b>Priority Assessment Score:</b>		N/A
<b>Action:</b>	N/A	
<b>Comments:</b>	N/A
