Project Number A-01339 (5908)

**Re-Inspection
Asbestos Survey Report**

**(20) 675 Army Air Corps
Somerset
TA1 5LJ**

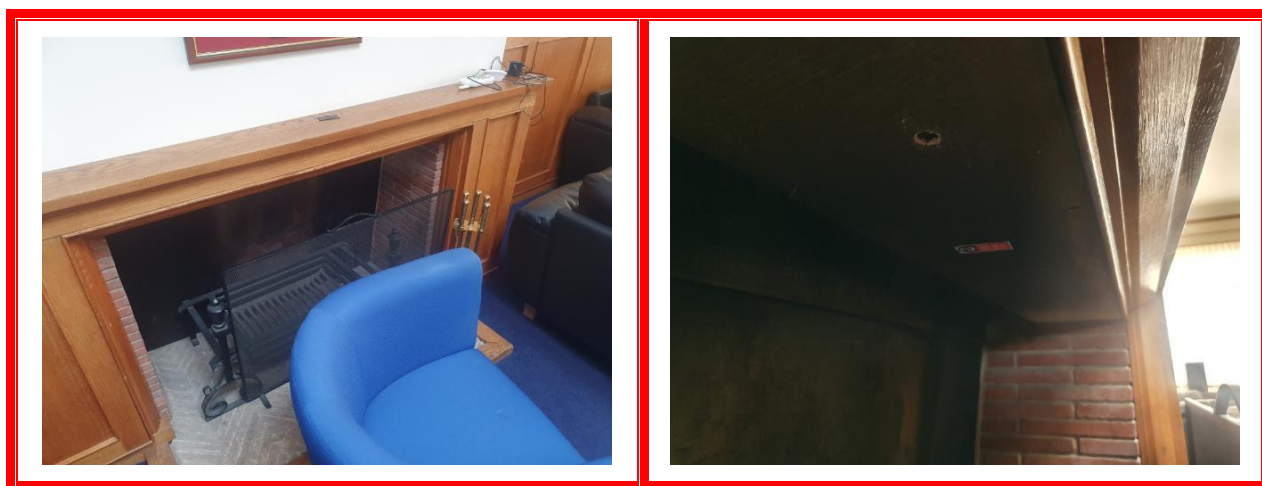
Item No:	1	Sample No:	N/A
Location:	First Floor - Officer's Lounge 001

Material Description:	Panel to Top of Fireplace - Cement Product	
Identification:	Previously Sampled - Asbestos Detected	
Approx. quantity:	1 m ²	
Accessibility	Medium	Assessment Score
Product type:	Cement	1
Extent of Damage:	Slight / minor damage	1
Surface Treatment:	Unsealed Cement	1
Asbestos type:	Chrysotile	1
Material Assessment Score:		4
Risk Assessment Score:		Negligible
Action:	Encapsulate	
Comments:	Previously sampled ref: Armour 18/6/19 Sample DK/1. Minor encapsulation required where panel is screwed in.

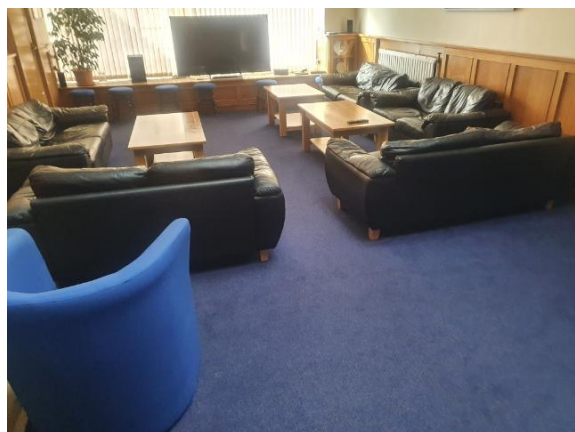
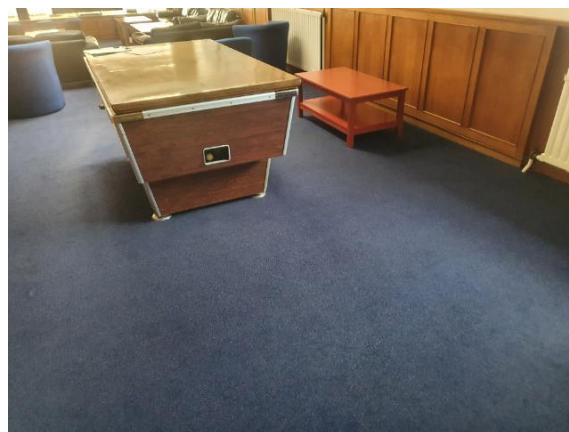
Location: First Floor - Officer's Lounge 002

Material Description:	Floor Tiles and Adhesive - Vinyl Products	
Identification:	Previously Sampled - Asbestos Detected	
Approx. quantity:	50 m ²	
Accessibility	Difficult	<i>Assessment Score</i>
Product type:	Vinyl	1
Extent of Damage:	Slight / minor damage	1
Surface Treatment:	Non-friable	0
Asbestos type:	Chrysotile	1
Material Assessment Score:		3
Risk Assessment Score:		Negligible
Action:	Manage	
Comments:	Previously sampled ref: Armour 18/6/19 Sample DK/2. Under carpet

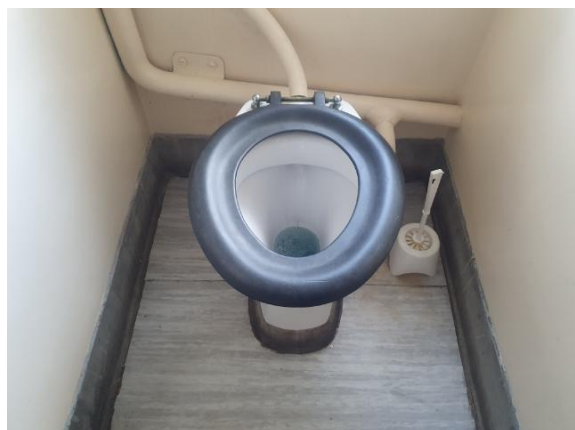
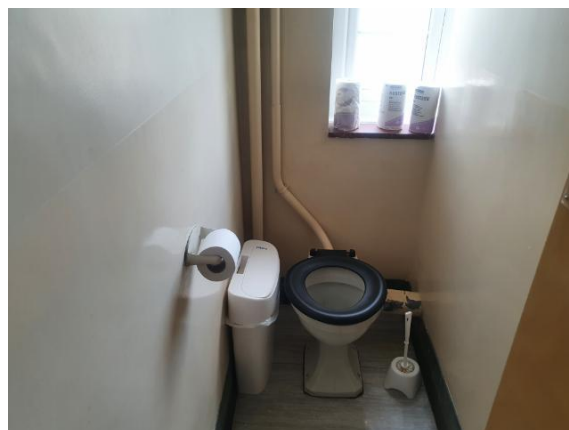
Location: First Floor - WC's x 2 003

Material Description:	Toilet Seats - PVC / Reinforced Plastics	
Identification:	Presumed to Contain Asbestos	
Approx. quantity:	2 no	
Accessibility	Easy	<i>Assessment Score</i>
Product type:	Bakelite	1
Extent of Damage:	Major damage	3
Surface Treatment:	Unsealed Insulation	3
Asbestos type:	Chrysotile	1
Material Assessment Score:		8
Risk Assessment Score:		Medium
Action:	Manage	
Comments:	Not possible to sample as may damage integrity of the seats - Low damage

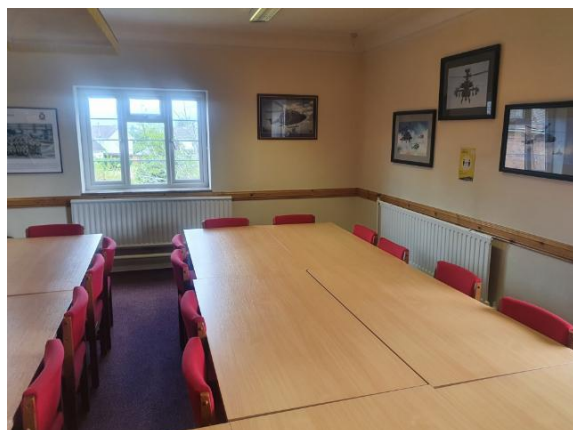
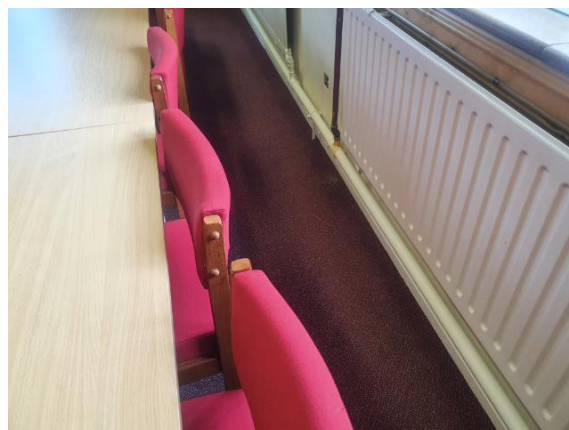
Location: First Floor - Conference Room 004

Material Description:	Floor Tiles and Adhesive - Vinyl Products	
Identification:	Previously Sampled - Asbestos Detected	
Approx. quantity:	49 m ²	
Accessibility	Difficult	<i>Assessment Score</i>
Product type:	Vinyl	1
Extent of Damage:	Slight / minor damage	1
Surface Treatment:	Non-friable	0
Asbestos type:	Chrysotile	1
Material Assessment Score:		3
Risk Assessment Score:		Negligible
Action:	Manage	
Comments:	Previously sampled ref: Armour 18/6/19 Sample DK/4. Under carpet

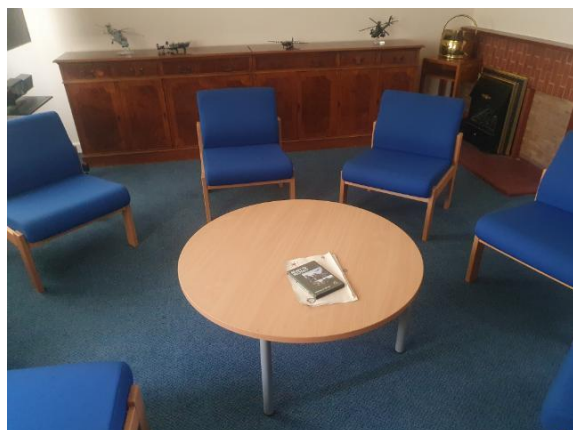
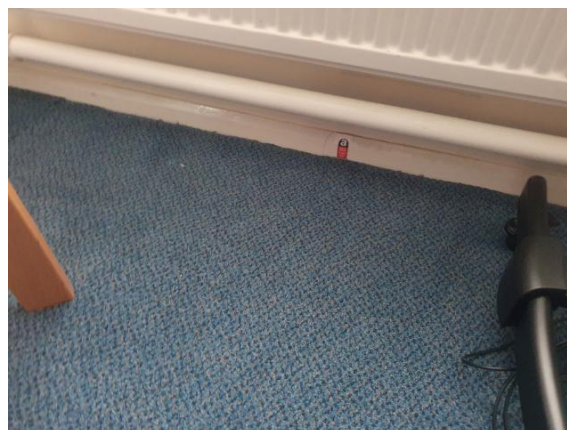
Location: First Floor - The Harding Room 005

Material Description:	Floor Tiles and Adhesive - Vinyl Products	
Identification:	Previously Sampled - Asbestos Detected	
Approx. quantity:	30 m ²	
Accessibility	Difficult	<i>Assessment Score</i>
Product type:	Vinyl	1
Extent of Damage:	Slight / minor damage	1
Surface Treatment:	Non-friable	0
Asbestos type:	Chrysotile	1
Material Assessment Score:		3
Risk Assessment Score:		Negligible
Action:	Manage	
Comments:	Previously sampled ref: Armour 18/6/19 Sample DK/6. Under carpet

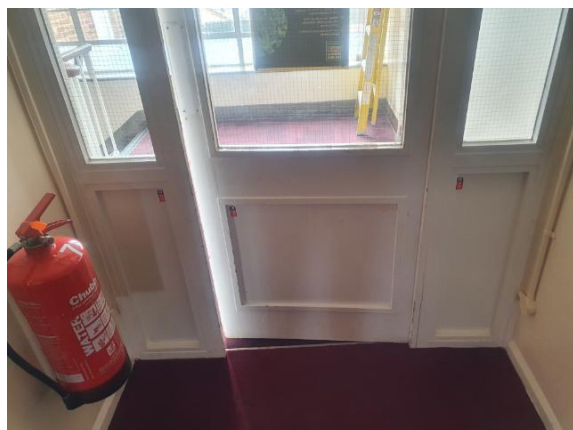
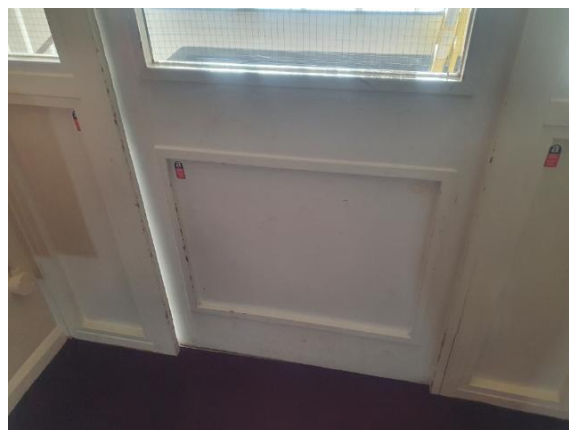
Location: First Floor - Corridor 006

Material Description:	Door Panel and Door Infill Panels - Insulating Board	
Identification:	Previously Sampled - Asbestos Detected	
Approx. quantity:	3 no	
Accessibility	Easy	<i>Assessment Score</i>
Product type:	Asbestos Insulating Board	2
Extent of Damage:	Slight / minor damage	1
Surface Treatment:	Encapsulated AIB	1
Asbestos type:	Amosite	2
Material Assessment Score:		6
Risk Assessment Score:		Low
Action:	Manage	
Comments:	Previously sampled ref: Armour 18/6/19 Sample DK/7. 3no panels

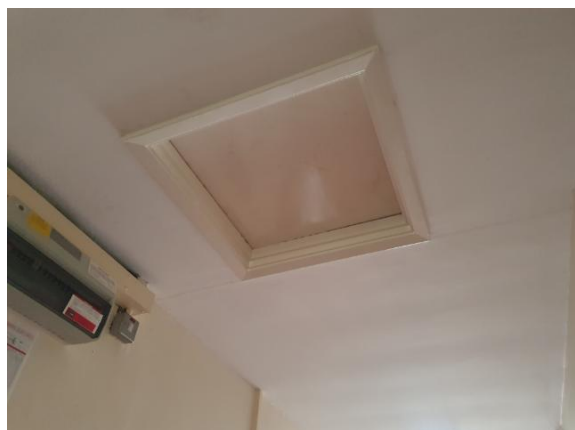
Location: First Floor - Loft Space 007

Material Description:	Panel to Door - Insulating Board	
Identification:	Presumed to Contain Asbestos	
Approx. quantity:	1 m ²	
Accessibility	Difficult	<i>Assessment Score</i>
Product type:	Asbestos Insulating Board	2
Extent of Damage:	Major damage	3
Surface Treatment:	Unsealed Insulation	3
Asbestos type:	Amosite, Chrysotile	2
Material Assessment Score:		10
Risk Assessment Score:		High
Action:	Manage	
Comments:	No safe access to inspect/sample panel. Limited access possible in loft space throughout - Apply caution

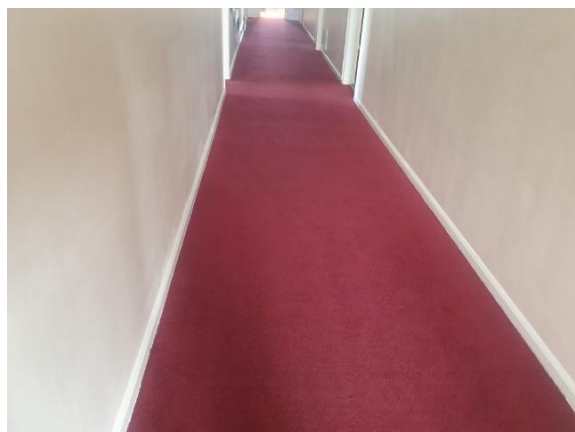
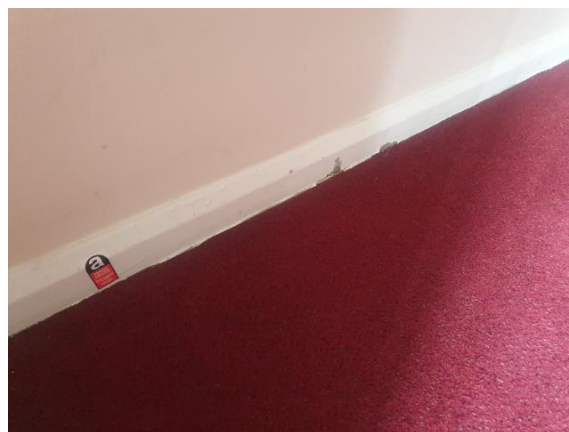
Location: First Floor - Corridor 008

Material Description:	Floor Tiles and Adhesive - Vinyl Products	
Identification:	Previously Sampled - Asbestos Detected	
Approx. quantity:	22 m ²	
Accessibility	Difficult	<i>Assessment Score</i>
Product type:	Vinyl	1
Extent of Damage:	Slight / minor damage	1
Surface Treatment:	Non-friable	0
Asbestos type:	Chrysotile	1
Material Assessment Score:		3
Risk Assessment Score:		Negligible
Action:	Manage	
Comments:	Previously sampled ref: Armour 18/6/19 Sample DK/6. Under carpet

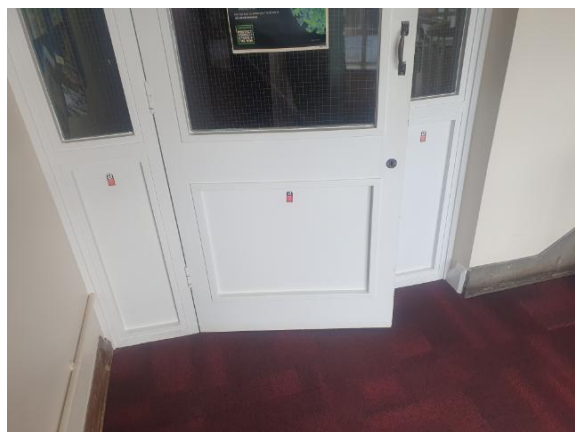
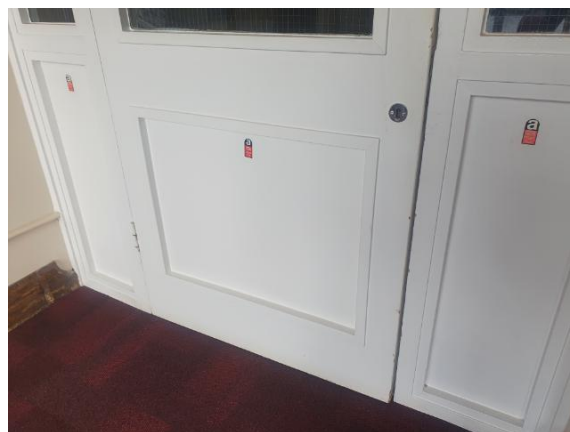
Location: First Floor - Landing 009

Material Description:	Door Panel and Door Infill Panels - Insulating Board	
Identification:	Previously Sampled - Asbestos Detected	
Approx. quantity:	3 no	
Accessibility	Easy	<i>Assessment Score</i>
Product type:	Asbestos Insulating Board	2
Extent of Damage:	Slight / minor damage	1
Surface Treatment:	Encapsulated AIB	1
Asbestos type:	Amosite	2
Material Assessment Score:		6
Risk Assessment Score:		Low
Action:	Manage	
Comments:	Previously sampled ref: Armour 18/6/19 Sample DK/7. 3no panels

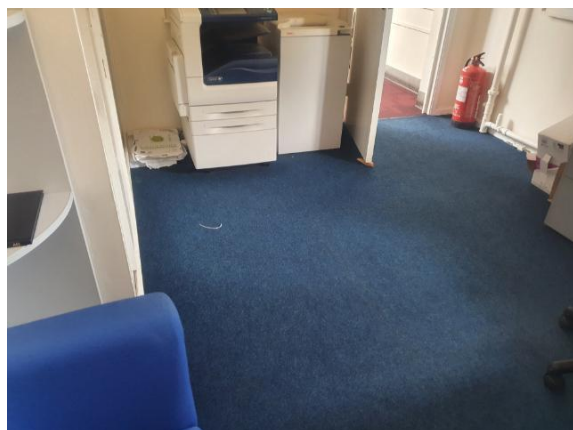
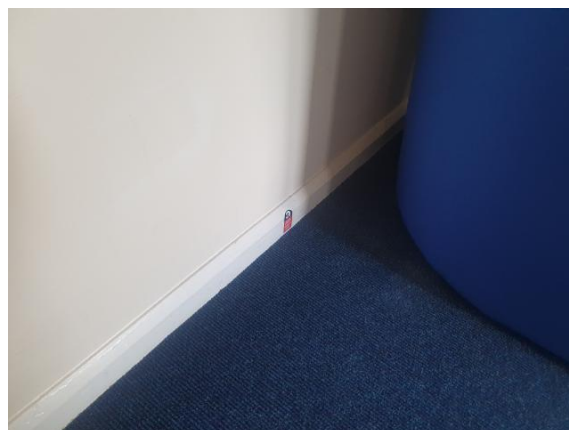
Location: First Floor - Office 010

Material Description:	Floor Tiles and Adhesive - Vinyl Products	
Identification:	Previously Sampled - Asbestos Detected	
Approx. quantity:	16 m ²	
Accessibility	Difficult	<i>Assessment Score</i>
Product type:	Vinyl	1
Extent of Damage:	Slight / minor damage	1
Surface Treatment:	Non-friable	0
Asbestos type:	Chrysotile	1
Material Assessment Score:		3
Risk Assessment Score:		Negligible
Action:	Manage	
Comments:	Previously sampled ref: Armour 18/6/19 Sample DK/6. Under carpet

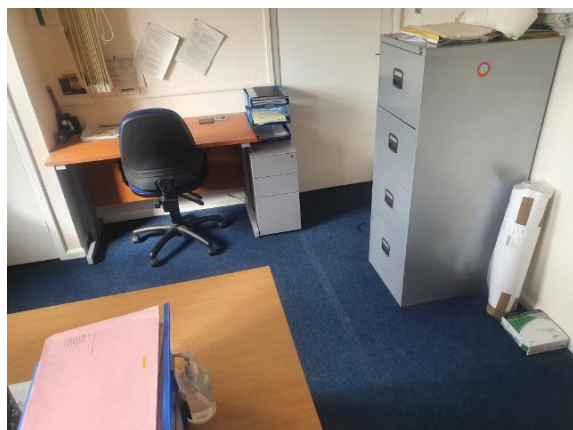
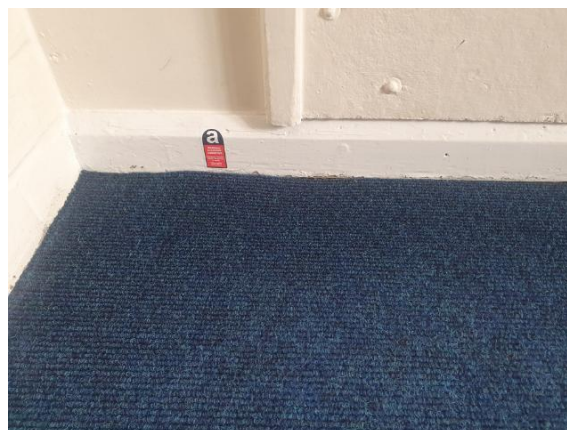
Location: First Floor - Office 011

Material Description:	Floor Tiles and Adhesive - Vinyl Products	
Identification:	Previously Sampled - Asbestos Detected	
Approx. quantity:	16 m ²	
Accessibility	Difficult	<i>Assessment Score</i>
Product type:	Vinyl	1
Extent of Damage:	Slight / minor damage	1
Surface Treatment:	Non-friable	0
Asbestos type:	Chrysotile	1
Material Assessment Score:		3
Risk Assessment Score:		Negligible
Action:	Manage	
Comments:	Previously sampled ref: Armour 18/6/19 Sample DK/6. Under carpet. No access within boxing within room

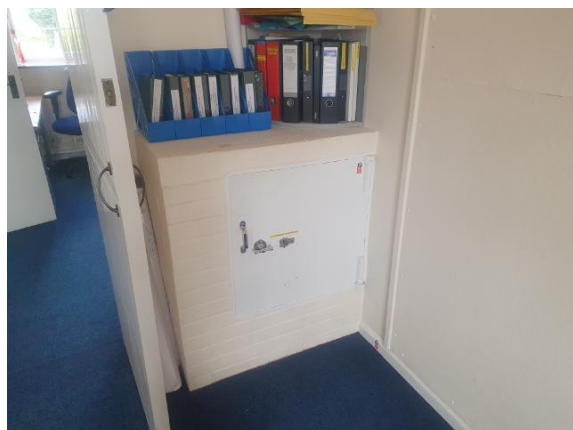
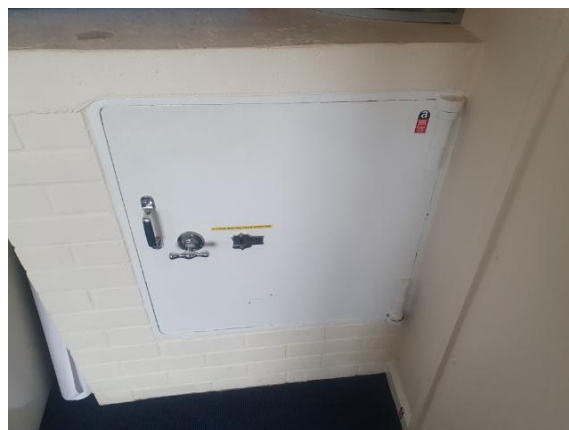
Location: First Floor - Office 012

Material Description:	Safe - No Access Gained	
Identification:	Presumed to Contain Asbestos	
Approx. quantity:	1 no	
Accessibility	Difficult	<i>Assessment Score</i>
Product type:	Asbestos Insulating Board	2
Extent of Damage:	Major damage	3
Surface Treatment:	Unsealed Insulation	3
Asbestos type:	Amosite, Chrysotile	2
Material Assessment Score:		10
Risk Assessment Score:		High
Action:	Manage	
Comments:	No access within safe. Asbestos panels can sometimes be found within the lining of the safe, although this is not accessible through normal use.

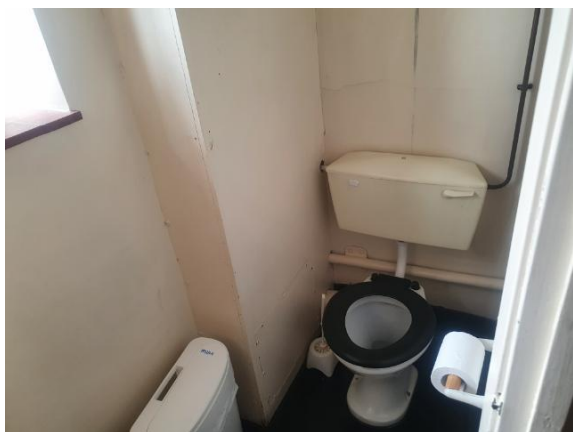
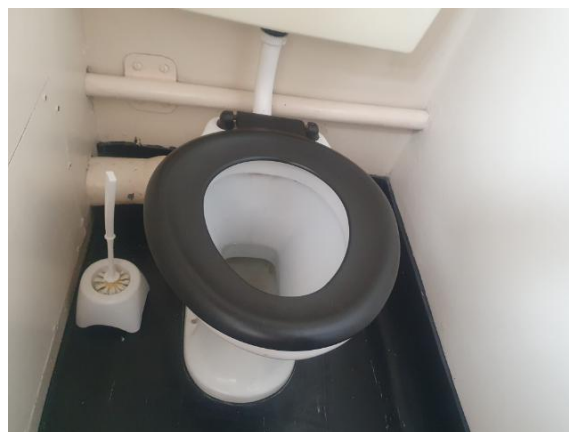
Location: First Floor - Ladies WC 013

Material Description:	Toilet Seat - PVC / Reinforced Plastics	
Identification:	Presumed to Contain Asbestos	
Approx. quantity:	1 no	
Accessibility	Easy	<i>Assessment Score</i>
Product type:	Bakelite	1
Extent of Damage:	Major damage	3
Surface Treatment:	Unsealed Insulation	3
Asbestos type:	Chrysotile	1
Material Assessment Score:		8
Risk Assessment Score:		Medium
Action:	Manage	
Comments:	Not possible to sample as may damage integrity of the seat - Low damage

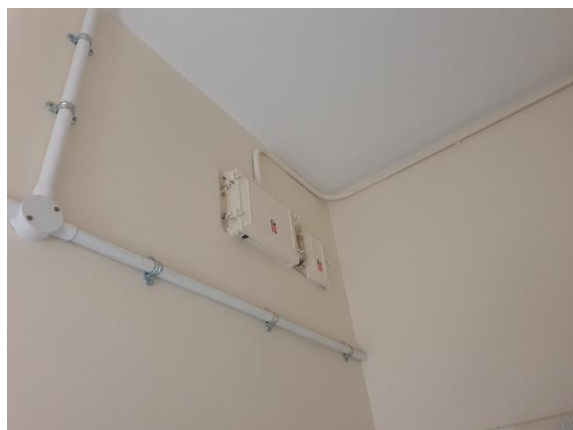
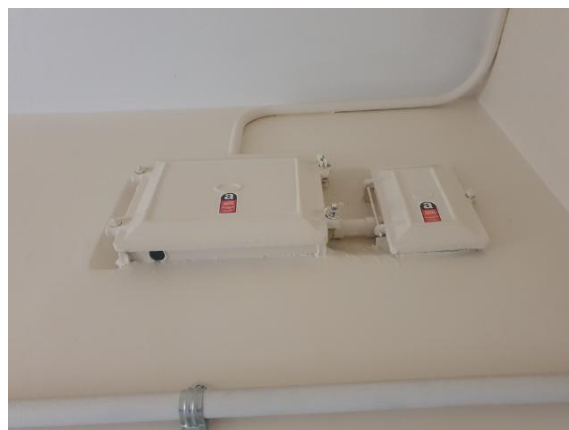
Location: First Floor - Corridor 014

Material Description:	Electrical Panels - Woven Product	
Identification:	Presumed to Contain Asbestos	
Approx. quantity:	2 no	
Accessibility	Difficult	<i>Assessment Score</i>
Product type:	Rope	2
Extent of Damage:	Major damage	3
Surface Treatment:	Unsealed Insulation	3
Asbestos type:	Chrysotile	1
Material Assessment Score:		9
Risk Assessment Score:		N/A
Action:	Manage	
Comments:	Presumed flashguards or rope within live electrical boxes.

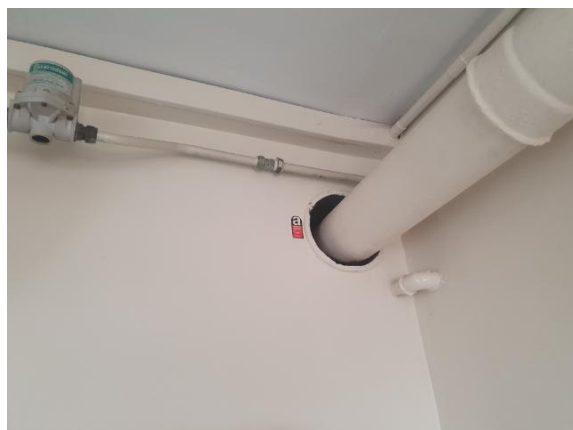
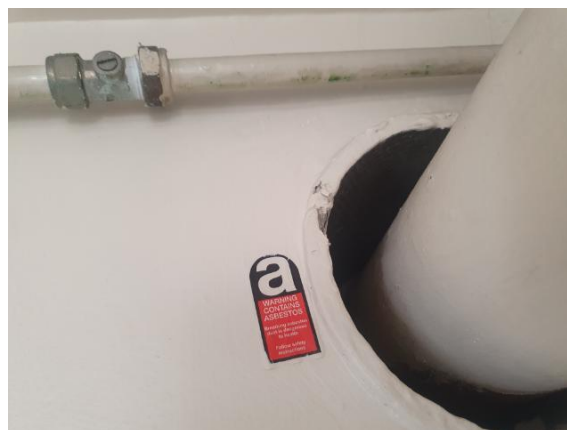
Location: Ground Floor - WC 016

Material Description:	Pipe Sleeve in Wall - Cement Product	
Identification:	Previously Sampled - Asbestos Detected	
Approx. quantity:	<1 m ²	
Accessibility	Difficult	Assessment Score
Product type:	Cement	1
Extent of Damage:	Slight / minor damage	1
Surface Treatment:	Unsealed Cement	1
Asbestos type:	Chrysotile	1
Material Assessment Score:		4
Risk Assessment Score:		Negligible
Action:	Encapsulate	
Comments:	Previously sampled ref: Armour 18/6/19 Sample DK/9. Under carpet

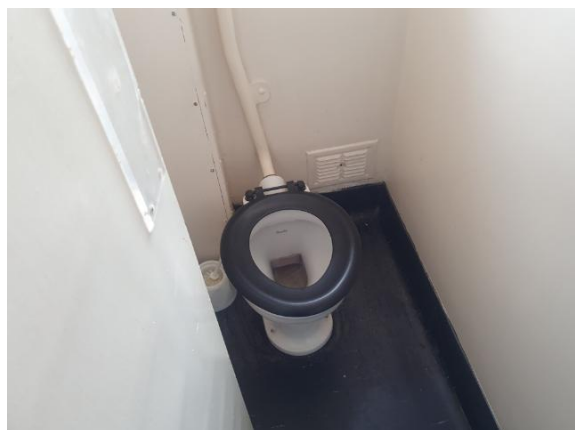
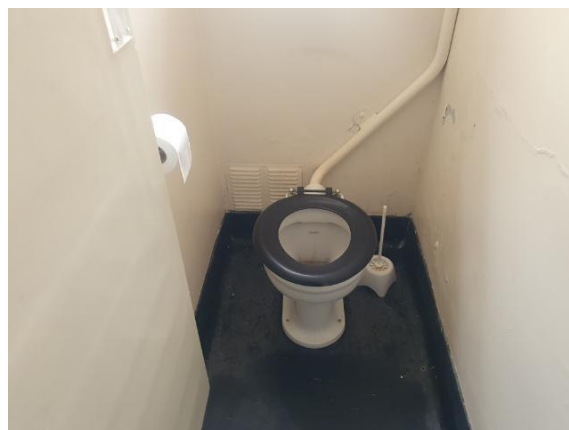
Location: Ground Floor - Changing Room 017

Material Description:	Toilet Seats - PVC / Reinforced Plastics	
Identification:	Presumed to Contain Asbestos	
Approx. quantity:	2 no	
Accessibility	Easy	<i>Assessment Score</i>
Product type:	Bakelite	1
Extent of Damage:	Major damage	3
Surface Treatment:	Unsealed Insulation	3
Asbestos type:	Chrysotile	1
Material Assessment Score:		8
Risk Assessment Score:		Medium
Action:	Manage	
Comments:	Not possible to sample as may damage integrity of the seats - Low damage

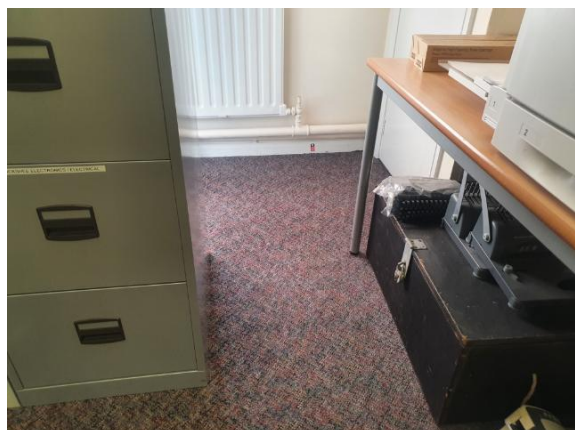
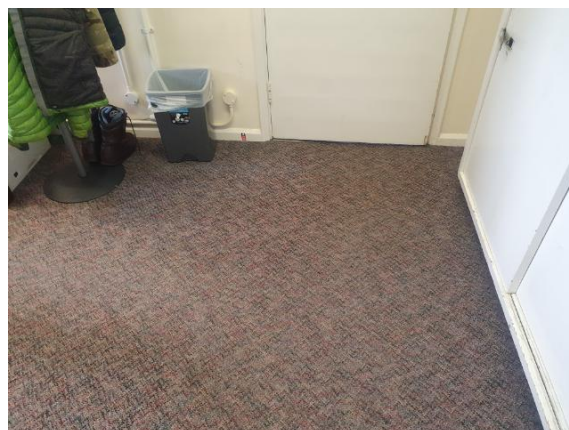
Location: Ground Floor - Offices x 2 018

Material Description:	Floor Tiles and Adhesive - Vinyl Products	
Identification:	Previously Sampled - Asbestos Detected	
Approx. quantity:	28 m ²	
Accessibility	Difficult	Assessment Score
Product type:	Vinyl	1
Extent of Damage:	Slight / minor damage	1
Surface Treatment:	Non-friable	0
Asbestos type:	Chrysotile	1
Material Assessment Score:		3
Risk Assessment Score:		Negligible
Action:	Manage	
Comments:	Previously sampled ref: Armour 18/6/19 Sample DK/10. Under carpets.

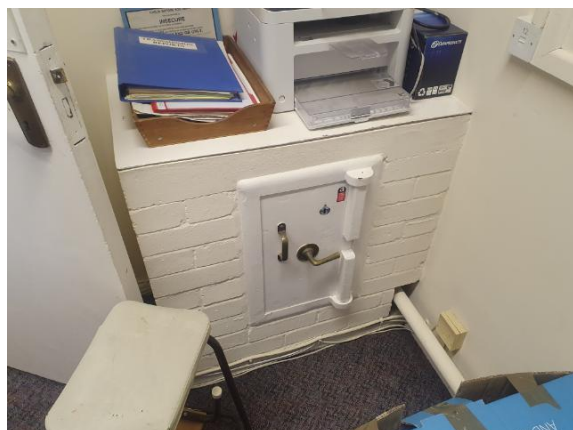
Location: Ground Floor - Office 019

Material Description:	Safe - No Access Gained	
Identification:	Presumed to Contain Asbestos	
Approx. quantity:	1 no	
Accessibility	Difficult	<i>Assessment Score</i>
Product type:	Asbestos Insulating Board	2
Extent of Damage:	Major damage	3
Surface Treatment:	Unsealed Insulation	3
Asbestos type:	Amosite, Chrysotile	2
Material Assessment Score:		10
Risk Assessment Score:		High
Action:	Manage	
Comments:	No access within safe. Asbestos panels can sometimes be found within the lining of the safe, although this is not accessible through normal use.

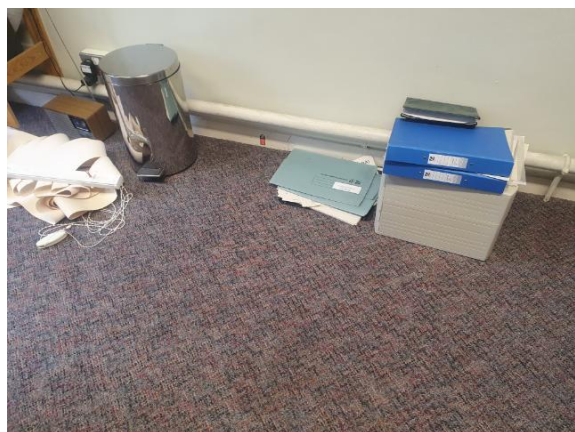
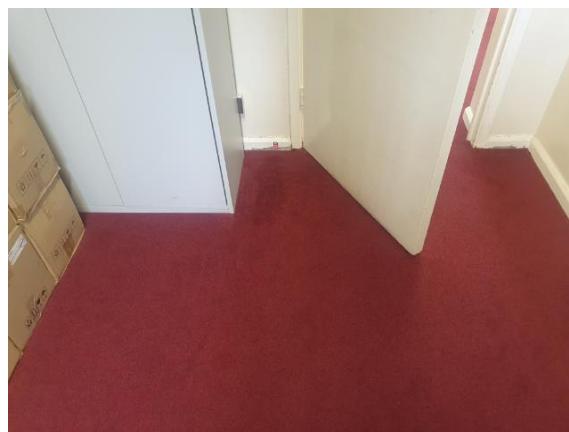
Location: Ground Floor - Offices x 2 020

Material Description:	Floor Tiles and Adhesive - Vinyl Products	
Identification:	Previously Sampled - Asbestos Detected	
Approx. quantity:	22 m ²	
Accessibility	Difficult	Assessment Score
Product type:	Vinyl	1
Extent of Damage:	Slight / minor damage	1
Surface Treatment:	Non-friable	0
Asbestos type:	Chrysotile	1
Material Assessment Score:		3
Risk Assessment Score:		Negligible
Action:	Manage	
Comments:	Previously sampled ref: Armour 18/6/19 Sample DK/10. Under carpets.

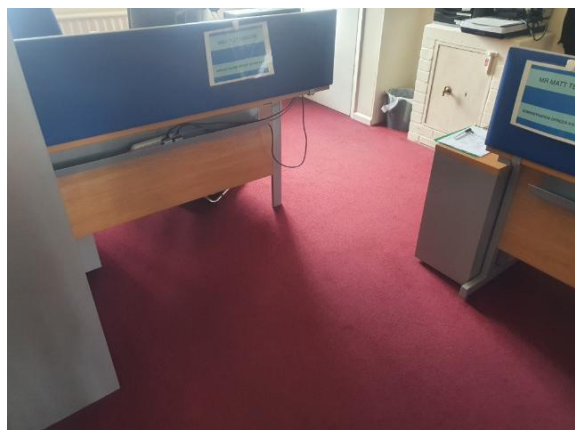
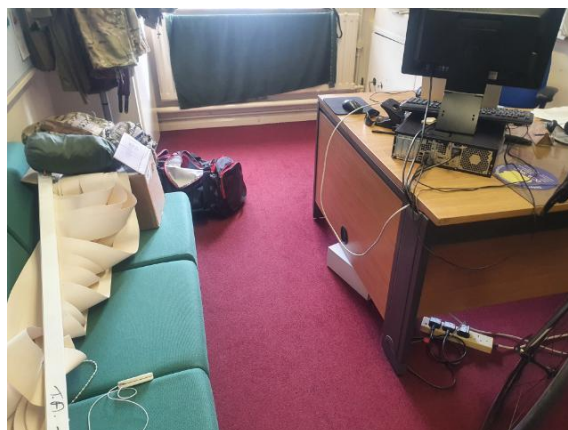
Location: Ground Floor - Offices x 2 021

Material Description:	Floor Tiles and Adhesive - Vinyl Products	
Identification:	Previously Sampled - Asbestos Detected	
Approx. quantity:	30 m ²	
Accessibility	Difficult	Assessment Score
Product type:	Vinyl	1
Extent of Damage:	Slight / minor damage	1
Surface Treatment:	Non-friable	0
Asbestos type:	Chrysotile	1
Material Assessment Score:		3
Risk Assessment Score:		Negligible
Action:	Manage	
Comments:	Previously sampled ref: Armour 18/6/19 Sample DK/10. Under carpets.

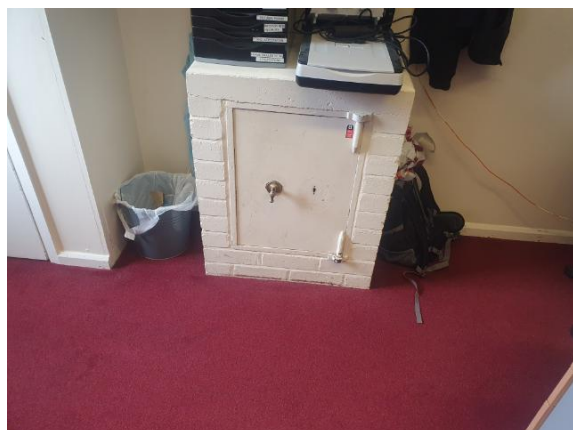
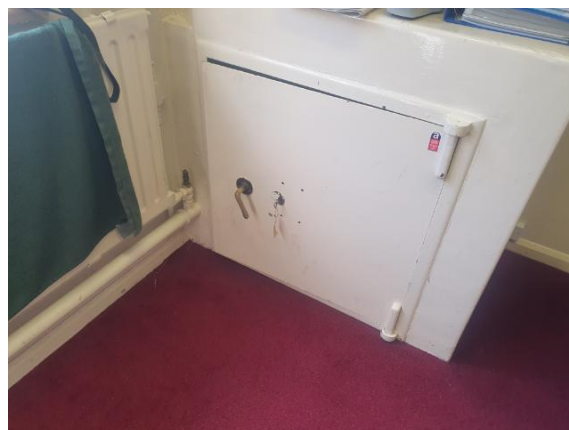
Location: Ground Floor - Offices x 2 022

Material Description:	Safes x 2 - No Access Gained	
Identification:	Presumed to Contain Asbestos	
Approx. quantity:	1 no	
Accessibility	Difficult	<i>Assessment Score</i>
Product type:	Asbestos Insulating Board	2
Extent of Damage:	Major damage	3
Surface Treatment:	Unsealed Insulation	3
Asbestos type:	Amosite, Chrysotile	2
Material Assessment Score:		10
Risk Assessment Score:		High
Action:	Manage	
Comments:	No access within safe. Asbestos panels can sometimes be found within the lining of the safe, although this is not accessible through normal use.

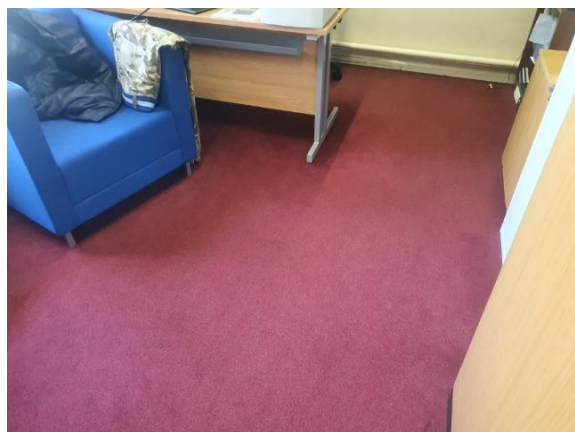
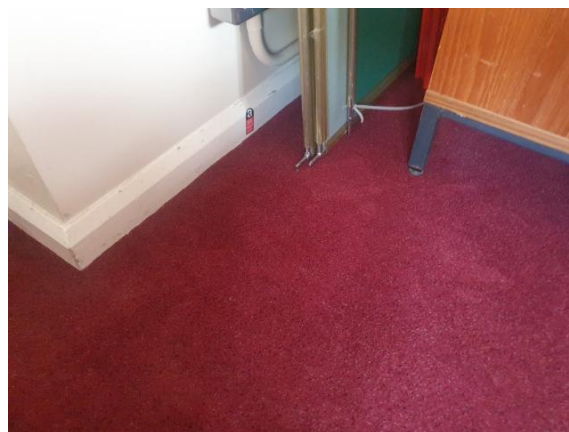
Location: Ground Floor - Offices x 3 023

Material Description:	Floor Tiles and Adhesive - Vinyl Products	
Identification:	Previously Sampled - Asbestos Detected	
Approx. quantity:	40 m ²	
Accessibility	Difficult	<i>Assessment Score</i>
Product type:	Vinyl	1
Extent of Damage:	Slight / minor damage	1
Surface Treatment:	Non-friable	0
Asbestos type:	Chrysotile	1
Material Assessment Score:		3
Risk Assessment Score:		Negligible
Action:	Manage	
Comments:	Previously sampled ref: Armour 18/6/19 Sample DK/10. Under carpets.

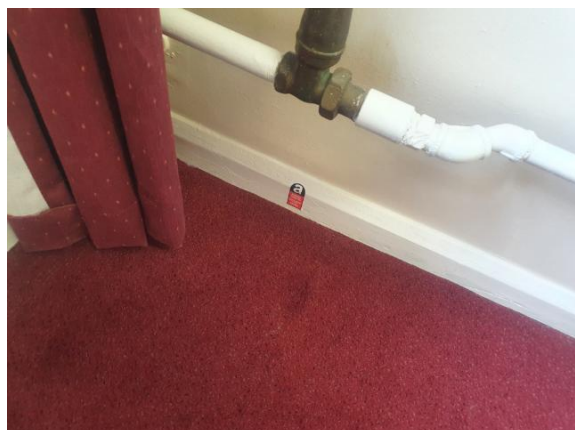
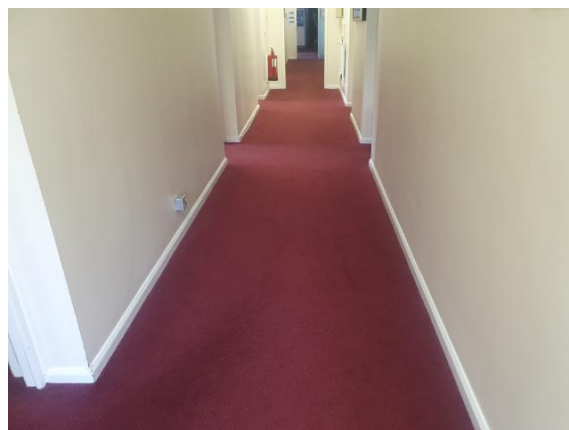
Location: Ground Floor - Corridor 024

Material Description:	Floor Tiles and Adhesive - Vinyl Products	
Identification:	Previously Sampled - Asbestos Detected	
Approx. quantity:	30 m ²	
Accessibility	Difficult	<i>Assessment Score</i>
Product type:	Vinyl	1
Extent of Damage:	Slight / minor damage	1
Surface Treatment:	Non-friable	0
Asbestos type:	Chrysotile	1
Material Assessment Score:		3
Risk Assessment Score:		Negligible
Action:	Manage	
Comments:	Previously sampled ref: Armour 18/6/19 Sample DK/10. Under carpets.

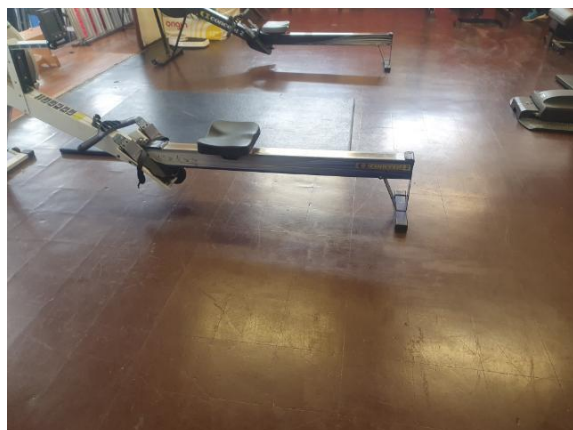
Location: Ground Floor - Stage/Gym 025

Material Description:	Floor Tiles and Adhesive - Vinyl Products	
Identification:	Previously Sampled - Asbestos Detected	
Approx. quantity:	50 m ²	
Accessibility	Easy	<i>Assessment Score</i>
Product type:	Vinyl	1
Extent of Damage:	Slight / minor damage	1
Surface Treatment:	Non-friable	0
Asbestos type:	Chrysotile	1
Material Assessment Score:		3
Risk Assessment Score:		Negligible
Action:	Manage	
Comments:	Previously sampled ref: Armour 18/6/19 Sample DK/11. Several areas of minor damage but risk remains low

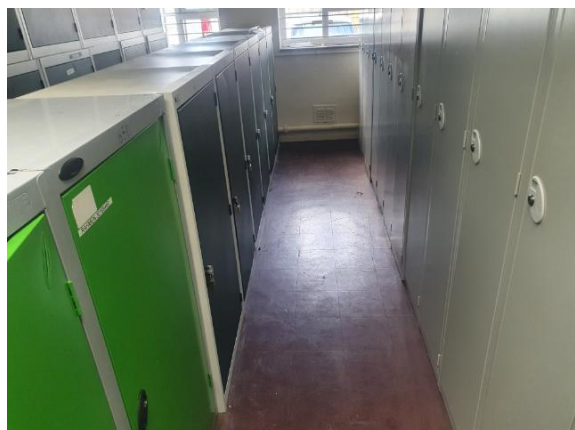
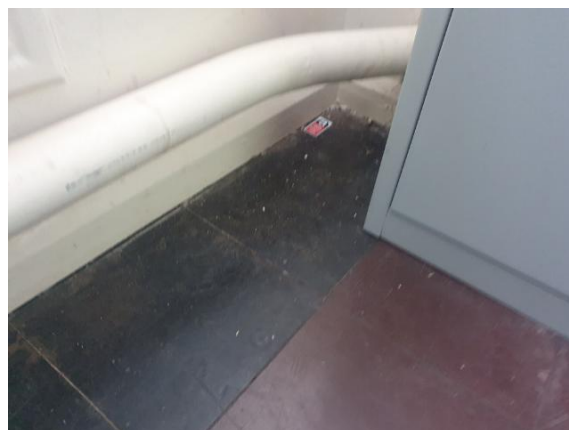
Location: Ground Floor - Cadet Locker Room 026

Material Description:	Floor Tiles and Adhesive - Vinyl Products	
Identification:	Previously Sampled - Asbestos Detected	
Approx. quantity:	18 m ²	
Accessibility	Easy	<i>Assessment Score</i>
Product type:	Vinyl	1
Extent of Damage:	Slight / minor damage	1
Surface Treatment:	Non-friable	0
Asbestos type:	Chrysotile	1
Material Assessment Score:		3
Risk Assessment Score:		Negligible
Action:	Manage	
Comments:	Previously sampled ref: Armour 18/6/19 Sample DK/10.

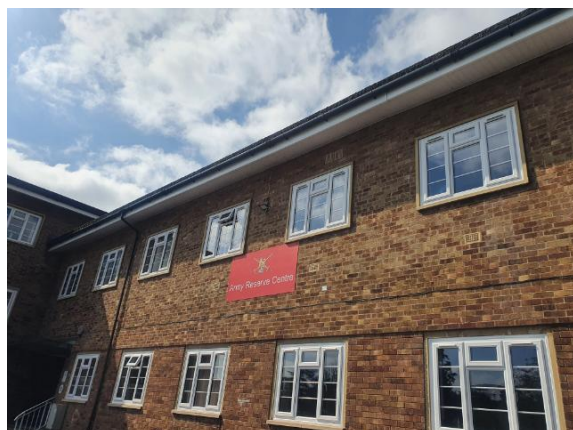
Location: External - Roof 027

Material Description:	Soffits - Insulating Board	
Identification:	Strongly Presumed to Contain Asbestos	
Approx. quantity:	110 LM	
Accessibility	Difficult	Assessment Score
Product type:	Asbestos Insulating Board	2
Extent of Damage:	Slight / minor damage	1
Surface Treatment:	Encapsulated AIB	1
Asbestos type:	Amosite, Chrysotile	2
Material Assessment Score:		6
Risk Assessment Score:		Low
Action:	Manage	
Comments:	No access above plastic soffit boards due to height restrictions

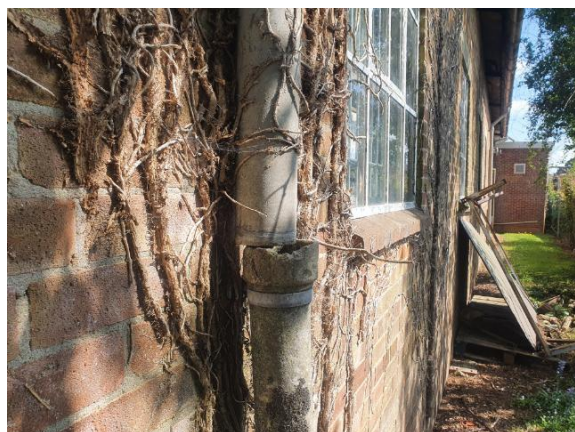
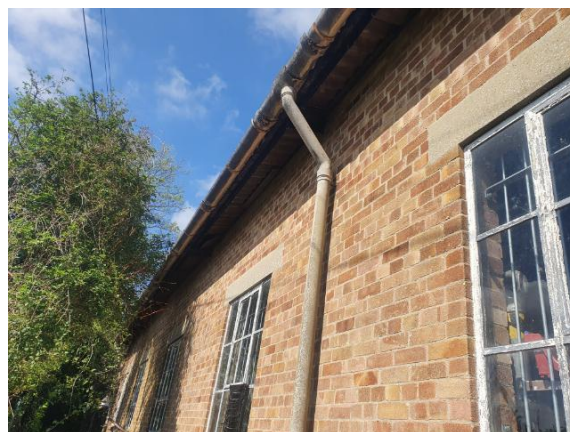
Location: External - Garages 028

Material Description:	Downpipes - Cement Product	
Identification:	Previously Sampled - Asbestos Detected	
Approx. quantity:	18 LM	
Accessibility	Medium	<i>Assessment Score</i>
Product type:	Cement	1
Extent of Damage:	Moderate damage	2
Surface Treatment:	Unsealed Cement	1
Asbestos type:	Chrysotile	1
Material Assessment Score:		5
Risk Assessment Score:		Low
Action:	Manage	
Comments:	Previously sampled ref: Armour 18/6/19 Sample DK/12. 3no pipes

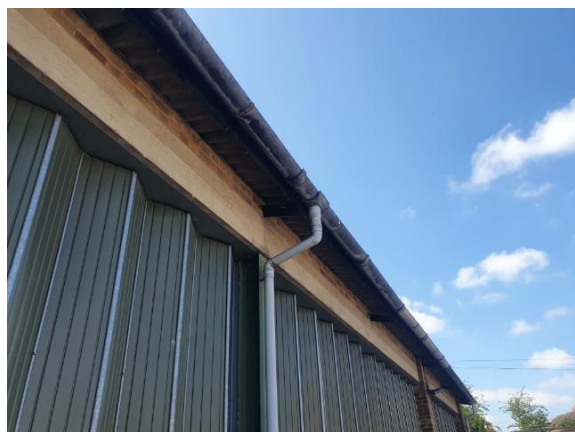
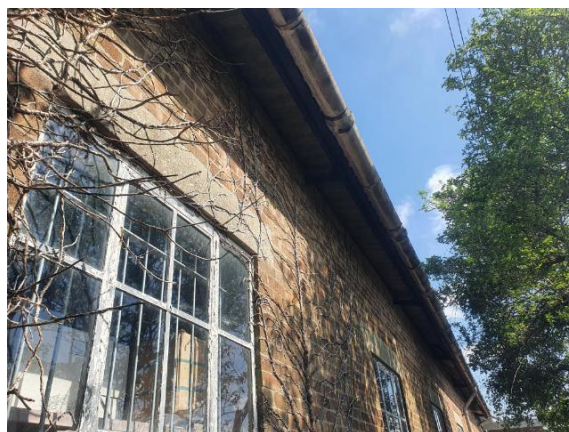
Location: External - Garages 029

Material Description:	Guttering - Cement Product	
Identification:	Previously Sampled - Asbestos Detected	
Approx. quantity:	60 LM	
Accessibility	Difficult	<i>Assessment Score</i>
Product type:	Cement	1
Extent of Damage:	Slight / minor damage	1
Surface Treatment:	Unsealed Cement	1
Asbestos type:	Chrysotile	1
Material Assessment Score:		4
Risk Assessment Score:		Negligible
Action:	Manage	
Comments:	Previously sampled ref: Armour 18/6/19 Sample DK/12.

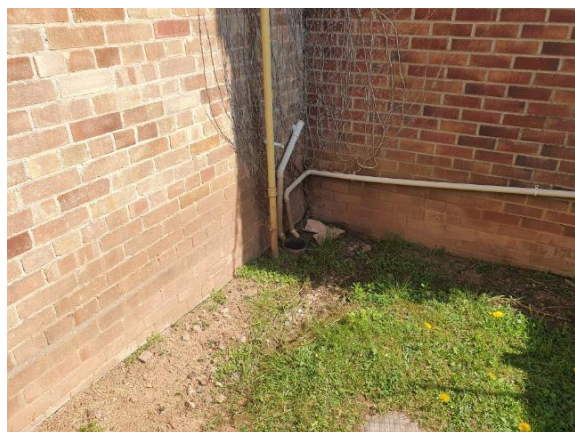
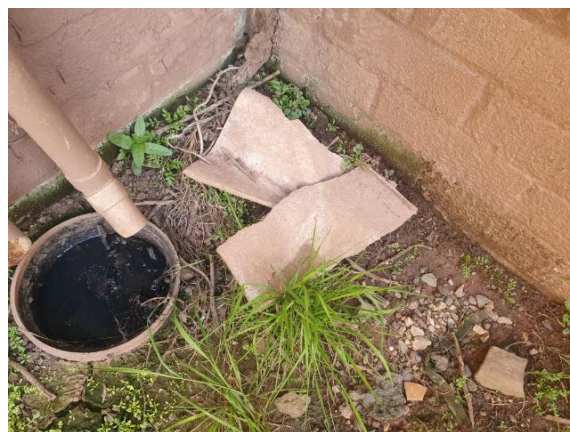
Location: External - Garages 030

Material Description:	Roof Sheet Debris - Cement Product	
Identification:	Previously Sampled - Asbestos Detected	
Approx. quantity:	<1 m ²	
Accessibility	Easy	<i>Assessment Score</i>
Product type:	Cement	1
Extent of Damage:	Moderate damage	2
Surface Treatment:	Unsealed Cement	1
Asbestos type:	Chrysotile	1
Material Assessment Score:		5
Risk Assessment Score:		Low
Action:	Remove	
Comments:	Previously sampled ref: Armour 18/6/19 Sample DK/19.

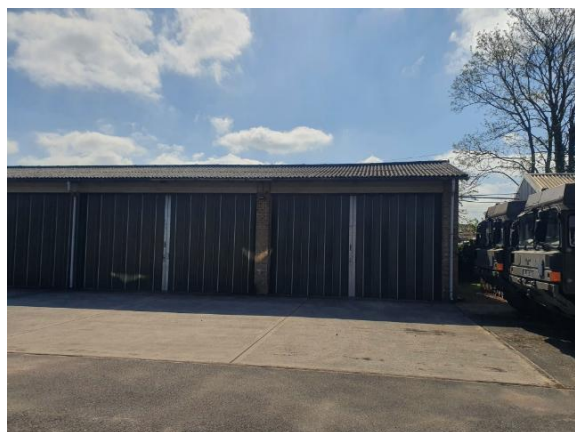
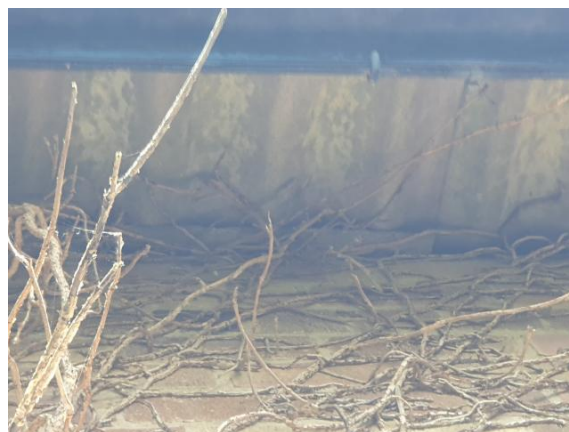
Location: External - Garages 031

Material Description:	Profiled Roof Sheets - Cement Product	
Identification:	Previously Sampled - Asbestos Detected	
Approx. quantity:	200 m ²	
Accessibility	Difficult	<i>Assessment Score</i>
Product type:	Cement	1
Extent of Damage:	Slight / minor damage	1
Surface Treatment:	Unsealed Cement	1
Asbestos type:	Chrysotile	1
Material Assessment Score:		4
Risk Assessment Score:		Negligible
Action:	Remove	
Comments:	Previously sampled ref: Armour 18/6/19 Sample DK/19.

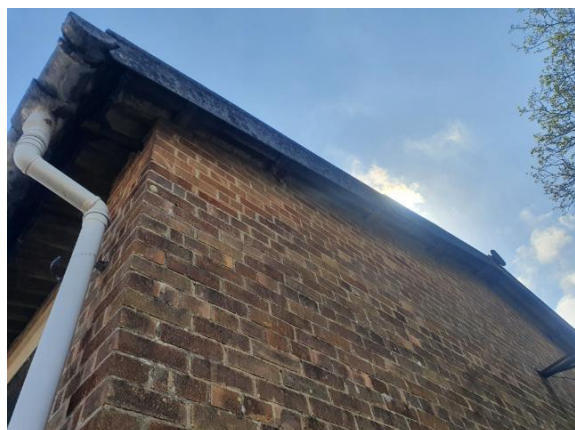
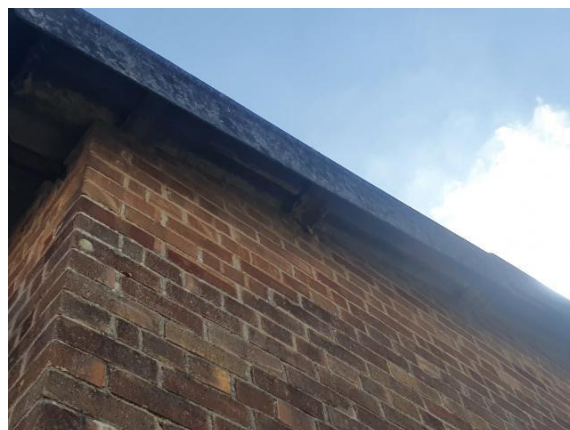
Location: External - Garages 032

Material Description:	Roof Edging - Cement Product	
Identification:	Previously Sampled - Asbestos Detected	
Approx. quantity:	10 LM	
Accessibility	Difficult	<i>Assessment Score</i>
Product type:	Cement	1
Extent of Damage:	Slight / minor damage	1
Surface Treatment:	Unsealed Cement	1
Asbestos type:	Chrysotile	1
Material Assessment Score:		4
Risk Assessment Score:		Negligible
Action:	Remove	
Comments:	Previously sampled ref: Armour 18/6/19 Sample DK/19.

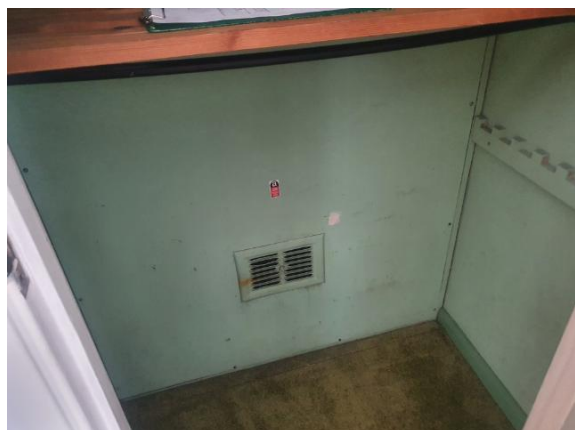
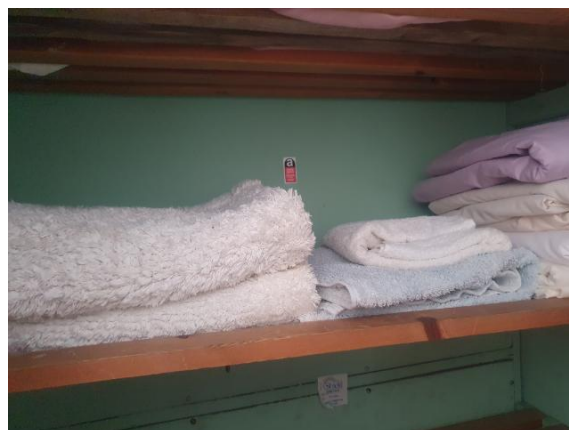
Location: Second Floor - Bedroom Cupboard 033

Material Description:	Wall Panels - Cement Product	
Identification:	Previously Sampled - Asbestos Detected	
Approx. quantity:	3 m ²	
Accessibility	Medium	Assessment Score
Product type:	Cement	1
Extent of Damage:	Slight / minor damage	1
Surface Treatment:	Unsealed Cement	1
Asbestos type:	Chrysotile	1
Material Assessment Score:		4
Risk Assessment Score:		Negligible
Action:	Manage	
Comments:	Previously sampled ref: Armour 18/6/19 Sample DK/13. Entire back wall of cupboard

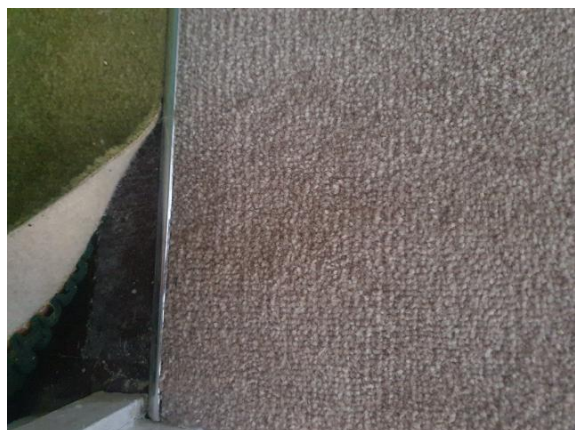
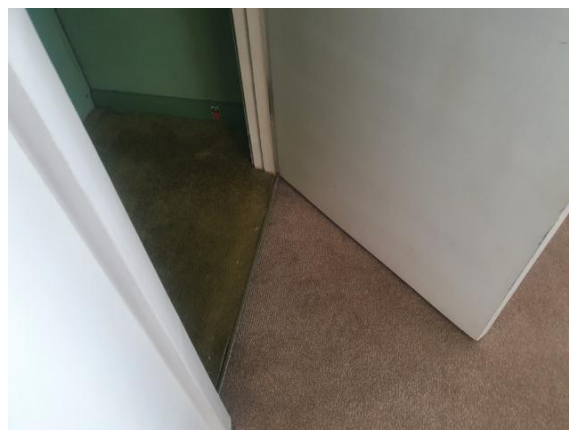
Location: Second Floor - Bedroom and Cupboard 034

Material Description:	Floor Tiles and Adhesive - Vinyl Products	
Identification:	Previously Sampled - Asbestos Detected	
Approx. quantity:	9 m ²	
Accessibility	Difficult	<i>Assessment Score</i>
Product type:	Vinyl	1
Extent of Damage:	Slight / minor damage	1
Surface Treatment:	Non-friable	0
Asbestos type:	Chrysotile	1
Material Assessment Score:		3
Risk Assessment Score:		Negligible
Action:	Manage	
Comments:	Previously sampled ref: Armour 18/6/19 Sample DK/14. Under carpet

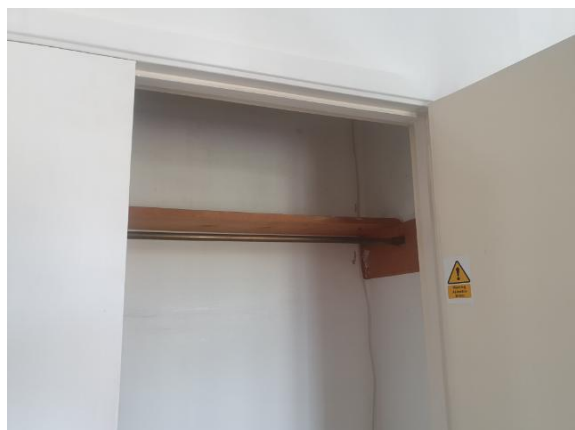
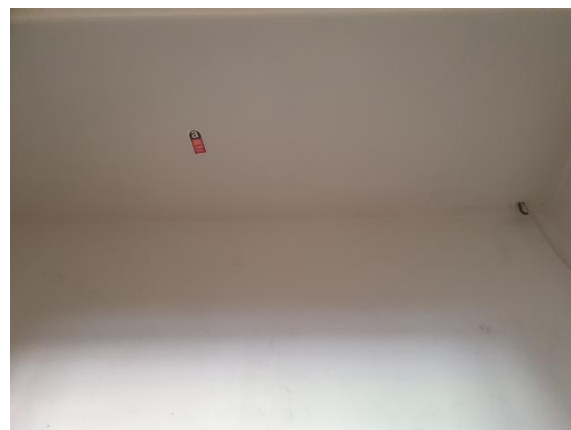
Location: Second Floor - Bedroom Cupboard 035

Material Description:	Ceiling Panel of Cupboard - Insulating Board	
Identification:	Previously Sampled - Asbestos Detected	
Approx. quantity:	2 m ²	
Accessibility	Difficult	Assessment Score
Product type:	Asbestos Insulating Board	2
Extent of Damage:	Slight / minor damage	1
Surface Treatment:	Encapsulated AIB	1
Asbestos type:	Amosite	2
Material Assessment Score:		6
Risk Assessment Score:		Low
Action:	Encapsulate	
Comments:	Previously sampled ref: GU/TA/001/17. 2no holes in panel require encapsulation. Do not remove wires

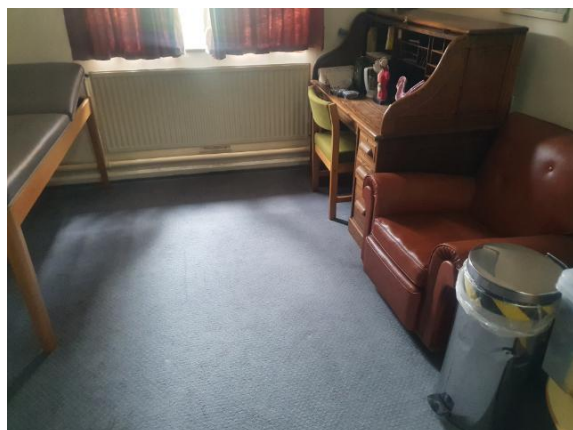
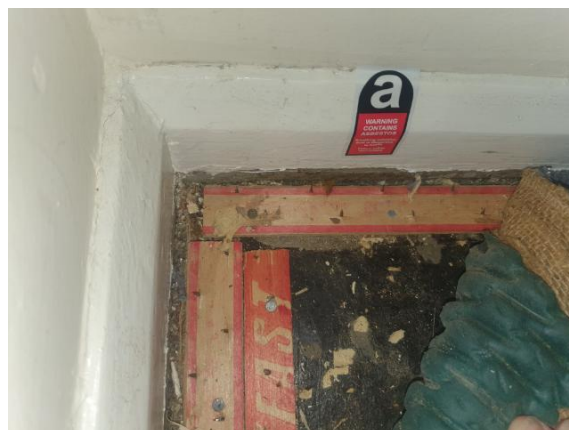
Location: First Floor - Medical Room 036

Material Description:	Floor Tiles and Adhesive - Vinyl Products	
Identification:	Previously Sampled - Asbestos Detected	
Approx. quantity:	15 m ²	
Accessibility	Difficult	<i>Assessment Score</i>
Product type:	Vinyl	1
Extent of Damage:	Slight / minor damage	1
Surface Treatment:	Non-friable	0
Asbestos type:	Chrysotile	1
Material Assessment Score:		3
Risk Assessment Score:		Negligible
Action:	Manage	
Comments:	Previously sampled ref: Armour 18/6/19 Sample DK/6. Under carpet

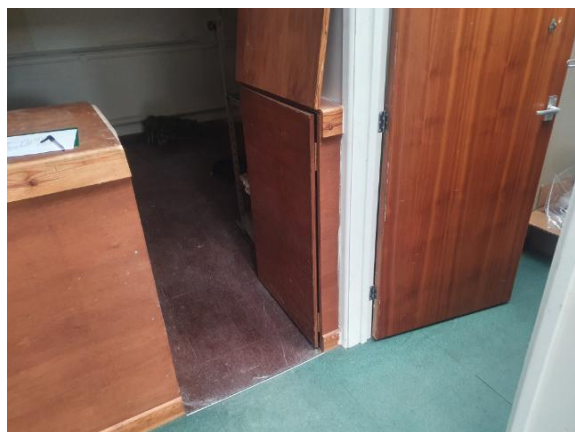
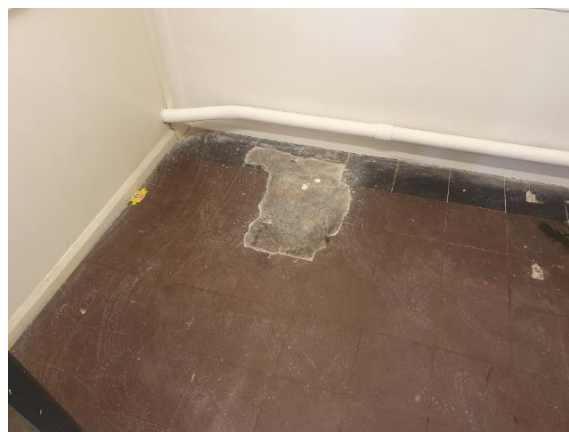
Location: Ground Floor - Signal Store and Cupboard 037

Material Description:	Floor Tiles and Adhesive - Vinyl Products	
Identification:	Previously Sampled - Asbestos Detected	
Approx. quantity:	30 m ²	
Accessibility	Easy	<i>Assessment Score</i>
Product type:	Vinyl	1
Extent of Damage:	Moderate damage	2
Surface Treatment:	Non-friable	0
Asbestos type:	Chrysotile	1
Material Assessment Score:		4
Risk Assessment Score:		Negligible
Action:	Manage	
Comments:	Previously sampled ref: Armour 18/6/19 Sample DK/10. Partially under carpet. Tiles damaged in two areas, but risk remains low

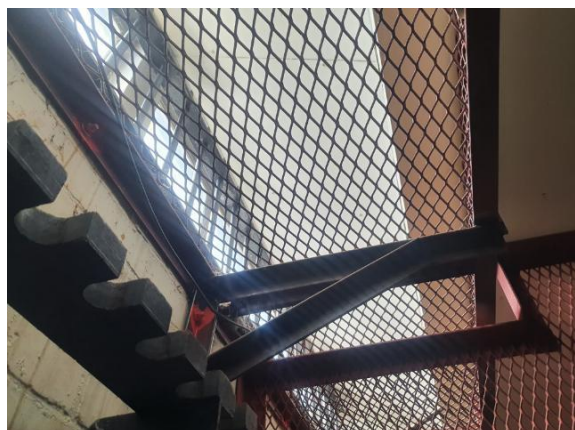
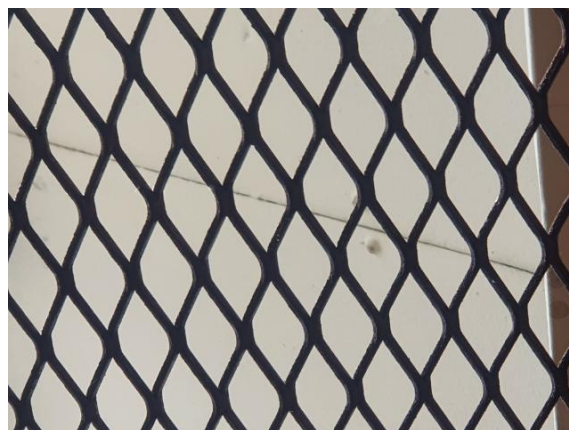
Location: Ground Floor - Armoury 038

Material Description:	Panels above Cage - Insulating Board	
Identification:	Presumed to Contain Asbestos	
Approx. quantity:	6 LM	
Accessibility	Difficult	<i>Assessment Score</i>
Product type:	Asbestos Insulating Board	2
Extent of Damage:	Major damage	3
Surface Treatment:	Unsealed Insulation	3
Asbestos type:	Amosite, Chrysotile	2
Material Assessment Score:		10
Risk Assessment Score:		High
Action:	Manage	
Comments:	No access above cage to sample panels.
