Project Number A-01339 (5908)

**Re-Inspection
Asbestos Survey Report**

**(20) 675 Army Air Corps
Somerset
TA1 5LJ**

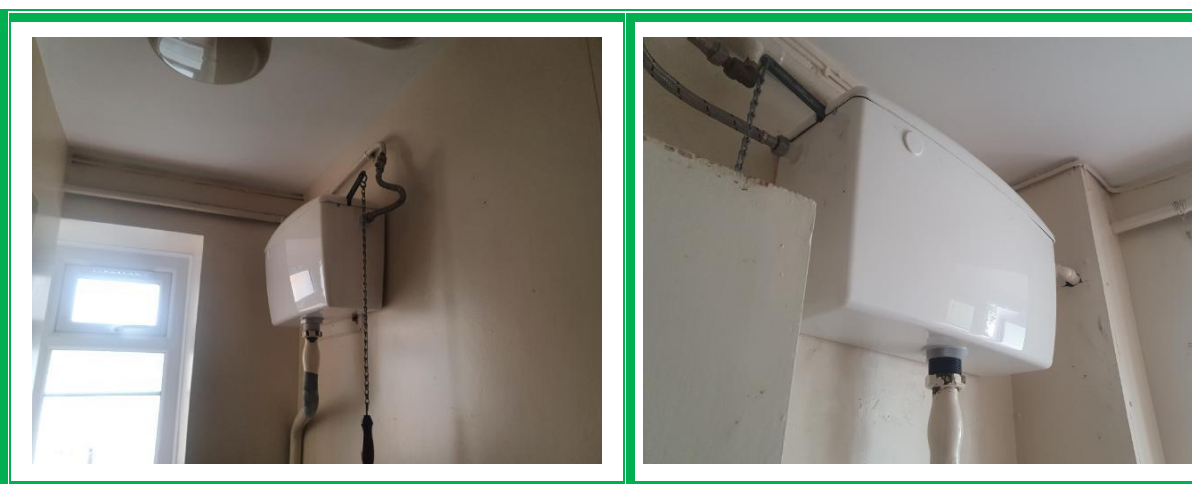
Item No:	15	Sample No:	N/A
Location:	Ground Floor - Changing Room 015

Material Description:	No Suspect Materials Found	
Identification:	N/A	
Approx. quantity:	N/A	
Accessibility	N/A	<i>Assessment Score</i>
Product type:	N/A	N/A
Extent of Damage:	N/A	N/A
Surface Treatment:	N/A	N/A
Asbestos type:	N/A	N/A
Material Assessment Score:		N/A
Priority Assessment Score:		N/A
Action:	N/A	
Comments:	Cisterns have been replaced
