Project Number A-00366 (3700)

**Re-Inspection
Asbestos Survey Report**

**Royal Wessex Yeomanry C
Gloucestershire
GL7 1TT**

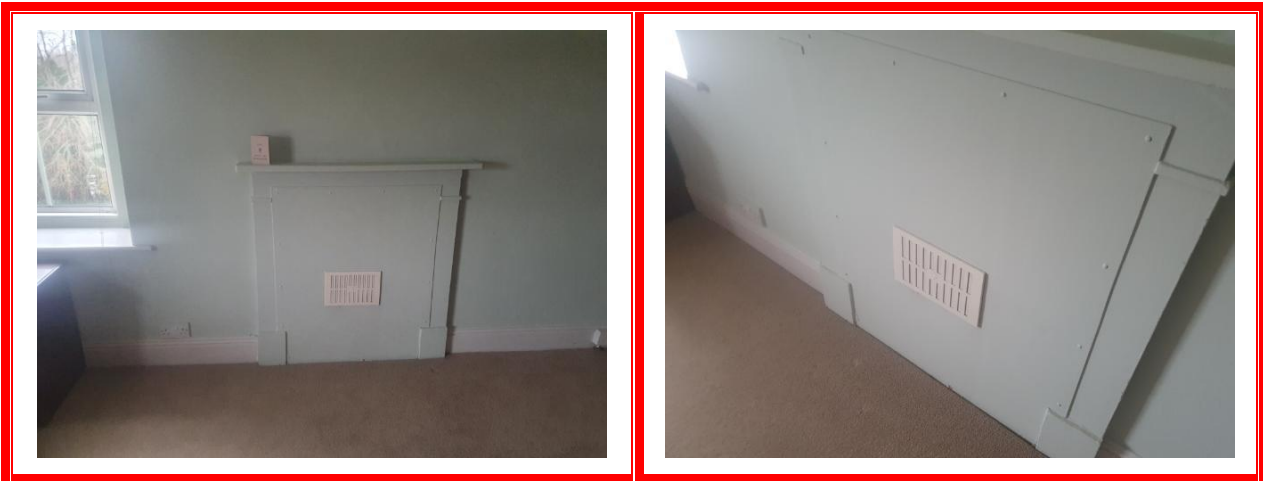
Item No:	1	Sample No:	N/A
Location:	Second Floor - Bedroom 1 001

Material Description:	Fireplace Panel - Cement Product	
Identification:	Previously Sampled - Asbestos Detected	
Approx. quantity:	1 m ²	
Accessibility	Easy	Assessment Score
Product type:	Cement	1
Extent of Damage:	Slight / Minor Damage	1
Surface Treatment:	Sealed Cement	0
Asbestos type:	Chrysotile	1
Material Assessment Score:		3
Priority Assessment Score:		Negligible
Action:	Manage	
Comments:	Previously sampled ref: Armour 2/10/19 - Sample DK/1

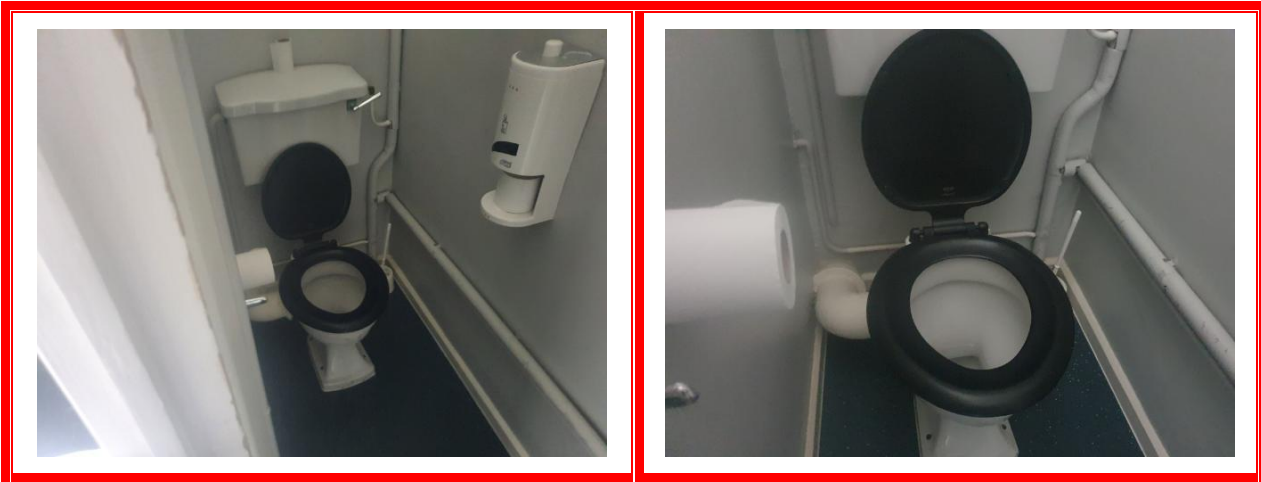
Item No:	2	Sample No:	N/A
Location:	First Floor - WC 002

Material Description:	Toilet Seat - PVC / Reinforced Plastics	
Identification:	Presumed to Contain Asbestos	
Approx. quantity:	1 no	
Accessibility	Easy	<i>Assessment Score</i>
Product type:	Reinforced Plastics	1
Extent of Damage:	Minor Damage	1
Surface Treatment:	Non-Friable	0
Asbestos type:	Chrysotile	1
Material Assessment Score:		3
Priority Assessment Score:		Negligible
Action:	Manage	
Comments:	Not possible to sample as may damage integrity of seat

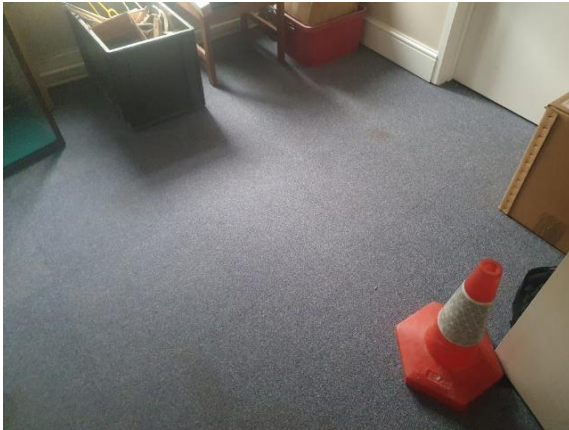
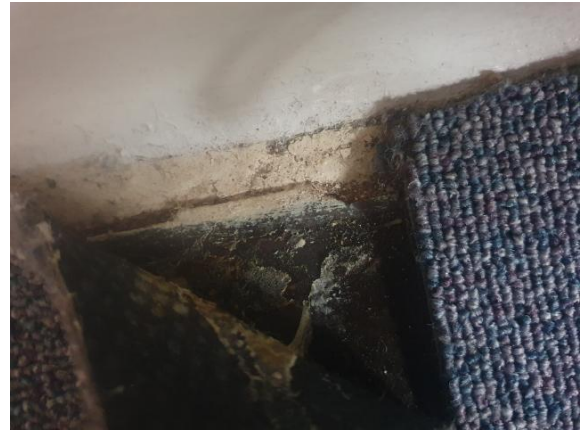
Item No:	3	Sample No:	N/A
Location:	First Floor - Circulation and Server Room 003

Material Description:	Floor Tiles and Adhesive - Vinyl Products	
Identification:	Previously Sampled - Asbestos Detected	
Approx. quantity:	26 m ²	
Accessibility	Difficult	<i>Assessment Score</i>
Product type:	Vinyl	1
Extent of Damage:	Slight / Minor Damage	1
Surface Treatment:	Non-Friable	0
Asbestos type:	Chrysotile	1
Material Assessment Score:		3
Priority Assessment Score:		Negligible
Action:	Manage	
Comments:	Under carpet. Previously sampled ref: Armour 2/10/19 - Sample DK/4

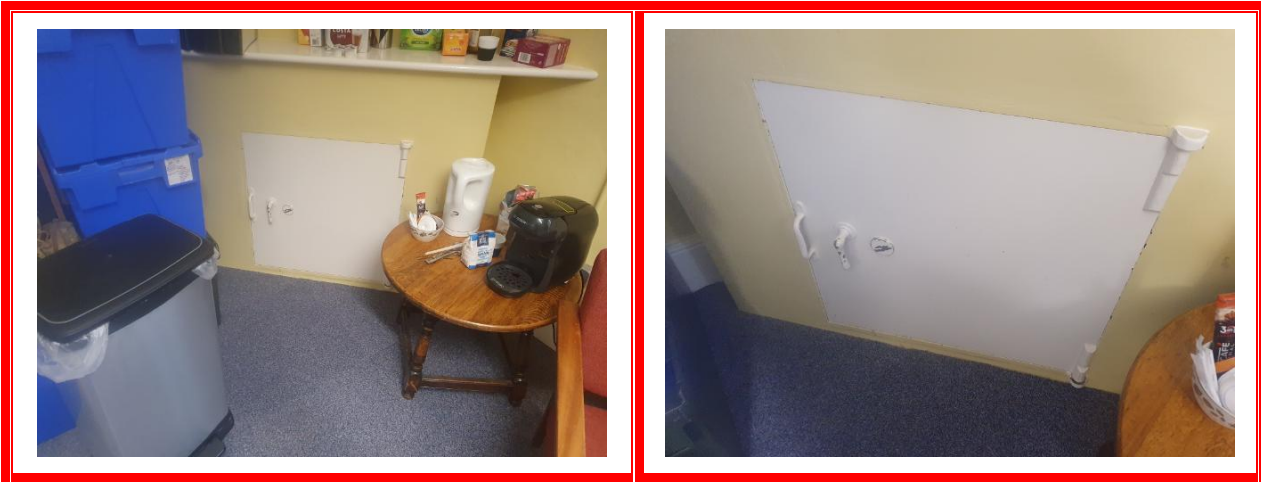
Item No:	4	Sample No:	N/A
Location:	First Floor - PSI's Office 004

Material Description:	Safe - No Access Gained	
Identification:	Presumed to Contain Asbestos	
Approx. quantity:	1 no	
Accessibility	Easy	<i>Assessment Score</i>
Product type:	Asbestos Insulating Board	2
Extent of Damage:	Major Damage	3
Surface Treatment:	Unsealed AIB	2
Asbestos type:	Amosite	2
Material Assessment Score:		9
Priority Assessment Score:		Medium
Action:	Manage	
Comments:	No access without damaging safe

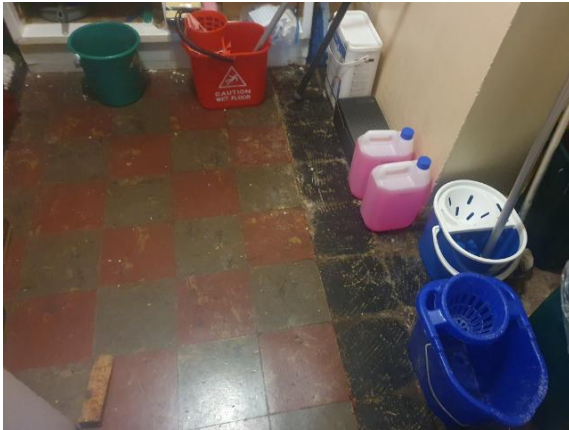
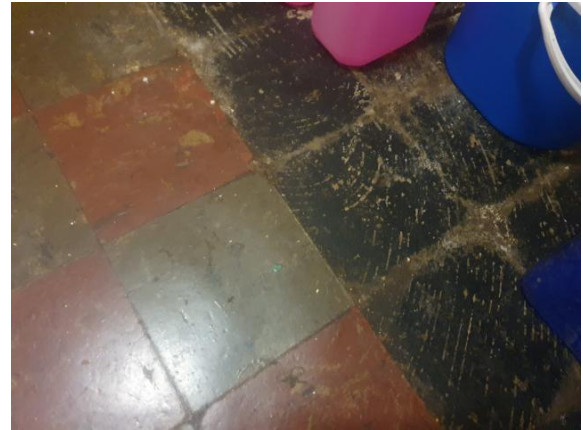
Item No:	5	Sample No:	N/A
Location:	Ground Floor - Caretakers Store 005

Material Description:	Floor Tiles and Adhesive - Vinyl Products	
Identification:	Previously Sampled - Asbestos Detected	
Approx. quantity:	8 m ²	
Accessibility	Easy	<i>Assessment Score</i>
Product type:	Vinyl	1
Extent of Damage:	Moderate Damage	2
Surface Treatment:	Non-Friable	0
Asbestos type:	Chrysotile	1
Material Assessment Score:		4
Priority Assessment Score:		Negligible
Action:	Manage	
Comments:	Previously sampled ref: Armour 2/10/19 - Sample DK/6

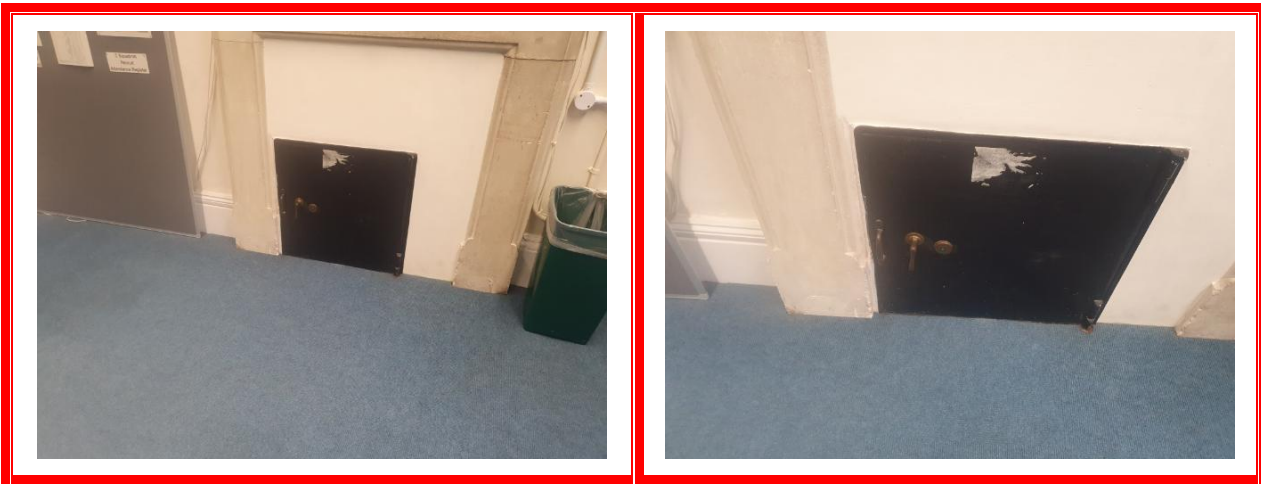
Item No:	6	Sample No:	N/A
Location:	Ground Floor - AO Office 006

Material Description:	Safe - No Access Gained	
Identification:	Presumed to Contain Asbestos	
Approx. quantity:	1 no	
Accessibility	Difficult	<i>Assessment Score</i>
Product type:	Asbestos Insulating Board	2
Extent of Damage:	Major Damage	3
Surface Treatment:	Unsealed AIB	2
Asbestos type:	Amosite	2
Material Assessment Score:		9
Priority Assessment Score:		Medium
Action:	Manage	
Comments:	No access without damaging safe

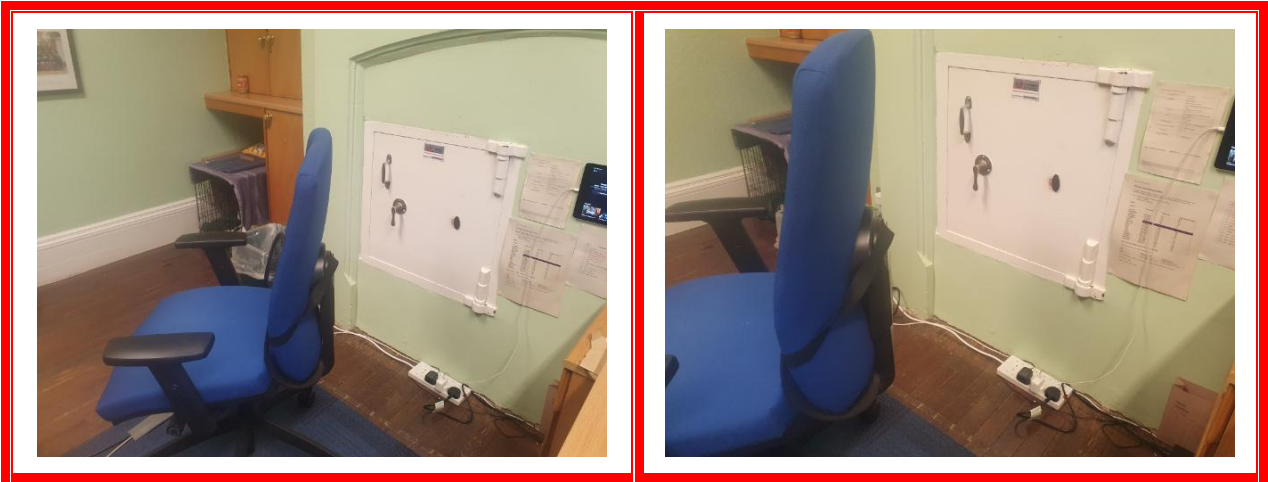
Item No:	7	Sample No:	N/A
Location:	Ground Floor - Office 007

Material Description:	Safe - No Access Gained	
Identification:	Presumed to Contain Asbestos	
Approx. quantity:	1 no	
Accessibility	Difficult	<i>Assessment Score</i>
Product type:	Asbestos Insulating Board	2
Extent of Damage:	Major Damage	3
Surface Treatment:	Unsealed AIB	2
Asbestos type:	Amosite	2
Material Assessment Score:		9
Priority Assessment Score:		Medium
Action:	Manage	
Comments:	No access without damaging safe

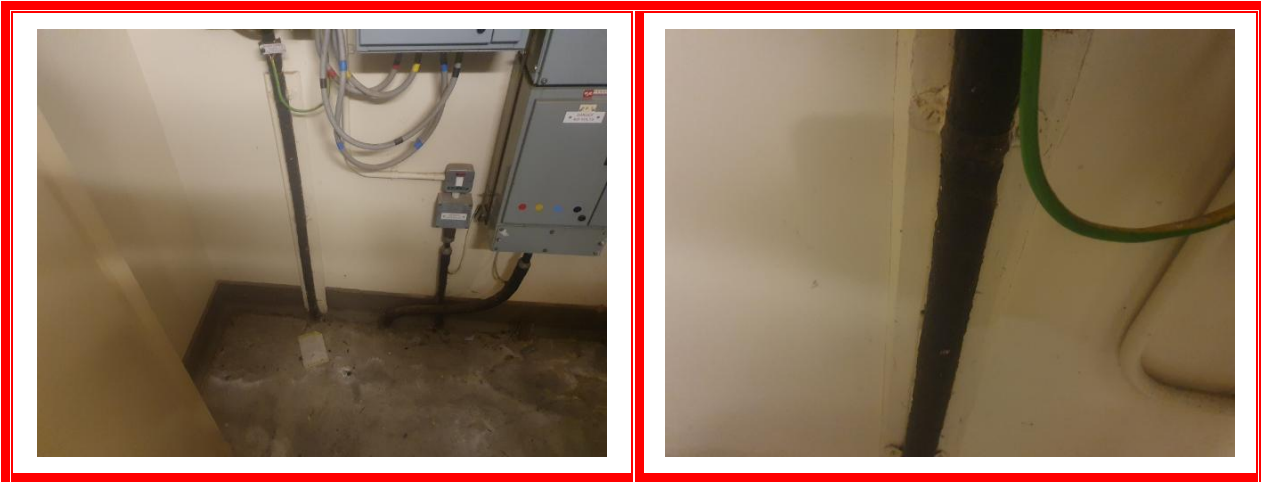
Item No:	8	Sample No:	N/A
Location:	Ground Floor - Firing Range Cupboard 008

Material Description:	Wrap to Mains Cable - Bituminous Product	
Identification:	Presumed to Contain Asbestos	
Approx. quantity:	2 LM	
Accessibility	Easy	<i>Assessment Score</i>
Product type:	Bitumen	1
Extent of Damage:	Minor Damage	1
Surface Treatment:	Non-Friable	0
Asbestos type:	Chrysotile	1
Material Assessment Score:		3
Priority Assessment Score:		Negligible
Action:	Manage	
Comments:	Not possible to sample as live. 3 x Cables

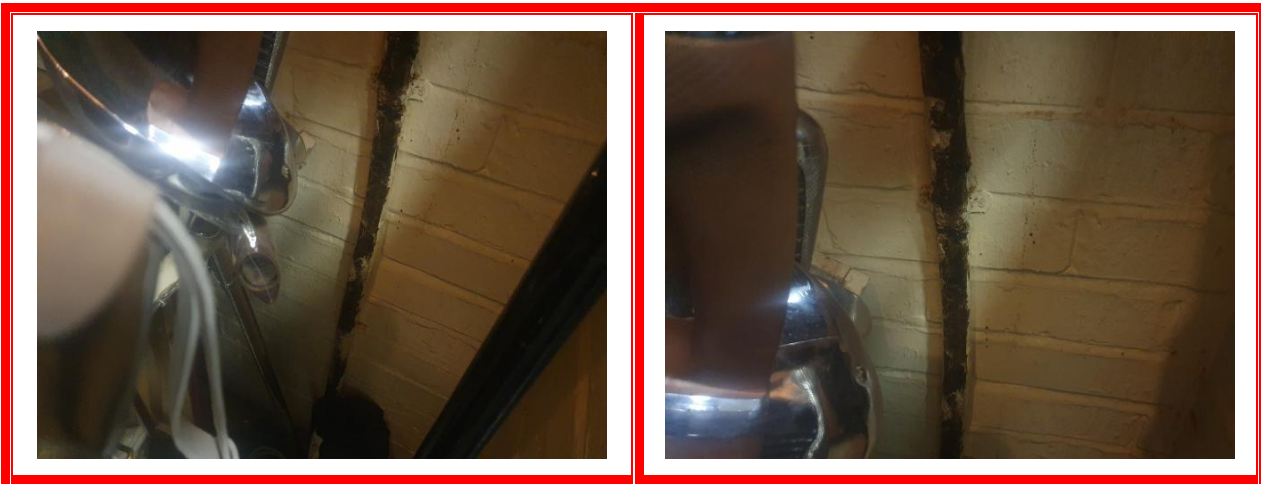
Item No:	9	Sample No:	N/A
Location:	Ground Floor - Silver Room 009

Material Description:	Wrap to Mains Cable - Bituminous Product	
Identification:	Presumed to Contain Asbestos	
Approx. quantity:	1 LM	
Accessibility	Easy	<i>Assessment Score</i>
Product type:	Bitumen	1
Extent of Damage:	Minor Damage	1
Surface Treatment:	Non-Friable	0
Asbestos type:	Chrysotile	1
Material Assessment Score:		3
Priority Assessment Score:		Negligible
Action:	Manage	
Comments:	Not possible to sample as live

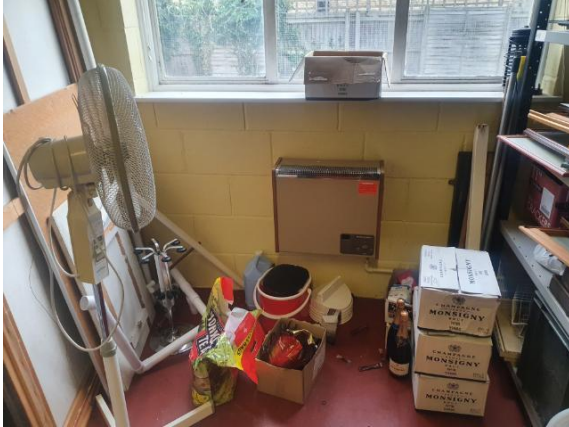
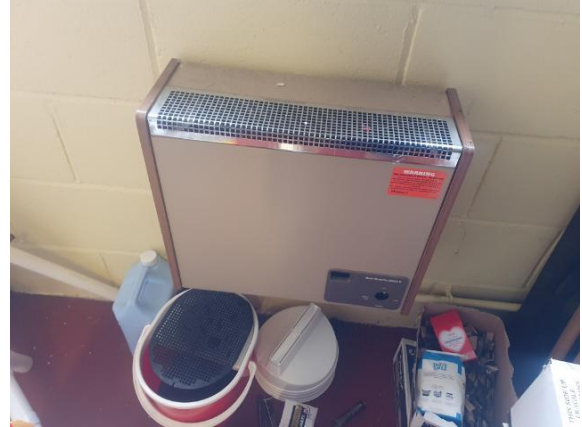
Item No:	11	Sample No:	N/A
Location:	Ground Floor - Store 011

Material Description:	Baxi Heater - No Access Gained	
Identification:	Presumed to Contain Asbestos	
Approx. quantity:	1 no	
Accessibility	Difficult	<i>Assessment Score</i>
Product type:	Asbestos Insulating Board	2
Extent of Damage:	Major Damage	3
Surface Treatment:	Unsealed AIB	2
Asbestos type:	Amosite	2
Material Assessment Score:		9
Priority Assessment Score:		Medium
Action:	Manage	
Comments:	Not possible to sample as live

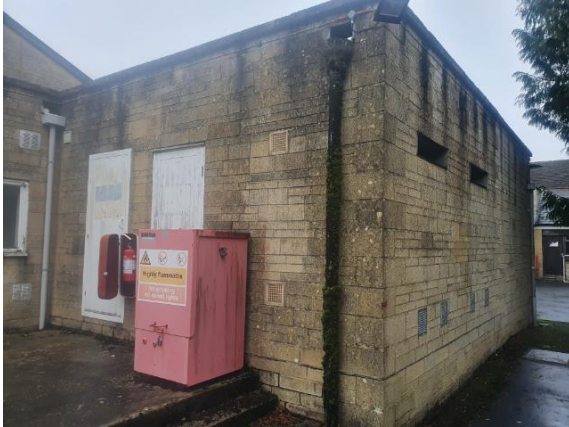
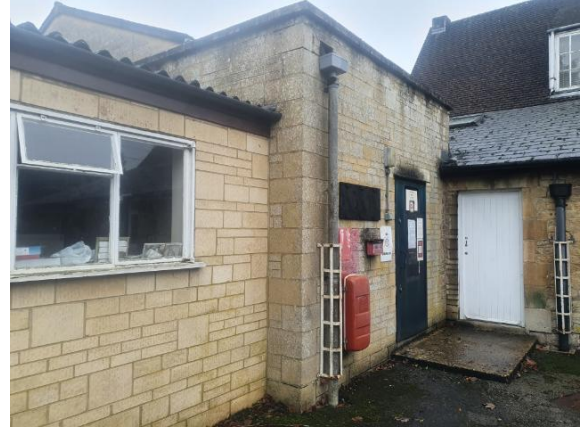
Item No:	12	Sample No:	N/A
Location:	External 012

Material Description:	Downpipes - Cement Product	
Identification:	Previously Sampled - Asbestos Detected	
Approx. quantity:	10 LM	
Accessibility	Easy	<i>Assessment Score</i>
Product type:	Cement	1
Extent of Damage:	Slight / Minor Damage	1
Surface Treatment:	Unsealed Cement	1
Asbestos type:	Chrysotile	1
Material Assessment Score:		4
Priority Assessment Score:		Negligible
Action:	Manage	
Comments:	3 x Pipes. Previously sampled ref: Armour 2/10/19 - Sample DK/11

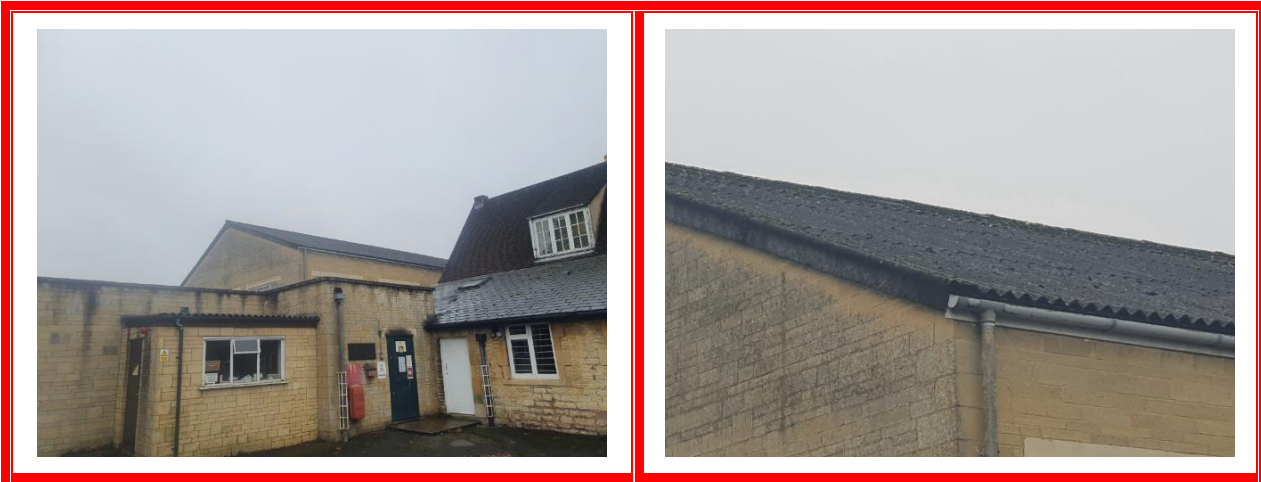
Item No:	14	Sample No:	N/A
Location:	External - Drill Hall 014

Material Description:	Profiled Roof - Cement Product	
Identification:	Presumed to Contain Asbestos	
Approx. quantity:	200 m ²	
Accessibility	Difficult	<i>Assessment Score</i>
Product type:	Cement	1
Extent of Damage:	Minor Damage	1
Surface Treatment:	Sealed Cement	1
Asbestos type:	Chrysotile	1
Material Assessment Score:		4
Priority Assessment Score:		Negligible
Action:	Manage	
Comments:	No access to sample due to height

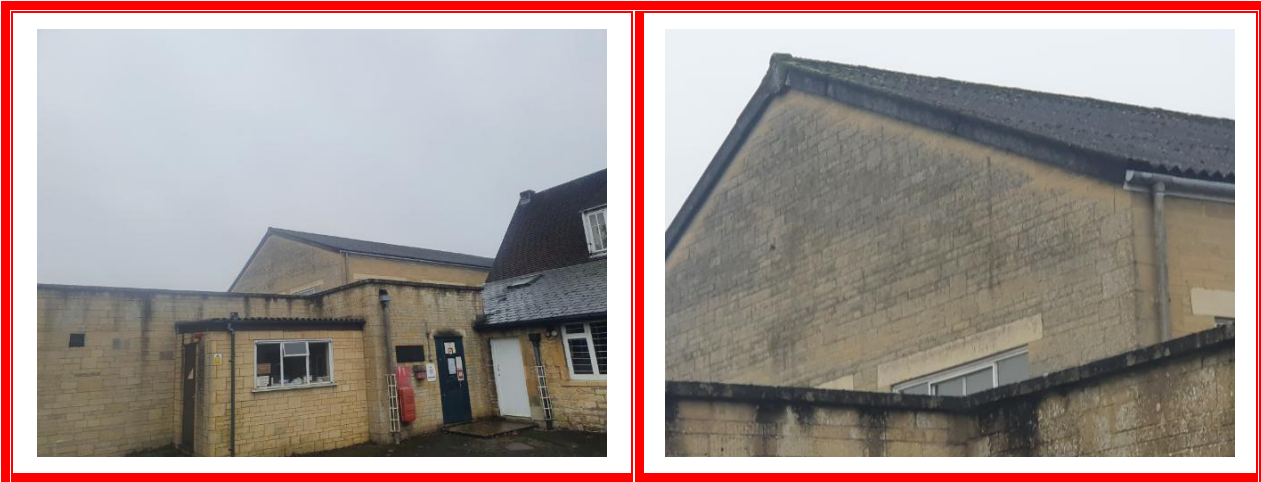
Item No:	15	Sample No:	N/A
Location:	External - Drill Hall 015

Material Description:	Roof Edging - Cement Product	
Identification:	Presumed to Contain Asbestos	
Approx. quantity:	36 LM	
Accessibility	Difficult	<i>Assessment Score</i>
Product type:	Cement	1
Extent of Damage:	Minor Damage	1
Surface Treatment:	Sealed Cement	1
Asbestos type:	Chrysotile	1
Material Assessment Score:		4
Priority Assessment Score:		Negligible
Action:	Manage	
Comments:	No access to sample due to height

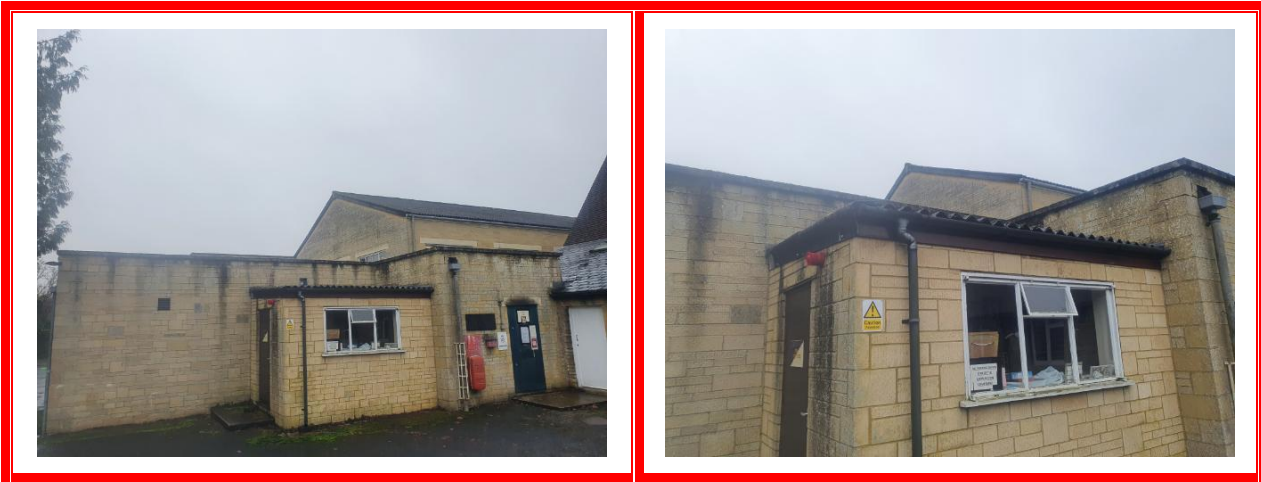
Item No:	16	Sample No:	N/A
Location:	External - RGH Office 016

Material Description:	Profiled Roof - Cement Product	
Identification:	Previously Sampled - Asbestos Detected	
Approx. quantity:	6 m ²	
Accessibility	Difficult	<i>Assessment Score</i>
Product type:	Cement	1
Extent of Damage:	Slight / Minor Damage	1
Surface Treatment:	Unsealed Cement	1
Asbestos type:	Chrysotile	1
Material Assessment Score:		4
Priority Assessment Score:		Negligible
Action:	Manage	
Comments:	Previously sampled ref: Armour 2/10/19 - Sample DK/13

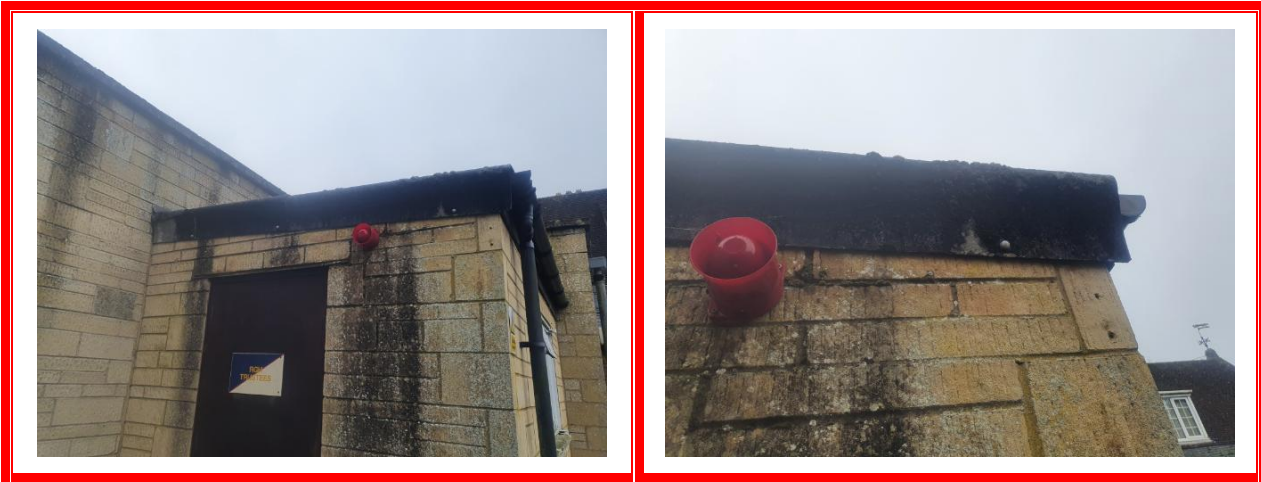
Item No:	17	Sample No:	N/A
Location:	External - RGH Office 017

Material Description:	Roof Edging - Cement Product	
Identification:	Previously Sampled - Asbestos Detected	
Approx. quantity:	2 LM	
Accessibility	Difficult	<i>Assessment Score</i>
Product type:	Cement	1
Extent of Damage:	Slight / Minor Damage	1
Surface Treatment:	Unsealed Cement	1
Asbestos type:	Chrysotile	1
Material Assessment Score:		4
Priority Assessment Score:		Negligible
Action:	Manage	
Comments:	Previously sampled ref: Armour 2/10/19 - Sample DK/14

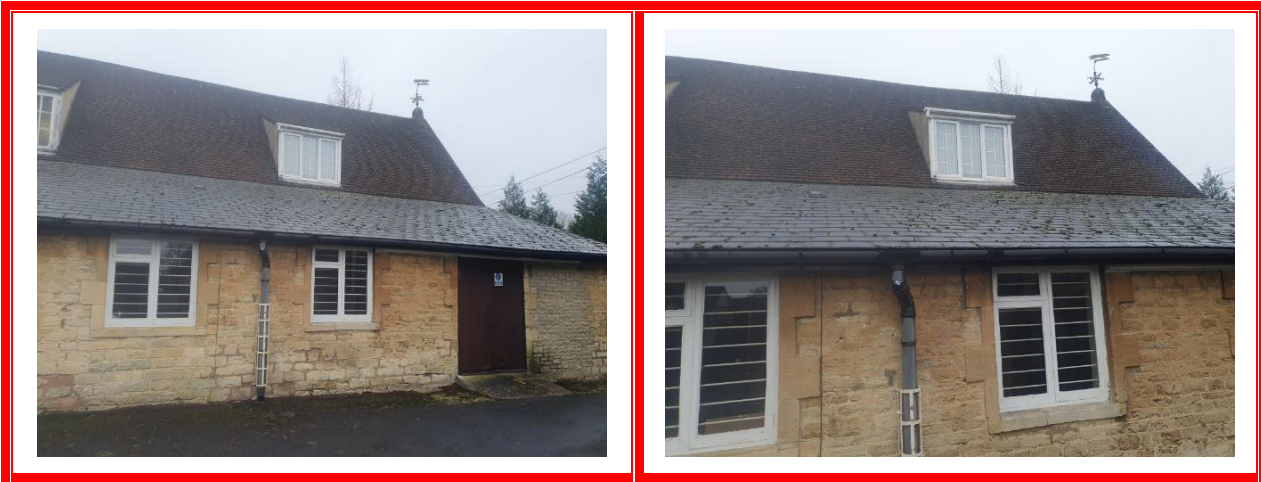
Item No:	18	Sample No:	N/A
Location:	External - Training Room 018

Material Description:	Roof Tiles - Cement Product	
Identification:	Previously Sampled - Asbestos Detected	
Approx. quantity:	60 m ²	
Accessibility	Difficult	<i>Assessment Score</i>
Product type:	Cement	1
Extent of Damage:	Slight / Minor Damage	1
Surface Treatment:	Unsealed Cement	1
Asbestos type:	Chrysotile	1
Material Assessment Score:		4
Priority Assessment Score:		Negligible
Action:	Manage	
Comments:	Previously sampled ref: Armour 2/10/19 - Sample DK/15

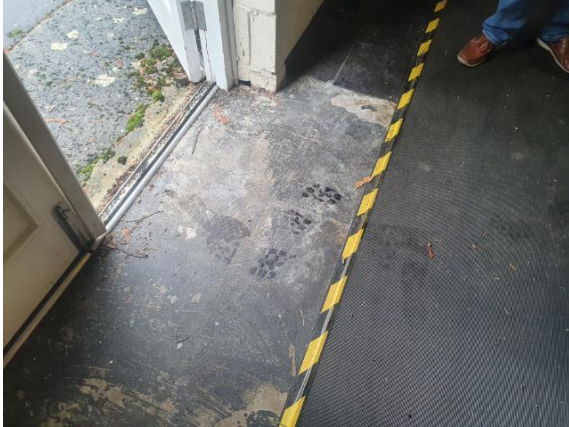
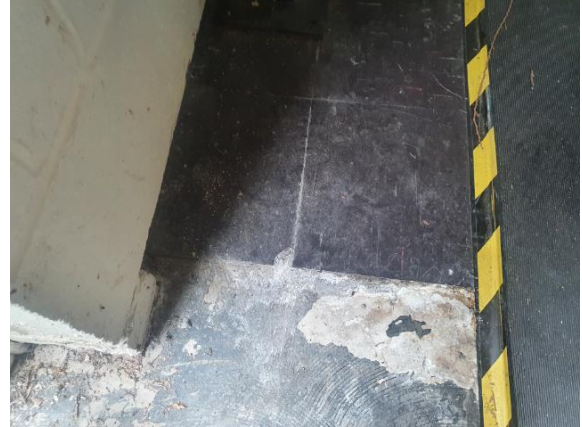
Item No:	19	Sample No:	N/A
Location:	Ground Floor - Gym Block - Store 019

Material Description:	Floor Tiles and Adhesive - Vinyl Products	
Identification:	Previously Sampled - Asbestos Detected	
Approx. quantity:	30 m ²	
Accessibility	Easy	<i>Assessment Score</i>
Product type:	Vinyl	1
Extent of Damage:	Slight / Minor Damage	1
Surface Treatment:	Non-Friable	0
Asbestos type:	Chrysotile	1
Material Assessment Score:		3
Priority Assessment Score:		Negligible
Action:	Manage	
Comments:	Previously sampled ref: Armour 2/10/19 - Sample DK/17

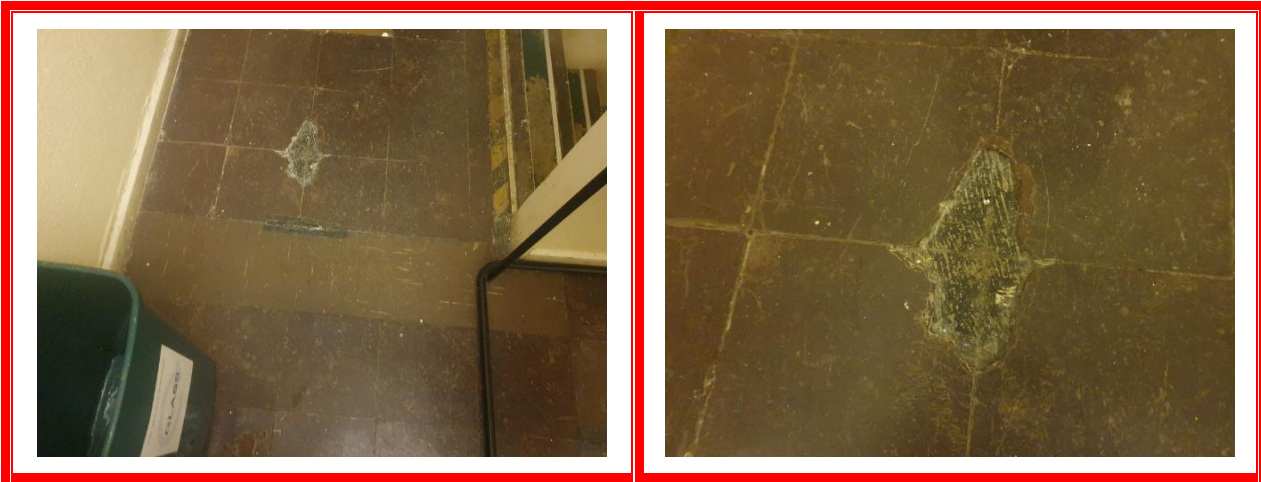
Item No:	20	Sample No:	N/A
Location:	First Floor - Cadet Area - Landing 020

Material Description:	Red and Brown Floor Tiles and Adhesive - Vinyl Products	
Identification:	Previously Sampled - Asbestos Detected	
Approx. quantity:	6 m ²	
Accessibility	Easy	<i>Assessment Score</i>
Product type:	Vinyl	1
Extent of Damage:	Moderate Damage	2
Surface Treatment:	Non-Friable	0
Asbestos type:	Chrysotile	1
Material Assessment Score:		4
Priority Assessment Score:		Negligible
Action:	Manage	
Comments:	Previously sampled ref: Armour 2/10/19 - Sample DK/19

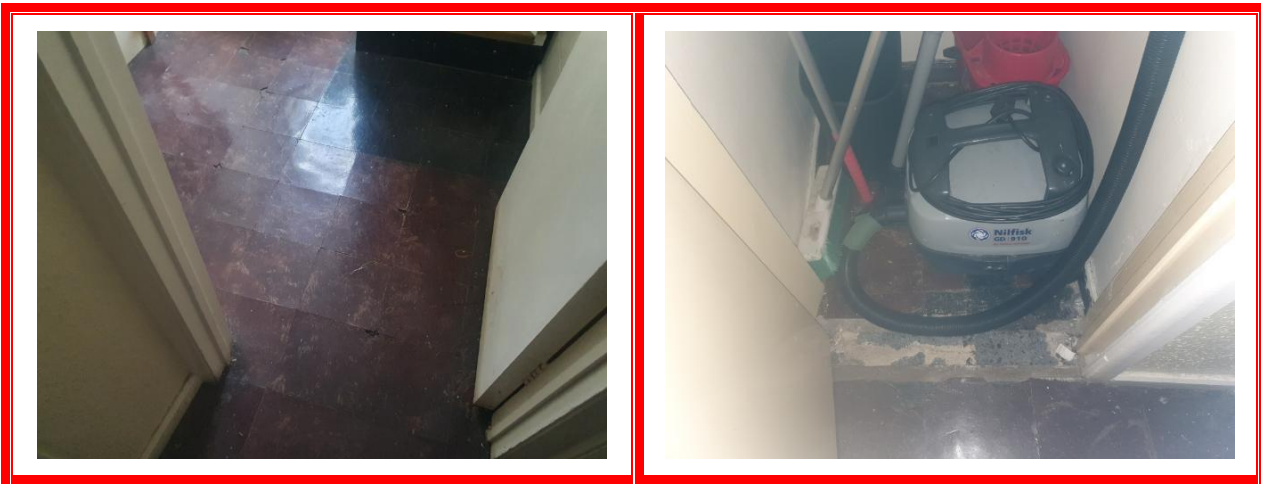
Item No:	21	Sample No:	N/A
Location:	First Floor - Cadet Area - Cupboard and WC 021

Material Description:	Red and Brown Floor Tiles and Adhesive - Vinyl Products	
Identification:	Previously Sampled - Asbestos Detected	
Approx. quantity:	6 m ²	
Accessibility	Easy	<i>Assessment Score</i>
Product type:	Vinyl	1
Extent of Damage:	Minor Damage	1
Surface Treatment:	Non-Friable	0
Asbestos type:	Chrysotile	1
Material Assessment Score:		3
Priority Assessment Score:		Negligible
Action:	Manage	
Comments:	Previously sampled ref: Armour 2/10/19 - Sample DK/19

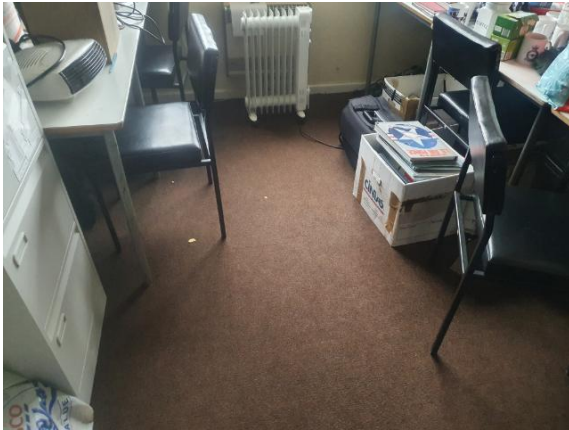
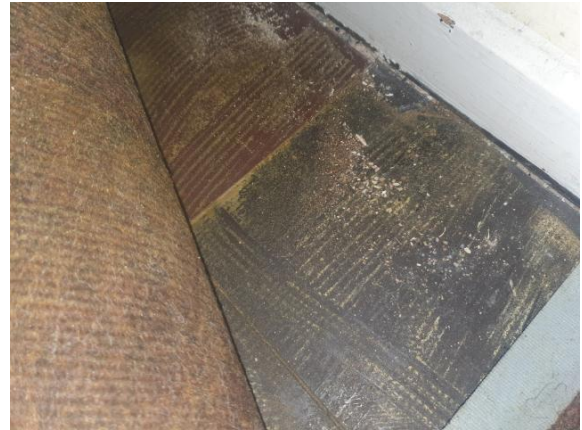
Item No: 22

Material Description:	Red and Brown Floor Tiles and Adhesive - Vinyl Products	
Identification:	Previously Sampled - Asbestos Detected	
Approx. quantity:	15 m ²	
Accessibility	Difficult	<i>Assessment Score</i>
Product type:	Vinyl	1
Extent of Damage:	Minor Damage	1
Surface Treatment:	Non-Friable	0
Asbestos type:	Chrysotile	1
Material Assessment Score:		3
Priority Assessment Score:		Negligible
Action:	Manage	
Comments:	Under carpet. Previously sampled ref: Armour 2/10/19 - Sample DK/19

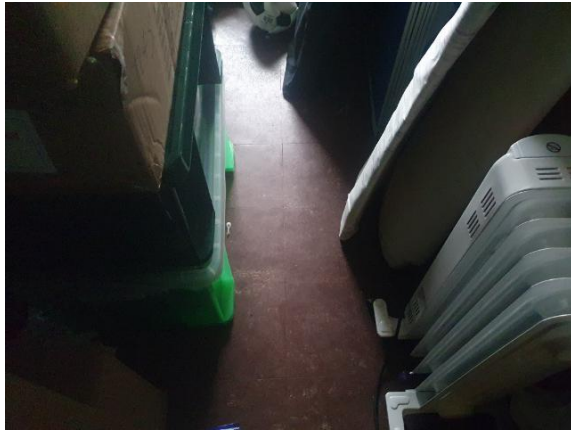
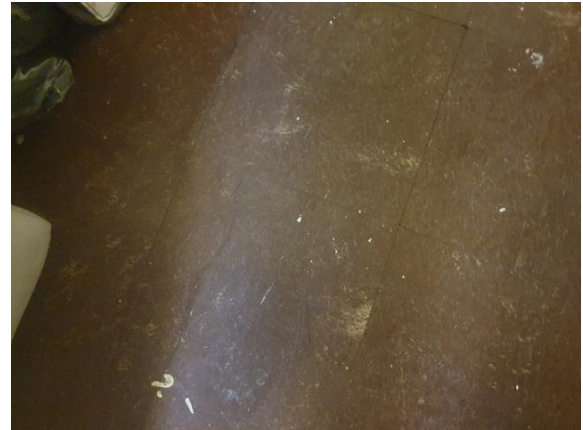
Item No:	23	Sample No:	N/A
Location:	First Floor - Cadet Area - Store and Cupboard 023

Material Description:	Floor Tiles and Adhesive - Vinyl Products	
Identification:	Previously Sampled - Asbestos Detected	
Approx. quantity:	19 m ²	
Accessibility	Easy	<i>Assessment Score</i>
Product type:	Vinyl	1
Extent of Damage:	Minor Damage	1
Surface Treatment:	Non-Friable	0
Asbestos type:	Chrysotile	1
Material Assessment Score:		3
Priority Assessment Score:		Negligible
Action:	Manage	
Comments:	Under carpet. Previously sampled ref: Armour 2/10/19 - Sample DK/19

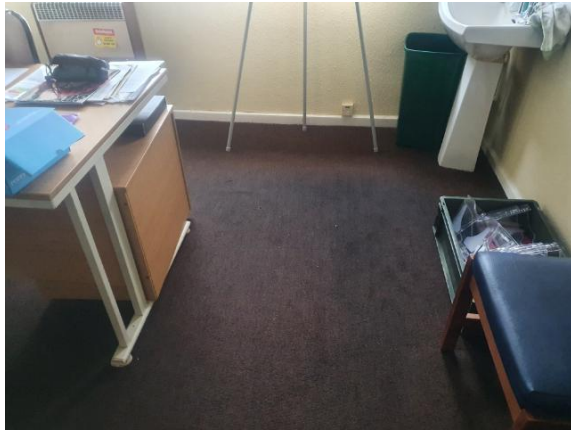
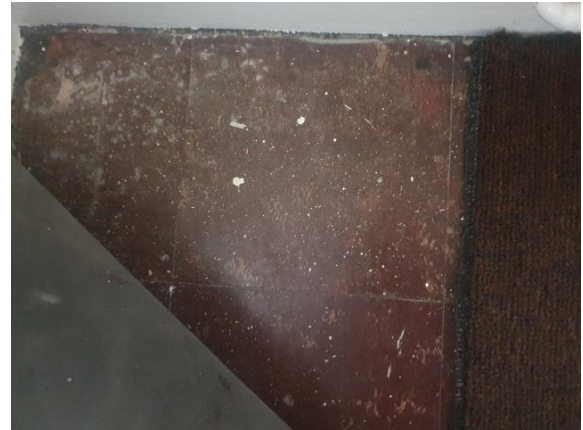
Item No: 24

Material Description:	Floor Tiles and Adhesive - Vinyl Products	
Identification:	Previously Sampled - Asbestos Detected	
Approx. quantity:	12 m ²	
Accessibility	Difficult	<i>Assessment Score</i>
Product type:	Vinyl	1
Extent of Damage:	Minor Damage	1
Surface Treatment:	Non-Friable	0
Asbestos type:	Chrysotile	1
Material Assessment Score:		3
Priority Assessment Score:		Negligible
Action:	Manage	
Comments:	Under carpet. Previously sampled ref: Armour 2/10/19 - Sample DK/21

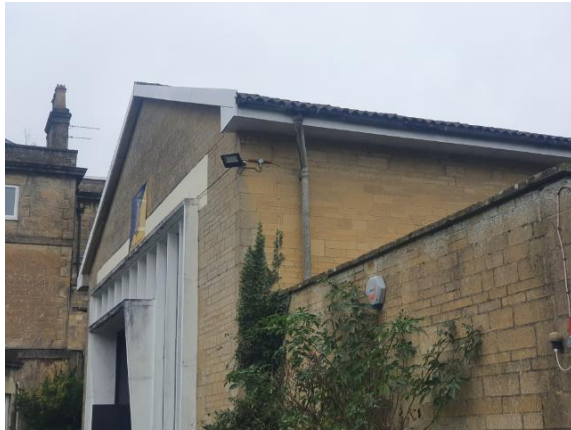
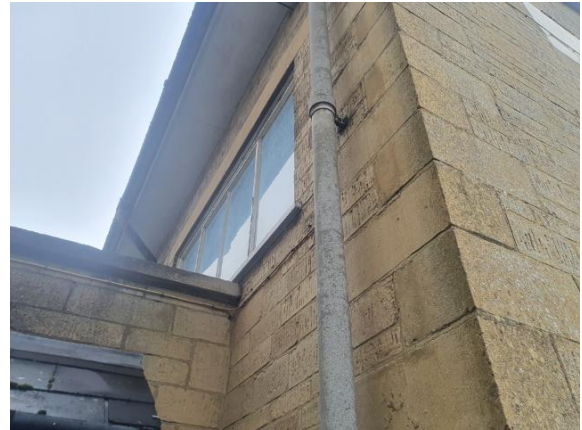
Item No:	25	Sample No:	N/A
Location:	External - Main Building 025

Material Description:	Downpipes - Cement Product	
Identification:	Previously Sampled - Asbestos Detected	
Approx. quantity:	25 LM	
Accessibility	Difficult	<i>Assessment Score</i>
Product type:	Cement	1
Extent of Damage:	Slight / Minor Damage	1
Surface Treatment:	Unsealed Cement	1
Asbestos type:	Chrysotile	1
Material Assessment Score:		4
Priority Assessment Score:		Negligible
Action:	Manage	
Comments:	5 x Pipes. Previously sampled ref: Armour 2/10/19 - Sample DK/22

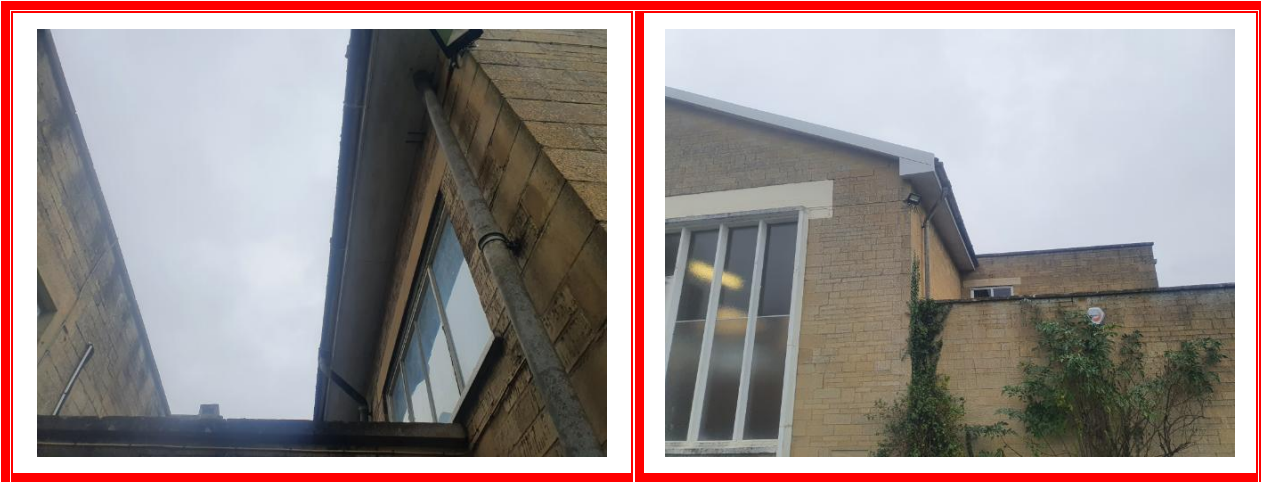
Item No:	26	Sample No:	N/A
Location:	External - Drill Hall 026

Material Description:	Guttering - Cement Product	
Identification:	Previously Sampled - Asbestos Detected	
Approx. quantity:	12 LM	
Accessibility	Difficult	<i>Assessment Score</i>
Product type:	Cement	1
Extent of Damage:	Slight / Minor Damage	1
Surface Treatment:	Unsealed Cement	1
Asbestos type:	Chrysotile	1
Material Assessment Score:		4
Priority Assessment Score:		Negligible
Action:	Manage	
Comments:	2 x Pipes. Previously sampled ref: Armour 2/10/19 - Sample DK/22

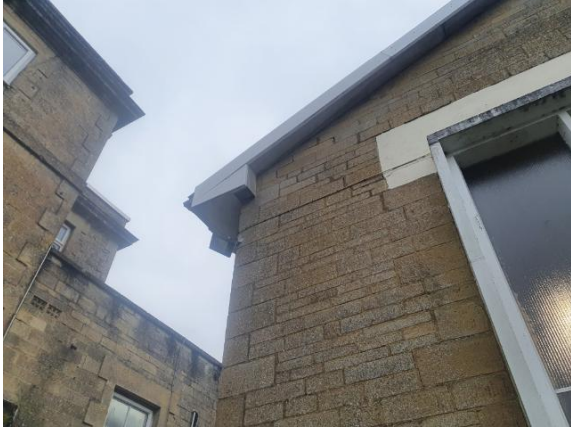
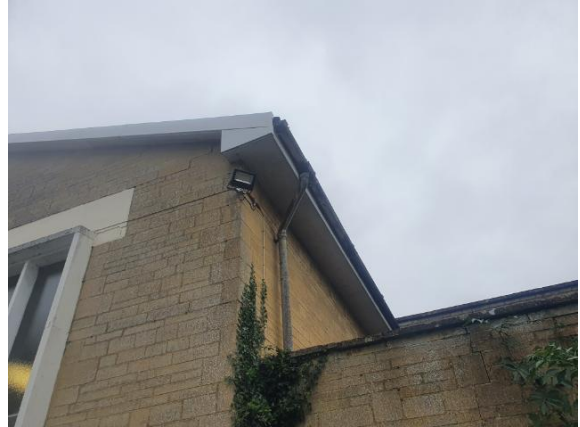
Item No:	27	Sample No:	N/A
Location:	External - Drill Hall 027

Material Description:	Soffits - Insulating Board	
Identification:	Presumed to Contain Asbestos	
Approx. quantity:	22 LM	
Accessibility	Difficult	<i>Assessment Score</i>
Product type:	Asbestos Insulating Board	2
Extent of Damage:	Minor Damage	1
Surface Treatment:	Unsealed AIB	2
Asbestos type:	Amosite	2
Material Assessment Score:		7
Priority Assessment Score:		Medium
Action:	Manage	
Comments:	No access to sample due to height

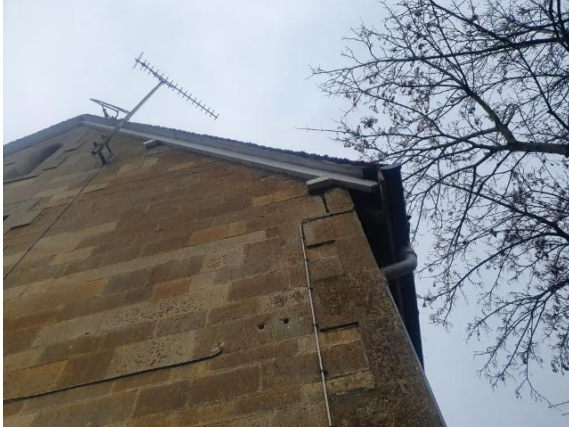
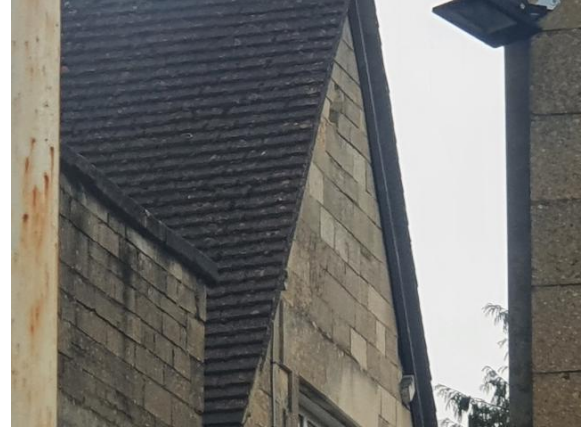
Item No:	28	Sample No:	N/A
Location:	External - Main Building 028

Material Description:	Undercloaking to Gable Ends - Cement Product	
Identification:	Presumed to Contain Asbestos	
Approx. quantity:	20 LM	
Accessibility	Difficult	<i>Assessment Score</i>
Product type:	Cement	1
Extent of Damage:	Minor Damage	1
Surface Treatment:	Unsealed Cement	1
Asbestos type:	Chrysotile	1
Material Assessment Score:		4
Priority Assessment Score:		Negligible
Action:	Manage	
Comments:	No access to sample due to height

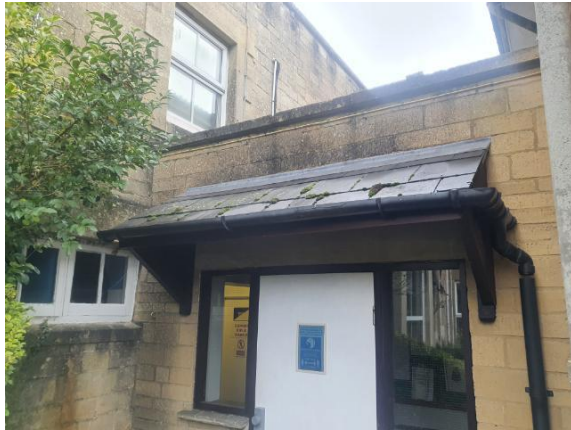
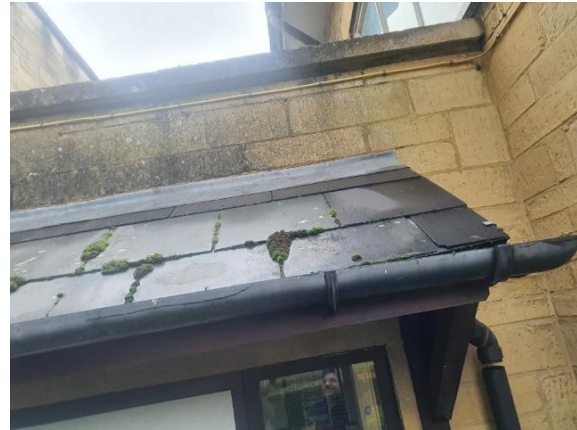
Item No: 29

Material Description:	Roof Tiles - Cement Product	
Identification:	Previously Sampled - Asbestos Detected	
Approx. quantity:	2 m ²	
Accessibility	Difficult	<i>Assessment Score</i>
Product type:	Cement	1
Extent of Damage:	Minor Damage	1
Surface Treatment:	Unsealed Cement	1
Asbestos type:	Chrysotile	1
Material Assessment Score:		4
Priority Assessment Score:		Negligible
Action:	Manage	
Comments:	Previously sampled ref: Armour 2/10/19 - Sample DK/23

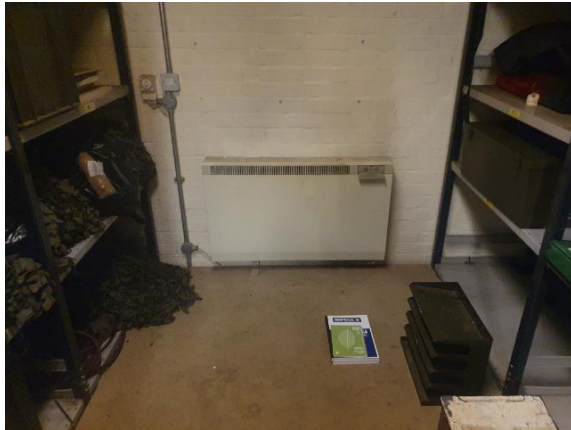
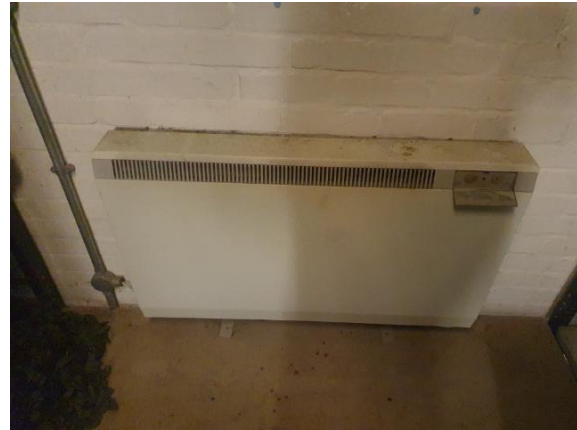
Item No:	31	Sample No:	N/A
Location:	First Floor - Garage Block - Store and Mezzanine 031

Material Description:	Night Storage Heater - No Access Gained	
Identification:	Presumed to Contain Asbestos	
Approx. quantity:	2 no	
Accessibility	Difficult	<i>Assessment Score</i>
Product type:	Asbestos Insulating Board	2
Extent of Damage:	Major Damage	3
Surface Treatment:	Unsealed AIB	2
Asbestos type:	Amosite	2
Material Assessment Score:		9
Priority Assessment Score:		Medium
Action:	Manage	
Comments:	No access as live

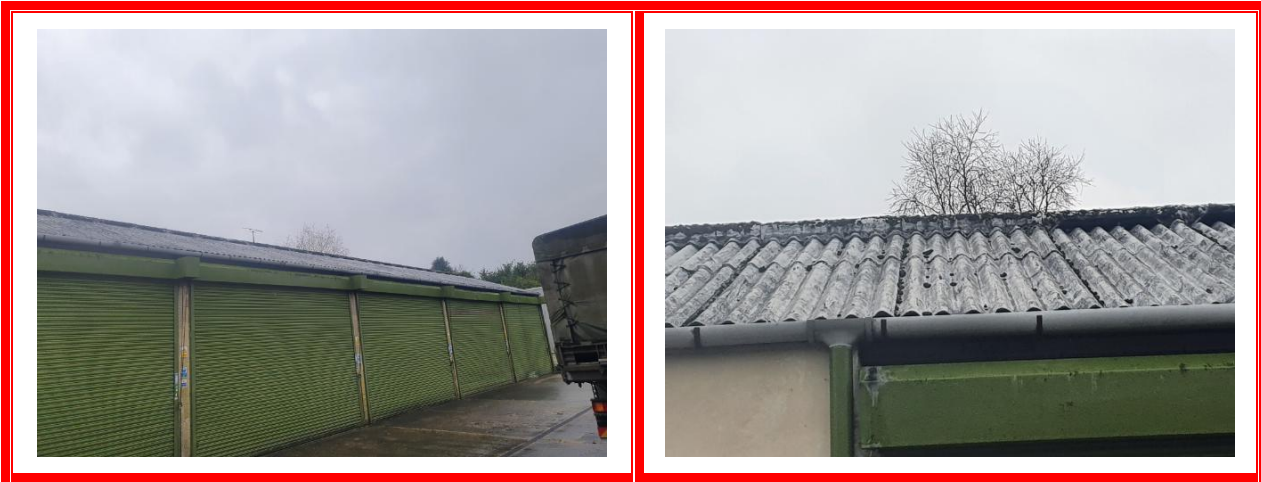
Item No:	32	Sample No:	N/A
Location:	External - Garage Block - Garages 032

Material Description:	Profiled Roof - Cement Product	
Identification:	Presumed to Contain Asbestos	
Approx. quantity:	360 m ²	
Accessibility	Difficult	<i>Assessment Score</i>
Product type:	Cement	1
Extent of Damage:	Minor Damage	1
Surface Treatment:	Unsealed Cement	1
Asbestos type:	Chrysotile	1
Material Assessment Score:		4
Priority Assessment Score:		Negligible
Action:	Manage	
Comments:	No access to sample due to height

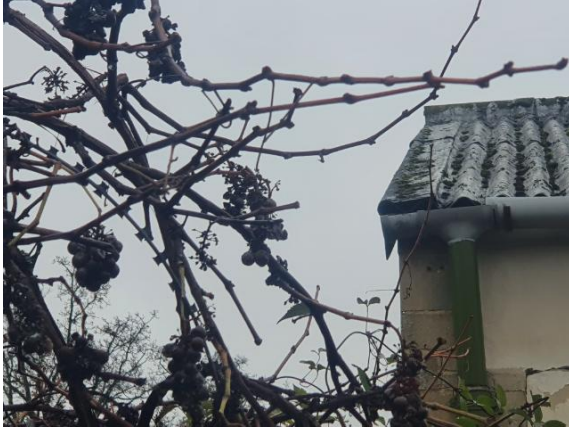
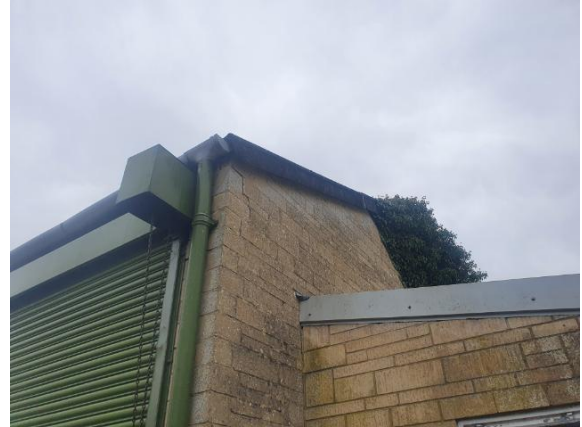
Item No:	33	Sample No:	N/A
Location:	External - Garage Block - Garages 033

Material Description:	Roof Edging - Cement Product	
Identification:	Presumed to Contain Asbestos	
Approx. quantity:	16 LM	
Accessibility	Difficult	<i>Assessment Score</i>
Product type:	Cement	1
Extent of Damage:	Minor Damage	1
Surface Treatment:	Unsealed Cement	1
Asbestos type:	Chrysotile	1
Material Assessment Score:		4
Priority Assessment Score:		Negligible
Action:	Manage	
Comments:	No access to sample due to height

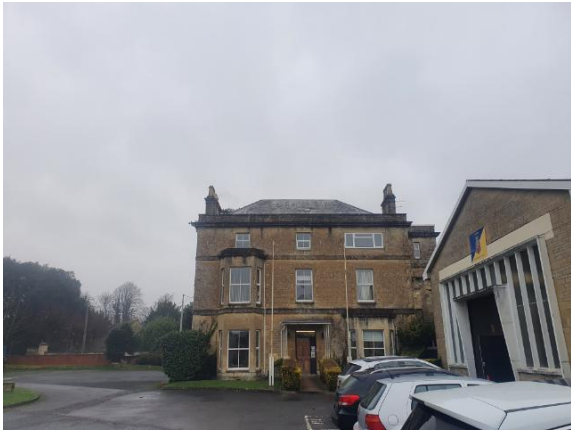
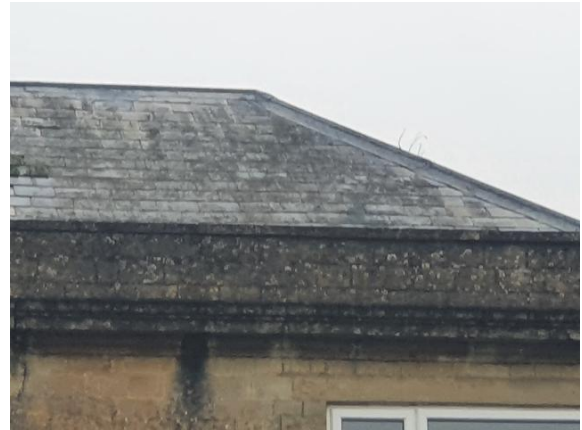
Item No: 34

Material Description:	Roof Tiles - Cement Product	
Identification:	Presumed to Contain Asbestos	
Approx. quantity:	80 m ²	
Accessibility	Difficult	<i>Assessment Score</i>
Product type:	Cement	1
Extent of Damage:	Minor Damage	1
Surface Treatment:	Unsealed Cement	1
Asbestos type:	Chrysotile	1
Material Assessment Score:		4
Priority Assessment Score:		Negligible
Action:	Manage	
Comments:	No access to sample due to height

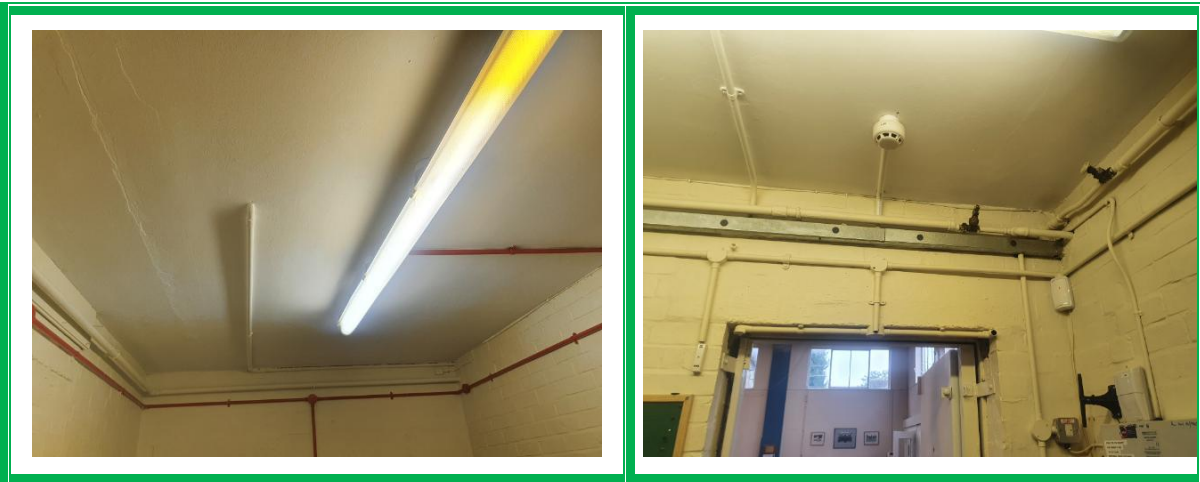
Item No:	10	Sample No:	N/A
Location:	Ground Floor - Armoury 010

Material Description:	No Suspect Materials Found	
Identification:	N/A	
Approx. quantity:	N/A	
Accessibility	N/A	<i>Assessment Score</i>
Product type:	N/A	N/A
Extent of Damage:	N/A	N/A
Surface Treatment:	N/A	N/A
Asbestos type:	N/A	N/A
Material Assessment Score:		
Priority Assessment Score:		
Action:	N/A	
Comments:	Previously un-accessed area. Now accessed and no asbestos found. Brick walls and concrete floor and ceiling
