Project Number A-00366 (3700)

**Re-Inspection
Asbestos Survey Report**

**Royal Wessex Yeomanry C
Gloucestershire
GL7 1TT**

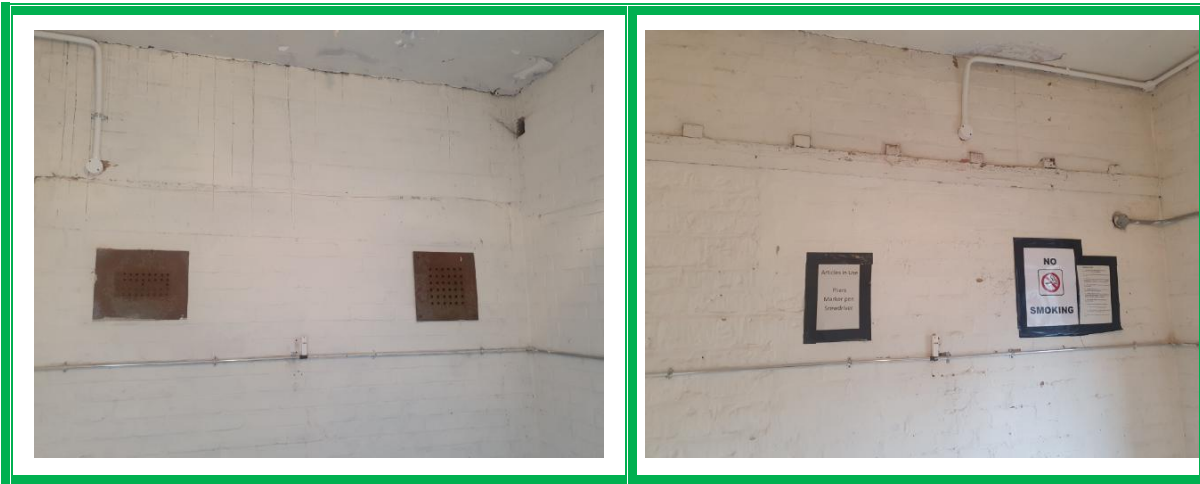
Item No:	13	Sample No:	N/A
Location:	Ground Floor - Ammo Store 013

Material Description:	No Suspect Materials Found	
Identification:	N/A	
Approx. quantity:	N/A	
Accessibility	N/A	<i>Assessment Score</i>
Product type:	N/A	N/A
Extent of Damage:	N/A	N/A
Surface Treatment:	N/A	N/A
Asbestos type:	N/A	N/A
Material Assessment Score:		
Priority Assessment Score:		
Action:	N/A	
Comments:	Previously un-accessed area. Now accessed and no asbestos found. Brick walls and concrete floor and ceiling

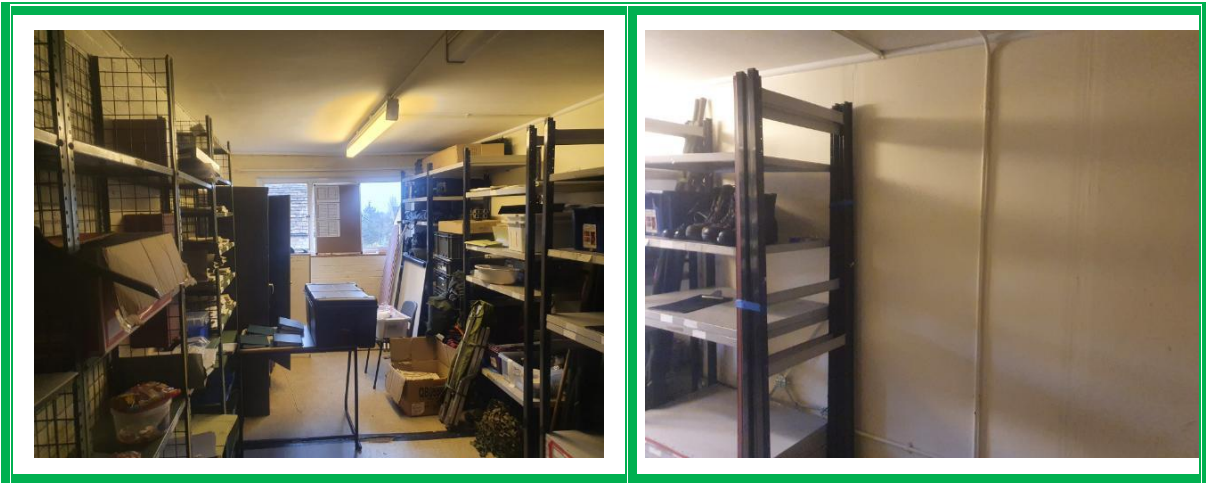
Item No:	30	Sample No:	N/A
Location:	First Floor - Cadet Area - Store Room 030

Material Description:	No Suspect Materials Found	
Identification:	N/A	
Approx. quantity:	N/A	
Accessibility	N/A	<i>Assessment Score</i>
Product type:	N/A	N/A
Extent of Damage:	N/A	N/A
Surface Treatment:	N/A	N/A
Asbestos type:	N/A	N/A
Material Assessment Score:		
Priority Assessment Score:		
Action:	N/A	
Comments:	Not accessed in previous survey as key as not available. Now accessed and no asbestos was found. Plasterboard walls and ceiling and non-asbestos electric heater.

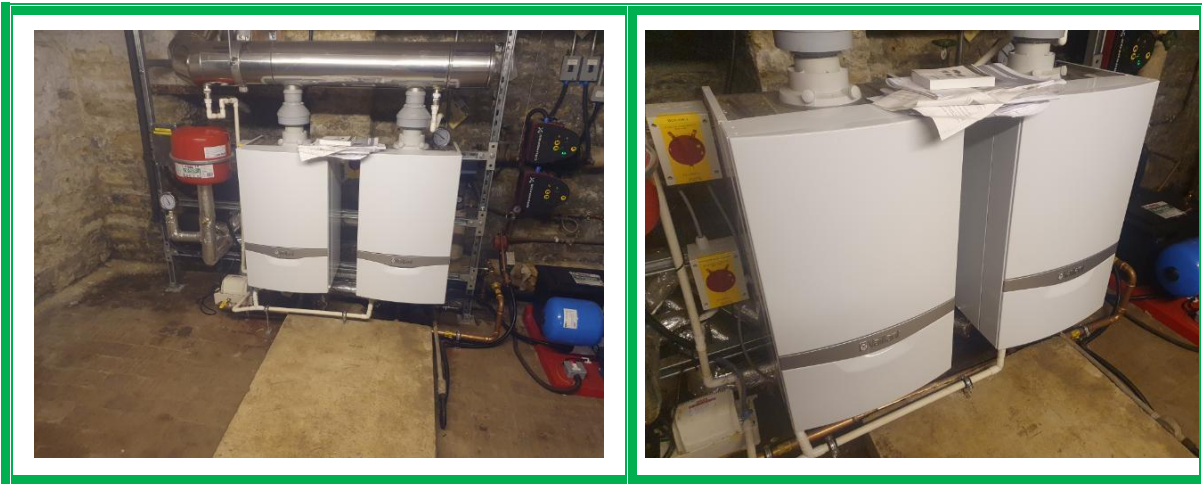
Item No:	35	Sample No:	N/A
Location:	Basement - Boiler Room 035

Material Description:	No Suspect Materials Found	
Identification:	N/A	
Approx. quantity:	N/A	
Accessibility	N/A	<i>Assessment Score</i>
Product type:	N/A	N/A
Extent of Damage:	N/A	N/A
Surface Treatment:	N/A	N/A
Asbestos type:	N/A	N/A
Material Assessment Score:		
Priority Assessment Score:		
Action:	N/A	
Comments:	Boilers have been replaced with modern Vaillant boilers.
