Project Number 2481

**Management
Asbestos Survey Report**

**Tiverton Platoon, King Street,
Devon, EX16 5JJ**

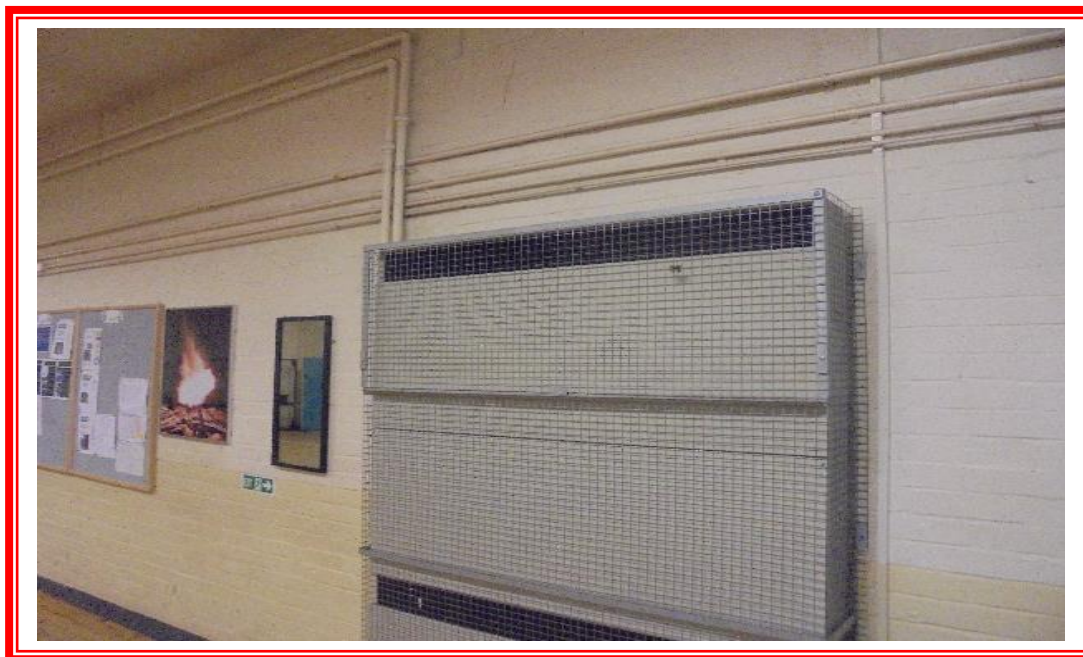
Item No: 2

Material Description:	Components within Gas Heater	
Identification:	Presumed to Contain Asbestos	
Approx. quantity:	X 4 Heaters	
Accessibility	Low	<i>Assessment Score</i>
Product type:	No Access	2
Extent of Damage:	No Access	2
Surface Treatment:	No Access	2
Asbestos type:	No Access	2
Material Assessment Score:		8
Priority Assessment Score:		Medium
Action:	Manage	
Comments:	No Access within heater as live. Limited access above suspended ceiling due to height

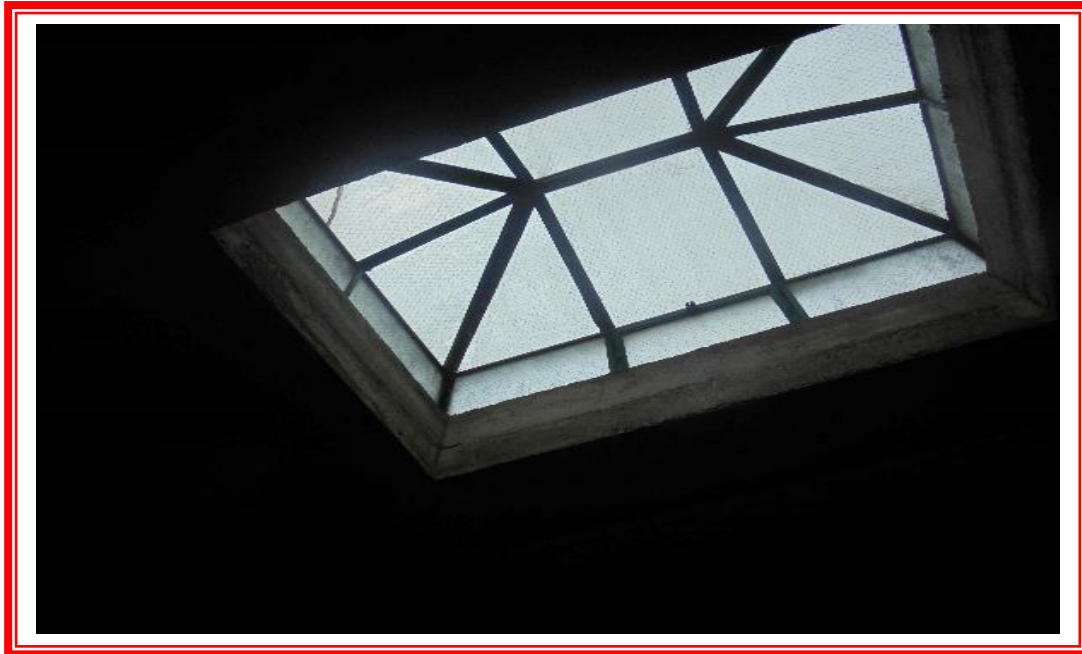
**Item No: 5****Sample No: N/A****Location: Ground Floor - Lobby & Circulation**

Material Description:	Rope Seals to Skylights	
Identification:	Presumed to Contain Asbestos	
Approx. quantity:	X 2 Skylights	
Accessibility	Low	<i>Assessment Score</i>
Product type:	Rope	2
Extent of Damage:	Minor	1
Surface Treatment:	Unsealed	1
Asbestos type:	Chrysotile	1
Material Assessment Score:		5
Priority Assessment Score:		Low
Action:	Manage	
Comments:	No Access due to height

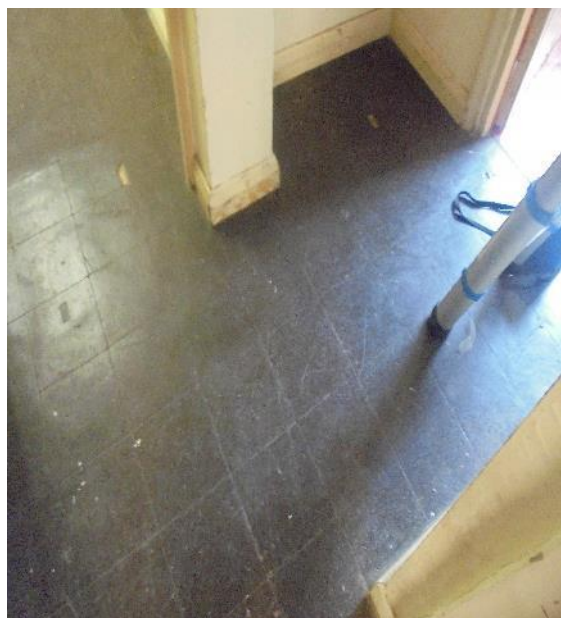
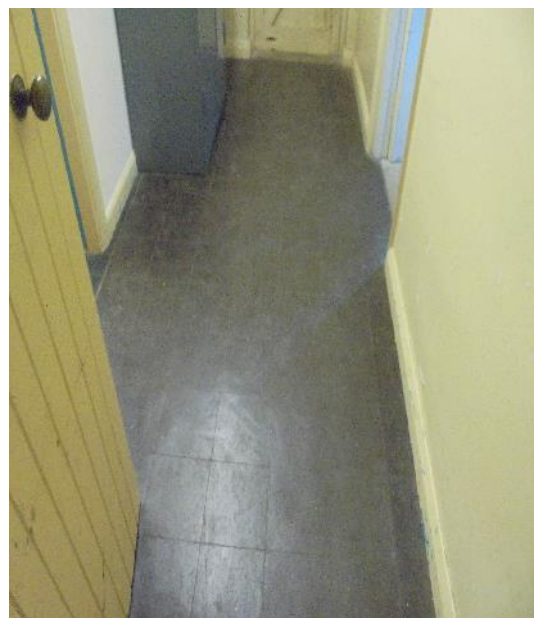
**Item No: 6****Sample No: DK/2****Location: Ground Floor - Lobby & Circulation**

Material Description:	Floor Tiles & Adhesive	
Identification:	Sampled – Asbestos Detected	
Approx. quantity:	8M2	
Accessibility	High	Assessment Score
Product type:	Composite	1
Extent of Damage:	Moderate	2
Surface Treatment:	Non-Friable	0
Asbestos type:	Chrysotile	1
Material Assessment Score:		4
Priority Assessment Score:		Negligible
Action:	Manage	
Comments:	N/A

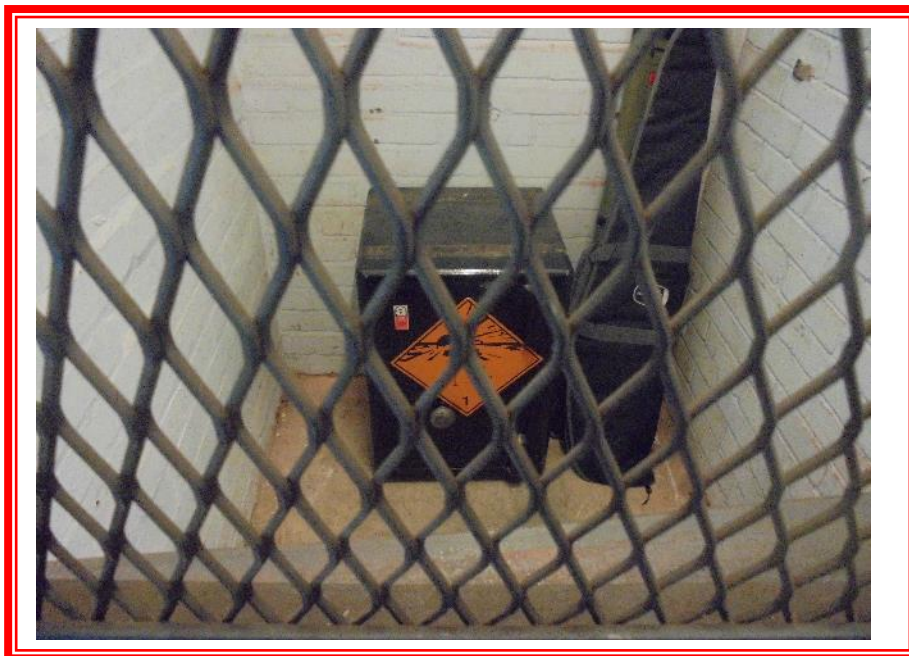
Item No: 8

Material Description:	Components within Safe	
Identification:	Presumed to Contain Asbestos	
Approx. quantity:	X 1 Safe	
Accessibility	Low	<i>Assessment Score</i>
Product type:	No Access	2
Extent of Damage:	No Access	2
Surface Treatment:	No Access	2
Asbestos type:	No Access	2
Material Assessment Score:		8
Priority Assessment Score:		Medium
Action:	Manage	
Comments:	No access within safe casing without damage

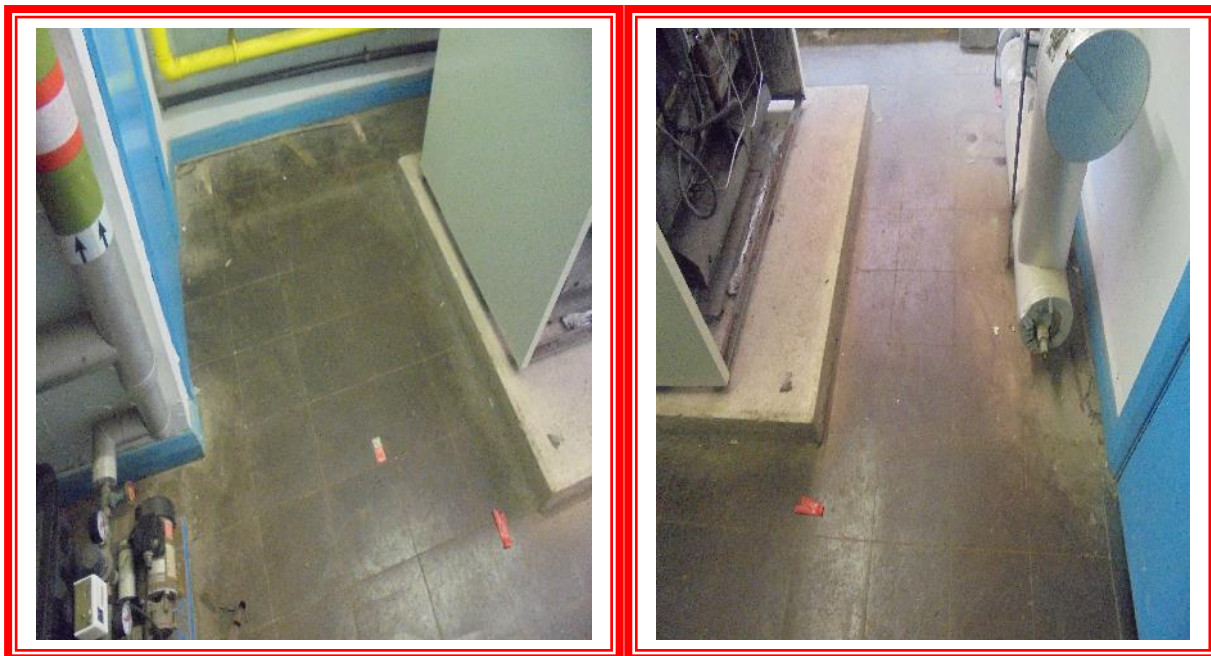
Item No: 9

Material Description:	Floor Tiles & Adhesive	
Identification:	As sample DK/2 – Asbestos Detected	
Approx. quantity:	8M2	
Accessibility	High	Assessment Score
Product type:	Composite Material	1
Extent of Damage:	Minor	1
Surface Treatment:	Non-Friable	0
Asbestos type:	Chrysotile	1
Material Assessment Score:		3
Priority Assessment Score:		Negligible
Action:	Manage	
Comments:	N/A

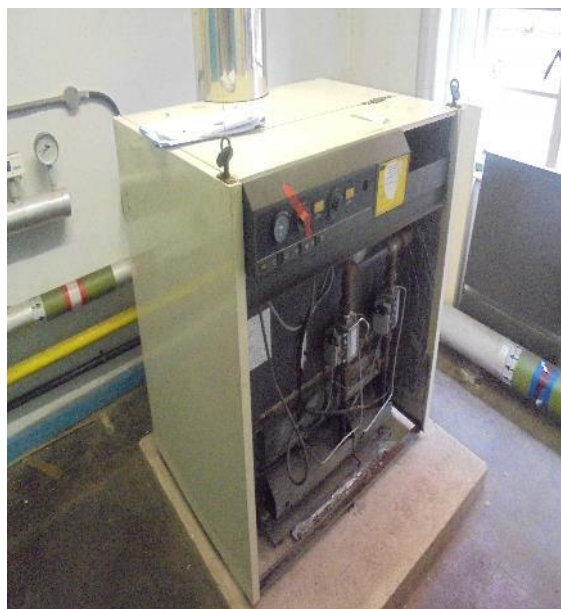
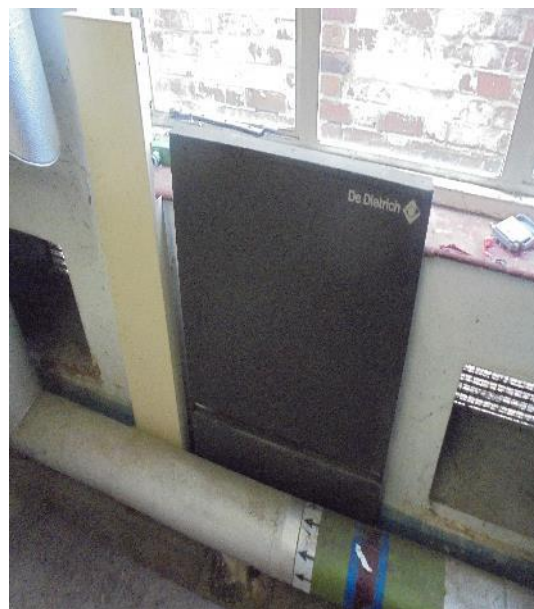
Item No: 10

Material Description:	Components within Boiler	
Identification:	Presumed to Contain Asbestos	
Approx. quantity:	X 1 Boiler	
Accessibility	Low	Assessment Score
Product type:	No Access	3
Extent of Damage:	No Access	3
Surface Treatment:	No Access	3
Asbestos type:	No Access	3
Material Assessment Score:		12
Priority Assessment Score:		High
Action:	Manage	
Comments:	No Access within Live Boiler

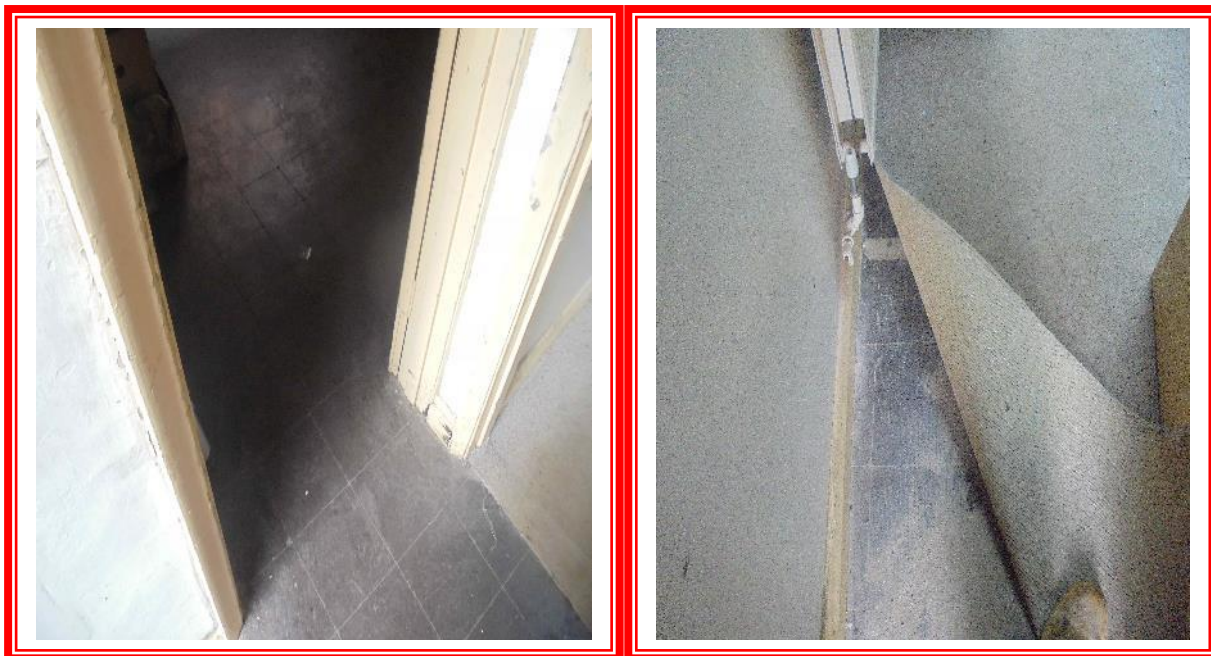
**Item No: 16****Sample No: DK/6****Location: Ground Floor – Lobby, Office & Store**

Material Description:	Floor Tiles & Adhesive	
Identification:	Sampled – Asbestos Detected	
Approx. quantity:	30M2	
Accessibility	High	Assessment Score
Product type:	Composite	1
Extent of Damage:	Moderate	2
Surface Treatment:	Non-Friable	0
Asbestos type:	Chrysotile	1
Material Assessment Score:		4
Priority Assessment Score:		Negligible
Action:	Manage	
Comments:	N/A

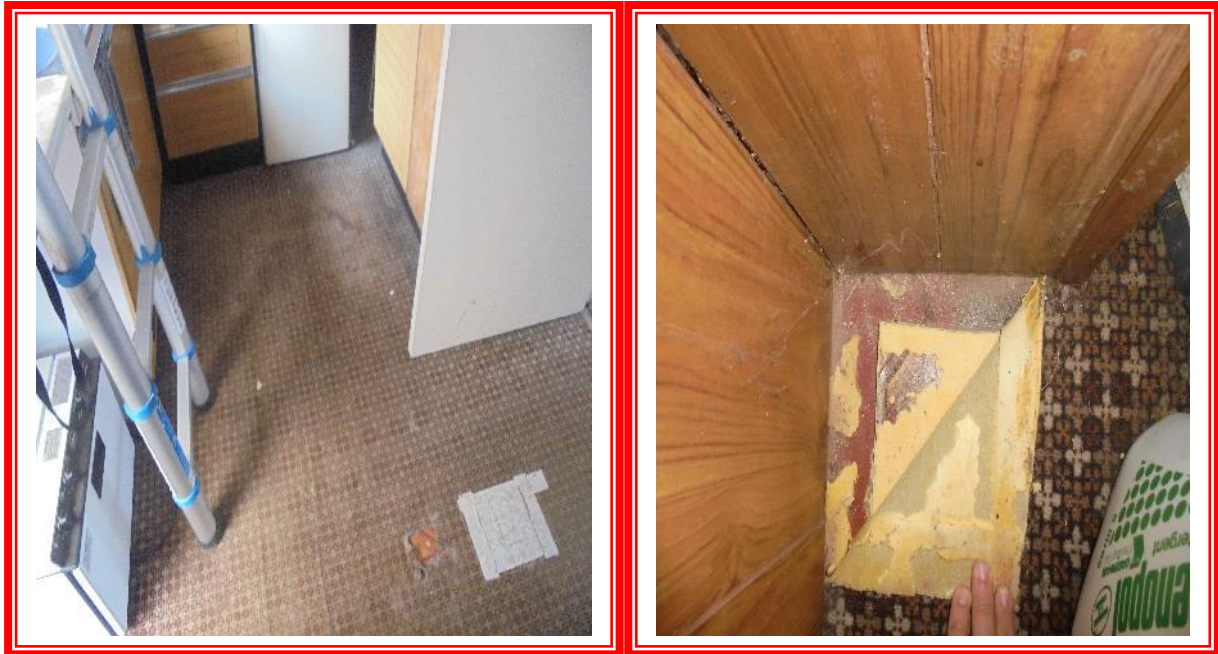
**Item No: 18****Sample No: DK/7****Location: Ground Floor - Kitchen**

Material Description:	Lino Flooring Under Carpet	
Identification:	Sampled – Asbestos Detected	
Approx. quantity:	12M2	
Accessibility	Low	Assessment Score
Product type:	Paper	2
Extent of Damage:	Moderate	2
Surface Treatment:	Unsealed	1
Asbestos type:	Chrysotile	1
Material Assessment Score:		6
Priority Assessment Score:		Low
Action:	Manage	
Comments:	N/A

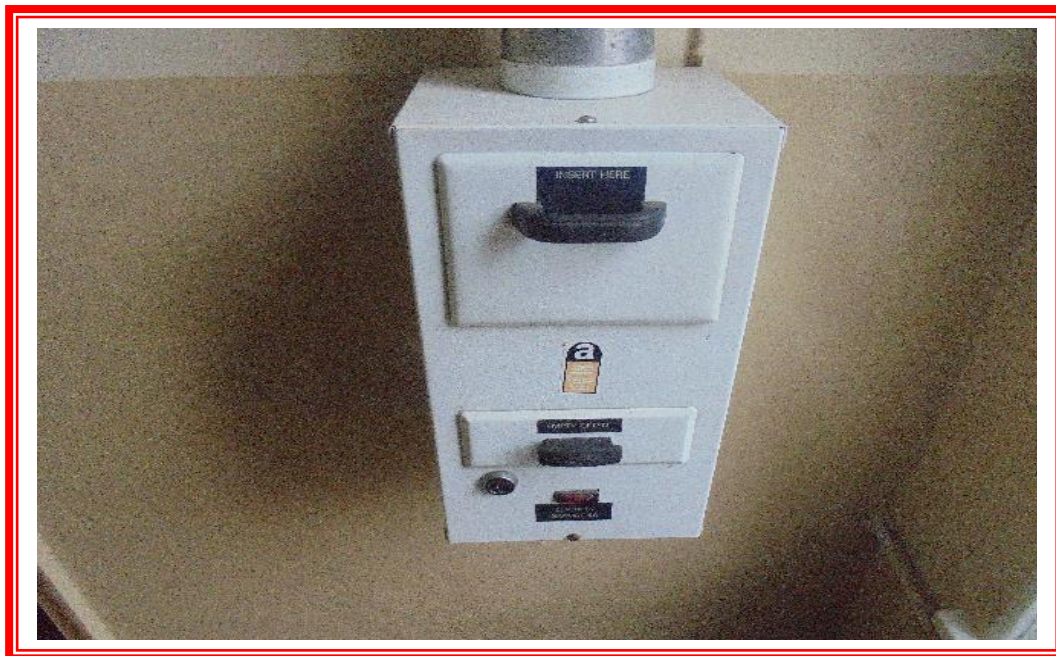
Item No: 30

Material Description:	Components within Incinerator unit	
Identification:	Presumed to Contain Asbestos	
Approx. quantity:	X 1 Unit	
Accessibility	Low	Assessment Score
Product type:	No Access	2
Extent of Damage:	No Access	2
Surface Treatment:	No Access	2
Asbestos type:	No Access	2
Material Assessment Score:		8
Priority Assessment Score:		Medium
Action:	Manage	
Comments:	N/A

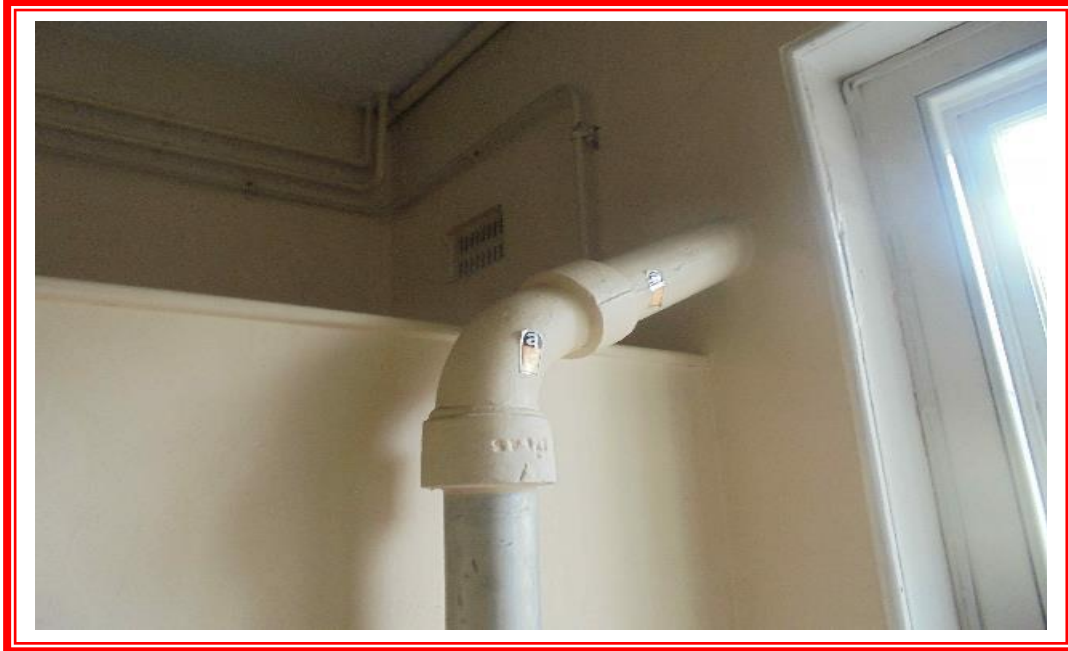
**Item No: 31****Sample No: N/A****Location: Ground Floor – Ladies WC**

Material Description:	Cement Flue pipe	
Identification:	As sample DK/11 – Asbestos Detected	
Approx. quantity:	1LM	
Accessibility	Low	<i>Assessment Score</i>
Product type:	Cement	1
Extent of Damage:	Minor	1
Surface Treatment:	Sealed	0
Asbestos type:	Chrysotile	1
Material Assessment Score:		3
Priority Assessment Score:		Negligible
Action:	Manage	
Comments:	N/A

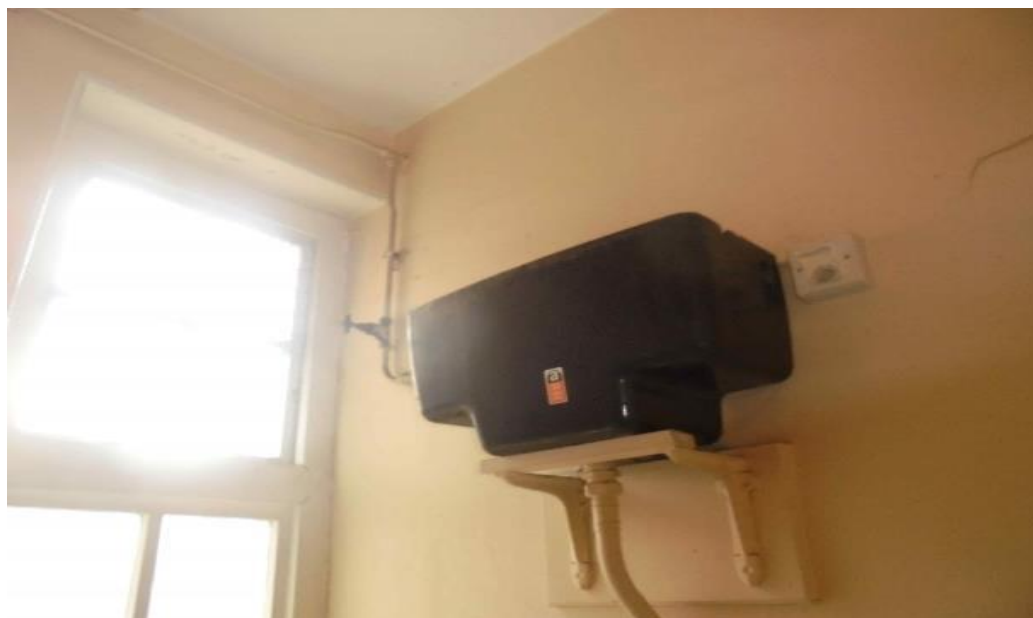
**Item No: 32****Sample No: DK/9****Location: Ground Floor – Men's WC and Cupboard**

Material Description:	Toilet Cistern	
Identification:	Sampled – Asbestos Detected	
Approx. quantity:	X 1 Cistern	
Accessibility	Low	<i>Assessment Score</i>
Product type:	Composite	1
Extent of Damage:	Minor	1
Surface Treatment:	Non-Friable	0
Asbestos type:	Amosite	2
Material Assessment Score:		4
Priority Assessment Score:		Negligible
Action:	Manage	
Comments:	N/A

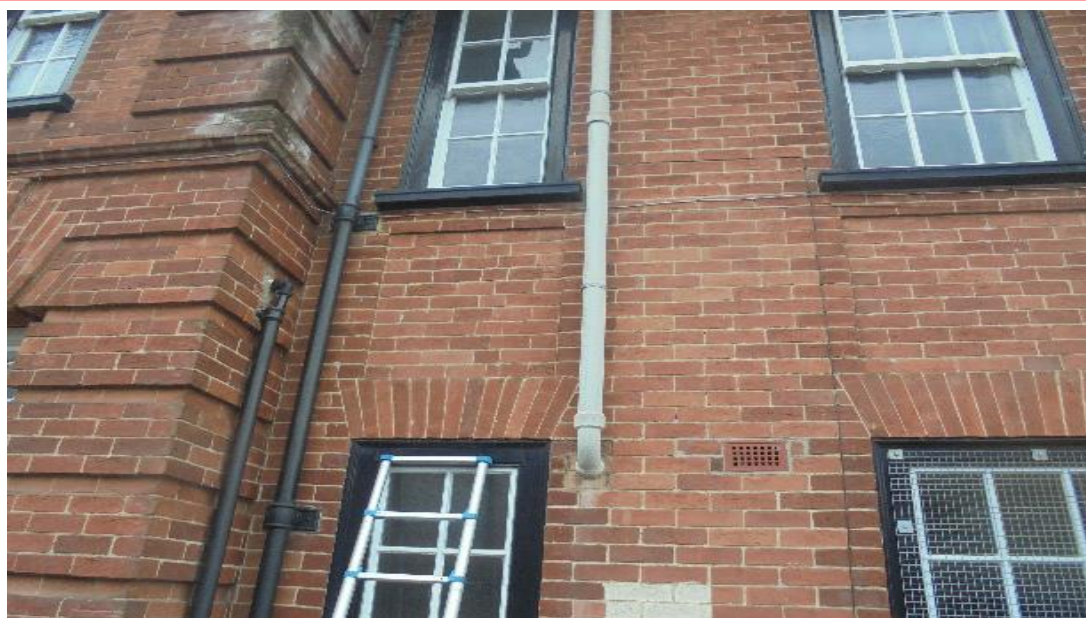
**Item No: 39****Sample No: DK/11****Location: External to Main Building**

Material Description:	Cement Flue Pipe	
Identification:	Sampled – Asbestos Detected	
Approx. quantity:	7LM	
Accessibility	Low	Assessment Score
Product type:	Cement	1
Extent of Damage:	Minor	1
Surface Treatment:	Unsealed	1
Asbestos type:	Chrysotile	1
Material Assessment Score:		4
Priority Assessment Score:		Negligible
Action:	Manage	
Comments:	N/A

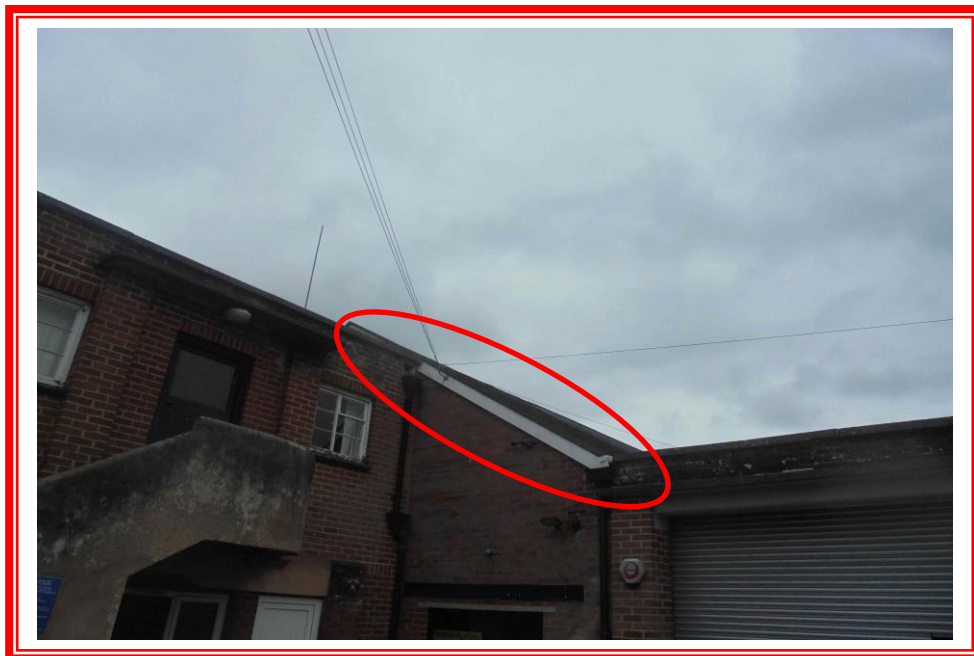
Item No: 41

Material Description:	Cement Roof Tiles	
Identification:	Presumed to Contain Asbestos	
Approx. quantity:	270M2	
Accessibility	Low	<i>Assessment Score</i>
Product type:	Cement	1
Extent of Damage:	Minor	1
Surface Treatment:	Unsealed	1
Asbestos type:	Chrysotile	1
Material Assessment Score:		4
Priority Assessment Score:		Negligible
Action:	Manage	
Comments:	No Access to Sample due to height

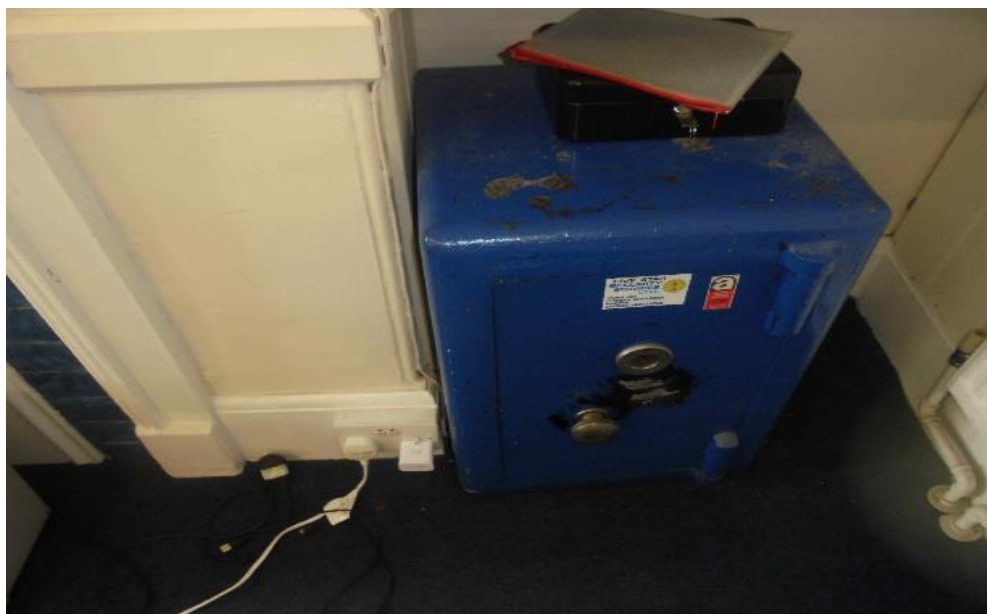
**Item No: 43****Sample No: N/A****Location: First Floor - Office**

Material Description:	Components within Safe	
Identification:	Presumed to Contain Asbestos	
Approx. quantity:	X 1 Safe	
Accessibility	Low	<i>Assessment Score</i>
Product type:	No Access	2
Extent of Damage:	No Access	2
Surface Treatment:	No Access	2
Asbestos type:	No Access	2
Material Assessment Score:		8
Priority Assessment Score:		Medium
Action:	Manage	
Comments:	No access within safe casing without damage

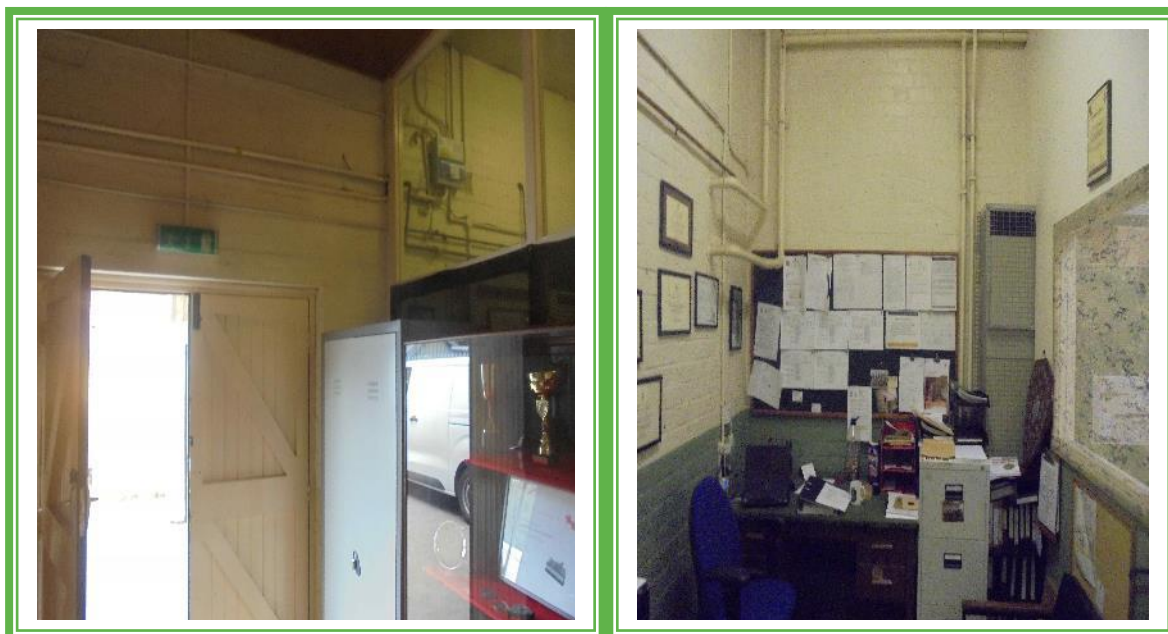
Item No: 1

Material Description:	Visual Inspection – No Suspect Materials Found	
Identification:	N/A	
Approx. quantity:	N/A	
Accessibility	N/A	<i>Assessment Score</i>
Product type:		N/A
Extent of Damage:		N/A
Surface Treatment:		N/A
Asbestos type:		N/A
Material Assessment Score:		N/A
Priority Assessment Score:		N/A
Action:	N/A	
Comments:	Plasterboard suspended ceiling panels

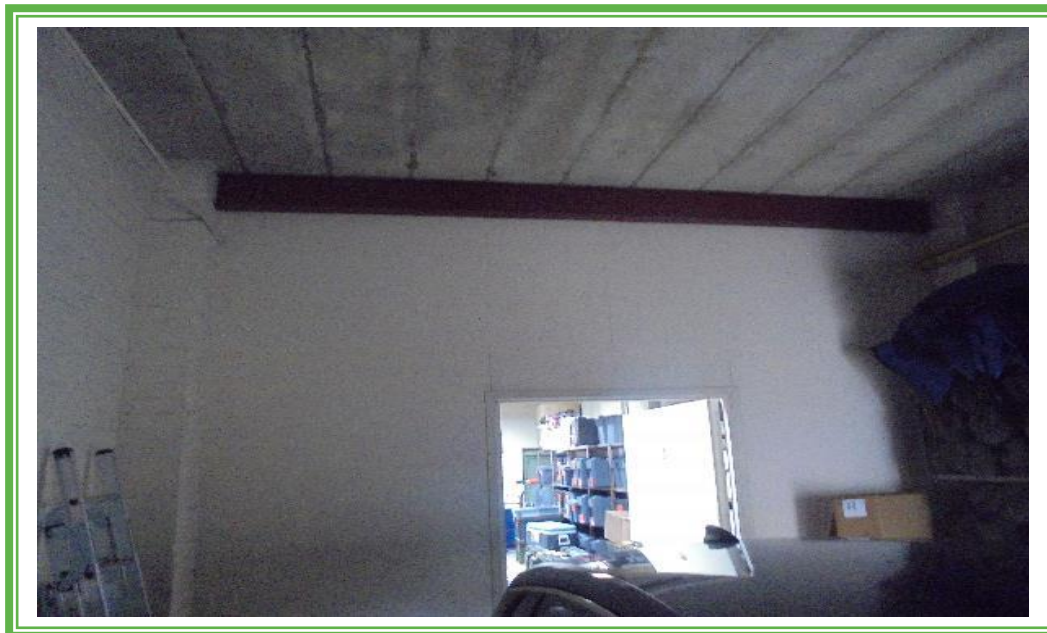
Item No: 4

Material Description:	Insulation board panels to door and walls	
Identification:	Sampled - No Asbestos Detected	
Approx. quantity:	12M2	
Accessibility	N/A	<i>Assessment Score</i>
Product type:		N/A
Extent of Damage:		N/A
Surface Treatment:		N/A
Asbestos type:		N/A
Material Assessment Score:		N/A
Priority Assessment Score:		N/A
Action:	N/A	
Comments:	N/A

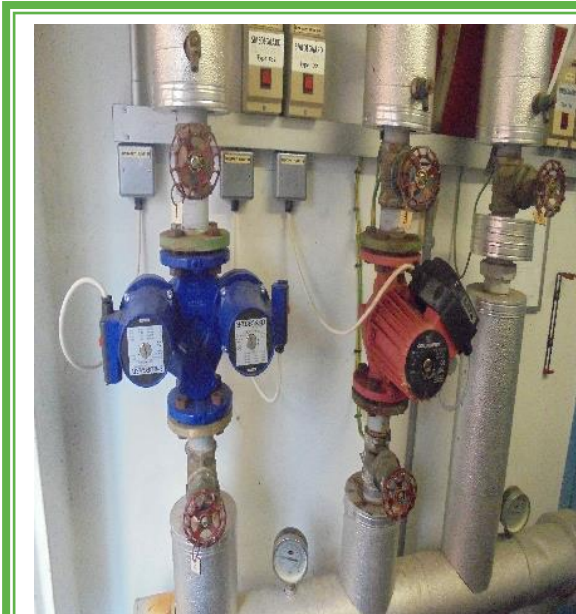
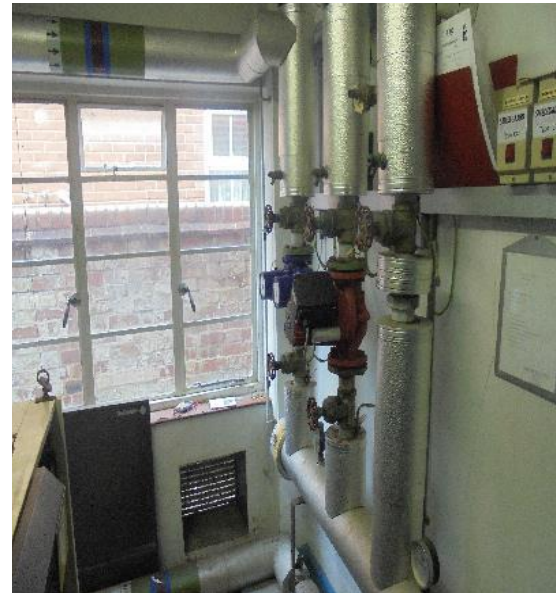
Item No: 11

Material Description:	Gaskets	
Identification:	Sampled – No Asbestos Detected	
Approx. quantity:	X 4 Gaskets	
Accessibility	N/A	<i>Assessment Score</i>
Product type:		N/A
Extent of Damage:		N/A
Surface Treatment:		N/A
Asbestos type:		N/A
Material Assessment Score:		N/A
Priority Assessment Score:		N/A
Action:	N/A	
Comments:	N/A

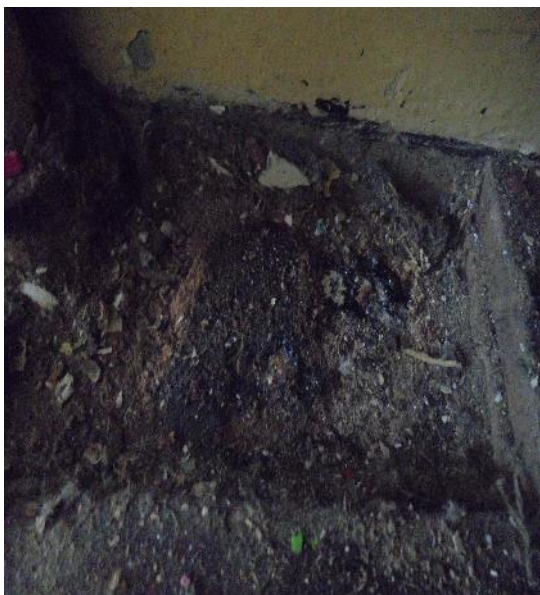
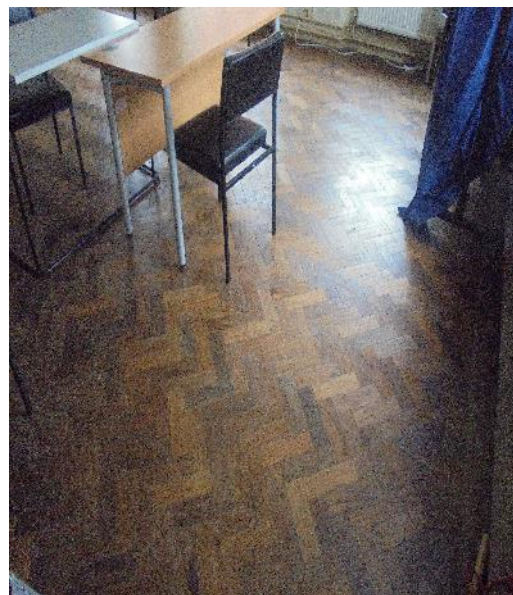
Item No: 13

Material Description:	Bitumen Adhesive under Parquet Flooring	
Identification:	Sampled – No Asbestos Detected	
Approx. quantity:	52M2	
Accessibility	N/A	<i>Assessment Score</i>
Product type:		N/A
Extent of Damage:		N/A
Surface Treatment:		N/A
Asbestos type:		N/A
Material Assessment Score:		N/A
Priority Assessment Score:		N/A
Action:	N/A	
Comments:	N/A

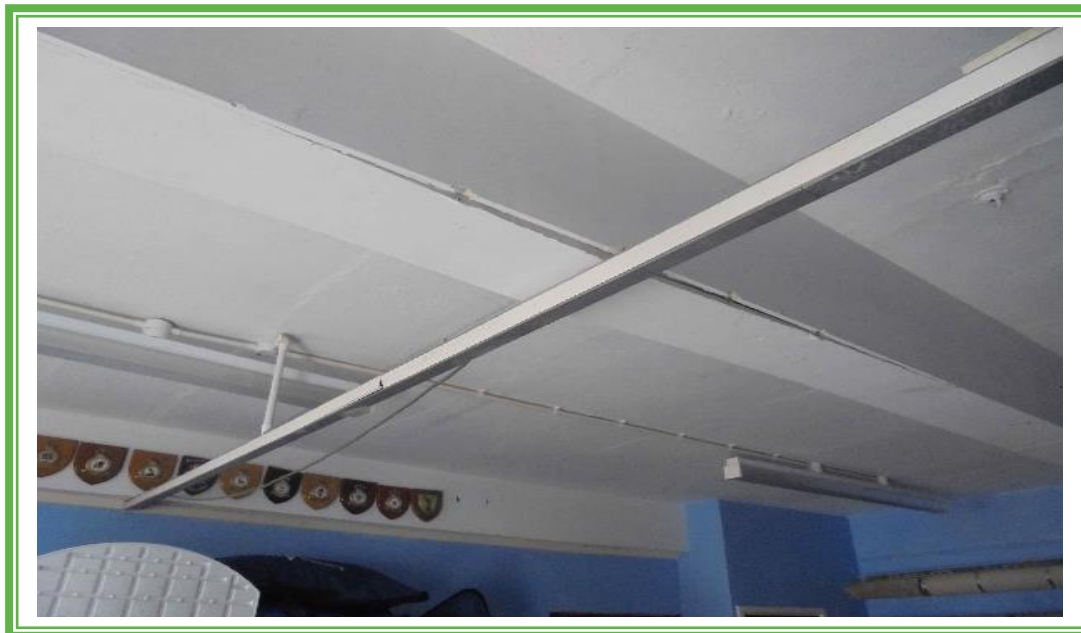
**Item No: 14****Sample No: DK/5****Location: Ground Floor – Stores x 3**

Material Description:	Insulation Board Panels to Beams	
Identification:	Sampled – No Asbestos Detected	
Approx. quantity:	14LM	
Accessibility	N/A	<i>Assessment Score</i>
Product type:		N/A
Extent of Damage:		N/A
Surface Treatment:		N/A
Asbestos type:		N/A
Material Assessment Score:		N/A
Priority Assessment Score:		N/A
Action:	N/A	
Comments:	Limited access into stores due to stored items

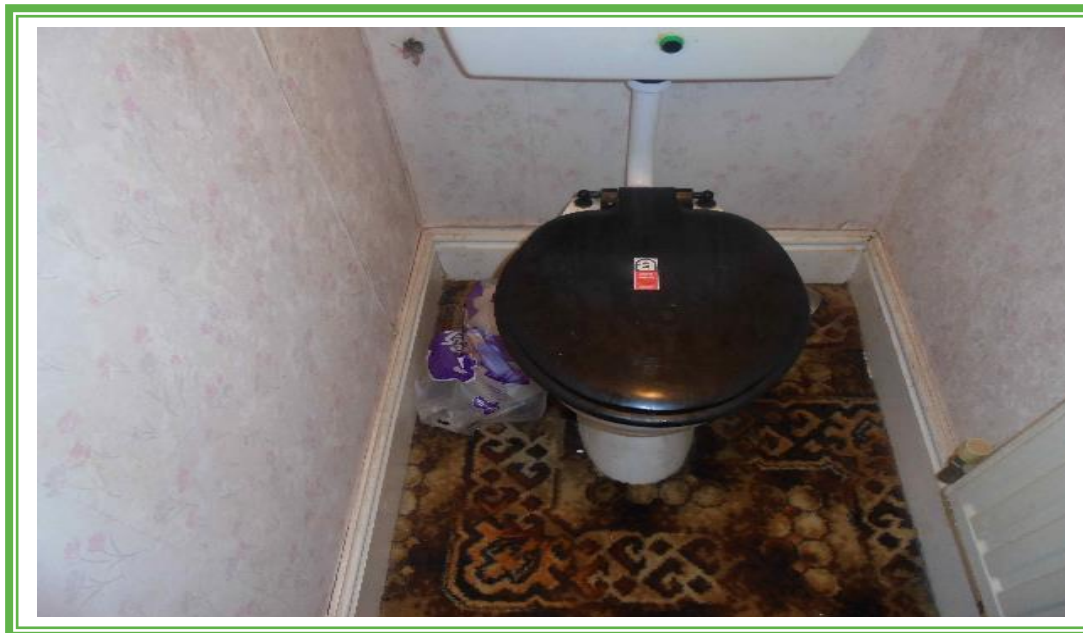
Item No: 22

Material Description:	Toilet seat	
Identification:	Sampled – No Asbestos Detected	
Approx. quantity:	X 1 Seat	
Accessibility	N/A	<i>Assessment Score</i>
Product type:		N/A
Extent of Damage:		N/A
Surface Treatment:		N/A
Asbestos type:		N/A
Material Assessment Score:		N/A
Priority Assessment Score:		N/A
Action:	N/A	
Comments:	Non-Asbestos fiberboard ceiling in WC. Non-Asbestos floor tiles under carpet

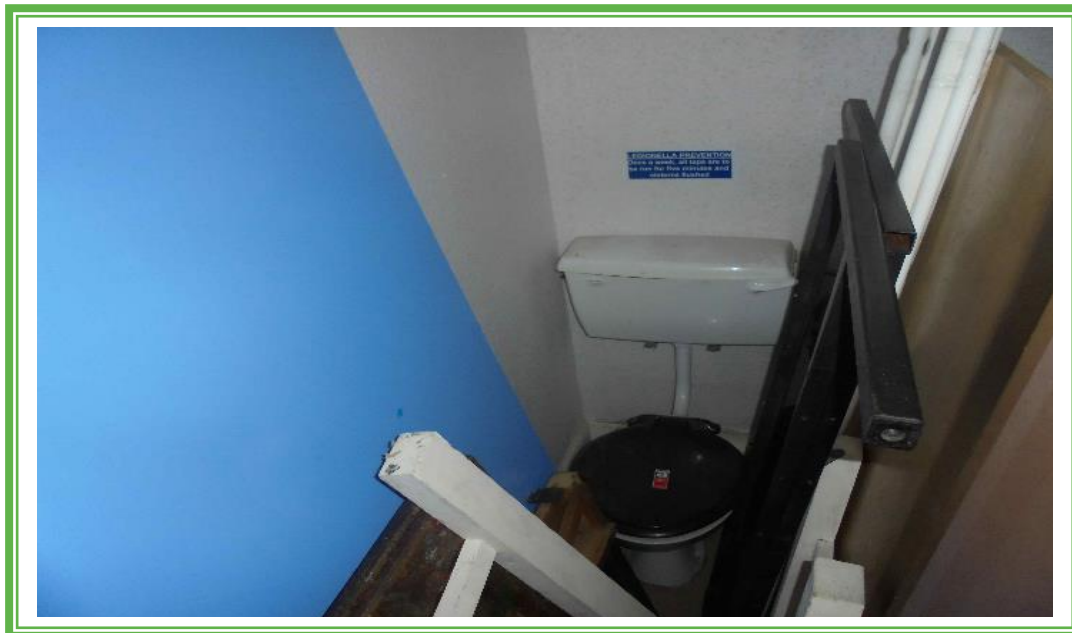
Item No: 25

Material Description:	Toilet Seat	
Identification:	As Per Sample DK/8 – No Asbestos Detected	
Approx. quantity:	X 1 Seat	
Accessibility	N/A	<i>Assessment Score</i>
Product type:		N/A
Extent of Damage:		N/A
Surface Treatment:		N/A
Asbestos type:		N/A
Material Assessment Score:		N/A
Priority Assessment Score:		N/A
Action:	N/A	
Comments:	Limited access into room due to stored items

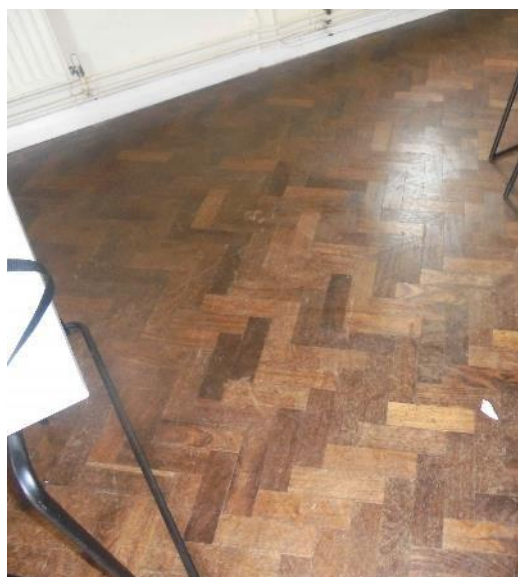
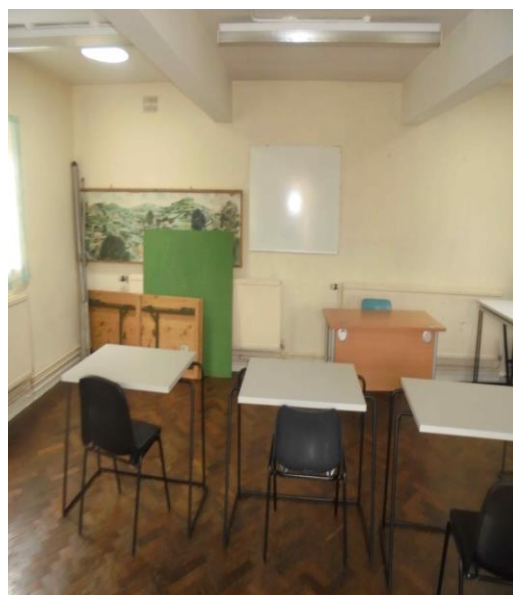
Item No: 29

Material Description:	Adhesive under parquet flooring	
Identification:	As Per Sample DK/4 – No Asbestos Detected	
Approx. quantity:	36M2	
Accessibility	N/A	<i>Assessment Score</i>
Product type:		N/A
Extent of Damage:		N/A
Surface Treatment:		N/A
Asbestos type:		N/A
Material Assessment Score:		N/A
Priority Assessment Score:		N/A
Action:	N/A	
Comments:	N/A

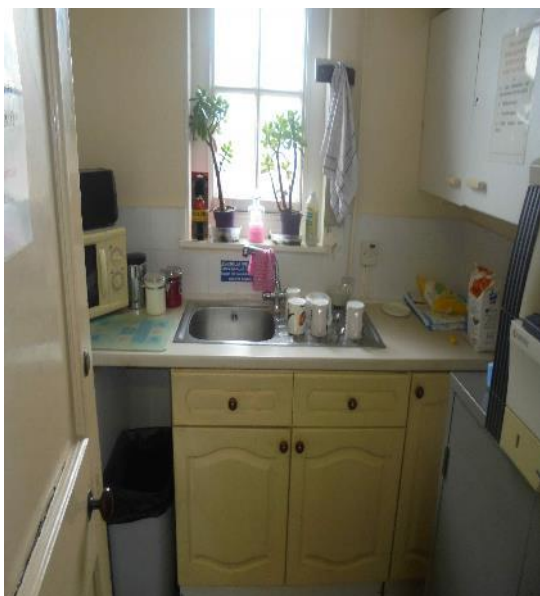
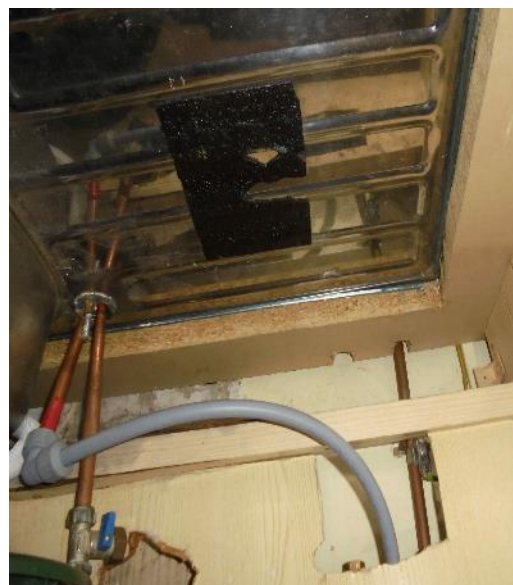
Material Description:	Sink Pad	
Identification:	Sampled – No Asbestos Detected	
Approx. quantity:	X 1 Sink	
Accessibility	N/A	<i>Assessment Score</i>
Product type:		N/A
Extent of Damage:		N/A
Surface Treatment:		N/A
Asbestos type:		N/A
Material Assessment Score:		N/A
Priority Assessment Score:		N/A
Action:	N/A	
Comments:	N/A

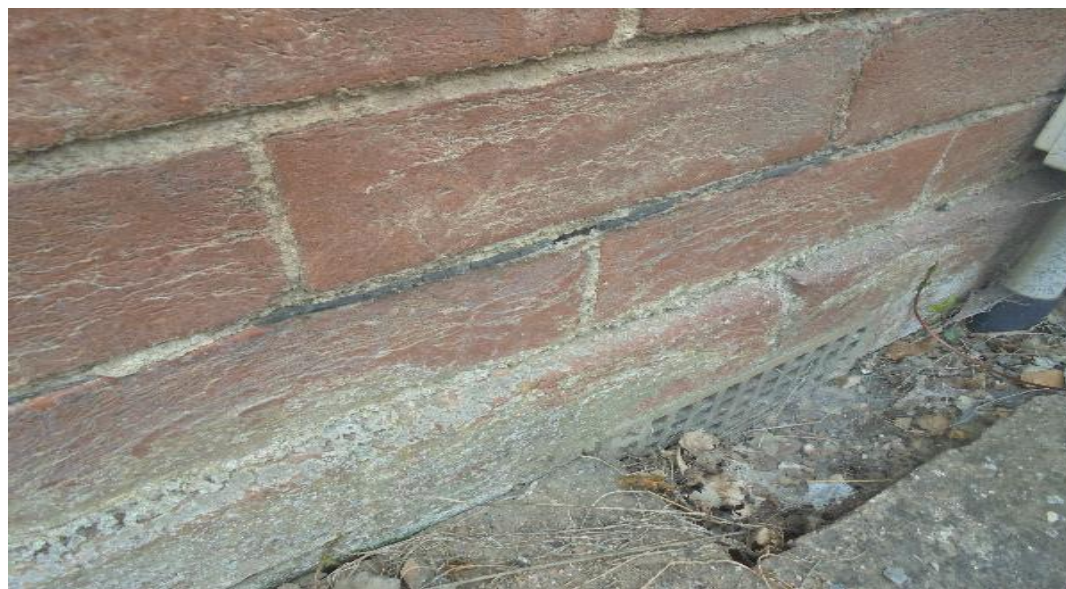
Material Description:	Bitumen Damp Proof Course	
Identification:	Sampled – No Asbestos Detected	
Approx. quantity:	To the entire perimeter of building	
Accessibility	N/A	<i>Assessment Score</i>
Product type:		N/A
Extent of Damage:		N/A
Surface Treatment:		N/A
Asbestos type:		N/A
Material Assessment Score:		N/A
Priority Assessment Score:		N/A
Action:	N/A	
Comments:	N/A
