**Project Number A-00649 (3700)**

**Re-Inspection  
Asbestos Survey Report**

**Yoxter Cadet Training Camp  
CTC Somerset  
Cheddar  
BS5 3BS**

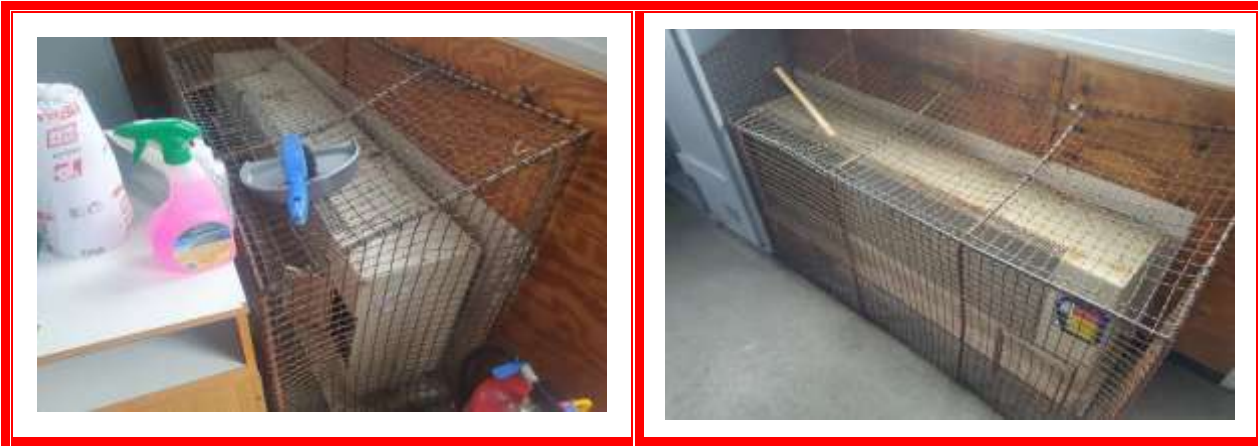
| <b>Location:</b> | Ground Floor - Building 4 - Bedroom 001 | | |

| <b>Material Description:</b> | Heaters - No Access Gained | |
| <b>Identification:</b> | Presumed to Contain Asbestos | |
| <b>Product type:</b> | Asbestos Insulating Board | 2 |
| <b>Extent of Damage:</b> | Major damage | 3 |
| <b>Surface Treatment:</b> | Unsealed Insulation | 3 |
| <b>Asbestos type:</b> | Amosite, Chrysotile | 2 |
| <b>Material Assessment Score:</b> | | 10 |
| <b>Priority Assessment Score:</b> | | High |
| <b>Comments:</b> | No access within live heaters | |

| <b>Action:</b> | Manage | |

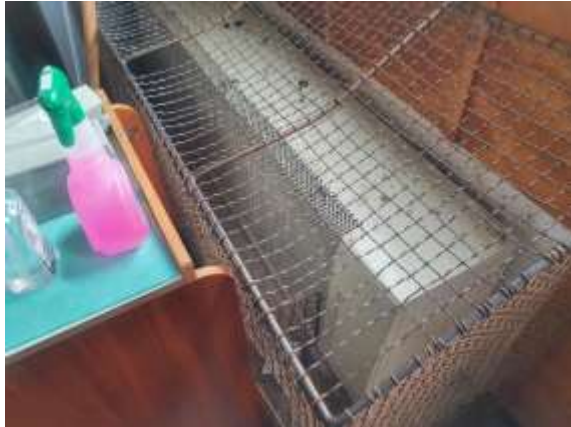
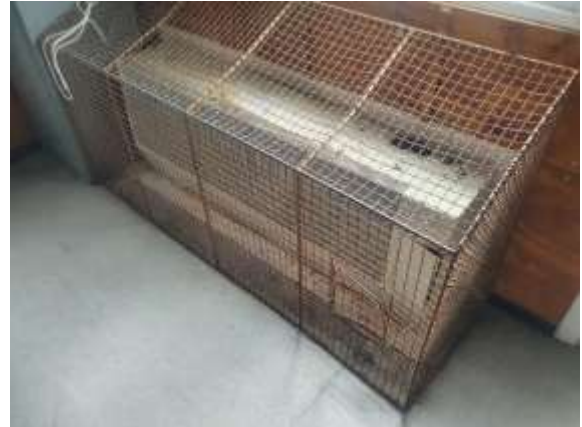
**Location:** Ground Floor - Building 6 - Classroom 002

| <b>Material Description:</b> | Heaters - No Access Gained | |
| <b>Identification:</b> | Presumed to Contain Asbestos | |
| <b>Product type:</b> | Asbestos Insulating Board | 2 |
| <b>Extent of Damage:</b> | Major damage | 3 |
| <b>Surface Treatment:</b> | Unsealed Insulation | 3 |
| <b>Asbestos type:</b> | Amosite, Chrysotile | 2 |
| <b>Material Assessment Score:</b> | | 10 |
| <b>Priority Assessment Score:</b> | | High |
| <b>Comments:</b> | No access within live heaters | |

| <b>Action:</b> | Manage | |

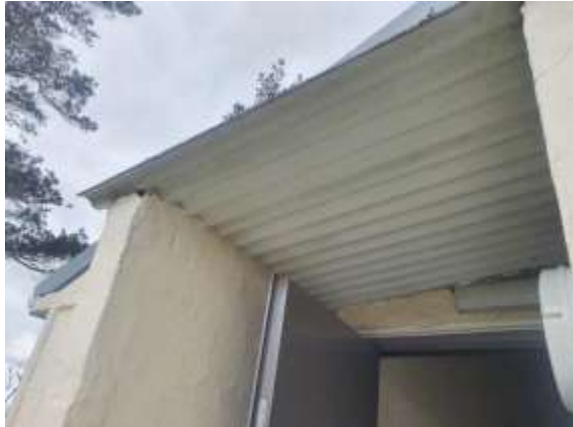
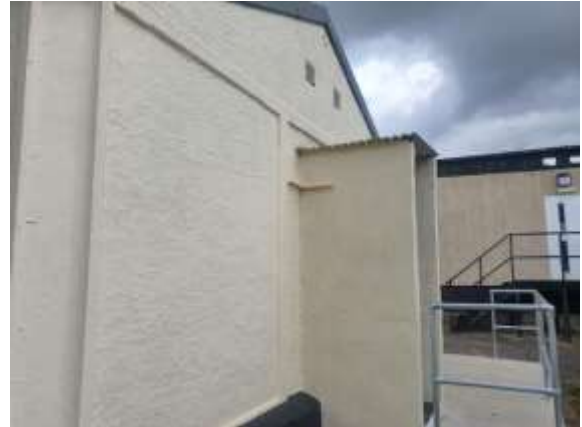
**Location:** External - Building 10 - Porch 009

| <b>Material Description:</b> | Profiled Roof - Cement Product | |
| <b>Identification:</b> | Previously Sampled - Asbestos Detected | |
| <b>Product type:</b> | Cement | 1 |
| <b>Extent of Damage:</b> | Slight / minor damage | 1 |
| <b>Surface Treatment:</b> | Unsealed Cement | 1 |
| <b>Asbestos type:</b> | Chrysotile | 1 |
| <b>Material Assessment Score:</b> | | 4 |
| <b>Priority Assessment Score:</b> | | Negligible |
| <b>Comments:</b> | Previously sampled ref: Armour 23/10/19 Sample DK/7 | |

| <b>Action:</b> | Manage | |

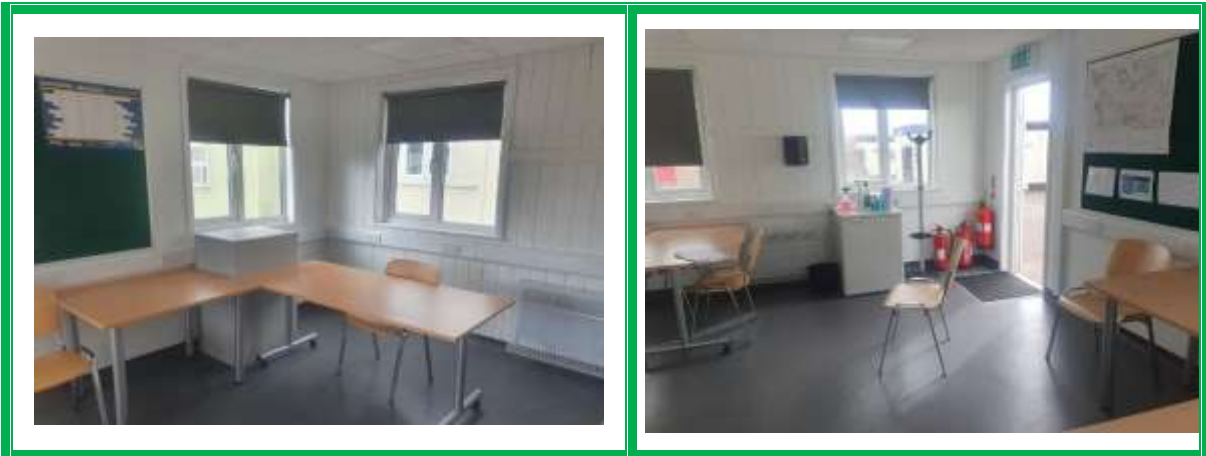
| <b>Location:</b> | Ground Floor - Building 8 - Office 003 | | |

| <b>Material Description:</b> | No Suspect Materials Found | |
| <b>Comments:</b> | Safe has been removed from site | |

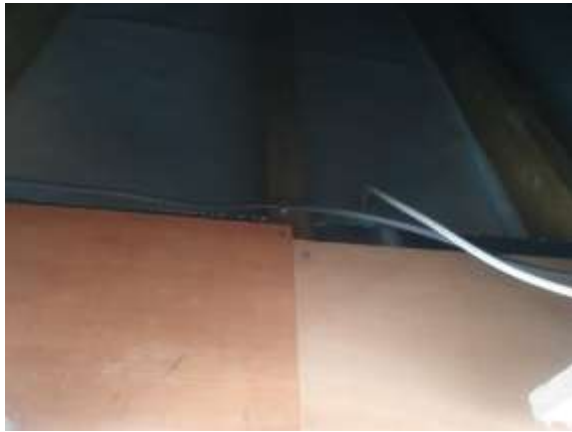
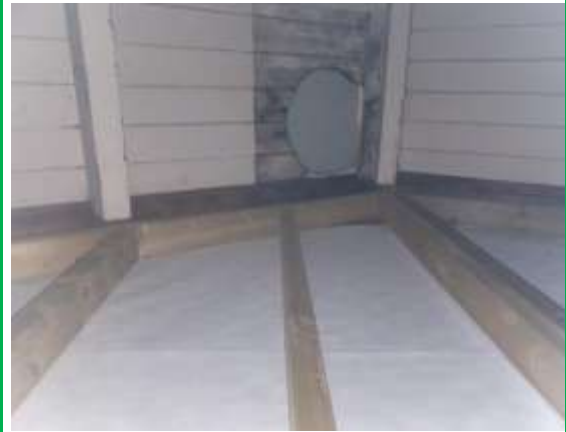
**Location:** Ground Floor - Building 8 - Office 004

| <b>Material Description:</b> | No Suspect Materials Found | |
| <b>Comments:</b> | Panels have been removed | |

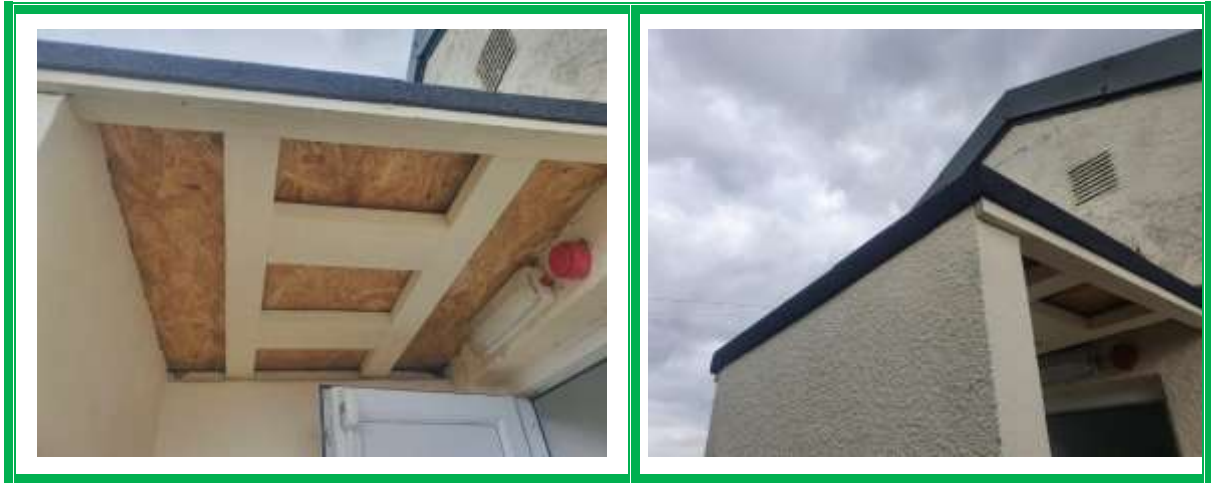
| <b>Location:</b> | External - Building 9 - Porch 005 | | |

| <b>Material Description:</b> | No Suspect Materials Found | |

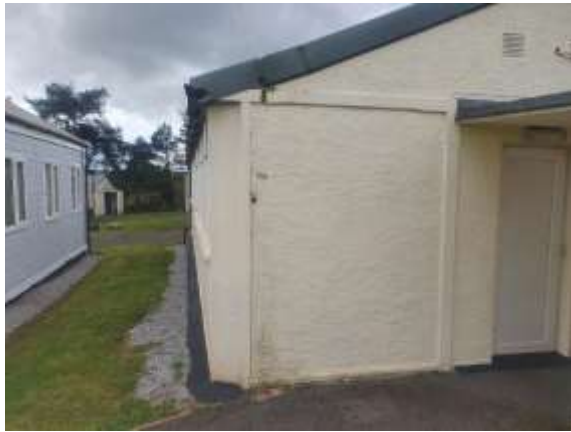
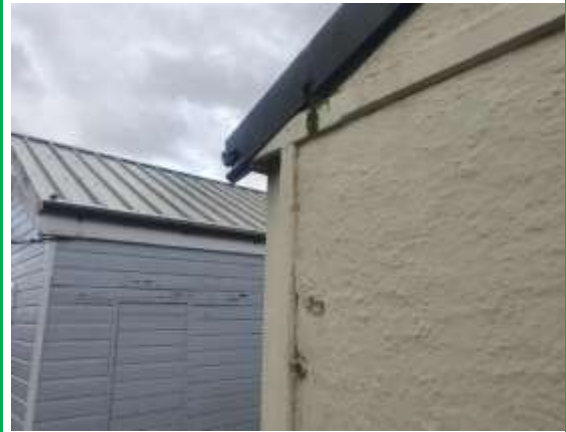
**Location:** External - Building 9 006

| <b>Material Description:</b> | No Suspect Materials Found | |
| <b>Comments:</b> | Downpipe has been removed | |

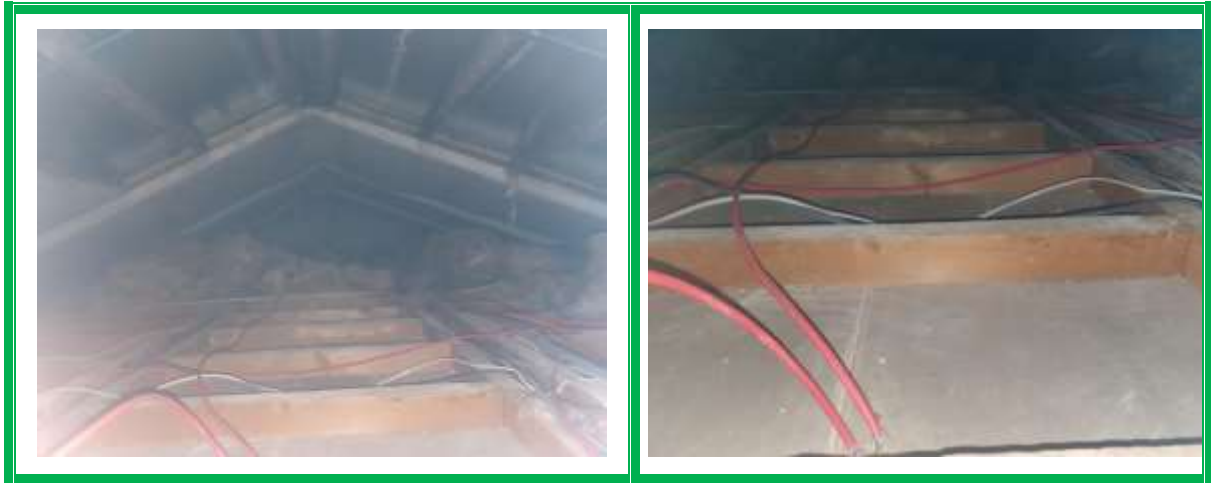
**Location:** Ground Floor - Building 9 - Loft Space 007

| <b>Material Description:</b> | No Suspect Materials Found | |
| <b>Comments:</b> | Roof space has been completed refurbished and all debris removed | |

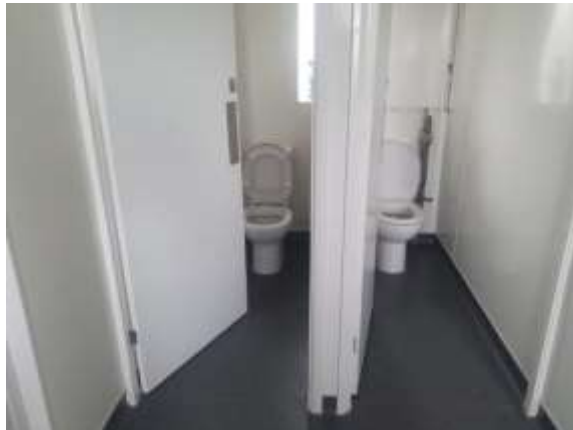
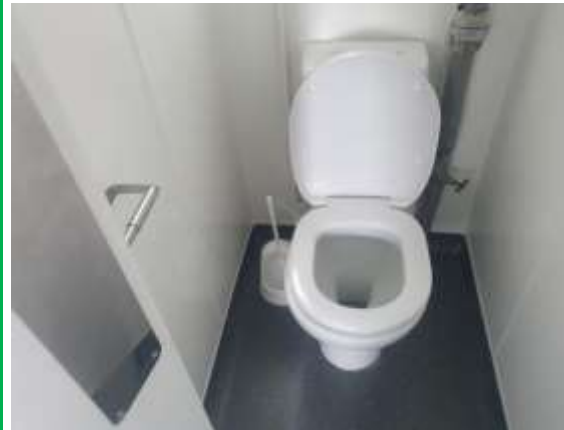
**Location:** Ground Floor - Building 9 - WC 008

| <b>Material Description:</b> | No Suspect Materials Found | |
| <b>Comments:</b> | Toilet seat removed | |

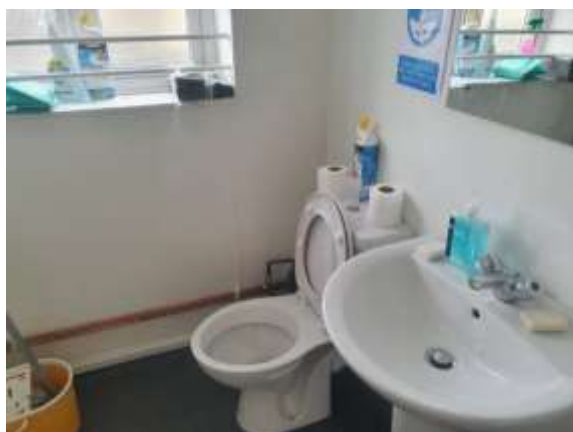
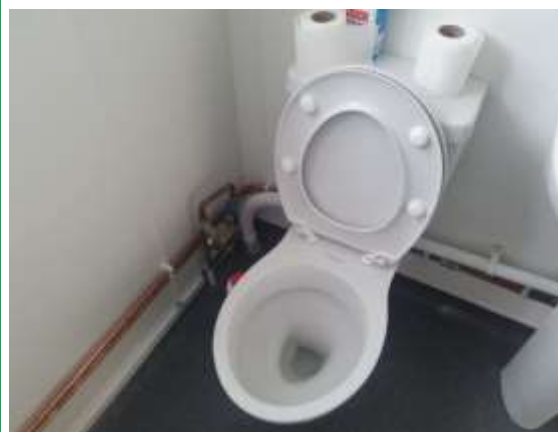
**Location:** Ground Floor - Building 10 - WC 010

| <b>Material Description:</b> | No Suspect Materials Found | |
| <b>Comments:</b> | Toilet seat removed | |

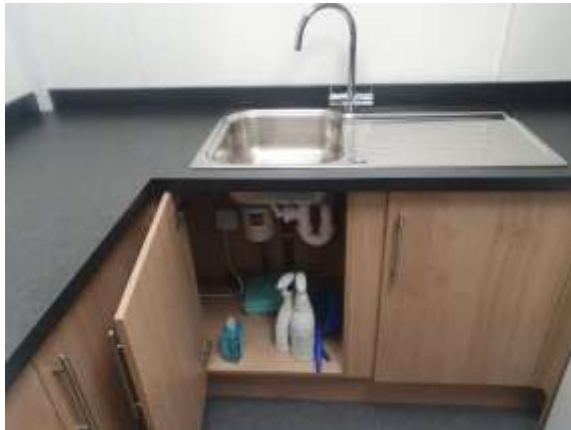
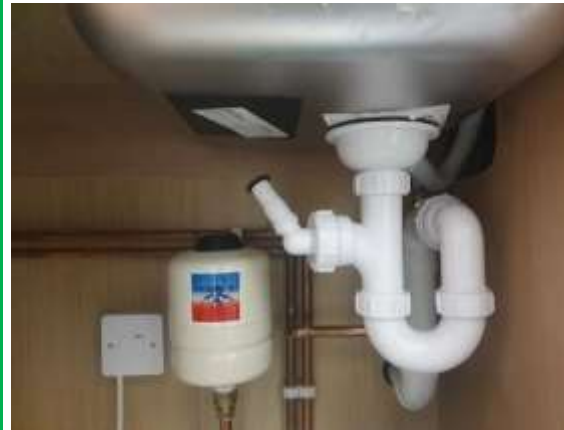
**Location:** Ground Floor - Building 10 - Bar 011

| <b>Material Description:</b> | No Suspect Materials Found | |
| <b>Comments:</b> | Sink replaced. Modern sink pad | |

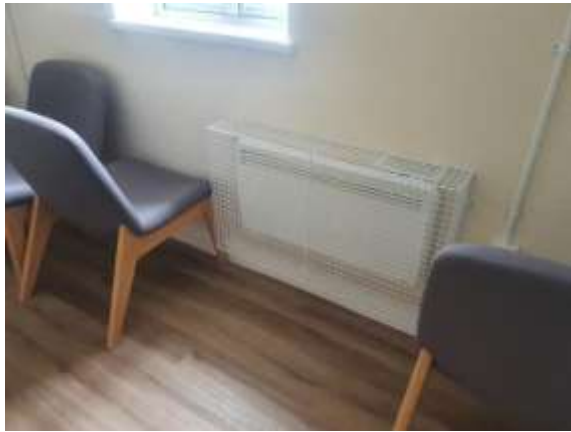
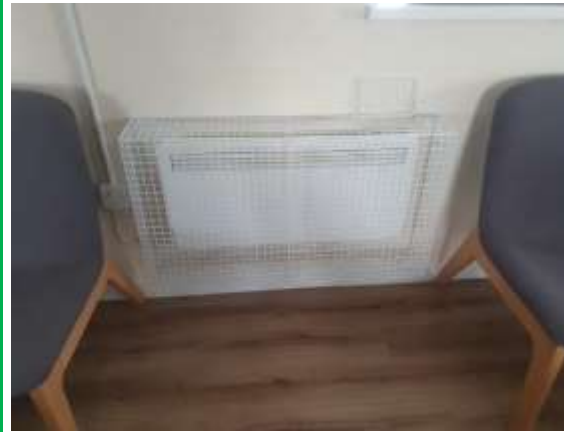
**Location:** Ground Floor - Building 10 - Mess Room 012

| <b>Material Description:</b> | No Suspect Materials Found | |
| <b>Comments:</b> | Heaters replaced with modern heaters | |
