**Project Number 2481**

**Management  
Asbestos Survey Report**

**Priorswood Platoon, Taunton, TA2 7EF**

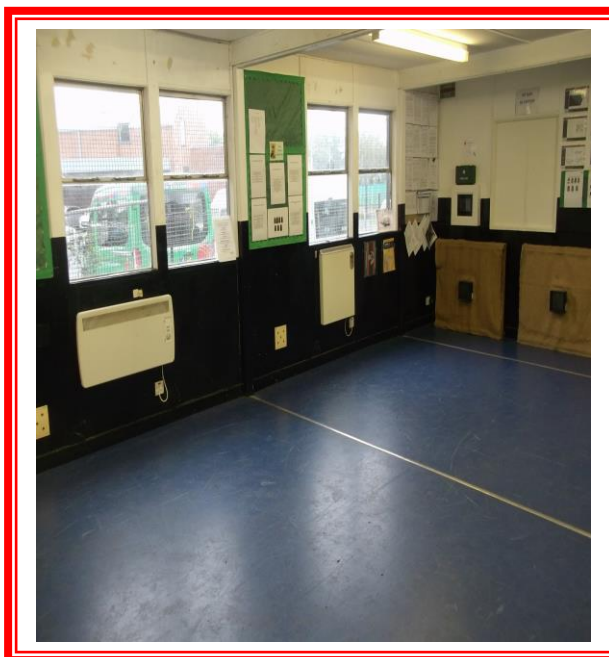
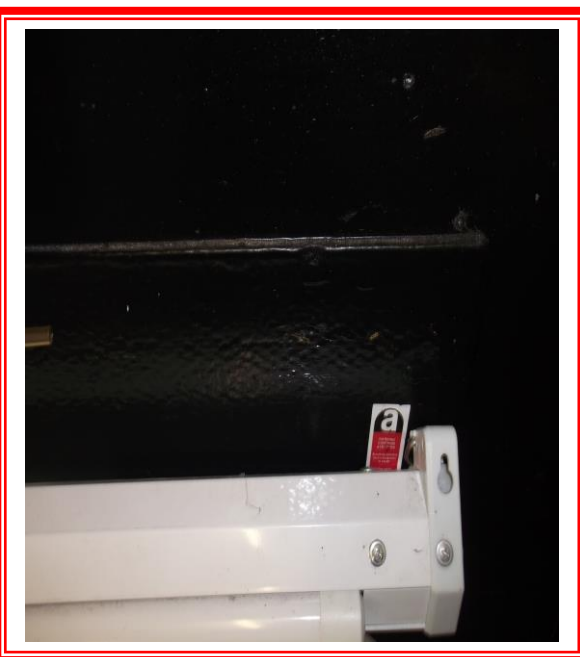
**Item No: 1**

<b>Material Description:</b>	Insulating Board behind Wall Heaters	
<b>Identification:</b>	As Per Previous Sample – Asbestos Detected	
<b>Approx. quantity:</b>	X 4	
<b>Accessibility</b>	Medium	<i>Assessment Score</i>
<b>Product type:</b>	Insulating Board	2
<b>Extent of Damage:</b>	Moderate	2
<b>Surface Treatment:</b>	Sealed	1
<b>Asbestos type:</b>	Amosite	2
<b>Material Assessment Score:</b>		7
<b>Priority Assessment Score:</b>		Medium
<b>Action:</b>	Manage	
<b>Comments:</b>	Fineline Environmental Survey, 20 <sup>th</sup> November 2018, Sample Number 6-98774

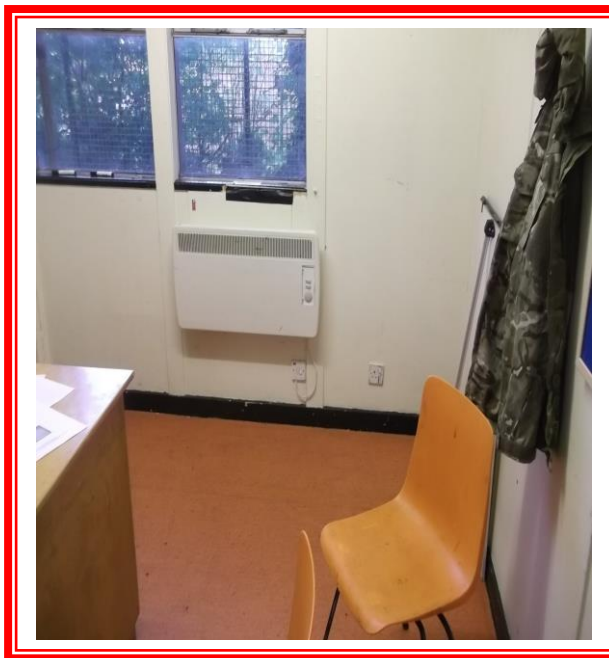
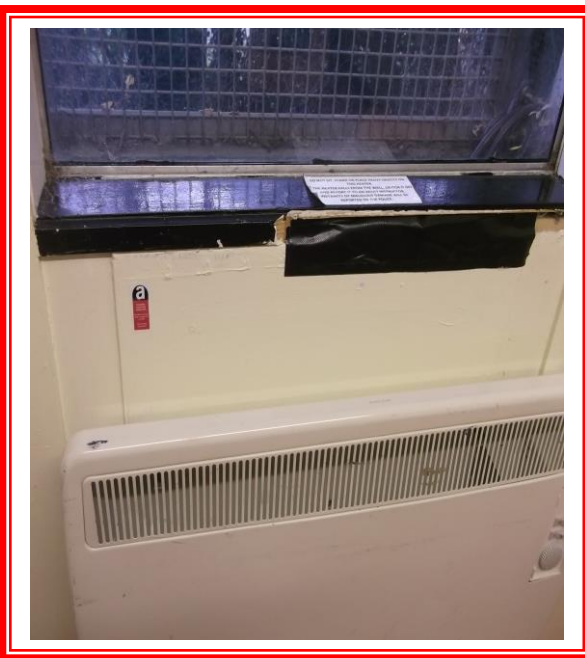
**Item No: 2**

<b>Material Description:</b>	Insulation Board behind Wall Heaters	
<b>Identification:</b>	As Per Previous Sample – Asbestos Detected	
<b>Approx. quantity:</b>	X 2	
<b>Accessibility</b>	Medium	Assessment Score
<b>Product type:</b>	Insulation Board	2
<b>Extent of Damage:</b>	Major	3
<b>Surface Treatment:</b>	Unsealed	2
<b>Asbestos type:</b>	Amosite	2
<b>Material Assessment Score:</b>		9
<b>Priority Assessment Score:</b>		Medium
<b>Action:</b>	Remove	
<b>Comments:</b>	Fineline Environmental Survey, 20 <sup>th</sup> November 2018, Sample Number 6-98774

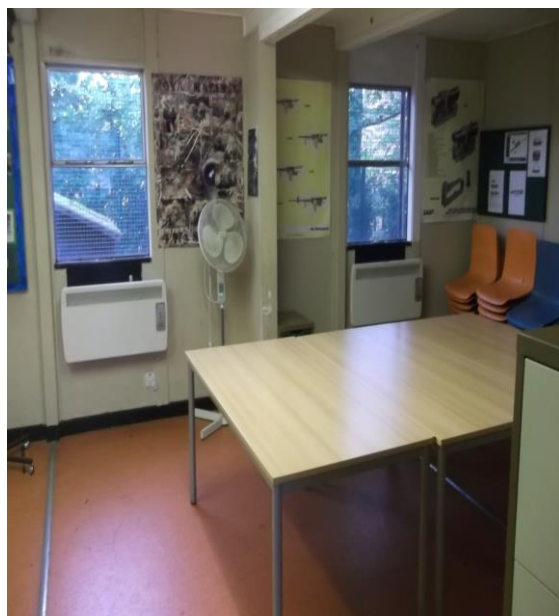
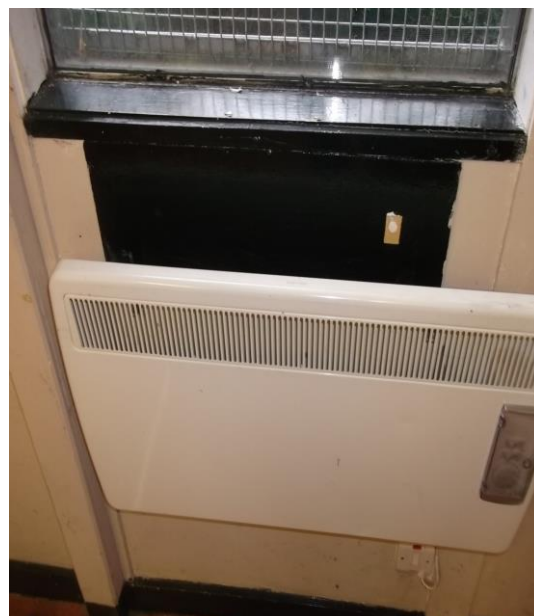
**Item No: 3**

<b>Material Description:</b>	Insulation Board behind Wall Heaters	
<b>Identification:</b>	As Per Previous Sample – Asbestos Detected	
<b>Approx. quantity:</b>	X 2	
<b>Accessibility</b>	Medium	Assessment Score
<b>Product type:</b>	Insulation Board	2
<b>Extent of Damage:</b>	Major	3
<b>Surface Treatment:</b>	Sealed	1
<b>Asbestos type:</b>	Amosite	2
<b>Material Assessment Score:</b>		8
<b>Priority Assessment Score:</b>		Medium
<b>Action:</b>	Manage	
<b>Comments:</b>	Fineline Environmental Survey, 20 <sup>th</sup> November 2018, Sample Number 6-98774

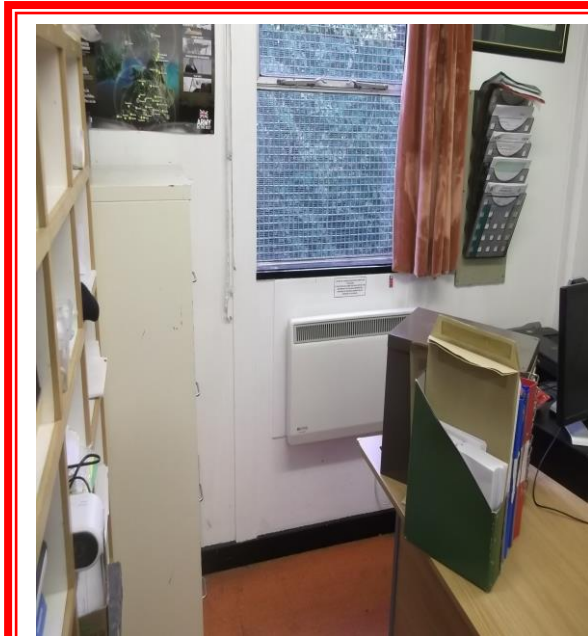
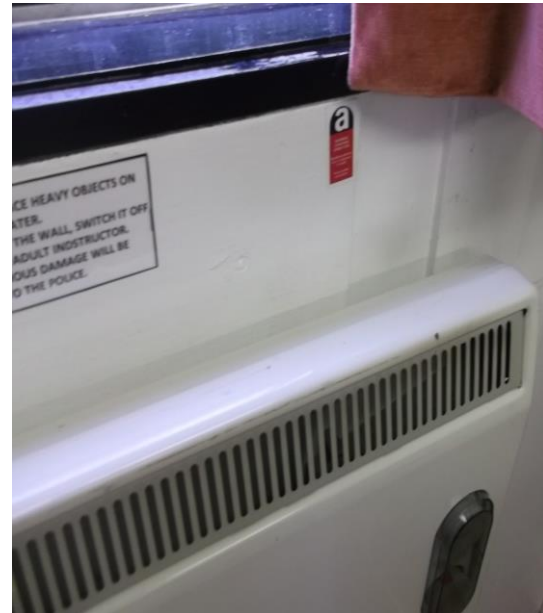
**Item No: 5**

<b>Material Description:</b>	Insulation Board behind Wall Heater	
<b>Identification:</b>	As Per Previous Sample – Asbestos Detected	
<b>Approx. quantity:</b>	X 1	
<b>Accessibility</b>	Medium	Assessment Score
<b>Product type:</b>	Insulation Board	2
<b>Extent of Damage:</b>	Moderate	2
<b>Surface Treatment:</b>	Sealed	1
<b>Asbestos type:</b>	Amosite	2
<b>Material Assessment Score:</b>		7
<b>Priority Assessment Score:</b>		Negligible
<b>Action:</b>	Manage	
<b>Comments:</b>	Fineline Environmental Survey, 20 <sup>th</sup> November 2018, Sample Number 6-98774

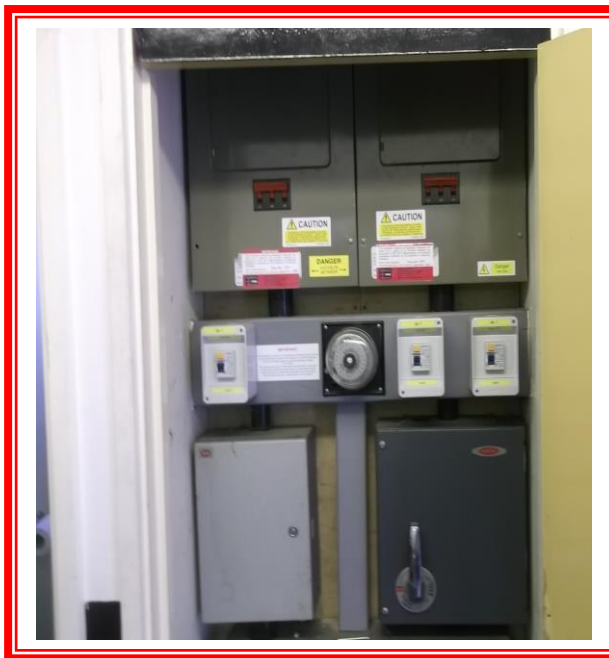
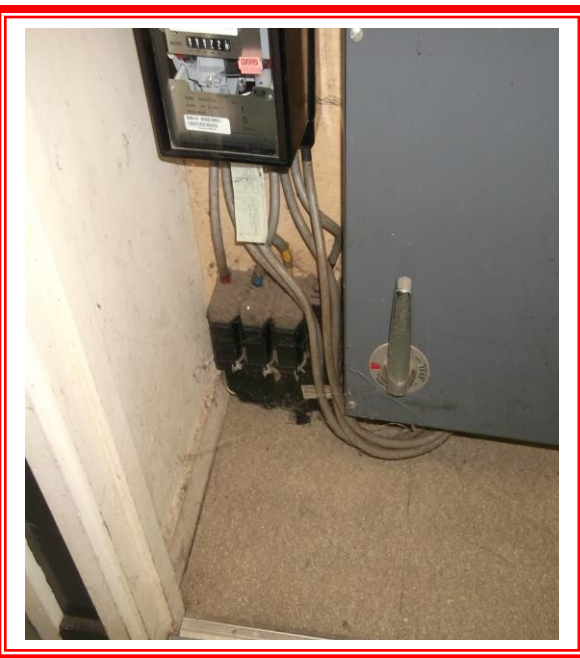
**Item No: 7**

**Item 7 – Ground Floor – Lobby and Electric Cupboard – Flashguards to Electrics – Strongly Presumed to Contain Asbestos – No Safe Access to Sample**

<b>Material Description:</b>	Flashguards to Electrics	
<b>Identification:</b>	Strongly Presumed to Contain Asbestos	
<b>Approx. quantity:</b>	X 3	
<b>Accessibility</b>	High	Assessment Score
<b>Product type:</b>	Textile	1
<b>Extent of Damage:</b>	No Access	3
<b>Surface Treatment:</b>	Unsealed	1
<b>Asbestos type:</b>	Chrysotile	1
<b>Material Assessment Score:</b>		6
<b>Priority Assessment Score:</b>		Low
<b>Action:</b>	Manage	
<b>Comments:</b>	No Safe Access to Safely Sample

The presence of asbestos in these areas cannot be ascertained at this time. If any works are to be carried out in these areas in the future, then these works should be approached cautiously.

In accordance with current legislation, any suspect materials encountered in these areas are to be assumed to contain asbestos until proven otherwise. This will normally involve cessation of works in the affected area.

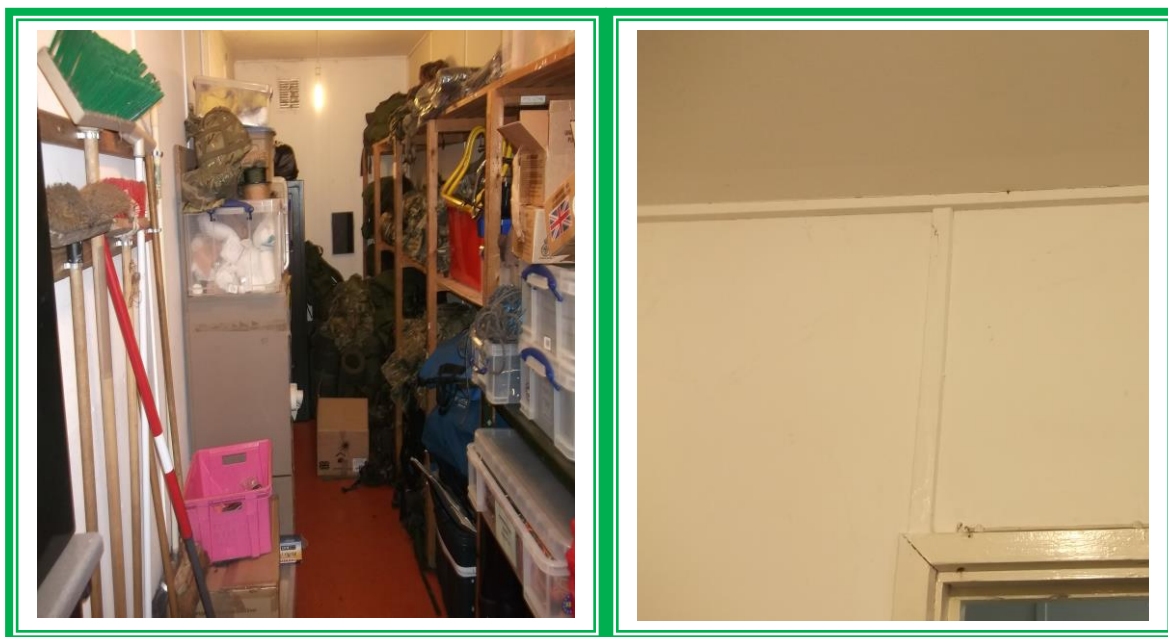
**Item No: 4**
**Sample No: N/A**
**Location: Ground Floor - Stores**

<b>Material Description:</b>	Visual Inspection – No Suspect Materials Found	
<b>Identification:</b>	N/A	
<b>Approx. quantity:</b>	N/A	
<b>Accessibility</b>	N/A	<i>Assessment Score</i>
<b>Product type:</b>	N/A	N/A
<b>Extent of Damage:</b>	N/A	N/A
<b>Surface Treatment:</b>	N/A	N/A
<b>Asbestos type:</b>	N/A	N/A
<b>Material Assessment Score:</b>		N/A
<b>Priority Assessment Score:</b>		N/A
<b>Action:</b>	N/A	
<b>Comments:</b>	N/A

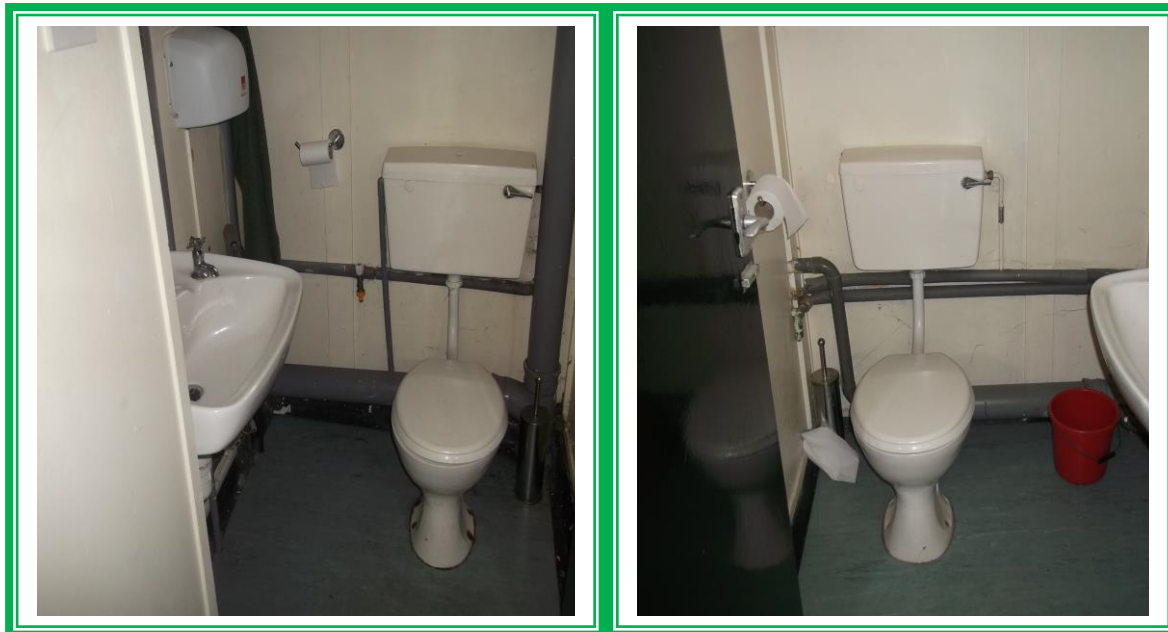
**Item No: 6**

<b>Material Description:</b>	Visual Inspection – No Suspect Materials Found	
<b>Identification:</b>	N/A	
<b>Approx. quantity:</b>	N/A	
<b>Accessibility</b>	N/A	<i>Assessment Score</i>
<b>Product type:</b>	N/A	N/A
<b>Extent of Damage:</b>	N/A	N/A
<b>Surface Treatment:</b>	N/A	N/A
<b>Asbestos type:</b>	N/A	N/A
<b>Material Assessment Score:</b>		N/A
<b>Priority Assessment Score:</b>		N/A
<b>Action:</b>	N/A	
<b>Comments:</b>	N/A

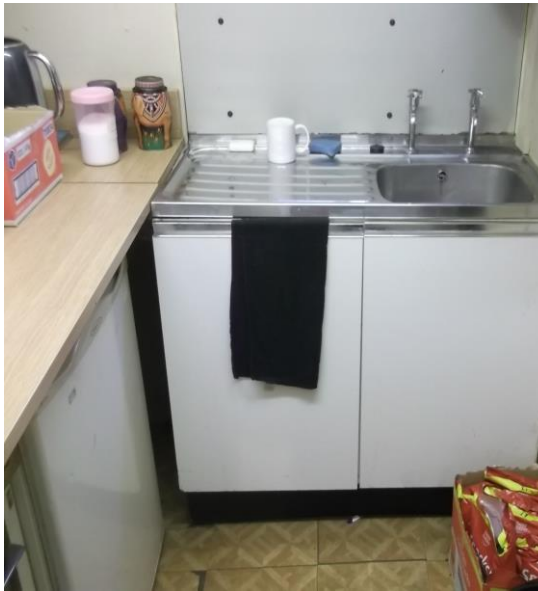
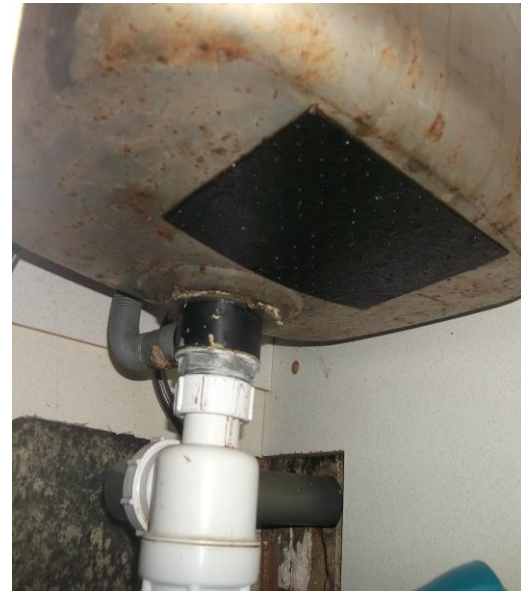
**Item No: 8**

Sample Number	Sample Type	Location	Analysis
GR001	Sink Pad to Sink	Kitchen	N.A.D.I.S

<b>Material Description:</b>	Sink Pad to Sink	
<b>Identification:</b>	Sampled – No Asbestos Detected	
<b>Approx. quantity:</b>	N/A	
<b>Accessibility</b>	N/A	<i>Assessment Score</i>
<b>Product type:</b>	N/A	N/A
<b>Extent of Damage:</b>	N/A	N/A
<b>Surface Treatment:</b>	N/A	N/A
<b>Asbestos type:</b>	N/A	N/A
<b>Material Assessment Score:</b>		N/A
<b>Priority Assessment Score:</b>		N/A
<b>Action:</b>	N/A	
<b>Comments:</b>	Superlux non-Asbestos Panels on Wall in Kitchen

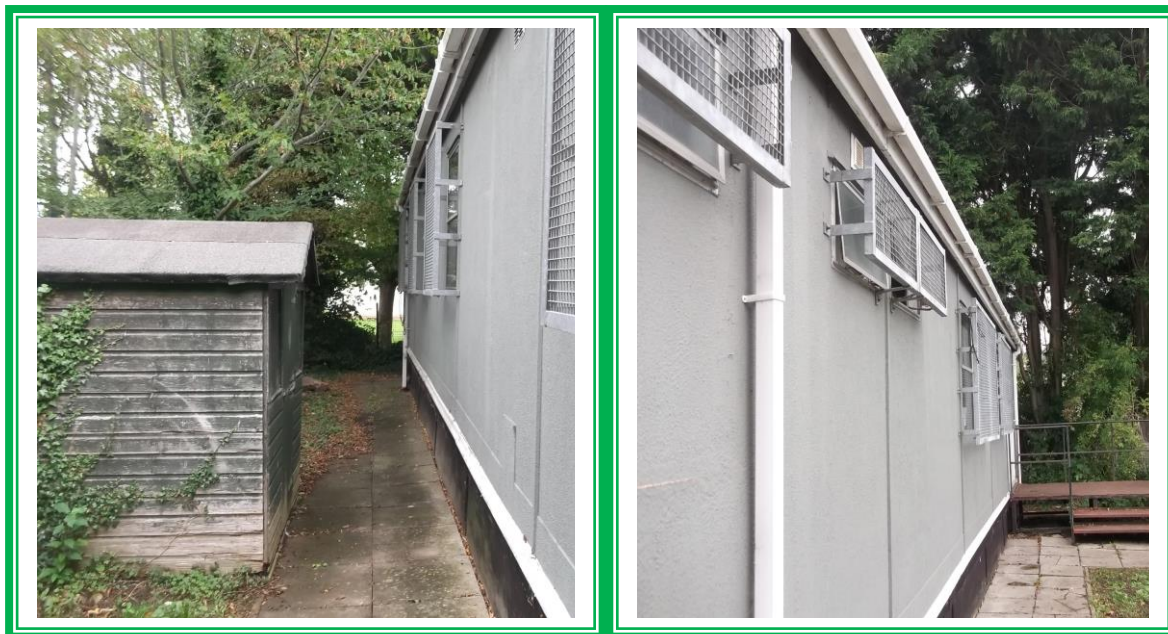
**Item No: 9**

<b>Material Description:</b>	Visual Inspection – No Suspect Materials Found	
<b>Identification:</b>	N/A	
<b>Approx. quantity:</b>	N/A	
<b>Accessibility</b>	N/A	<i>Assessment Score</i>
<b>Product type:</b>	N/A	N/A
<b>Extent of Damage:</b>	N/A	N/A
<b>Surface Treatment:</b>	N/A	N/A
<b>Asbestos type:</b>	N/A	N/A
<b>Material Assessment Score:</b>		N/A
<b>Priority Assessment Score:</b>		N/A
<b>Action:</b>	N/A	
<b>Comments:</b>	N/A
