Project Number A-00524 (5435)

**Re-Inspection
Asbestos Survey Report - Revised**

**6th Battalion the Rifles
C Company (Poole Detachment)
Dorset
BH12 5AD**

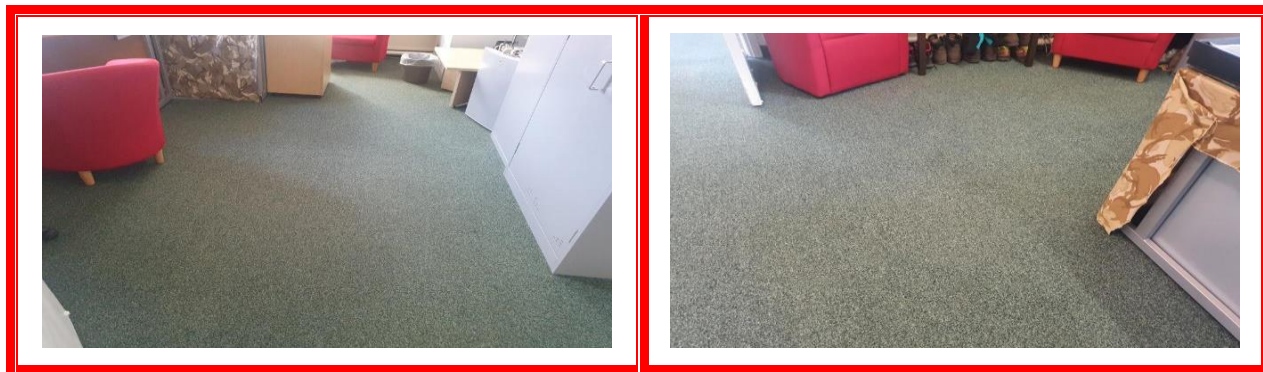
Item No:	1	Sample No:	N/A
Location:	Ground Floor - Main Building - Offices 0.02 and 0.03 001

Material Description:	Floor Tiles and Adhesive - Vinyl Products	
Identification:	Previously Sampled - Asbestos Detected	
Approx. quantity:	32 m ²	
Accessibility	Difficult	Assessment Score
Product type:	Vinyl	1
Extent of Damage:	Slight / minor damage	1
Surface Treatment:	Non-friable	0
Asbestos type:	Chrysotile	1
Material Assessment Score:		3
Priority Assessment Score:		Negligible
Action:	Manage	
Comments:	Previously sampled ref: Armour 4/12/19 Sample DK/2. Under carpet

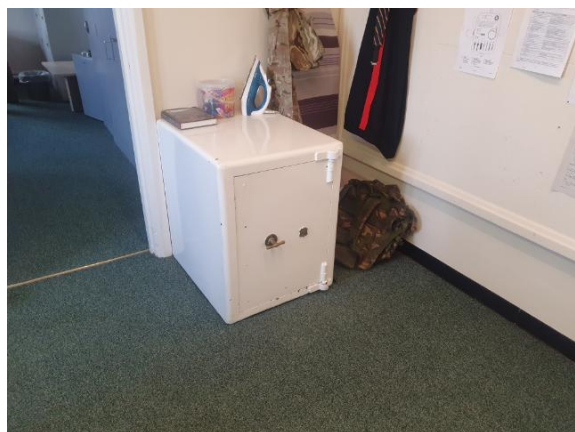
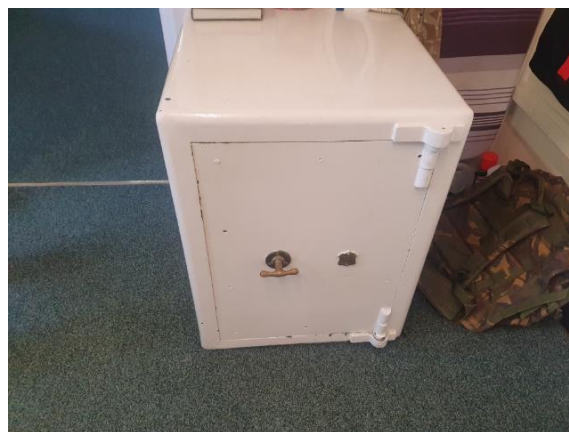
Location: Ground Floor - Main Building- Office 0.02 002

Material Description:	Safe Casings - Insulating Board	
Identification:	Presumed to Contain Asbestos	
Approx. quantity:	1 no	
Accessibility	Difficult	<i>Assessment Score</i>
Product type:	Asbestos Insulating Board	2
Extent of Damage:	Minor damage	1
Surface Treatment:	Unsealed AIB	2
Asbestos type:	Amosite, Chrysotile	2
Material Assessment Score:		7
Priority Assessment Score:		Medium
Action:	Manage	
Comments:	No access within safe casings

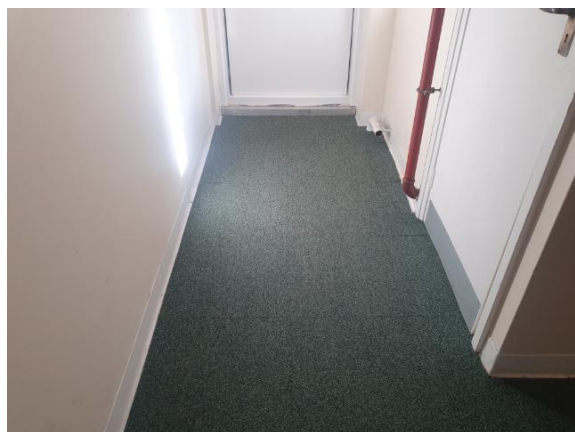
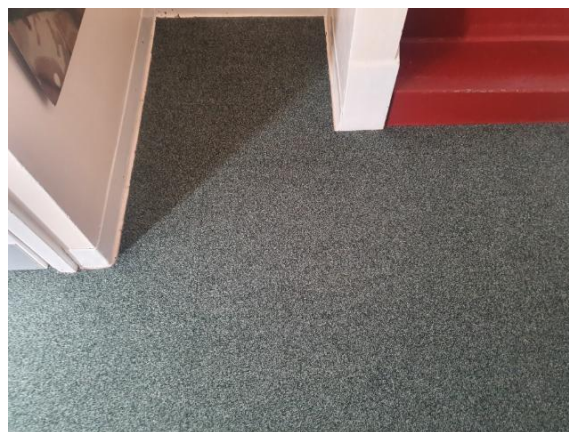
Location: Ground Floor - Main Building - Lobby 0.06 003

Material Description:	Floor Tiles and Adhesive - Vinyl Products	
Identification:	Previously Sampled - Asbestos Detected	
Approx. quantity:	5 m ²	
Accessibility	Difficult	<i>Assessment Score</i>
Product type:	Vinyl	1
Extent of Damage:	Slight / minor damage	1
Surface Treatment:	Non-friable	0
Asbestos type:	Chrysotile	1
Material Assessment Score:		3
Priority Assessment Score:		Negligible
Action:	Manage	
Comments:	Previously sampled ref: Armour 4/12/19 Sample DK/2. Under carpet

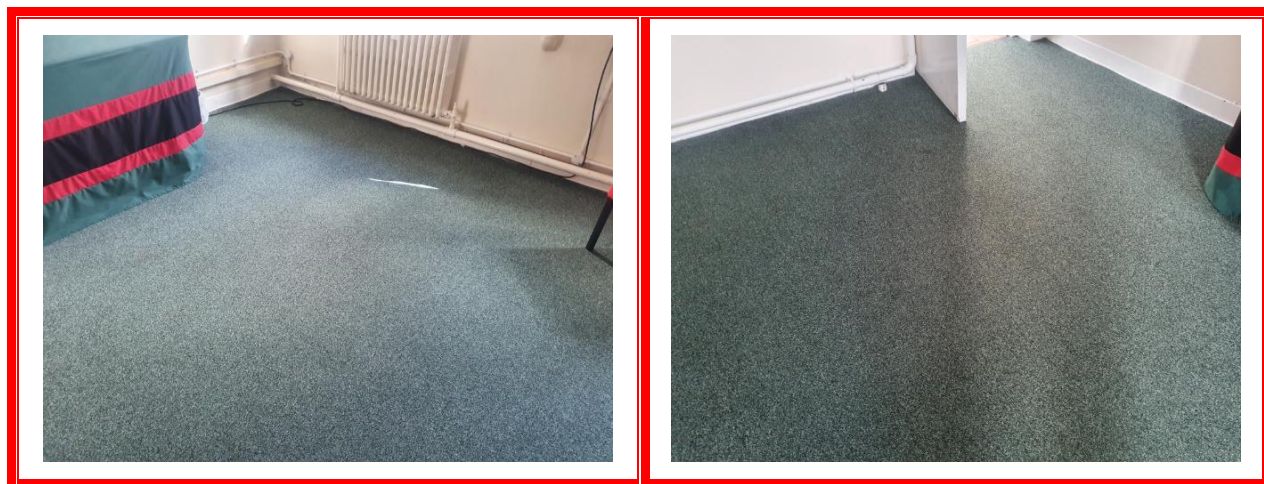
Item No:	4	Sample No:	N/A
Location:	Ground Floor - Main Building - Classroom 0.08 004

Material Description:	Floor Tiles and Adhesive - Vinyl Products	
Identification:	Previously Sampled - Asbestos Detected	
Approx. quantity:	25 m ²	
Accessibility	Difficult	<i>Assessment Score</i>
Product type:	Vinyl	1
Extent of Damage:	Slight / minor damage	1
Surface Treatment:	Non-friable	0
Asbestos type:	Chrysotile	1
Material Assessment Score:		3
Priority Assessment Score:		Negligible
Action:	Manage	
Comments:	Previously sampled ref: Armour 4/12/19 Sample DK/2. Under carpet

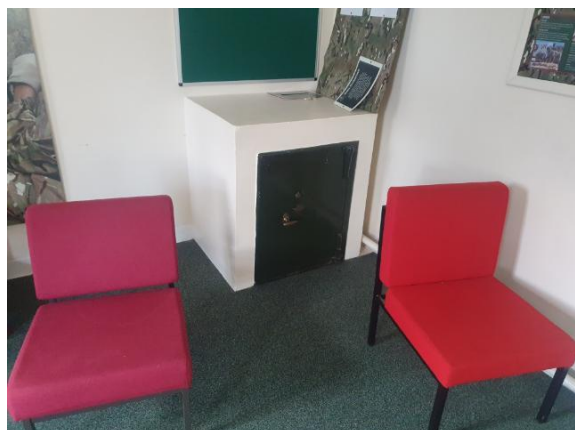
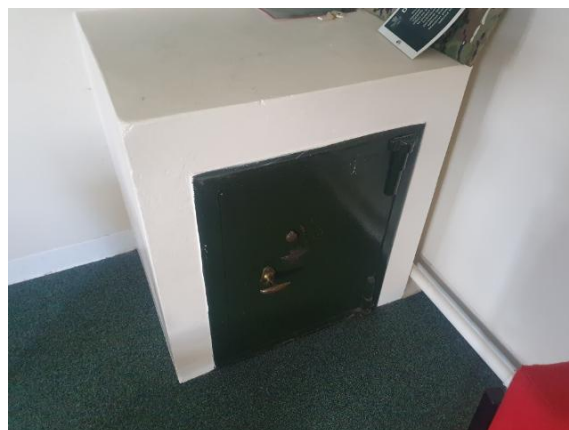
Location: Ground Floor - Main Building- Classroom 0.08 005

Material Description:	Safe Casings - Insulating Board	
Identification:	Presumed to Contain Asbestos	
Approx. quantity:	1 no	
Accessibility	Difficult	<i>Assessment Score</i>
Product type:	Asbestos Insulating Board	2
Extent of Damage:	Minor damage	1
Surface Treatment:	Unsealed AIB	2
Asbestos type:	Amosite, Chrysotile	2
Material Assessment Score:		7
Priority Assessment Score:		Low
Action:	Manage	
Comments:	No access within safe casings

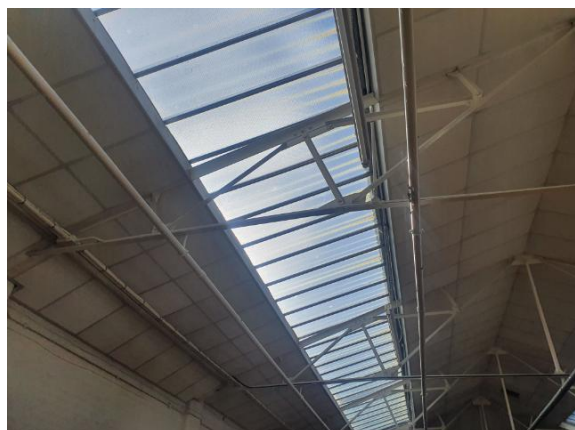
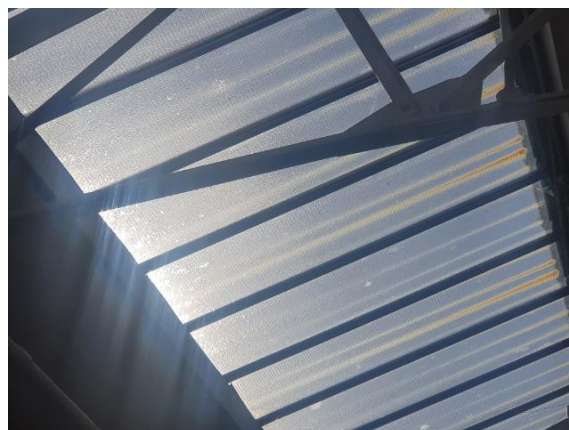
Location: Ground Floor - Main Building - Drill Hall 006

Material Description:	Rope Seals to Skylights - Gaskets (rope/woven)	
Identification:	Presumed to Contain Asbestos	
Approx. quantity:	30 m ²	
Accessibility	Difficult	<i>Assessment Score</i>
Product type:	Rope	2
Extent of Damage:	Minor damage	1
Surface Treatment:	Woven	1
Asbestos type:	Chrysotile	1
Material Assessment Score:		5
Priority Assessment Score:		Low
Action:	Manage	
Comments:	No access to sample due to height restrictions

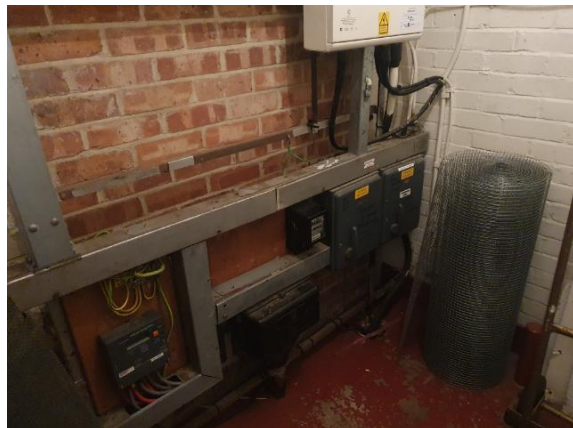
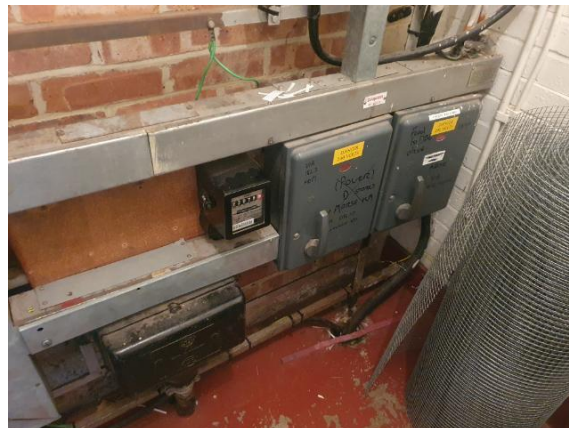
Item No:	7	Sample No:	N/A
Location:	Ground Floor - Main Building - Electrical Cupboard 0.05 007

Material Description:	Electrical Panels - Gaskets (compressed)	
Identification:	Presumed to Contain Asbestos	
Approx. quantity:	2 no	
Accessibility	Difficult	Assessment Score
Product type:	Flashguards	2
Extent of Damage:	Minor damage	1
Surface Treatment:	Woven	1
Asbestos type:	Chrysotile	1
Material Assessment Score:		5
Priority Assessment Score:		Low
Action:	Manage	
Comments:	No access within live electrics

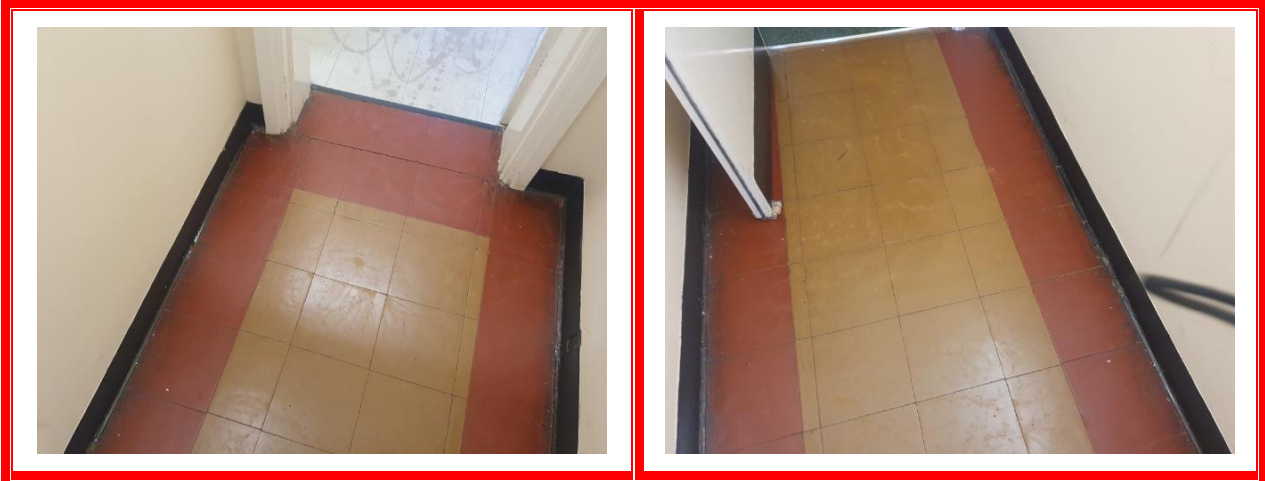
Item No:	8	Sample No:	N/A
Location:	Ground Floor - Main Building - Ladies WC Lobby 0.13 008

Material Description:	Floor Tiles and Adhesive - Vinyl Products	
Identification:	Previously Sampled - Asbestos Detected	
Approx. quantity:	3 m ²	
Accessibility	Easy	Assessment Score
Product type:	Vinyl	1
Extent of Damage:	Slight / minor damage	1
Surface Treatment:	Non-friable	0
Asbestos type:	Chrysotile	1
Material Assessment Score:		3
Priority Assessment Score:		Negligible
Action:	Manage	
Comments:	Previously sampled ref: Armour 4/12/19 Sample DK/2

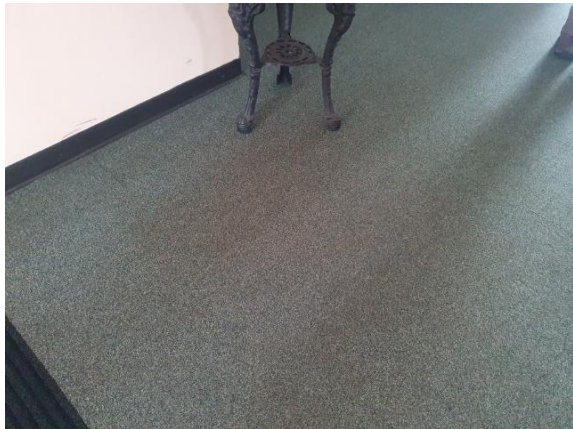
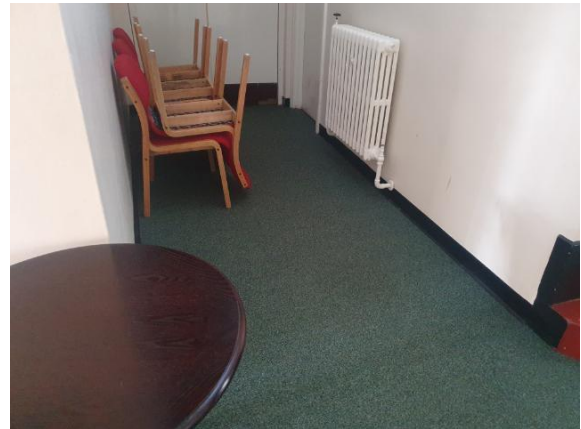
Location: Ground Floor - Main Building - Lobby 0.12 009

Material Description:	Floor Tiles and Adhesive - Vinyl Products	
Identification:	Previously Sampled - Asbestos Detected	
Approx. quantity:	20 m ²	
Accessibility	Difficult	<i>Assessment Score</i>
Product type:	Vinyl	1
Extent of Damage:	Slight / minor damage	1
Surface Treatment:	Non-friable	0
Asbestos type:	Chrysotile	1
Material Assessment Score:		3
Priority Assessment Score:		Negligible
Action:	Manage	
Comments:	Previously sampled ref: Armour 4/12/19 Sample DK/5. Under carpet

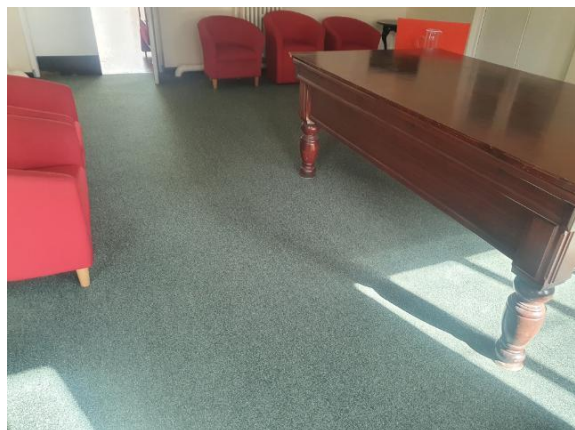
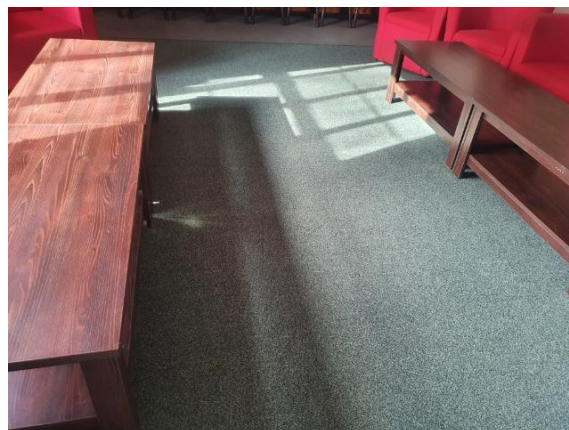
Location: Ground Floor - Main Building - Mess Room 0.20 and 0.21 010

Material Description:	Floor Tiles and Adhesive - Vinyl Products	
Identification:	Previously Sampled - Asbestos Detected	
Approx. quantity:	60 m ²	
Accessibility	Difficult	Assessment Score
Product type:	Vinyl	1
Extent of Damage:	Slight / minor damage	1
Surface Treatment:	Non-friable	0
Asbestos type:	Chrysotile	1
Material Assessment Score:		3
Priority Assessment Score:		Negligible
Action:	Manage	
Comments:	Previously sampled ref: Armour 4/12/19 Sample DK/2 and DK/5. Under carpet

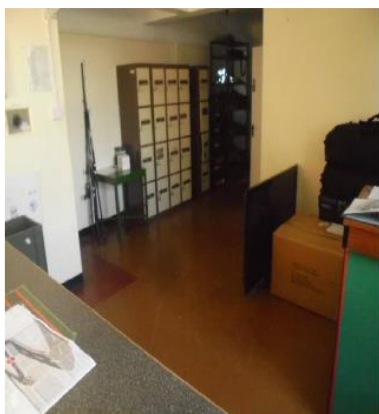
Location: Ground Floor - Main Building - Stores 0.33 013

Material Description:	Floor Tiles and Adhesive - Vinyl Products	
Identification:	Previously Sampled - Asbestos Detected	
Approx. quantity:	32 m ²	
Accessibility	Easy	<i>Assessment Score</i>
Product type:	Vinyl	1
Extent of Damage:	Slight / minor damage	1
Surface Treatment:	Non-friable	0
Asbestos type:	Chrysotile	1
Material Assessment Score:		3
Priority Assessment Score:		Negligible
Action:	Manage	
Comments:	Previously sampled ref: Armour 4/12/19 Sample DK/2 and DK/5.

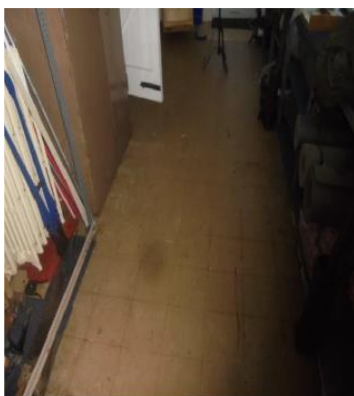
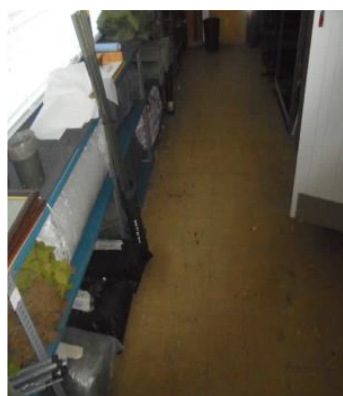
Location: Ground Floor - Main Building - Store 0.36 014

Material Description:	Floor Tiles and Adhesive - Vinyl Products	
Identification:	Previously Sampled - Asbestos Detected	
Approx. quantity:	14 m ²	
Accessibility	Easy	<i>Assessment Score</i>
Product type:	Vinyl	1
Extent of Damage:	Moderate damage	2
Surface Treatment:	Non-friable	0
Asbestos type:	Chrysotile	1
Material Assessment Score:		4
Priority Assessment Score:		Negligible
Action:	Manage	
Comments:	Previously sampled ref: Armour 4/12/19 Sample DK/9

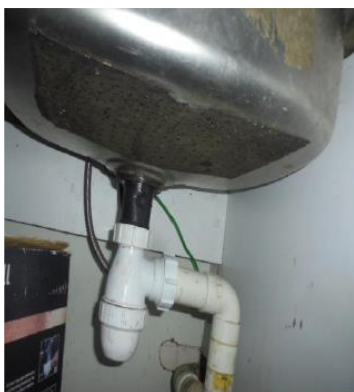
Location: Ground Floor - Main Building - Store 0.36 015

Material Description:	Sink Pad - Bituminous Product	
Identification:	Previously Sampled - Asbestos Detected	
Approx. quantity:	1 no	
Accessibility	Medium	Assessment Score
Product type:	Bitumen	1
Extent of Damage:	Slight / minor damage	1
Surface Treatment:	Non-friable	0
Asbestos type:	Chrysotile	1
Material Assessment Score:		3
Priority Assessment Score:		Negligible
Action:	Manage	
Comments:	Previously sampled ref: Armour 4/12/19 Sample DK/10

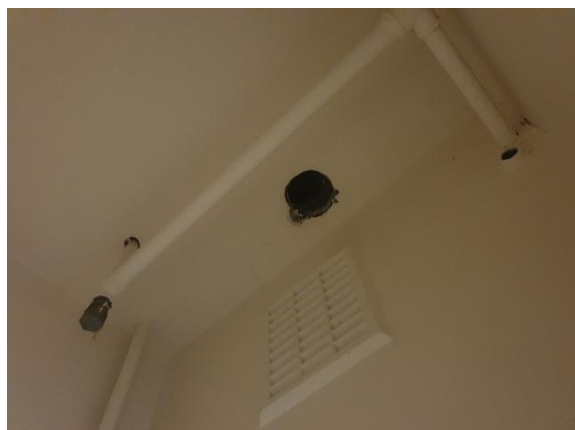
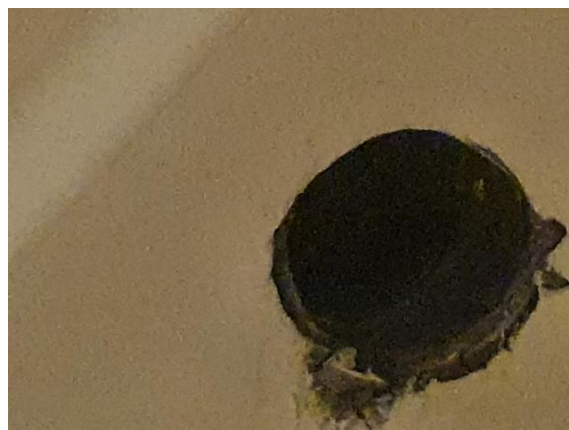
Location: First Floor - Main Building - Store 1.15 017

Material Description:	Pipe Running through Ceiling - Cement Product	
Identification:	Presumed to Contain Asbestos	
Approx. quantity:	<1 LM	
Accessibility	Difficult	<i>Assessment Score</i>
Product type:	Cement	1
Extent of Damage:	Moderate damage	2
Surface Treatment:	Unsealed Cement	1
Asbestos type:	Chrysotile	1
Material Assessment Score:		5
Priority Assessment Score:		Low
Action:	Manage	
Comments:	Not possible to sample due to stored items blocking access

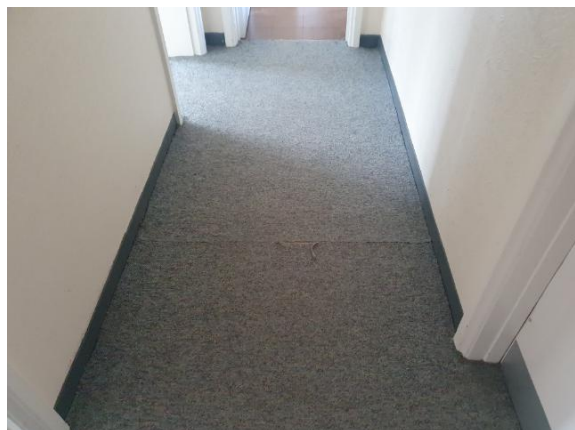
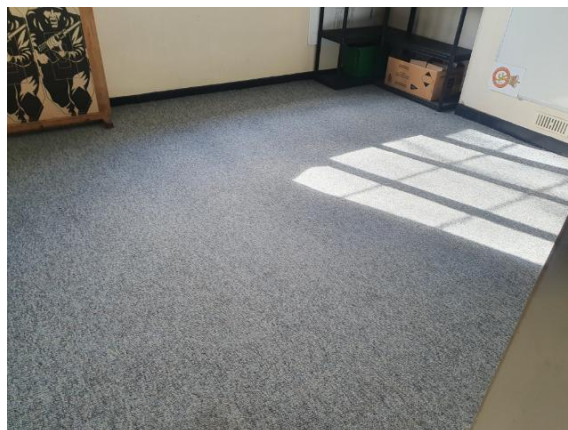
Location: First Floor - Main Building - Offices 1.24,1.21,1.22 and Corridor 1.20]

Material Description:	Floor Tiles and Adhesive - Vinyl Products	
Identification:	Previously Sampled - Asbestos Detected	
Approx. quantity:	32 m ²	
Accessibility	Easy	Assessment Score
Product type:	Vinyl	1
Extent of Damage:	Slight / minor damage	1
Surface Treatment:	Non-friable	0
Asbestos type:	Chrysotile	1
Material Assessment Score:		3
Priority Assessment Score:		Negligible
Action:	Manage	
Comments:	Previously sampled ref: Armour 4/12/19 Sample DK/12. Under carpet in 3 rooms

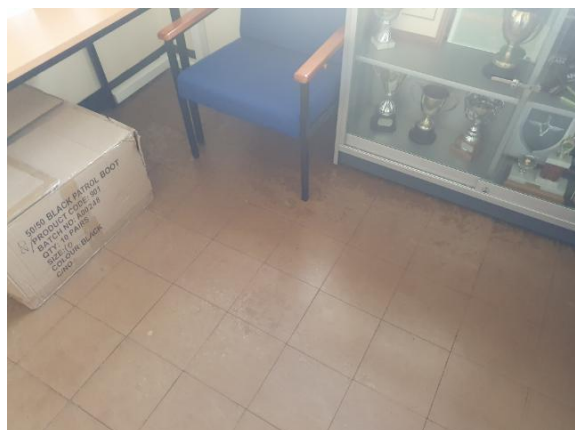
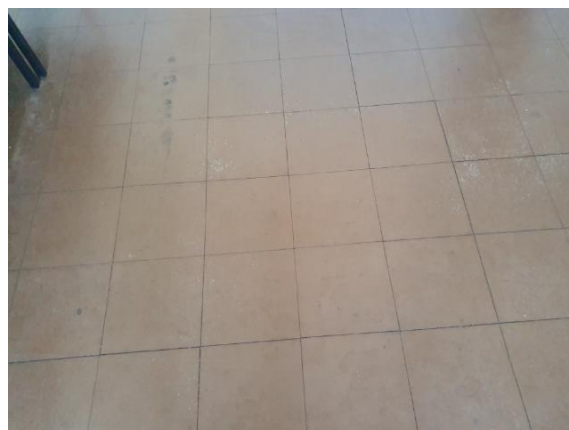
Location: First Floor - Main Building - Rooms 1.18 and 1.19

Material Description:	Floor Tiles and Adhesive - Vinyl Products	
Identification:	Previously Sampled - Asbestos Detected	
Approx. quantity:	15 m ²	
Accessibility	Easy	Assessment Score
Product type:	Vinyl	1
Extent of Damage:	Slight / minor damage	1
Surface Treatment:	Non-friable	0
Asbestos type:	Chrysotile	1
Material Assessment Score:		3
Priority Assessment Score:		Negligible
Action:	Manage	
Comments:	Previously sampled ref: Armour 4/12/19 Sample DK/12

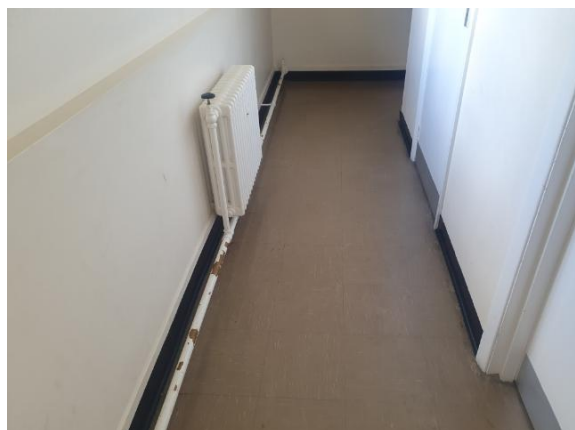
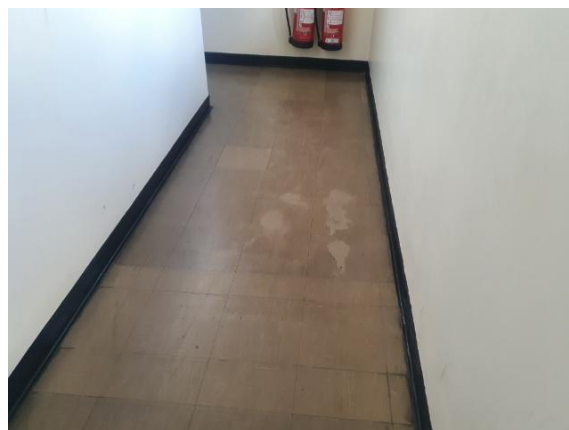
Location: First Floor - Main Building - Corridor 021

Material Description:	Floor Tiles and Adhesive - Vinyl Products	
Identification:	Previously Sampled - Asbestos Detected	
Approx. quantity:	17 m ²	
Accessibility	Easy	Assessment Score
Product type:	Vinyl	1
Extent of Damage:	Slight / minor damage	1
Surface Treatment:	Non-friable	0
Asbestos type:	Chrysotile	1
Material Assessment Score:		3
Priority Assessment Score:		Negligible
Action:	Manage	
Comments:	Previously sampled ref: Armour 4/12/19 Sample DK/16

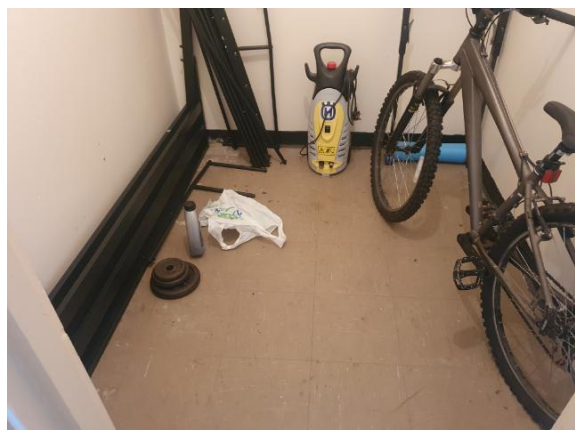
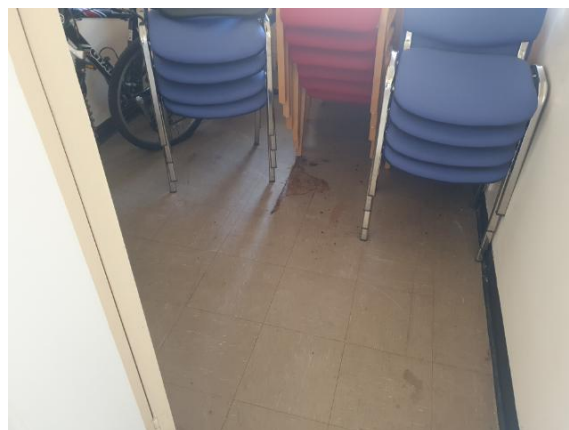
Location: First Floor - Main Building - Stores 1.28,1.31 and 1.34

Material Description:	Floor Tiles and Adhesive - Vinyl Products	
Identification:	Previously Sampled - Asbestos Detected	
Approx. quantity:	12 m ²	
Accessibility	Easy	Assessment Score
Product type:	Vinyl	1
Extent of Damage:	Slight / minor damage	1
Surface Treatment:	Non-friable	0
Asbestos type:	Chrysotile	1
Material Assessment Score:		3
Priority Assessment Score:		Negligible
Action:	Manage	
Comments:	Previously sampled ref: Armour DK/16

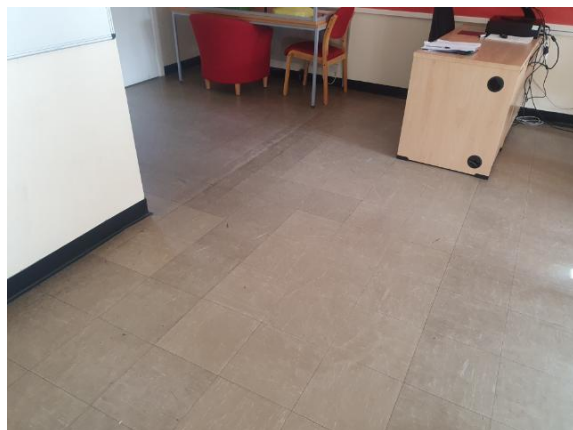
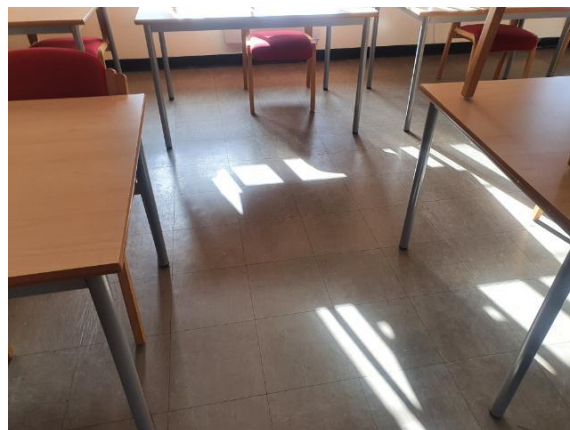
Location: First Floor - Main Building - Classrooms 1.29, 1.30 and Cupboard 1.32

Material Description:	Floor Tiles and Adhesive - Vinyl Products	
Identification:	Previously Sampled - Asbestos Detected	
Approx. quantity:	54 m ²	
Accessibility	Easy	Assessment Score
Product type:	Vinyl	1
Extent of Damage:	Slight / minor damage	1
Surface Treatment:	Non-friable	0
Asbestos type:	Chrysotile	1
Material Assessment Score:		3
Priority Assessment Score:		Negligible
Action:	Manage	
Comments:	Previously sampled ref: Armour 4/12/19 Sample DK/16

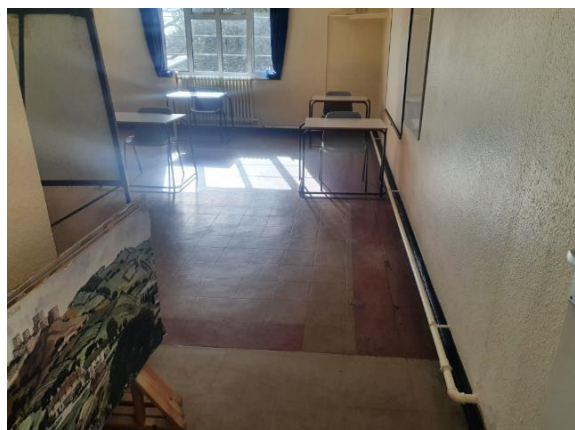
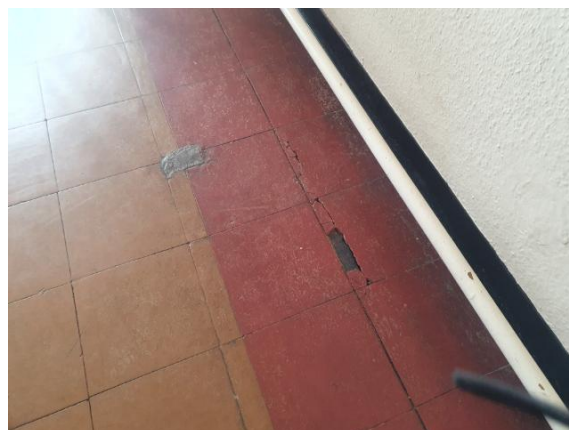
Location: First Floor - Main Building - Classroom 1.29

Material Description:	Floor Tiles and Adhesive - Vinyl Products	
Identification:	Previously Sampled - Asbestos Detected	
Approx. quantity:	25 m ²	
Accessibility	Easy	<i>Assessment Score</i>
Product type:	Vinyl	1
Extent of Damage:	Moderate damage	2
Surface Treatment:	Non-friable	0
Asbestos type:	Chrysotile	1
Material Assessment Score:		4
Priority Assessment Score:		Negligible
Action:	Manage	
Comments:	Previously sampled ref: Armour 4/12/19 Sample DK/12

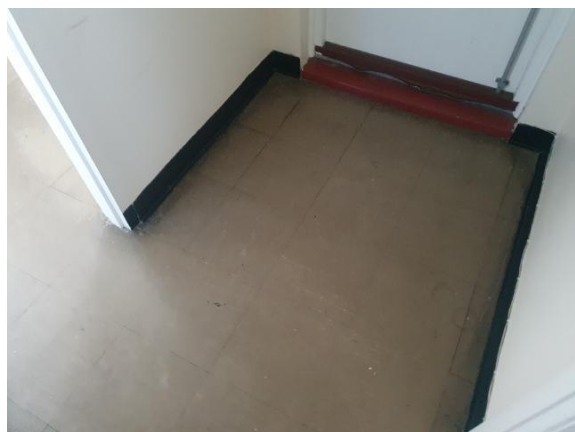
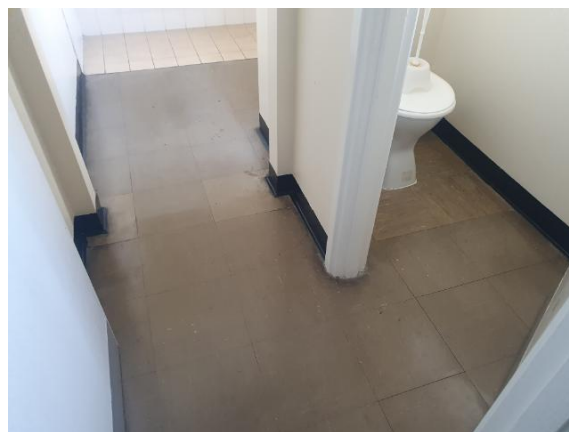
Location: First Floor - Main Building - WC 1.27 and Corridor

Material Description:	Floor Tiles and Adhesive - Vinyl Products	
Identification:	Previously Sampled - Asbestos Detected	
Approx. quantity:	8 m ²	
Accessibility	Easy	<i>Assessment Score</i>
Product type:	Vinyl	1
Extent of Damage:	Slight / minor damage	1
Surface Treatment:	Non-friable	0
Asbestos type:	Chrysotile	1
Material Assessment Score:		3
Priority Assessment Score:		Negligible
Action:	Manage	
Comments:	Previously sampled ref: Armour 4/12/19 Sample DK/16

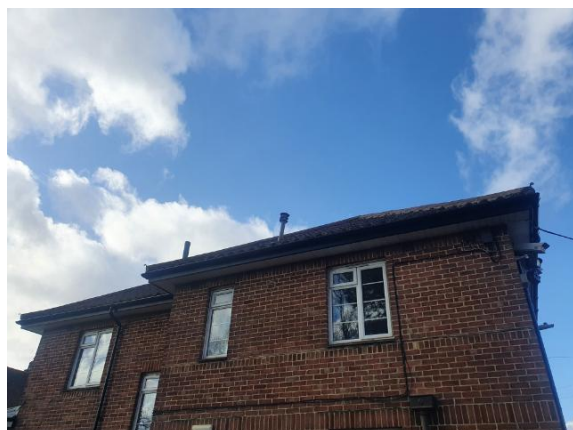
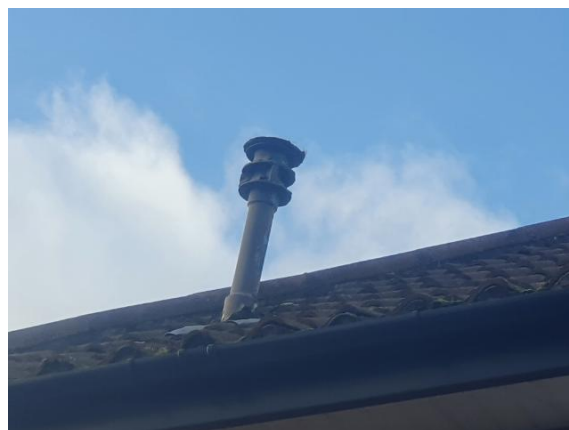
Location: External - Main Building 026

Material Description:	Cement Flue Pipes - Cement Product	
Identification:	Strongly Presumed to Contain Asbestos	
Approx. quantity:	1 LM	
Accessibility	Difficult	<i>Assessment Score</i>
Product type:	Cement	1
Extent of Damage:	Moderate damage	2
Surface Treatment:	Unsealed Cement	1
Asbestos type:	Chrysotile	1
Material Assessment Score:		5
Priority Assessment Score:		Low
Action:	Remove	
Comments:	No access to sample due to height restrictions. Pipe appears to be leaning which could be caused by damage. Remove flue

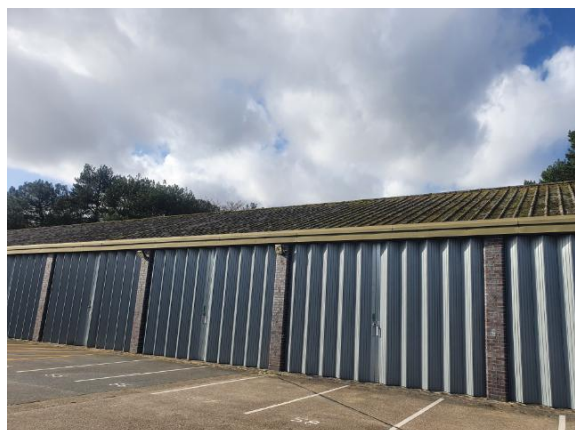
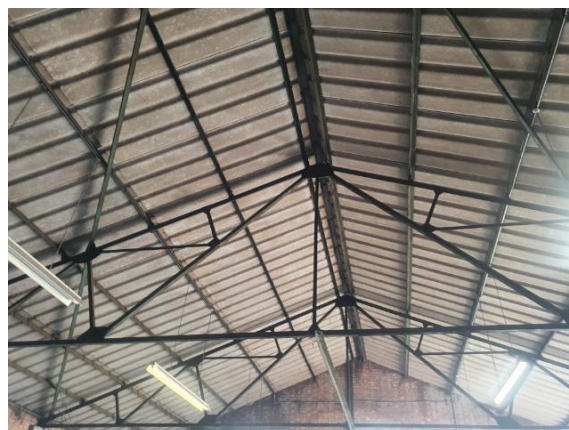
Location: Sixth Floor - Building 7 027

Material Description:	Profiled Roof - Cement Product	
Identification:	Strongly Presumed to Contain Asbestos	
Approx. quantity:	800 m ²	
Accessibility	Difficult	<i>Assessment Score</i>
Product type:	Cement	1
Extent of Damage:	Moderate damage	2
Surface Treatment:	Unsealed Cement	1
Asbestos type:	Chrysotile	1
Material Assessment Score:		5
Priority Assessment Score:		Low
Action:	Manage	
Comments:	Several holes in roof

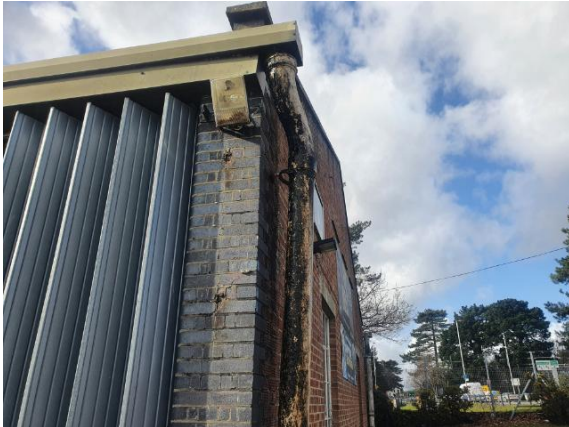
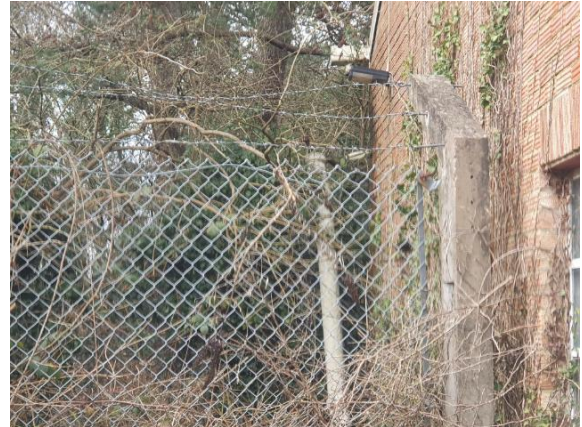
Location: External - Building 7 028

Material Description:	Downpipes - Cement Product	
Identification:	Previously Sampled - Asbestos Detected	
Approx. quantity:	3 no	
Accessibility	Medium	<i>Assessment Score</i>
Product type:	Cement	1
Extent of Damage:	Moderate damage	2
Surface Treatment:	Unsealed Cement	1
Asbestos type:	Chrysotile	1
Material Assessment Score:		5
Priority Assessment Score:		Low
Action:	Remove	
Comments:	Previous sample ref: Armour Sample DK/17. One pipe has fallen off and the other two appear to be loose. 15LM

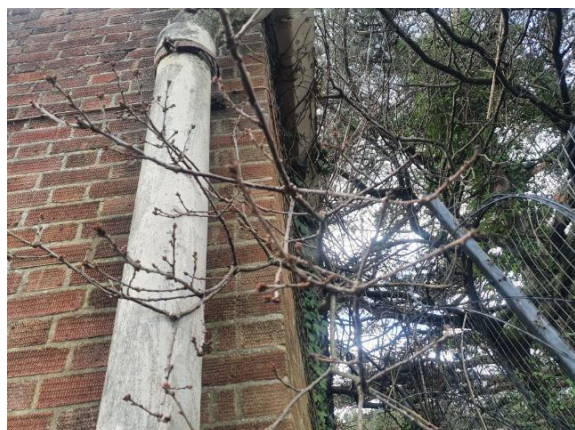
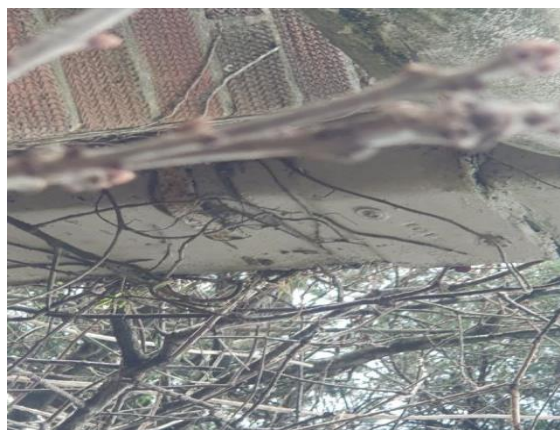
Location: External - Building 7 029

Material Description:	Guttering - Cement Product	
Identification:	Previously Sampled - Asbestos Detected	
Approx. quantity:	55 LM	
Accessibility	Difficult	<i>Assessment Score</i>
Product type:	Cement	1
Extent of Damage:	Slight / minor damage	1
Surface Treatment:	Unsealed Cement	1
Asbestos type:	Chrysotile	1
Material Assessment Score:		4
Priority Assessment Score:		Negligible
Action:	Manage	
Comments:	Previously sampled ref: Armour Sample DK/17

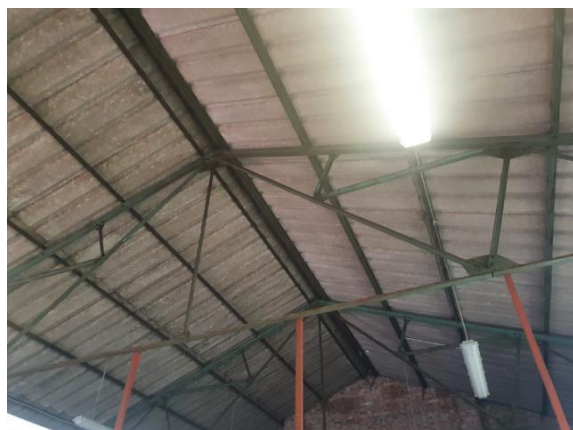
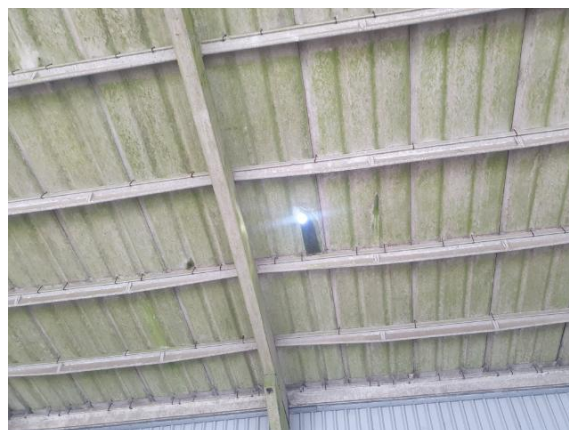
Location: External - Building 4 030

Material Description:	Profiled Roof - Cement Product	
Identification:	Strongly Presumed to Contain Asbestos	
Approx. quantity:	510 m ²	
Accessibility	Difficult	<i>Assessment Score</i>
Product type:	Cement	1
Extent of Damage:	Moderate damage	2
Surface Treatment:	Unsealed Cement	1
Asbestos type:	Chrysotile	1
Material Assessment Score:		5
Priority Assessment Score:		Low
Action:	Manage	
Comments:	Several holes in roof and likely debris. Do not sweep floor

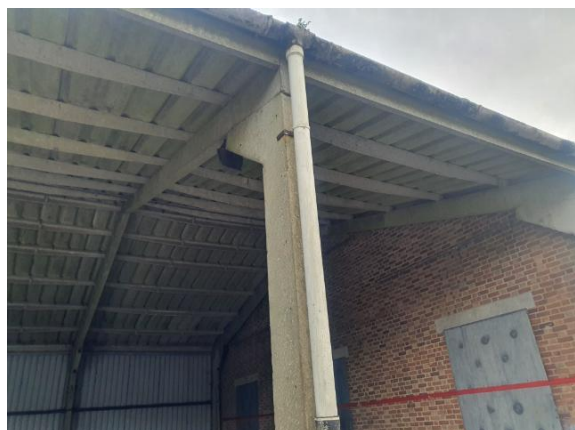
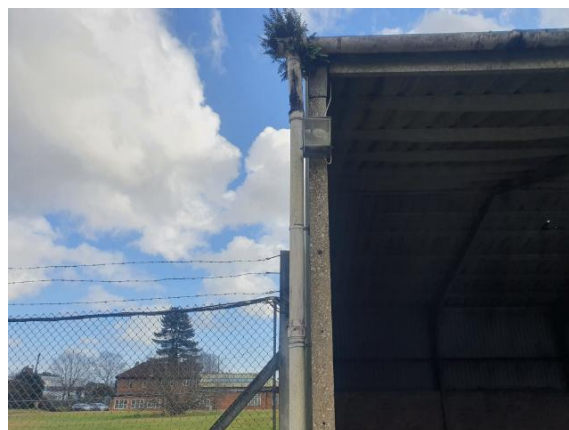
Location: External - Building 4 031

Material Description:	Downpipes - Cement Product	
Identification:	Previously Sampled - Asbestos Detected	
Approx. quantity:	6 no	
Accessibility	Medium	<i>Assessment Score</i>
Product type:	Cement	1
Extent of Damage:	Slight / minor damage	1
Surface Treatment:	Unsealed Cement	1
Asbestos type:	Chrysotile	1
Material Assessment Score:		4
Priority Assessment Score:		Negligible
Action:	Remove	
Comments:	Previous sample ref: Armour Sample DK/17. 30LM

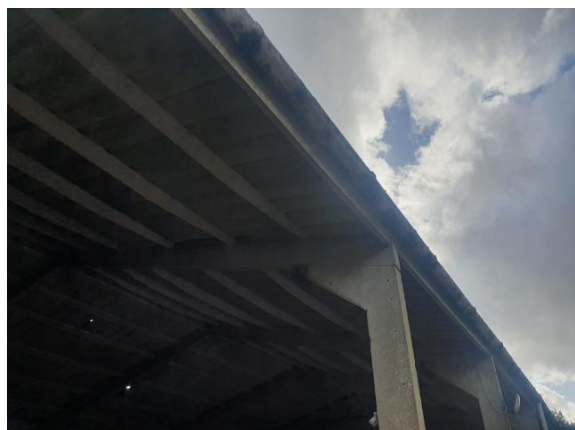
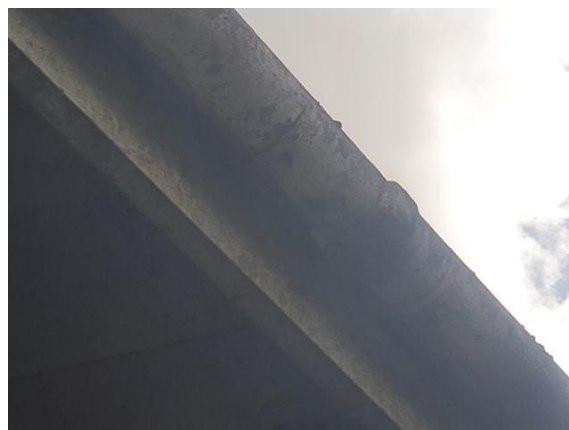
Location: External - Building 4 032

Material Description:	Guttering - Cement Product	
Identification:	Previously Sampled - Asbestos Detected	
Approx. quantity:	55 LM	
Accessibility	Difficult	<i>Assessment Score</i>
Product type:	Cement	1
Extent of Damage:	Slight / minor damage	1
Surface Treatment:	Unsealed Cement	1
Asbestos type:	Chrysotile	1
Material Assessment Score:		4
Priority Assessment Score:		Negligible
Action:	Manage	
Comments:	Previously sampled ref: Armour Sample DK/17

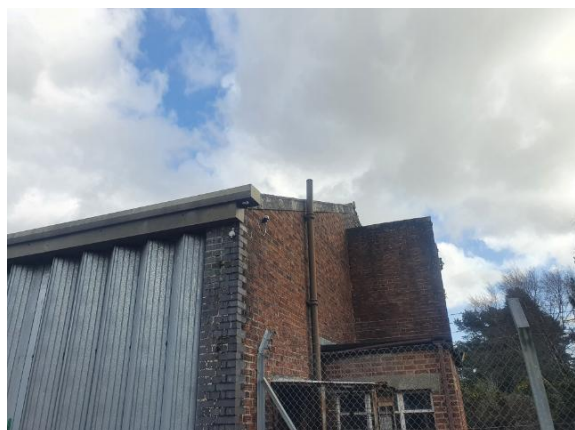
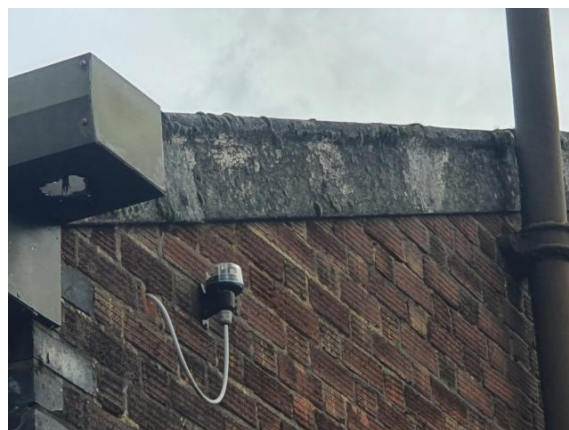
Location: External - Building 4 033

Material Description:	Roof Edging - Cement Product	
Identification:	Strongly Presumed to Contain Asbestos	
Approx. quantity:	42 LM	
Accessibility	Difficult	<i>Assessment Score</i>
Product type:	Cement	1
Extent of Damage:	Slight / minor damage	1
Surface Treatment:	Unsealed Cement	1
Asbestos type:	Chrysotile	1
Material Assessment Score:		4
Priority Assessment Score:		Negligible
Action:	Manage	
Comments:	N/A

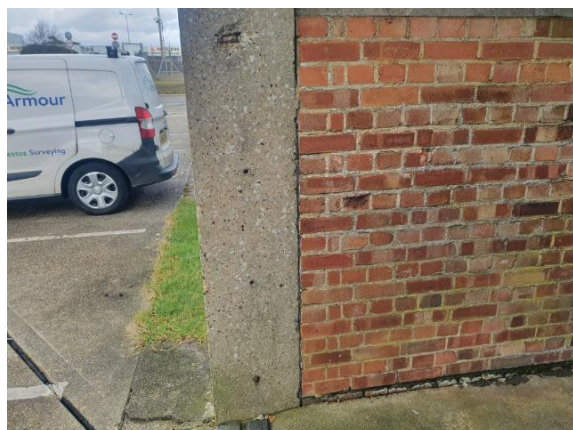
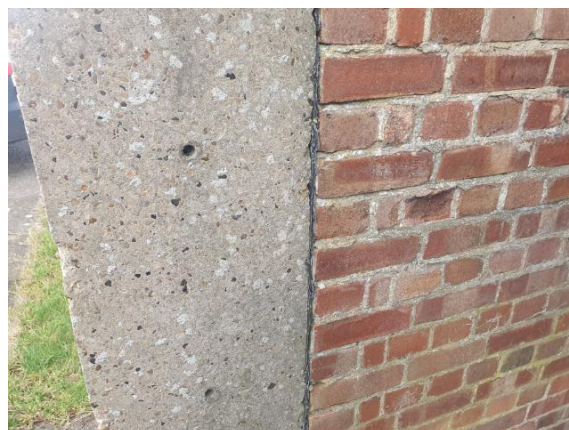
Location: External - Building 4 034

Material Description:	Damp Proof Course - Bituminous Product	
Identification:	Previously Sampled - Asbestos Detected	
Approx. quantity:	Entire Perimeter	
Accessibility	Difficult	Assessment Score
Product type:	Bitumen	1
Extent of Damage:	Slight / minor damage	1
Surface Treatment:	Non-friable	0
Asbestos type:	Chrysotile	1
Material Assessment Score:		3
Priority Assessment Score:		Negligible
Action:	Manage	
Comments:	Previously sampled ref: Armour Sample DK/18

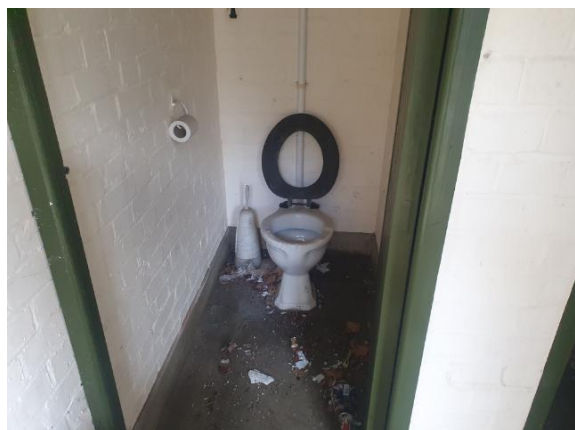
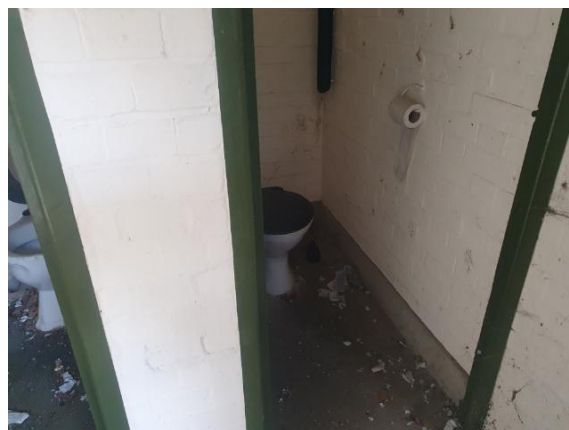
Location: Ground Floor - Building 4 - WC and Store 035

Material Description:	Toilet Seats - PVC / Reinforced Plastics	
Identification:	Strongly Presumed to Contain Asbestos	
Approx. quantity:	2 LM	
Accessibility	Difficult	<i>Assessment Score</i>
Product type:	Bakelite	1
Extent of Damage:	Slight / minor damage	1
Surface Treatment:	Non-friable	0
Asbestos type:	Chrysotile	1
Material Assessment Score:		3
Priority Assessment Score:		Negligible
Action:	Manage	
Comments:	Not possible to sample as may damage integrity of seats

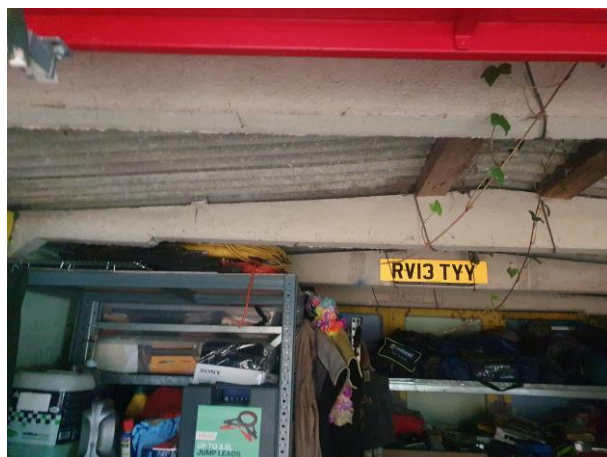
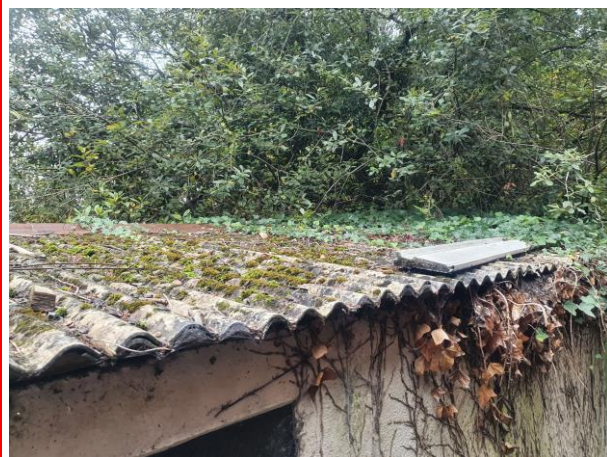
Location: Building 9 Garage 036

Material Description:	Profiled Cement Roof	
Identification:	Sampled – DK/19	
Approx. quantity:	18 m2	
Accessibility	Low	Assessment Score
Product type:	Cement	1
Extent of Damage:	Minor	1
Surface Treatment:	Unsealed	1
Asbestos type:	Chrysotile	1
Material Assessment Score:		3
Priority Assessment Score:		Low
Action:	Manage	
Comments:	Previously a no access area, now accessed.

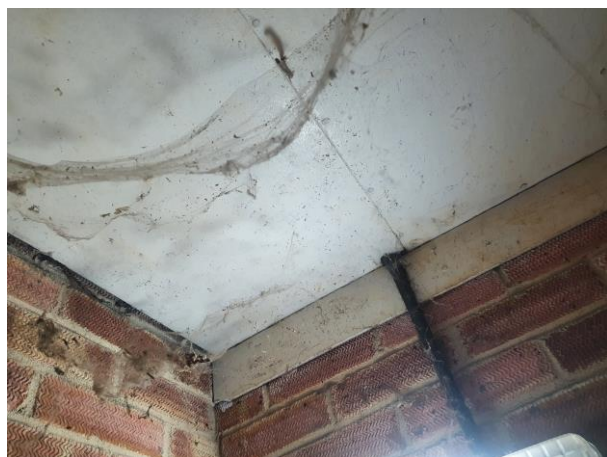
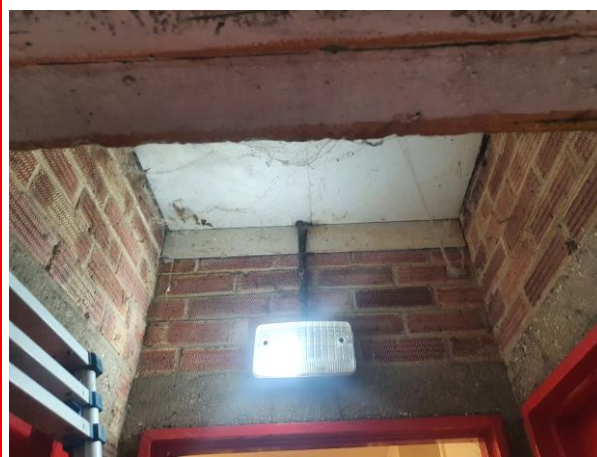
Location: Building 8 GF Lobby 037

Material Description:	Ceiling Panels	
Identification:	Sampled – DK/20	
Approx. quantity:	1m2	
Accessibility	Medium	Assessment Score
Product type:	Cement	1
Extent of Damage:	Minor	1
Surface Treatment:	Unsealed	1
Asbestos type:	Chrysotile	1
Material Assessment Score:		3
Priority Assessment Score:		Low
Action:	Manage	
Comments:	Previously a no access area, now accessed.

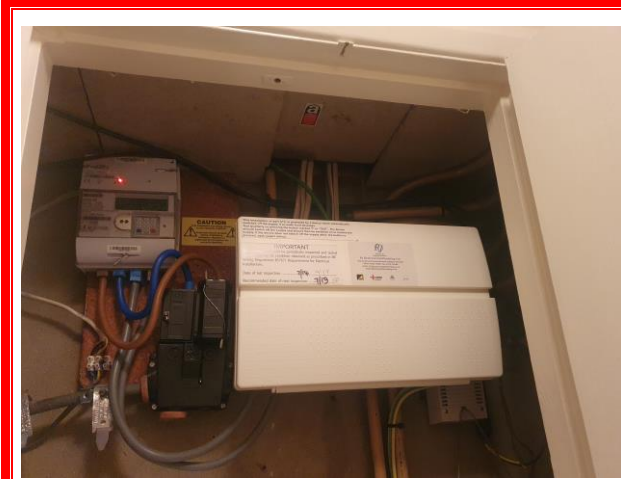
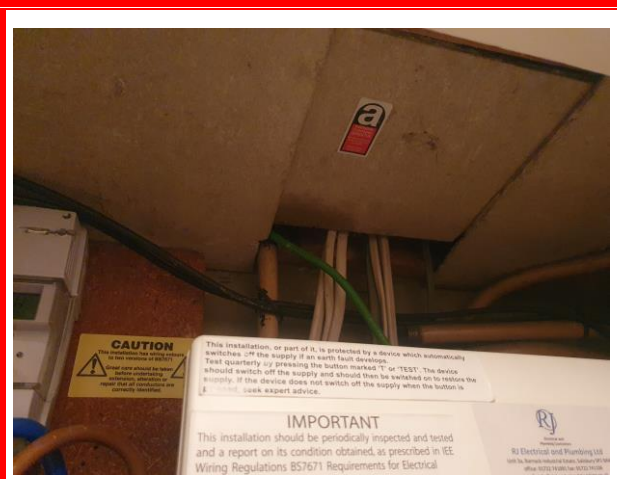
Location: Building 8 GF Electrical Cupboard 038

Material Description:	Ceiling Panels	
Identification:	Sampled – DK/21	
Approx. quantity:	1m2	
Accessibility	Medium	Assessment Score
Product type:	Cement	1
Extent of Damage:	Minor	1
Surface Treatment:	Unsealed	1
Asbestos type:	Chrysotile	1
Material Assessment Score:		3
Priority Assessment Score:		Low
Action:	Manage	
Comments:	Previously a no access area, now accessed.
