**Project Number 2481**

**Management  
Asbestos Survey Report**

**Penryn Platoon, Cornwall, TR10 8HF**

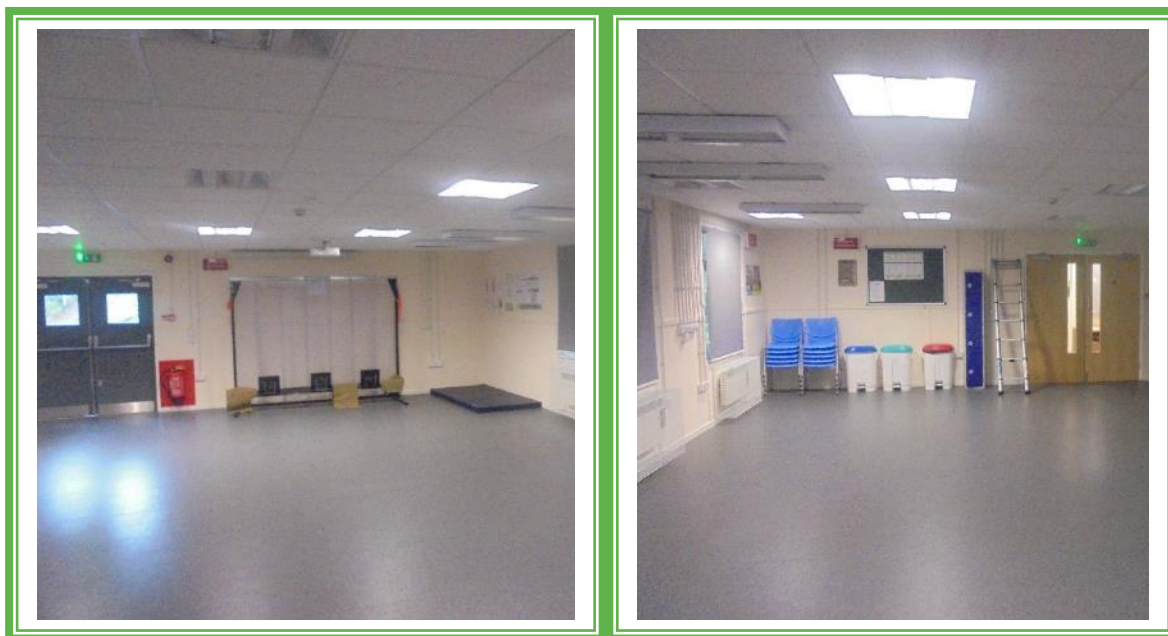
**Location: Training Hall**

| <b>Material Description:</b> | Visual Inspection – No Suspect Materials Found | |

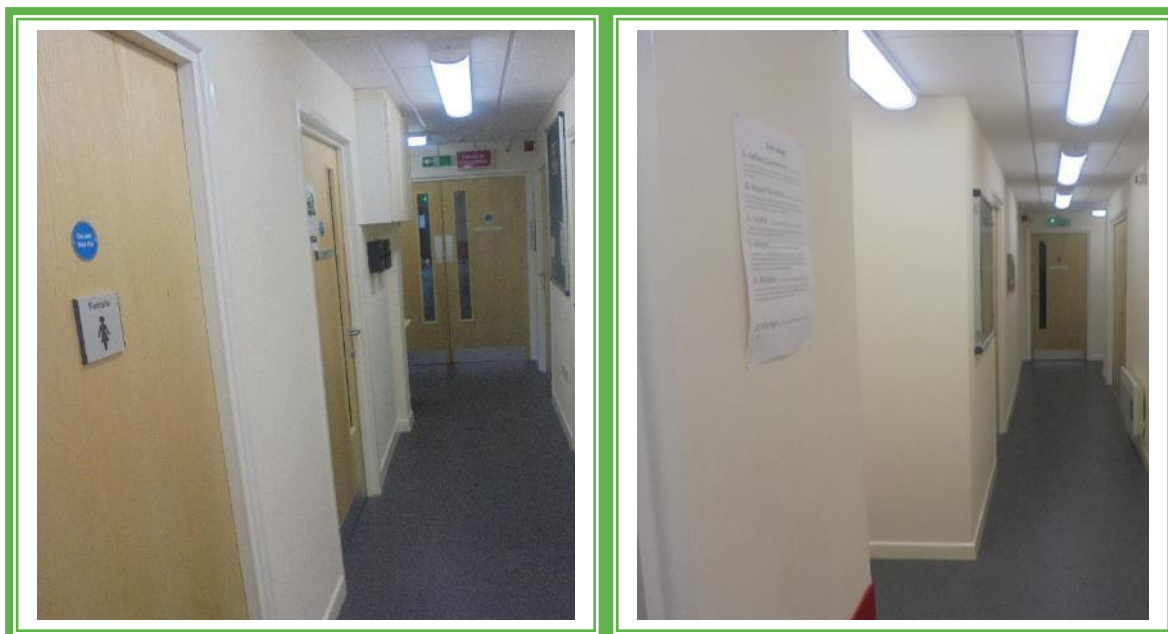
**Location: Corridor**

| <b>Material Description:</b> | Visual Inspection – No Suspect Materials Found | |

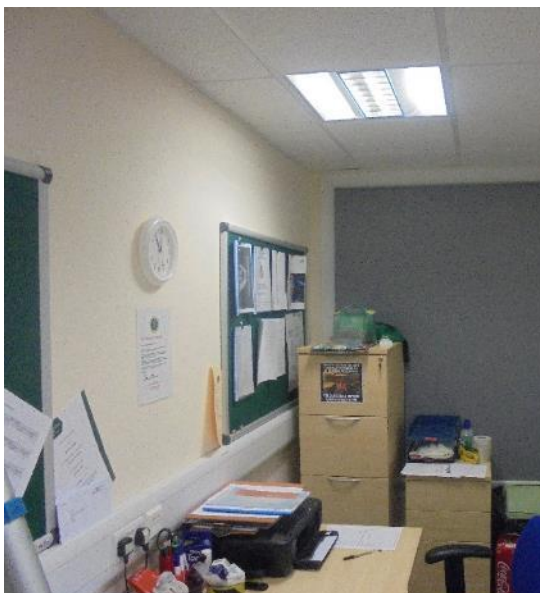
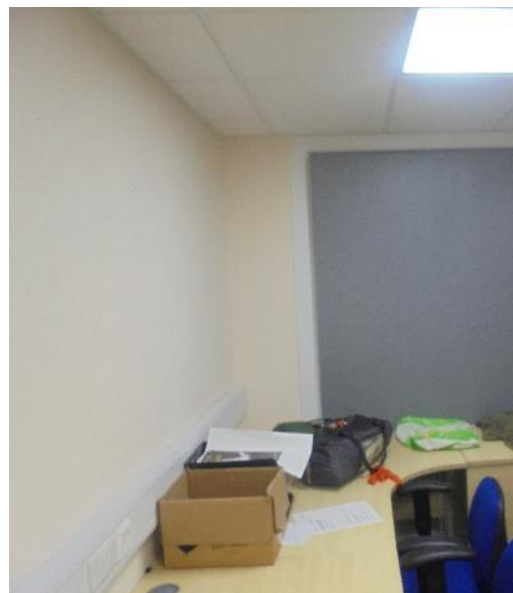
**Item No: 3****Sample No: N/A****Location: Offices x 2**

| <b>Material Description:</b> | Visual Inspection – No Suspect Materials Found | |

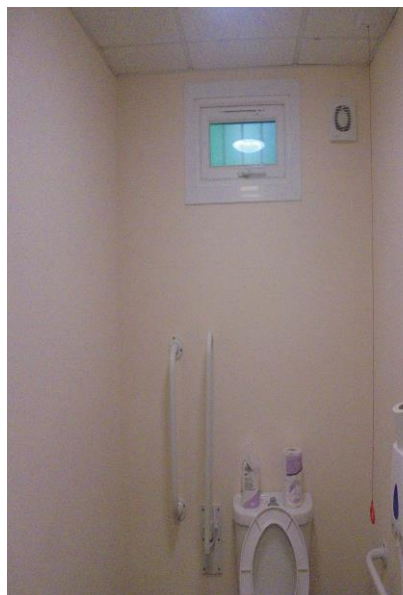
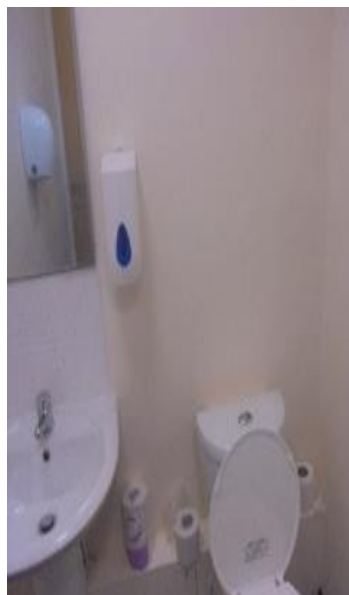
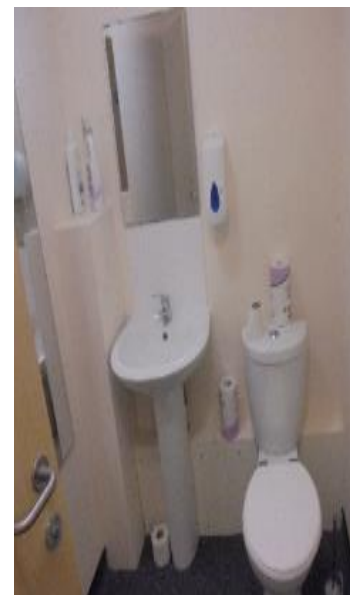
**Location: WC's x 3**

| <b>Material Description:</b> | Visual Inspection – No Suspect Materials Found | |

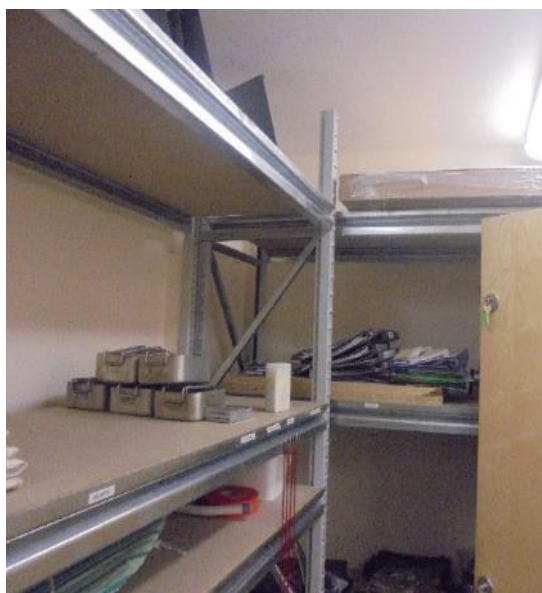
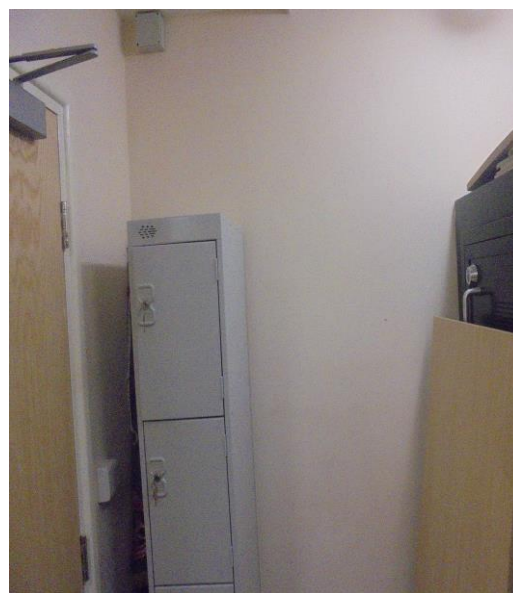
**Location: Store**

| <b>Material Description:</b> | Visual Inspection – No Suspect Materials Found | |

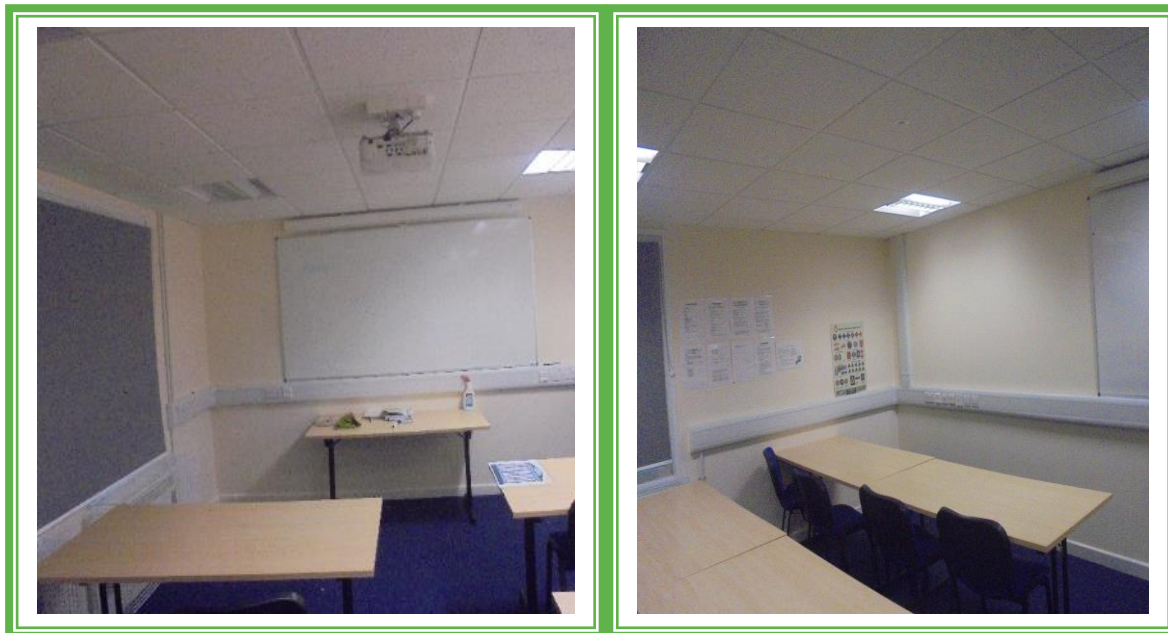
**Location: Lecture Rooms 1&2**

| <b>Material Description:</b> | Visual Inspection – No Suspect Materials Found | |

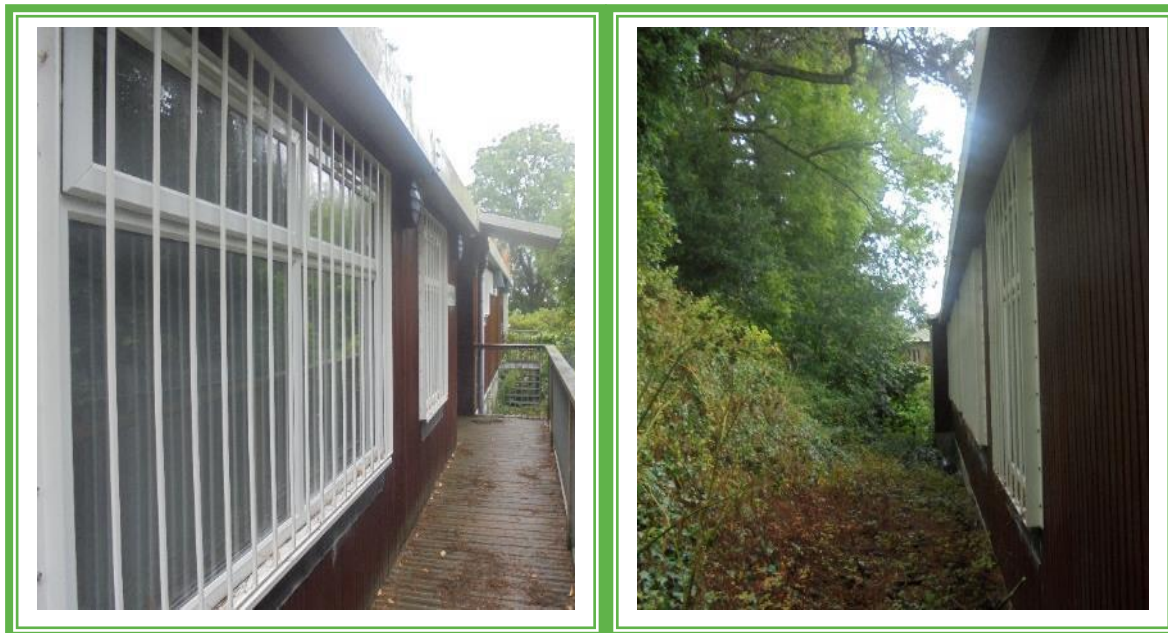
**Location: External**

| <b>Material Description:</b> | Visual Inspection – No Suspect Materials Found | |
| <b>Comments:</b> | No damp proof course visible, so was not included as part of the management survey | |

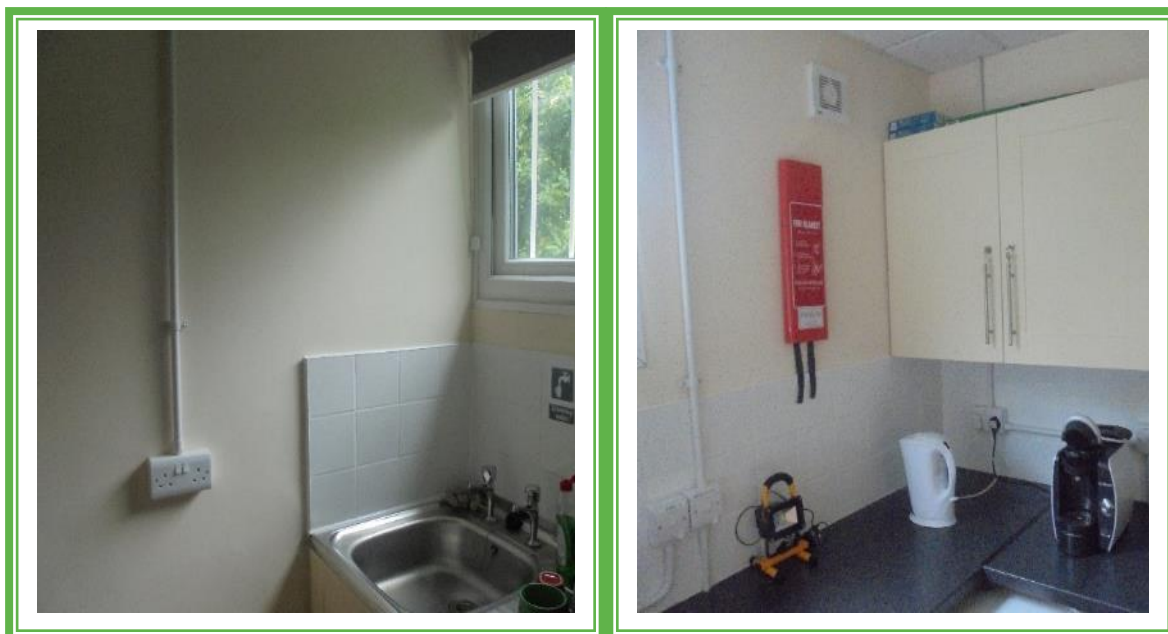
**Location: Servery**

| <b>Material Description:</b> | Visual Inspection – No Suspect Materials Found | |
