**Project Number A-00566 (3700)**

**Re-Inspection  
Asbestos Survey Report**

**Totnes Platoon  
Totnes  
Devon  
TQ9 5XW**

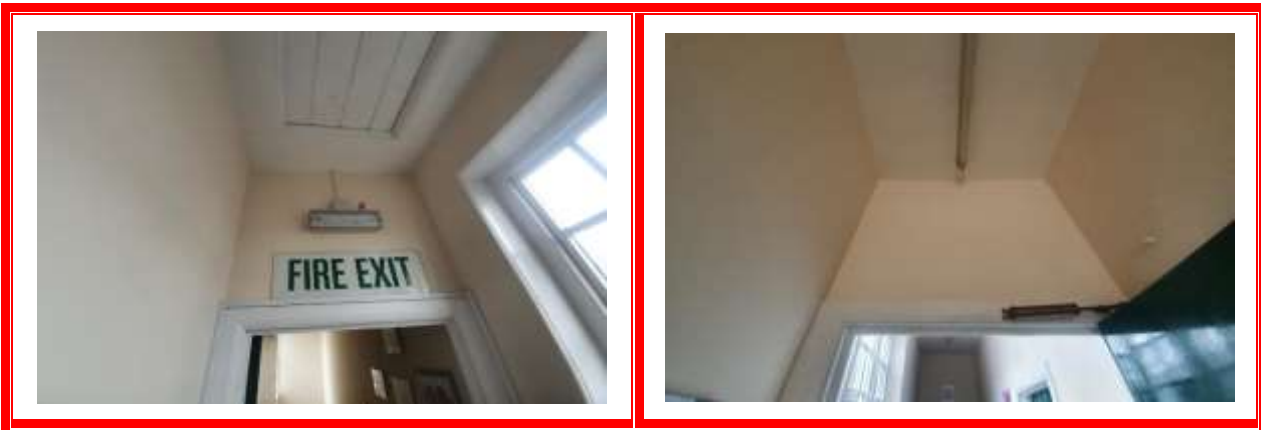
<b>Item No:</b>	<b>1</b>	<b>Sample No:</b>	<b>N/A</b>
<b>Location:</b>	First Floor - Corridor 001

<b>Material Description:</b>	Panels above Fire Exit Door - Insulating Board	
<b>Identification:</b>	Previously Sampled - Asbestos Detected	
<b>Approx. quantity:</b>	2 no	
<b>Accessibility</b>	Difficult	Assessment Score
<b>Product type:</b>	Asbestos Insulating Board	2
<b>Extent of Damage:</b>	Slight / minor damage	1
<b>Surface Treatment:</b>	Unsealed AIB	2
<b>Asbestos type:</b>	Amosite	2
<b>Material Assessment Score:</b>		7
<b>Priority Assessment Score:</b>		Medium
<b>Action:</b>	Encapsulate	
<b>Comments:</b>	Previously sampled ref: Armour 23/10/19 - Sample DK/3

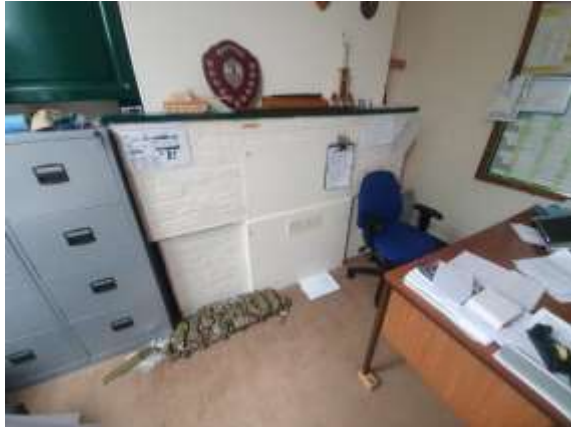
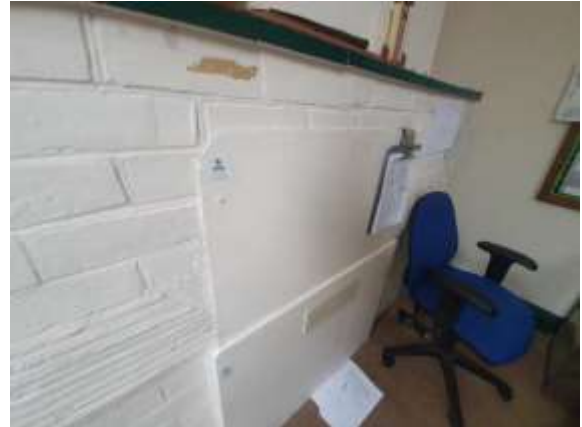
**Location:** Ground Floor - Office 002

<b>Material Description:</b>	Panel to Fireplace - Cement Product	
<b>Identification:</b>	Previously Sampled - Asbestos Detected	
<b>Approx. quantity:</b>	<1 m <sup>2</sup>	
<b>Accessibility</b>	Easy	<i>Assessment Score</i>
<b>Product type:</b>	Cement	1
<b>Extent of Damage:</b>	Slight / minor damage	1
<b>Surface Treatment:</b>	Unsealed Cement	1
<b>Asbestos type:</b>	Chrysotile	1
<b>Material Assessment Score:</b>		4
<b>Priority Assessment Score:</b>		Negligible
<b>Action:</b>	Manage	
<b>Comments:</b>	Previously sampled ref: Armour 23/10/19 - Sample DK/7

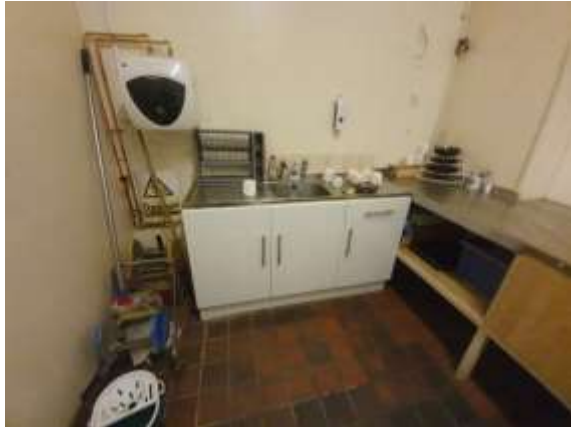
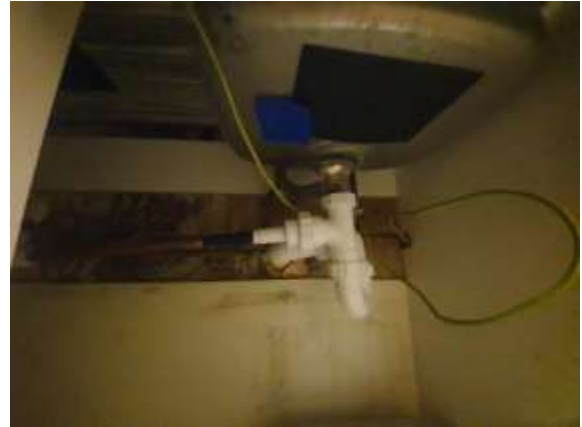
**Location:** Ground Floor - Kitchen 003

<b>Material Description:</b>	Sink Pad - Bituminous Product	
<b>Identification:</b>	Previously Sampled - Asbestos Detected	
<b>Approx. quantity:</b>	1 no	
<b>Accessibility</b>	Medium	<i>Assessment Score</i>
<b>Product type:</b>	Bitumen	1
<b>Extent of Damage:</b>	Slight / minor damage	1
<b>Surface Treatment:</b>	Non-friable	0
<b>Asbestos type:</b>	Chrysotile	1
<b>Material Assessment Score:</b>		3
<b>Priority Assessment Score:</b>		Negligible
<b>Action:</b>	Manage	
<b>Comments:</b>	Previously sampled ref: Armour 23/10/19 - Sample DK/9

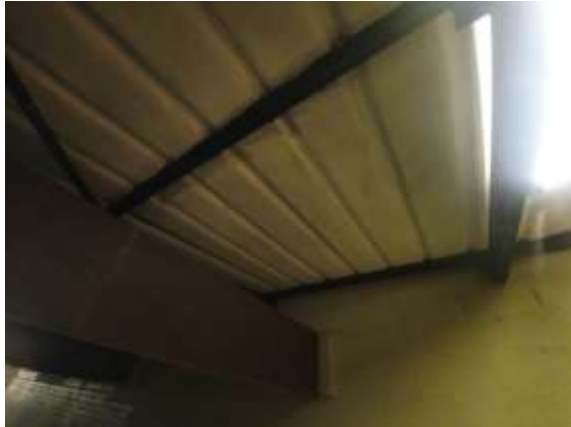
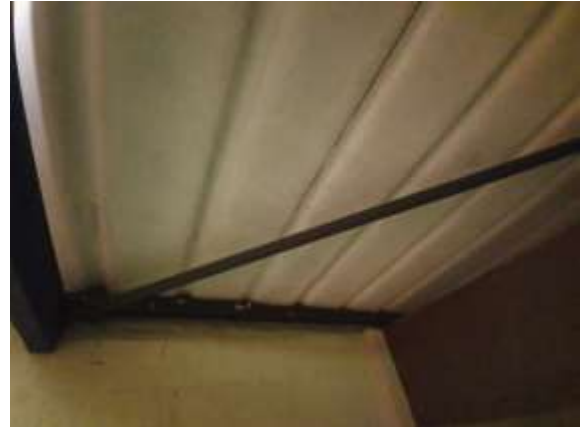
**Location:** First Floor - Firing Range 004

<b>Material Description:</b>	Profiled Roof - Cement Product	
<b>Identification:</b>	Previously Sampled - Asbestos Detected	
<b>Approx. quantity:</b>	112 m <sup>2</sup>	
<b>Accessibility</b>	Difficult	<i>Assessment Score</i>
<b>Product type:</b>	Cement	1
<b>Extent of Damage:</b>	Slight / minor damage	1
<b>Surface Treatment:</b>	Unsealed Cement	1
<b>Asbestos type:</b>	Chrysotile	1
<b>Material Assessment Score:</b>		4
<b>Priority Assessment Score:</b>		Negligible
<b>Action:</b>	Manage	
<b>Comments:</b>	Previously sampled ref: Armour 23/10/19 - Sample DK/10

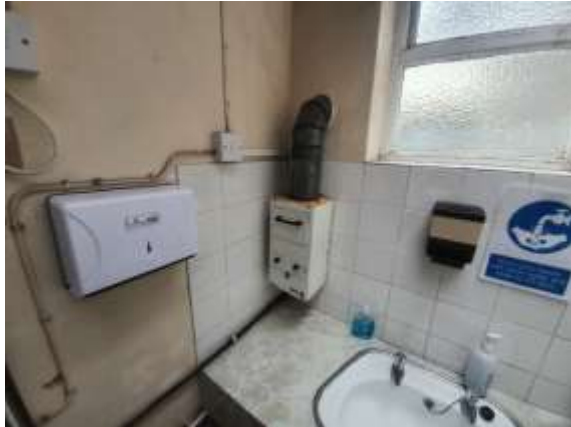
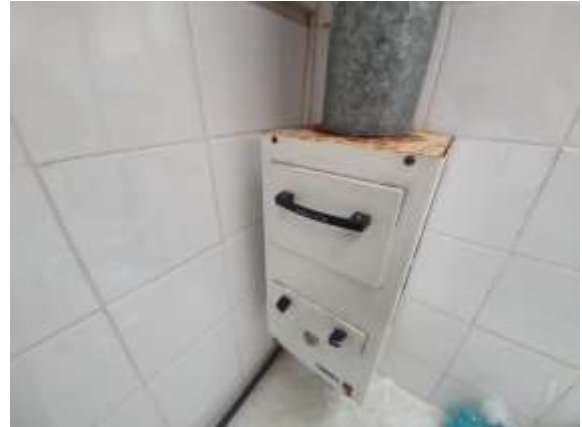
**Location:** Ground Floor - Ladies WC 005

<b>Material Description:</b>	Incinerator Unit - No Access Gained	
<b>Identification:</b>	Presumed to Contain Asbestos	
<b>Approx. quantity:</b>	1 no	
<b>Accessibility</b>	Difficult	<i>Assessment Score</i>
<b>Product type:</b>	Asbestos Insulating Board	2
<b>Extent of Damage:</b>	Major damage	3
<b>Surface Treatment:</b>	Unsealed Insulation	3
<b>Asbestos type:</b>	Amosite, Chrysotile	2
<b>Material Assessment Score:</b>		10
<b>Priority Assessment Score:</b>		High
<b>Action:</b>	Manage	
<b>Comments:</b>	No access within live incinerator

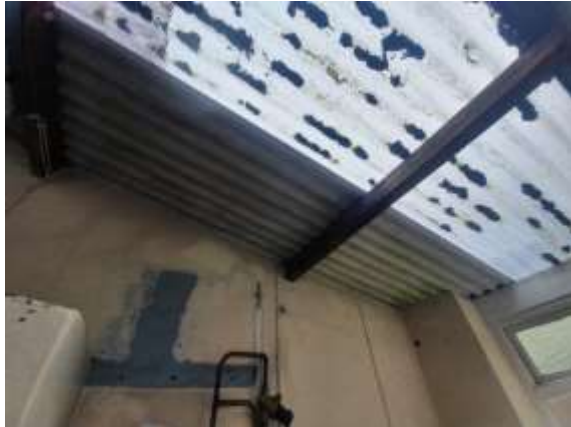
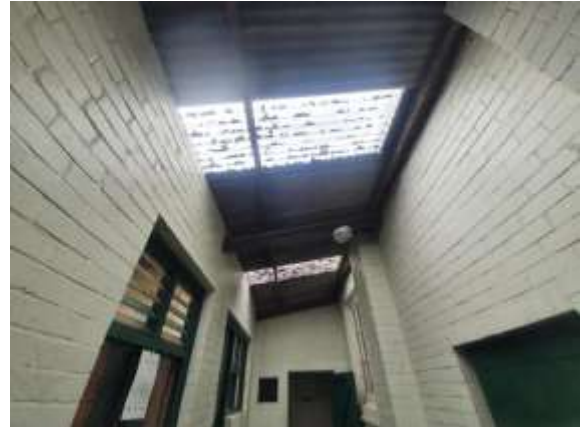
**Location:** Ground Floor - WC's x 2 and Corridor 006

<b>Material Description:</b>	Profiled Roof - Cement Product	
<b>Identification:</b>	Previously Sampled - Asbestos Detected	
<b>Approx. quantity:</b>	30 m <sup>2</sup>	
<b>Accessibility</b>	Difficult	<i>Assessment Score</i>
<b>Product type:</b>	Cement	1
<b>Extent of Damage:</b>	Slight / minor damage	1
<b>Surface Treatment:</b>	Unsealed Cement	1
<b>Asbestos type:</b>	Chrysotile	1
<b>Material Assessment Score:</b>		4
<b>Priority Assessment Score:</b>		Negligible
<b>Action:</b>	Manage	
<b>Comments:</b>	Previously sampled ref: Armour 23/10/19 - Sample DK/12

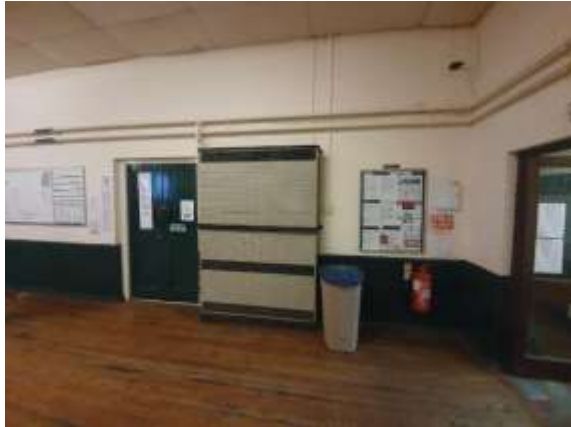
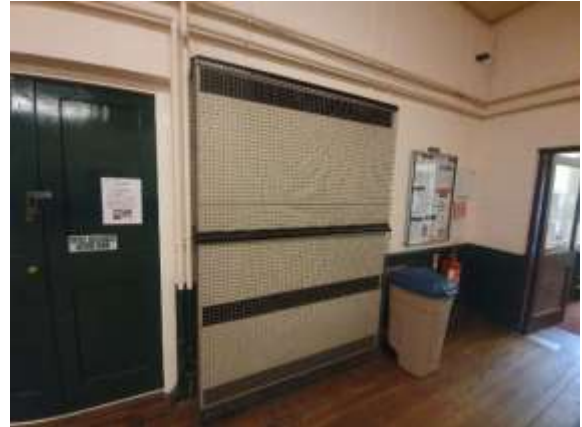
**Location:** Ground Floor - Drill Hall 007

<b>Material Description:</b>	Heaters - Insulating Board	
<b>Identification:</b>	Presumed to Contain Asbestos	
<b>Approx. quantity:</b>	4 no	
<b>Accessibility</b>	Difficult	<i>Assessment Score</i>
<b>Product type:</b>	Asbestos Insulating Board	2
<b>Extent of Damage:</b>	Major damage	3
<b>Surface Treatment:</b>	Unsealed Insulation	3
<b>Asbestos type:</b>	Amosite, Chrysotile	2
<b>Material Assessment Score:</b>		10
<b>Priority Assessment Score:</b>		High
<b>Action:</b>	Manage	
<b>Comments:</b>	No access within live heaters

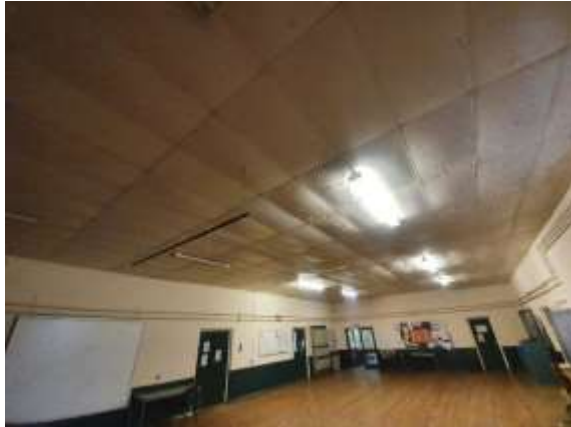
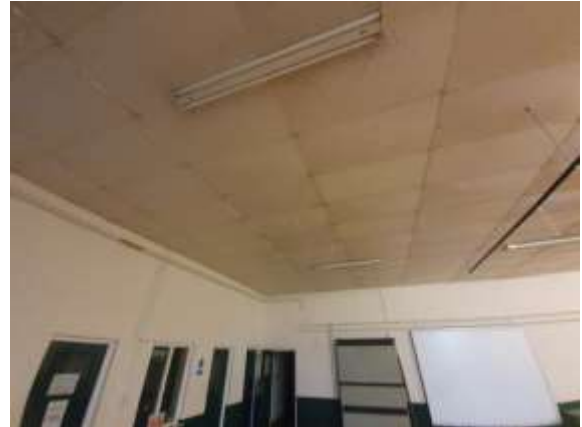
**Location:** Ground Floor - Drill Hall 008

<b>Material Description:</b>	Profiled Roof - Cement Product	
<b>Identification:</b>	Strongly Presumed to Contain Asbestos	
<b>Approx. quantity:</b>	40 m <sup>2</sup>	
<b>Accessibility</b>	Difficult	<i>Assessment Score</i>
<b>Product type:</b>	Cement	1
<b>Extent of Damage:</b>	Slight / minor damage	1
<b>Surface Treatment:</b>	Unsealed Cement	1
<b>Asbestos type:</b>	Chrysotile	1
<b>Material Assessment Score:</b>		4
<b>Priority Assessment Score:</b>		Negligible
<b>Action:</b>	Manage	
<b>Comments:</b>	Above suspended ceiling

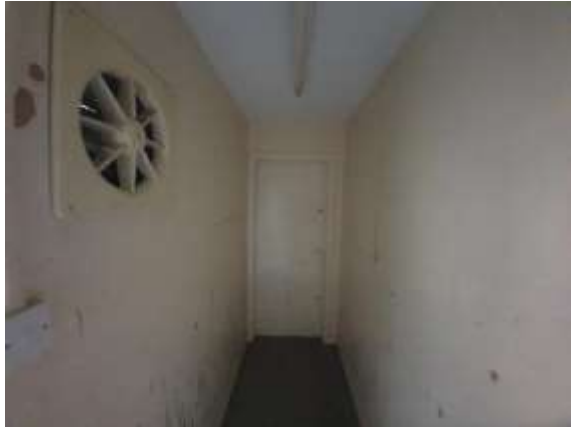
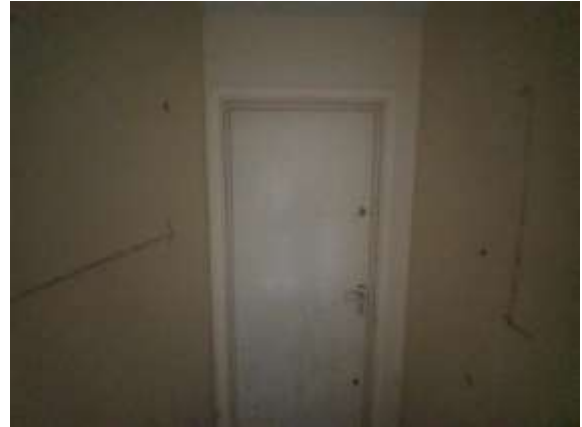
**Location:** Ground Floor - Armoury 009

<b>Material Description:</b>	All - No Access Gained	
<b>Identification:</b>	Presumed to Contain Asbestos	
<b>Approx. quantity:</b>	1 no	
<b>Accessibility</b>	Difficult	<i>Assessment Score</i>
<b>Product type:</b>	Pipe Insulation	3
<b>Extent of Damage:</b>	Major damage	3
<b>Surface Treatment:</b>	Unsealed Insulation	3
<b>Asbestos type:</b>	Amosite, Chrysotile, Crocidolite	3
<b>Material Assessment Score:</b>		12
<b>Priority Assessment Score:</b>		High
<b>Action:</b>	Further Investigation Needed	
<b>Comments:</b>	No access as no key is kept on site

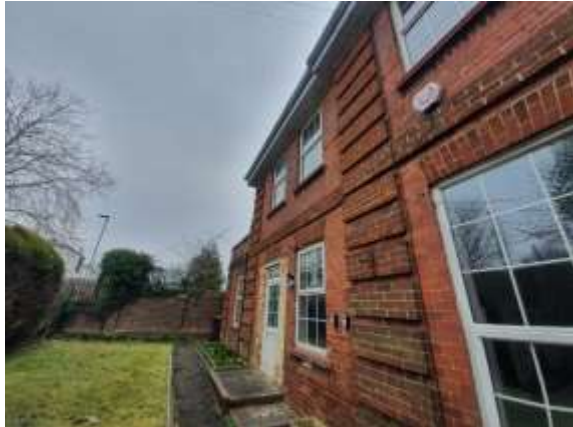
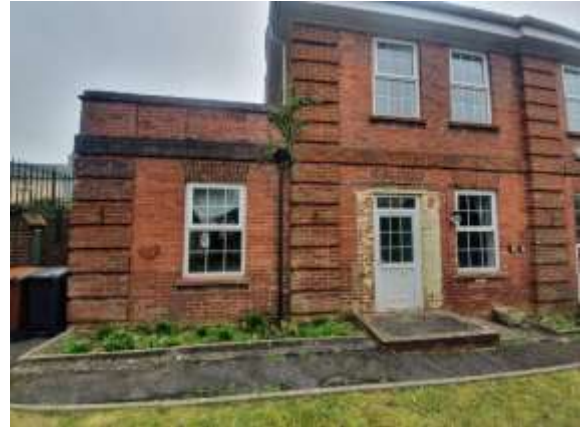
**Location:** Ground Floor - Caretakers Flat - All Rooms 010

<b>Material Description:</b>	All - No Access Gained	
<b>Identification:</b>	Presumed to Contain Asbestos	
<b>Approx. quantity:</b>	1 no	
<b>Accessibility</b>	Difficult	<i>Assessment Score</i>
<b>Product type:</b>	Pipe Insulation	3
<b>Extent of Damage:</b>	Major damage	3
<b>Surface Treatment:</b>	Unsealed Insulation	3
<b>Asbestos type:</b>	Amosite, Chrysotile, Crocidolite	3
<b>Material Assessment Score:</b>		12
<b>Priority Assessment Score:</b>		High
<b>Action:</b>	Further Investigation Needed	
<b>Comments:</b>	No access as it is unknown where key is located

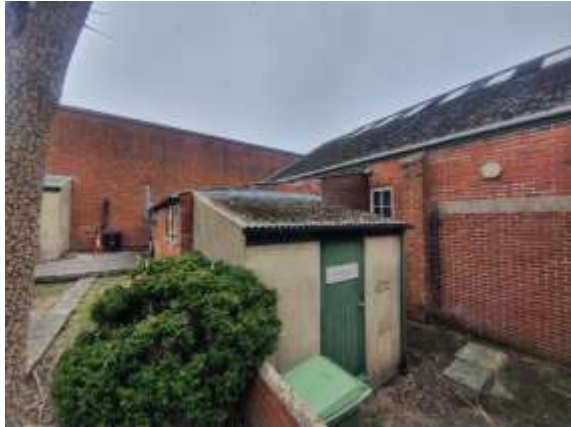
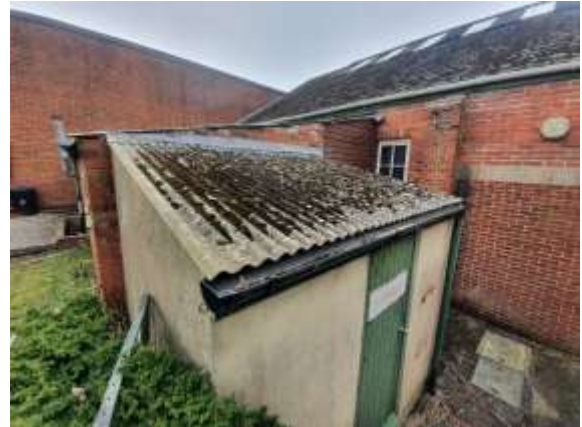
**Location:** External - Store 011

<b>Material Description:</b>	Profiled Roof - Cement Product	
<b>Identification:</b>	Strongly Presumed to Contain Asbestos	
<b>Approx. quantity:</b>	6 m <sup>2</sup>	
<b>Accessibility</b>	Difficult	<i>Assessment Score</i>
<b>Product type:</b>	Cement	1
<b>Extent of Damage:</b>	Slight / minor damage	1
<b>Surface Treatment:</b>	Unsealed Cement	1
<b>Asbestos type:</b>	Chrysotile	1
<b>Material Assessment Score:</b>		4
<b>Priority Assessment Score:</b>		Negligible
<b>Action:</b>	Manage	
<b>Comments:</b>	Previously sampled ref: Armour 23/10/19 - Sample DK/12

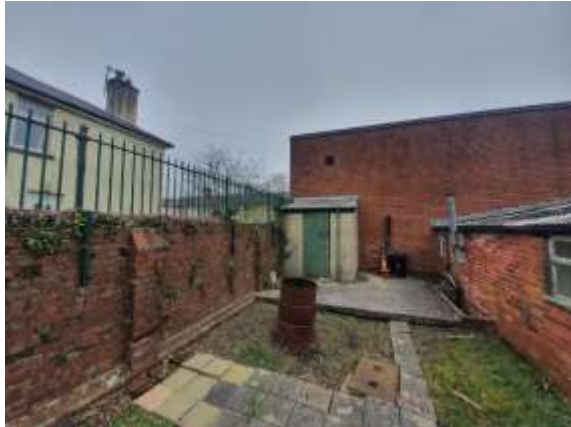
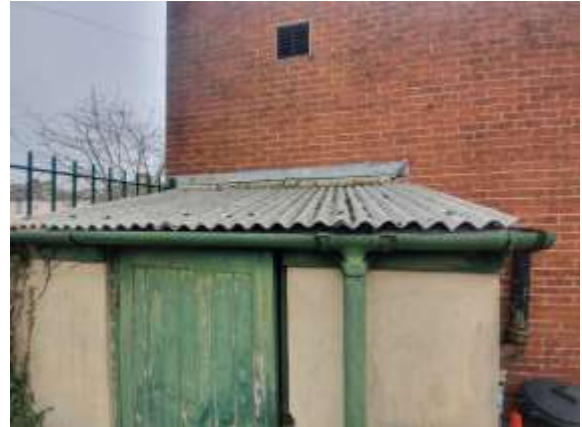
**Location:** External - Shed 012

<b>Material Description:</b>	Profiled Roof - Cement Product	
<b>Identification:</b>	Strongly Presumed to Contain Asbestos	
<b>Approx. quantity:</b>	4 m <sup>2</sup>	
<b>Accessibility</b>	Difficult	<i>Assessment Score</i>
<b>Product type:</b>	Cement	1
<b>Extent of Damage:</b>	Slight / minor damage	1
<b>Surface Treatment:</b>	Unsealed Cement	1
<b>Asbestos type:</b>	Chrysotile	1
<b>Material Assessment Score:</b>		4
<b>Priority Assessment Score:</b>		Negligible
<b>Action:</b>	Manage	
<b>Comments:</b>	Previously sampled ref: Armour 23/10/19 - Sample DK/12

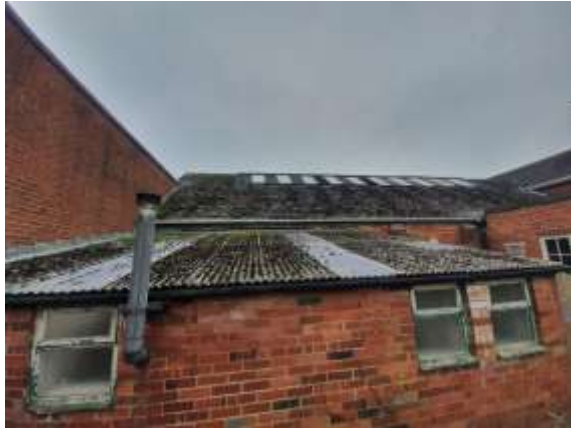
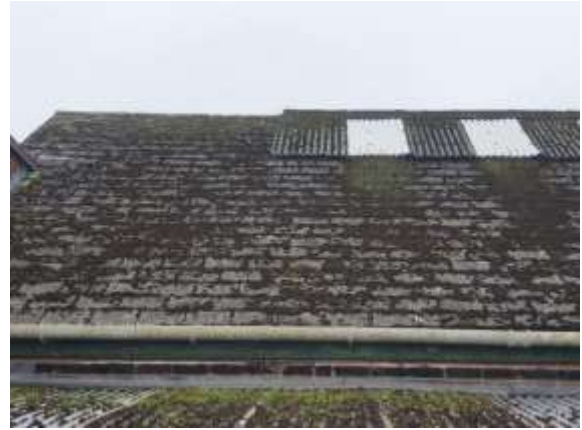
**Location:** External - Main Hall 013

<b>Material Description:</b>	Cement Tiles & Profiled Roof - Cement Product	
<b>Identification:</b>	Strongly Presumed to Contain Asbestos	
<b>Approx. quantity:</b>	110 m <sup>2</sup>	
<b>Accessibility</b>	Difficult	<i>Assessment Score</i>
<b>Product type:</b>	Cement	1
<b>Extent of Damage:</b>	Slight / minor damage	1
<b>Surface Treatment:</b>	Unsealed Cement	1
<b>Asbestos type:</b>	Chrysotile	1
<b>Material Assessment Score:</b>		4
<b>Priority Assessment Score:</b>		Negligible
<b>Action:</b>	Manage	
<b>Comments:</b>	N/A

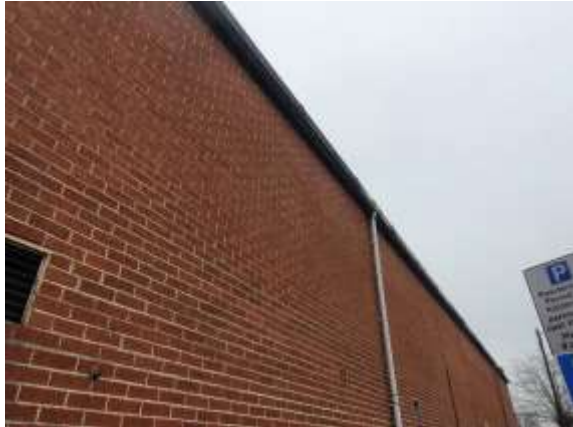
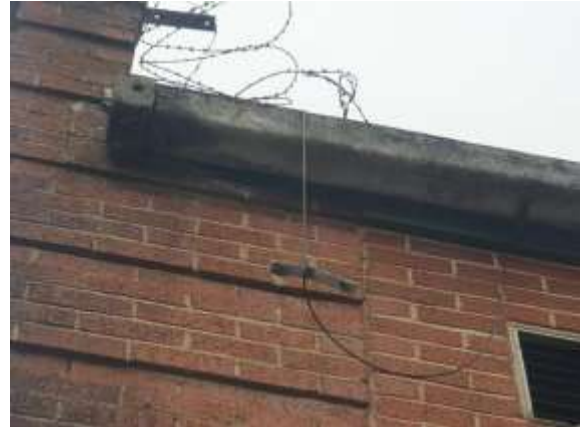
**Location:** External - Range 014

<b>Material Description:</b>	Guttering - Cement Product	
<b>Identification:</b>	Strongly Presumed to Contain Asbestos	
<b>Approx. quantity:</b>	28 LM	
<b>Accessibility</b>	Difficult	<i>Assessment Score</i>
<b>Product type:</b>	Cement	1
<b>Extent of Damage:</b>	Slight / minor damage	1
<b>Surface Treatment:</b>	Unsealed Cement	1
<b>Asbestos type:</b>	Chrysotile	1
<b>Material Assessment Score:</b>		4
<b>Priority Assessment Score:</b>		Negligible
<b>Action:</b>	Manage	
<b>Comments:</b>	N/A
