Project Number A-00420 (3700)

**Re-Inspection
Asbestos Survey Report - Revised**

**Christchurch Platoon
Portfield Road
Dorset
BH23 2AQ**

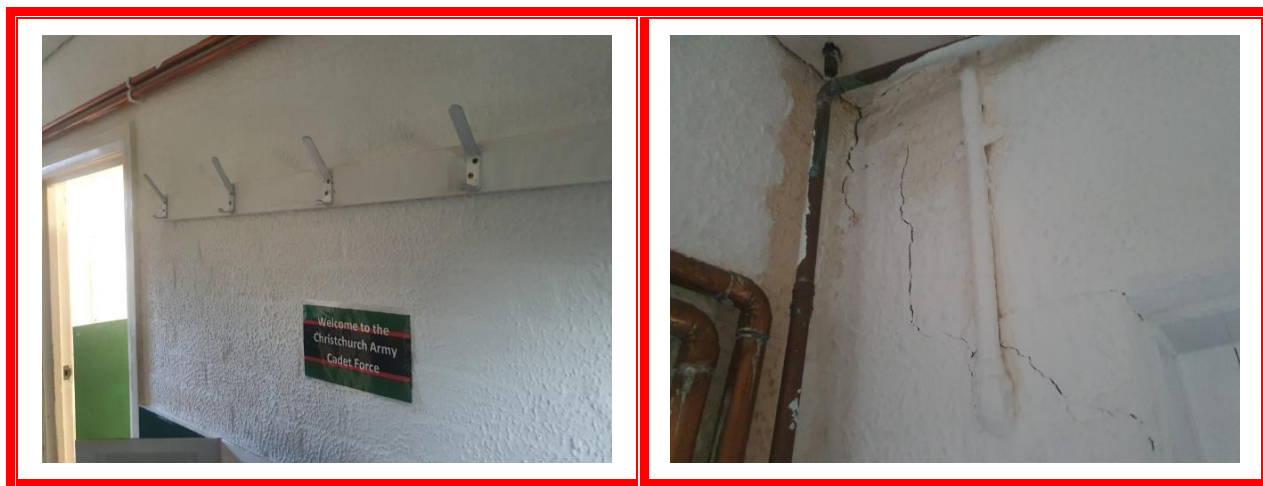
Item No:	1	Sample No:	N/A
Location:	Ground Floor - Corridor 1

Material Description:	Walls - Textured Coating	
Identification:	Previously Sampled - Asbestos Detected	
Approx. quantity:	20 m ²	
Accessibility	Easy	Assessment Score
Product type:	Textured Coating	1
Extent of Damage:	Moderate damage	2
Surface Treatment:	Non-friable	0
Asbestos type:	Chrysotile	1
Material Assessment Score:		4
Priority Assessment Score:		Negligible
Action:	Manage	
Comments:	Previously sampled ref: Armour 30/10/19 Sample GR002

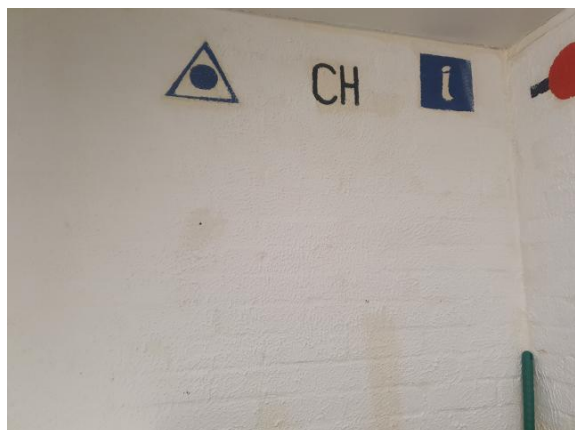
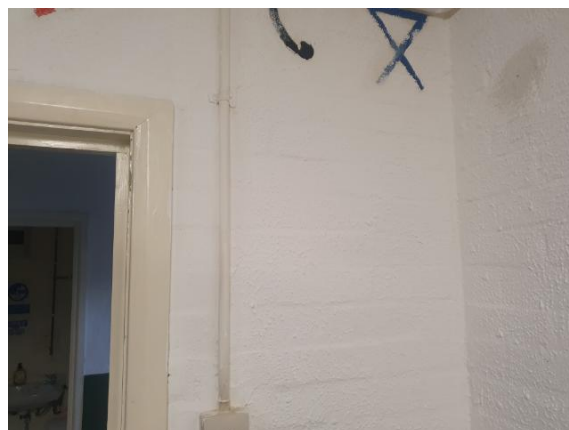
Location: Ground Floor - Kitchen and Lecture Room 2

Material Description:	Walls - Textured Coating	
Identification:	Previously Sampled - Asbestos Detected	
Approx. quantity:	24 m ²	
Accessibility	Easy	<i>Assessment Score</i>
Product type:	Textured Coating	1
Extent of Damage:	Slight / minor damage	1
Surface Treatment:	Non-friable	0
Asbestos type:	Chrysotile	1
Material Assessment Score:		3
Priority Assessment Score:		Negligible
Action:	Manage	
Comments:	Previously sampled ref: Armour 30/10/19 Sample GR002

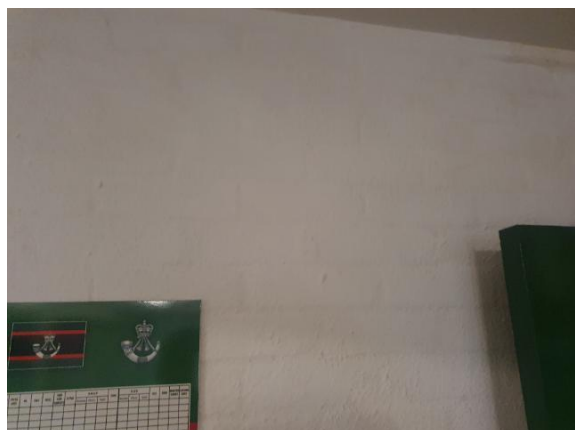
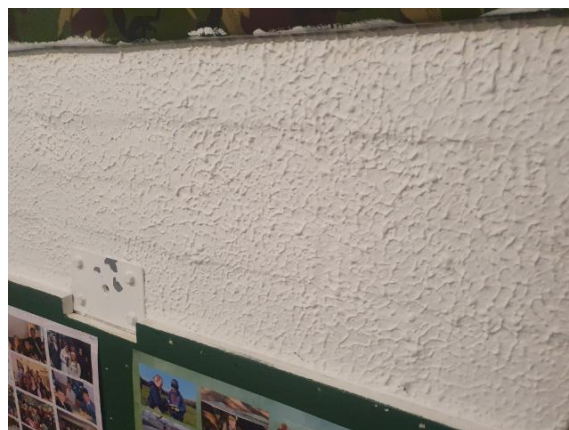
Location: Ground Floor - Drill Hall

Material Description:	Walls - Textured Coating	
Identification:	Previously Sampled - Asbestos Detected	
Approx. quantity:	28 m ²	
Accessibility	Easy	<i>Assessment Score</i>
Product type:	Textured Coating	1
Extent of Damage:	Slight / minor damage	1
Surface Treatment:	Non-friable	0
Asbestos type:	Chrysotile	1
Material Assessment Score:		3
Priority Assessment Score:		Negligible
Action:	Manage	
Comments:	Previously sampled ref: Armour 30/10/19 Sample GR002

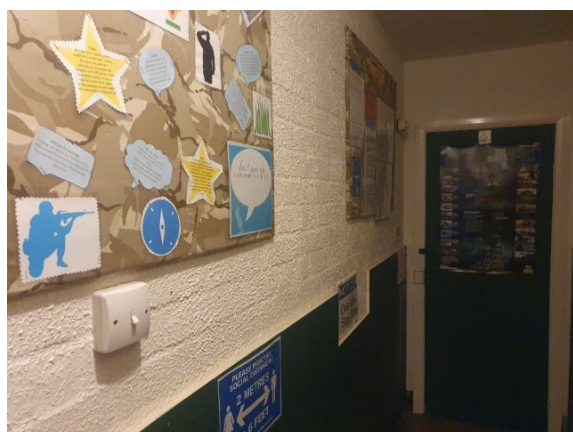
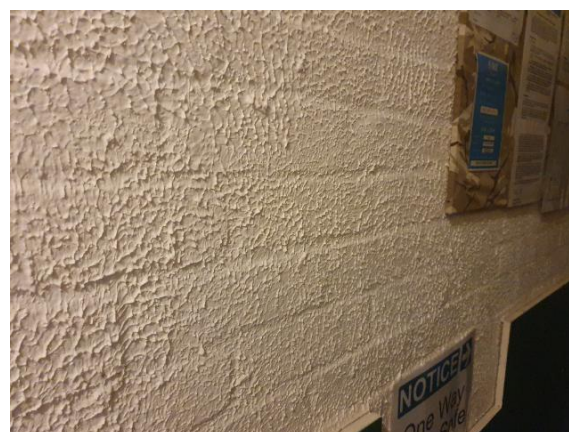
Location: Ground Floor - Corridor 2

Material Description:	Walls - Textured Coating	
Identification:	Previously Sampled - Asbestos Detected	
Approx. quantity:	14 m ²	
Accessibility	Easy	Assessment Score
Product type:	Textured Coating	1
Extent of Damage:	Slight / minor damage	1
Surface Treatment:	Non-friable	0
Asbestos type:	Chrysotile	1
Material Assessment Score:		3
Priority Assessment Score:		Negligible
Action:	Manage	
Comments:	Previously sampled ref: Armour 30/10/19 Sample GR002

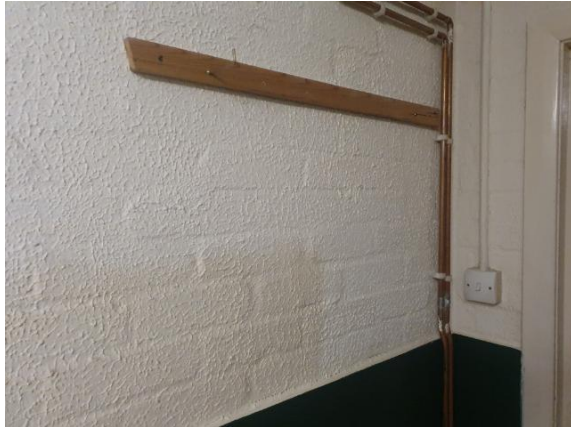
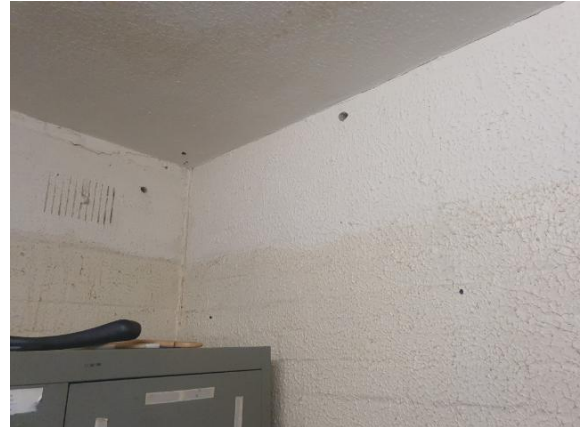
Location: Ground Floor - Stores

Material Description:	Walls - Textured Coating	
Identification:	Previously Sampled - Asbestos Detected	
Approx. quantity:	20 m ²	
Accessibility	Easy	Assessment Score
Product type:	Textured Coating	1
Extent of Damage:	Slight / minor damage	1
Surface Treatment:	Non-friable	0
Asbestos type:	Chrysotile	1
Material Assessment Score:		3
Priority Assessment Score:		Negligible
Action:	Manage	
Comments:	Previously sampled ref: Armour 30/10/19 Sample GR003

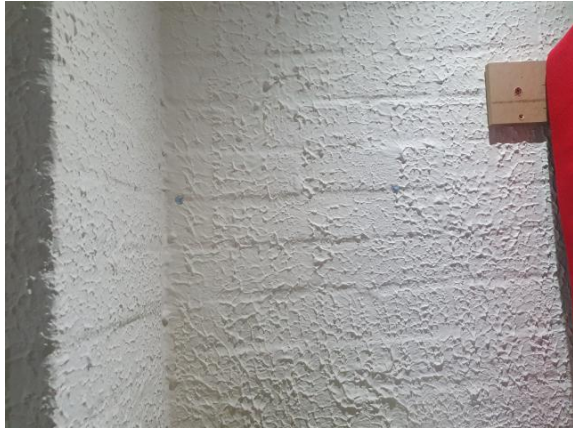
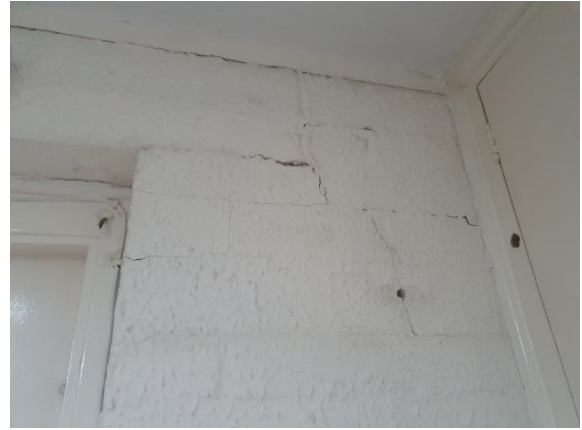
Location: Ground Floor - Office

Material Description:	Walls - Textured Coating	
Identification:	Previously Sampled - Asbestos Detected	
Approx. quantity:	20 m ²	
Accessibility	Easy	<i>Assessment Score</i>
Product type:	Textured Coating	1
Extent of Damage:	Moderate damage	2
Surface Treatment:	Non-friable	0
Asbestos type:	Chrysotile	1
Material Assessment Score:		4
Priority Assessment Score:		Negligible
Action:	Manage	
Comments:	Previously sampled ref: Armour 30/10/19 Sample GR003

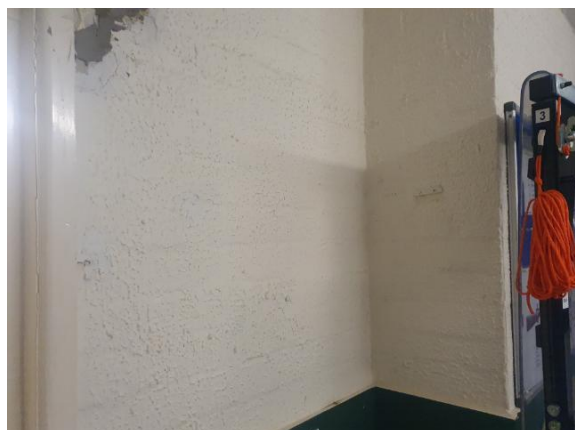
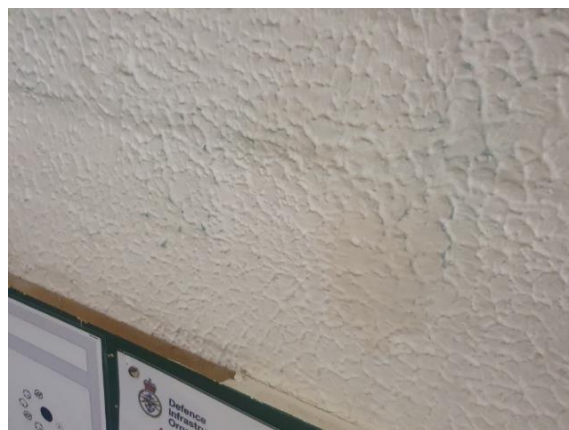
Location: Ground Floor - Lecture Room 1

Material Description:	Walls - Textured Coating	
Identification:	Previously Sampled - Asbestos Detected	
Approx. quantity:	20 m ²	
Accessibility	Easy	<i>Assessment Score</i>
Product type:	Textured Coating	1
Extent of Damage:	Slight / minor damage	1
Surface Treatment:	Non-friable	0
Asbestos type:	Chrysotile	1
Material Assessment Score:		3
Priority Assessment Score:		Negligible
Action:	Manage	
Comments:	Previously sampled ref: Armour 30/10/19 Sample GR003

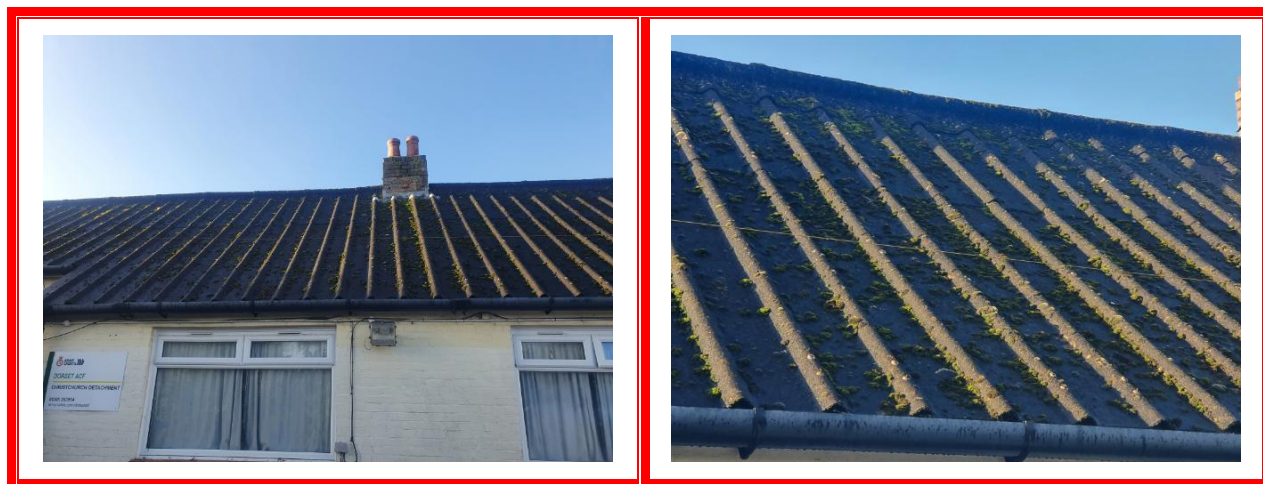
Item No:	8	Sample No:	DK/01
Location:	External - Roof

Material Description:	Profiled Roof - Cement Product	
Identification:	Sampled - Asbestos Detected	
Approx. quantity:	100 m ²	
Accessibility	Difficult	<i>Assessment Score</i>
Product type:	Cement Product	1
Extent of Damage:	Slight / minor damage	1
Surface Treatment:	Non-friable	0
Asbestos type:	Chrysotile	1
Material Assessment Score:		3
Priority Assessment Score:		Negligible
Action:	Manage	
Comments:	N/A

Sample No.	Sample Ref.	Location	Asbestos Detected	Asbestos Type
DK/01	BS647883	External - Profiled cement roof.	Yes	Chrysotile

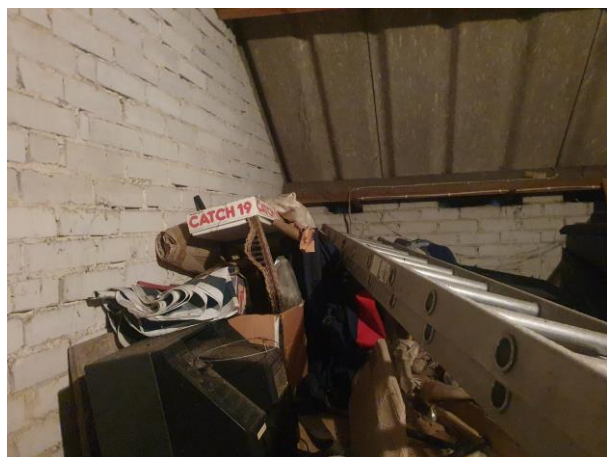
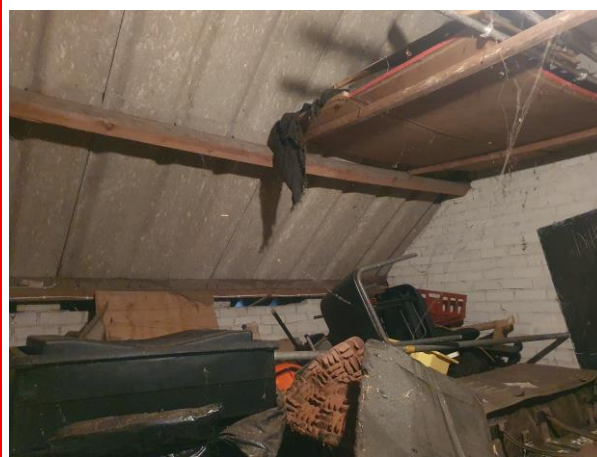
Location: Ground Floor - Loft Space

Material Description:	Cement Product	
Identification:	As per Sample DK/01	
Approx. quantity:	100 m ²	
Accessibility	Difficult	<i>Assessment Score</i>
Product type:	Cement	1
Extent of Damage:	Minor/ Slight damage	1
Surface Treatment:	Non-Friable	0
Asbestos type:	Chrysotile	1
Material Assessment Score:		3
Priority Assessment Score:		Negligible
Action:	Manage	
Comments:	Previously a no access area, now accessed. Limited access within loft space. Rodent droppings throughout.
