Project Number A-00564 (3700)

**Re-Inspection
Asbestos Survey Report**

**Teignmouth Platoon
Devon
TQ14 8HB**

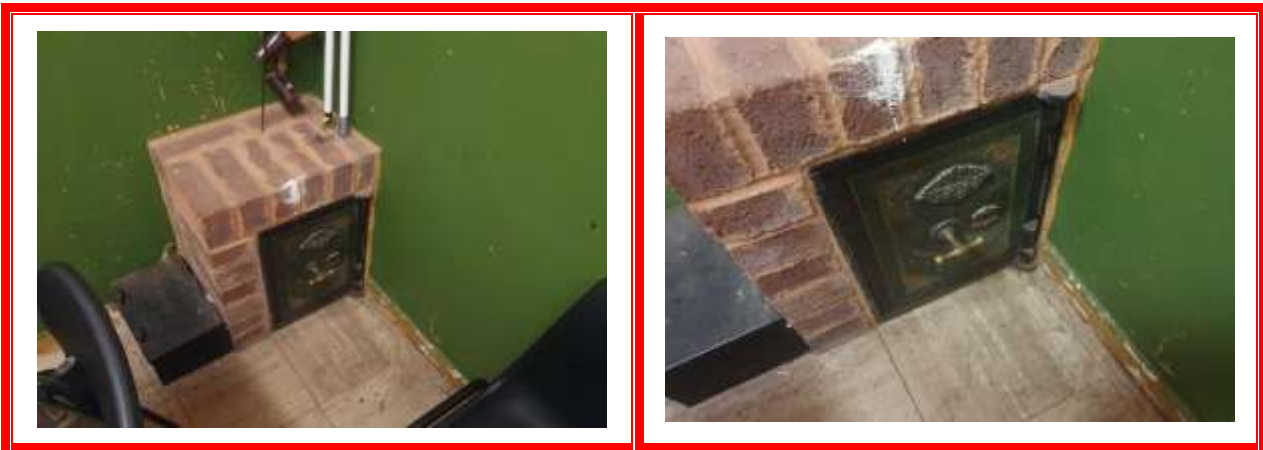
Item No:	1	Sample No:	N/A
Location:	Ground Floor - ACF Centre - NCO Office 001

Material Description:	Safe	
Identification:	Presumed to Contain Asbestos	
Approx. quantity:	1 no	
Accessibility	Difficult	Assessment Score
Product type:	Asbestos Insulating Board	2
Extent of Damage:	Major damage	3
Surface Treatment:	Unsealed Insulation	3
Asbestos type:	Amosite, Chrysotile	2
Material Assessment Score:		10
Priority Assessment Score:		High
Action:	Manage	
Comments:	No access within safe casings without damaging safe

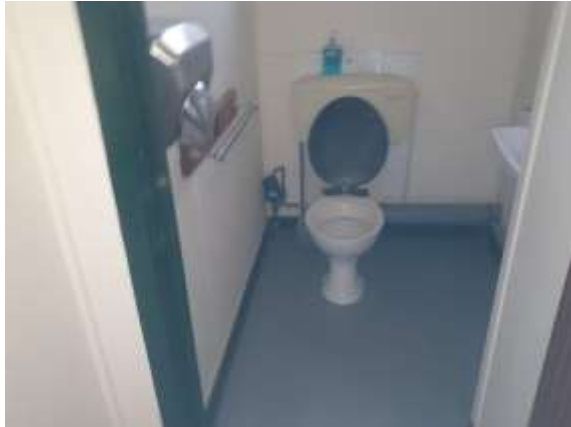
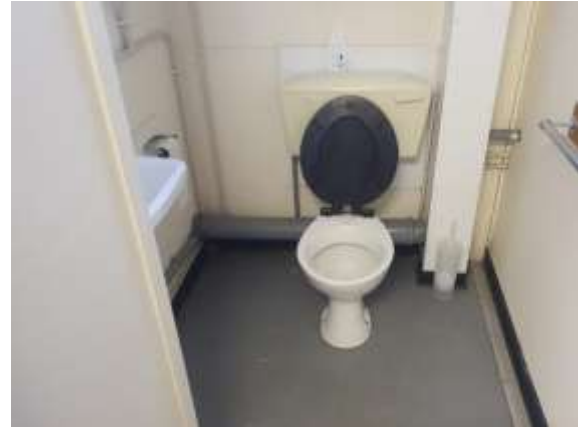
Location: Ground Floor - External Stores Hut - WC's x 2 002

Material Description:	Toilet Seats - PVC / Reinforced Plastics	
Identification:	Presumed to Contain Asbestos	
Approx. quantity:	2 no	
Accessibility	Easy	<i>Assessment Score</i>
Product type:	Bakelite	1
Extent of Damage:	Major damage	3
Surface Treatment:	Unsealed Insulation	3
Asbestos type:	Chrysotile	1
Material Assessment Score:		8
Priority Assessment Score:		Medium
Action:	Manage	
Comments:	Not possible to sample without damaging the integrity of the seat

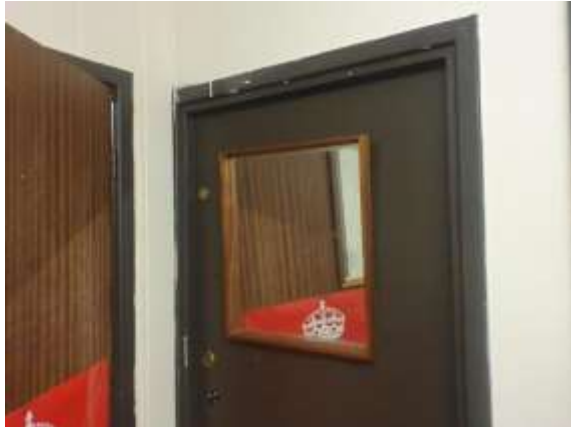
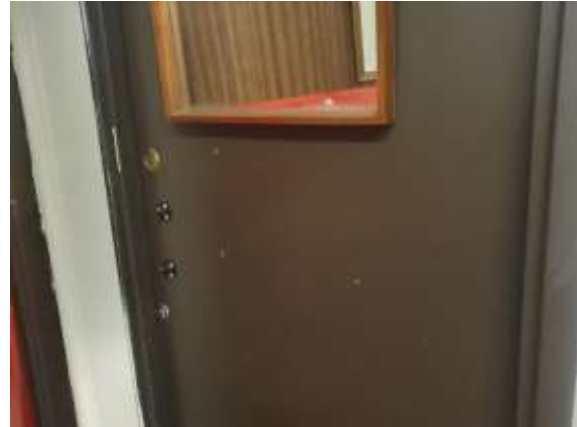
Location: Ground Floor - External Stores Hut - Armoury 003

Material Description:	All - No Access Gained	
Identification:	Presumed to Contain Asbestos	
Approx. quantity:	1 no	
Accessibility	Difficult	<i>Assessment Score</i>
Product type:	Pipe Insulation	3
Extent of Damage:	Major damage	3
Surface Treatment:	Unsealed Insulation	3
Asbestos type:	Amosite, Chrysotile, Crocidolite	3
Material Assessment Score:		12
Priority Assessment Score:		High
Action:	Further Investigation Needed	
Comments:	No access within room as key was not held on site

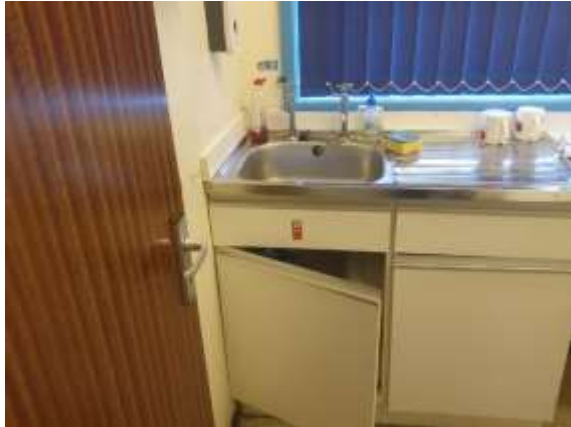
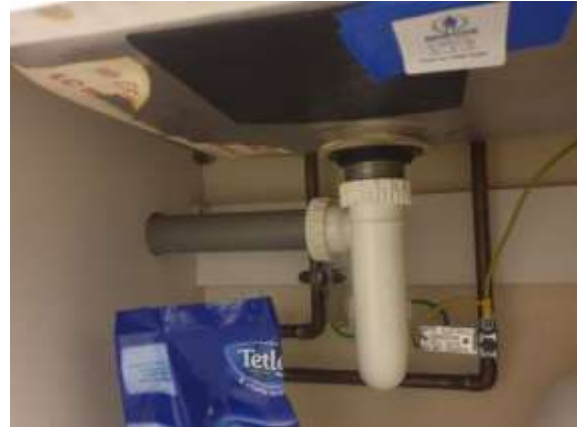
Location: Ground Floor - External Stores Hut - Kitchen 004

Material Description:	Sink Pad - Bituminous Product	
Identification:	Previously Sampled - Asbestos Detected	
Approx. quantity:	1 no	
Accessibility	Medium	Assessment Score
Product type:	Bitumen	1
Extent of Damage:	Slight / minor damage	1
Surface Treatment:	Non-friable	0
Asbestos type:	Chrysotile	1
Material Assessment Score:		3
Priority Assessment Score:		Negligible
Action:	Manage	
Comments:	Previously sampled ref: Armour 30/9/19 - Sample DK/4

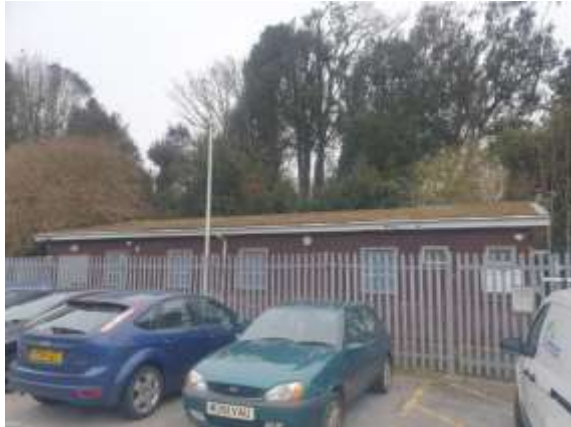
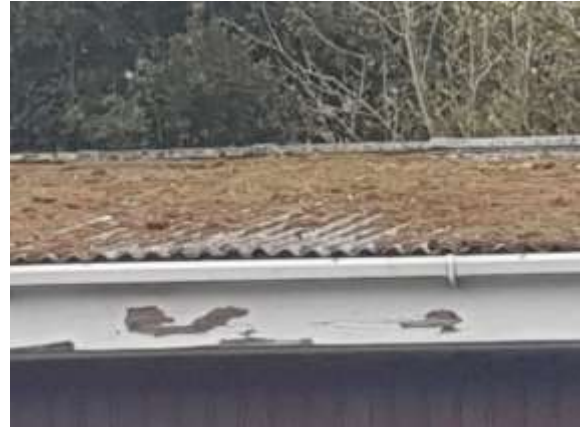
Location: External - External Stores Hut 005

Material Description:	Profiled Roof - Cement Product	
Identification:	Previously Sampled - Asbestos Detected	
Approx. quantity:	120 m ²	
Accessibility	Difficult	<i>Assessment Score</i>
Product type:	Cement	1
Extent of Damage:	Slight / minor damage	1
Surface Treatment:	Unsealed Cement	1
Asbestos type:	Chrysotile	1
Material Assessment Score:		4
Priority Assessment Score:		Negligible
Action:	Manage	
Comments:	Previously sampled ref: Armour 30/9/19 - Sample DK/5
