Project Number A-00519 (3700)

**Re-Inspection
Asbestos Survey Report - Revised**

**243 Field Hospital
Ashmead Road
Somerset
BS31 1SX**

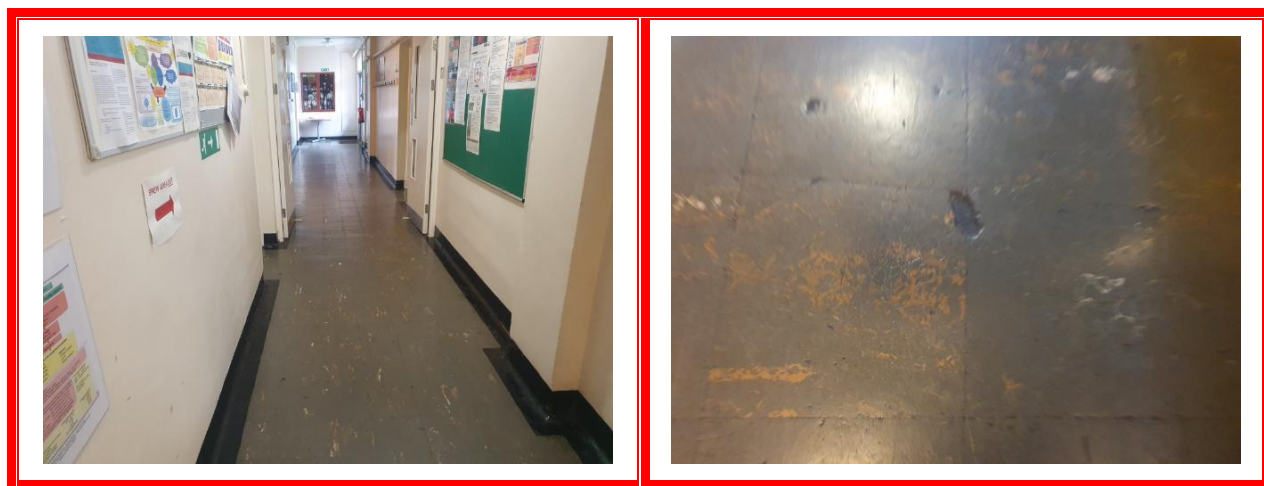
Item No:	3	Sample No:	N/A
Location:	Ground Floor - Corridors between Main Hall and Junior Mess 003

Material Description:	Floor Tiles and Adhesive - Vinyl Products	
Identification:	Previously Sampled - Asbestos Detected	
Approx. quantity:	70 m ²	
Accessibility	Difficult	Assessment Score
Product type:	Vinyl	1
Extent of Damage:	Moderate damage	2
Surface Treatment:	Non-friable	0
Asbestos type:	Chrysotile	1
Material Assessment Score:		4
Priority Assessment Score:		Negligible
Action:	Manage	
Comments:	Previously sampled ref: Armour GR004

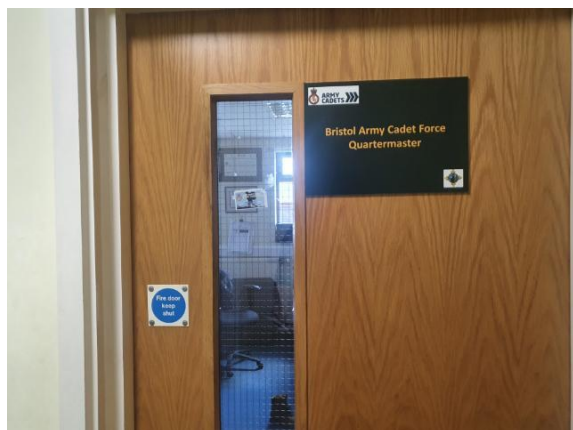
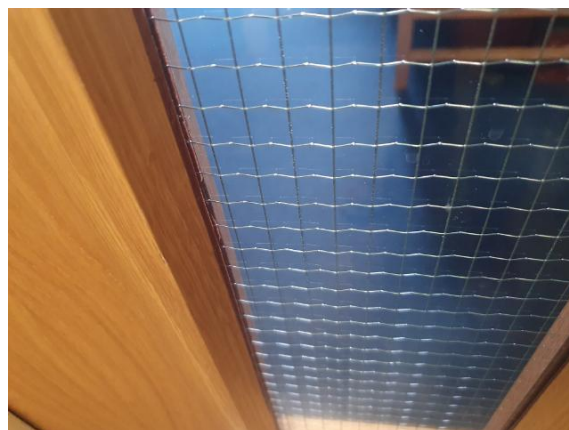
Location: Ground Floor - Office G45 004

Material Description:	Floor Tiles and Adhesive - Vinyl Products	
Identification:	Previously Sampled - Asbestos Detected	
Approx. quantity:	12 m ²	
Accessibility	Difficult	Assessment Score
Product type:	Vinyl	1
Extent of Damage:	Moderate damage	2
Surface Treatment:	Non-friable	0
Asbestos type:	Chrysotile	1
Material Assessment Score:		4
Priority Assessment Score:		Negligible
Action:	Manage	
Comments:	Previously sampled ref: Armour GR004. Under carpet

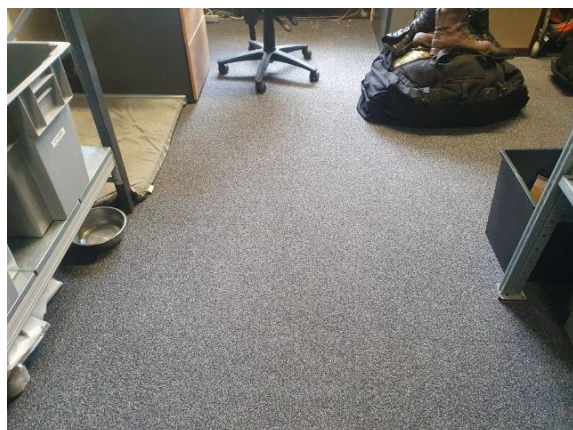
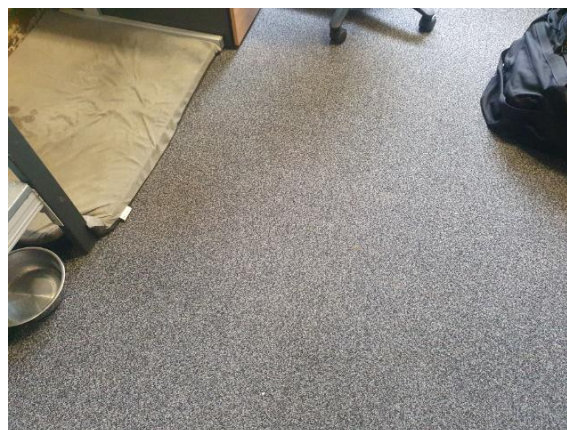
Location: Ground Floor - QM Store 005

Material Description:	Floor Tiles and Adhesive - Vinyl Products	
Identification:	Previously Sampled - Asbestos Detected	
Approx. quantity:	20 m ²	
Accessibility	Difficult	<i>Assessment Score</i>
Product type:	Vinyl	1
Extent of Damage:	Moderate damage	2
Surface Treatment:	Non-friable	0
Asbestos type:	Chrysotile	1
Material Assessment Score:		4
Priority Assessment Score:		Negligible
Action:	Manage	
Comments:	<p>Previously sampled ref: Armour GR004. Located under carpet.</p> <p>Non asbestos supalux boxing and panel on ceiling above door.</p> <p>No access within boxing</p>

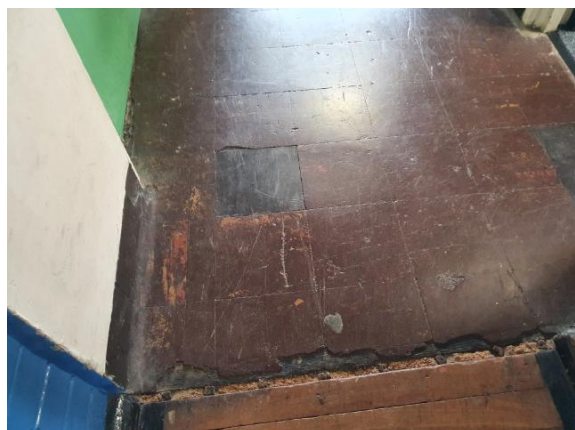
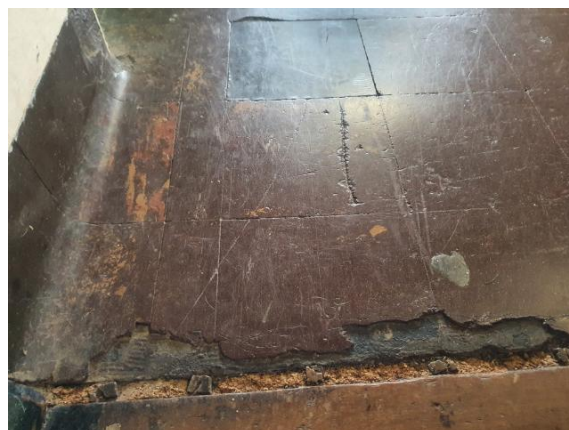
Location: Ground Floor - Lobby 006

Material Description:	Floor Tiles and Adhesive - Vinyl Products	
Identification:	Previously Sampled - Asbestos Detected	
Approx. quantity:	3 m ²	
Accessibility	Difficult	<i>Assessment Score</i>
Product type:	Vinyl	1
Extent of Damage:	Moderate damage	2
Surface Treatment:	Non-friable	0
Asbestos type:	Chrysotile	1
Material Assessment Score:		4
Priority Assessment Score:		Negligible
Action:	Manage	
Comments:	Previously sampled ref: Armour GR004

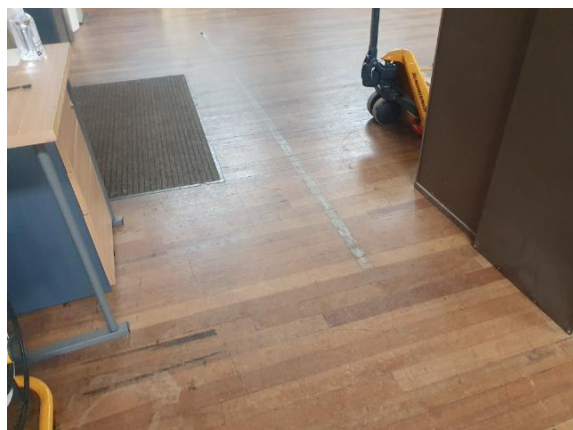
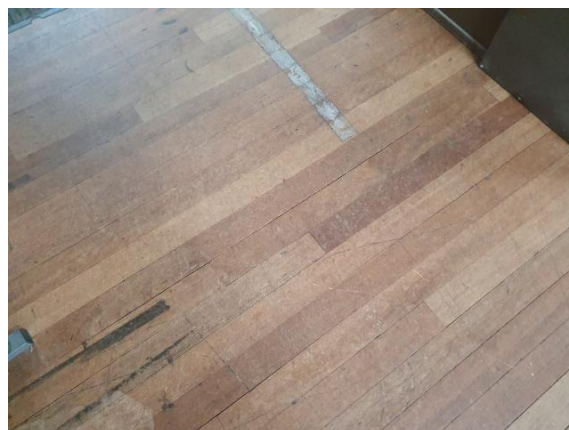
Location: Ground Floor - Drill Hall 007

Material Description:	Adhesive under Parquet Flooring - Bituminous Product	
Identification:	Presumed to Contain Asbestos	
Approx. quantity:	100 m ²	
Accessibility	Difficult	<i>Assessment Score</i>
Product type:	Bitumen	1
Extent of Damage:	Minor damage	1
Surface Treatment:	Non-friable	0
Asbestos type:	Chrysotile	1
Material Assessment Score:		3
Priority Assessment Score:		Negligible
Action:	Manage	
Comments:	No access to sample without damaging flooring

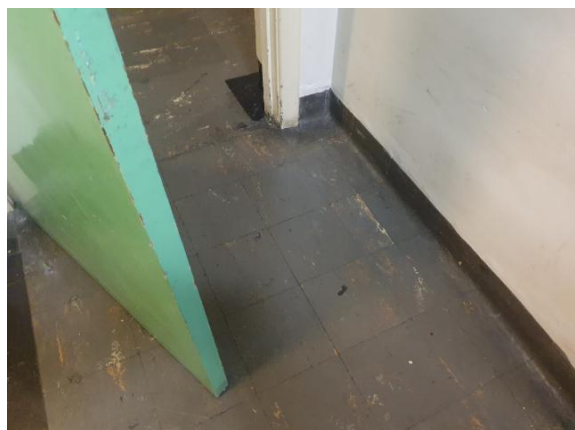
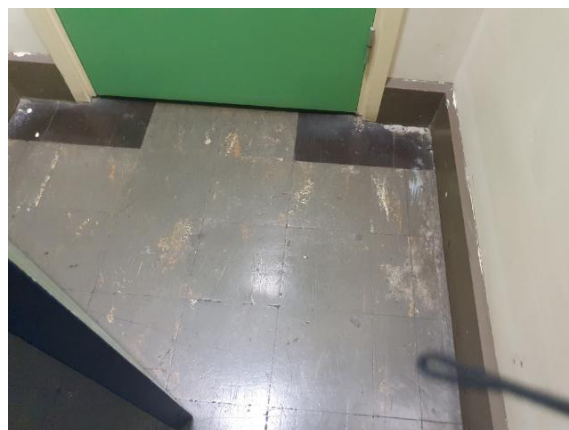
Location: Ground Floor - Lobby and Store 008

Material Description:	Floor Tiles and Adhesive - Vinyl Products	
Identification:	Previously Sampled - Asbestos Detected	
Approx. quantity:	6 m ²	
Accessibility	Difficult	<i>Assessment Score</i>
Product type:	Vinyl	1
Extent of Damage:	Slight / minor damage	1
Surface Treatment:	Non-friable	0
Asbestos type:	Chrysotile	1
Material Assessment Score:		3
Priority Assessment Score:		Negligible
Action:	Manage	
Comments:	Previously sampled ref: Armour GR004

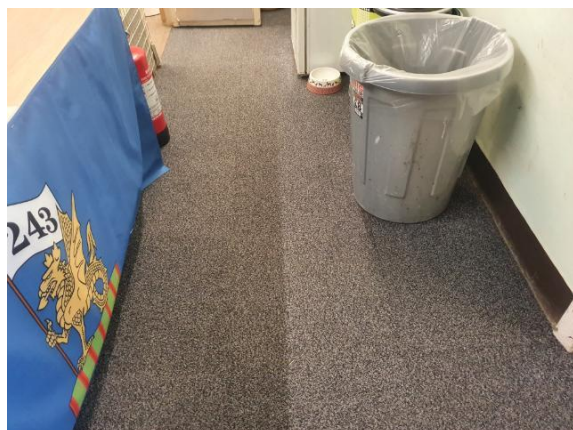
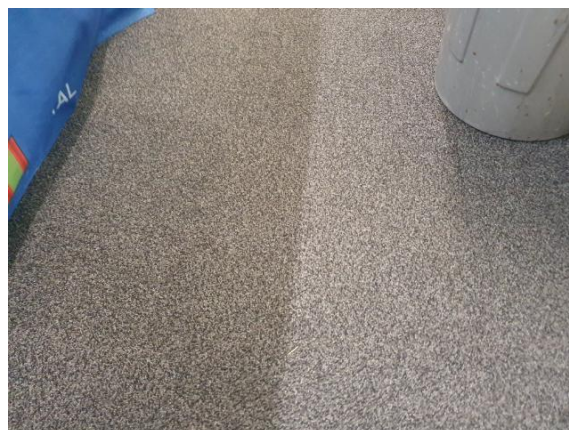
Location: Ground Floor - Store G80 009

Material Description:	Floor Tiles and Adhesive - Vinyl Products	
Identification:	Previously Sampled - Asbestos Detected	
Approx. quantity:	40 m ²	
Accessibility	Difficult	<i>Assessment Score</i>
Product type:	Vinyl	1
Extent of Damage:	Moderate damage	2
Surface Treatment:	Non-friable	0
Asbestos type:	Chrysotile	1
Material Assessment Score:		4
Priority Assessment Score:		Negligible
Action:	Manage	
Comments:	Previously sampled ref: Armour GR006. Now under carpet

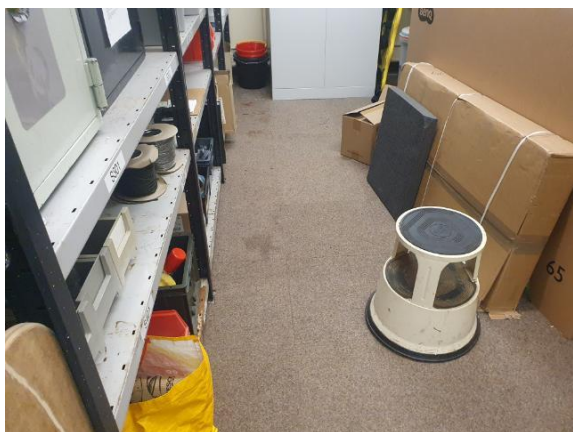
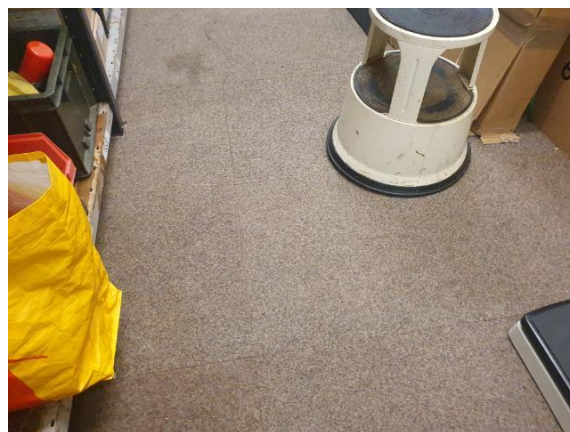
Location: Ground Floor - Store G80 - Cage 010

Material Description:	Floor Tiles and Adhesive - Vinyl Products	
Identification:	Previously Sampled - Asbestos Detected	
Approx. quantity:	12 m ²	
Accessibility	Difficult	<i>Assessment Score</i>
Product type:	Vinyl	1
Extent of Damage:	Moderate damage	2
Surface Treatment:	Non-friable	0
Asbestos type:	Chrysotile	1
Material Assessment Score:		4
Priority Assessment Score:		Negligible
Action:	Manage	
Comments:	Previously sampled ref: Armour GR006. Now under carpet

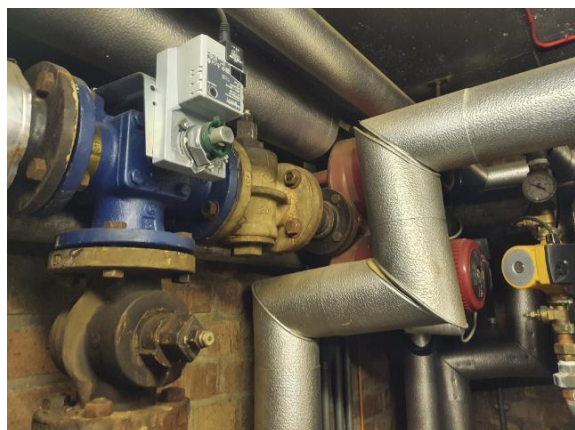
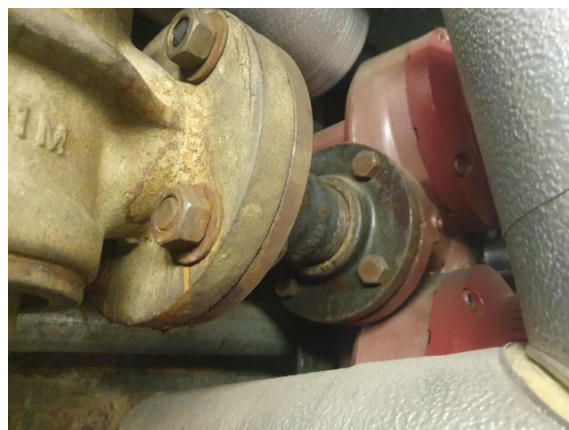
Location: Basement - Boiler Room 011

Material Description:	Gaskets - Gaskets (compressed)	
Identification:	Presumed to Contain Asbestos	
Approx. quantity:	2 m ²	
Accessibility	Difficult	<i>Assessment Score</i>
Product type:	Gaskets	2
Extent of Damage:	Moderate damage	2
Surface Treatment:	Gaskets	1
Asbestos type:	Chrysotile	1
Material Assessment Score:		6
Priority Assessment Score:		Low
Action:	Manage	
Comments:	No access within live boilers

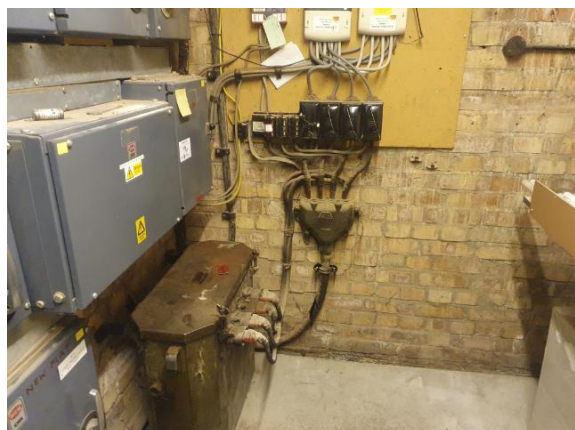
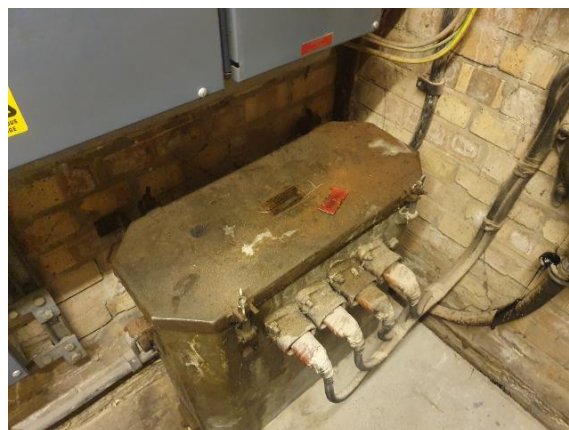
Location: Basement - Boiler Room 012

Material Description:	Old Electrical Panels - Gaskets (rope/woven)	
Identification:	Presumed to Contain Asbestos	
Approx. quantity:	6 no	
Accessibility	Difficult	<i>Assessment Score</i>
Product type:	Flashguards	2
Extent of Damage:	Minor damage	1
Surface Treatment:	Woven	1
Asbestos type:	Chrysotile	1
Material Assessment Score:		5
Priority Assessment Score:		Low
Action:	Manage	
Comments:	No access within live electrics

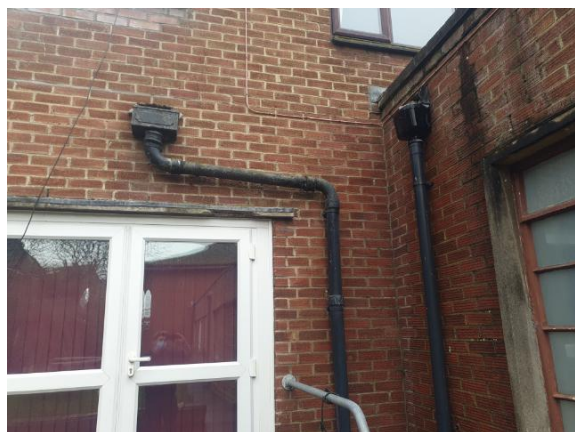
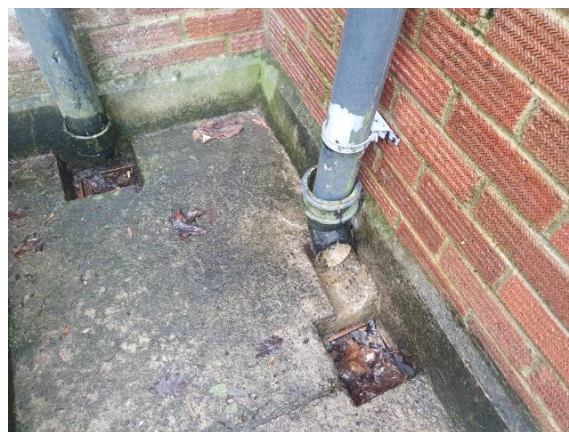
Location: External - Main Building 013

Material Description:	Downpipes - Cement Product	
Identification:	Strongly Presumed to Contain Asbestos	
Approx. quantity:	6 LM	
Accessibility	Medium	<i>Assessment Score</i>
Product type:	Cement	1
Extent of Damage:	Slight / minor damage	1
Surface Treatment:	Unsealed Cement	1
Asbestos type:	Chrysotile	1
Material Assessment Score:		4
Priority Assessment Score:		Negligible
Action:	Manage	
Comments:	N/A

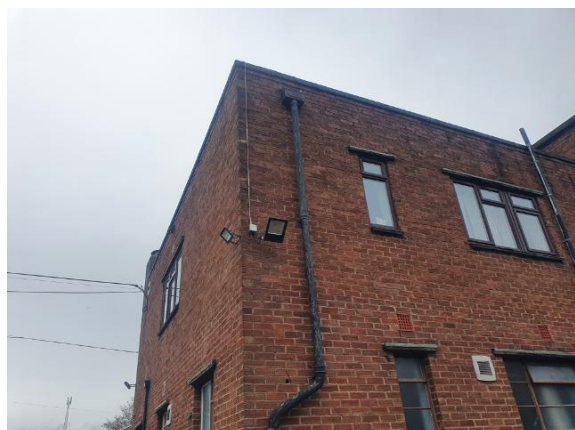
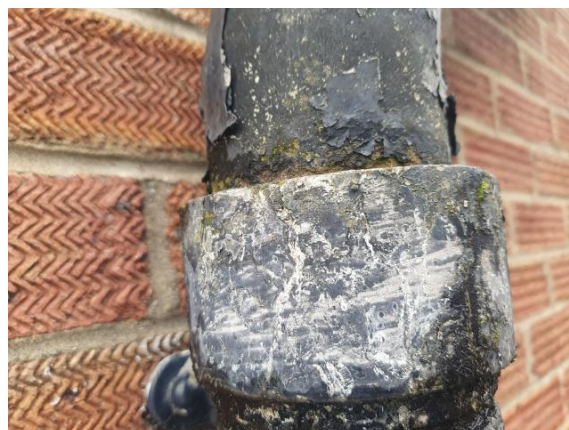
Location: External - Main Building 014

Material Description:	Downpipes - Cement Product	
Identification:	Strongly Presumed to Contain Asbestos	
Approx. quantity:	3 no	
Accessibility	Medium	<i>Assessment Score</i>
Product type:	Cement	1
Extent of Damage:	Slight / minor damage	1
Surface Treatment:	Unsealed Cement	1
Asbestos type:	Chrysotile	1
Material Assessment Score:		4
Priority Assessment Score:		Negligible
Action:	Manage	
Comments:	3no pipes

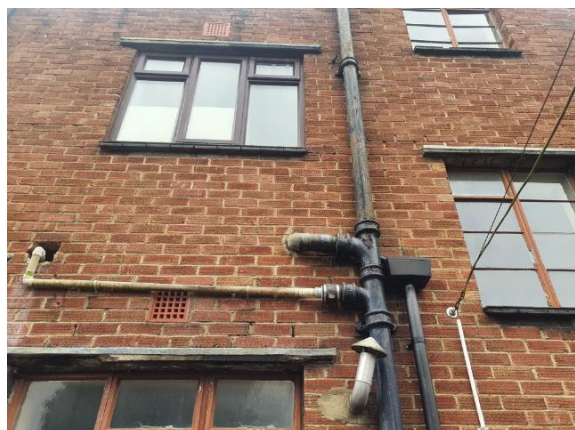
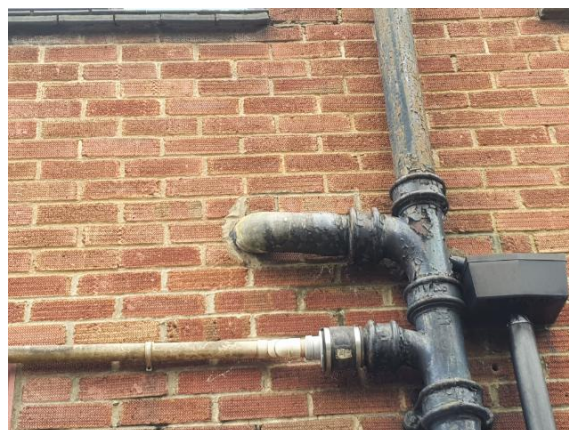
Location: External - Main Building 015

Material Description:	Soil Pipe - Cement Product	
Identification:	Strongly Presumed to Contain Asbestos	
Approx. quantity:	1 LM	
Accessibility	Difficult	<i>Assessment Score</i>
Product type:	Cement	1
Extent of Damage:	Slight / minor damage	1
Surface Treatment:	Unsealed Cement	1
Asbestos type:	Chrysotile	1
Material Assessment Score:		4
Priority Assessment Score:		Negligible
Action:	Manage	
Comments:	N/A

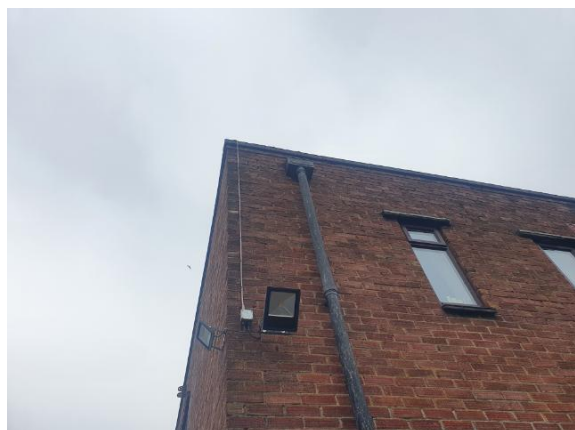
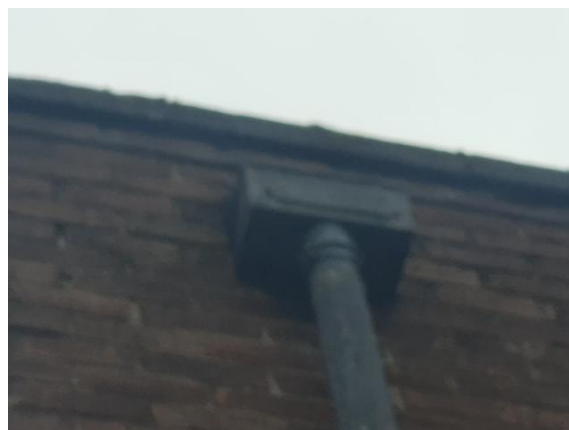
Location: External - Main Building 016

Material Description:	Rainwater Hoppers and Packers within- Cement Product	
Identification:	Strongly Presumed to Contain Asbestos	
Approx. quantity:	9 no	
Accessibility	Difficult	<i>Assessment Score</i>
Product type:	Cement	1
Extent of Damage:	Slight / minor damage	1
Surface Treatment:	Unsealed Cement	1
Asbestos type:	Chrysotile	1
Material Assessment Score:		4
Priority Assessment Score:		Negligible
Action:	Manage	
Comments:	N/A

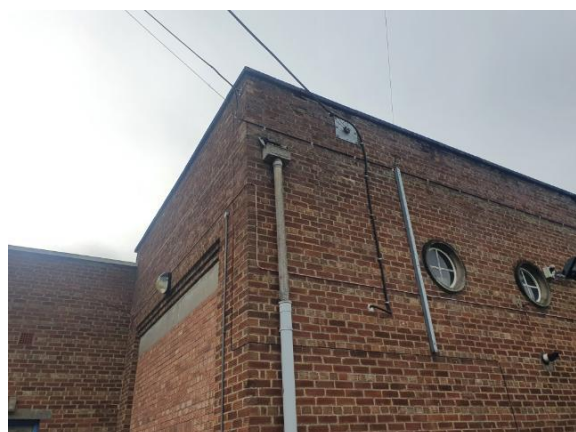
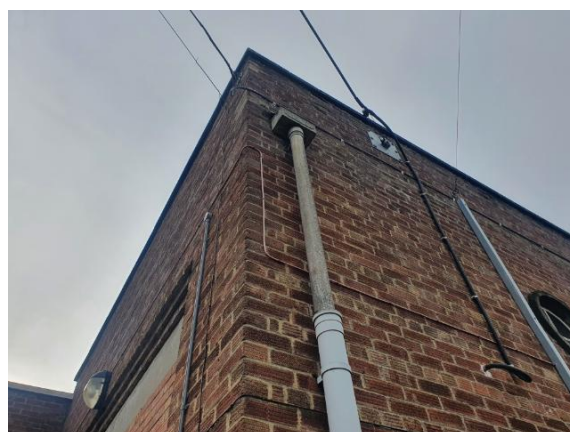
Location: External - QM Stores 017

Material Description:	Downpipe, Hoppers and Packers within - Cement Product	
Identification:	Strongly Presumed to Contain Asbestos	
Approx. quantity:	4 LM	
Accessibility	Difficult	<i>Assessment Score</i>
Product type:	Cement	1
Extent of Damage:	Slight / minor damage	1
Surface Treatment:	Unsealed Cement	1
Asbestos type:	Chrysotile	1
Material Assessment Score:		4
Priority Assessment Score:		Negligible
Action:	Manage	
Comments:	N/A

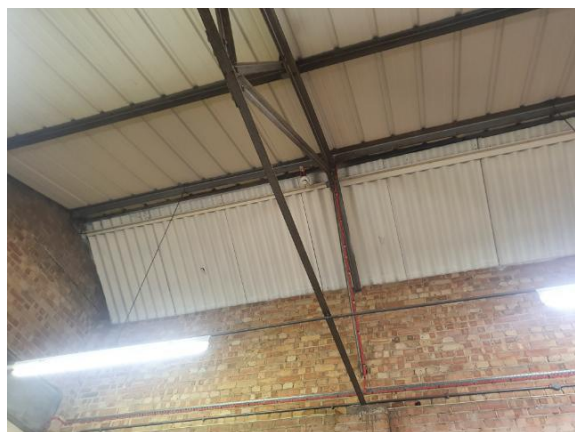
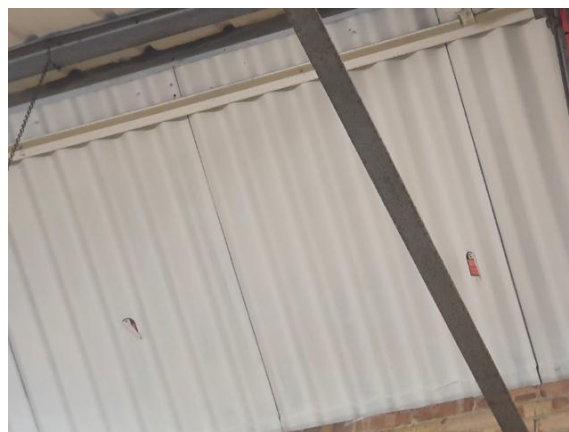
Location: External - Stores 018

Material Description:	Profiled Cement Roof - Cement Product	
Identification:	Strongly Presumed to Contain Asbestos	
Approx. quantity:	20 m ²	
Accessibility	Difficult	<i>Assessment Score</i>
Product type:	Cement	1
Extent of Damage:	Slight / minor damage	1
Surface Treatment:	Unsealed Cement	1
Asbestos type:	Chrysotile	1
Material Assessment Score:		4
Priority Assessment Score:		Negligible
Action:	Manage	
Comments:	Only partially cement. The rest of roof is metal

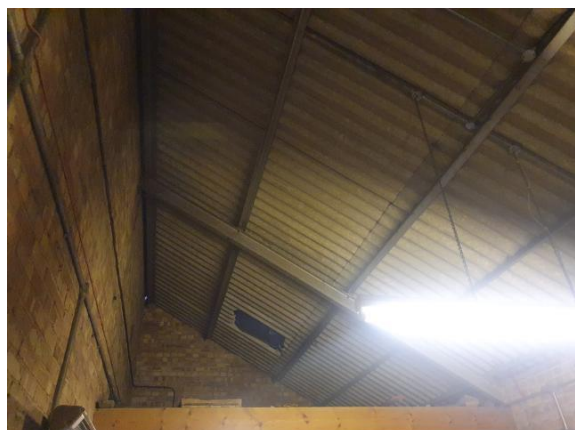
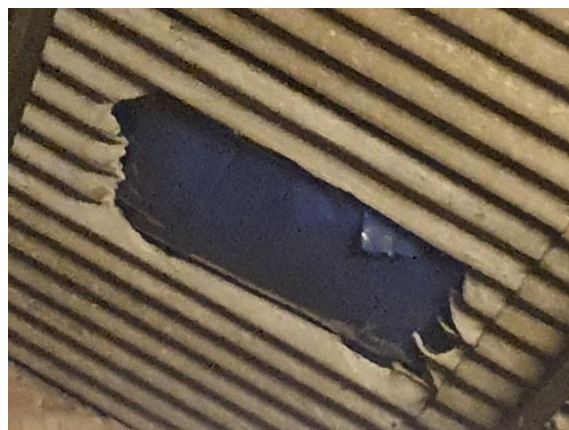
Location: Ground Floor - Range 019

Material Description:	Profiled Cement Roof - Cement Product	
Identification:	Strongly Presumed to Contain Asbestos	
Approx. quantity:	75 m ²	
Accessibility	Difficult	<i>Assessment Score</i>
Product type:	Cement	1
Extent of Damage:	Moderate damage	2
Surface Treatment:	Unsealed Cement	1
Asbestos type:	Chrysotile	1
Material Assessment Score:		5
Priority Assessment Score:		Low
Action:	Encapsulate	
Comments:	Large hole in roof and other small areas of damage

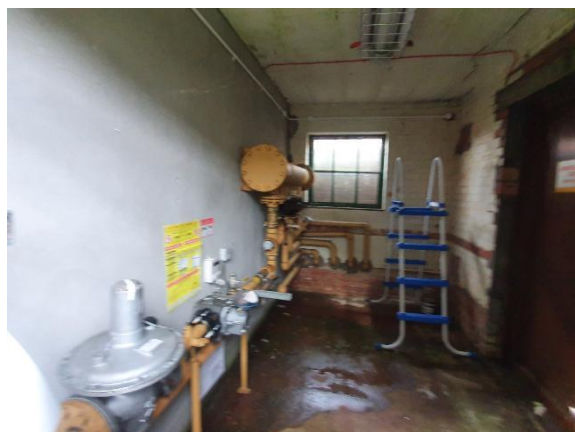
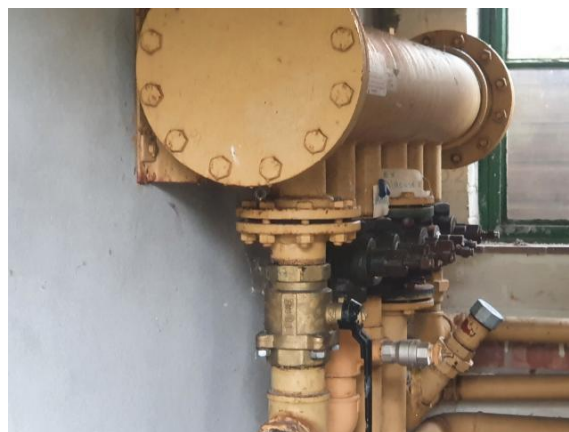
Location: Ground Floor - Gas Intake Room 021

Material Description:	Gaskets - Gaskets (compressed)	
Identification:	Strongly Presumed to Contain Asbestos	
Approx. quantity:	5 no	
Accessibility	Difficult	<i>Assessment Score</i>
Product type:	Gaskets	2
Extent of Damage:	Slight / minor damage	1
Surface Treatment:	Gaskets	1
Asbestos type:	Chrysotile	1
Material Assessment Score:		5
Priority Assessment Score:		Low
Action:	Manage	
Comments:	N/A

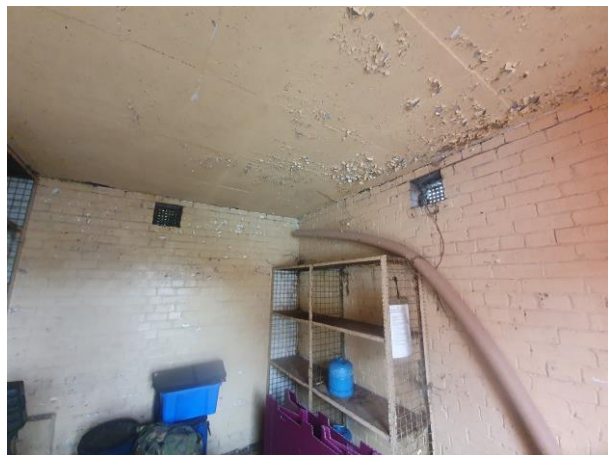
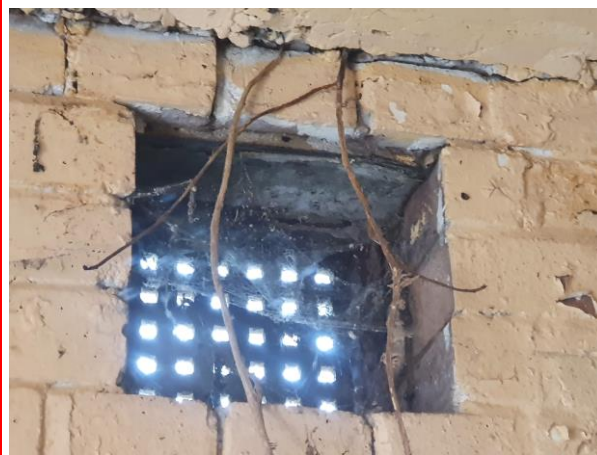
Location: Ground Floor – Salt Store 022

Material Description:	Cement Lining to Vents – Cement Product	
Identification:	Strongly Presumed to Contain Asbestos	
Approx. quantity:	3 no	
Accessibility	Difficult	<i>Assessment Score</i>
Product type:	Cement	1
Extent of Damage:	Slight / minor damage	1
Surface Treatment:	Unsealed Cement	1
Asbestos type:	Chrysotile	1
Material Assessment Score:		4
Priority Assessment Score:		Negligible
Action:	Manage	
Comments:	N/A

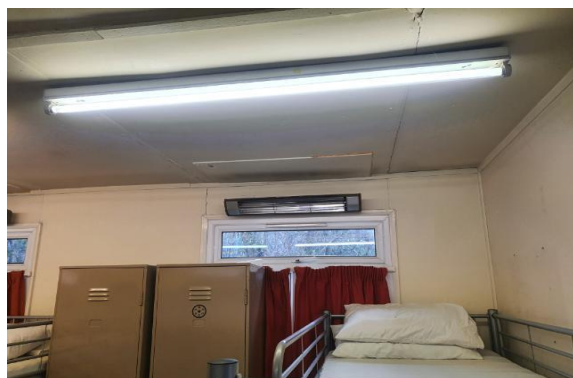
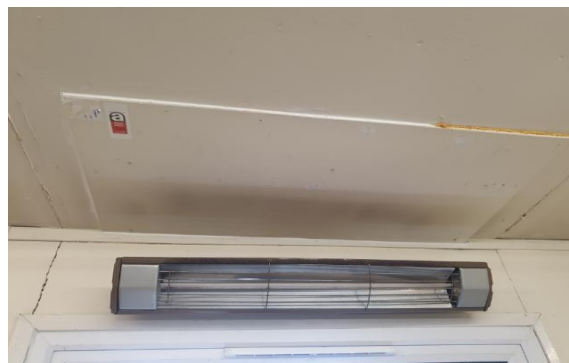
Location: Ground Floor - Model Ward 023

Material Description:	Panels on Ceiling - Insulating Board	
Identification:	Previously Sampled - Asbestos Detected	
Approx. quantity:	4 m ²	
Accessibility	Easy	<i>Assessment Score</i>
Product type:	Asbestos Insulating Board	2
Extent of Damage:	Slight / minor damage	1
Surface Treatment:	Encapsulated AIB	1
Asbestos type:	Amosite	2
Material Assessment Score:		6
Priority Assessment Score:		Low
Action:	Encapsulate/Remove	
Comments:	Previously sampled ref: Fineline Environmental sample GU/TA/017/26. Consider boxing in or removing due to proximity to beds but panels are currently in good condition. 8no panels

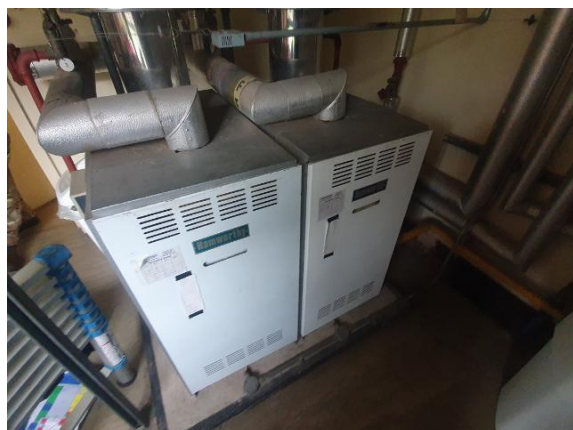
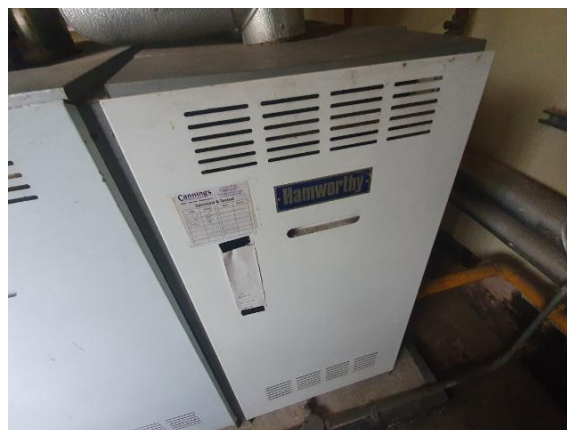
Location: Ground Floor - Boiler Room G01 025

Material Description:	Boilers - No Access Gained	
Identification:	Presumed to Contain Asbestos	
Approx. quantity:	5 no	
Accessibility	Difficult	<i>Assessment Score</i>
Product type:	Asbestos Insulating Board	2
Extent of Damage:	Slight / minor damage	1
Surface Treatment:	Enclosed Insulation	1
Asbestos type:	Amosite, Chrysotile	2
Material Assessment Score:		6
Priority Assessment Score:		Low
Action:	Manage	
Comments:	No access within live Hamworthy Boilers. Including boilers in lower ground floor boiler room

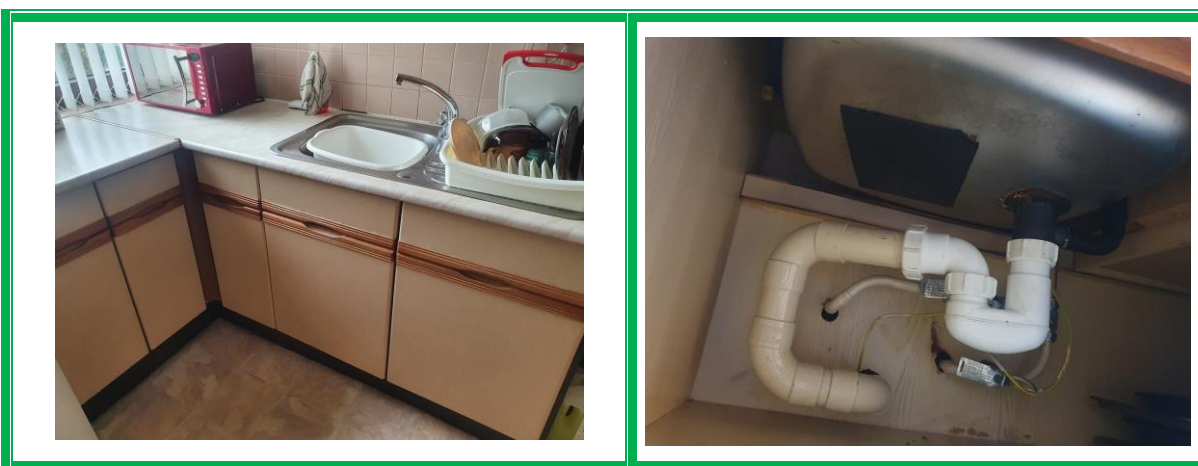
Item No:	1	Sample No:	DK/03
Location:	First Floor - Caretakers Flat 001

Material Description:	Sink Pad – Bitumen	
Identification:	Sampled - No Asbestos Found	
Approx. quantity:	N/A	
Accessibility	N/A	Assessment Score
Product type:	N/A	N/A
Extent of Damage:	N/A	N/A
Surface Treatment:	N/A	N/A
Asbestos type:	N/A	N/A
Material Assessment Score:		N/A
Priority Assessment Score:		N/A
Action:	N/A	
Comments:	Previously a no access area, now accessed. No asbestos found.

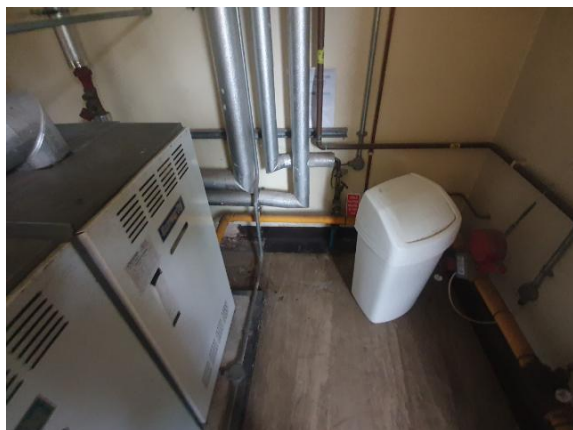
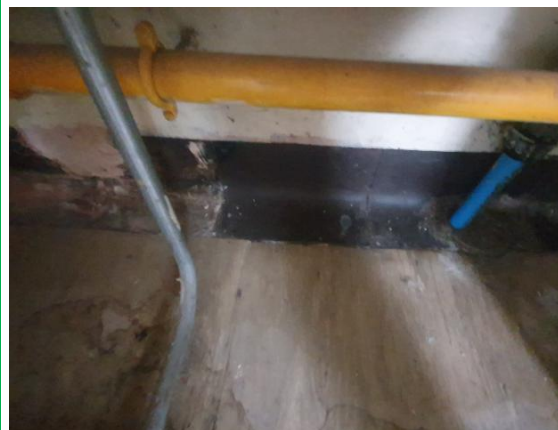
Location: Ground Floor - Boiler Room G01 002

Material Description:	Skirting Board Tiles and Adhesive - Vinyl Products	
Identification:	Sampled - No Asbestos Found	
Approx. quantity:	N/A	
Accessibility	N/A	Assessment Score
Product type:	N/A	N/A
Extent of Damage:	N/A	N/A
Surface Treatment:	N/A	N/A
Asbestos type:	N/A	N/A
Material Assessment Score:		N/A
Priority Assessment Score:		N/A
Action:	N/A	
Comments:	Partially to perimeter of room

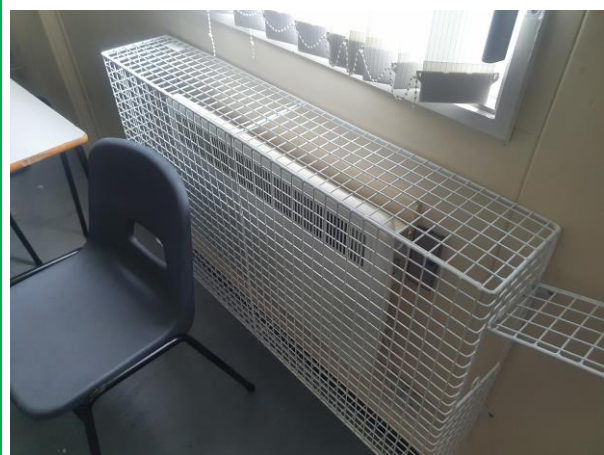
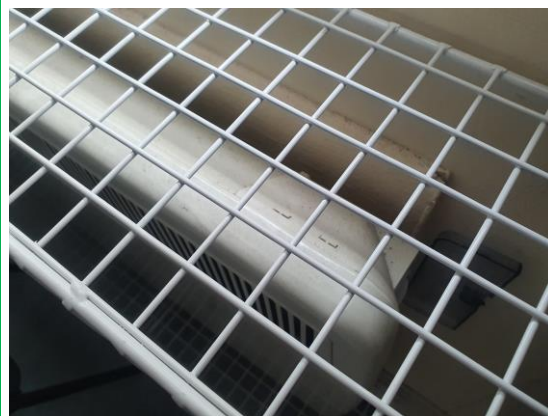
Location: Ground Floor - ACF Cadet Hut - Store 020

Material Description:	Insulation board panels behind heaters	
Identification:	Sampled - No Asbestos Found	
Approx. quantity:	N/A	
Accessibility	N/A	Assessment Score
Product type:	N/A	N/A
Extent of Damage:	N/A	N/A
Surface Treatment:	N/A	N/A
Asbestos type:	N/A	N/A
Material Assessment Score:		N/A
Priority Assessment Score:		N/A
Action:	N/A	
Comments:	Previously a no access area, now accessed. No asbestos found.

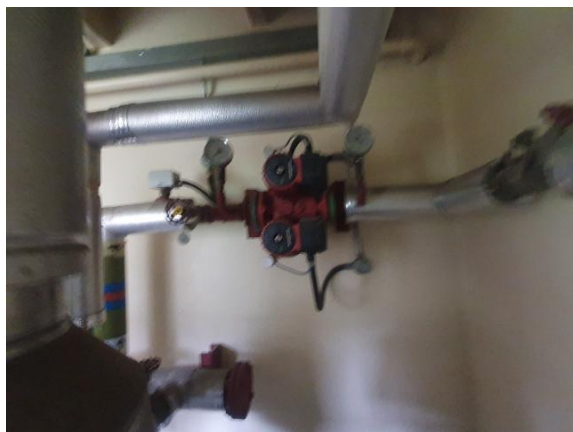
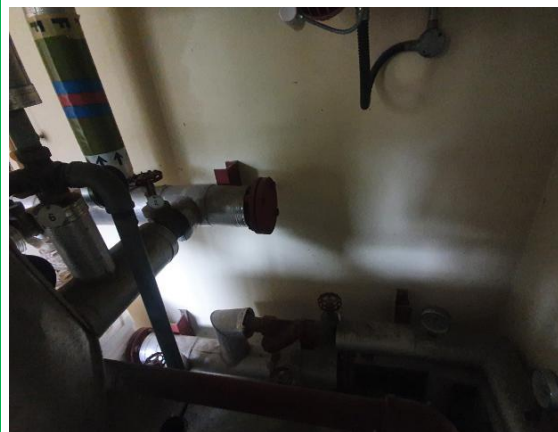
Location: Ground Floor - Boiler Room G01 024

Material Description:	Gaskets - Gaskets (compressed)	
Identification:	Sampled - No Asbestos Found	
Approx. quantity:	N/A	
Accessibility	N/A	<i>Assessment Score</i>
Product type:	N/A	N/A
Extent of Damage:	N/A	N/A
Surface Treatment:	N/A	N/A
Asbestos type:	N/A	N/A
Material Assessment Score:		N/A
Priority Assessment Score:		N/A
Action:	N/A	
Comments:	N/A

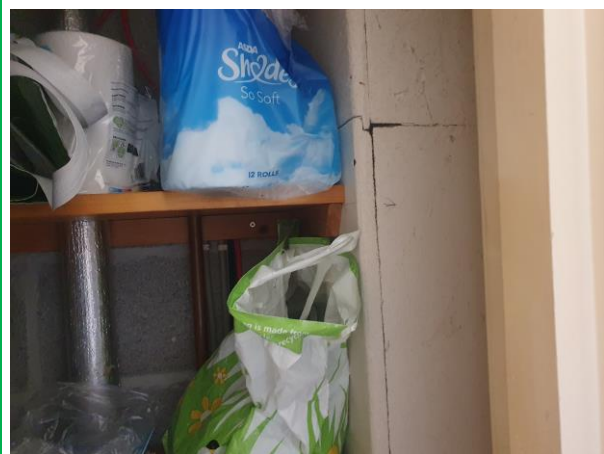
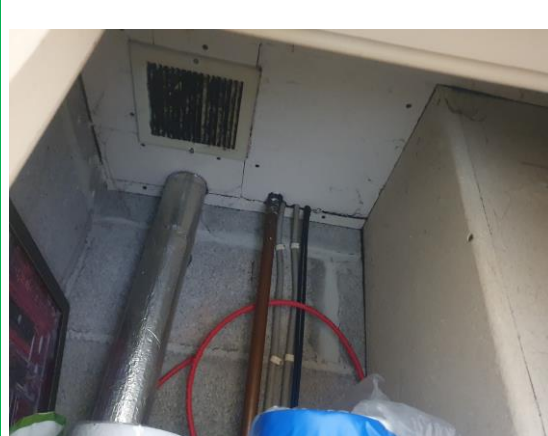
Location: First Floor Caretakers Flat – Kitchen Cupboard 026

Material Description:	Insulation Board	
Identification:	Sampled - No Asbestos Found	
Approx. quantity:	N/A	
Accessibility	N/A	Assessment Score
Product type:	N/A	N/A
Extent of Damage:	N/A	N/A
Surface Treatment:	N/A	N/A
Asbestos type:	N/A	N/A
Material Assessment Score:		N/A
Priority Assessment Score:		N/A
Action:	N/A	
Comments:	Previously a no access area, now access. No asbestos found.

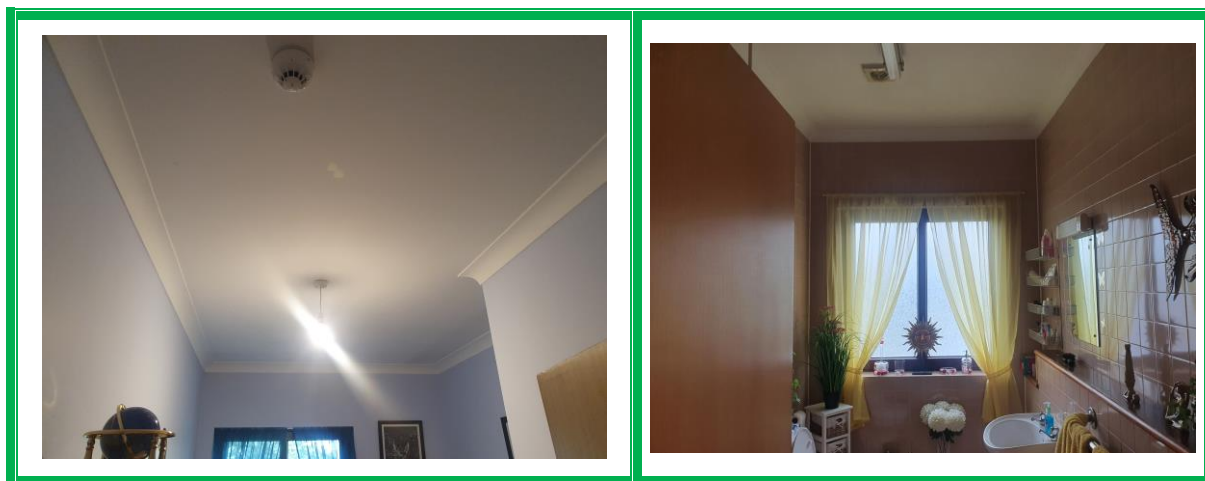
Location: First Floor Caretakers Flat – Bedroom x 3, Living Room, Bathroom and Hallway 027

Material Description:	No asbestos suspected	
Identification:	No asbestos suspected	
Approx. quantity:	N/A	
Accessibility	N/A	<i>Assessment Score</i>
Product type:	N/A	N/A
Extent of Damage:	N/A	N/A
Surface Treatment:	N/A	N/A
Asbestos type:	N/A	N/A
Material Assessment Score:		N/A
Priority Assessment Score:		N/A
Action:	N/A	
Comments:	Previously a no access area, now access. No asbestos found.

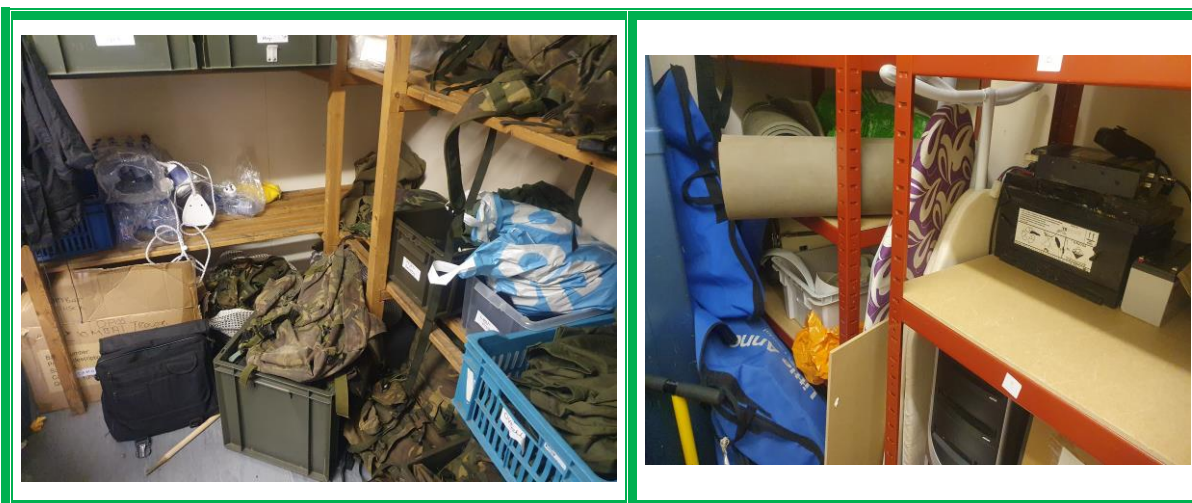
Item No:	28	Sample No:	N/A
Location:	ACF Store, Corridor, Armoury, W.C's x 3 and Kitchen 028

Material Description:	No asbestos suspected	
Identification:	No asbestos suspected	
Approx. quantity:	N/A	
Accessibility	N/A	<i>Assessment Score</i>
Product type:	N/A	N/A
Extent of Damage:	N/A	N/A
Surface Treatment:	N/A	N/A
Asbestos type:	N/A	N/A
Material Assessment Score:		N/A
Priority Assessment Score:		N/A
Action:	N/A	
Comments:	Previously a no access area, now access. No asbestos found.
