Project Number A-00540 (3700)

**Re-Inspection
Asbestos Survey Report - Revised**

**2391 Parkstone
Poole
Dorset
BH12 4HY**

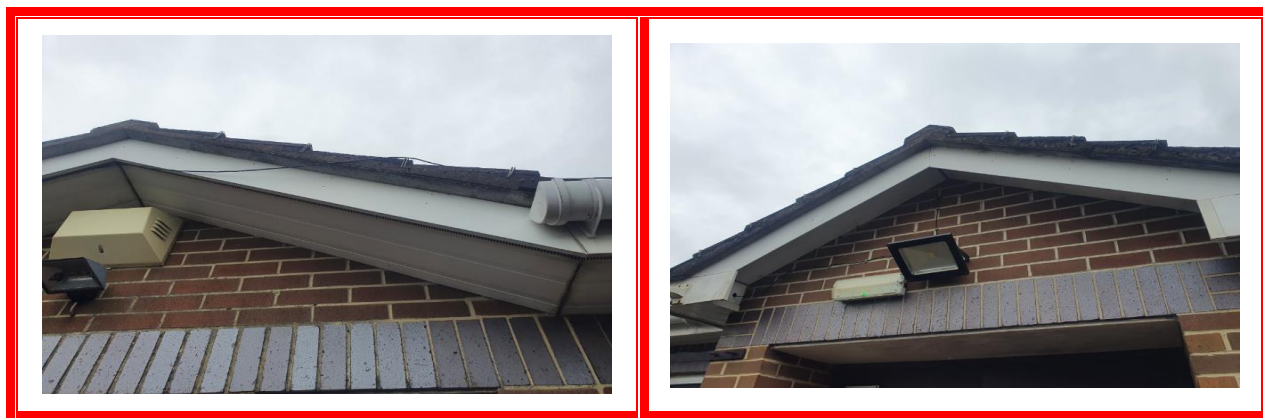
Item No:	2	Sample No:	N/A
Location:	External - Roof 002

Material Description:	Undercloaking - Cement Product	
Identification:	Previously Sampled - Asbestos Detected	
Approx. quantity:	6 LM	
Accessibility	Difficult	Assessment Score
Product type:	Cement	1
Extent of Damage:	Moderate damage	2
Surface Treatment:	Unsealed Cement	1
Asbestos type:	Chrysotile	1
Material Assessment Score:		5
Priority Assessment Score:		Low
Action:	Manage	
Comments:	Previously sampled ref: Armour Sample

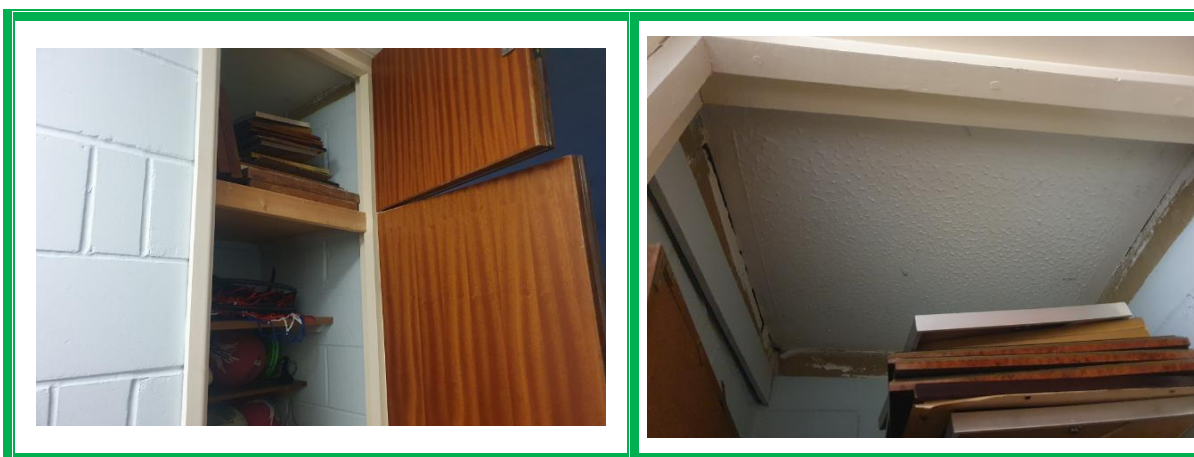
Item No:	1	Sample No:	N/A
Location:	Ground Floor - Cupboard Opposite Kitchen 001

Material Description:	Textured Coating to Ceiling	
Identification:	N/A	
Approx. quantity:	N/A	
Accessibility	N/A	<i>Assessment Score</i>
Product type:	N/A	N/A
Extent of Damage:	N/A	N/A
Surface Treatment:	N/A	N/A
Asbestos type:	N/A	N/A
Material Assessment Score:		N/A
Priority Assessment Score:		N/A
Action:	N/A	
Comments:	Previously sampled ref: Armour 23/10/19 Sample 1

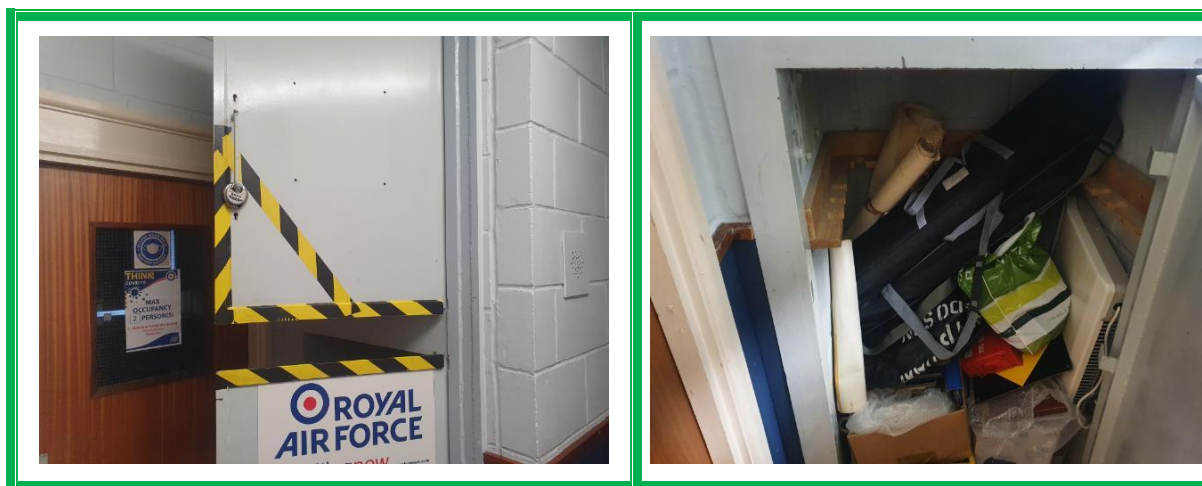
Item No:	3	Sample No:	N/A
Location:	Ground Floor - Former Armoury Cupboard 003

Material Description:	No Suspect Materials Found	
Identification:	N/A	
Approx. quantity:	N/A	
Accessibility	N/A	<i>Assessment Score</i>
Product type:	N/A	N/A
Extent of Damage:	N/A	N/A
Surface Treatment:	N/A	N/A
Asbestos type:	N/A	N/A
Material Assessment Score:		N/A
Priority Assessment Score:		N/A
Action:	N/A	
Comments:	Previously a no access area now accessed. No asbestos suspected.
