Project Number A-00564 (3700)

Re-Inspection Asbestos Survey Report - Revised

> **Teignmouth Platoon Devon TQ148HB**

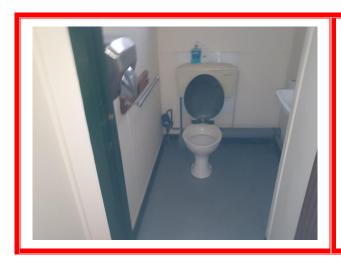
Location: Ground Floor - External Stores Hut - WC's x 2 002

Material Description:	Toilet Seats - PVC / Reinforced Plastics			
Identification:	Presumed to Contain Asbestos			
Approx. quantity:	2 no			
Accessibility	Easy Assessment Sco			
Product type:	Bakelite 1			
Extent of Damage:	Major damage 3			
Surface Treatment:	Unsealed Insulation 3			
Asbestos type:	Chrysotile 1			
	Material Assessment Score:	8		
	Priority Assessment Score: Medium			
Action:	Manage			
Comments:	Not possible to sample without damagin	ig the integrity of the
