## LEGIONELLA RISK ASSESSMENT

<b>Client:</b>	Wessex RFCA
<b>Site:</b>	ARC Dorchester
<b>Address:</b>	Poundbury Road, Dorchester, DT1 1SL
<b>Risk Rating:</b>	Medium
<b>Report Ref:</b>	AQRA/AQST/LRA/087
<b>Surveyed By:</b>	Jon Barton
<b>Survey Date:</b>	7 <sup>th</sup> August 2023
<b>Report Date:</b>	10 <sup>th</sup> August 2023
<b>Recommended Review Date:</b>	August 2025

### 6.1 MAINS WATER SUPPLY REPORT

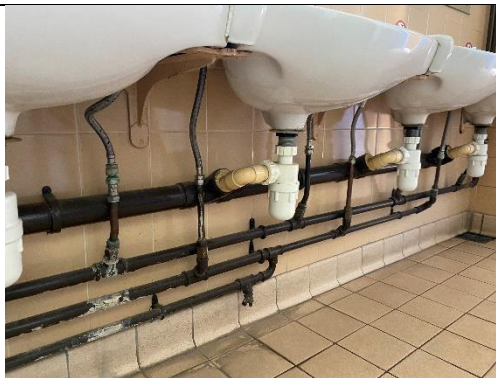
**Example of the use of flexible hoses (male toilet basins)**

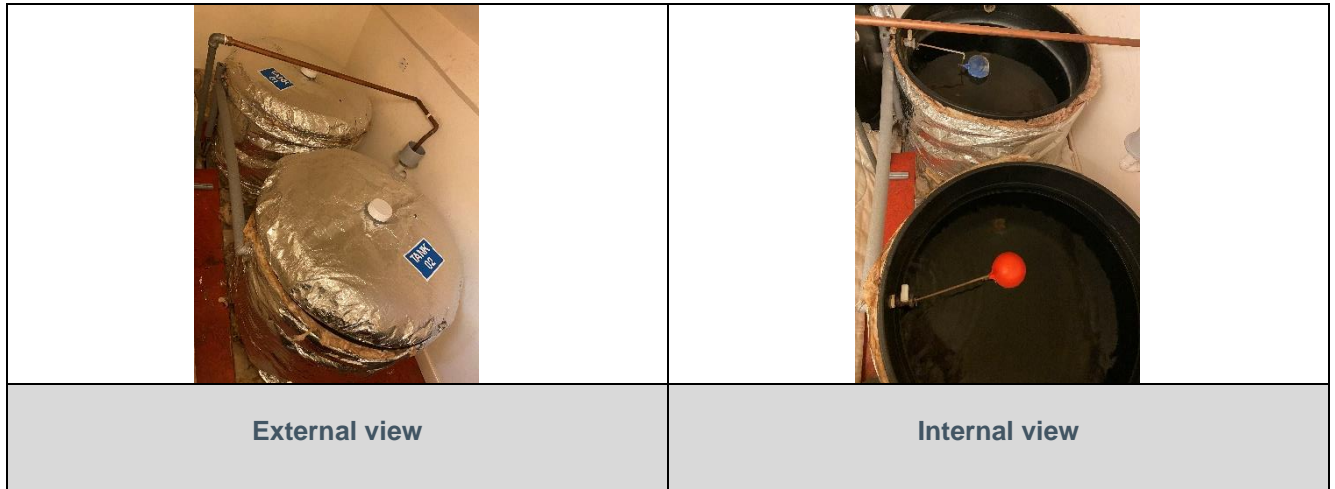
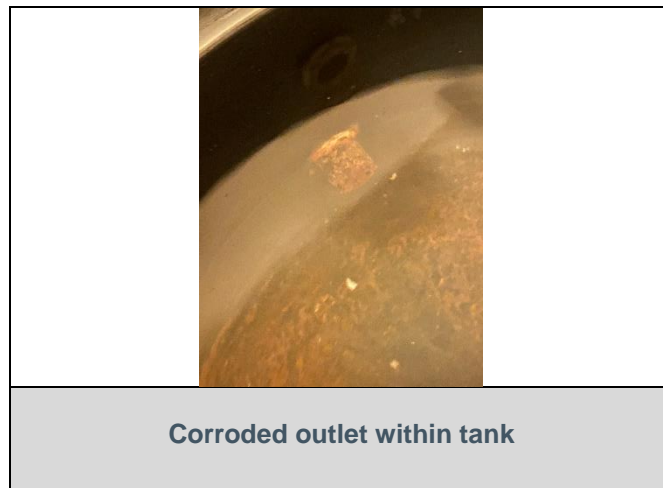
Tank Ref : Tank 1-2 (linked)

<b>Drain valve</b>	Is there a drain valve – size if applicable	N/A
<b>Water in Tank</b>	Temperature C	Tank 1: 18.5      Tank 2: 18.5
	Degree of sediment	Light
	Biological slime severe/medium/light	Light
	Extent of corrosion	Heavy on galvanised pipework
	Is there adequate crossflow within the tank? i.e. inlet opposed from outlet?	Yes
	Is the stored water over capacity??	No
<b>Labels</b>	Is the tank labelled	Yes
	Supply pipe labelled or coded	No
	Outlets labelled or coded	No
<b>Operation</b>	How far to adequate drain	20m
	Power supply – volts/distance	5m
	Is lighting adequate	Yes
	Access limit ht x w	Single door
<b>CWST Risk Score</b>		Medium

- Replace the corroded outlets and link pipe.

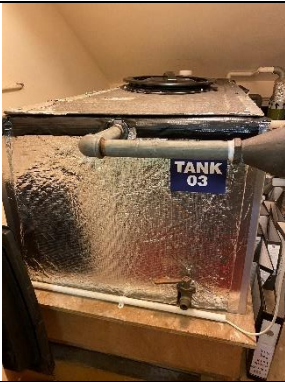
<b>Water in Tank</b>	Temperature C	18.C
	Degree of sediment	Light
	Biological slime severe/medium/light	Light
	Extent of corrosion	Light pitting
	Is there adequate crossflow within the tank? i.e. inlet opposed from outlet?	Yes
	Is the stored water over capacity??	No
<b>Labels</b>	Is the tank labelled	Yes
	Supply pipe labelled or coded	No
	Outlets labelled or coded	No
<b>Operation</b>	How far to adequate drain	20m
	Power supply – volts/distance	5m
	Is lighting adequate	Yes
	Access limit ht x w	Single door
<b>CWST Risk Score</b>		Medium

External view		Internal view

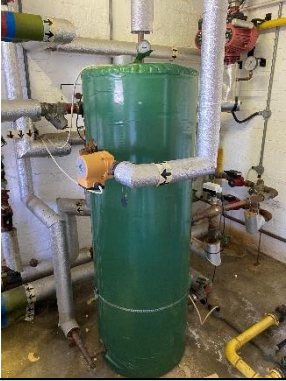
Location of hot water storage vessel	Boiler room
Construction	Copper
Size of hot water storage vessel	1500 x 450
Horizontal/vertical	Vertical
Storage/non-storage	Storage
Main heat source	Primary coil
Supplementary heating	Immersion
Insulation type	Pre-insulated
Is there an open vent	Yes
Is there an Expansion Vessel	No
Size of Expansion Vessel	-
IS there a flow through Valve fitted?	-
Is there a drain fitted & what size?	-
What size is access hatch	None
Is there a drain valve – if yes give size	Yes – ½ inch
Does drain valve work	Not attempted
Condition of water from drain valve	-
Size and materials cold feed pipe	28mm copper
Is cold feed valved	Yes
Fed from mains, tank or softened	Tank
Pressure gauge reading	N/A
Temp from main gauge on hot water flow	20.C
Temp from gauge on sec return flow	20.C
Safety valve size	N/A
Is system circulated by sec return (yes/no)	Yes – single
Is calorifier circulated	No
Anti-stratification Pump (yes/no)	No

<p>Cal 2</p>	<p>Discoloured water within the 1<sup>st</sup> floor female WC area</p>

- The storage temperature should be increased to 60.C.
- Discoloured water observed from associated outlets (see picture). This is likely to be due to galvanised pipework and lack of use (due to not producing hot water).

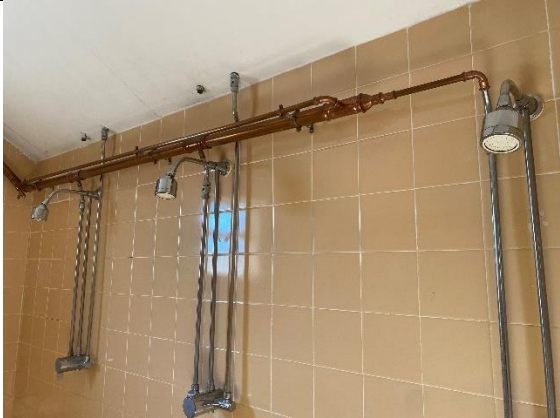
Location	Nos of showers	Dismantled/ cleaned and disinfected YES/NO	Overall condition	Any repairs replacements	Regularity of Use
GF female WC	1	No	Good	No	Flushed weekly
GF male WC	6	No	Good	No	Flushed weekly
Caretakers house	?	No	?	?	No access
<b>COMMENTS:</b>					
All showers were free some scale and in good working order. Site flush all showers on a weekly basis.

Mixer showers within male WC area	Example of clean shower head

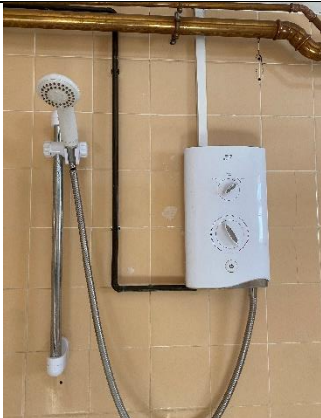
Electric shower within male WC area
