**Project Number 2481**

**Management  
Asbestos Survey Report**

**Torpoint Platoon, Anthony Road, Cornwall,  
PL11 2JP**

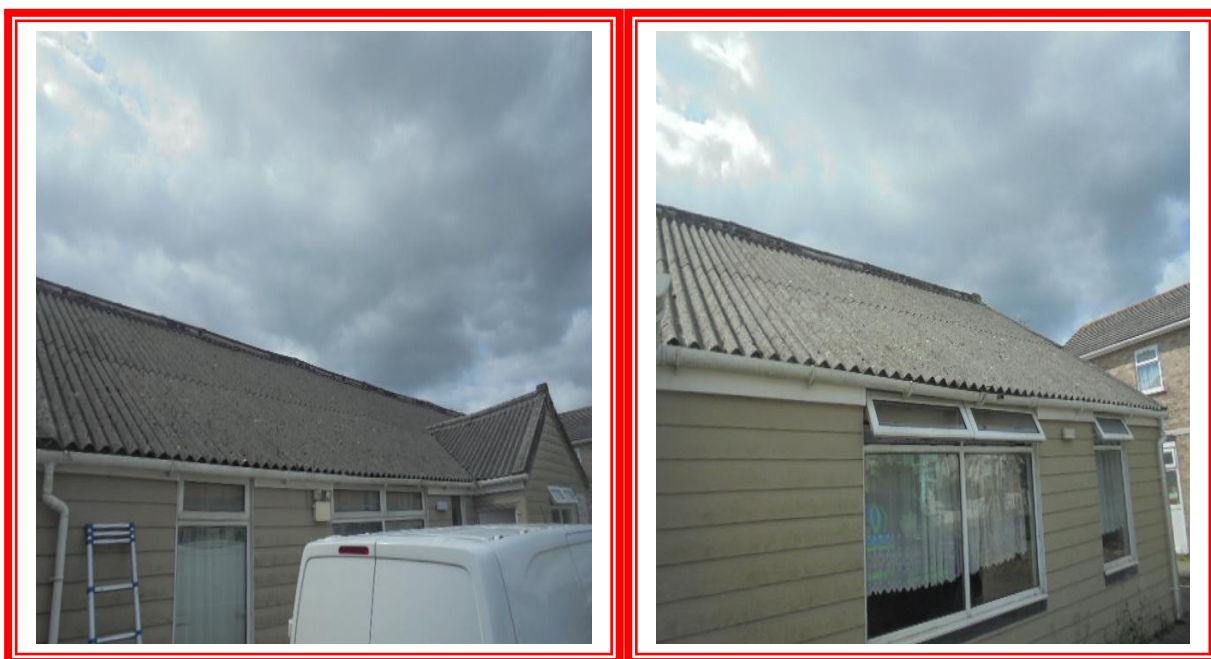
**Item No: 11**
**Sample No: DK/3**
**Location: External**

| <b>Material Description:</b> | Profiled Cement Roof | |
| <b>Identification:</b> | Sampled – Asbestos Detected | |
| <b>Approx. quantity:</b> | 330M2 | |
| <b>Extent of Damage:</b> | Minor | 1 |
| <b>Asbestos type:</b> | Chrysotile | 1 |
| <b>Material Assessment Score:</b> | | 4 |
| <b>Priority Assessment Score:</b> | | Negligible |

| <b>Action:</b> | Manage | |

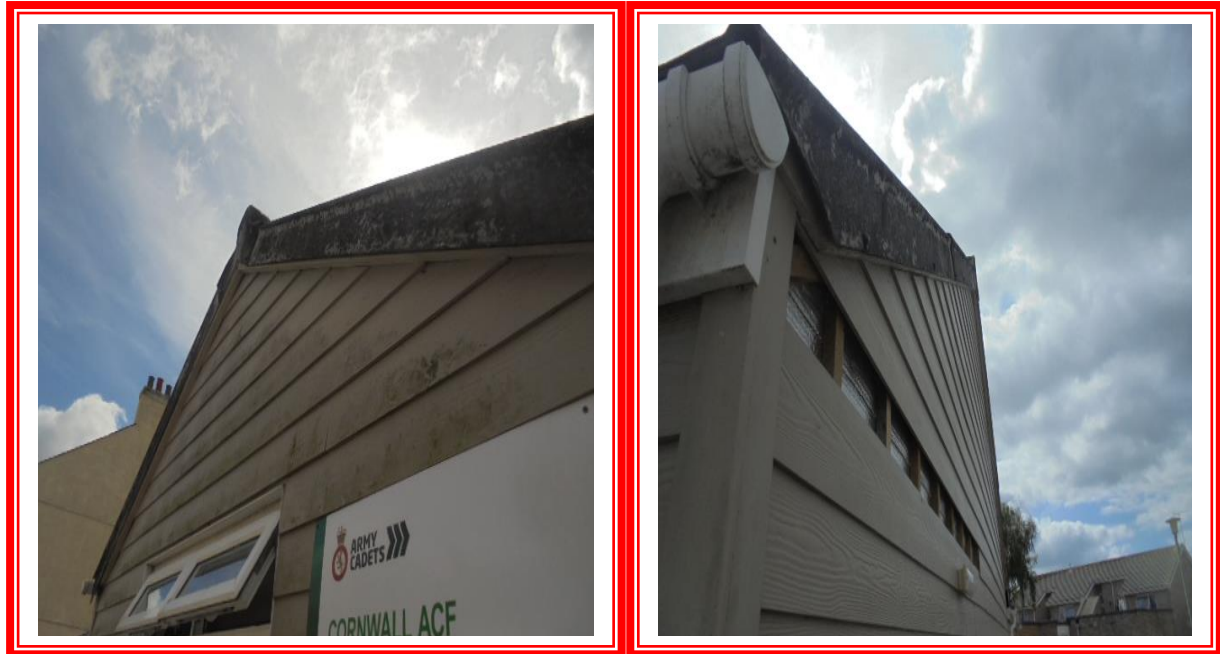
**Item No: 12**

| <b>Material Description:</b> | Cement Roof Edging to Gable Ends | |
| <b>Identification:</b> | Sampled – Asbestos Detected | |
| <b>Approx. quantity:</b> | 36LM | |
| <b>Extent of Damage:</b> | Minor | 1 |
| <b>Asbestos type:</b> | Chrysotile | 1 |
| <b>Material Assessment Score:</b> | | 4 |
| <b>Priority Assessment Score:</b> | | Negligible |

| <b>Action:</b> | Manage | |

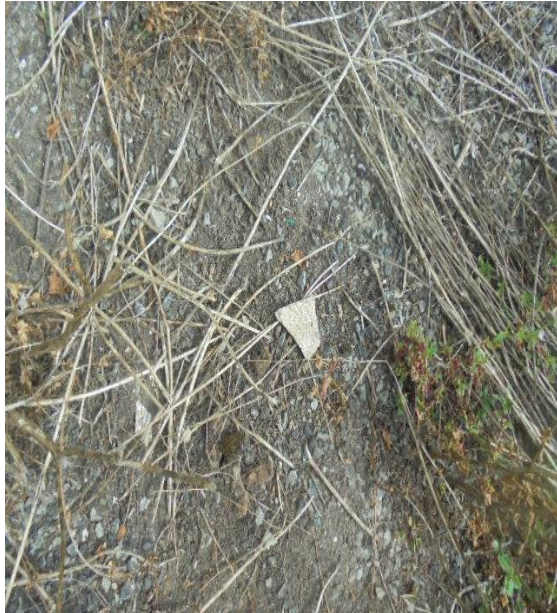
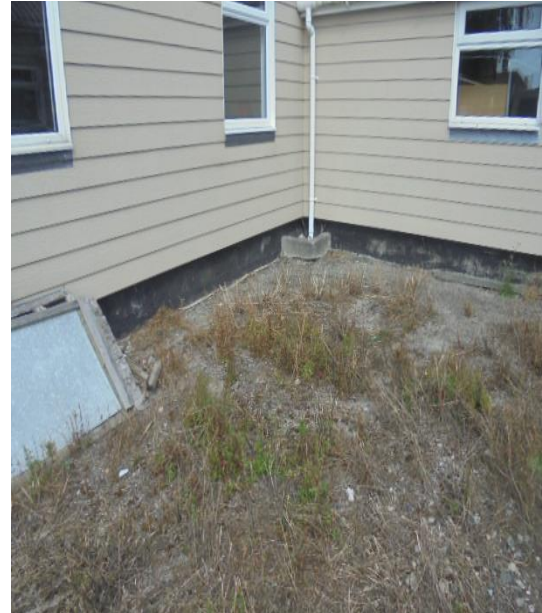
**Item No: 13**

| <b>Material Description:</b> | Cement Debris | |
| <b>Identification:</b> | Sampled – Asbestos Detected | |
| <b>Extent of Damage:</b> | Moderate | 2 |
| <b>Material Assessment Score:</b> | | 5 |
| <b>Priority Assessment Score:</b> | | Low |
| <b>Comments:</b> | Found Sporadically Throughout Externals | |

| <b>Action:</b> | Remove | |

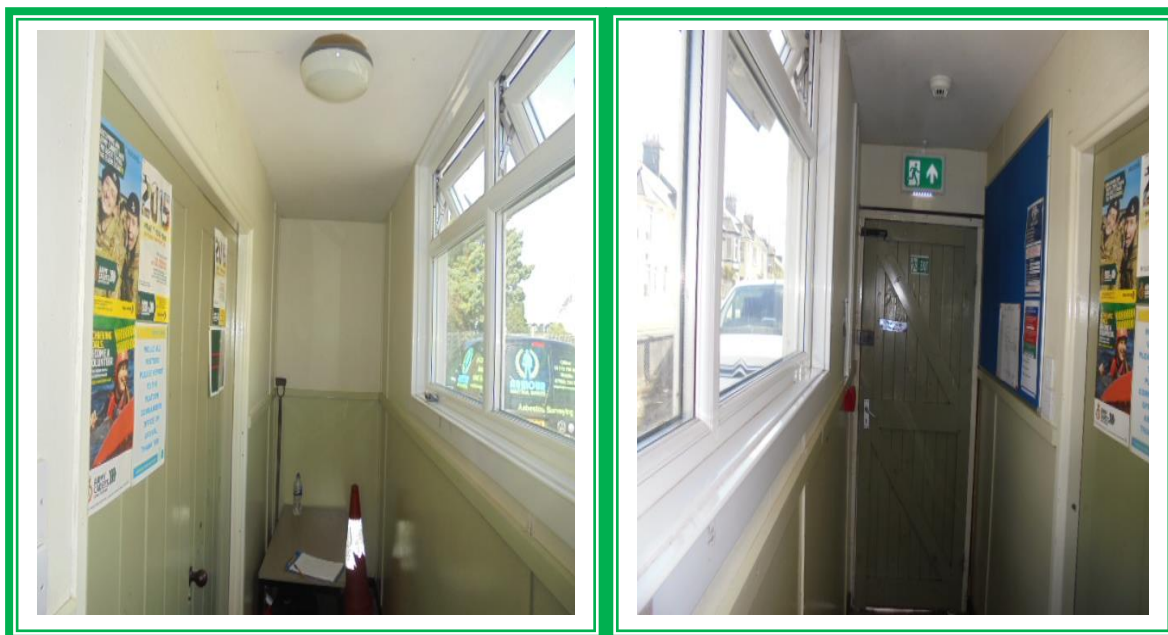
**Item No: 1**

| <b>Material Description:</b> | Visual Inspection – No Suspect Materials Found | |

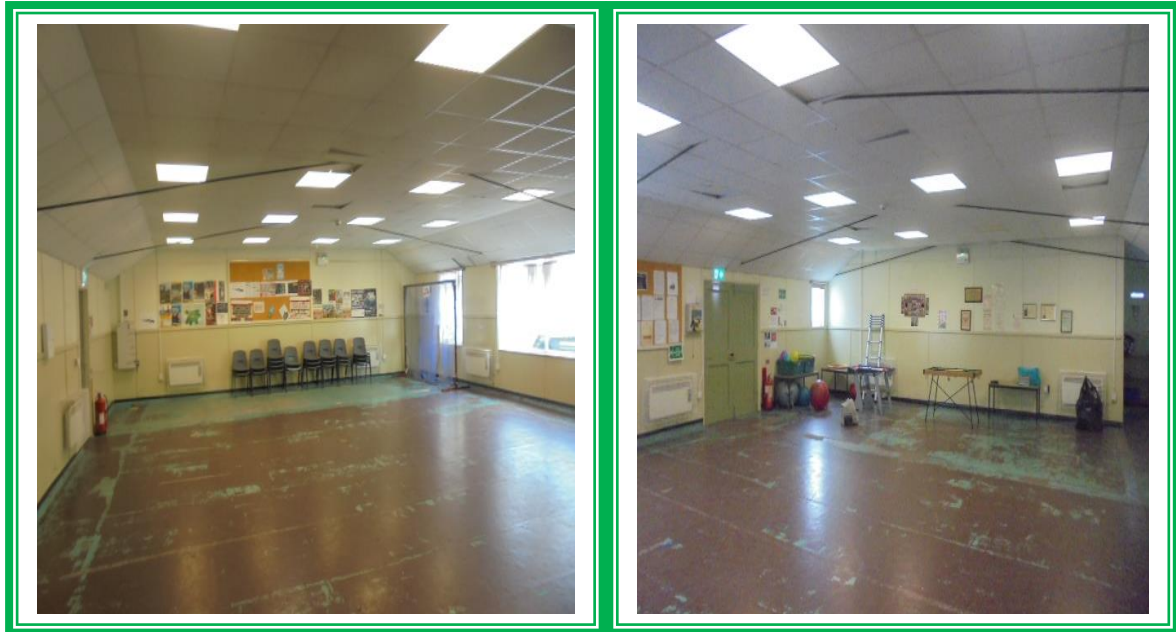
**Item No: 2**

| <b>Material Description:</b> | Visual Inspection – No Suspect Materials Found | |
| <b>Comments:</b> | Modern Electric Heater | |

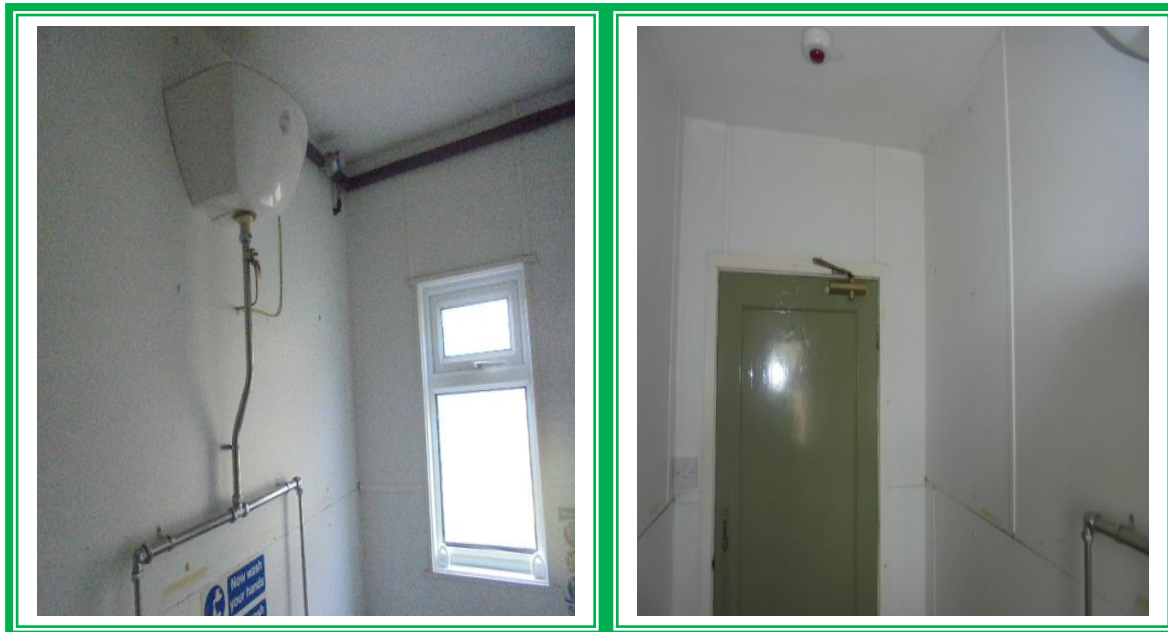
**Item No: 3**

| <b>Material Description:</b> | Visual Inspection – No Suspect Materials Found | |
| <b>Comments:</b> | Non-Asbestos Fiberboard Ceiling to Circulation | |

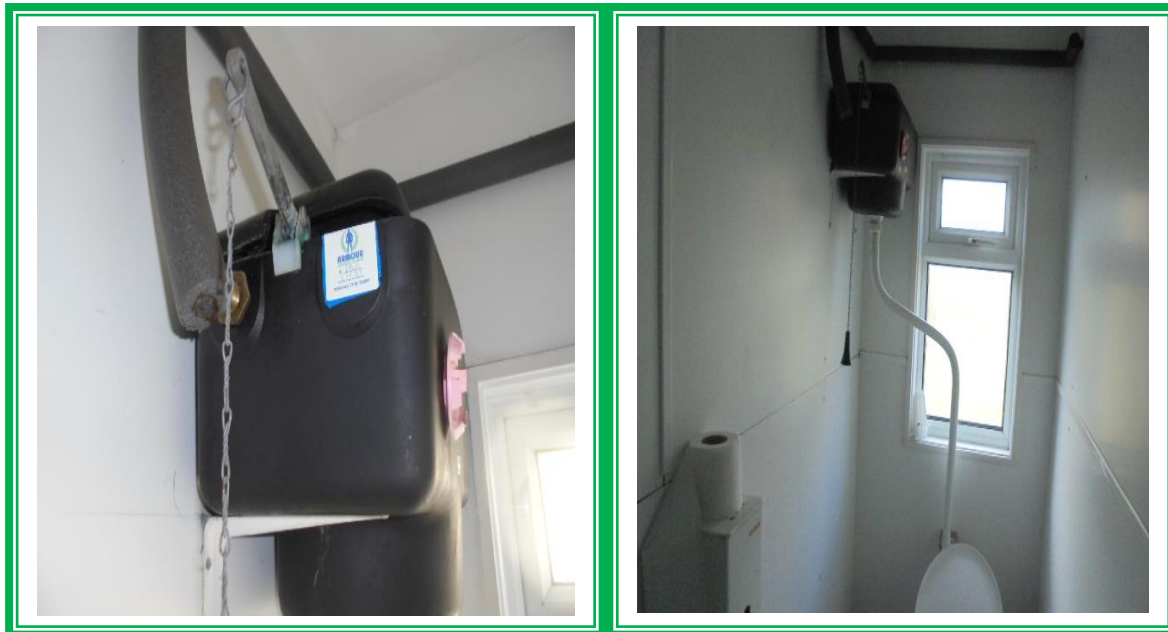
**Item No: 4**

| <b>Material Description:</b> | Toilet Cistern | |
| <b>Identification:</b> | Sampled – No Asbestos Detected | |

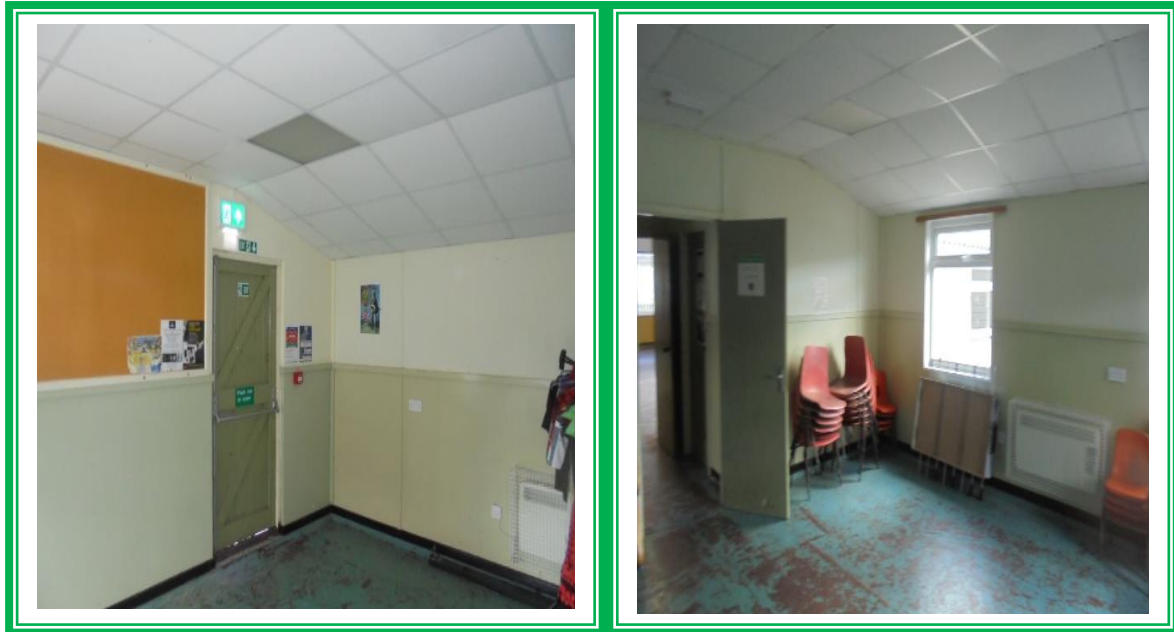
**Item No: 5**

| <b>Material Description:</b> | Visual Inspection – No Suspect Materials Found | |

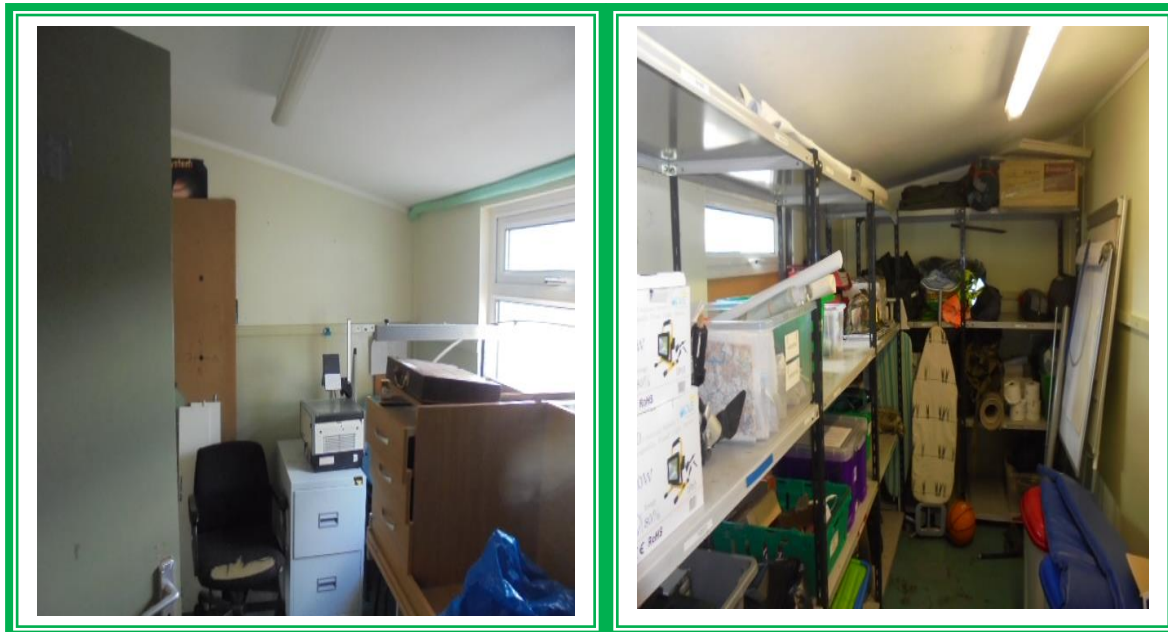
**Item No: 6**

| <b>Material Description:</b> | Visual Inspection – No Suspect Materials Found | |

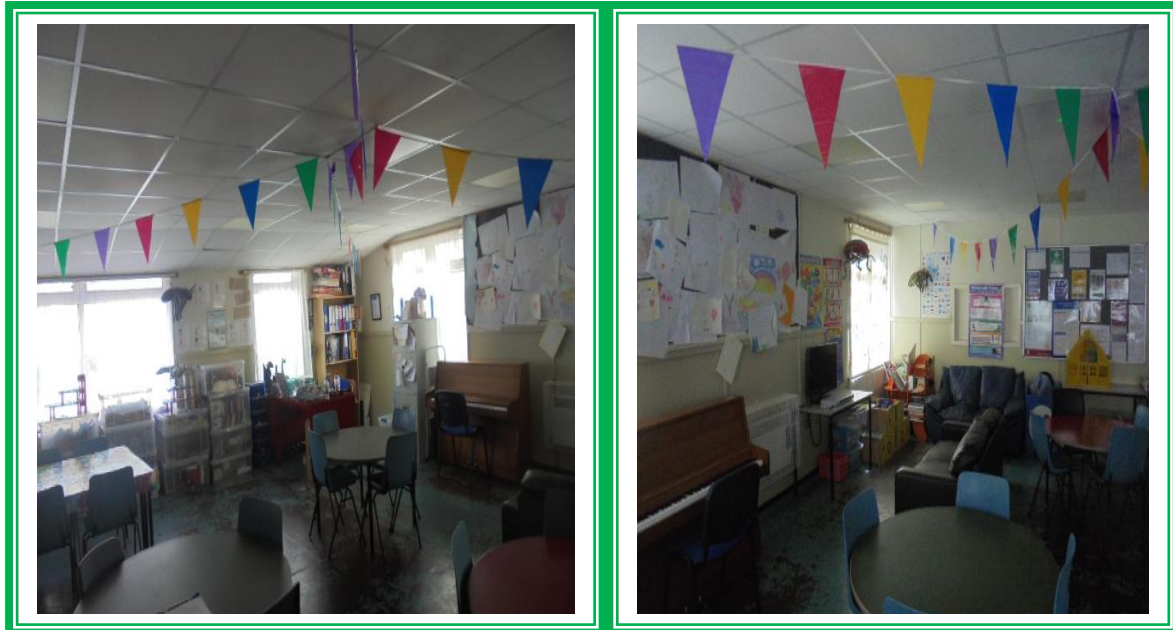
**Item No: 7**

| <b>Material Description:</b> | Visual Inspection – No Suspect Materials Found | |

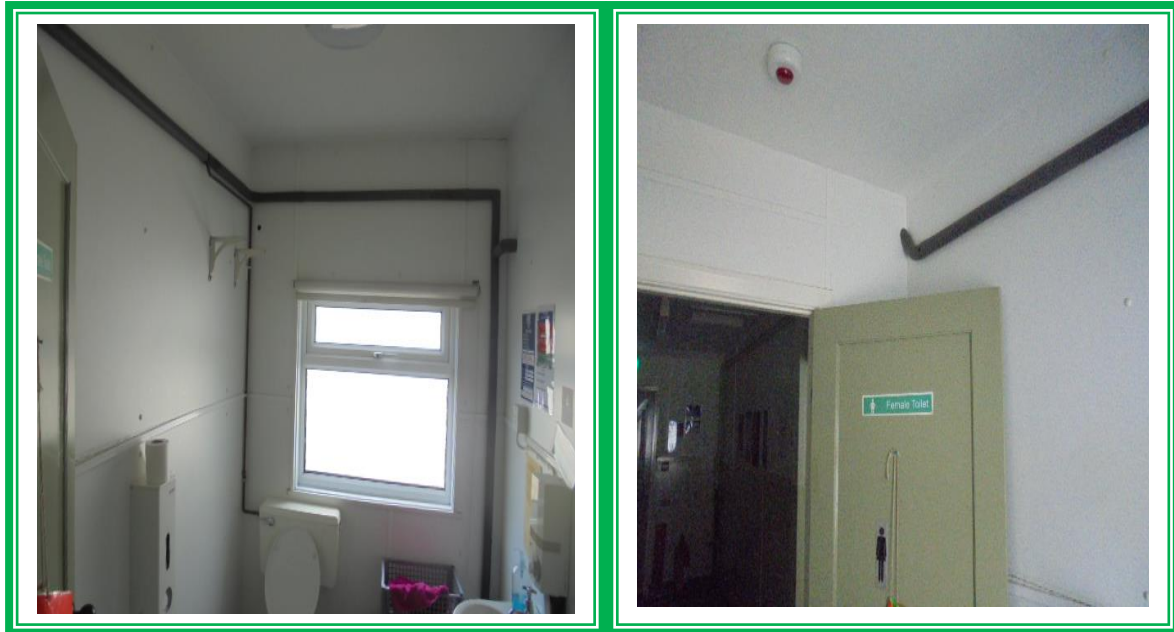
**Item No: 8**

| <b>Material Description:</b> | Visual Inspection – No Suspect Materials Found | |

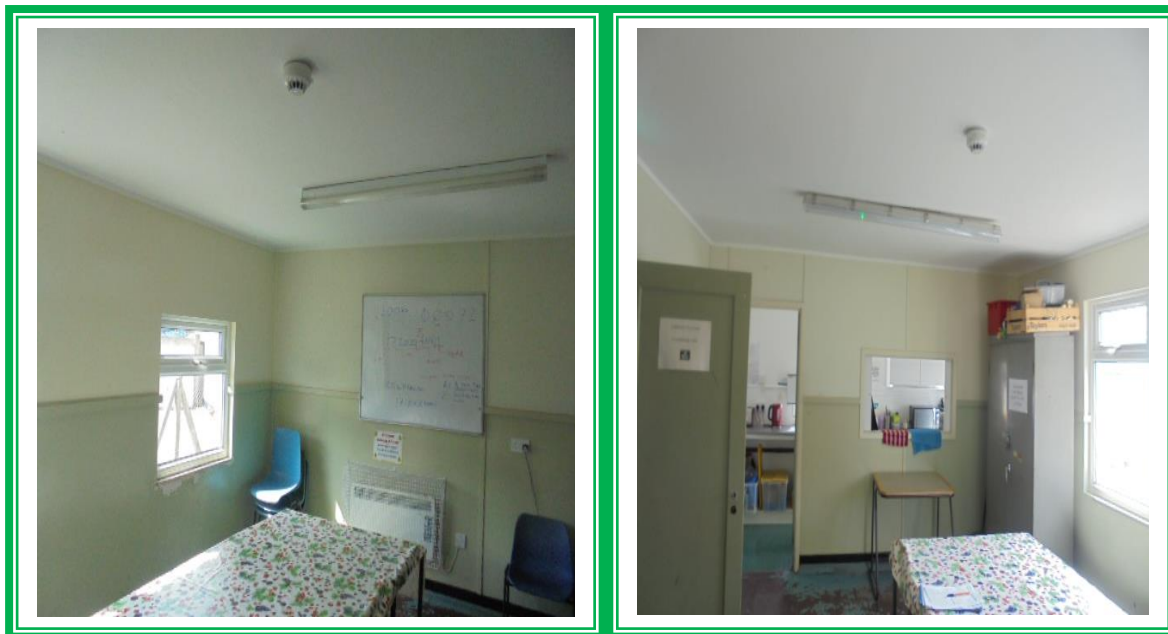
**Item No: 9**

| <b>Material Description:</b> | Visual Inspection – No Suspect Materials Found | |

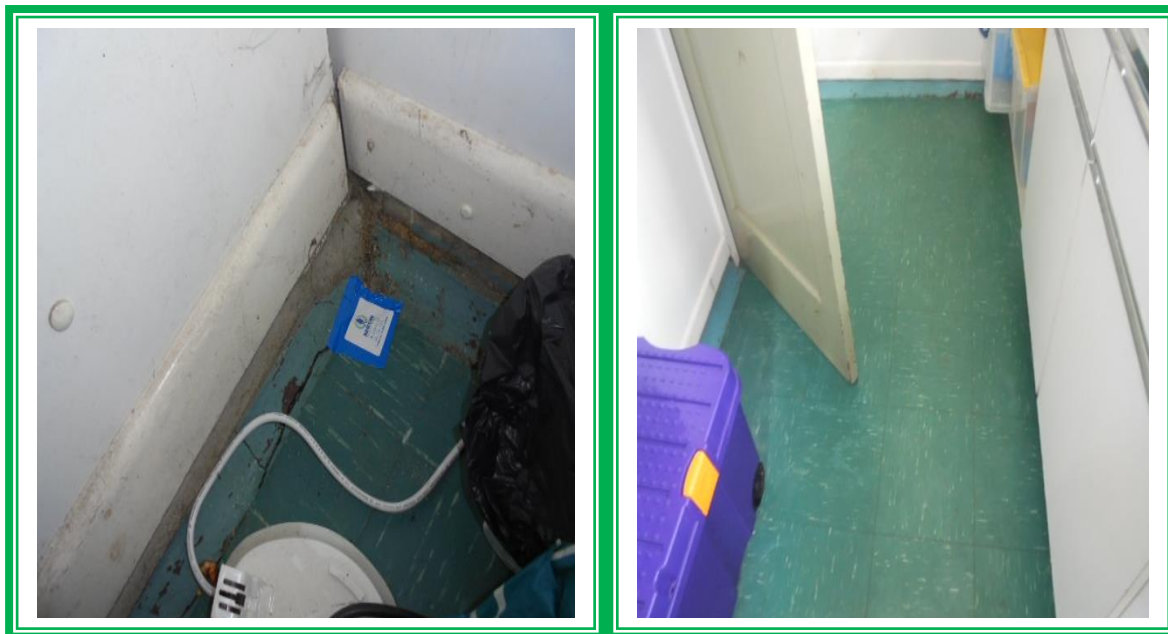
**Item No: 10**

| <b>Material Description:</b> | Floor Tiles | |
| <b>Identification:</b> | Sampled – No Asbestos Detected | |

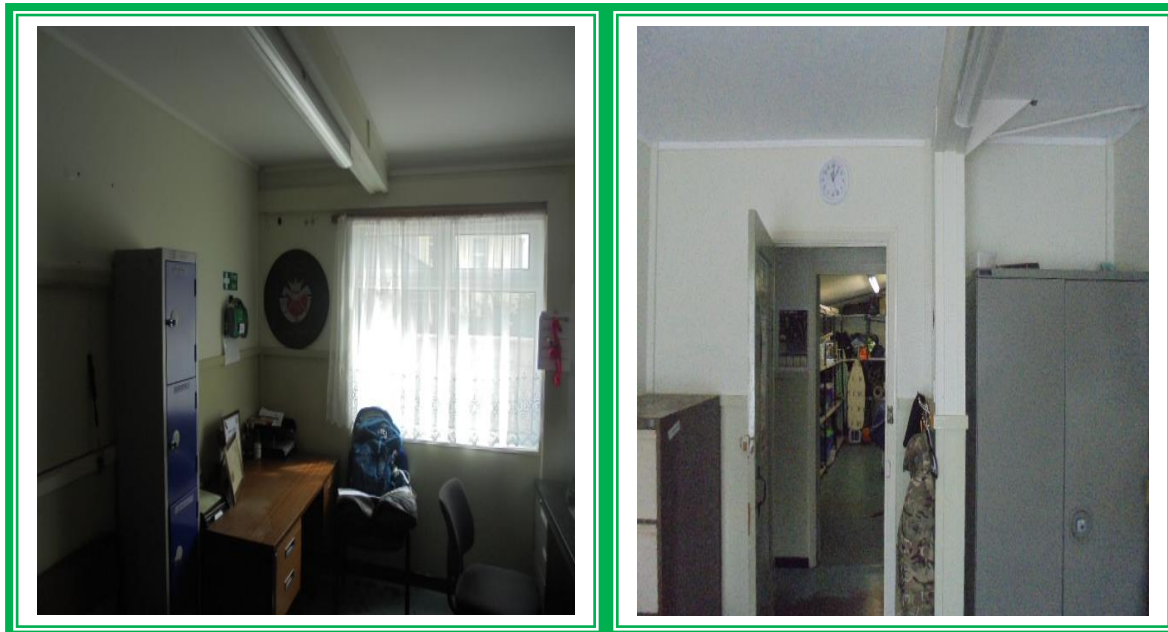
**Item No: 14**

| <b>Material Description:</b> | Visual Inspection – No Suspect Materials Found | |

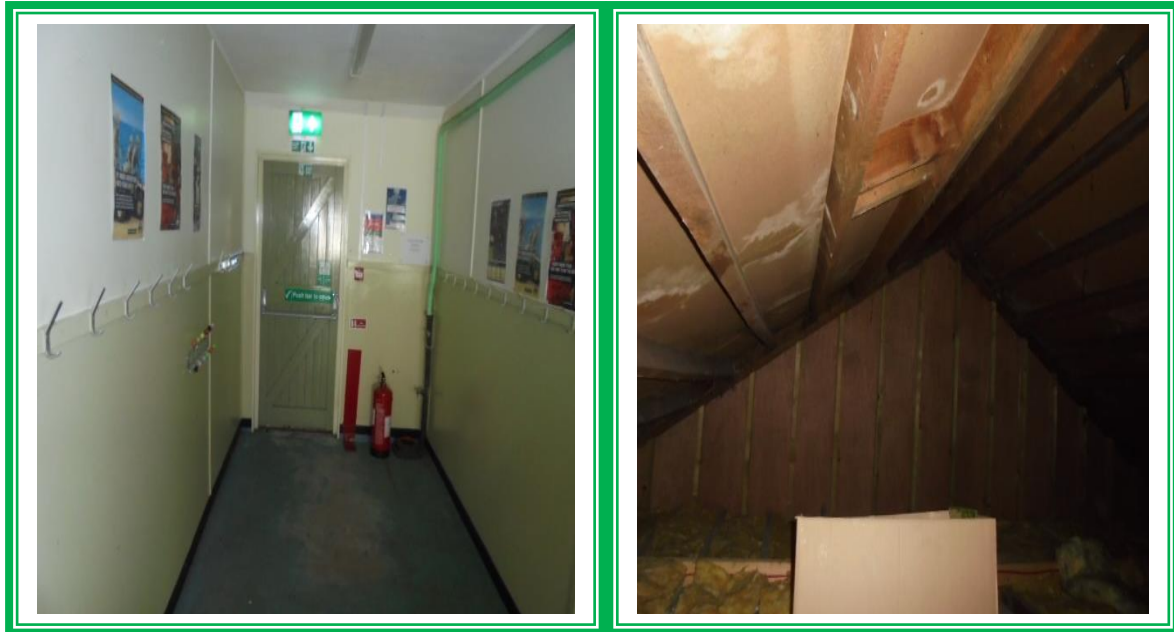
**Item No: 15**

| <b>Material Description:</b> | Visual Inspection – No Suspect Materials Found | |
| <b>Comments:</b> | Limited access into loft as no crawlboards were available | |
