Project Number 2481

**Management
Asbestos Survey Report**

**The Royal Wessex, Hanger L5, Swindon,
SN4 0QZ and Wessex RFCA, Storage
Hanger, Swindon, Wiltshire, SN4 0QZ**

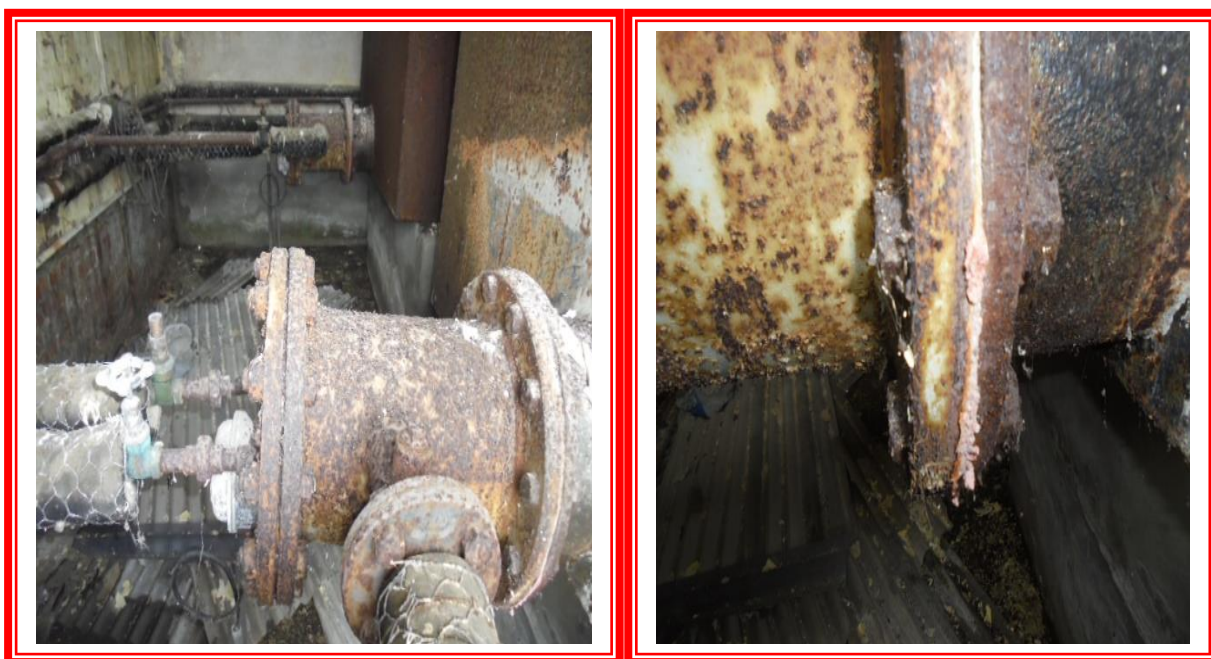
Item No: 7
Sample No: DK/4
Location: Ground Floor - Tank Room

Material Description:	Gaskets	
Identification:	Sampled – Asbestos Detected	
Approx. quantity:	X 6 Gaskets	
Accessibility	Low	<i>Assessment Score</i>
Product type:	Textiles	2
Extent of Damage:	Moderate	2
Surface Treatment:	Unsealed	1
Asbestos type:	Chrysotile	1
Material Assessment Score:		6
Priority Assessment Score:		Low
Action:	Manage	
Comments:	N/A

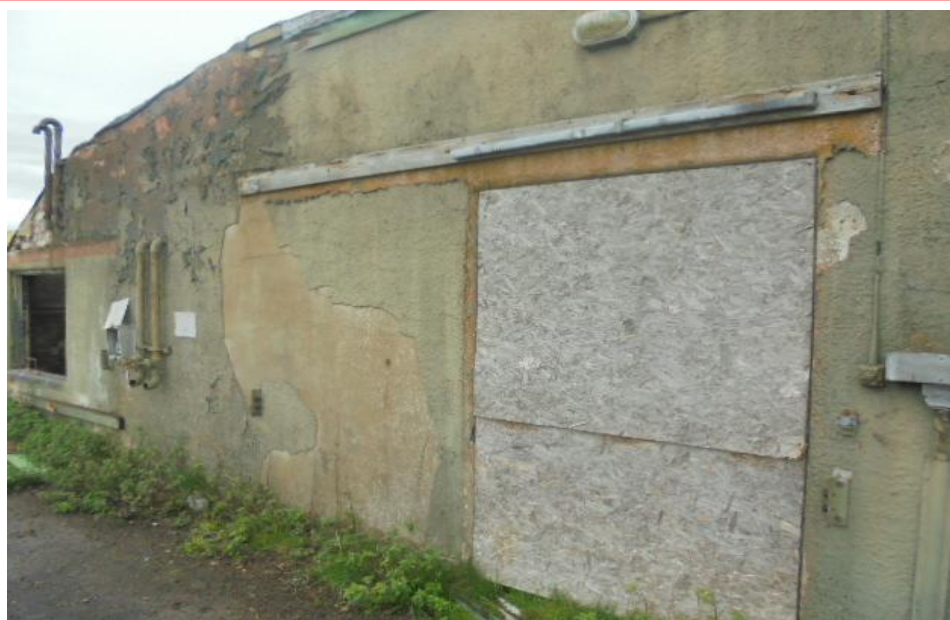
Item No: 8

Item 8 – Boiler Room – No Access within room as boarded up

Material Description:	No Access Within Room	
Identification:	Presumed to Contain Asbestos	
Approx. quantity:	X 1 Room	
Accessibility	Low	<i>Assessment Score</i>
Product type:	No Access	3
Extent of Damage:	No Access	3
Surface Treatment:	No Access	3
Asbestos type:	No Access	3
Material Assessment Score:		12
Priority Assessment Score:		High
Action:	Further Investigation Required	
Comments:	No access as boarded up

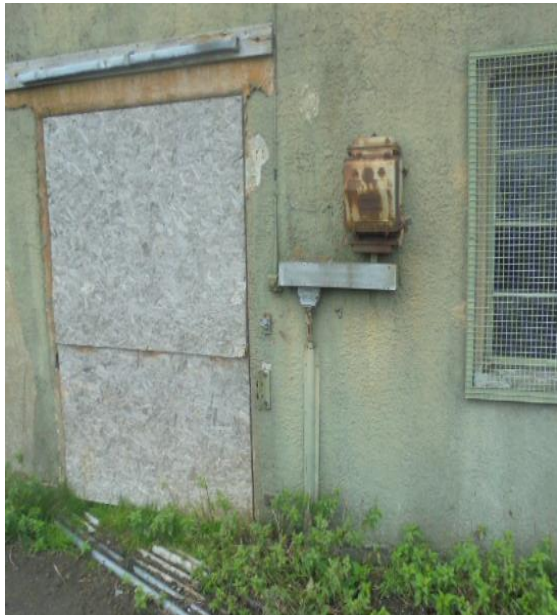
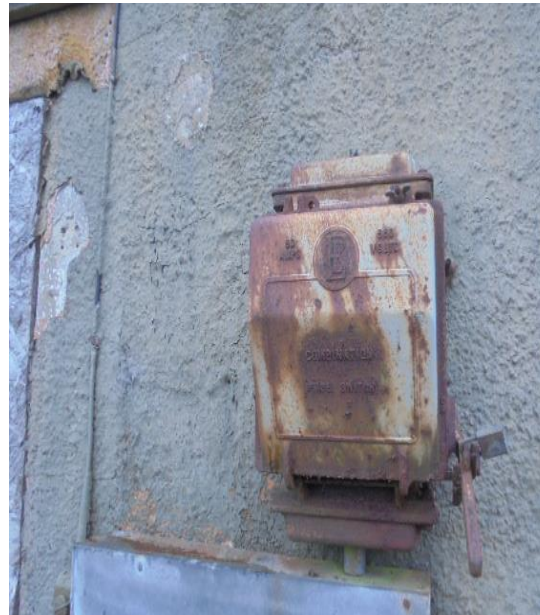
Item No: 9

Item 9 – External – Electrical Box – No Access as Live Electrics

Material Description:	No Access within live electrics	
Identification:	Presumed to Contain Asbestos	
Approx. quantity:	X 1 Box	
Accessibility	Low	Assessment Score
Product type:	No Access	2
Extent of Damage:	No Access	1
Surface Treatment:	No Access	1
Asbestos type:	No Access	1
Material Assessment Score:		5
Priority Assessment Score:		Low
Action:	Manage	
Comments:	N/A

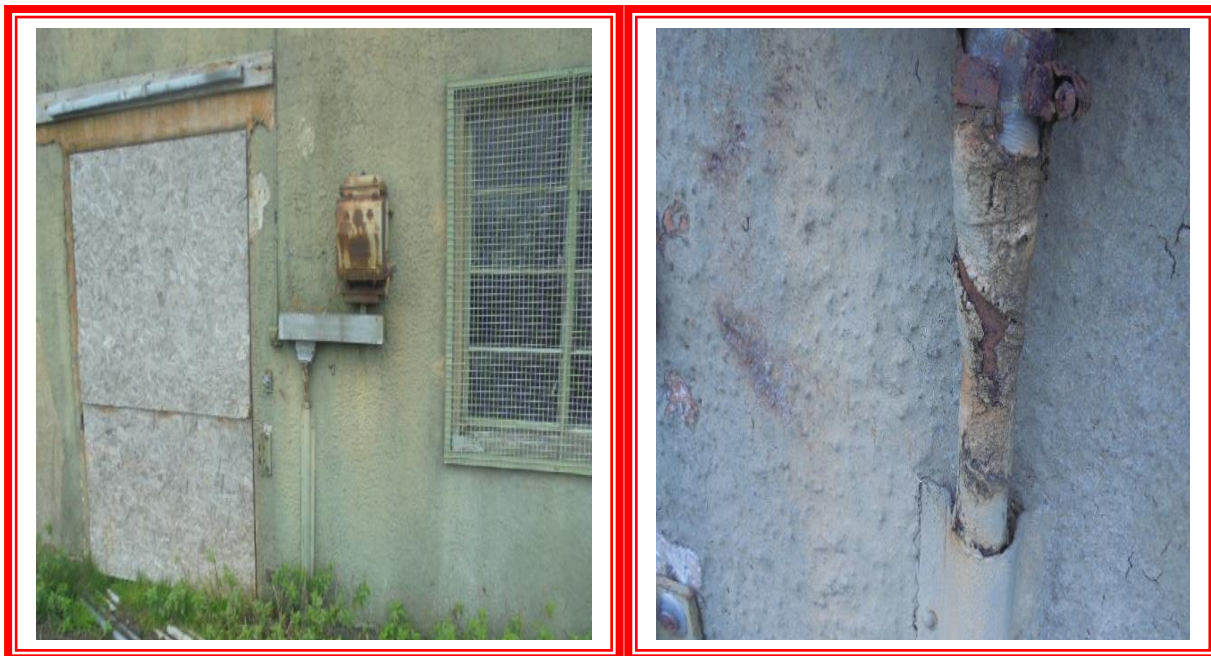
Item No: 10

Item 10 – External – Bitumen Wrap to Main Cable – No Access as live electrics

Material Description:	Bitumen Wrap to Mains Cable	
Identification:	Presumed to Contain Asbestos	
Approx. quantity:	2LM	
Accessibility	Low	Assessment Score
Product type:	Bitumen	1
Extent of Damage:	Minor	1
Surface Treatment:	Non-Friable	0
Asbestos type:	Chrysotile	1
Material Assessment Score:		3
Priority Assessment Score:		Negligible
Action:	Manage	
Comments:	N/A

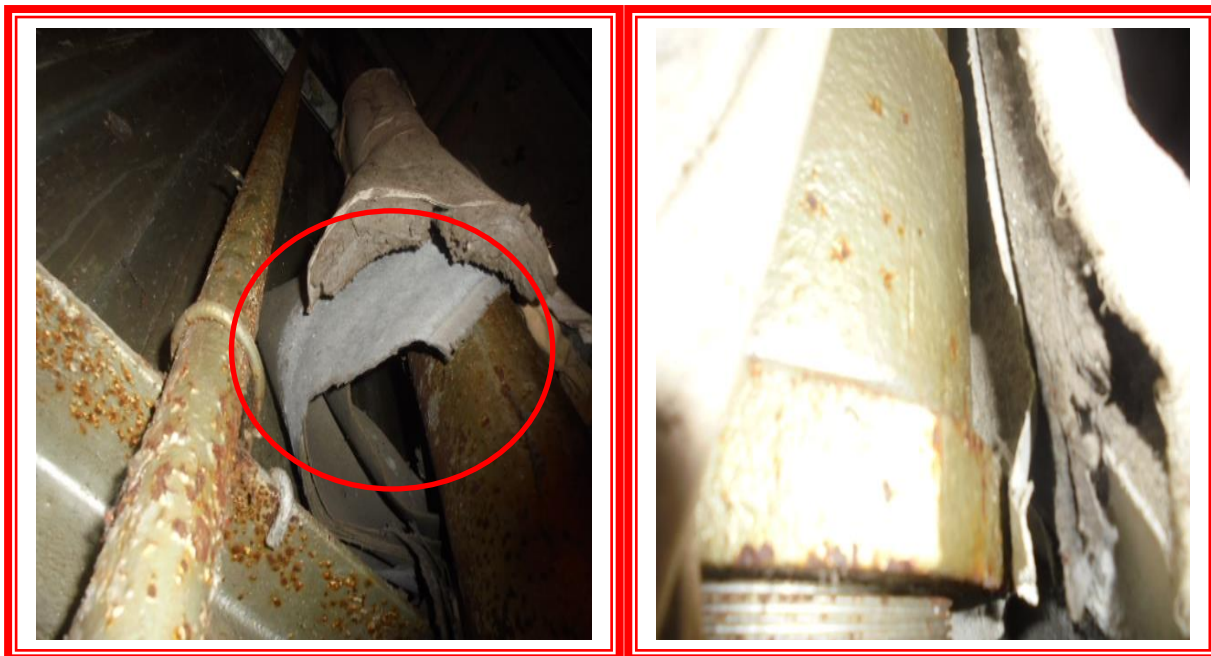
Item No: 11

Material Description:	Paper lining to Pipework	
Identification:	Sampled – Asbestos Detected	
Approx. quantity:	4LM	
Accessibility	Medium	Assessment Score
Product type:	Paper	2
Extent of Damage:	Moderate	2
Surface Treatment:	Unsealed	1
Asbestos type:	Chrysotile	1
Material Assessment Score:		6
Priority Assessment Score:		Low
Action:	Encapsulate/Remove	
Comments:	Located to inside layer of pipework insulation. Paper lining hanging off and may fall

Sample No.	Sample Ref.	Location	Asbestos Detected	Asbestos Type
DK/5	BS579063	Main Hanger - Paper lining to pipework	Yes	Chrysotile
DK/6	BS579064	Externals - Bitumen Coating to Hangar Roof	No

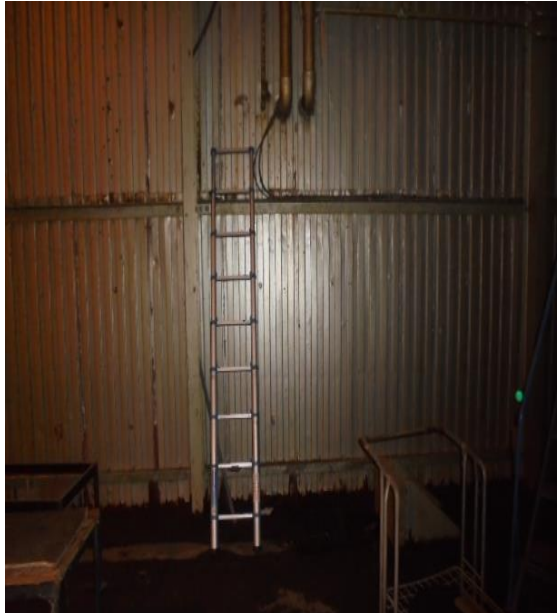
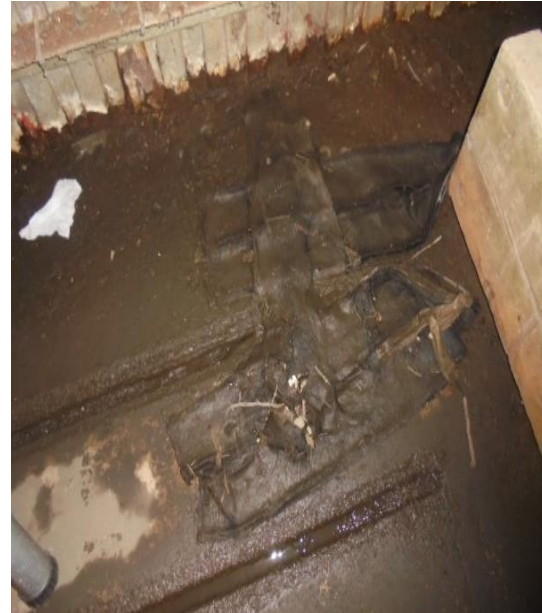
Item No: 12

Material Description:	Paper lining Debris on Floor	
Identification:	As Per Sample DK/5 – Asbestos Detected	
Approx. quantity:	Non-Quantifiable	
Accessibility	High	Assessment Score
Product type:	Paper	2
Extent of Damage:	Major	3
Surface Treatment:	Unsealed	1
Asbestos type:	Chrysotile	1
Material Assessment Score:		7
Priority Assessment Score:		Medium
Action:	Remove	
Comments:	Located directly below damaged pipework insulation from item 11. Likely containing asbestos paper lining

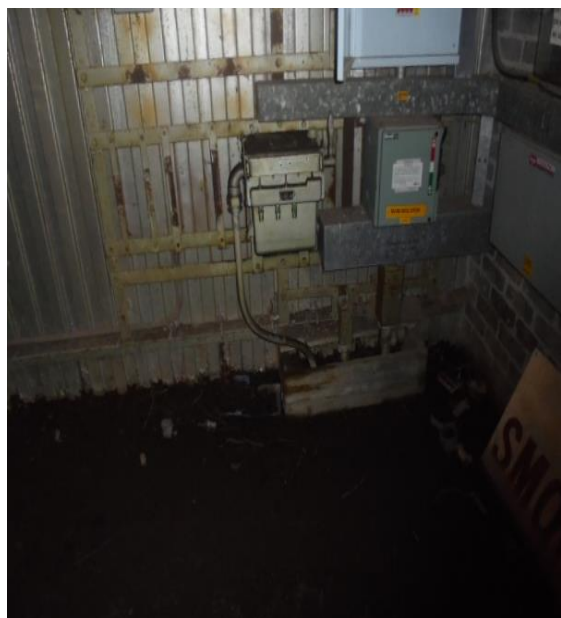
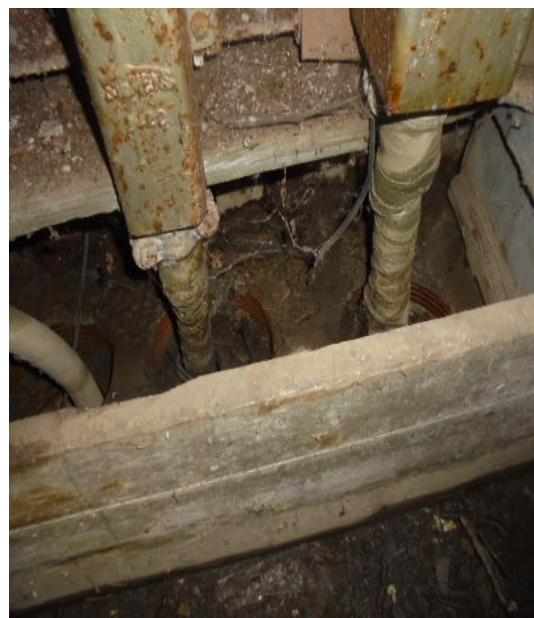
Item No: 13

Item 13 – Main Hanger – Bitumen Wrap to Mains Cable – No Access as Live electrics

Material Description:	Bitumen Wrap to Mains Cables	
Identification:	Presumed to Contain Asbestos	
Approx. quantity:	X 2 Cables (1LM Total)	
Accessibility	Low	<i>Assessment Score</i>
Product type:	Bitumen	1
Extent of Damage:	Minor	1
Surface Treatment:	Non-Friable	0
Asbestos type:	Chrysotile	1
Material Assessment Score:		3
Priority Assessment Score:		Negligible
Action:	Manage	
Comments:	No access to sample as live

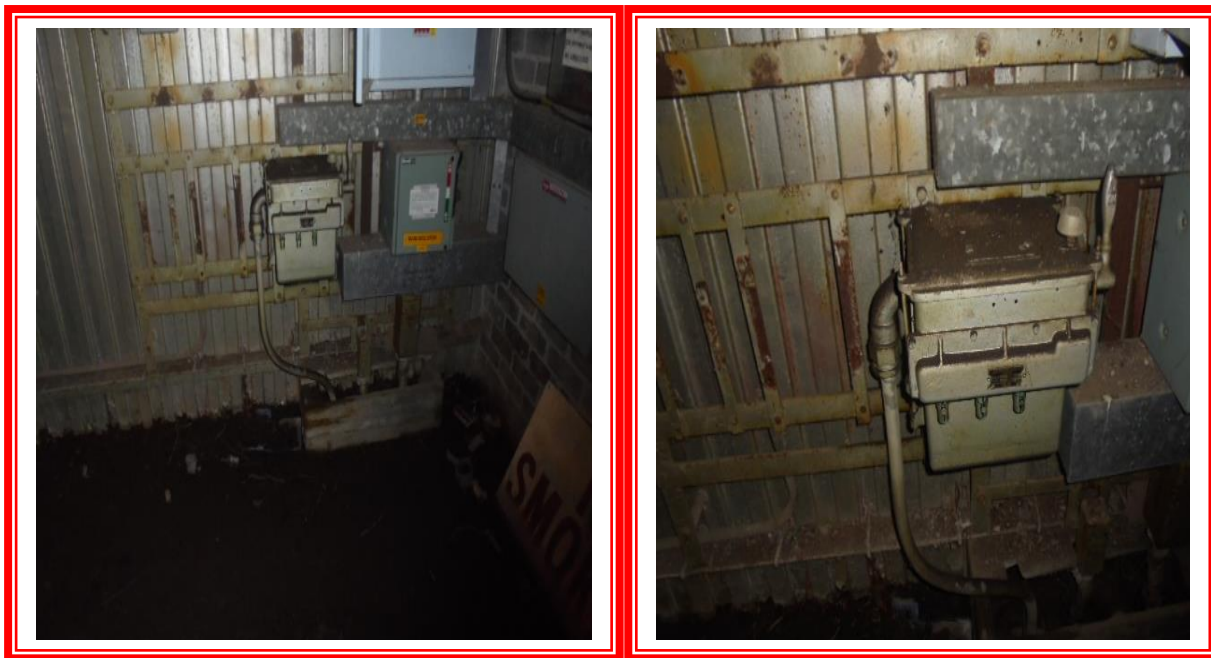
Item No: 14

Item 14 – Main Hanger – Electrical Boxes – No Access as Live Electrics

Material Description:	No Access within Live Electrics	
Identification:	Presumed to Contain Asbestos	
Approx. quantity:	X 1 Box	
Accessibility	Low	Assessment Score
Product type:	No Access	2
Extent of Damage:	No Access	1
Surface Treatment:	No Access	1
Asbestos type:	No Access	1
Material Assessment Score:		5
Priority Assessment Score:		Low
Action:	Manage	
Comments:	Treat as uniform to electrical panels throughout building

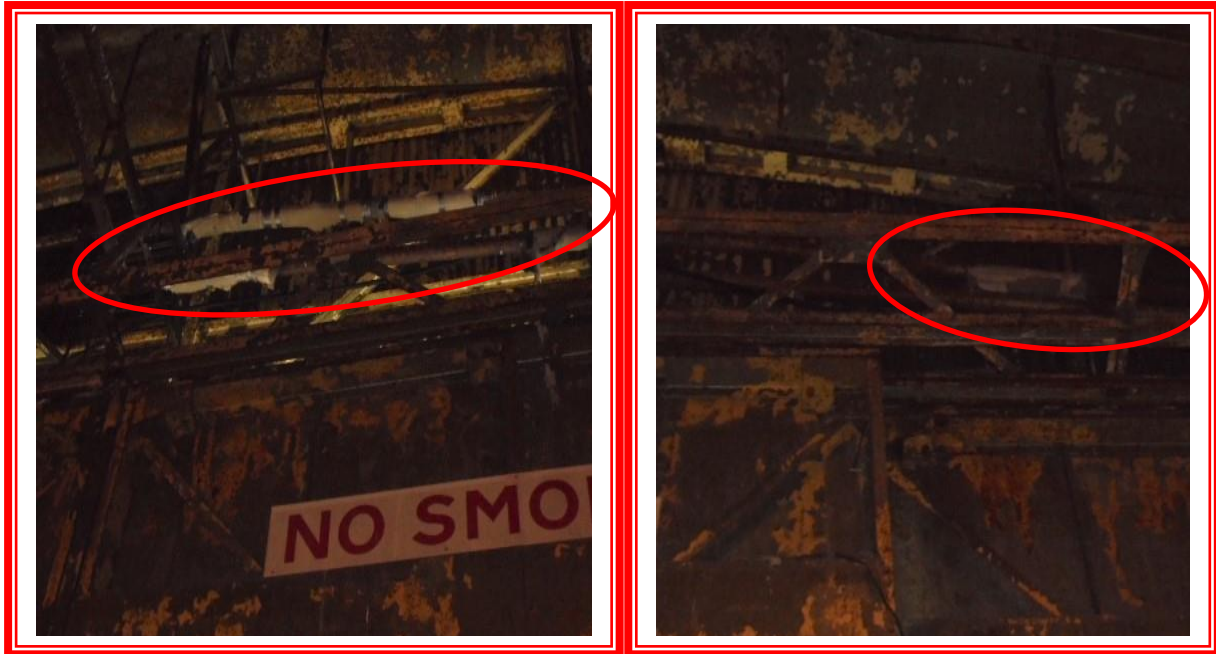
Item No: 16

Material Description:	Paper lining to Pipework	
Identification:	As Per Sample DK/5 – Asbestos Detected	
Approx. quantity:	7LM	
Accessibility	Low	<i>Assessment Score</i>
Product type:	Paper	2
Extent of Damage:	Moderate	2
Surface Treatment:	Unsealed	1
Asbestos type:	Chrysotile	1
Material Assessment Score:		6
Priority Assessment Score:		Low
Action:	Encapsulate/Remove	
Comments:	Located at high level above main hangar door. Visually similar to pipework in item 11 and on the same pipe run. In poor condition with areas of insulation hanging off

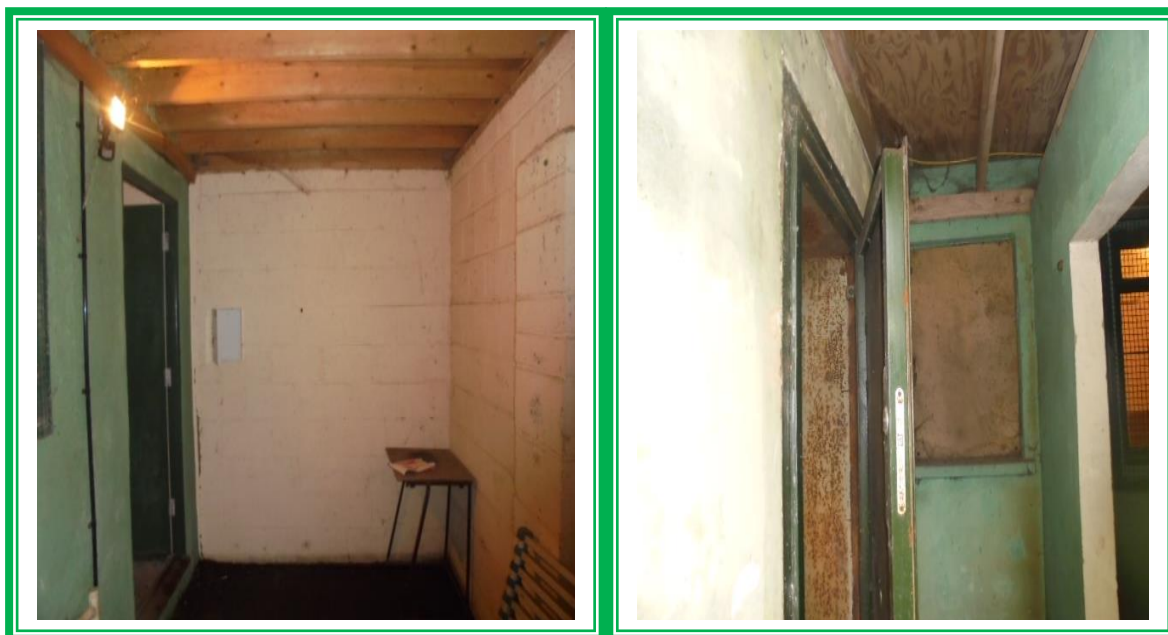
Item No: 1

Material Description:	Visual Inspection – No Suspect Materials Found	
Identification:	N/A	
Approx. quantity:	N/A	
Accessibility	N/A	<i>Assessment Score</i>
Product type:	N/A	N/A
Extent of Damage:	N/A	N/A
Surface Treatment:	N/A	N/A
Asbestos type:	N/A	N/A
Material Assessment Score:		N/A
Priority Assessment Score:		N/A
Action:	N/A	
Comments:	N/A

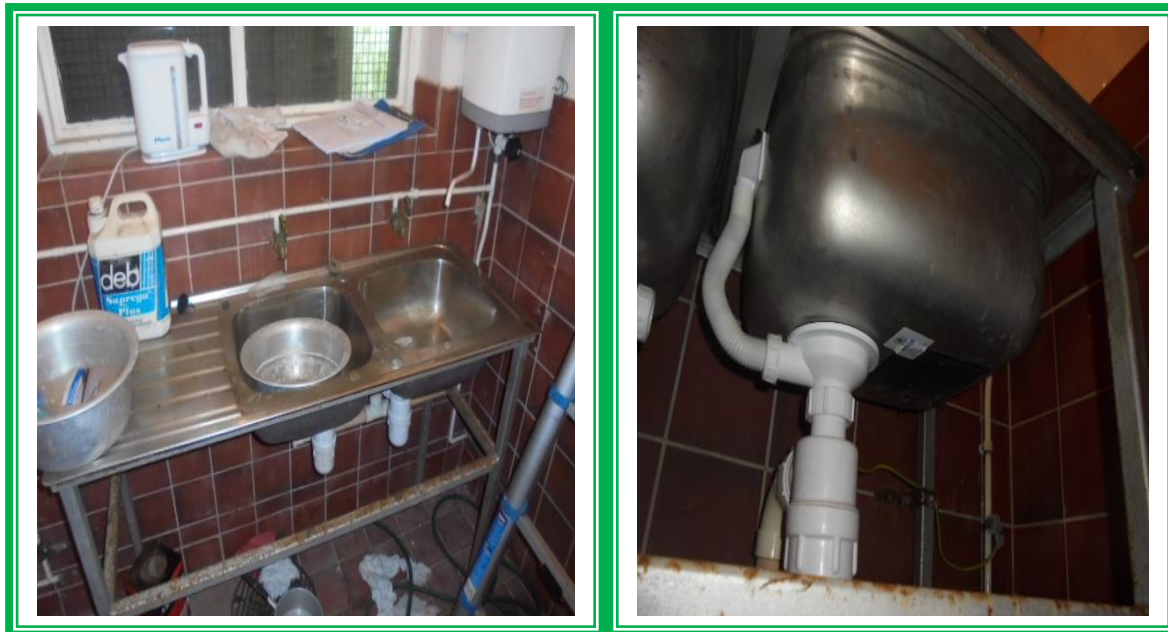
Item No: 2

Material Description:	Sink Pad	
Identification:	Sampled – No Asbestos Detected	
Approx. quantity:	X 2 Pads	
Accessibility	N/A	<i>Assessment Score</i>
Product type:	N/A	N/A
Extent of Damage:	N/A	N/A
Surface Treatment:	N/A	N/A
Asbestos type:	N/A	N/A
Material Assessment Score:		N/A
Priority Assessment Score:		N/A
Action:	N/A	
Comments:	N/A

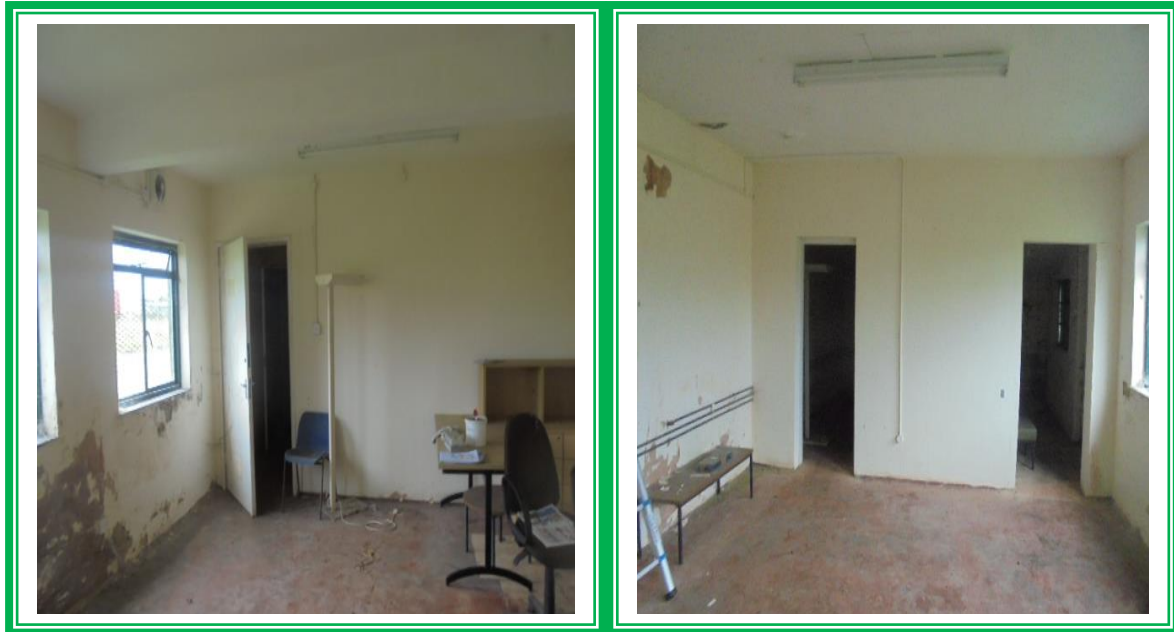
Item No: 3

Material Description:	Visual Inspection – No Suspect Materials Found	
Identification:	N/A	
Approx. quantity:	N/A	
Accessibility	N/A	<i>Assessment Score</i>
Product type:	N/A	N/A
Extent of Damage:	N/A	N/A
Surface Treatment:	N/A	N/A
Asbestos type:	N/A	N/A
Material Assessment Score:		N/A
Priority Assessment Score:		N/A
Action:	N/A	
Comments:	N/A

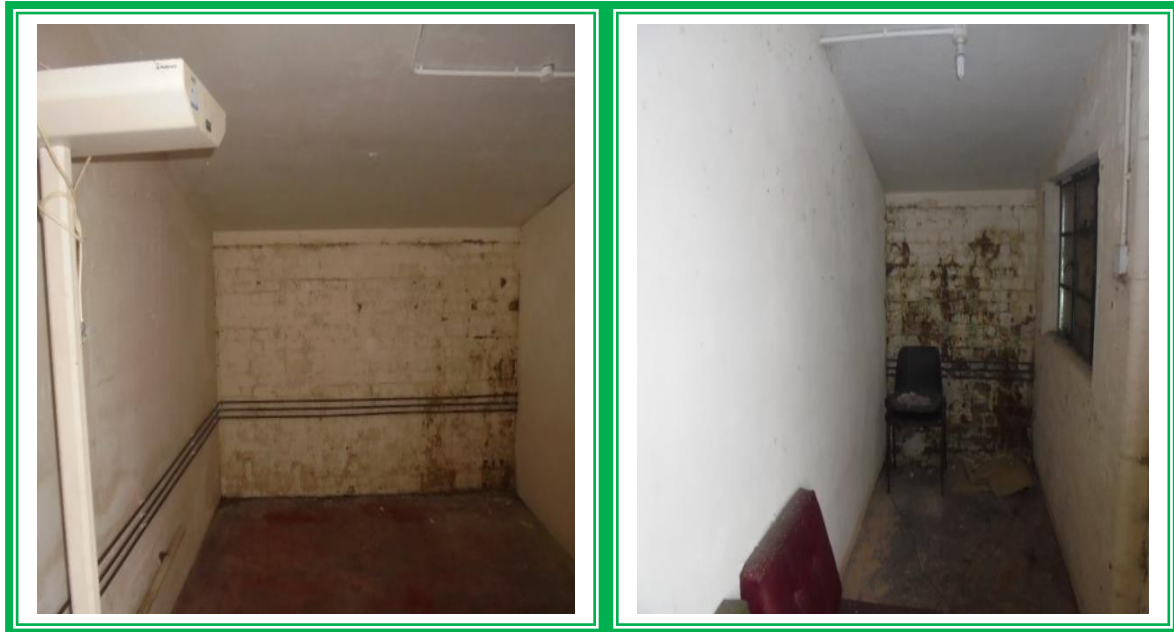
Item No: 4

Material Description:	Visual Inspection – No Suspect Materials Found	
Identification:	N/A	
Approx. quantity:	N/A	
Accessibility	N/A	<i>Assessment Score</i>
Product type:	N/A	N/A
Extent of Damage:	N/A	N/A
Surface Treatment:	N/A	N/A
Asbestos type:	N/A	N/A
Material Assessment Score:		N/A
Priority Assessment Score:		N/A
Action:	N/A	
Comments:	N/A

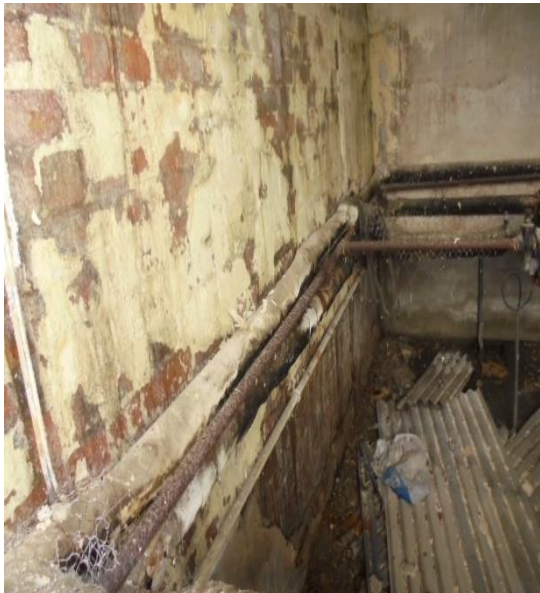
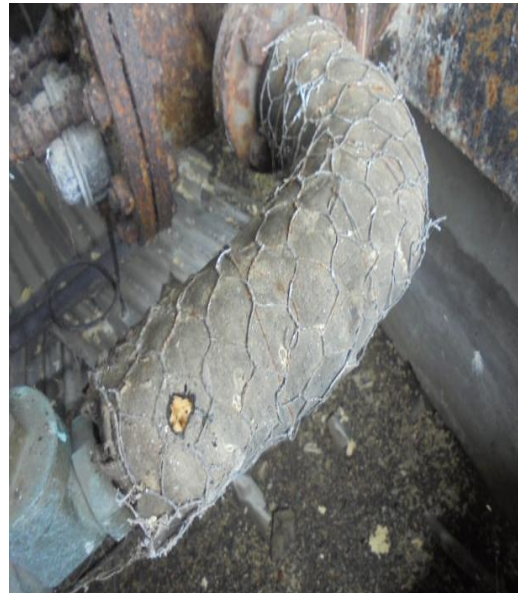
**Item No: 5****Sample No: DK/2****Location: Ground Floor – Tank Room**

Material Description:	Bitumen Covering to Pipework	
Identification:	Sampled – No Asbestos Detected	
Approx. quantity:	25LM	
Accessibility	N/A	<i>Assessment Score</i>
Product type:	N/A	N/A
Extent of Damage:	N/A	N/A
Surface Treatment:	N/A	N/A
Asbestos type:	N/A	N/A
Material Assessment Score:		N/A
Priority Assessment Score:		N/A
Action:	N/A	
Comments:	N/A

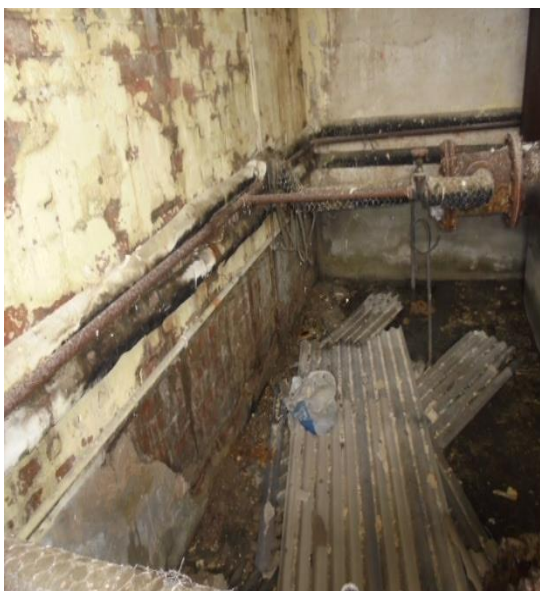
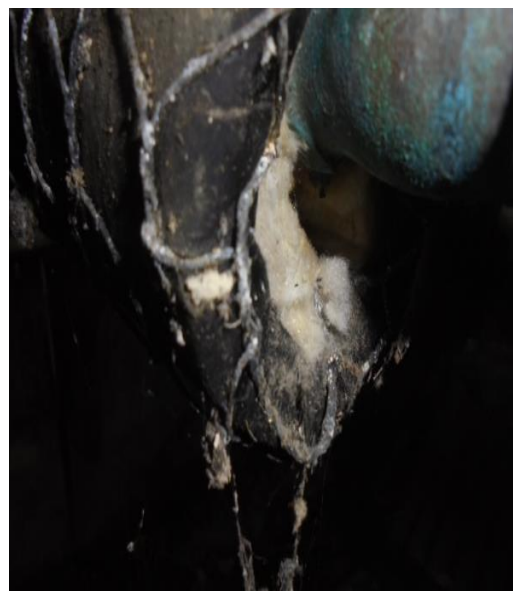
Item No: 6

Material Description:	Pipework Insulation	
Identification:	Sampled – No Asbestos Detected	
Approx. quantity:	25LM	
Accessibility	N/A	<i>Assessment Score</i>
Product type:	N/A	N/A
Extent of Damage:	N/A	N/A
Surface Treatment:	N/A	N/A
Asbestos type:	N/A	N/A
Material Assessment Score:		N/A
Priority Assessment Score:		N/A
Action:	N/A	
Comments:	N/A

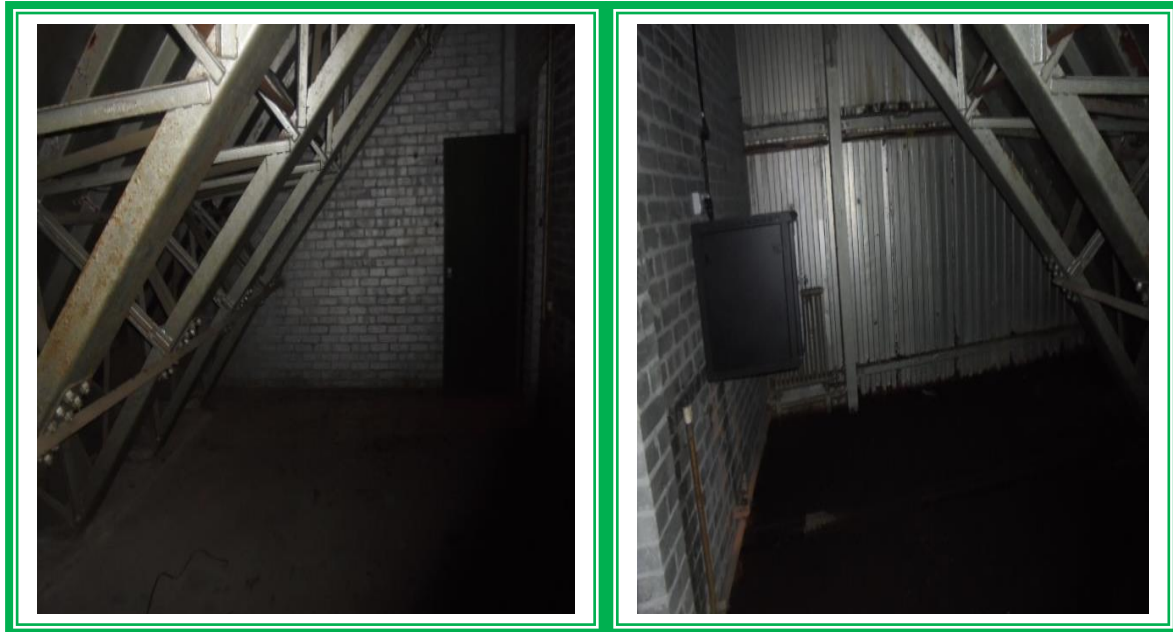
Item No: 15

Material Description:	Visual Inspection – No Suspect Materials Found	
Identification:	N/A	
Approx. quantity:	N/A	
Accessibility	N/A	<i>Assessment Score</i>
Product type:	N/A	N/A
Extent of Damage:	N/A	N/A
Surface Treatment:	N/A	N/A
Asbestos type:	N/A	N/A
Material Assessment Score:		N/A
Priority Assessment Score:		N/A
Action:	N/A	
Comments:	N/A

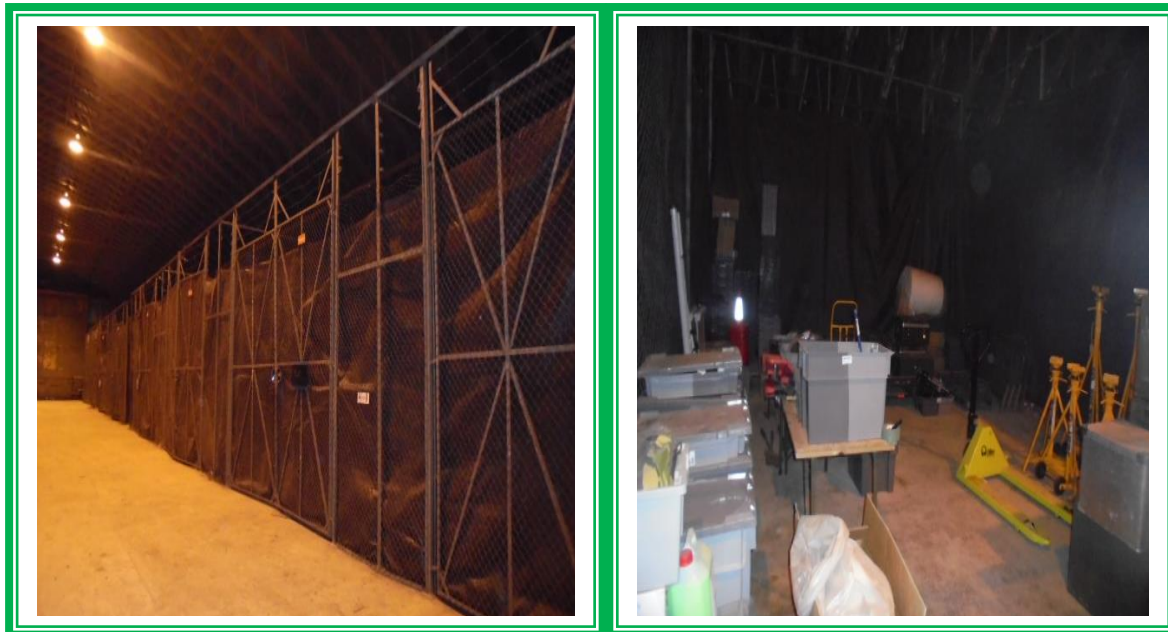
Item No: 17

Material Description:	Visual Inspection – No Suspect Materials Found	
Identification:	N/A	
Approx. quantity:	N/A	
Accessibility	N/A	<i>Assessment Score</i>
Product type:	N/A	N/A
Extent of Damage:	N/A	N/A
Surface Treatment:	N/A	N/A
Asbestos type:	N/A	N/A
Material Assessment Score:		N/A
Priority Assessment Score:		N/A
Action:	N/A	
Comments:	No access within cages as they were locked but no asbestos was visible from the outside

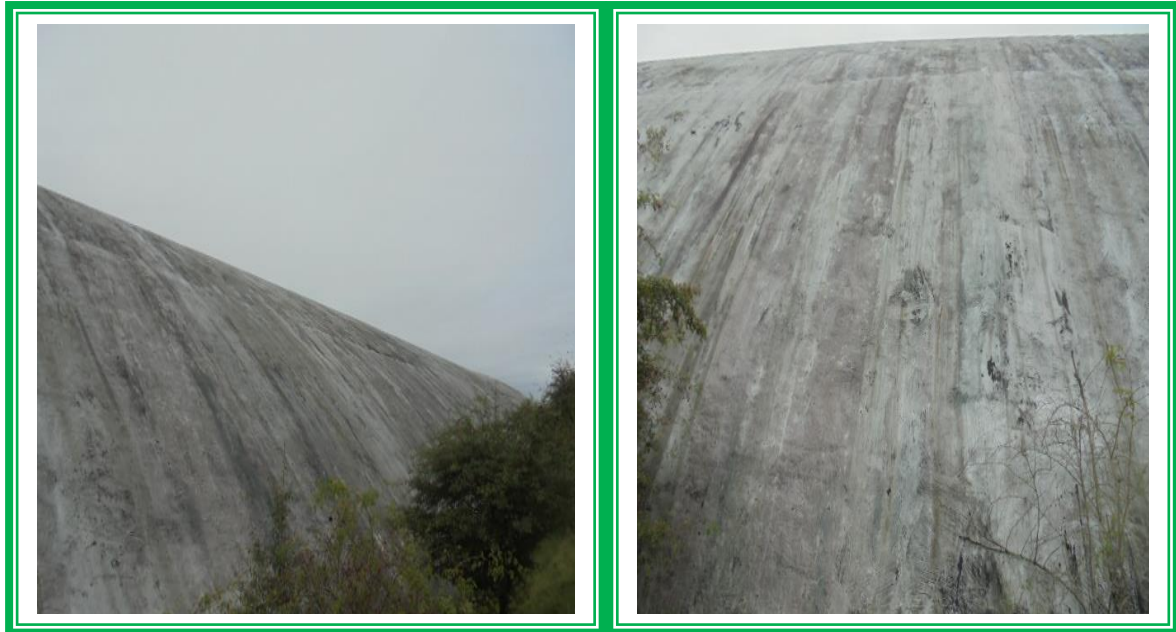
**Item No: 18****Sample No: DK/6****Location: External**

Material Description:	Bitumen Cover to Roof	
Identification:	Sampled – No Asbestos Detected	
Approx. quantity:	4500M2	
Accessibility	N/A	<i>Assessment Score</i>
Product type:	N/A	N/A
Extent of Damage:	N/A	N/A
Surface Treatment:	N/A	N/A
Asbestos type:	N/A	N/A
Material Assessment Score:		N/A
Priority Assessment Score:		N/A
Action:	N/A	
Comments:	A previous survey identified the bitumen cover to the roof as containing asbestos. Although the sample was negative, caution should be applied if making alterations to roof.
