**Project Number 2481**

**Management  
Asbestos Survey Report**

**Portland Platoon, Easton Road,  
Dorset, DT5 1BW**

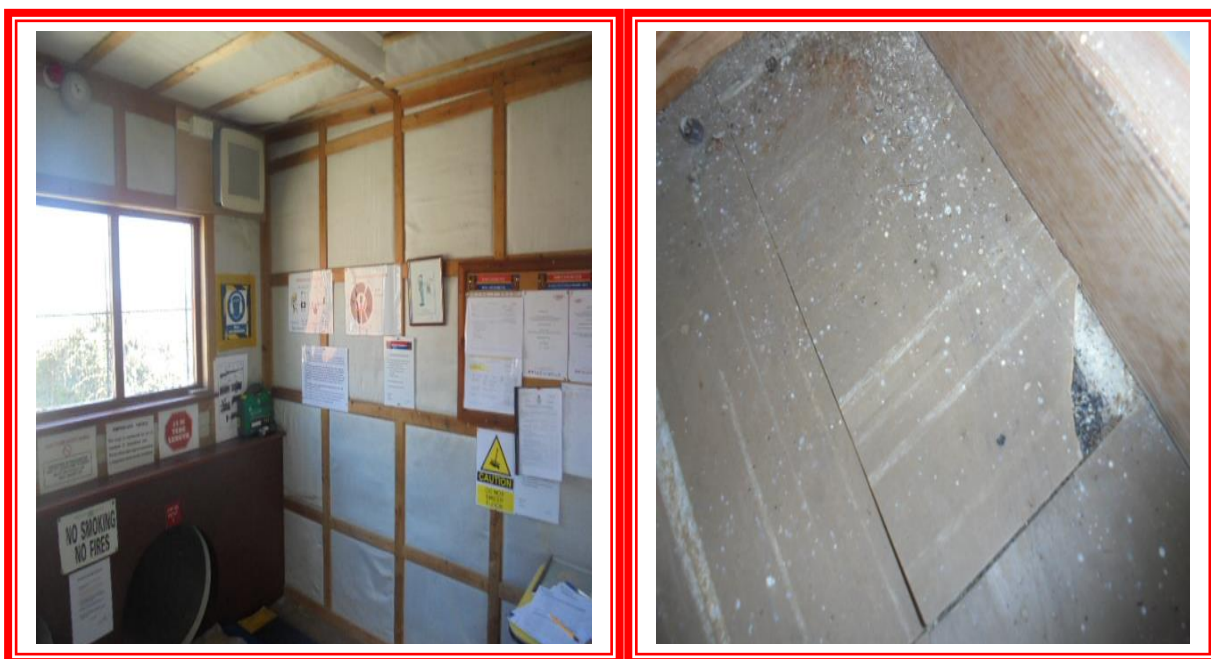
**Item No: 6**
**Sample No: 3**
**Location: Ground Floor – Firing Range 1**

<b>Material Description:</b>	Floor Tiles and Adhesive	
<b>Identification:</b>	Sampled – Asbestos Detected	
<b>Approx. quantity:</b>	9M2	
<b>Accessibility</b>	High	<i>Assessment Score</i>
<b>Product type:</b>	Composite	1
<b>Extent of Damage:</b>	Minor	1
<b>Surface Treatment:</b>	Non-Friable	0
<b>Asbestos type:</b>	Chrysotile	1
<b>Material Assessment Score:</b>		3
<b>Priority Assessment Score:</b>		Negligible
<b>Action:</b>	Manage	
<b>Comments:</b>	N/A

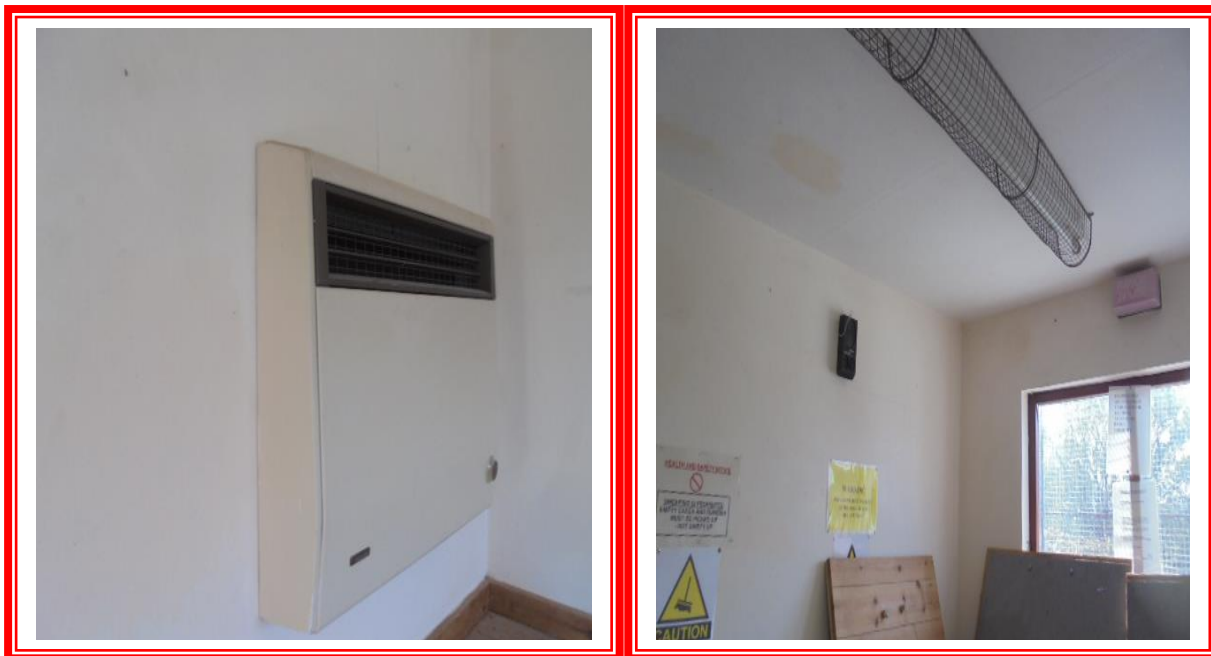
**Location: Ground Floor – Firing Range 2**

### **Item 7 – Ground Floor - Firing Range 2 – Electrical Heater – Unable to sample as live**

The presence of asbestos in these areas cannot be ascertained at this time. If any works are to be carried out in these areas in the future, then these works should be approached cautiously.

<b>Material Description:</b>	Live Heater	
<b>Identification:</b>	Presumed to Contain Asbestos	
<b>Approx. quantity:</b>	X 1 Heater	
<b>Accessibility</b>	Low	Assessment Score
<b>Product type:</b>	No Access	2
<b>Extent of Damage:</b>	No Access	2
<b>Surface Treatment:</b>	No Access	2
<b>Asbestos type:</b>	No Access	2
<b>Material Assessment Score:</b>		8
<b>Priority Assessment Score:</b>		Medium
<b>Action:</b>	Manage	
<b>Comments:</b>	N/A

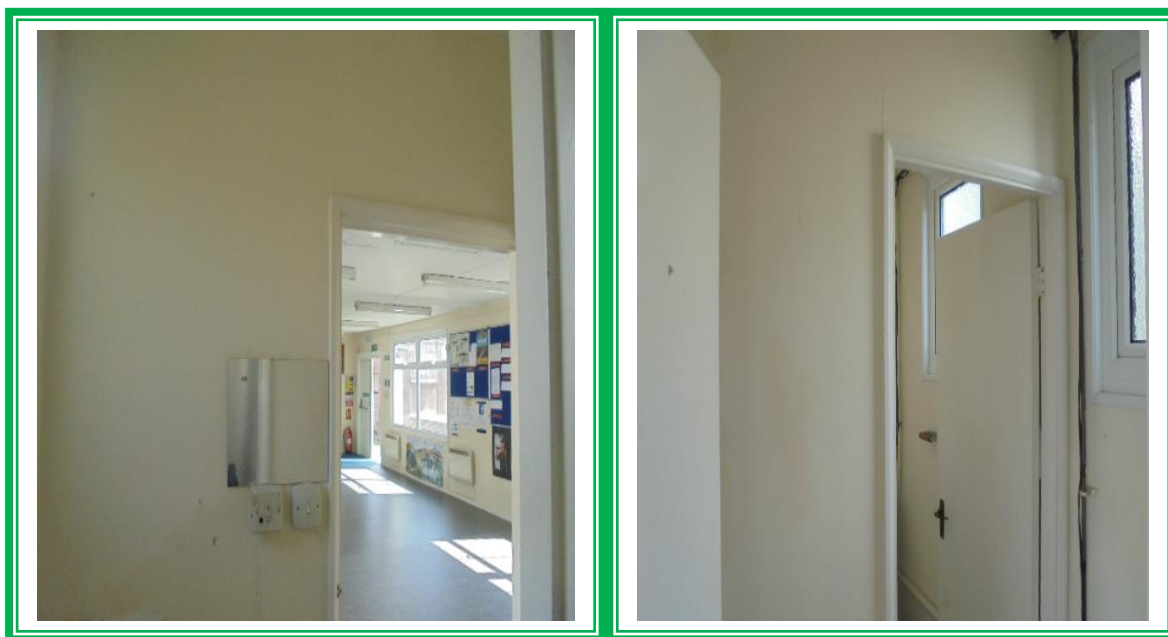
**Item No: 1**
**Sample No: N/A**
**Location: Ground Floor - WC**

<b>Material Description:</b>	Visual Inspection – No Suspect Materials Found	
<b>Identification:</b>	N/A	
<b>Approx. quantity:</b>	N/A	
<b>Accessibility</b>	N/A	<i>Assessment Score</i>
<b>Product type:</b>	N/A	N/A
<b>Extent of Damage:</b>	N/A	N/A
<b>Surface Treatment:</b>	N/A	N/A
<b>Asbestos type:</b>	N/A	N/A
<b>Material Assessment Score:</b>		N/A
<b>Priority Assessment Score:</b>		N/A
<b>Action:</b>	N/A	
<b>Comments:</b>	N/A

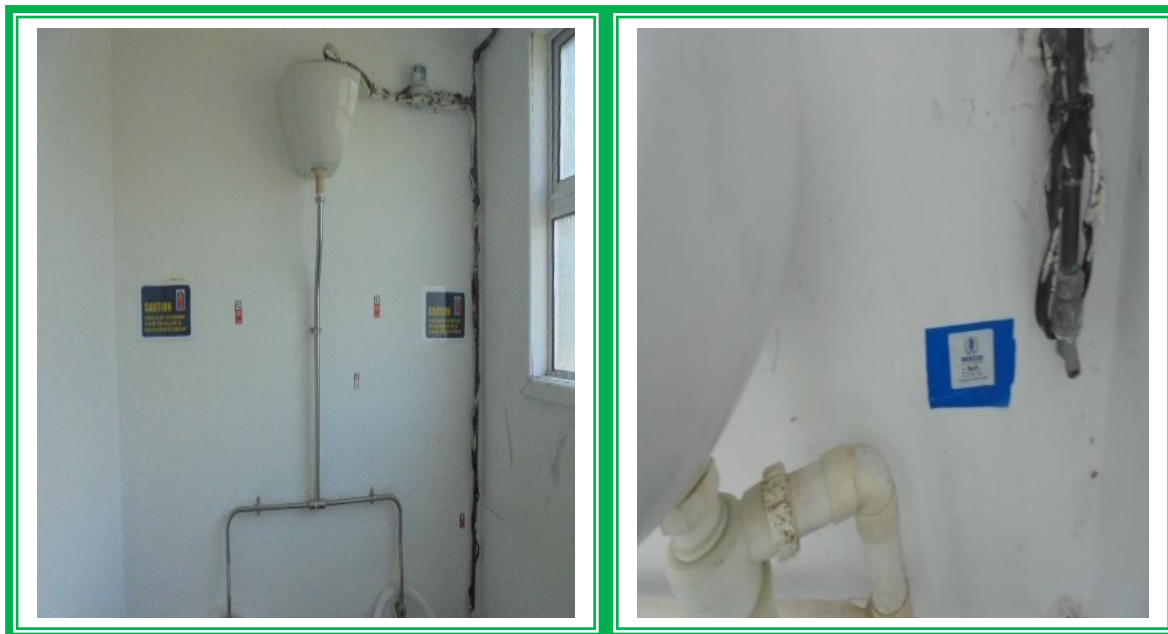
**Location: Ground Floor – Men's WC**

<b>Material Description:</b>	Insulation Board Wall Panels	
<b>Identification:</b>	Sampled – No Asbestos Detected	
<b>Approx. quantity:</b>	6M2	
<b>Accessibility</b>	N/A	<i>Assessment Score</i>
<b>Product type:</b>	N/A	N/A
<b>Extent of Damage:</b>	N/A	N/A
<b>Surface Treatment:</b>	N/A	N/A
<b>Asbestos type:</b>	N/A	N/A
<b>Material Assessment Score:</b>		N/A
<b>Priority Assessment Score:</b>		N/A
<b>Action:</b>	N/A	
<b>Comments:</b>	Panels appear to be plasterboard, but a previous sample shows the panels to be asbestos. No access was possible within the wall cavity -Apply caution

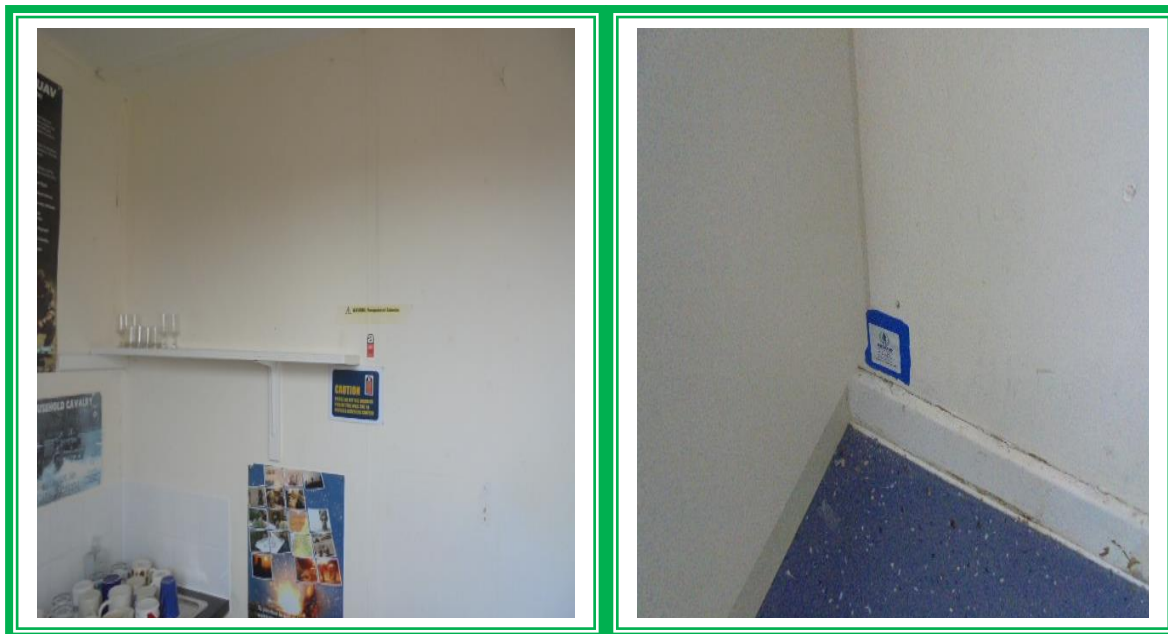
**Item No: 3****Sample No: 2****Location: Ground Floor - Kitchen**

<b>Material Description:</b>	Insulation Board Wall Panels	
<b>Identification:</b>	Sampled – No Asbestos Detected	
<b>Approx. quantity:</b>	6M2	
<b>Accessibility</b>	N/A	<i>Assessment Score</i>
<b>Product type:</b>	N/A	N/A
<b>Extent of Damage:</b>	N/A	N/A
<b>Surface Treatment:</b>	N/A	N/A
<b>Asbestos type:</b>	N/A	N/A
<b>Material Assessment Score:</b>		N/A
<b>Priority Assessment Score:</b>		N/A
<b>Action:</b>	N/A	
<b>Comments:</b>	Panels appear to be plasterboard, but a previous sample shows the panels to be asbestos. No access was possible within the wall cavity -Apply caution

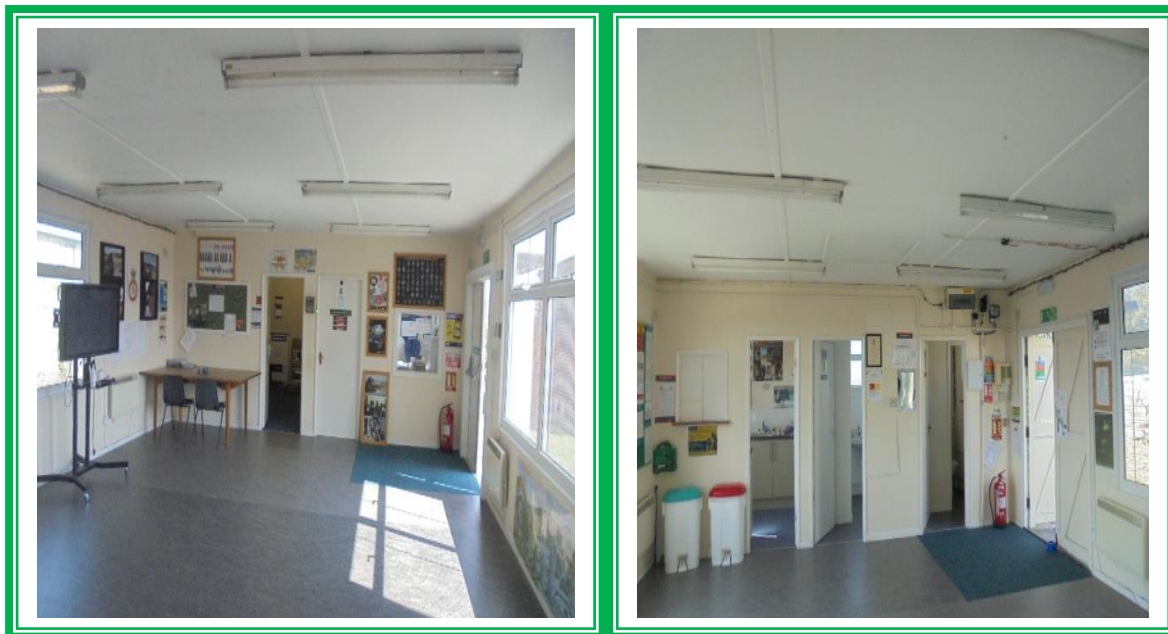
**Location: Ground Floor – Main Hall**

<b>Material Description:</b>	Visual Inspection – No Suspect Materials Found	
<b>Identification:</b>	N/A	
<b>Approx. quantity:</b>	N/A	
<b>Accessibility</b>	N/A	<i>Assessment Score</i>
<b>Product type:</b>	N/A	N/A
<b>Extent of Damage:</b>	N/A	N/A
<b>Surface Treatment:</b>	N/A	N/A
<b>Asbestos type:</b>	N/A	N/A
<b>Material Assessment Score:</b>		N/A
<b>Priority Assessment Score:</b>		N/A
<b>Action:</b>	N/A	
<b>Comments:</b>	Modern Electrics

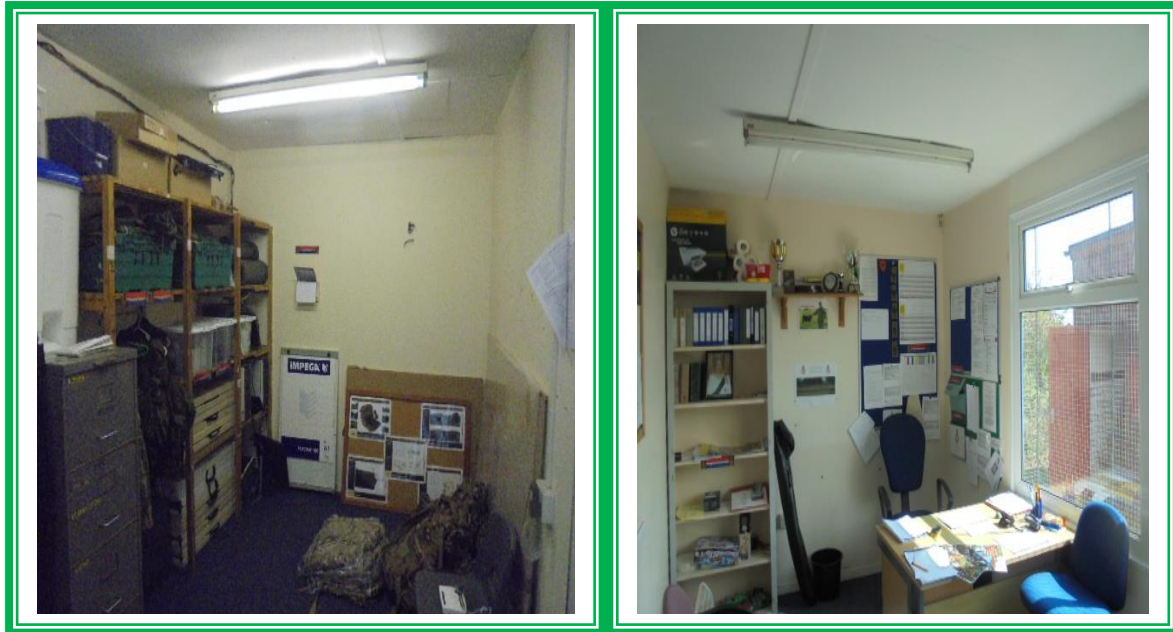
**Location: Ground Floor – Office and Store**

<b>Material Description:</b>	Visual Inspection – No Suspect Materials Found	
<b>Identification:</b>	N/A	
<b>Approx. quantity:</b>	N/A	
<b>Accessibility</b>	N/A	<i>Assessment Score</i>
<b>Product type:</b>	N/A	N/A
<b>Extent of Damage:</b>	N/A	N/A
<b>Surface Treatment:</b>	N/A	N/A
<b>Asbestos type:</b>	N/A	N/A
<b>Material Assessment Score:</b>		N/A
<b>Priority Assessment Score:</b>		N/A
<b>Action:</b>	N/A	
<b>Comments:</b>	N/A
