**Project Number A-00623 (3700)**

**Re-Inspection  
Asbestos Survey Report - Revised**

**165 Port and Maritime  
Brest Road  
Devon  
PL6 5EW**

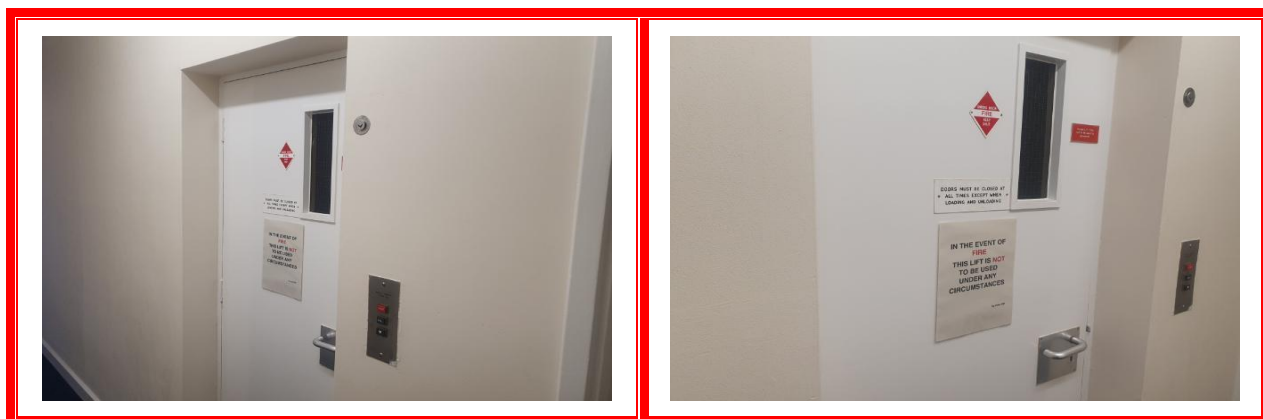
<b>Item No:</b>	<b>1</b>	<b>Sample No:</b>	<b>N/A</b>
<b>Location:</b>	All Floors - Lift Shaft 001

<b>Material Description:</b>	All - No Access Gained	
<b>Identification:</b>	Presumed to Contain Asbestos	
<b>Approx. quantity:</b>	1 no	
<b>Accessibility</b>	Difficult	Assessment Score
<b>Product type:</b>	Pipe Insulation	3
<b>Extent of Damage:</b>	Major damage	3
<b>Surface Treatment:</b>	Unsealed Insulation	3
<b>Asbestos type:</b>	Amosite, Chrysotile, Crocidolite	3
<b>Material Assessment Score:</b>		12
<b>Priority Assessment Score:</b>		High
<b>Action:</b>	Further Investigation Needed	
<b>Comments:</b>	No access within the lift shaft as there was no lift engineer on site

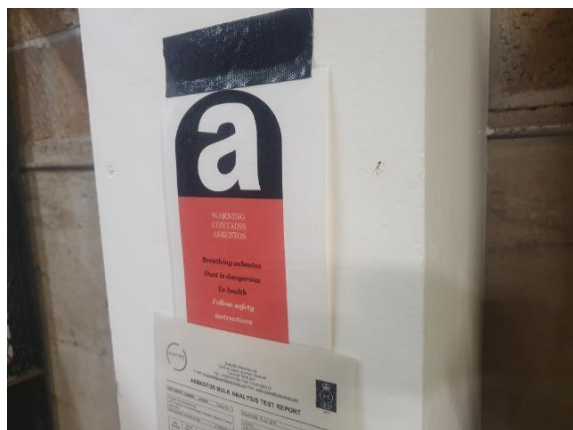
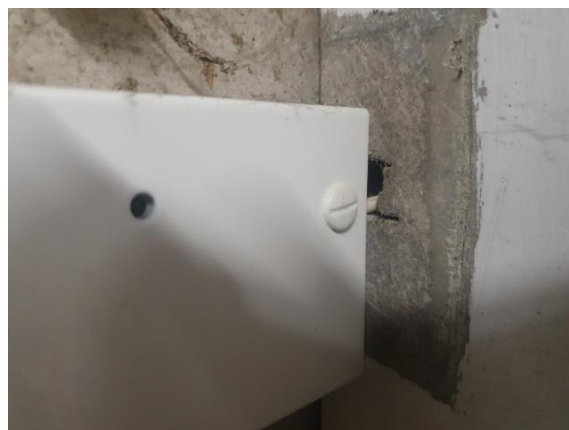
**Location:** Ground Floor - Armoury 003

<b>Material Description:</b>	Boxing Panels - Cement Product	
<b>Identification:</b>	Previously Sampled - Asbestos Detected	
<b>Approx. quantity:</b>	3 LM	
<b>Accessibility</b>	Easy	<i>Assessment Score</i>
<b>Product type:</b>	Cement	1
<b>Extent of Damage:</b>	Slight / minor damage	1
<b>Surface Treatment:</b>	Unsealed Cement	1
<b>Asbestos type:</b>	Chrysotile	1
<b>Material Assessment Score:</b>		4
<b>Priority Assessment Score:</b>		Negligible
<b>Action:</b>	Encapsulate	
<b>Comments:</b>	Previously sampled ref: Armour 23/10/19 - Sample DK/1

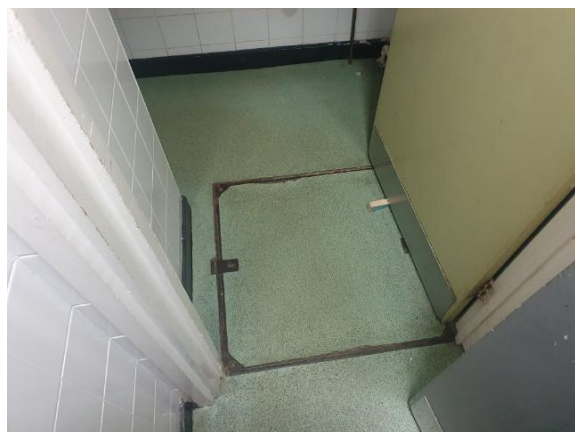
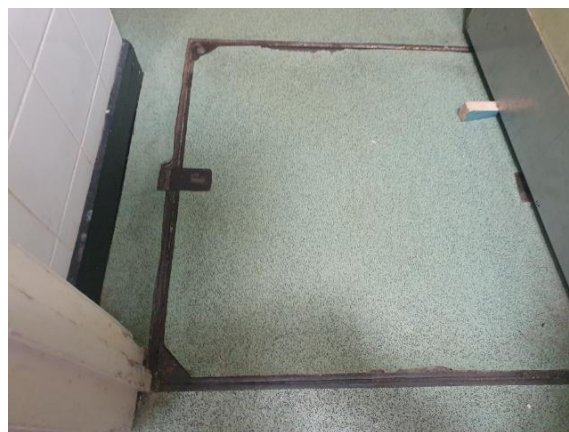
**Location:** Ground Floor - Floor Ducts 005

<b>Material Description:</b>	All - No Access Gained	
<b>Identification:</b>	Presumed to Contain Asbestos	
<b>Approx. quantity:</b>	1 no	
<b>Accessibility</b>	Difficult	<i>Assessment Score</i>
<b>Product type:</b>	Pipe Insulation	3
<b>Extent of Damage:</b>	Major damage	3
<b>Surface Treatment:</b>	Unsealed Insulation	3
<b>Asbestos type:</b>	Amosite, Chrysotile, Crocidolite	3
<b>Material Assessment Score:</b>		12
<b>Priority Assessment Score:</b>		High
<b>Action:</b>	Further Investigation Needed	
<b>Comments:</b>	No access within floor ducts due to lone working/confined space

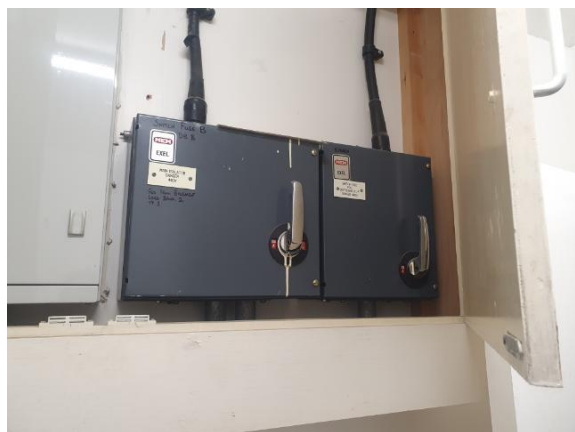
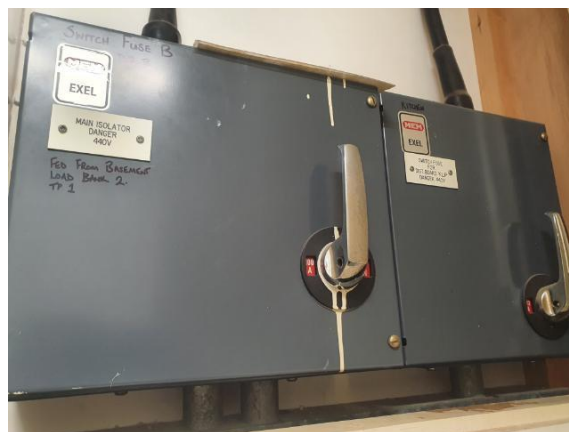
**Location:** Ground Floor - Wash Room 006

<b>Material Description:</b>	Electrical Panels - Woven Product	
<b>Identification:</b>	Presumed to Contain Asbestos	
<b>Approx. quantity:</b>	2 no	
<b>Accessibility</b>	Difficult	<i>Assessment Score</i>
<b>Product type:</b>	Flashguards	2
<b>Extent of Damage:</b>	Low damage	1
<b>Surface Treatment:</b>	Woven	1
<b>Asbestos type:</b>	Chrysotile	1
<b>Material Assessment Score:</b>		5
<b>Priority Assessment Score:</b>		Low
<b>Action:</b>	Manage	
<b>Comments:</b>	No access within live electrics

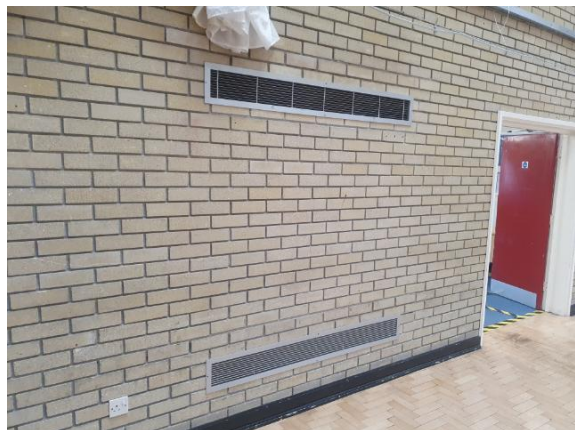
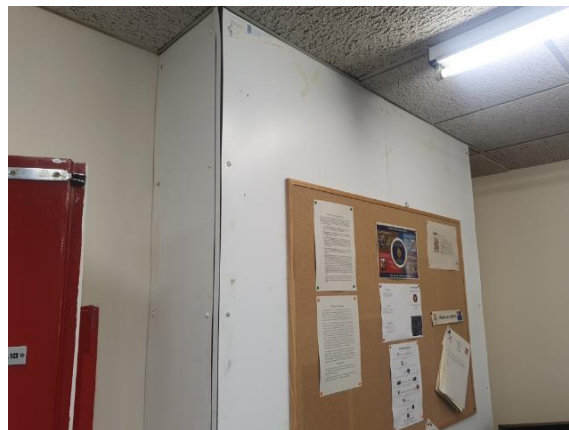
**Location:** Ground Floor - Drill Hall 007

<b>Material Description:</b>	Heaters - Insulating Board	
<b>Identification:</b>	Presumed to Contain Asbestos	
<b>Approx. quantity:</b>	6 no	
<b>Accessibility</b>	Difficult	<i>Assessment Score</i>
<b>Product type:</b>	Asbestos Insulating Board	2
<b>Extent of Damage:</b>	Low damage	1
<b>Surface Treatment:</b>	Unsealed AIB	2
<b>Asbestos type:</b>	Amosite, Chrysotile	2
<b>Material Assessment Score:</b>		7
<b>Priority Assessment Score:</b>		Medium
<b>Action:</b>	Manage	
<b>Comments:</b>	No access within live heaters throughout building

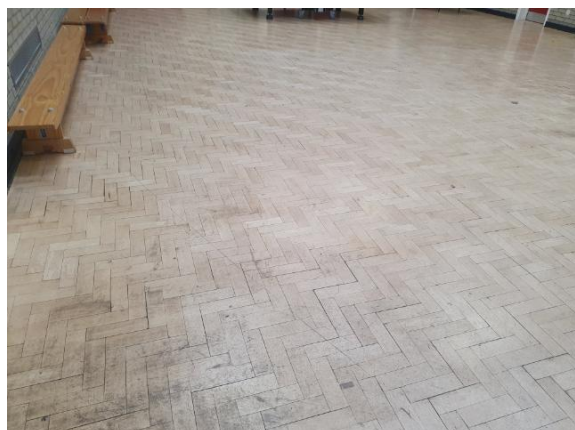
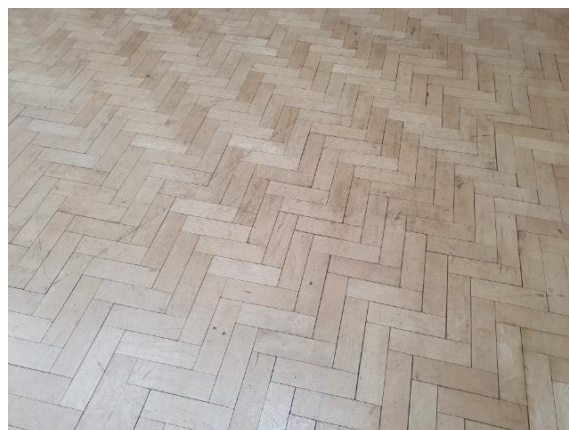
**Location:** Ground Floor - Drill Hall 008

<b>Material Description:</b>	Adhesive under Parquet Flooring - Bituminous Product	
<b>Identification:</b>	Presumed to Contain Asbestos	
<b>Approx. quantity:</b>	100 m <sup>2</sup>	
<b>Accessibility</b>	Difficult	<i>Assessment Score</i>
<b>Product type:</b>	Bitumen	1
<b>Extent of Damage:</b>	Low damage	1
<b>Surface Treatment:</b>	Non Friable	0
<b>Asbestos type:</b>	Chrysotile	1
<b>Material Assessment Score:</b>		3
<b>Priority Assessment Score:</b>		Negligible
<b>Action:</b>	Manage	
<b>Comments:</b>	No access under flooring without irreparable damage

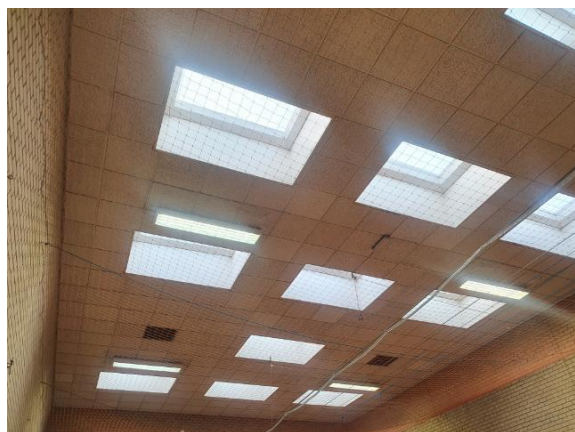
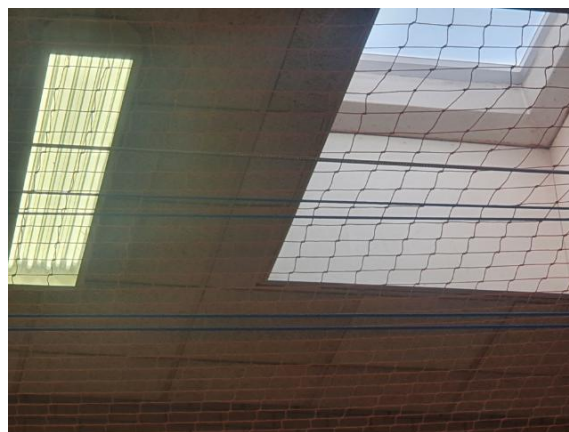
**Location:** Ground Floor - Drill Hall 009

<b>Material Description:</b>	Above Suspended Ceiling - No Access Gained	
<b>Identification:</b>	Presumed to Contain Asbestos	
<b>Approx. quantity:</b>	Unknown	
<b>Accessibility</b>	Difficult	<i>Assessment Score</i>
<b>Product type:</b>	Pipe Insulation	3
<b>Extent of Damage:</b>	Major damage	3
<b>Surface Treatment:</b>	Unsealed Insulation	3
<b>Asbestos type:</b>	Amosite, Chrysotile, Crocidolite	3
<b>Material Assessment Score:</b>		12
<b>Priority Assessment Score:</b>		High
<b>Action:</b>	Further Investigation Needed	
<b>Comments:</b>	No access to inspect above suspended ceiling due to height restrictions

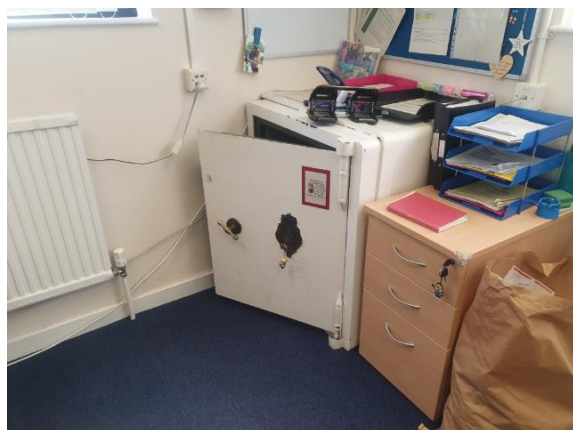
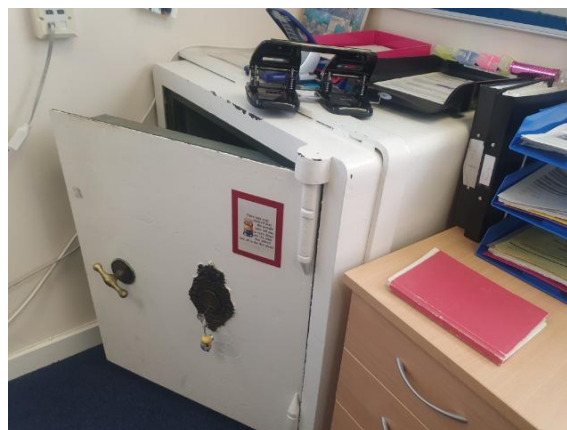
**Location:** Ground Floor - Office 010

<b>Material Description:</b>	Safe - Insulating Board	
<b>Identification:</b>	Presumed to Contain Asbestos	
<b>Approx. quantity:</b>	1 no	
<b>Accessibility</b>	Difficult	<i>Assessment Score</i>
<b>Product type:</b>	Asbestos Insulating Board	2
<b>Extent of Damage:</b>	Low damage	1
<b>Surface Treatment:</b>	Unsealed AIB	2
<b>Asbestos type:</b>	Amosite, Chrysotile	2
<b>Material Assessment Score:</b>		7
<b>Priority Assessment Score:</b>		Medium
<b>Action:</b>	Manage	
<b>Comments:</b>	No access within safe casings without damaging safe

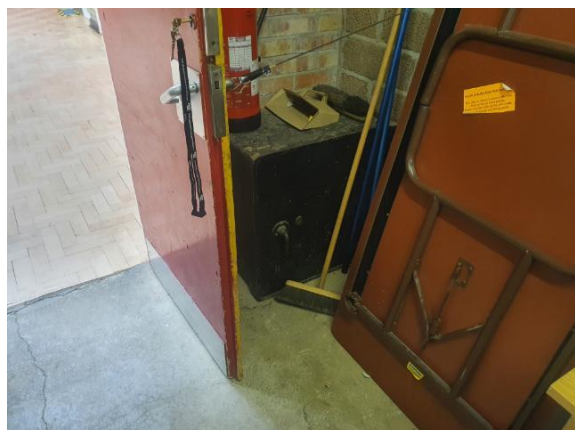
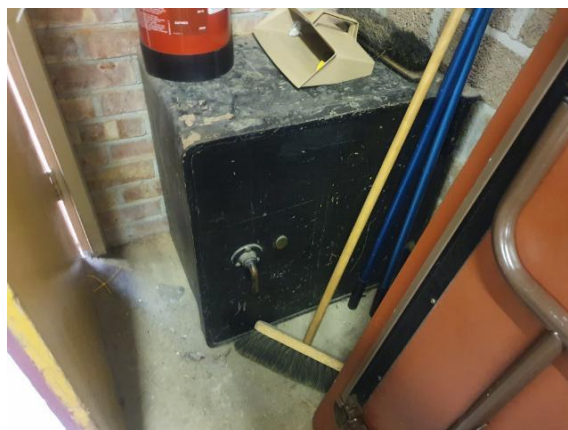
**Location:** Ground Floor - Stores 011

<b>Material Description:</b>	Safe - Insulating Board	
<b>Identification:</b>	Presumed to Contain Asbestos	
<b>Approx. quantity:</b>	1 no	
<b>Accessibility</b>	Difficult	<i>Assessment Score</i>
<b>Product type:</b>	Asbestos Insulating Board	2
<b>Extent of Damage:</b>	Low damage	1
<b>Surface Treatment:</b>	Unsealed AIB	2
<b>Asbestos type:</b>	Amosite, Chrysotile	2
<b>Material Assessment Score:</b>		7
<b>Priority Assessment Score:</b>		Medium
<b>Action:</b>	Manage	
<b>Comments:</b>	No access within safe casings without damaging safe

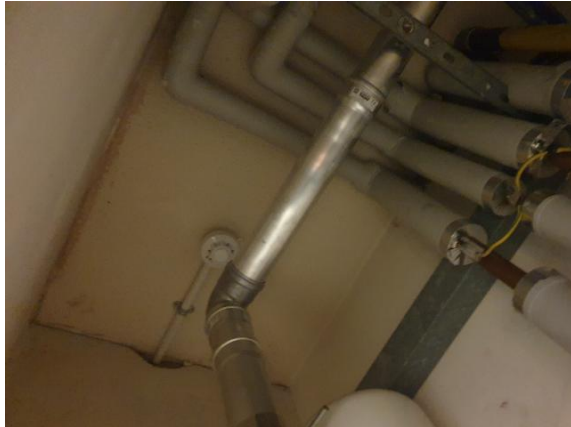
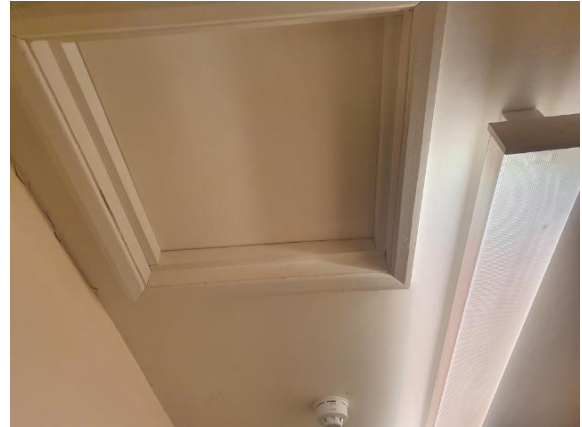
**Location:** Ground Floor - Kitchen Office and Plantroom 012

<b>Material Description:</b>	Ceilings - Textured Coating	
<b>Identification:</b>	Previously Sampled - Asbestos Detected	
<b>Approx. quantity:</b>	6 m <sup>2</sup>	
<b>Accessibility</b>	Difficult	<i>Assessment Score</i>
<b>Product type:</b>	Textured Coating	1
<b>Extent of Damage:</b>	Slight / minor damage	1
<b>Surface Treatment:</b>	Non-friable	0
<b>Asbestos type:</b>	Chrysotile	1
<b>Material Assessment Score:</b>		3
<b>Priority Assessment Score:</b>		Negligible
<b>Action:</b>	Manage	
<b>Comments:</b>	Previously sampled ref: Armour 23/10/19 - Sample DK/5. Visible in hatch above kitchen

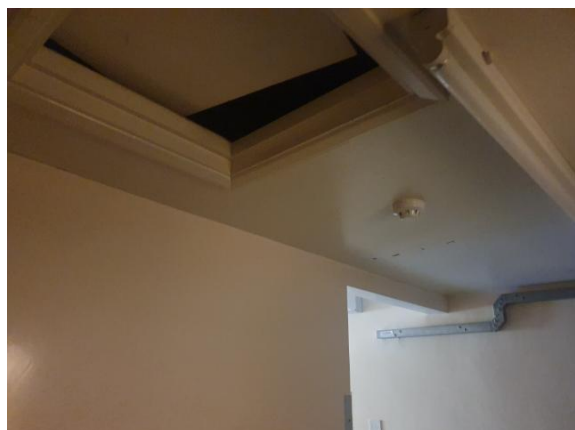
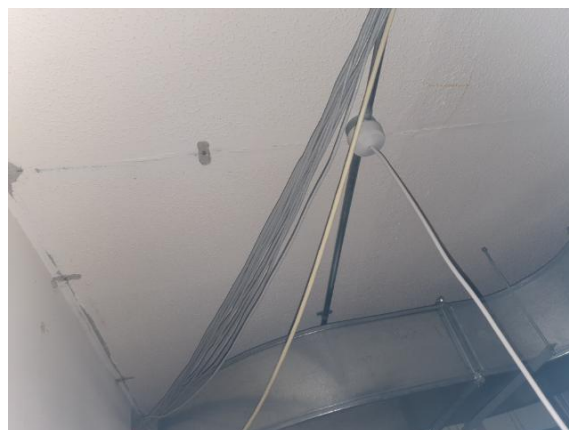
**Location:** Ground Floor - Kitchen Circulation 013

<b>Material Description:</b>	Ceiling - Textured Coating	
<b>Identification:</b>	Previously Sampled - Asbestos Detected	
<b>Approx. quantity:</b>	6 m <sup>2</sup>	
<b>Accessibility</b>	Difficult	<i>Assessment Score</i>
<b>Product type:</b>	Textured Coating	1
<b>Extent of Damage:</b>	Slight / minor damage	1
<b>Surface Treatment:</b>	Non-friable	0
<b>Asbestos type:</b>	Chrysotile	1
<b>Material Assessment Score:</b>		3
<b>Priority Assessment Score:</b>		Negligible
<b>Action:</b>	Manage	
<b>Comments:</b>	Previously sampled ref: Armour 23/10/19 - Sample DK/6

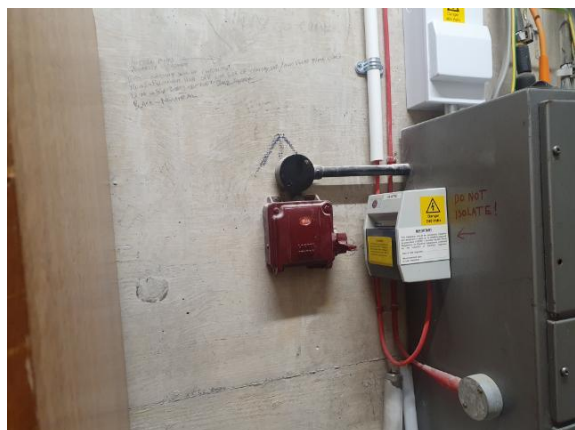
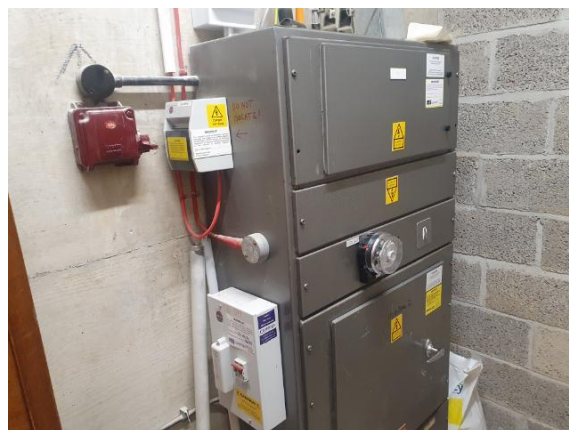
**Location:** Basement - Electrical Cupboard 016

<b>Material Description:</b>	Electrics - Woven Product	
<b>Identification:</b>	Presumed to Contain Asbestos	
<b>Approx. quantity:</b>	2 no	
<b>Accessibility</b>	Difficult	<i>Assessment Score</i>
<b>Product type:</b>	Flashguards	2
<b>Extent of Damage:</b>	Low damage	1
<b>Surface Treatment:</b>	Woven	1
<b>Asbestos type:</b>	Chrysotile	1
<b>Material Assessment Score:</b>		5
<b>Priority Assessment Score:</b>		Low
<b>Action:</b>	Manage	
<b>Comments:</b>	No access within live electrics

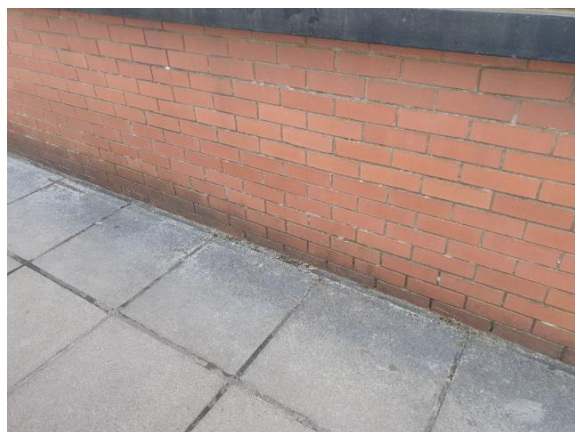
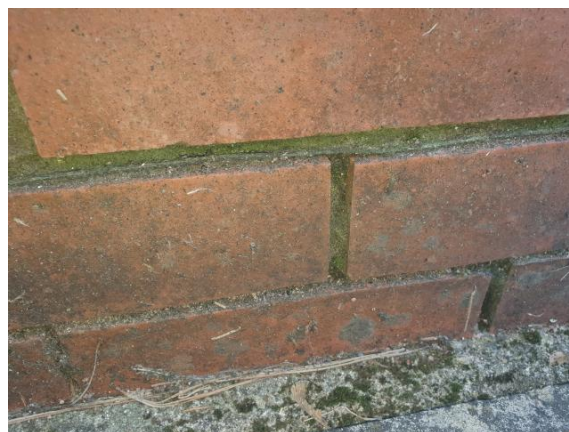
**Location:** External - Walls 019

<b>Material Description:</b>	Damp Proof Course - Bituminous Product	
<b>Identification:</b>	Previously Sampled - Asbestos Detected	
<b>Approx. quantity:</b>	Entire perimeter	
<b>Accessibility</b>	Difficult	<i>Assessment Score</i>
<b>Product type:</b>	Bitumen	1
<b>Extent of Damage:</b>	Slight / minor damage	1
<b>Surface Treatment:</b>	Non-friable	0
<b>Asbestos type:</b>	Chrysotile	1
<b>Material Assessment Score:</b>		3
<b>Priority Assessment Score:</b>		Negligible
<b>Action:</b>	Manage	
<b>Comments:</b>	Previously sampled ref: Armour 23/10/19 - Sample DK/10

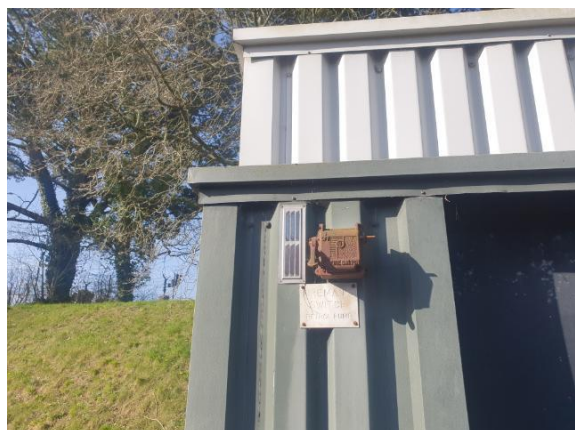
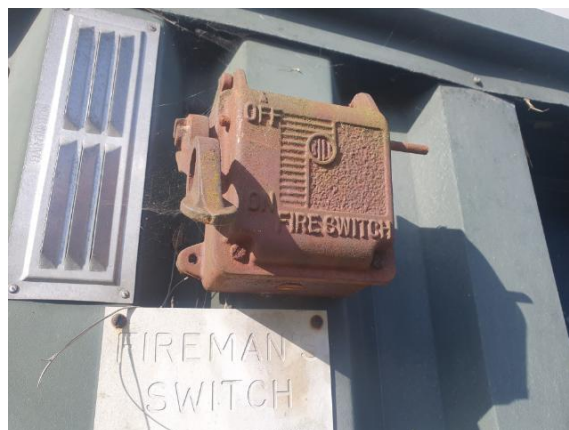
**Location:** External - Gas Intake Store 021

<b>Material Description:</b>	Electrics - Woven Product	
<b>Identification:</b>	Presumed to Contain Asbestos	
<b>Approx. quantity:</b>	1 no	
<b>Accessibility</b>	Difficult	<i>Assessment Score</i>
<b>Product type:</b>	Flashguards	2
<b>Extent of Damage:</b>	Low damage	1
<b>Surface Treatment:</b>	Woven	1
<b>Asbestos type:</b>	Chrysotile	1
<b>Material Assessment Score:</b>		5
<b>Priority Assessment Score:</b>		Low
<b>Action:</b>	Manage	
<b>Comments:</b>	No access within live electrics

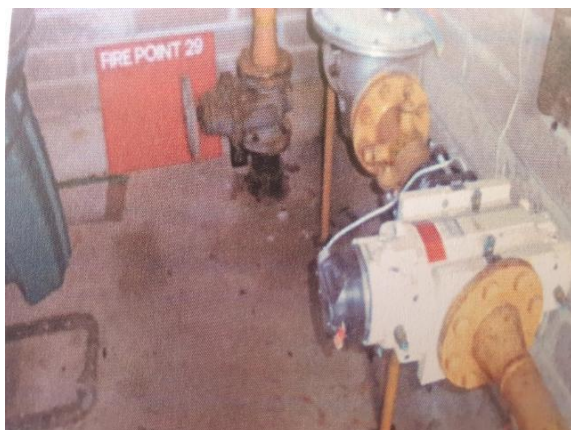
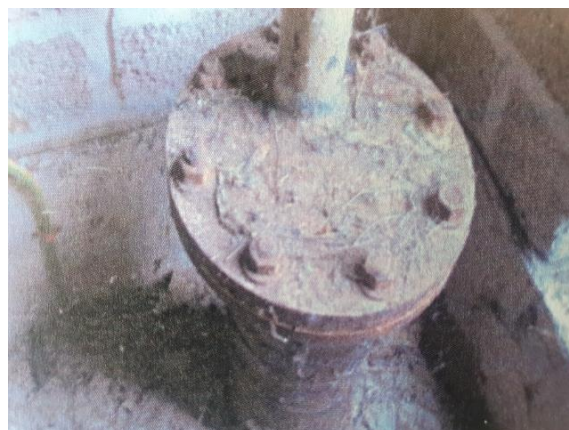
**Location:** Ground Floor - Gas Intake Store 022

<b>Material Description:</b>	Gaskets - Gaskets (compressed)	
<b>Identification:</b>	Previously Sampled - Asbestos Detected	
<b>Approx. quantity:</b>	5 no	
<b>Accessibility</b>	Difficult	<i>Assessment Score</i>
<b>Product type:</b>	Gaskets (Compressed)	2
<b>Extent of Damage:</b>	Slight / minor damage	1
<b>Surface Treatment:</b>	Gaskets	1
<b>Asbestos type:</b>	Chrysotile	1
<b>Material Assessment Score:</b>		5
<b>Priority Assessment Score:</b>		Low
<b>Action:</b>	Manage	
<b>Comments:</b>	Previously sampled ref: Armour 23/10/19 - Sample DK/11

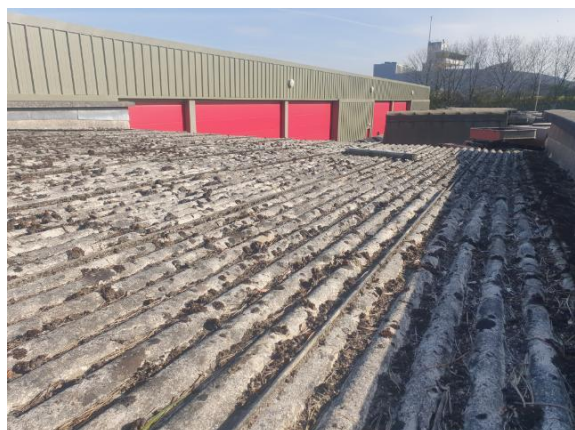
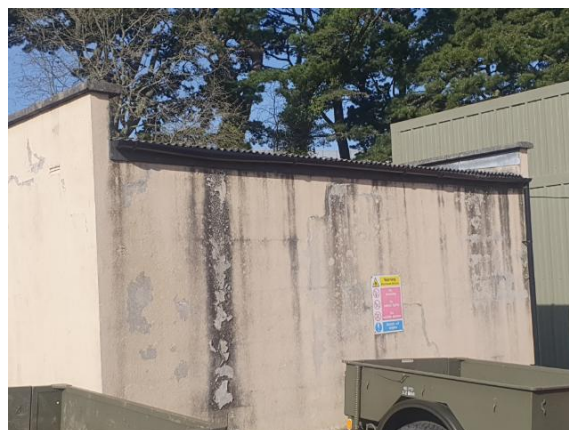
**Location:** External - POL Store 024

<b>Material Description:</b>	Profiled Roof - Cement Product	
<b>Identification:</b>	Previously Sampled - Asbestos Detected	
<b>Approx. quantity:</b>	30 m <sup>2</sup>	
<b>Accessibility</b>	Difficult	<i>Assessment Score</i>
<b>Product type:</b>	Cement	1
<b>Extent of Damage:</b>	Slight / minor damage	1
<b>Surface Treatment:</b>	Unsealed Cement	1
<b>Asbestos type:</b>	Chrysotile	1
<b>Material Assessment Score:</b>		4
<b>Priority Assessment Score:</b>		Negligible
<b>Action:</b>	Manage	
<b>Comments:</b>	Previously sampled ref: Armour 23/10/19 - Sample DK/12

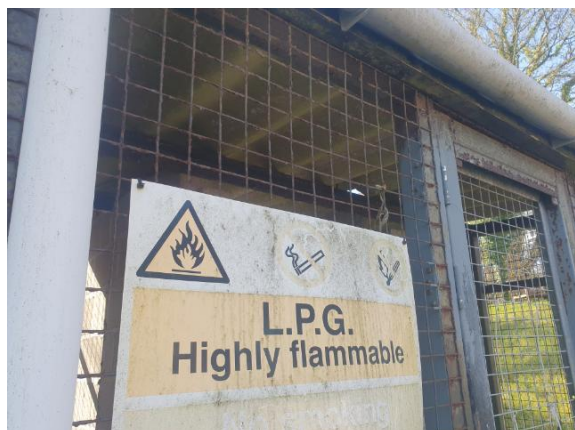
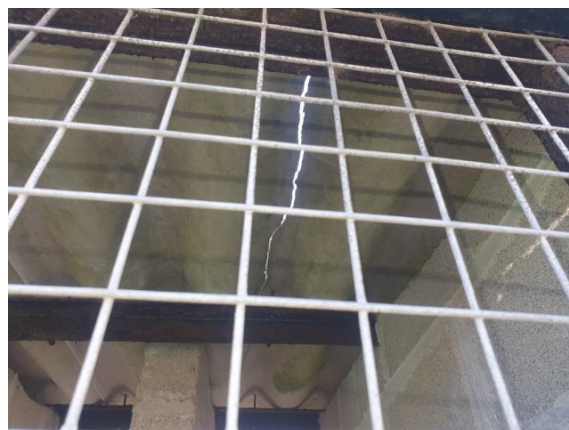
**Location:** External - LPG Store 025

<b>Material Description:</b>	Profiled Roof - Cement Product	
<b>Identification:</b>	Previously Sampled - Asbestos Detected	
<b>Approx. quantity:</b>	12 m <sup>2</sup>	
<b>Accessibility</b>	Difficult	Assessment Score
<b>Product type:</b>	Cement	1
<b>Extent of Damage:</b>	Moderate damage	2
<b>Surface Treatment:</b>	Unsealed Cement	1
<b>Asbestos type:</b>	Chrysotile	1
<b>Material Assessment Score:</b>		5
<b>Priority Assessment Score:</b>		Low
<b>Action:</b>	Manage	
<b>Comments:</b>	Previously sampled ref: Armour 23/10/19 - Sample DK/13. Large crack in one sheet

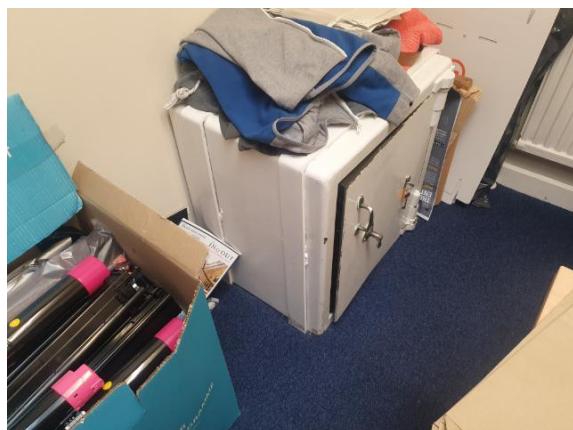
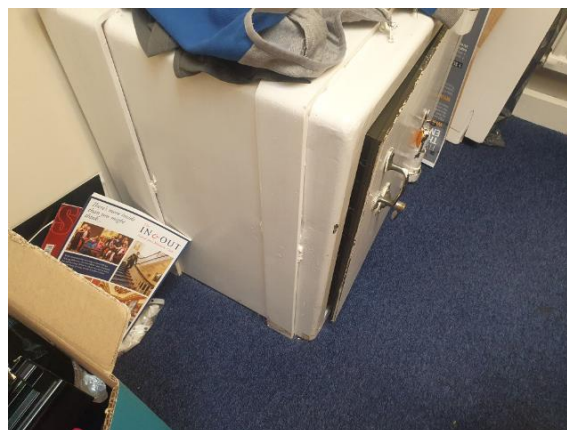
**Location:** First Floor - Office 026

<b>Material Description:</b>	Safe - Insulating Board	
<b>Identification:</b>	Presumed to Contain Asbestos	
<b>Approx. quantity:</b>	1 no	
<b>Accessibility</b>	Difficult	<i>Assessment Score</i>
<b>Product type:</b>	Asbestos Insulating Board	2
<b>Extent of Damage:</b>	Low damage	1
<b>Surface Treatment:</b>	Unsealed AIB	2
<b>Asbestos type:</b>	Amosite, Chrysotile	2
<b>Material Assessment Score:</b>		7
<b>Priority Assessment Score:</b>		Medium
<b>Action:</b>	Manage	
<b>Comments:</b>	No access within safe casings without damaging safe

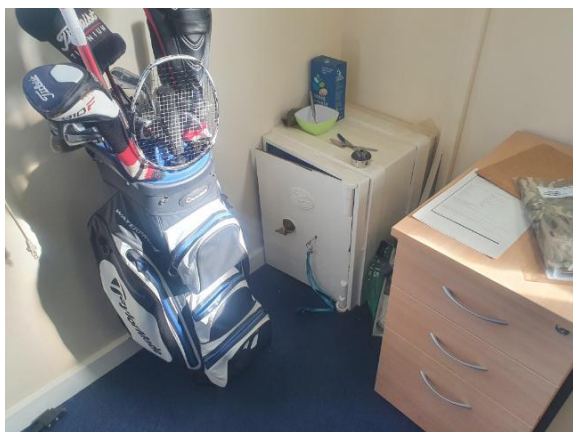
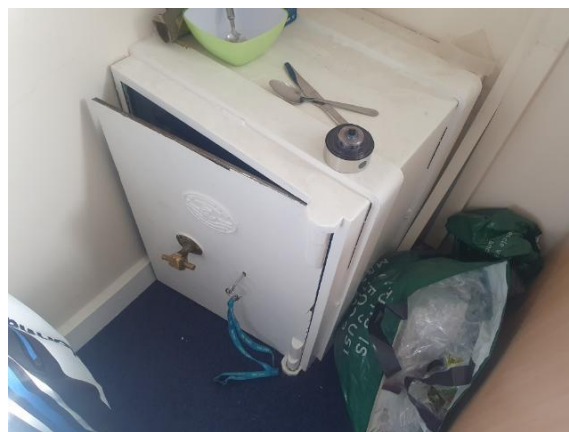
**Location:** Ground Floor - Office 027

<b>Material Description:</b>	Safe - Insulating Board	
<b>Identification:</b>	Presumed to Contain Asbestos	
<b>Approx. quantity:</b>	1 no	
<b>Accessibility</b>	Difficult	<i>Assessment Score</i>
<b>Product type:</b>	Asbestos Insulating Board	2
<b>Extent of Damage:</b>	Low damage	1
<b>Surface Treatment:</b>	Unsealed AIB	2
<b>Asbestos type:</b>	Amosite, Chrysotile	2
<b>Material Assessment Score:</b>		7
<b>Priority Assessment Score:</b>		Medium
<b>Action:</b>	Manage	
<b>Comments:</b>	No access within safe casings without damaging safe

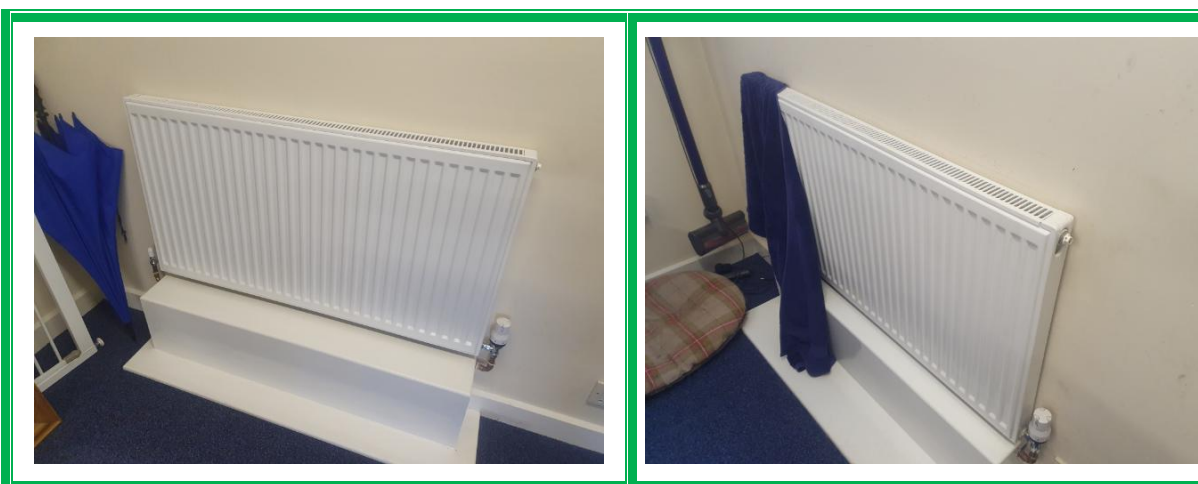
<b>Item No:</b>	<b>2</b>	<b>Sample No:</b>	<b>N/A</b>
<b>Location:</b>	First Floor - Office 002

<b>Material Description:</b>	No Suspect Materials Found	
<b>Identification:</b>	N/A	
<b>Approx. quantity:</b>	N/A	
<b>Accessibility</b>	N/A	<i>Assessment Score</i>
<b>Product type:</b>	N/A	N/A
<b>Extent of Damage:</b>	N/A	N/A
<b>Surface Treatment:</b>	N/A	N/A
<b>Asbestos type:</b>	N/A	N/A
<b>Material Assessment Score:</b>		N/A
<b>Priority Assessment Score:</b>		N/A
<b>Action:</b>	N/A	
<b>Comments:</b>	Heaters replaced with radiators

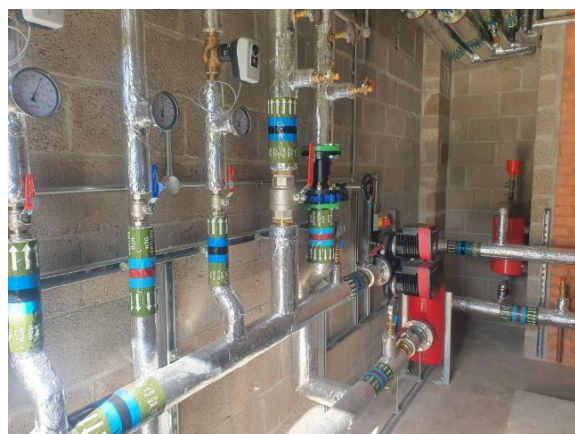
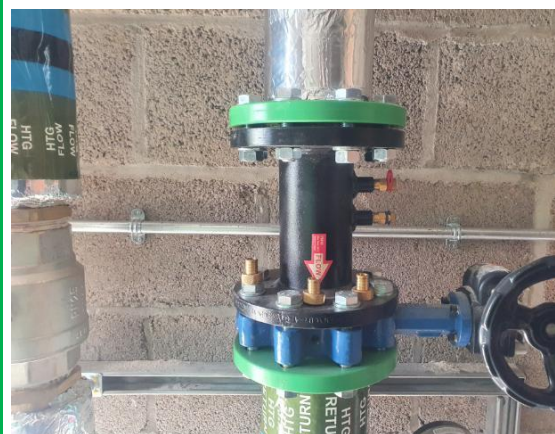
**Location:** Basement - Boiler Room 014

<b>Material Description:</b>	No Suspect Materials Found	
<b>Identification:</b>	N/A	
<b>Approx. quantity:</b>	N/A	
<b>Accessibility</b>	N/A	<i>Assessment Score</i>
<b>Product type:</b>	N/A	N/A
<b>Extent of Damage:</b>	N/A	N/A
<b>Surface Treatment:</b>	N/A	N/A
<b>Asbestos type:</b>	N/A	N/A
<b>Material Assessment Score:</b>		N/A
<b>Priority Assessment Score:</b>		N/A
<b>Action:</b>	N/A	
<b>Comments:</b>	All old gaskets removed and replaced with modern gaskets

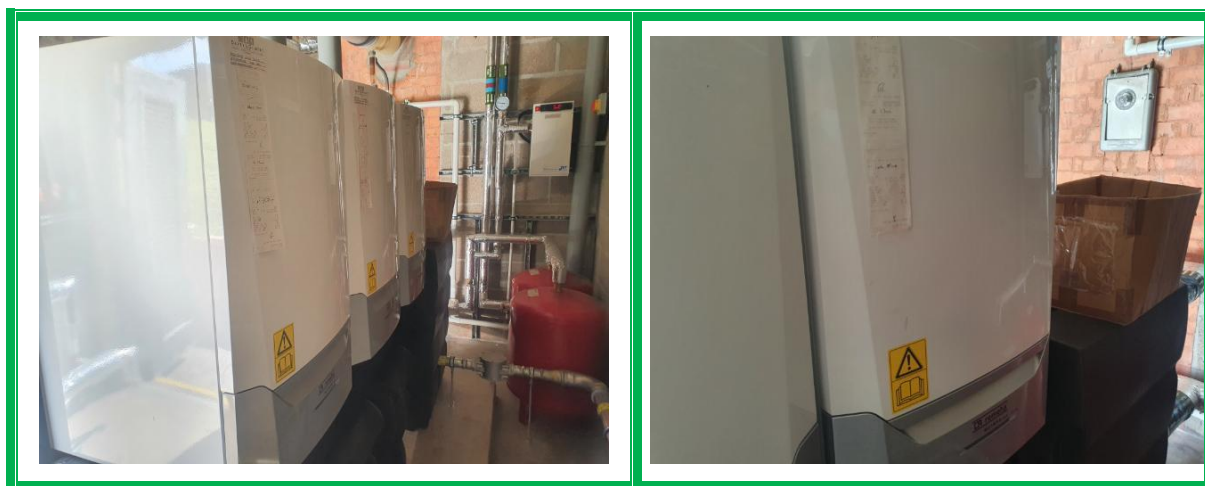
**Location:** Basement - Boiler Room 015

<b>Material Description:</b>	No Suspect Materials Found	
<b>Identification:</b>	N/A	
<b>Approx. quantity:</b>	N/A	
<b>Accessibility</b>	N/A	<i>Assessment Score</i>
<b>Product type:</b>	N/A	N/A
<b>Extent of Damage:</b>	N/A	N/A
<b>Surface Treatment:</b>	N/A	N/A
<b>Asbestos type:</b>	N/A	N/A
<b>Material Assessment Score:</b>		N/A
<b>Priority Assessment Score:</b>		N/A
<b>Action:</b>	N/A	
<b>Comments:</b>	Boilers replaced with modern boilers

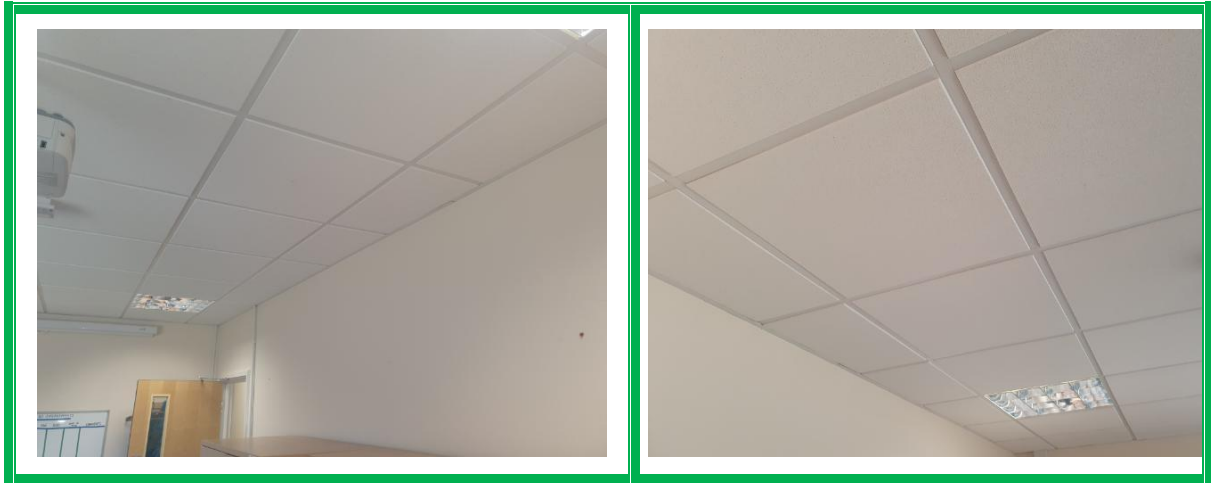
<b>Item No:</b>	<b>17</b>	<b>Sample No:</b>	<b>N/A</b>
<b>Location:</b>	Basement - Offices x 2, Sports and Silver Stores 017

<b>Material Description:</b>	No Suspect Materials Found	
<b>Identification:</b>	N/A	
<b>Approx. quantity:</b>	N/A	
<b>Accessibility</b>	N/A	<i>Assessment Score</i>
<b>Product type:</b>	N/A	N/A
<b>Extent of Damage:</b>	N/A	N/A
<b>Surface Treatment:</b>	N/A	N/A
<b>Asbestos type:</b>	N/A	N/A
<b>Material Assessment Score:</b>		N/A
<b>Priority Assessment Score:</b>		N/A
<b>Action:</b>	N/A	
<b>Comments:</b>	Non asbestos pipework in ceiling void. Plastic pipes in timber boxings

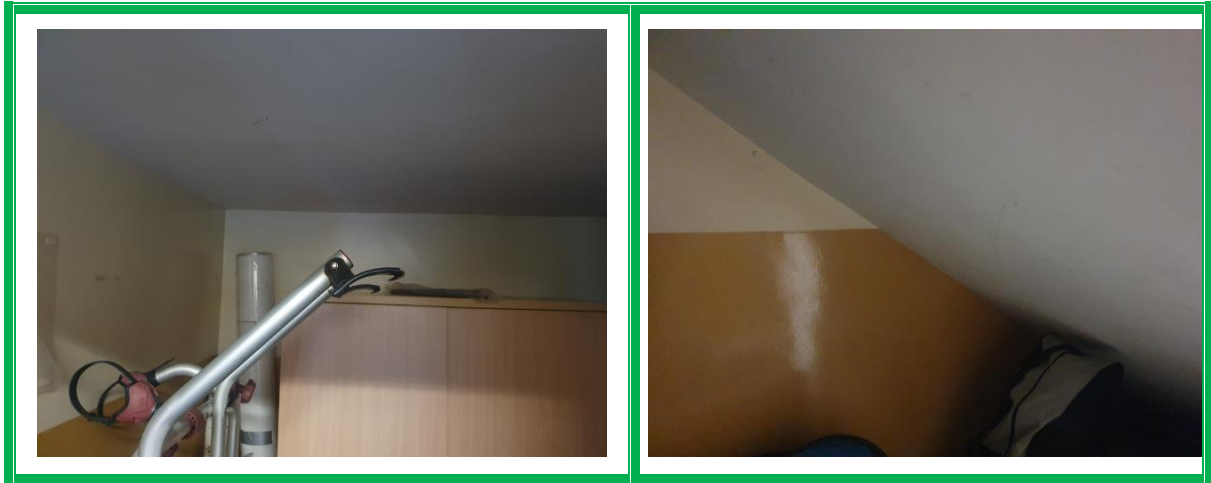
**Location:** Ground Floor - Understairs Cupboard 018

<b>Material Description:</b>	No Suspect Materials Found	
<b>Identification:</b>	N/A	
<b>Approx. quantity:</b>	N/A	
<b>Accessibility</b>	N/A	<i>Assessment Score</i>
<b>Product type:</b>	N/A	N/A
<b>Extent of Damage:</b>	N/A	N/A
<b>Surface Treatment:</b>	N/A	N/A
<b>Asbestos type:</b>	N/A	N/A
<b>Material Assessment Score:</b>		N/A
<b>Priority Assessment Score:</b>		N/A
<b>Action:</b>	N/A	
<b>Comments:</b>	No access under Lino flooring

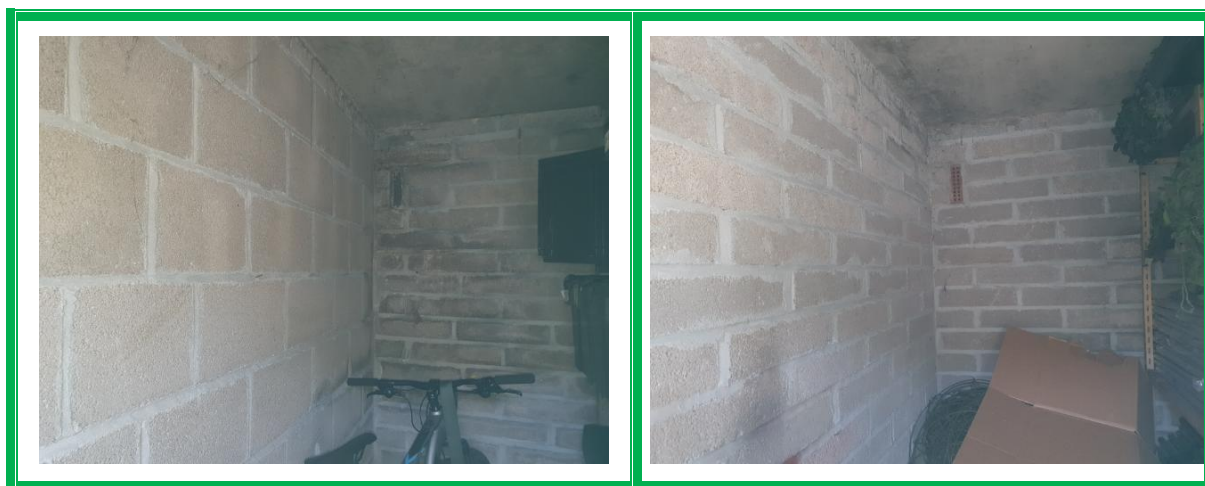
**Location:** Ground Floor - Gas Intake Stores x 2 020

<b>Material Description:</b>	No Suspect Materials Found	
<b>Identification:</b>	N/A	
<b>Approx. quantity:</b>	N/A	
<b>Accessibility</b>	N/A	<i>Assessment Score</i>
<b>Product type:</b>	N/A	N/A
<b>Extent of Damage:</b>	N/A	N/A
<b>Surface Treatment:</b>	N/A	N/A
<b>Asbestos type:</b>	N/A	N/A
<b>Material Assessment Score:</b>		N/A
<b>Priority Assessment Score:</b>		N/A
<b>Action:</b>	N/A	
<b>Comments:</b>	Previously a no access area. Now accessed and no asbestos found. Non asbestos fuses

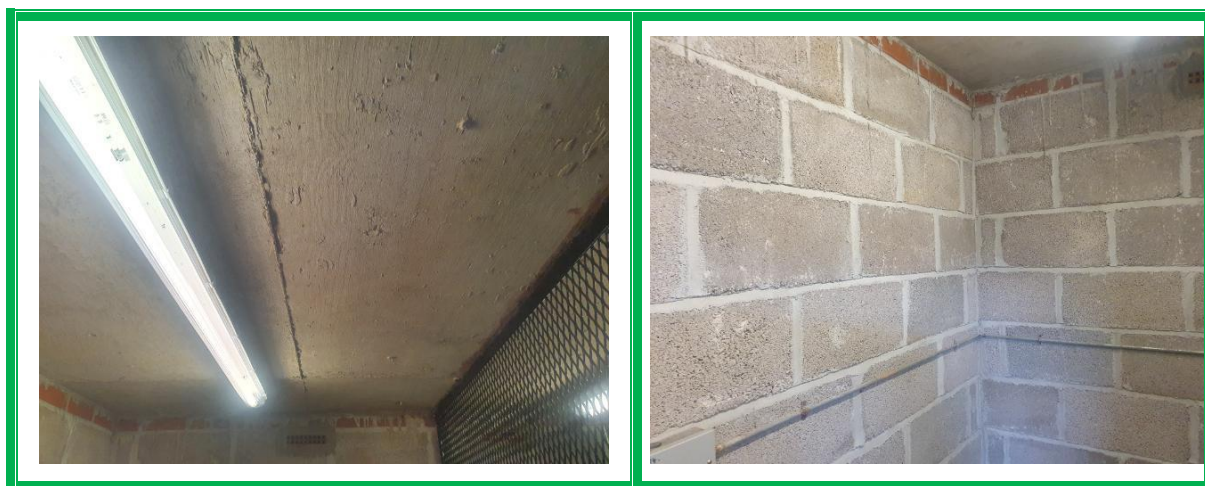
**Location:** Ground Floor - External Armoury 023

<b>Material Description:</b>	No Suspect Materials Found	
<b>Identification:</b>	N/A	
<b>Approx. quantity:</b>	N/A	
<b>Accessibility</b>	N/A	<i>Assessment Score</i>
<b>Product type:</b>	N/A	N/A
<b>Extent of Damage:</b>	N/A	N/A
<b>Surface Treatment:</b>	N/A	N/A
<b>Asbestos type:</b>	N/A	N/A
<b>Material Assessment Score:</b>		N/A
<b>Priority Assessment Score:</b>		N/A
<b>Action:</b>	N/A	
<b>Comments:</b>	Previously a no access area. Now accessed and no asbestos found

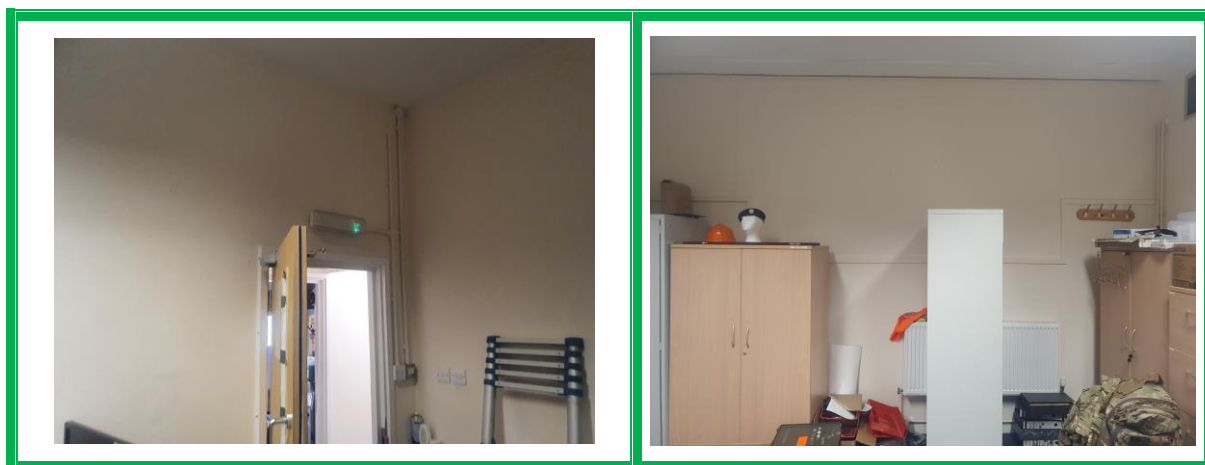
**Location:** Basement - SPSI - PSI Office 028

<b>Material Description:</b>	No Suspect Materials Found	
<b>Identification:</b>	N/A	
<b>Approx. quantity:</b>	N/A	
<b>Accessibility</b>	N/A	<i>Assessment Score</i>
<b>Product type:</b>	N/A	N/A
<b>Extent of Damage:</b>	N/A	N/A
<b>Surface Treatment:</b>	N/A	N/A
<b>Asbestos type:</b>	N/A	N/A
<b>Material Assessment Score:</b>		N/A
<b>Priority Assessment Score:</b>		N/A
<b>Action:</b>	N/A	
<b>Comments:</b>	Previously a no access area. Now accessed and no asbestos found. Non-asbestos lino under carpet, solid plasterboard and non-asbestos Fibreboard walls. Concrete ceiling. Non asbestos electric heater.
