Project Number 2481

**Management
Asbestos Survey Report**

**125 Cheltenham, Horsefair Street,
Gloucestershire, GL53 8JU**

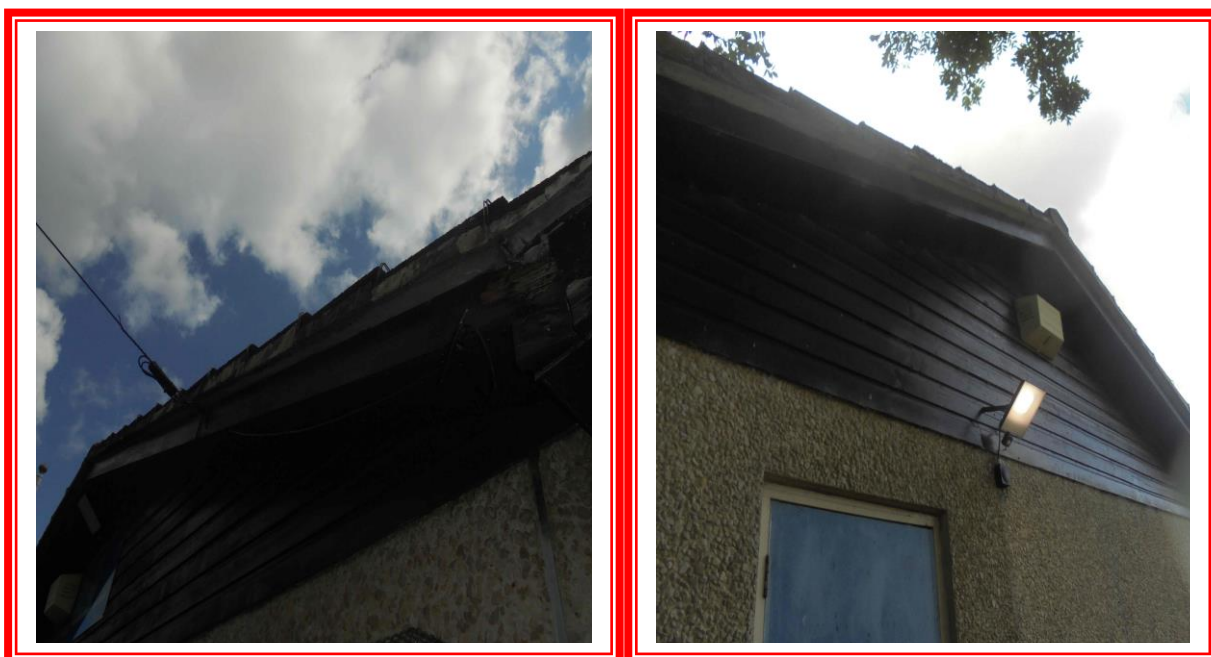
Item No: 12

Material Description:	Cement Undercloaking	
Identification:	Sampled – Asbestos Detected	
Approx. quantity:	14LM	
Accessibility	Low	<i>Assessment Score</i>
Product type:	Cement	1
Extent of Damage:	Minor	1
Surface Treatment:	Unsealed	1
Asbestos type:	Chrysotile	1
Material Assessment Score:		4
Priority Assessment Score:		Negligible
Action:	Manage	
Comments:	Located to both gables ends

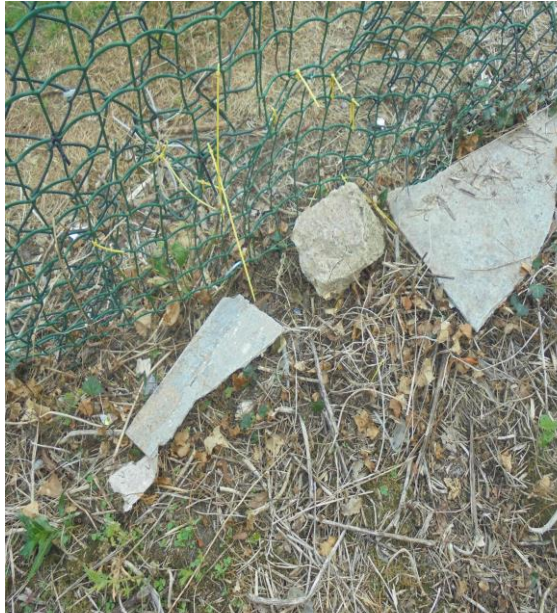
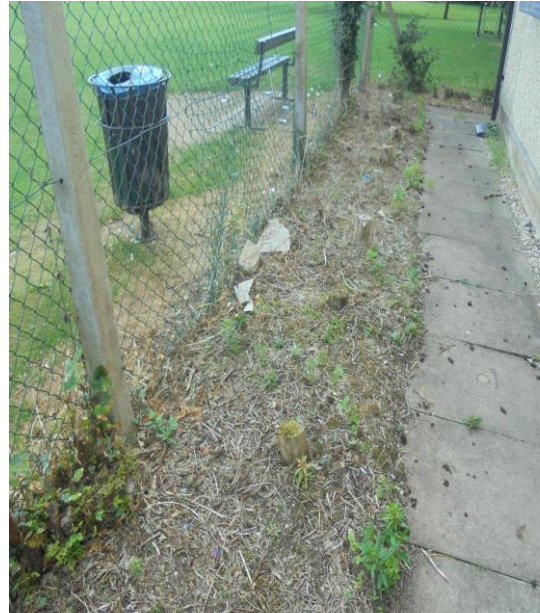
**Item No: 13****Sample No: 5****Location: External**

Material Description:	Cement Debris	
Identification:	Sampled – Asbestos Detected	
Approx. quantity:	<1M2	
Accessibility	Medium	<i>Assessment Score</i>
Product type:	Cement	1
Extent of Damage:	Moderate	2
Surface Treatment:	Unsealed	1
Asbestos type:	Chrysotile	1
Material Assessment Score:		5
Priority Assessment Score:		Low
Action:	Remove	
Comments:	Appears to have been part of the cement undercloaking (item 12) but has fallen off and is now on the floor to side of building

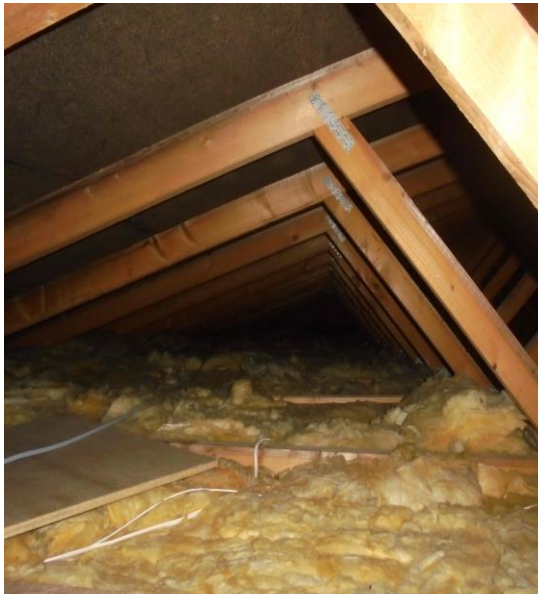
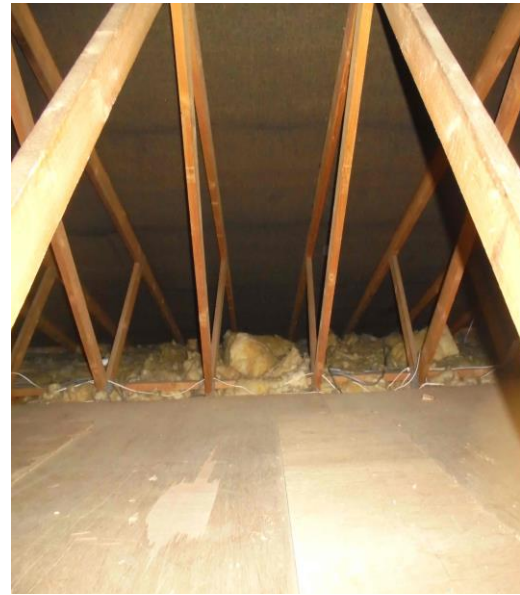
Item No: 1

Material Description:	Visual Inspection – No Suspect Materials Found	
Identification:	N/A	
Approx. quantity:	N/A	
Accessibility	N/A	<i>Assessment Score</i>
Product type:		N/A
Extent of Damage:		N/A
Surface Treatment:		N/A
Asbestos type:		N/A
Material Assessment Score:		N/A
Priority Assessment Score:		N/A
Action:	N/A	
Comments:	Modern roof felt

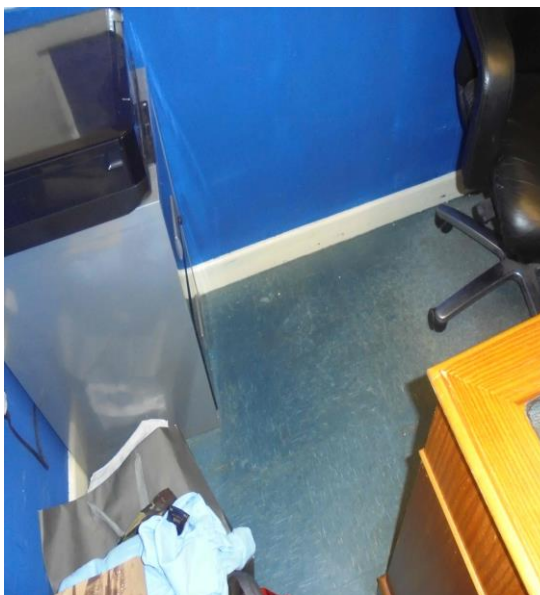
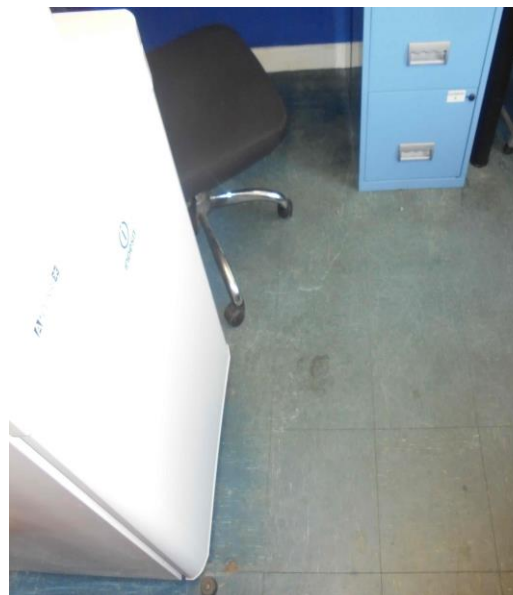
Item No: 2

Material Description:	Floor Tiles	
Identification:	Sampled – No Asbestos Detected	
Approx. quantity:	14M2	
Accessibility	N/A	<i>Assessment Score</i>
Product type:		N/A
Extent of Damage:		N/A
Surface Treatment:		N/A
Asbestos type:		N/A
Material Assessment Score:		N/A
Priority Assessment Score:		N/A
Action:	N/A	
Comments:	N/A

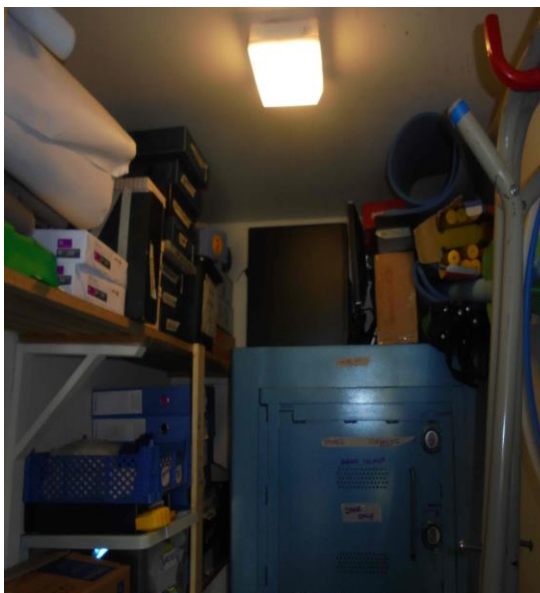
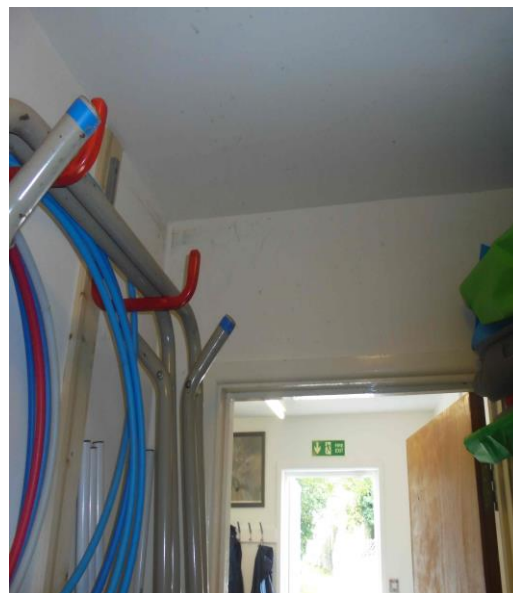
Item No: 3

Material Description:	Visual Inspection – No Suspect Materials Found	
Identification:	N/A	
Approx. quantity:	N/A	
Accessibility	N/A	<i>Assessment Score</i>
Product type:		N/A
Extent of Damage:		N/A
Surface Treatment:		N/A
Asbestos type:		N/A
Material Assessment Score:		N/A
Priority Assessment Score:		N/A
Action:	N/A	
Comments:	N/A

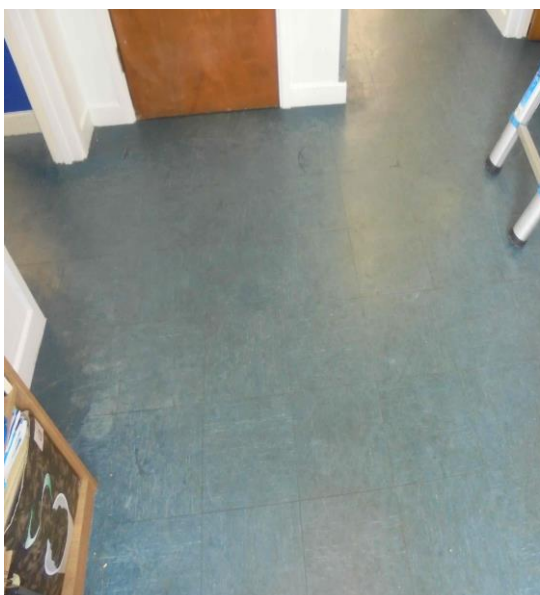
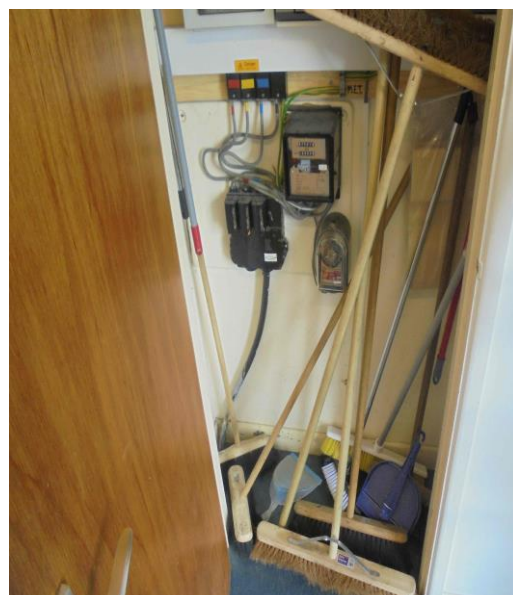
Item No: 4

Material Description:	Floor Tiles	
Identification:	As per Sample 1 – No Asbestos Detected	
Approx. quantity:	10M2	
Accessibility	N/A	<i>Assessment Score</i>
Product type:		N/A
Extent of Damage:		N/A
Surface Treatment:		N/A
Asbestos type:		N/A
Material Assessment Score:		N/A
Priority Assessment Score:		N/A
Action:	N/A	
Comments:	Modern electrics in cupboard

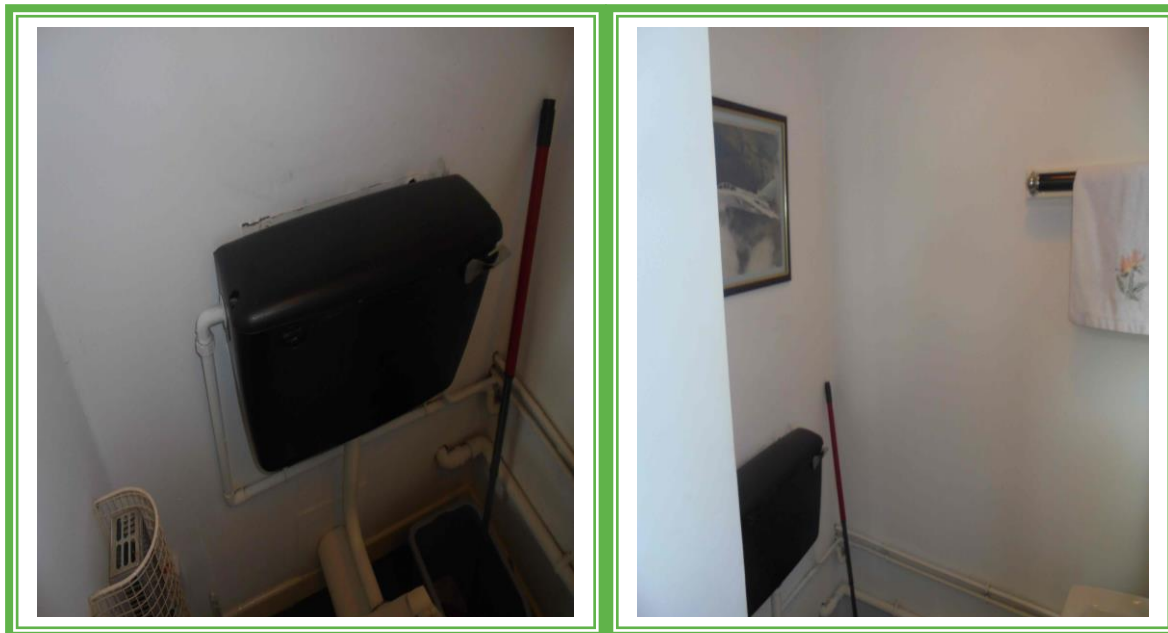
**Item No: 5****Sample No: 2****Location: Men's WC**

Material Description:	Toilet Cistern	
Identification:	Sampled – No Asbestos Detected	
Approx. quantity:	X 1	
Accessibility	N/A	<i>Assessment Score</i>
Product type:		N/A
Extent of Damage:		N/A
Surface Treatment:		N/A
Asbestos type:		N/A
Material Assessment Score:		N/A
Priority Assessment Score:		N/A
Action:	N/A	
Comments:	N/A

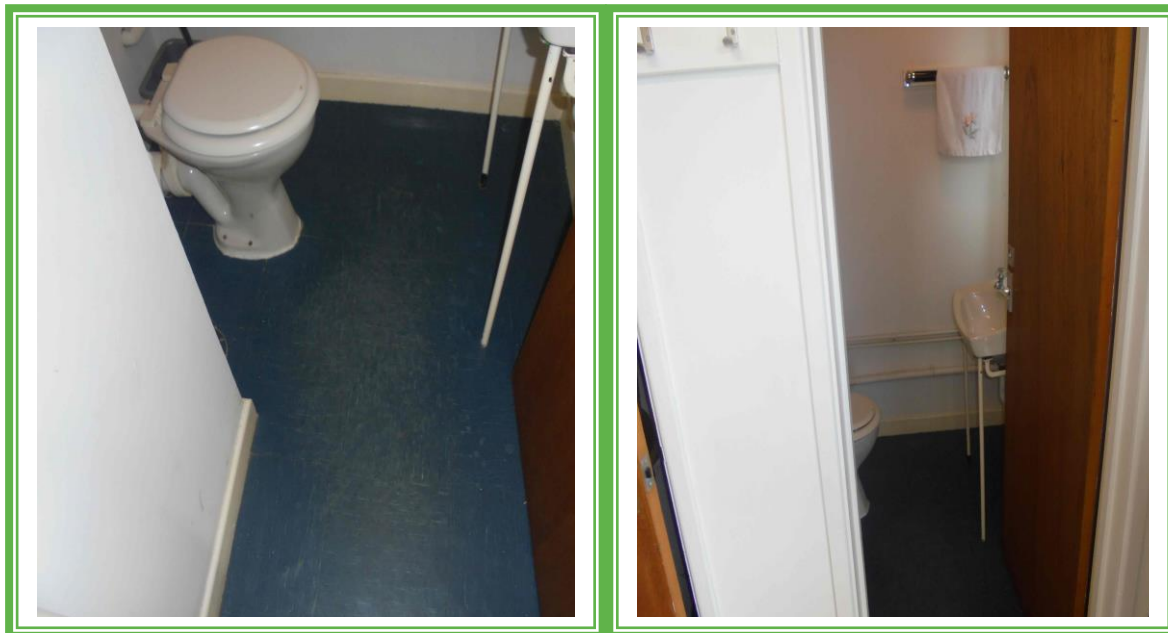
Item No: 6

Material Description:	Floor Tiles	
Identification:	As per Sample 1 – No Asbestos Detected	
Approx. quantity:	3M2	
Accessibility	N/A	<i>Assessment Score</i>
Product type:		N/A
Extent of Damage:		N/A
Surface Treatment:		N/A
Asbestos type:		N/A
Material Assessment Score:		N/A
Priority Assessment Score:		N/A
Action:	N/A	
Comments:	N/A

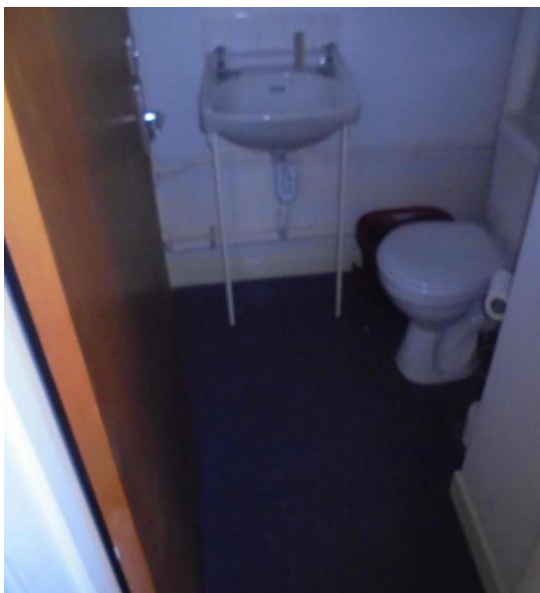
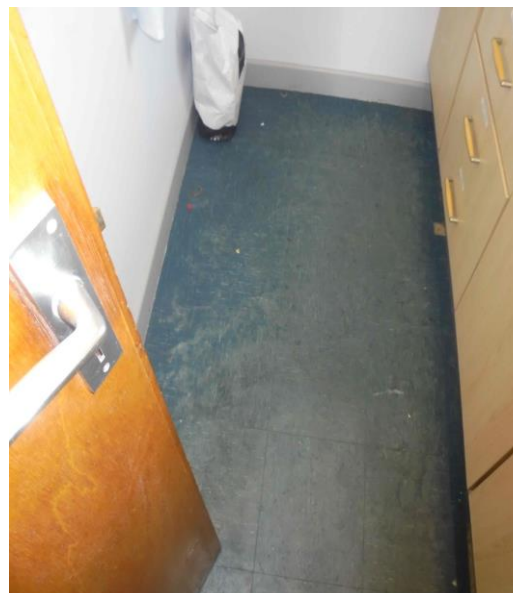
Item No: 7

Material Description:	Floor Tiles	
Identification:	As per Sample 1 – No Asbestos Detected	
Approx. quantity:	7M2	
Accessibility	N/A	<i>Assessment Score</i>
Product type:		N/A
Extent of Damage:		N/A
Surface Treatment:		N/A
Asbestos type:		N/A
Material Assessment Score:		N/A
Priority Assessment Score:		N/A
Action:	N/A	
Comments:	Modern sink pad in kitchen

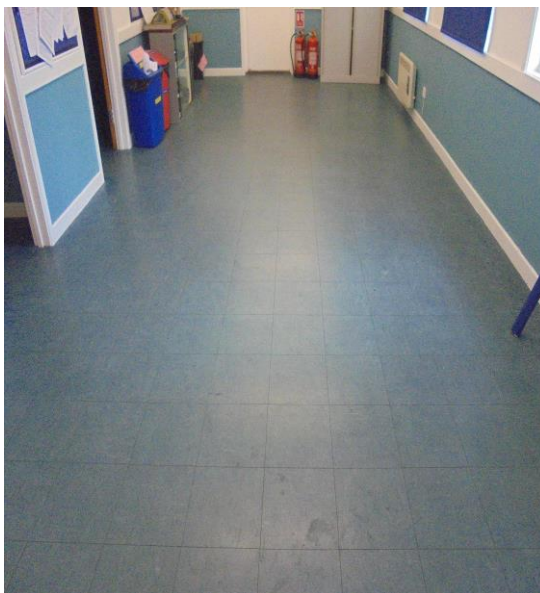
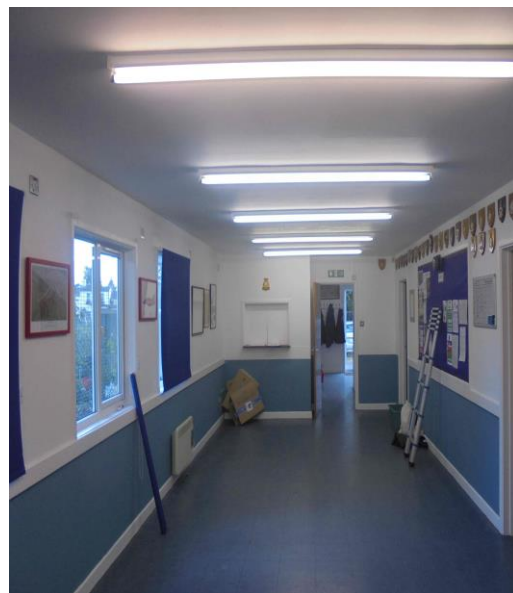
Item No: 8

Material Description:	Floor Tiles	
Identification:	As per Sample 1 – No Asbestos Detected	
Approx. quantity:	32M2	
Accessibility	N/A	<i>Assessment Score</i>
Product type:		N/A
Extent of Damage:		N/A
Surface Treatment:		N/A
Asbestos type:		N/A
Material Assessment Score:		N/A
Priority Assessment Score:		N/A
Action:	N/A	
Comments:	N/A

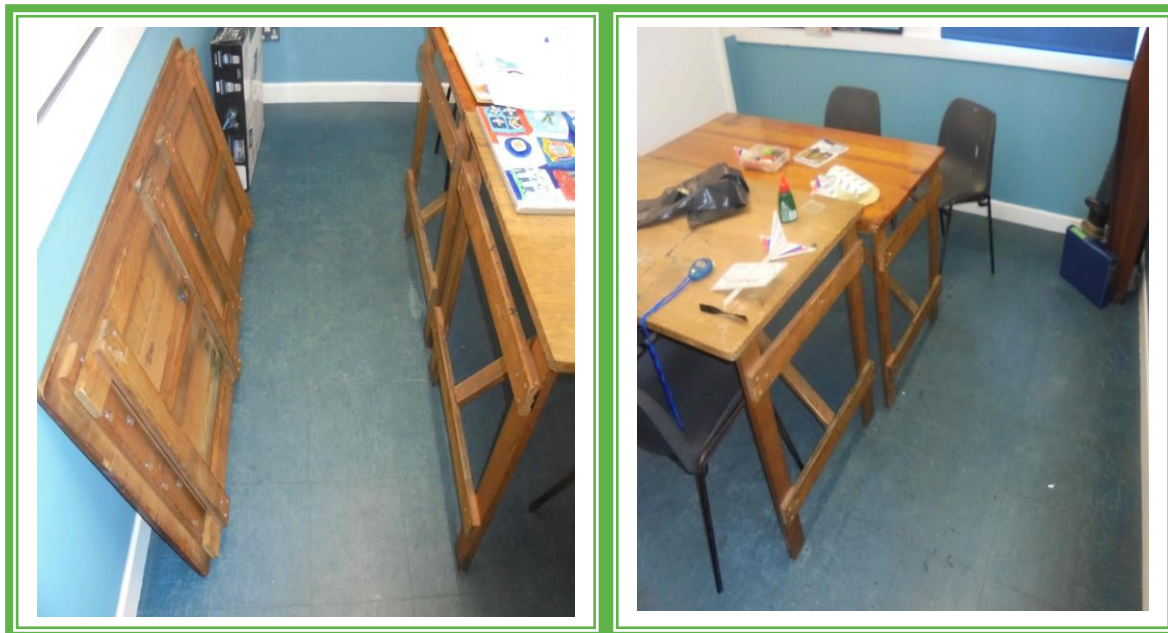
**Item No: 9****Sample No: N/A****Location: Classroom 1 & 2**

Material Description:	Floor Tiles	
Identification:	As per Sample 1 – No Asbestos Detected	
Approx. quantity:	20M2	
Accessibility	N/A	<i>Assessment Score</i>
Product type:		N/A
Extent of Damage:		N/A
Surface Treatment:		N/A
Asbestos type:		N/A
Material Assessment Score:		N/A
Priority Assessment Score:		N/A
Action:	N/A	
Comments:	N/A

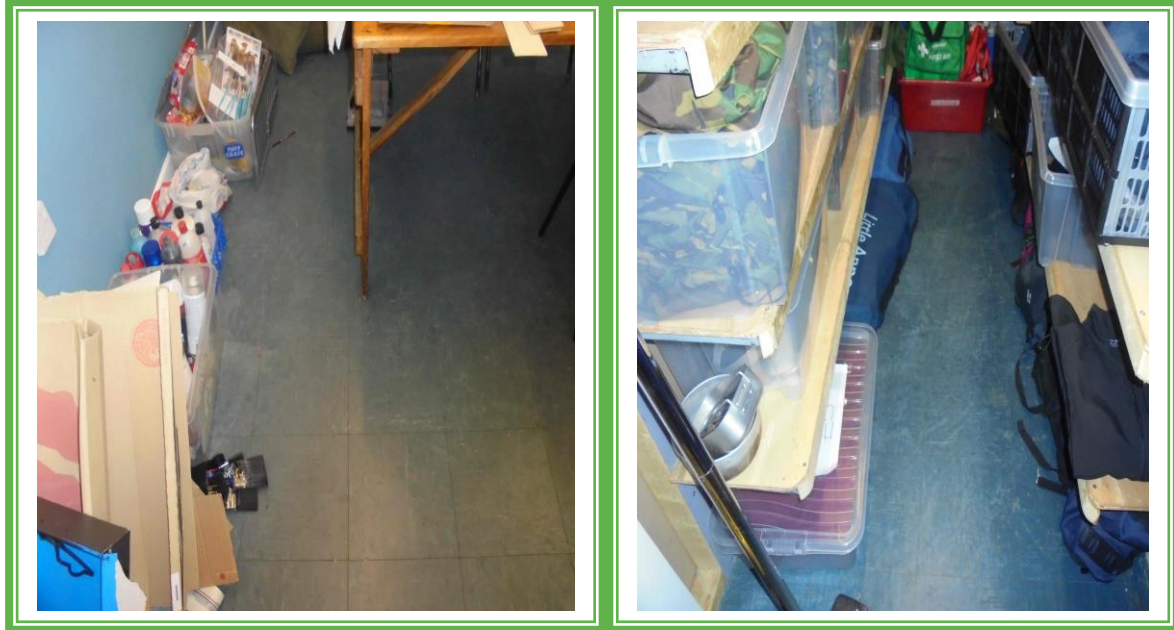
Item No: 10

Material Description:	Floor Tiles	
Identification:	As per Sample 1 – No Asbestos Detected	
Approx. quantity:	14M2	
Accessibility	N/A	<i>Assessment Score</i>
Product type:		N/A
Extent of Damage:		N/A
Surface Treatment:		N/A
Asbestos type:		N/A
Material Assessment Score:		N/A
Priority Assessment Score:		N/A
Action:	N/A	
Comments:	N/A

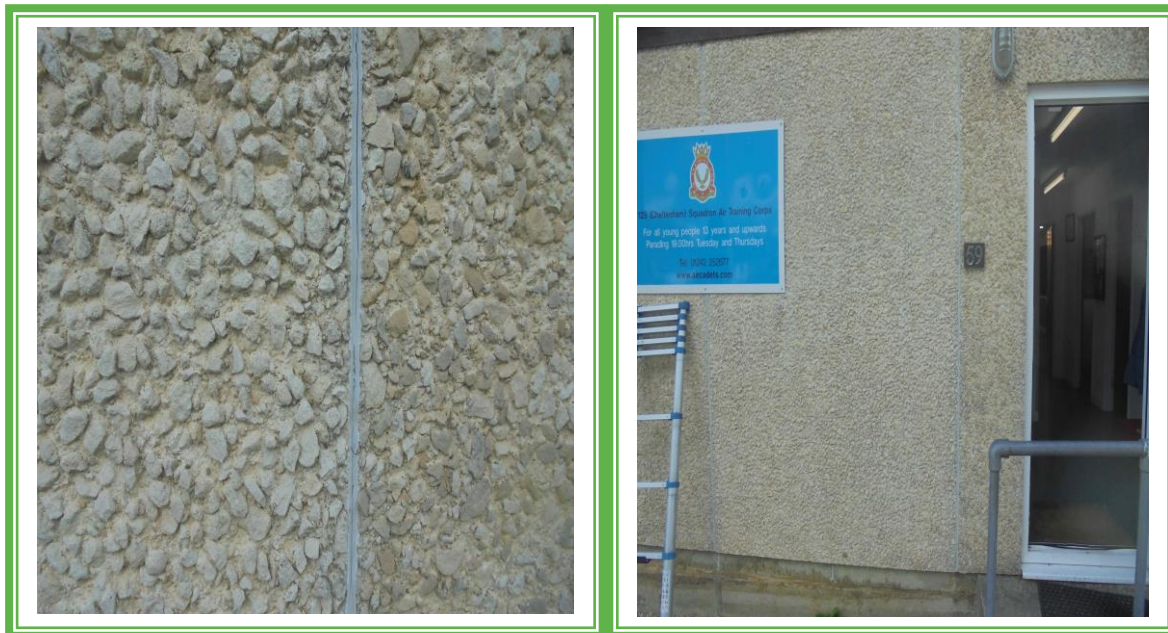
Item No: 11

Material Description:	Putty Between concrete Wall Panelling	
Identification:	Sampled – No Asbestos Detected	
Approx. quantity:	100LM	
Accessibility	N/A	<i>Assessment Score</i>
Product type:		N/A
Extent of Damage:		N/A
Surface Treatment:		N/A
Asbestos type:		N/A
Material Assessment Score:		N/A
Priority Assessment Score:		N/A
Action:	N/A	
Comments:	N/A
