**Project Number A-00397 (3700)**

**Re-Inspection  
Asbestos Survey Report - Revised**

**Royal Wessex Yeomanry D  
Oakleigh Road  
Devon  
EX32 8JT**

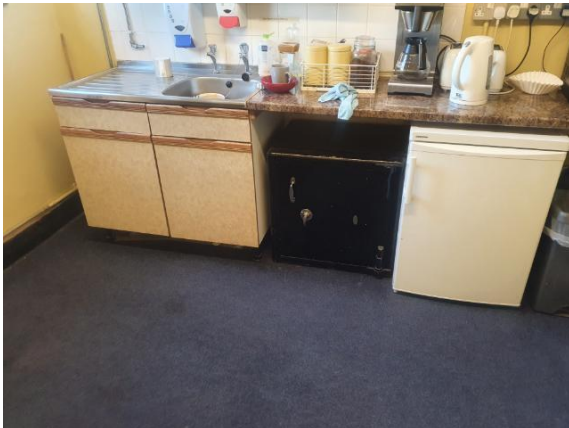
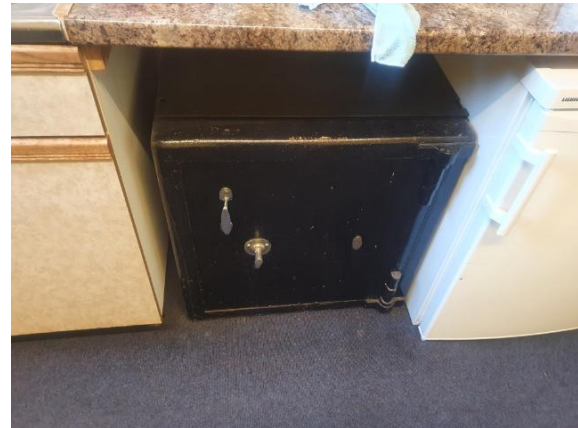
<b>Item No:</b>	<b>1</b>	<b>Sample No:</b>	<b>N/A</b>
<b>Location:</b>	First Floor - Staff Kitchen 001

<b>Material Description:</b>	Safe - No Access Gained	
<b>Identification:</b>	Presumed to Contain Asbestos	
<b>Approx. quantity:</b>	1 no	
<b>Accessibility</b>	Difficult	<i>Assessment Score</i>
<b>Product type:</b>	Asbestos insulating board	2
<b>Extent of Damage:</b>	Major damage	3
<b>Surface Treatment:</b>	Unsealed AIB	2
<b>Asbestos type:</b>	Amosite, Chrysotile	2
<b>Material Assessment Score:</b>		9
<b>Priority Assessment Score:</b>		Medium
<b>Action:</b>	Manage	
<b>Comments:</b>	No access within safe casing without damaging safe

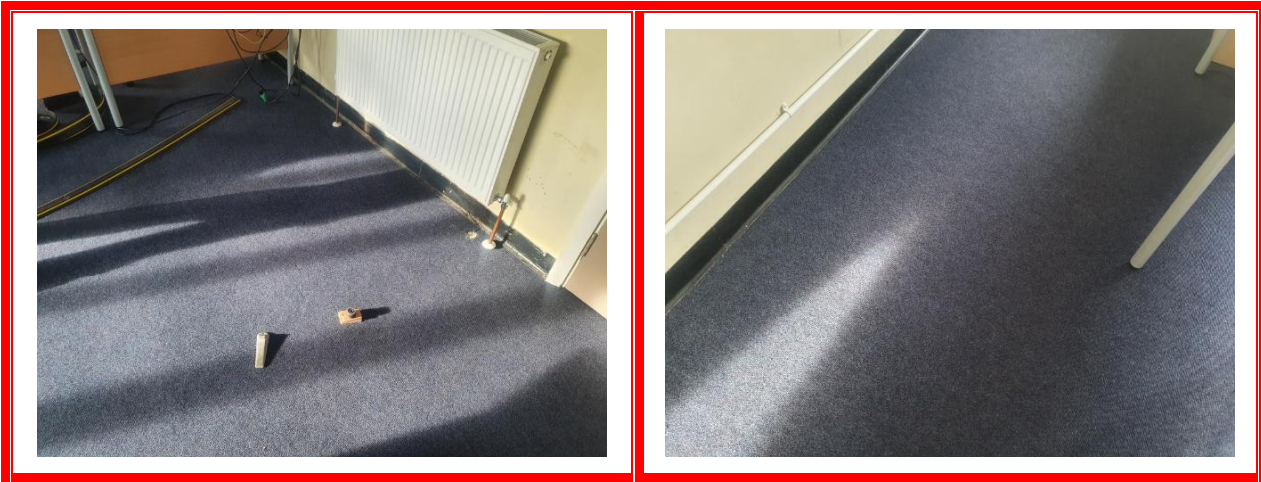
<b>Item No:</b>	<b>2</b>	<b>Sample No:</b>	<b>N/A</b>
<b>Location:</b>	First Floor - Lecture Room 002

<b>Material Description:</b>	Floor Tiles & Adhesive - Vinyl Products	
<b>Identification:</b>	Previously Sampled - Asbestos Detected	
<b>Approx. quantity:</b>	66 m <sup>2</sup>	
<b>Accessibility</b>	Difficult	<i>Assessment Score</i>
<b>Product type:</b>	Vinyl	1
<b>Extent of Damage:</b>	Slight / minor damage	1
<b>Surface Treatment:</b>	Non-friable	0
<b>Asbestos type:</b>	Chrysotile	1
<b>Material Assessment Score:</b>		3
<b>Priority Assessment Score:</b>		Negligible
<b>Action:</b>	Manage	
<b>Comments:</b>	Under carpet. Previously sampled ref: Armour 17/10/19 Sample DK/2

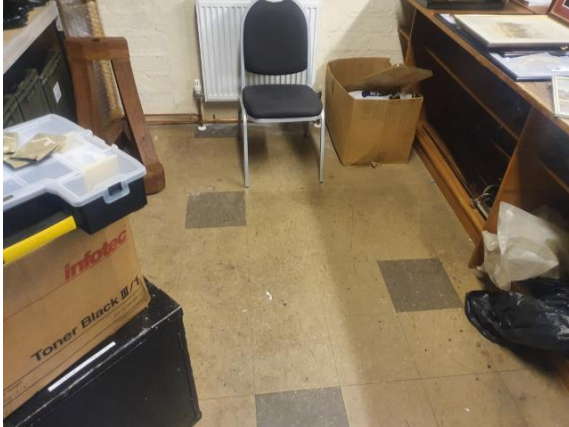
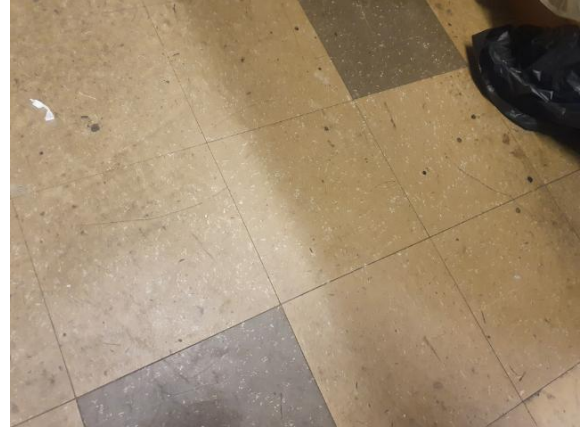
<b>Item No:</b>	<b>3</b>	<b>Sample No:</b>	<b>N/A</b>
<b>Location:</b>	First Floor - Armoury Store 003

<b>Material Description:</b>	Floor Tiles & Adhesive - Vinyl Products	
<b>Identification:</b>	Previously Sampled - Asbestos Detected	
<b>Approx. quantity:</b>	20 m <sup>2</sup>	
<b>Accessibility</b>	Easy	<i>Assessment Score</i>
<b>Product type:</b>	Vinyl	1
<b>Extent of Damage:</b>	Slight / minor damage	1
<b>Surface Treatment:</b>	Non-friable	0
<b>Asbestos type:</b>	Chrysotile	1
<b>Material Assessment Score:</b>		3
<b>Priority Assessment Score:</b>		Negligible
<b>Action:</b>	Manage	
<b>Comments:</b>	Previously sampled ref: Armour 17/10/19 Sample DK/3

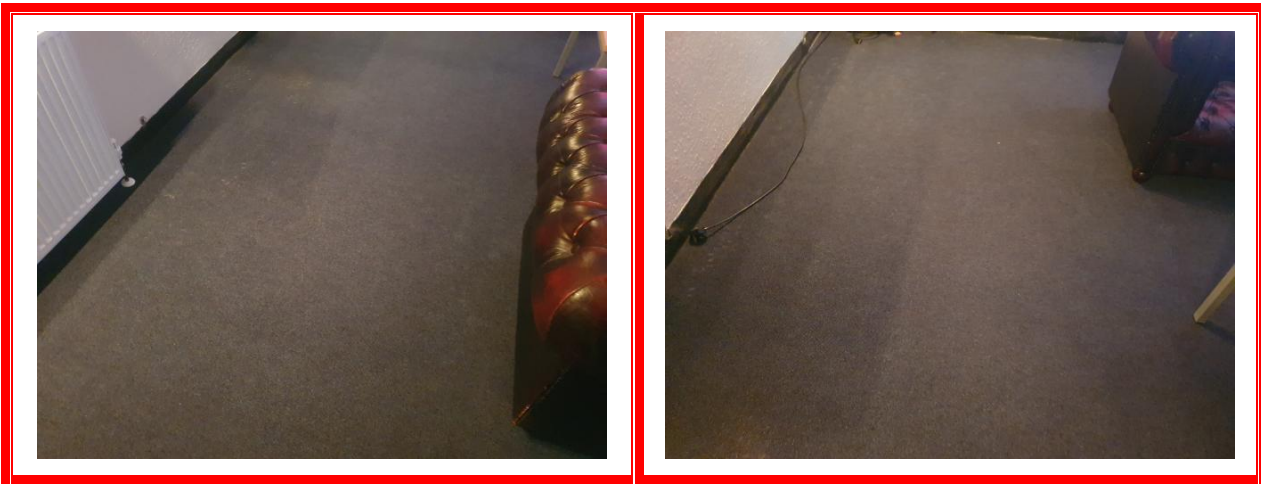
<b>Item No:</b>	<b>4</b>	<b>Sample No:</b>	<b>N/A</b>
<b>Location:</b>	First Floor - Bar Extension 004

<b>Material Description:</b>	Floor Tiles & Adhesive - Vinyl Products	
<b>Identification:</b>	Previously Sampled - Asbestos Detected	
<b>Approx. quantity:</b>	24 m <sup>2</sup>	
<b>Accessibility</b>	Difficult	<i>Assessment Score</i>
<b>Product type:</b>	Vinyl	1
<b>Extent of Damage:</b>	Slight / minor damage	1
<b>Surface Treatment:</b>	Non-friable	0
<b>Asbestos type:</b>	Chrysotile	1
<b>Material Assessment Score:</b>		3
<b>Priority Assessment Score:</b>		Negligible
<b>Action:</b>	Manage	
<b>Comments:</b>	Under carpet. Previously sampled ref: Armour 17/10/19 Sample DK/5

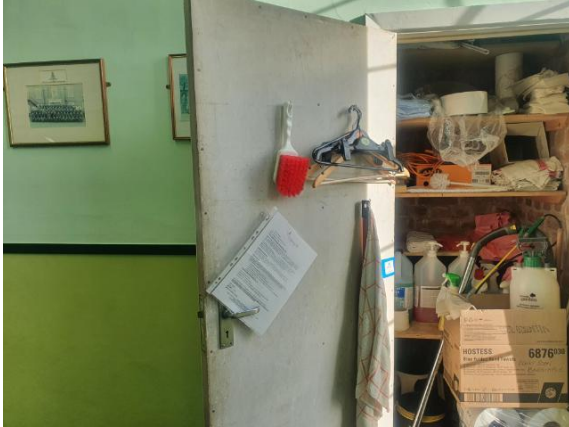
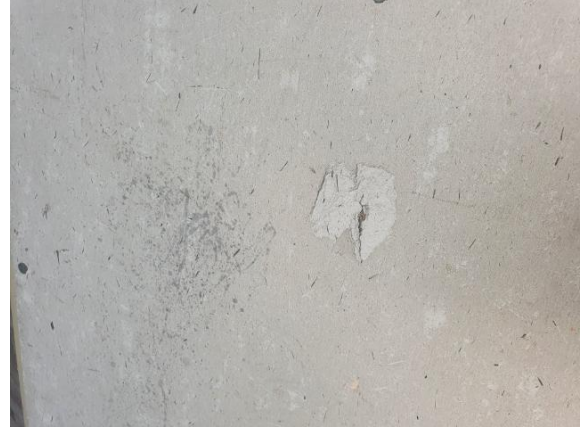
<b>Item No:</b>	<b>5</b>	<b>Sample No:</b>	<b>N/A</b>
<b>Location:</b>	First Floor - Cleaners Cupboards x 2 005

<b>Material Description:</b>	Panels to Doors - Insulating Board	
<b>Identification:</b>	Previously Sampled - Asbestos Detected	
<b>Approx. quantity:</b>	4 m <sup>2</sup>	
<b>Accessibility</b>	Easy	Assessment Score
<b>Product type:</b>	Asbestos insulating board	2
<b>Extent of Damage:</b>	Moderate damage	2
<b>Surface Treatment:</b>	Unsealed AIB	2
<b>Asbestos type:</b>	Amosite	2
<b>Material Assessment Score:</b>		8
<b>Priority Assessment Score:</b>		Medium
<b>Action:</b>	Encapsulate/Restrict Access	
<b>Comments:</b>	Several areas of damage. Restrict access to cupboards until encapsulated. Previously sampled ref: Armour 17/10/19 Sample DK/9

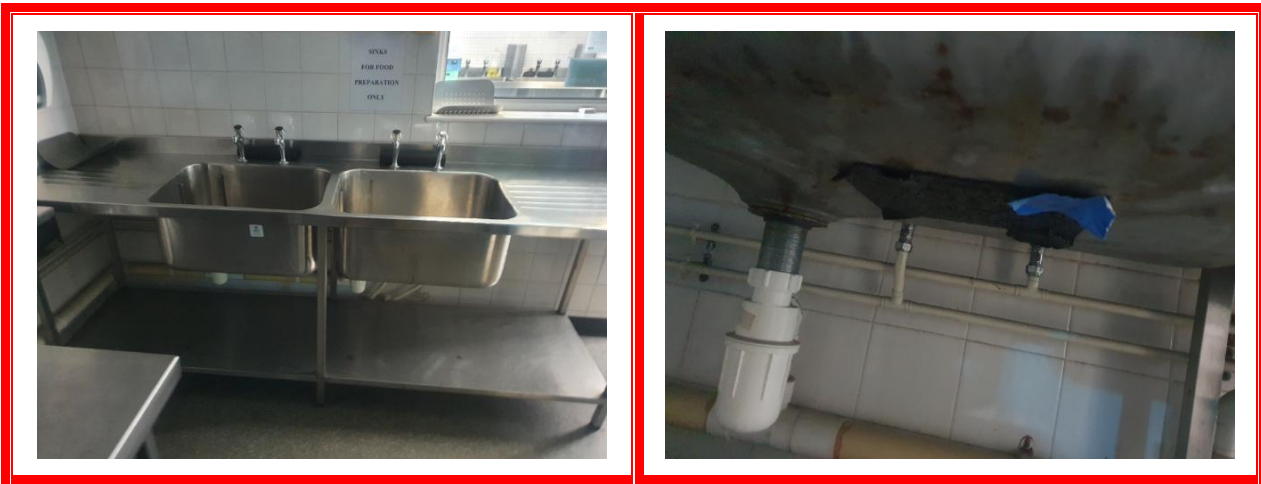
<b>Item No:</b>	<b>8</b>	<b>Sample No:</b>	<b>N/A</b>
<b>Location:</b>	Ground Floor - Kitchen 008

<b>Material Description:</b>	Sink Pad - Bituminous Product	
<b>Identification:</b>	Previously Sampled - Asbestos Detected	
<b>Approx. quantity:</b>	2 no	
<b>Accessibility</b>	Medium	Assessment Score
<b>Product type:</b>	Bitumen	1
<b>Extent of Damage:</b>	Slight / minor damage	1
<b>Surface Treatment:</b>	Non-friable	0
<b>Asbestos type:</b>	Chrysotile	1
<b>Material Assessment Score:</b>		3
<b>Priority Assessment Score:</b>		Negligible
<b>Action:</b>	Manage	
<b>Comments:</b>	Previously sampled ref: Armour 17/10/19 Sample DK/14

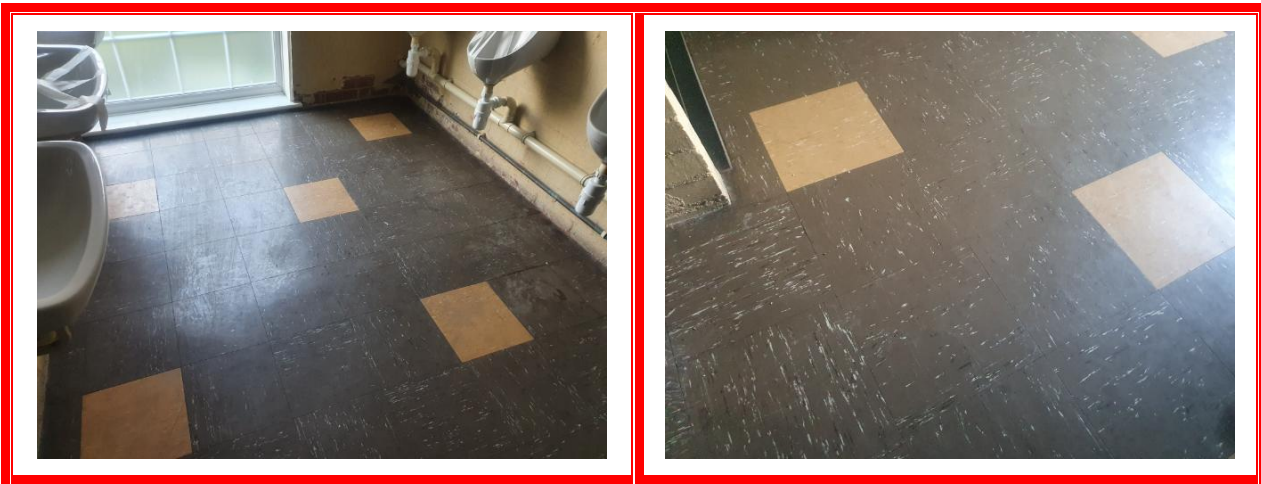
<b>Item No:</b>	<b>9</b>	<b>Sample No:</b>	<b>N/A</b>
<b>Location:</b>	Ground Floor - WC/Shower 009

<b>Material Description:</b>	Floor Tiles & Adhesive - Vinyl Products	
<b>Identification:</b>	Previously Sampled - Asbestos Detected	
<b>Approx. quantity:</b>	30 m <sup>2</sup>	
<b>Accessibility</b>	Easy	<i>Assessment Score</i>
<b>Product type:</b>	Vinyl	1
<b>Extent of Damage:</b>	Slight / minor damage	1
<b>Surface Treatment:</b>	Non-friable	0
<b>Asbestos type:</b>	Chrysotile	1
<b>Material Assessment Score:</b>		3
<b>Priority Assessment Score:</b>		Negligible
<b>Action:</b>	Manage	
<b>Comments:</b>	Previously sampled ref: Armour 17/10/19 Sample DK/17

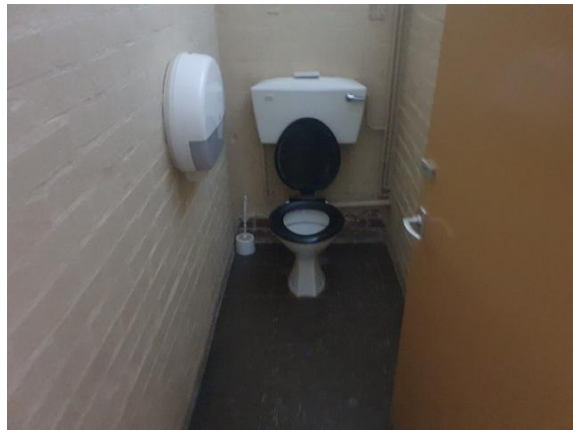
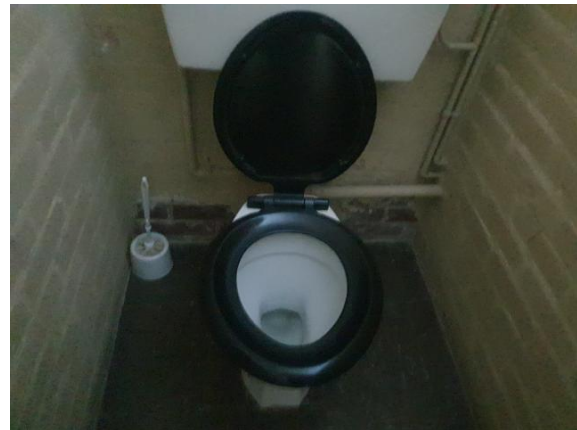
<b>Item No:</b>	<b>10</b>	<b>Sample No:</b>	<b>N/A</b>
<b>Location:</b>	Ground Floor - WC/Shower 010

<b>Material Description:</b>	Toilet Seats - PVC / Reinforced Plastics	
<b>Identification:</b>	Presumed to Contain Asbestos	
<b>Approx. quantity:</b>	2 no	
<b>Accessibility</b>	Easy	<i>Assessment Score</i>
<b>Product type:</b>	Reinforced Plastics	1
<b>Extent of Damage:</b>	Minor damage	1
<b>Surface Treatment:</b>	Non-friable	0
<b>Asbestos type:</b>	Chrysotile	1
<b>Material Assessment Score:</b>		8
<b>Priority Assessment Score:</b>		Medium
<b>Action:</b>	Manage	
<b>Comments:</b>	Not possible to sample as may damage integrity of seat

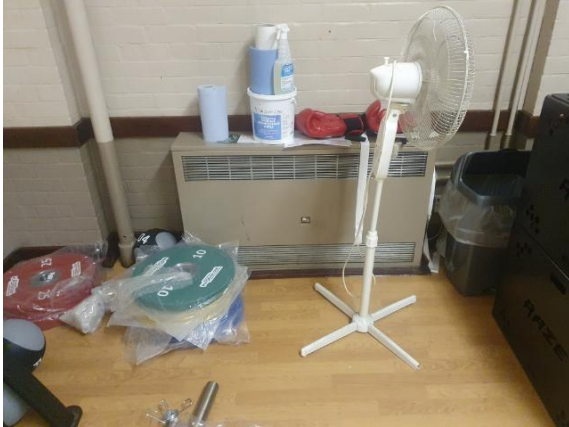
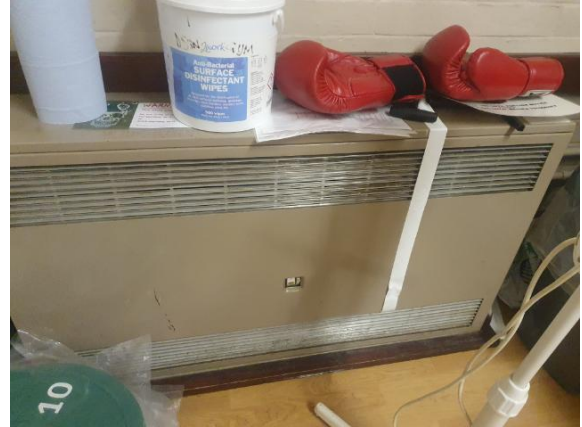
<b>Item No:</b>	<b>11</b>	<b>Sample No:</b>	<b>N/A</b>
<b>Location:</b>	Ground Floor - Gym 011

<b>Material Description:</b>	Heater - No Access Gained	
<b>Identification:</b>	Presumed to Contain Asbestos	
<b>Approx. quantity:</b>	1 no	
<b>Accessibility</b>	Difficult	<i>Assessment Score</i>
<b>Product type:</b>	Asbestos insulating board	2
<b>Extent of Damage:</b>	Major damage	3
<b>Surface Treatment:</b>	Unsealed AIB	2
<b>Asbestos type:</b>	Amosite, Chrysotile	2
<b>Material Assessment Score:</b>		9
<b>Priority Assessment Score:</b>		Medium
<b>Action:</b>	Manage	
<b>Comments:</b>	No access within live heater

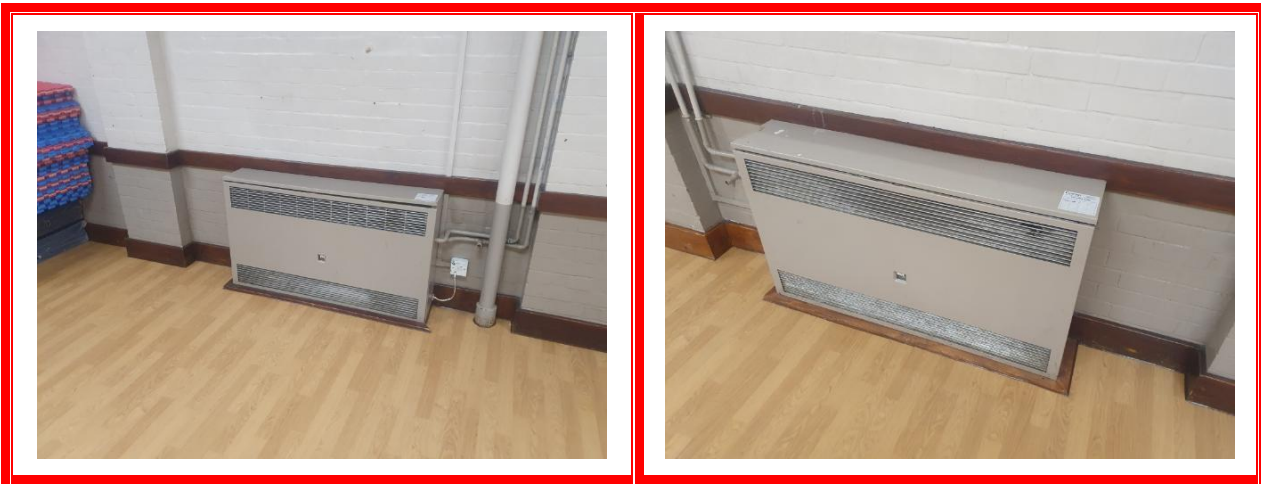
<b>Item No:</b>	<b>12</b>	<b>Sample No:</b>	<b>N/A</b>
<b>Location:</b>	Ground Floor - Drill Hall 012

<b>Material Description:</b>	Heaters - No Access Gained	
<b>Identification:</b>	Presumed to Contain Asbestos	
<b>Approx. quantity:</b>	3 no	
<b>Accessibility</b>	Difficult	<i>Assessment Score</i>
<b>Product type:</b>	Asbestos insulating board	2
<b>Extent of Damage:</b>	Major damage	3
<b>Surface Treatment:</b>	Unsealed AIB	2
<b>Asbestos type:</b>	Amosite, Chrysotile	2
<b>Material Assessment Score:</b>		9
<b>Priority Assessment Score:</b>		Medium
<b>Action:</b>	Manage	
<b>Comments:</b>	No access within live heaters

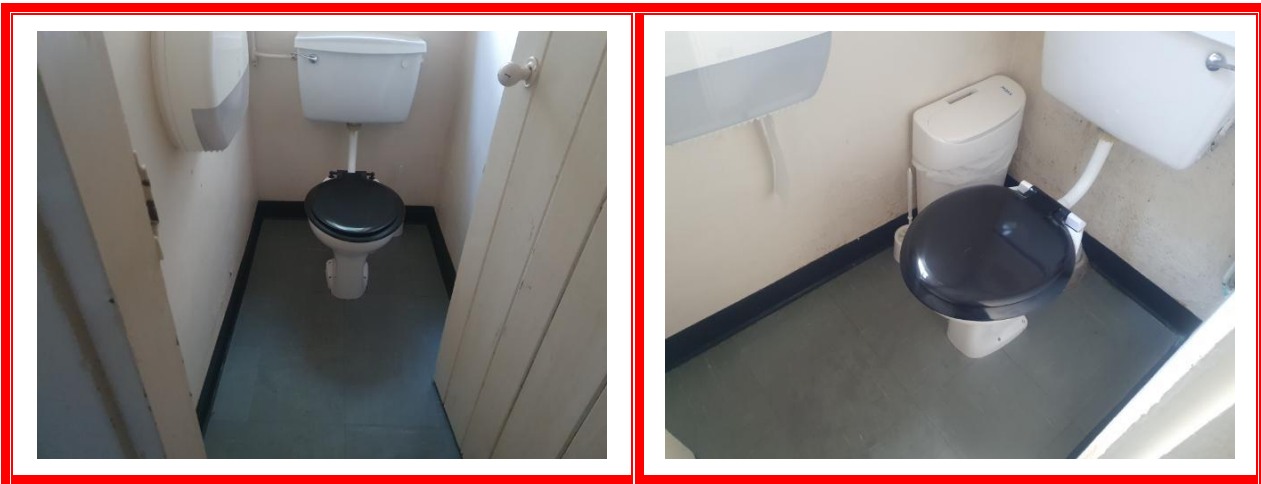
<b>Item No:</b>	<b>13</b>	<b>Sample No:</b>	<b>N/A</b>
<b>Location:</b>	Ground Floor - WC's x 2 013

<b>Material Description:</b>	Toilet Seats - PVC / Reinforced Plastics	
<b>Identification:</b>	Presumed to Contain Asbestos	
<b>Approx. quantity:</b>	2 no	
<b>Accessibility</b>	Easy	<i>Assessment Score</i>
<b>Product type:</b>	Reinforced Plastics	1
<b>Extent of Damage:</b>	Minor damage	1
<b>Surface Treatment:</b>	Non-friable	0
<b>Asbestos type:</b>	Chrysotile	1
<b>Material Assessment Score:</b>		3
<b>Priority Assessment Score:</b>		Negligible
<b>Action:</b>	Manage	
<b>Comments:</b>	Not possible to sample as may damage integrity of seat

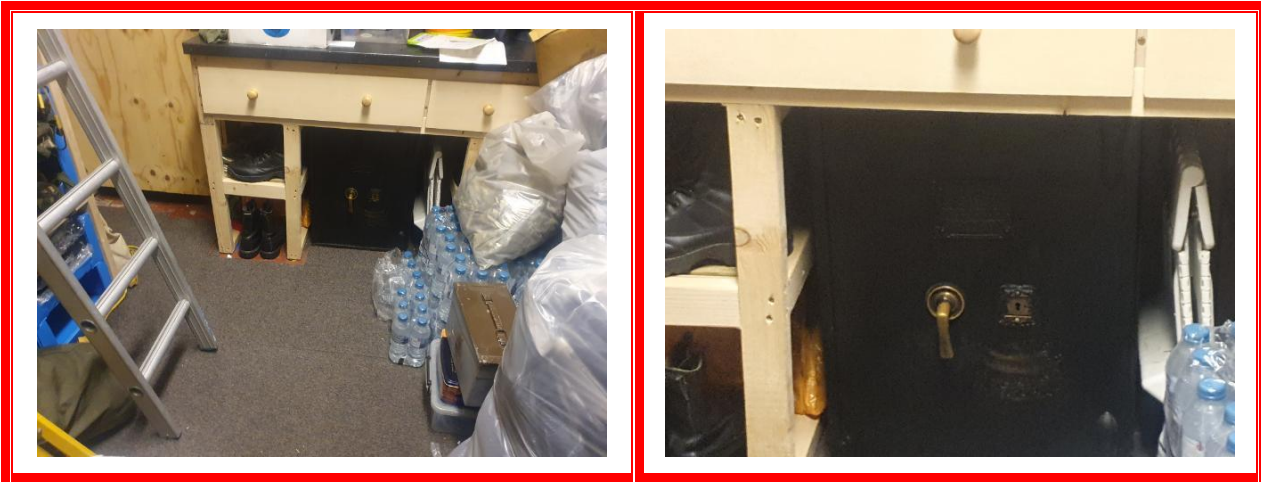
<b>Item No:</b>	<b>15</b>	<b>Sample No:</b>	<b>N/A</b>
<b>Location:</b>	Ground Floor - Store 015

<b>Material Description:</b>	Safe - No Access Gained	
<b>Identification:</b>	Presumed to Contain Asbestos	
<b>Approx. quantity:</b>	1 no	
<b>Accessibility</b>	Difficult	<i>Assessment Score</i>
<b>Product type:</b>	Asbestos insulating board	2
<b>Extent of Damage:</b>	Major damage	3
<b>Surface Treatment:</b>	Unsealed AIB	2
<b>Asbestos type:</b>	Amosite, Chrysotile	2
<b>Material Assessment Score:</b>		9
<b>Priority Assessment Score:</b>		Medium
<b>Action:</b>	Manage	
<b>Comments:</b>	No access within safe casing without damaging safe

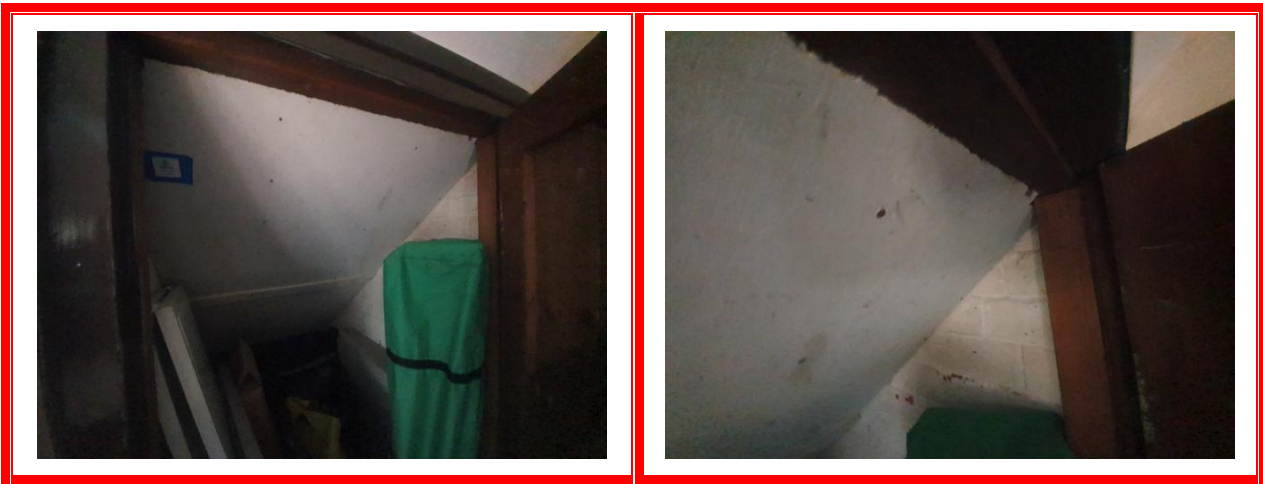
<b>Item No:</b>	<b>16</b>	<b>Sample No:</b>	<b>N/A</b>
<b>Location:</b>	Ground Floor - Classroom Cupboard 016

<b>Material Description:</b>	Ceiling - Insulating Board	
<b>Identification:</b>	Previously Sampled - Asbestos Detected	
<b>Approx. quantity:</b>	2 m <sup>2</sup>	
<b>Accessibility</b>	Easy	<i>Assessment Score</i>
<b>Product type:</b>	Asbestos insulating board	2
<b>Extent of Damage:</b>	Slight / minor damage	1
<b>Surface Treatment:</b>	Unsealed AIB	2
<b>Asbestos type:</b>	Amosite	2
<b>Material Assessment Score:</b>		7
<b>Priority Assessment Score:</b>		Medium
<b>Action:</b>	Encapsulate/Restrict Access	
<b>Comments:</b>	Frayed edges and several areas of low damage. Restrict access to cupboards until encapsulated. Previously sampled ref: Armour 17/10/19 Sample DK/20

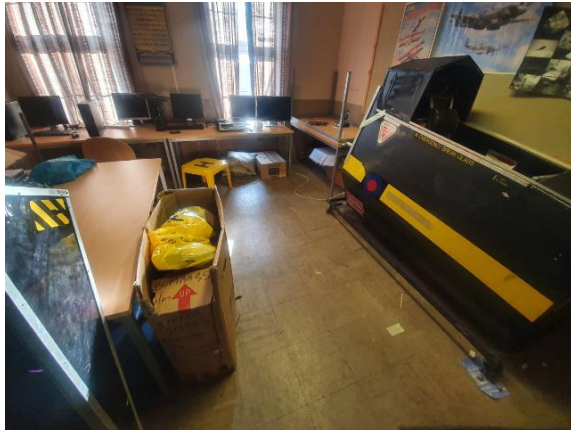
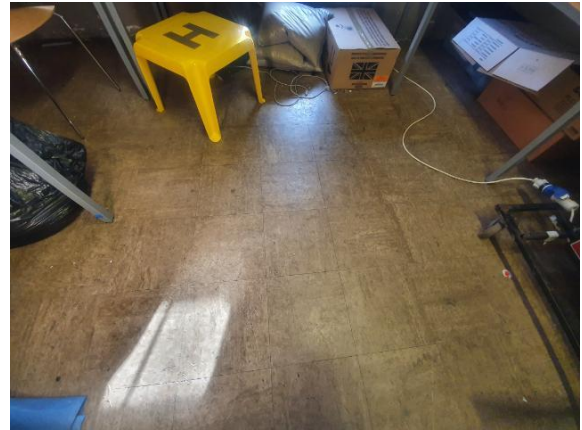
<b>Item No:</b>	<b>17</b>	<b>Sample No:</b>	<b>N/A</b>
<b>Location:</b>	Ground Floor - Lecture Room 2 017

<b>Material Description:</b>	Floor Tiles & Adhesive - Vinyl Products	
<b>Identification:</b>	Previously Sampled - Asbestos Detected	
<b>Approx. quantity:</b>	30 m <sup>2</sup>	
<b>Accessibility</b>	Easy	<i>Assessment Score</i>
<b>Product type:</b>	Vinyl	1
<b>Extent of Damage:</b>	Slight / minor damage	1
<b>Surface Treatment:</b>	Non-friable	0
<b>Asbestos type:</b>	Chrysotile	1
<b>Material Assessment Score:</b>		3
<b>Priority Assessment Score:</b>		Negligible
<b>Action:</b>	Manage	
<b>Comments:</b>	Previously sampled ref: Armour 17/10/19 Sample DK/21

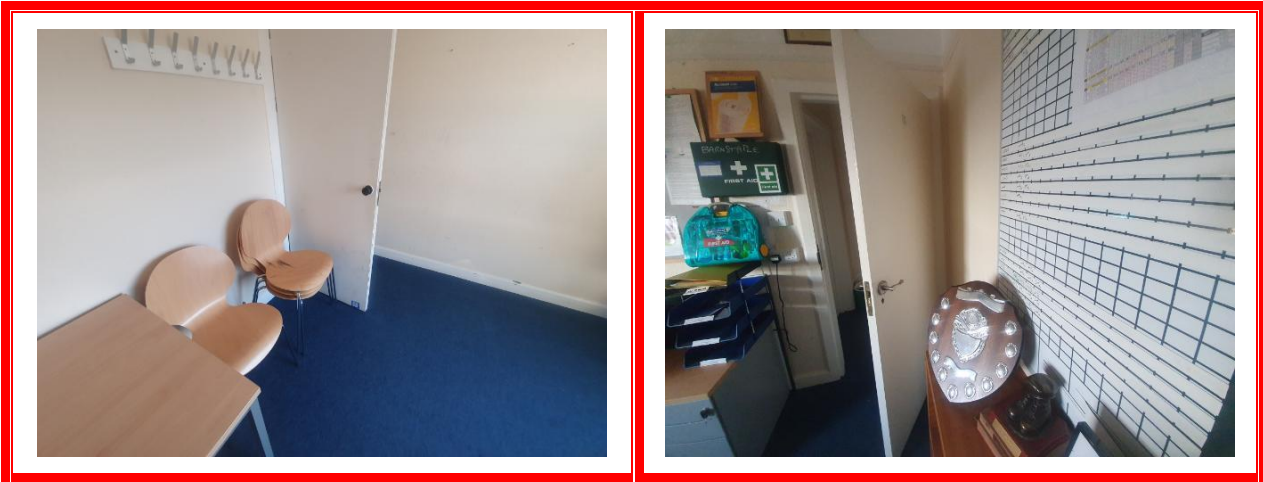
<b>Item No:</b>	<b>18</b>	<b>Sample No:</b>	<b>N/A</b>
<b>Location:</b>	First Floor - Classroom & Office 018

<b>Material Description:</b>	Panels to Doors - Insulating Board	
<b>Identification:</b>	Previously Sampled - Asbestos Detected	
<b>Approx. quantity:</b>	4 m <sup>2</sup>	
<b>Accessibility</b>	Easy	Assessment Score
<b>Product type:</b>	Asbestos insulating board	2
<b>Extent of Damage:</b>	Slight / minor damage	1
<b>Surface Treatment:</b>	Encapsulated AIB	1
<b>Asbestos type:</b>	Amosite	2
<b>Material Assessment Score:</b>		6
<b>Priority Assessment Score:</b>		Low
<b>Action:</b>	Encapsulate	
<b>Comments:</b>	Minor encapsulation required, 2 x doors. Previously sampled ref: Armour 17/10/19 Sample DK/24

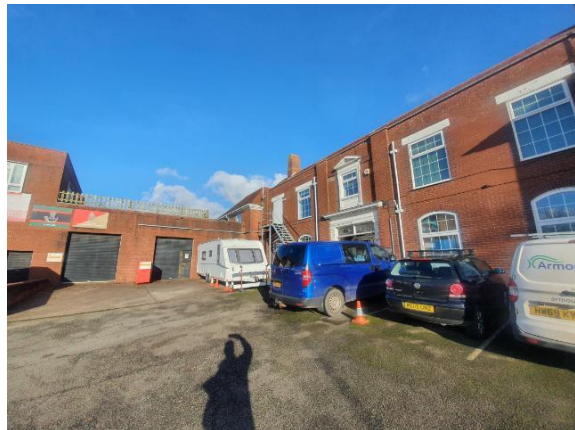
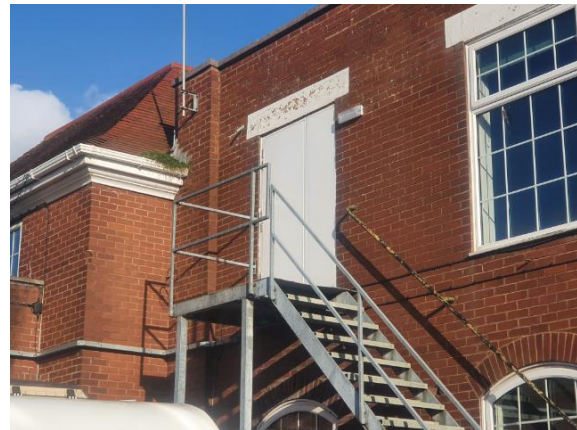
<b>Item No:</b>	<b>21</b>	<b>Sample No:</b>	<b>N/A</b>
<b>Location:</b>	First Floor - Caretakers Flat 021

<b>Material Description:</b>	All - No Access Gained	
<b>Identification:</b>	Presumed to Contain Asbestos	
<b>Approx. quantity:</b>	All Rooms	
<b>Accessibility</b>	Difficult	<i>Assessment Score</i>
<b>Product type:</b>	Pipe insulation, spray coating, friable debris	3
<b>Extent of Damage:</b>	Major damage	3
<b>Surface Treatment:</b>	Unsealed Pipe Insulation or Spray Coating	3
<b>Asbestos type:</b>	Amosite, Chrysotile, Crocidolite	3
<b>Material Assessment Score:</b>		12
<b>Priority Assessment Score:</b>		High
<b>Action:</b>	Further Investigation Needed	
<b>Comments:</b>	No access within caretakers flat on request of the caretaker

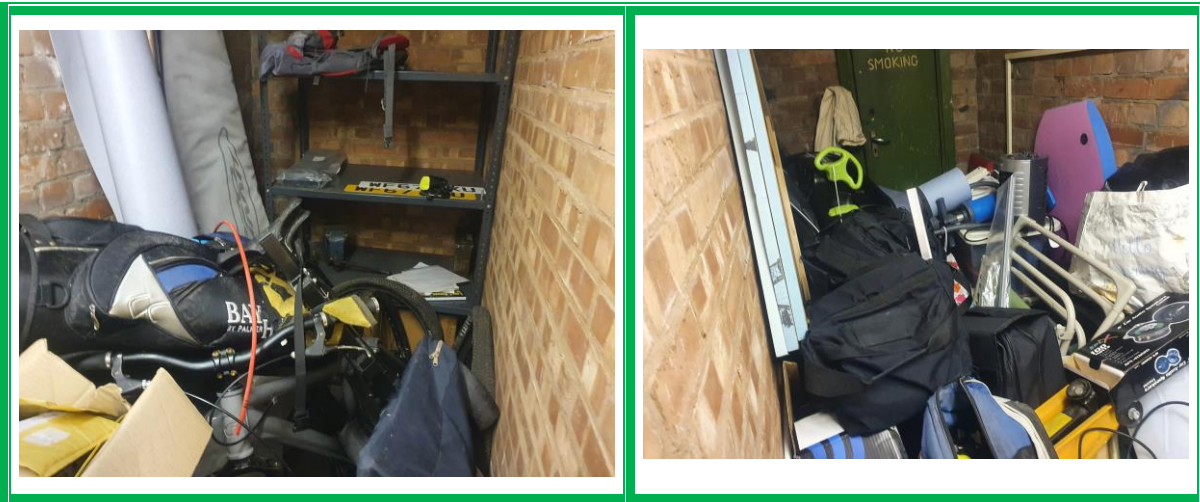
<b>Item No:</b>	<b>6</b>	<b>Sample No:</b>	<b>N/A</b>
<b>Location:</b>	Ground Floor – Store 006

<b>Material Description:</b>	No Asbestos Suspected	
<b>Identification:</b>	N/A	
<b>Approx. quantity:</b>	N/A	
<b>Accessibility</b>	N/A	<i>Assessment Score</i>
<b>Product type:</b>	N/A	N/A
<b>Extent of Damage:</b>	N/A	N/A
<b>Surface Treatment:</b>	N/A	N/A
<b>Asbestos type:</b>	N/A	N/A
<b>Material Assessment Score:</b>		
<b>Priority Assessment Score:</b>		
<b>Action:</b>	N/A	
<b>Comments:</b>	Previously a no access area, now accessed. No asbestos suspected.

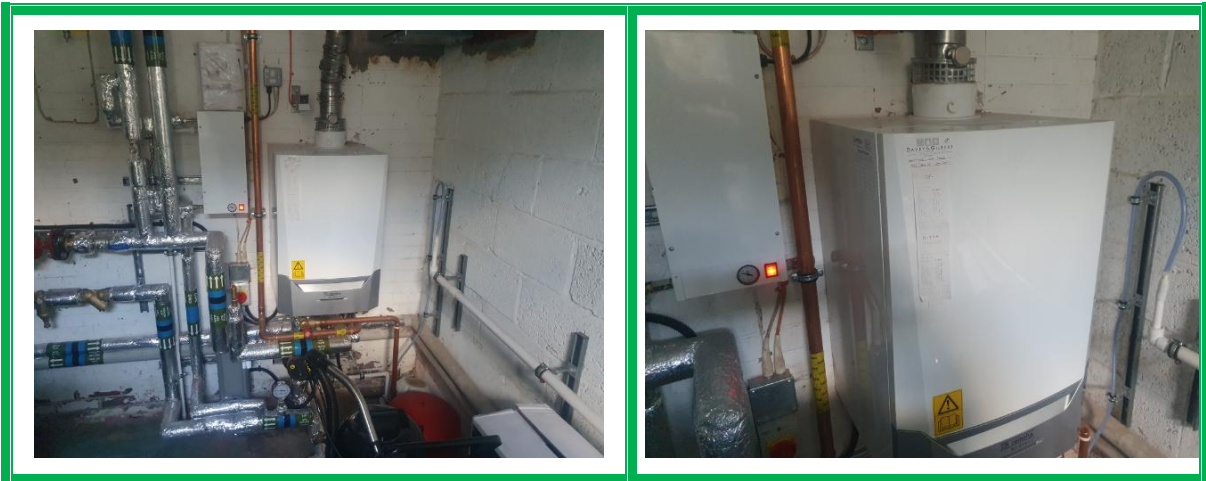
<b>Item No:</b>	<b>7</b>	<b>Sample No:</b>	<b>N/A</b>
<b>Location:</b>	Ground Floor - Boiler Room 007

<b>Material Description:</b>	Boiler	
<b>Identification:</b>	N/A	
<b>Approx. quantity:</b>	N/A	
<b>Accessibility</b>	N/A	Assessment Score
<b>Product type:</b>	N/A	N/A
<b>Extent of Damage:</b>	N/A	N/A
<b>Surface Treatment:</b>	N/A	N/A
<b>Asbestos type:</b>	N/A	N/A
<b>Material Assessment Score:</b>		
<b>Priority Assessment Score:</b>		
<b>Action:</b>	N/A	
<b>Comments:</b>	Boiler has been replaced. Plasterboard panels on ceiling

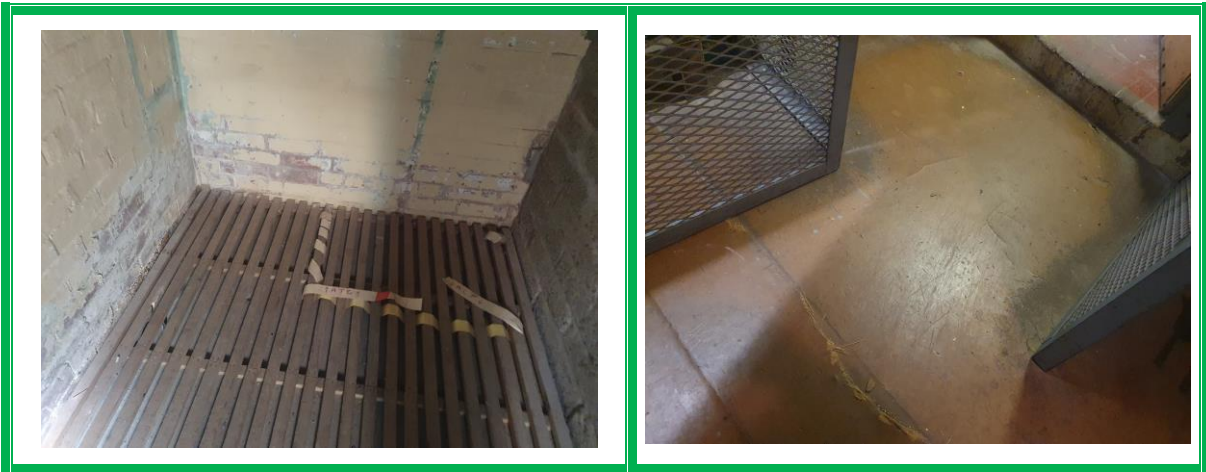
<b>Item No:</b>	<b>14</b>	<b>Sample No:</b>	<b>N/A</b>
<b>Location:</b>	GF Armoury x 2 014

<b>Material Description:</b>	No Asbestos Suspected	
<b>Identification:</b>	N/A	
<b>Approx. quantity:</b>	N/A	
<b>Accessibility</b>	N/A	<i>Assessment Score</i>
<b>Product type:</b>	N/A	N/A
<b>Extent of Damage:</b>	N/A	N/A
<b>Surface Treatment:</b>	N/A	N/A
<b>Asbestos type:</b>	N/A	N/A
<b>Material Assessment Score:</b>		
<b>Priority Assessment Score:</b>		
<b>Action:</b>	N/A	
<b>Comments:</b>	Previously a no access area, now accessed. No asbestos suspected. Lathe and plaster ceiling above metal cage.

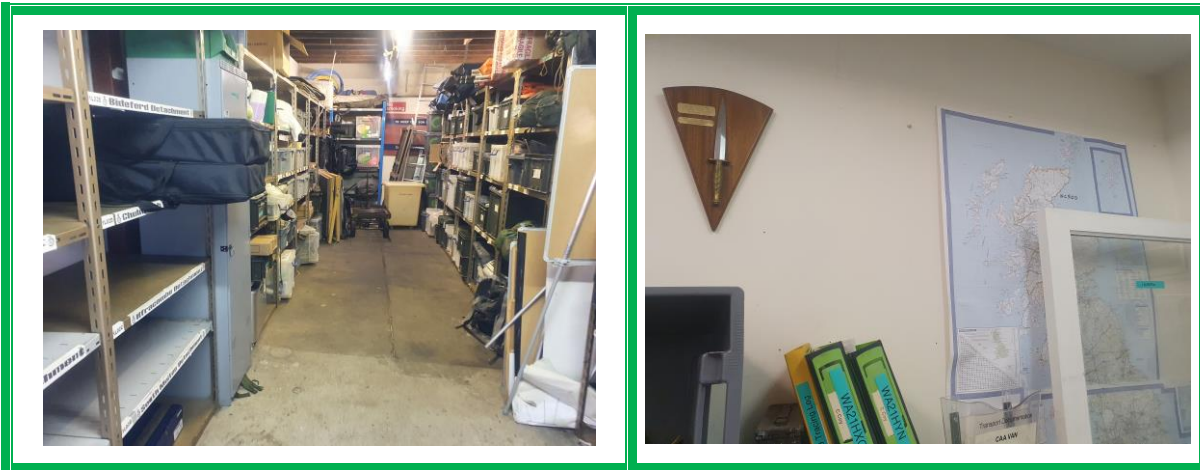
<b>Item No:</b>	<b>19</b>	<b>Sample No:</b>	<b>N/A</b>
<b>Location:</b>	GF Cadet Building, Office, and Store 019

<b>Material Description:</b>	No Asbestos Suspected	
<b>Identification:</b>	N/A	
<b>Approx. quantity:</b>	N/A	
<b>Accessibility</b>	N/A	<i>Assessment Score</i>
<b>Product type:</b>	N/A	N/A
<b>Extent of Damage:</b>	N/A	N/A
<b>Surface Treatment:</b>	N/A	N/A
<b>Asbestos type:</b>	N/A	N/A
<b>Material Assessment Score:</b>		
<b>Priority Assessment Score:</b>		
<b>Action:</b>	N/A	
<b>Comments:</b>	<p>Previously a no access area, now accessed.</p> <p>No asbestos suspected. Non asbestos wall panels were previously sampled within office.</p>

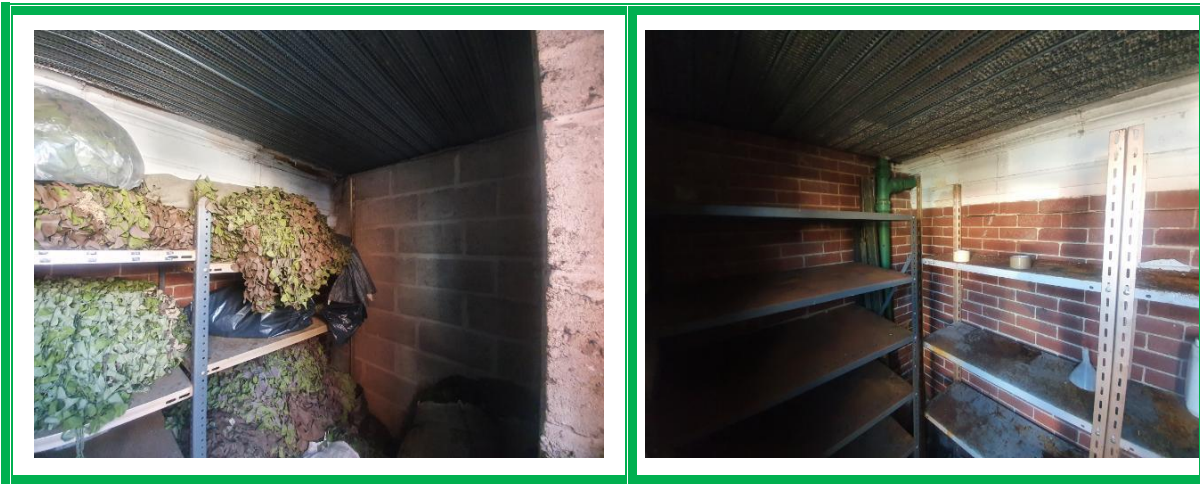
<b>Item No:</b>	<b>20</b>	<b>Sample No:</b>	<b>N/A</b>
<b>Location:</b>	Ground Floor - Stores x 2 020

<b>Material Description:</b>	No Suspect Materials Found	
<b>Identification:</b>	N/A	
<b>Approx. quantity:</b>	N/A	
<b>Accessibility</b>	N/A	<i>Assessment Score</i>
<b>Product type:</b>	N/A	N/A
<b>Extent of Damage:</b>	N/A	N/A
<b>Surface Treatment:</b>	N/A	N/A
<b>Asbestos type:</b>	N/A	N/A
<b>Material Assessment Score:</b>		
<b>Priority Assessment Score:</b>		
<b>Action:</b>	N/A	
<b>Comments:</b>	Previously un-accessed rooms. Now accessed and no asbestos found.

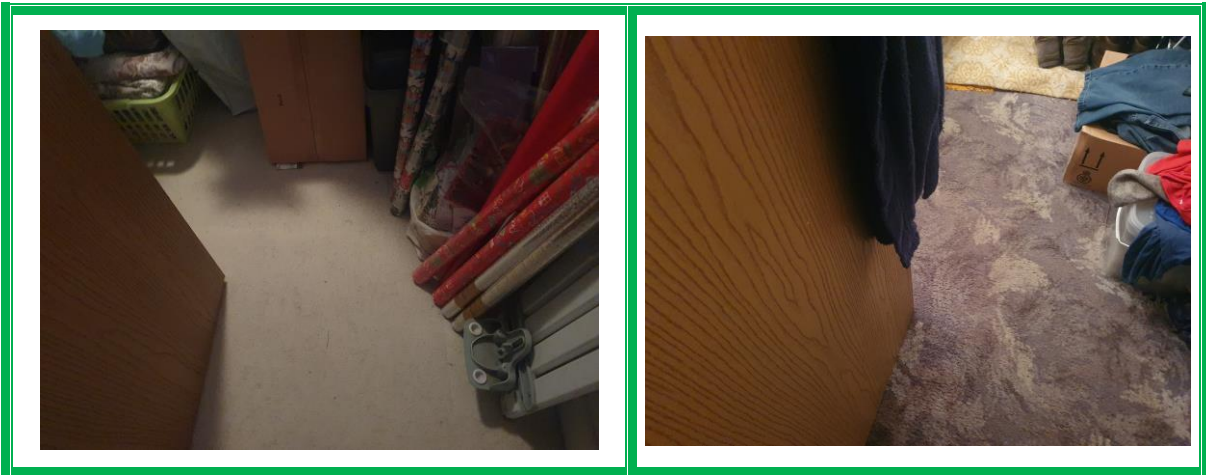
<b>Item No:</b>	<b>21</b>	<b>Sample No:</b>	<b>N/A</b>
<b>Location:</b>	FF Bedrooms x 3 and Bathroom 021

<b>Material Description:</b>	No Asbestos Suspected	
<b>Identification:</b>	N/A	
<b>Approx. quantity:</b>	N/A	
<b>Accessibility</b>	N/A	<i>Assessment Score</i>
<b>Product type:</b>	N/A	N/A
<b>Extent of Damage:</b>	N/A	N/A
<b>Surface Treatment:</b>	N/A	N/A
<b>Asbestos type:</b>	N/A	N/A
<b>Material Assessment Score:</b>		
<b>Priority Assessment Score:</b>		
<b>Action:</b>	N/A	
<b>Comments:</b>	Previously a no access area, now accessed. No asbestos suspected.

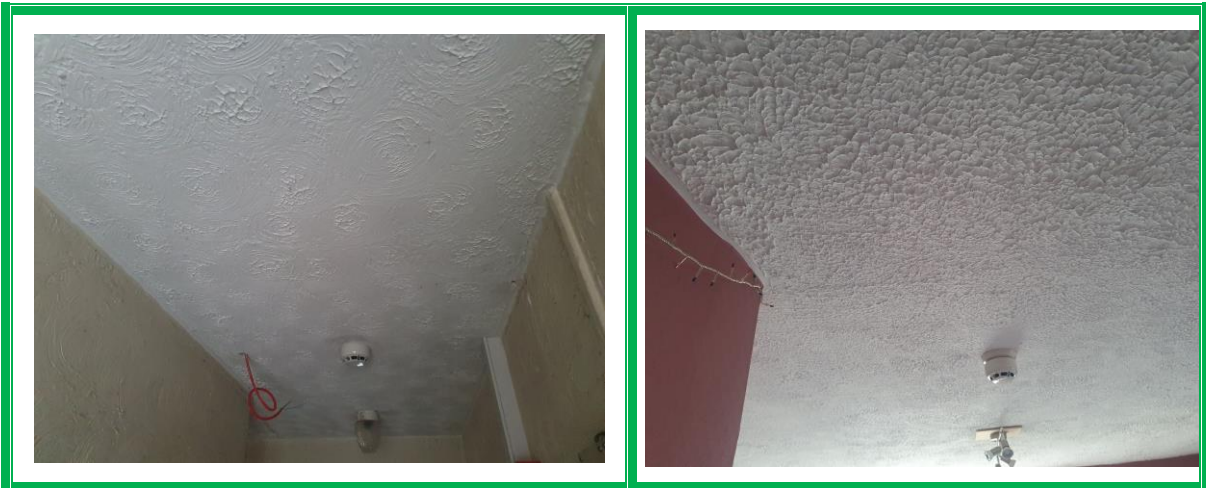
<b>Item No:</b>	<b>22</b>	<b>Sample No:</b>	<b>DK/27</b>
<b>Location:</b>	FF Corridor, Kitchen and Living Room 022

<b>Material Description:</b>	No Asbestos Suspected	
<b>Identification:</b>	Sampled – No Asbestos Suspected	
<b>Approx. quantity:</b>	N/A	
<b>Accessibility</b>	N/A	<i>Assessment Score</i>
<b>Product type:</b>	N/A	N/A
<b>Extent of Damage:</b>	N/A	N/A
<b>Surface Treatment:</b>	N/A	N/A
<b>Asbestos type:</b>	N/A	N/A
<b>Material Assessment Score:</b>		
<b>Priority Assessment Score:</b>		
<b>Action:</b>	N/A	
<b>Comments:</b>	Previously a no access area, now accessed. No asbestos suspected.

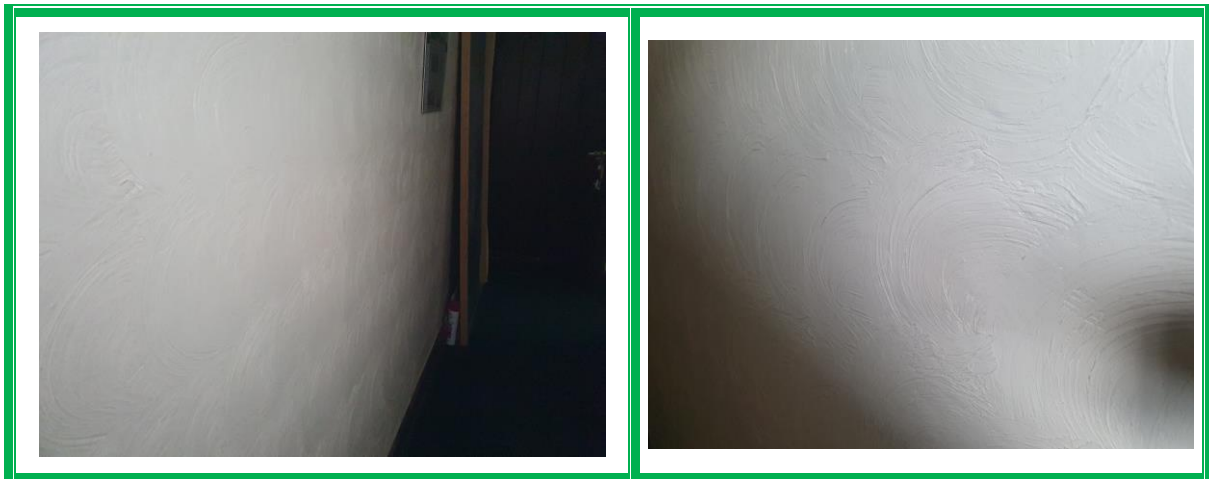
<b>Item No:</b>	<b>23</b>	<b>Sample No:</b>	<b>DK/28</b>
<b>Location:</b>	FF Corridor 023

<b>Material Description:</b>	No Asbestos Suspected	
<b>Identification:</b>	Sampled – No Asbestos Suspected	
<b>Approx. quantity:</b>	N/A	
<b>Accessibility</b>	N/A	<i>Assessment Score</i>
<b>Product type:</b>	N/A	N/A
<b>Extent of Damage:</b>	N/A	N/A
<b>Surface Treatment:</b>	N/A	N/A
<b>Asbestos type:</b>	N/A	N/A
<b>Material Assessment Score:</b>		
<b>Priority Assessment Score:</b>		
<b>Action:</b>	N/A	
<b>Comments:</b>	Previously a no access area, now accessed. No asbestos suspected.

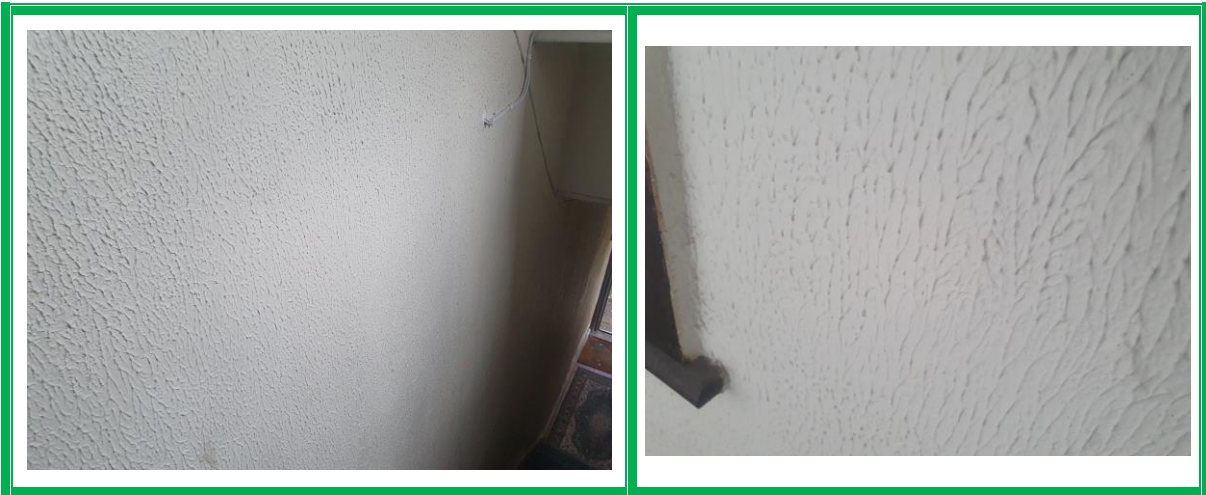
<b>Item No:</b>	<b>24</b>	<b>Sample No:</b>	<b>DK/29</b>
<b>Location:</b>	Caretakers Flat – Stairwell 024

<b>Material Description:</b>	No Asbestos Suspected	
<b>Identification:</b>	Sampled – No Asbestos Suspected	
<b>Approx. quantity:</b>	N/A	
<b>Accessibility</b>	N/A	<i>Assessment Score</i>
<b>Product type:</b>	N/A	N/A
<b>Extent of Damage:</b>	N/A	N/A
<b>Surface Treatment:</b>	N/A	N/A
<b>Asbestos type:</b>	N/A	N/A
<b>Material Assessment Score:</b>		
<b>Priority Assessment Score:</b>		
<b>Action:</b>	N/A	
<b>Comments:</b>	Previously a no access area, now accessed. No asbestos suspected.
