Project Number 2481

**Management
Asbestos Survey Report**

**Lostwithiel Platoon, ACF Centre, The Parade,
Lostwithiel, Cornwall, PL22 0DX**

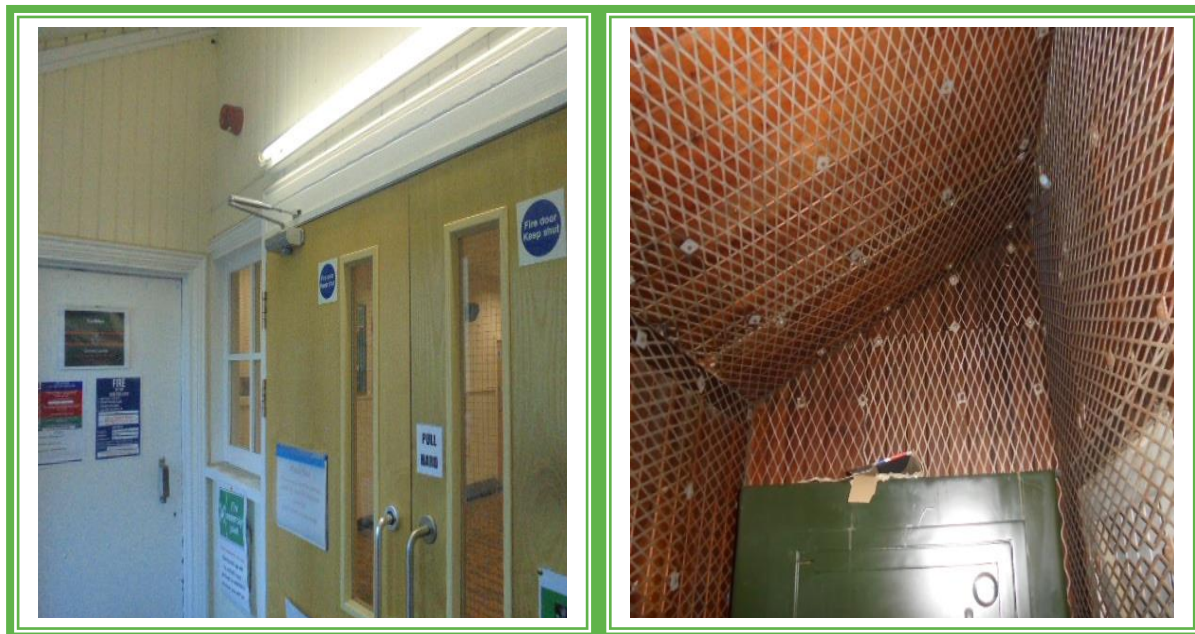
Item No: 1

Location: Lobby & Armoury

Material Description:	Visual Inspection – No Suspect Materials Found	
Identification:	N/A	
Approx. quantity:	N/A	
Accessibility	N/A	<i>Assessment Score</i>
Product type:		N/A
Extent of Damage:		N/A
Surface Treatment:		N/A
Asbestos type:		N/A
Material Assessment Score:		N/A
Priority Assessment Score:		N/A
Action:	N/A	
Comments:	N/A

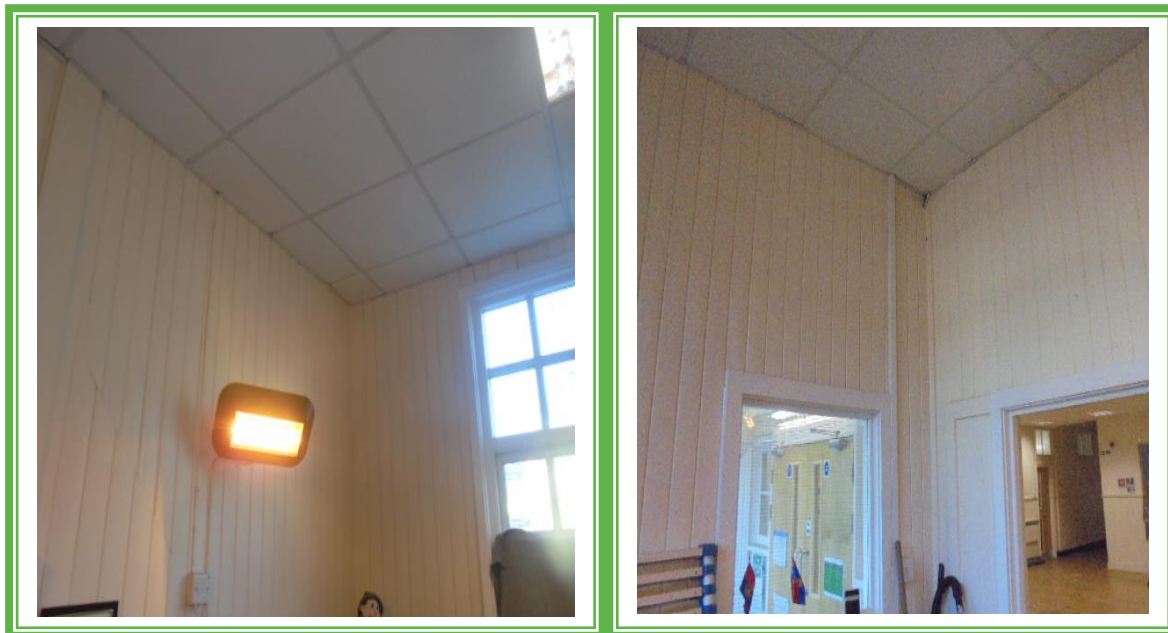
Item No: 2

Location: Office

Material Description:	Visual Inspection – No Suspect Materials Found	
Identification:	N/A	
Approx. quantity:	N/A	
Accessibility	N/A	<i>Assessment Score</i>
Product type:		N/A
Extent of Damage:		N/A
Surface Treatment:		N/A
Asbestos type:		N/A
Material Assessment Score:		N/A
Priority Assessment Score:		N/A
Action:	N/A	
Comments:	N/A

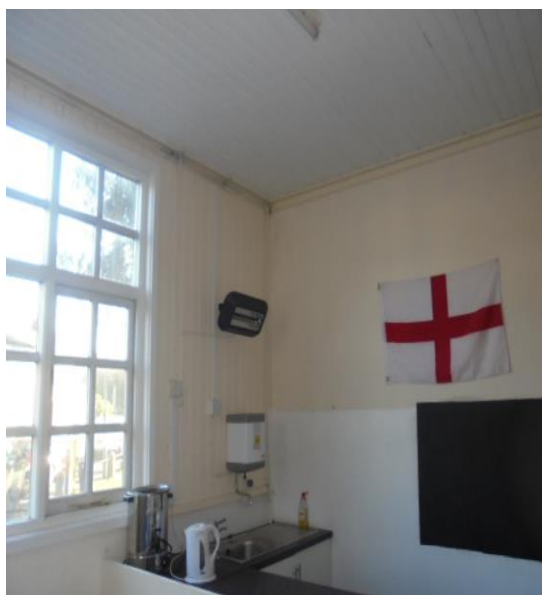
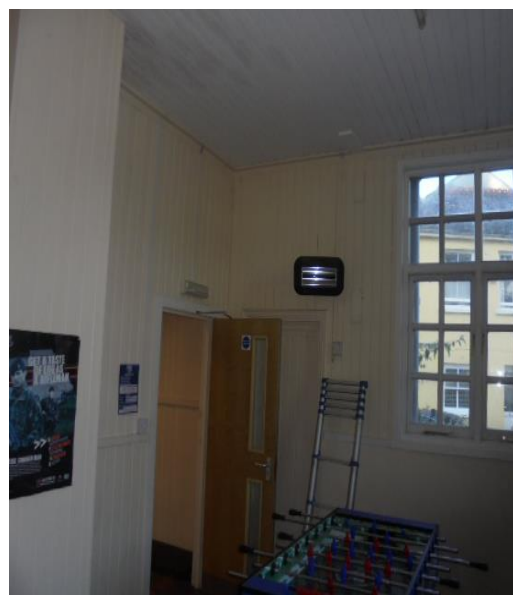
Item No: 3

Location: Kitchen

Material Description:	Visual Inspection – No Suspect Materials Found	
Identification:	N/A	
Approx. quantity:	N/A	
Accessibility	N/A	<i>Assessment Score</i>
Product type:		N/A
Extent of Damage:		N/A
Surface Treatment:		N/A
Asbestos type:		N/A
Material Assessment Score:		N/A
Priority Assessment Score:		N/A
Action:	N/A	
Comments:	Modern Sink Pad

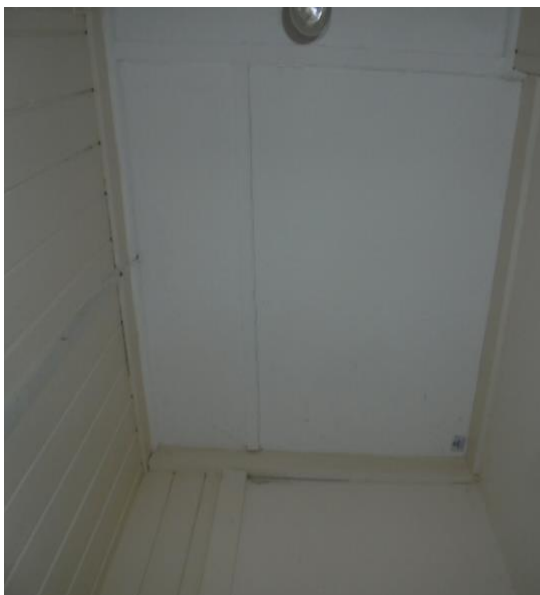
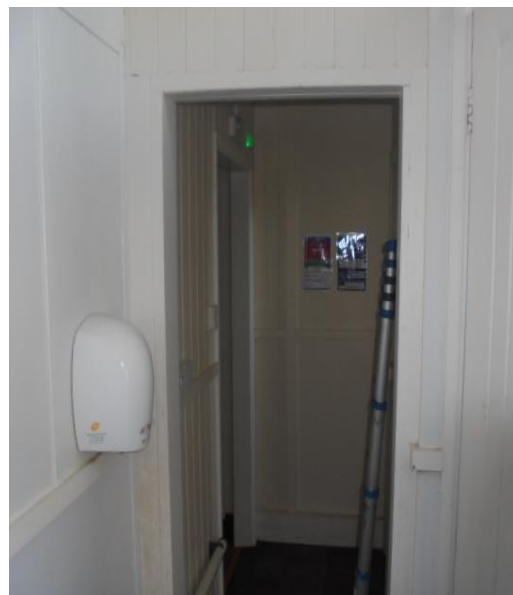
Item No: 4

Location: Men's WC Area

Material Description:	Fibreboard Ceiling Panels	
Identification:	Sampled – No Asbestos Detected	
Approx. quantity:	4M2	
Accessibility	N/A	<i>Assessment Score</i>
Product type:		N/A
Extent of Damage:		N/A
Surface Treatment:		N/A
Asbestos type:		N/A
Material Assessment Score:		N/A
Priority Assessment Score:		N/A
Action:	N/A	
Comments:	N/A

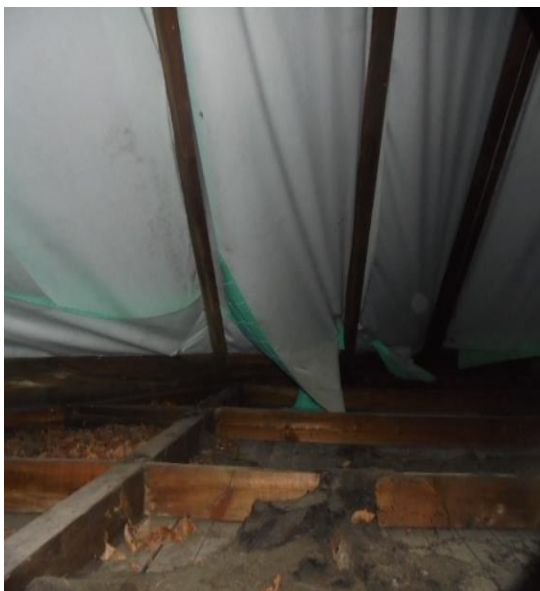
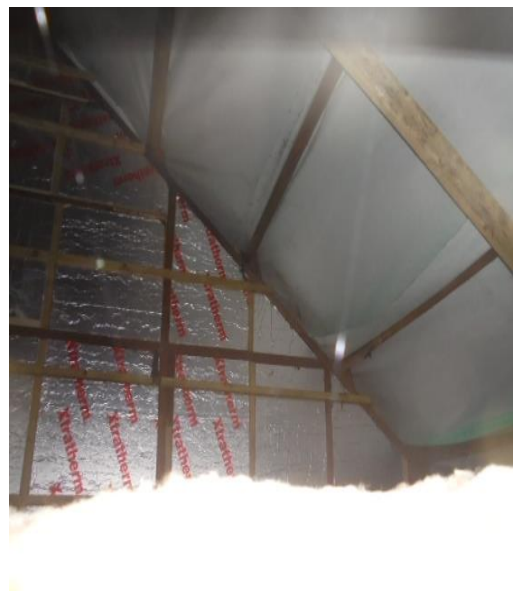
**Item No: 5****Sample No: N/A****Location: Loft Space**

Material Description:	Visual Inspection – No Suspect Materials Found	
Identification:	N/A	
Approx. quantity:	N/A	
Accessibility	N/A	<i>Assessment Score</i>
Product type:		N/A
Extent of Damage:		N/A
Surface Treatment:		N/A
Asbestos type:		N/A
Material Assessment Score:		N/A
Priority Assessment Score:		N/A
Action:	N/A	
Comments:	N/A

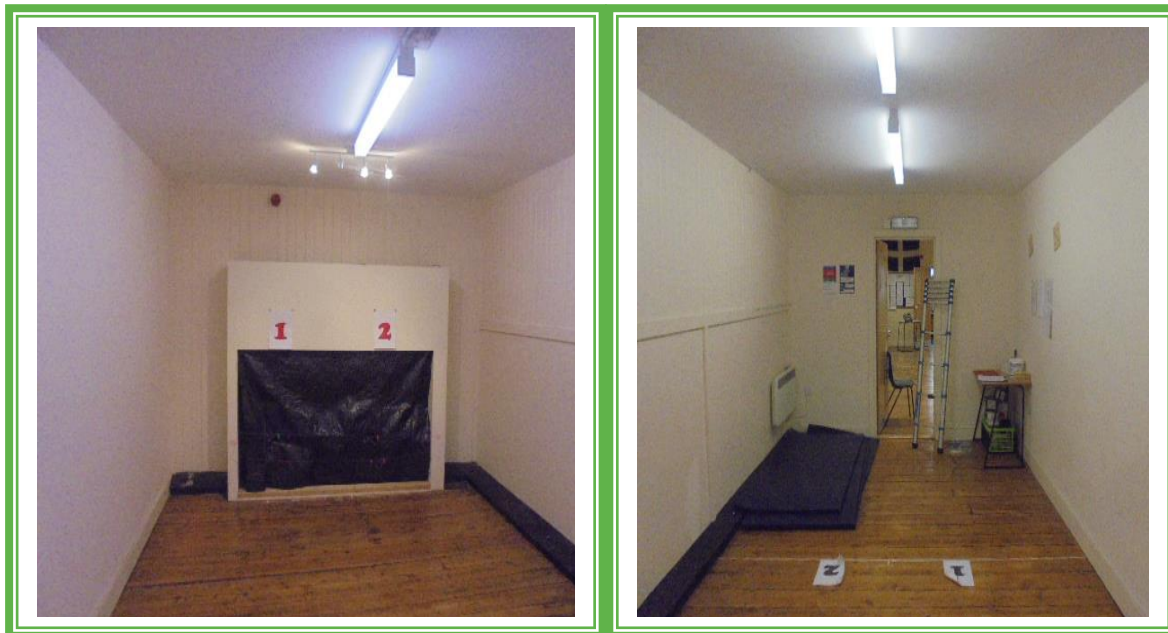
**Item No: 6****Sample No: N/A****Location: Range**

Material Description:	Visual Inspection – No Suspect Materials Found	
Identification:	N/A	
Approx. quantity:	N/A	
Accessibility	N/A	<i>Assessment Score</i>
Product type:		N/A
Extent of Damage:		N/A
Surface Treatment:		N/A
Asbestos type:		N/A
Material Assessment Score:		N/A
Priority Assessment Score:		N/A
Action:	N/A	
Comments:	N/A

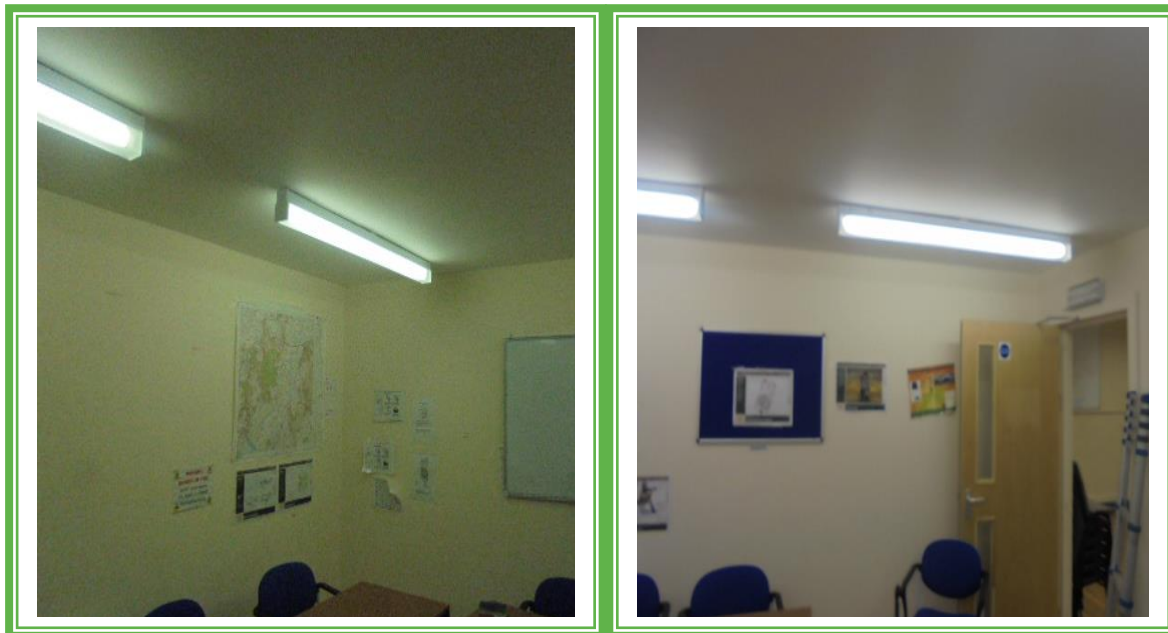
Item No: 7

Location: Classroom 1

Material Description:	Visual Inspection – No Suspect Materials Found	
Identification:	N/A	
Approx. quantity:	N/A	
Accessibility	N/A	<i>Assessment Score</i>
Product type:		N/A
Extent of Damage:		N/A
Surface Treatment:		N/A
Asbestos type:		N/A
Material Assessment Score:		N/A
Priority Assessment Score:		N/A
Action:	N/A	
Comments:	N/A

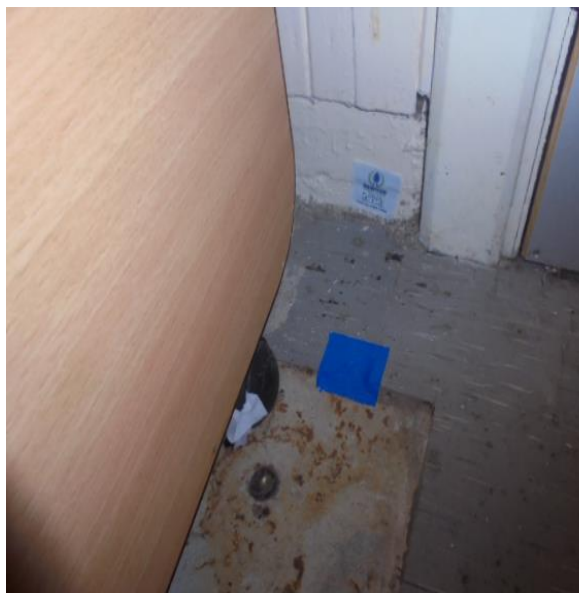
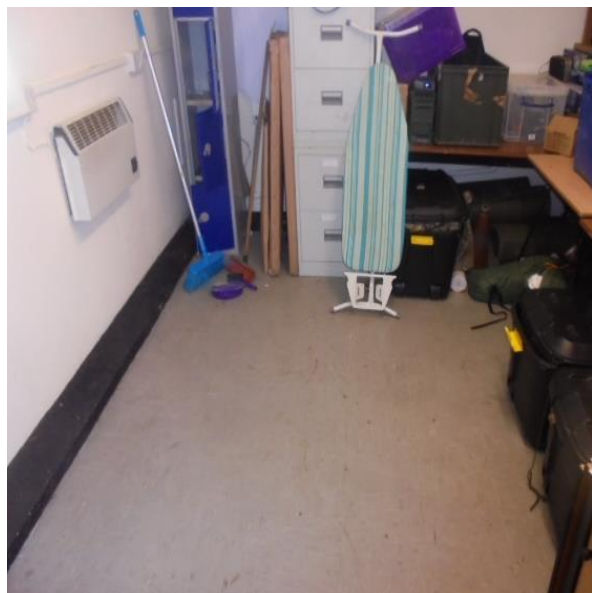
**Item No: 8****Sample No: DK/2****Location: Locker Room**

Material Description:	Floor Tiles & Adhesive	
Identification:	Sampled – No Asbestos Detected	
Approx. quantity:	15M2	
Accessibility	N/A	<i>Assessment Score</i>
Product type:		N/A
Extent of Damage:		N/A
Surface Treatment:		N/A
Asbestos type:		N/A
Material Assessment Score:		N/A
Priority Assessment Score:		N/A
Action:	N/A	
Comments:	N/A

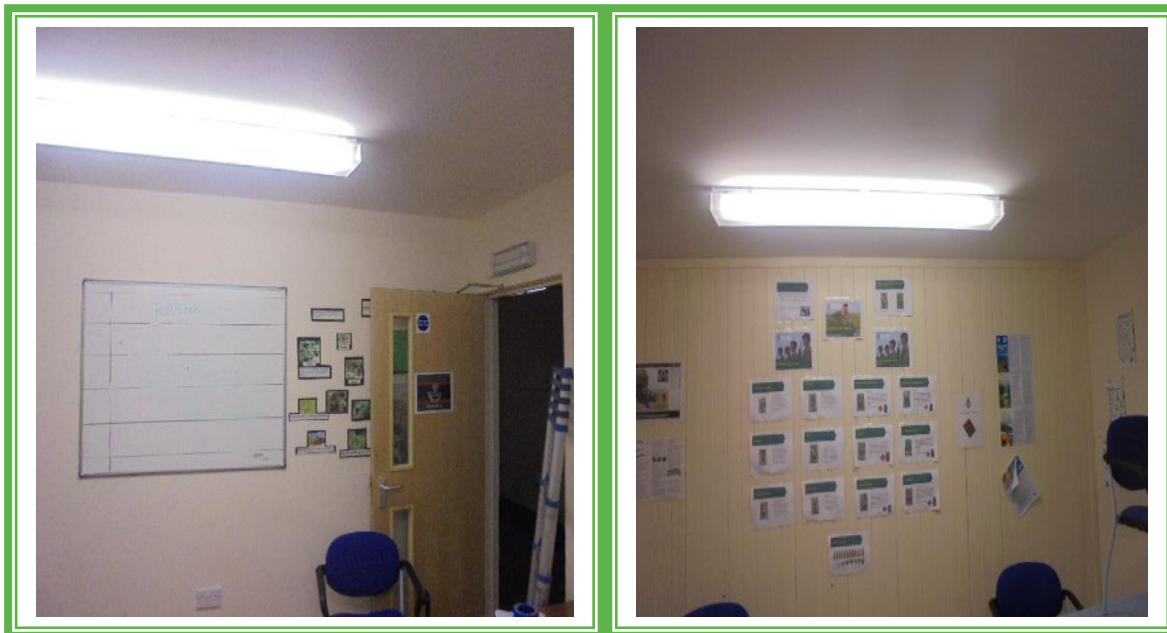
Item No: 9

Location: Classroom 2

Material Description:	Visual Inspection – No Suspect Materials Found	
Identification:	N/A	
Approx. quantity:	N/A	
Accessibility	N/A	<i>Assessment Score</i>
Product type:		N/A
Extent of Damage:		N/A
Surface Treatment:		N/A
Asbestos type:		N/A
Material Assessment Score:		N/A
Priority Assessment Score:		N/A
Action:	N/A	
Comments:	N/A

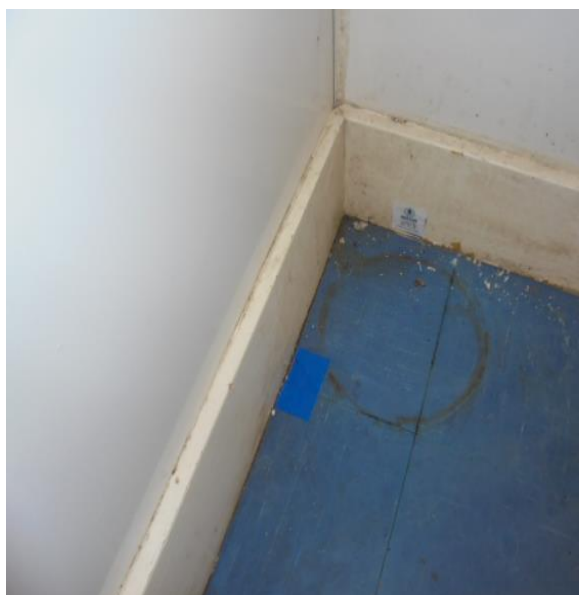
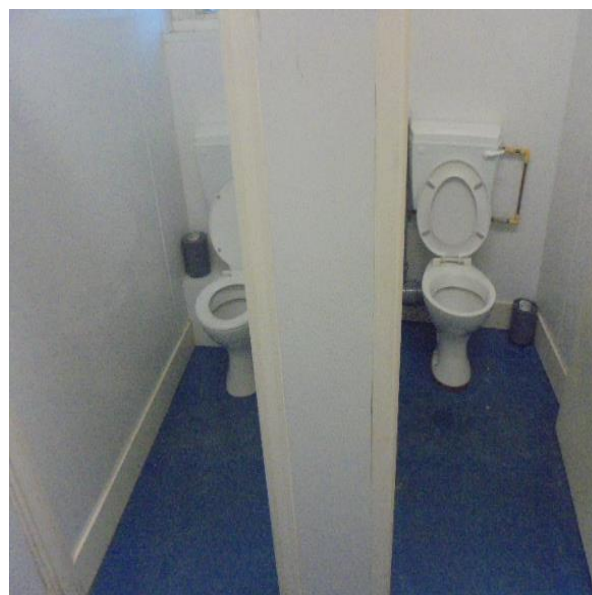
**Item No: 10****Sample No: DK/3****Location: Ladies WC**

Material Description:	Floor Tiles & Adhesive	
Identification:	Sampled – No Asbestos Detected	
Approx. quantity:	6M2	
Accessibility	N/A	<i>Assessment Score</i>
Product type:		N/A
Extent of Damage:		N/A
Surface Treatment:		N/A
Asbestos type:		N/A
Material Assessment Score:		N/A
Priority Assessment Score:		N/A
Action:	N/A	
Comments:	N/A

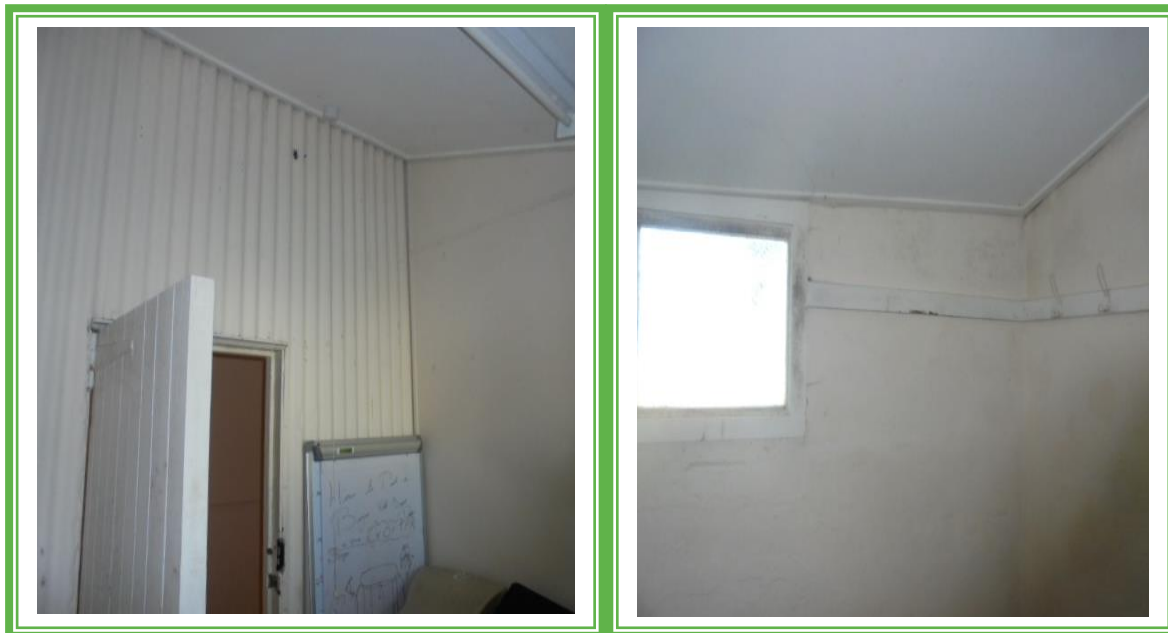
Item No: 11

Location: Store

Material Description:	Visual Inspection – No Suspect Materials Found	
Identification:	N/A	
Approx. quantity:	N/A	
Accessibility	N/A	<i>Assessment Score</i>
Product type:		N/A
Extent of Damage:		N/A
Surface Treatment:		N/A
Asbestos type:		N/A
Material Assessment Score:		N/A
Priority Assessment Score:		N/A
Action:	N/A	
Comments:	Profiled Metal Wall Panels

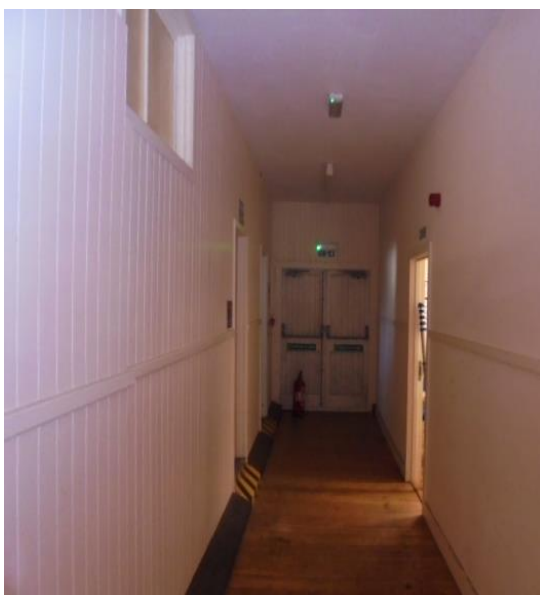
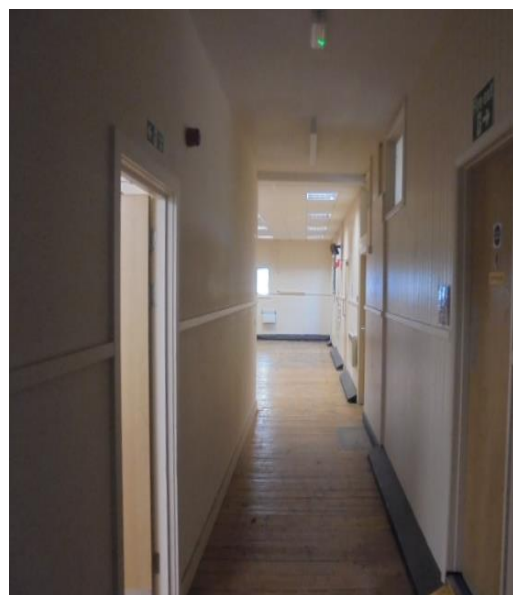
**Item No: 12****Sample No: N/A****Location: Corridor**

Material Description:	Visual Inspection – No Suspect Materials Found	
Identification:	N/A	
Approx. quantity:	N/A	
Accessibility	N/A	<i>Assessment Score</i>
Product type:		N/A
Extent of Damage:		N/A
Surface Treatment:		N/A
Asbestos type:		N/A
Material Assessment Score:		N/A
Priority Assessment Score:		N/A
Action:	N/A	
Comments:	N/A

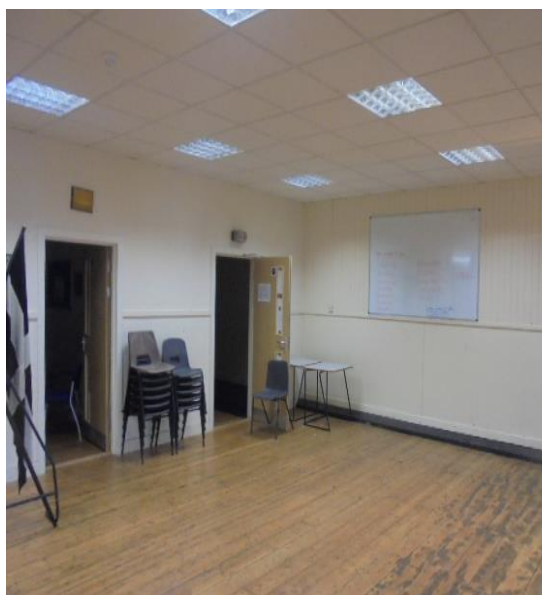
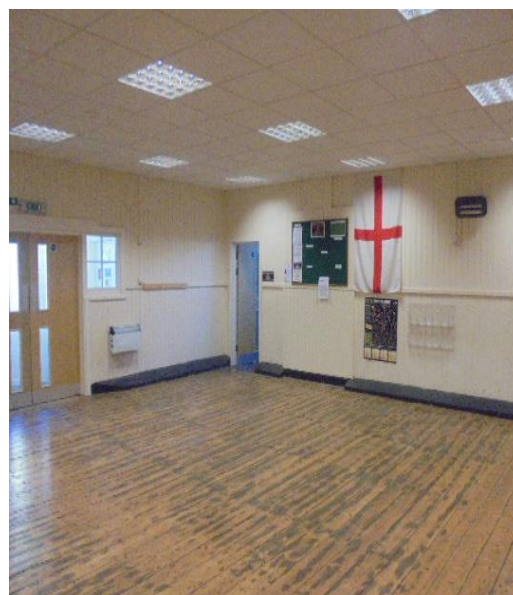
**Item No: 13****Sample No: N/A****Location: Drill Hall**

Material Description:	Visual Inspection – No Suspect Materials Found	
Identification:	N/A	
Approx. quantity:	N/A	
Accessibility	N/A	<i>Assessment Score</i>
Product type:		N/A
Extent of Damage:		N/A
Surface Treatment:		N/A
Asbestos type:		N/A
Material Assessment Score:		N/A
Priority Assessment Score:		N/A
Action:	N/A	
Comments:	Limited access above suspended ceiling due to large amount of insulation above tiles.

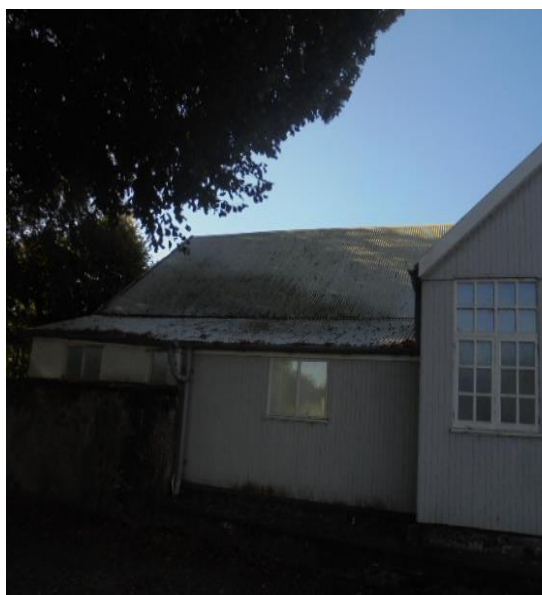
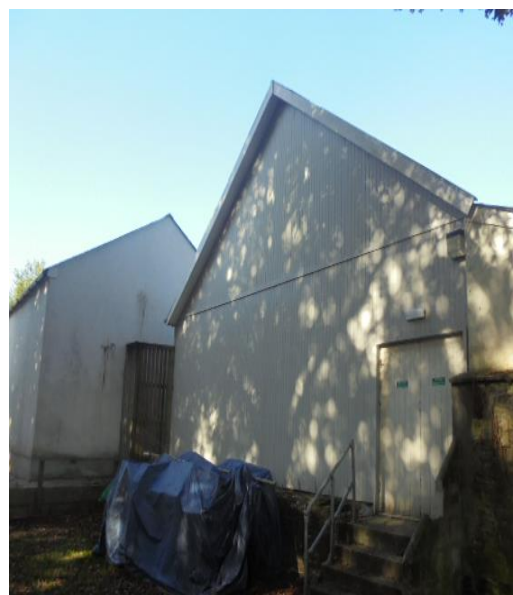
**Item No: 14****Sample No: N/A****Location: External**

Material Description:	Visual Inspection – No Suspect Materials Found	
Identification:	N/A	
Approx. quantity:	N/A	
Accessibility	N/A	<i>Assessment Score</i>
Product type:		N/A
Extent of Damage:		N/A
Surface Treatment:		N/A
Asbestos type:		N/A
Material Assessment Score:		N/A
Priority Assessment Score:		N/A
Action:	N/A	
Comments:	N/A
