Project Number A-00552 (3700)

**Re-Inspection
Asbestos Survey Report**

**Tiverton Platoon
King Street
Devon
EX16 5JJ**

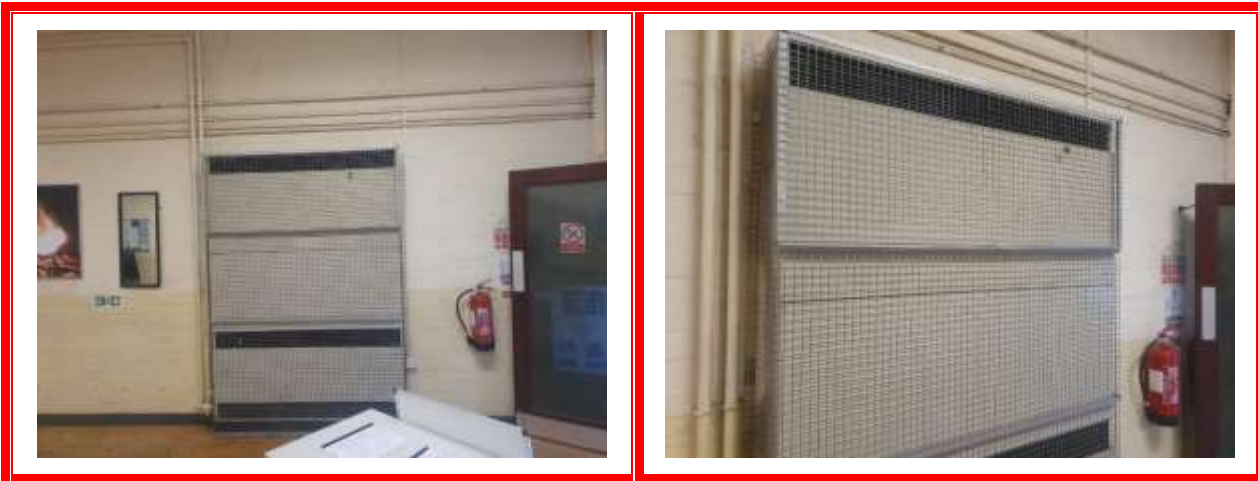
Item No:	1	Sample No:	N/A
Location:	Ground Floor - Hall 001

Material Description:	Components within Gas Heater - Insulating Board	
Identification:	Presumed to Contain Asbestos	
Approx. quantity:	4 no	
Accessibility	Difficult	Assessment Score
Product type:	Asbestos Insulating Board	2
Extent of Damage:	Major damage	3
Surface Treatment:	Unsealed Insulation	3
Asbestos type:	Amosite, Chrysotile	2
Material Assessment Score:		10
Priority Assessment Score:		High
Action:	Manage	
Comments:	Non access within live heaters

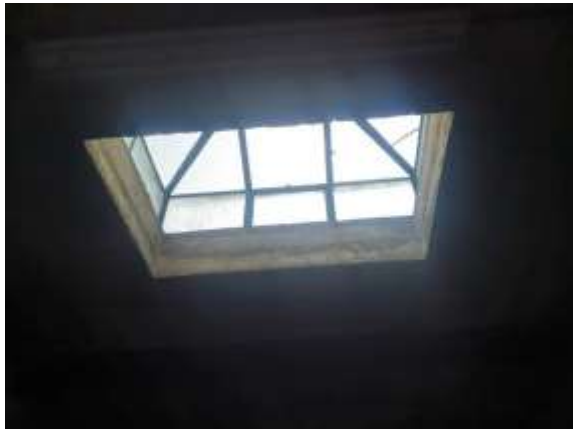
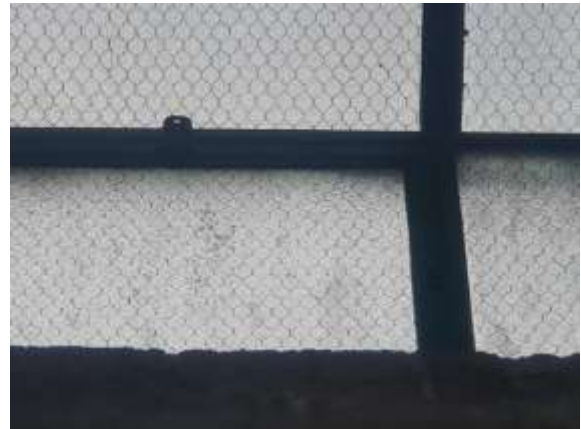
Location: Ground Floor - Store 002

Material Description:	Rope Seals within Skylights - Gaskets (rope/woven)	
Identification:	Presumed to Contain Asbestos	
Approx. quantity:	2 no	
Accessibility	Difficult	<i>Assessment Score</i>
Product type:	Rope	2
Extent of Damage:	Major damage	3
Surface Treatment:	Unsealed Insulation	3
Asbestos type:	Chrysotile	1
Material Assessment Score:		9
Priority Assessment Score:		N/A
Action:	Manage	
Comments:	No access due to height restrictions

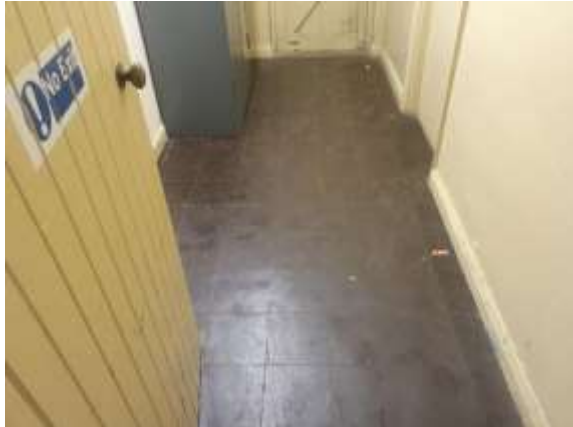
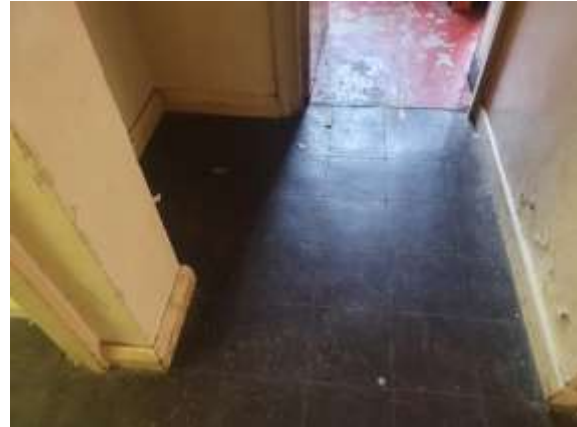
Location: Ground Floor - Lobby and Circulation 003

Material Description:	Floor Tiles and Adhesive - Vinyl Products	
Identification:	Previously Sampled - Asbestos Detected	
Approx. quantity:	8 m ²	
Accessibility	Easy	<i>Assessment Score</i>
Product type:	Vinyl	1
Extent of Damage:	Moderate damage	2
Surface Treatment:	Non-friable	0
Asbestos type:	Chrysotile	1
Material Assessment Score:		4
Priority Assessment Score:		Negligible
Action:	Manage	
Comments:	Previously sampled ref: Armour 30/8/19 - Sample DK/2

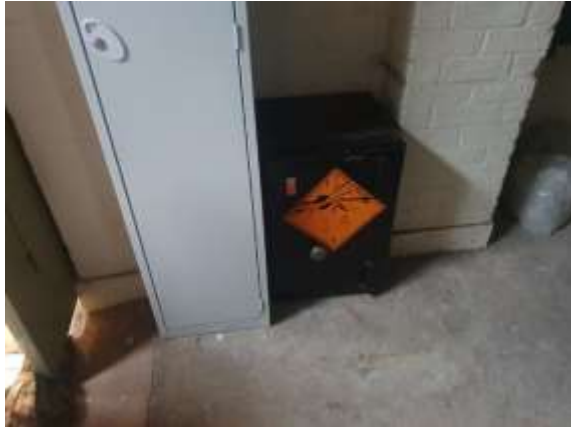
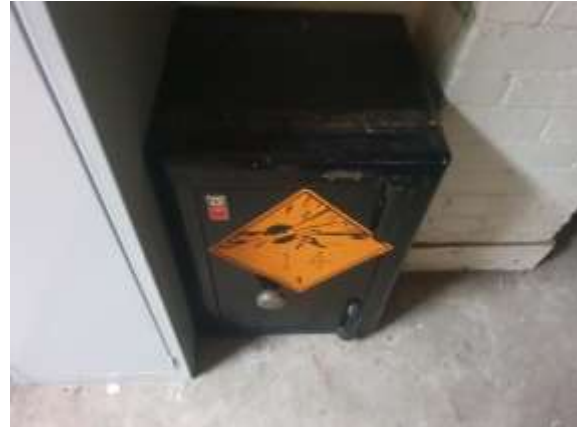
Location: Ground Floor - Store 004

Material Description:	Components within Safe - Insulating Board	
Identification:	Presumed to Contain Asbestos	
Approx. quantity:	1 no	
Accessibility	Difficult	<i>Assessment Score</i>
Product type:	Asbestos Insulating Board	2
Extent of Damage:	Major damage	3
Surface Treatment:	Unsealed Insulation	3
Asbestos type:	Amosite, Chrysotile	2
Material Assessment Score:		10
Priority Assessment Score:		High
Action:	Manage	
Comments:	No access within safe

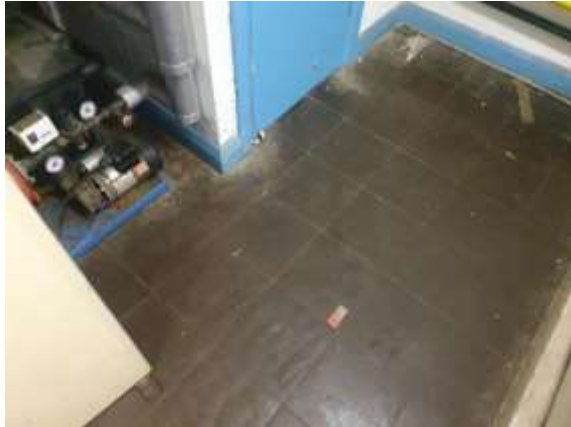
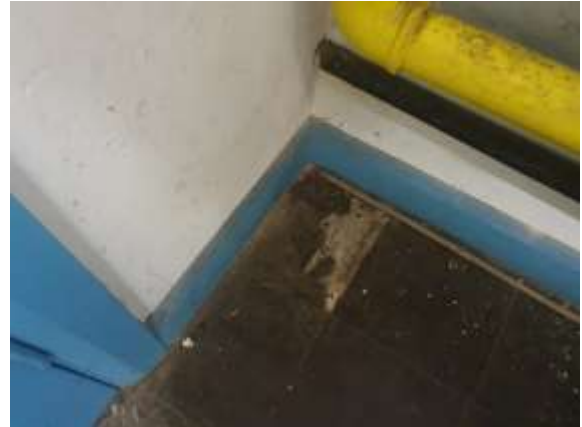
Location: Ground Floor - Boiler Room and Cupboard 005

Material Description:	Floor Tiles and Adhesive - Vinyl Products	
Identification:	Previously Sampled - Asbestos Detected	
Approx. quantity:	8 m ²	
Accessibility	Easy	<i>Assessment Score</i>
Product type:	Vinyl	1
Extent of Damage:	Major damage	3
Surface Treatment:	Non-friable	0
Asbestos type:	Chrysotile	1
Material Assessment Score:		5
Priority Assessment Score:		Low
Action:	Manage	
Comments:	Previously sampled ref: Armour 30/8/19 - Sample DK/2. Floor starting to break up. Remove broken tiles and consider removing all tiles

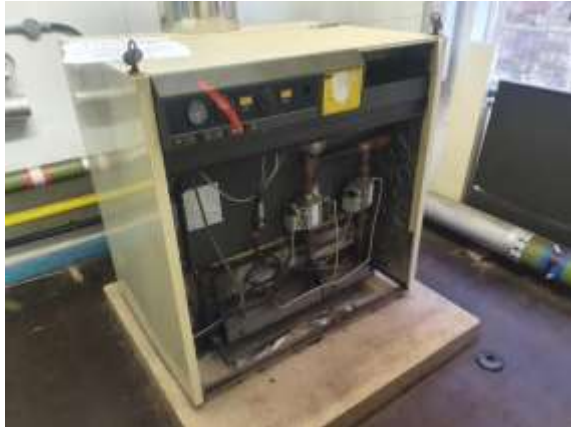
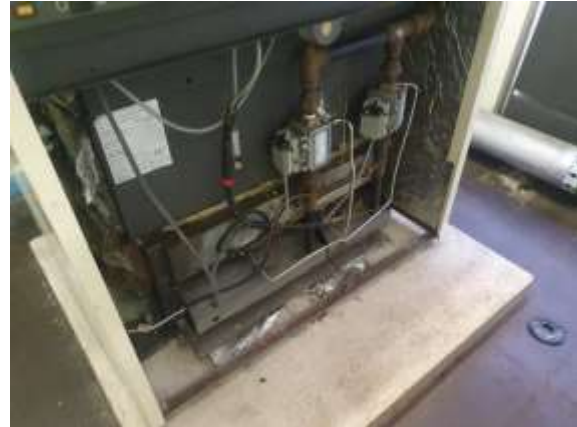
Location: Ground Floor - Boiler Room 006

Material Description:	Components within Boiler - Insulating Board	
Identification:	Presumed to Contain Asbestos	
Approx. quantity:	1 no	
Accessibility	Difficult	<i>Assessment Score</i>
Product type:	Asbestos Insulating Board	2
Extent of Damage:	Major damage	3
Surface Treatment:	Unsealed Insulation	3
Asbestos type:	Amosite, Chrysotile	2
Material Assessment Score:		10
Priority Assessment Score:		High
Action:	Manage	
Comments:	No access within live boiler

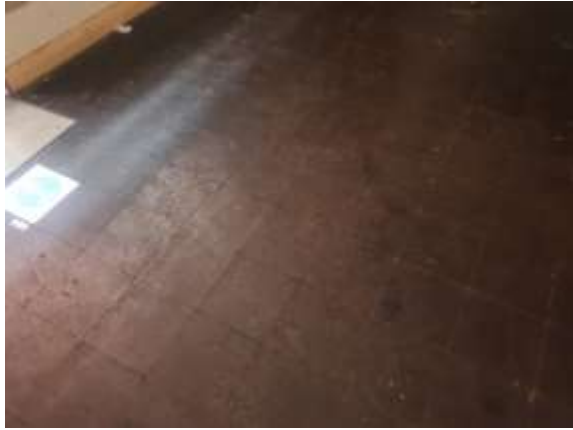
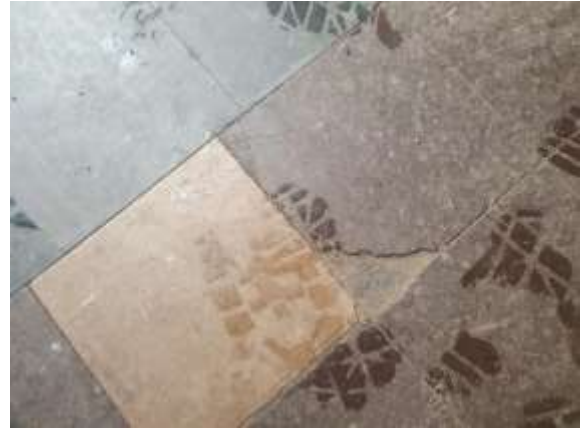
Location: Ground Floor - Lobby, Office and Store 007

Material Description:	Floor Tiles and Adhesive - Vinyl Products	
Identification:	Previously Sampled - Asbestos Detected	
Approx. quantity:	30 m ²	
Accessibility	Easy	<i>Assessment Score</i>
Product type:	Vinyl	1
Extent of Damage:	Moderate damage	2
Surface Treatment:	Non-friable	0
Asbestos type:	Chrysotile	1
Material Assessment Score:		4
Priority Assessment Score:		Negligible
Action:	Manage	
Comments:	Previously sampled ref: Armour 30/8/19 - Sample DK/6

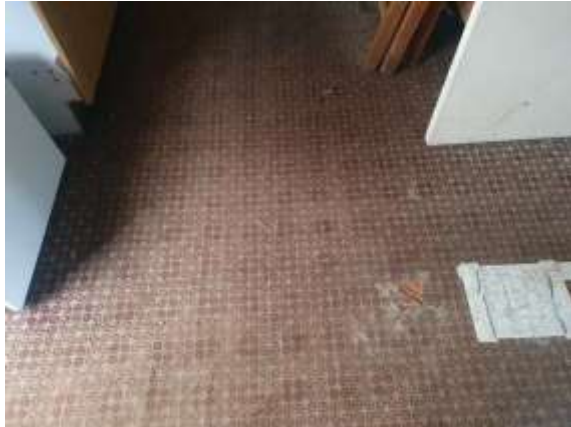
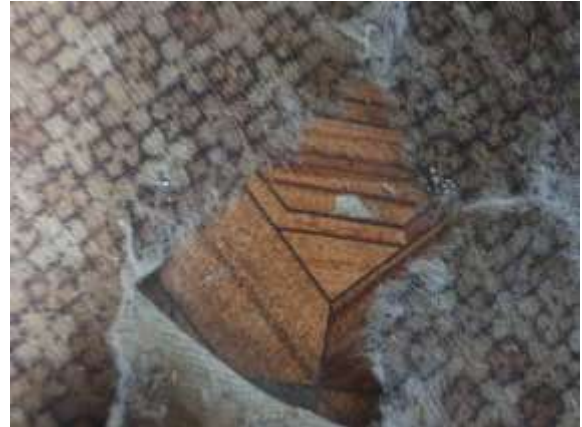
Location: Ground Floor - Kitchen 008

Material Description:	Lino Flooring under Carpet - Paper Product	
Identification:	Previously Sampled - Asbestos Detected	
Approx. quantity:	12 m ²	
Accessibility	Difficult	<i>Assessment Score</i>
Product type:	Paper	2
Extent of Damage:	Moderate damage	2
Surface Treatment:	Paper	1
Asbestos type:	Chrysotile	1
Material Assessment Score:		6
Priority Assessment Score:		Low
Action:	Manage	
Comments:	Previously sampled ref: Armour 30/8/19 - Sample DK/7

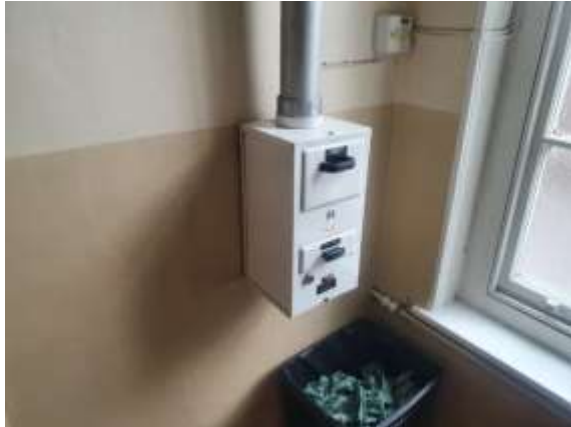
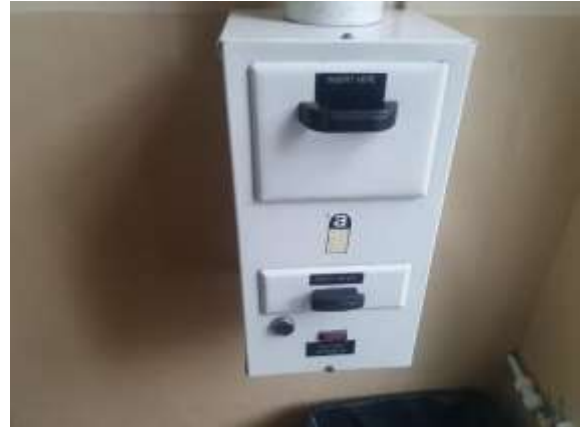
Location: Ground Floor - Ladies WC 009

Material Description:	Components within Incinerator Unit - Insulating Board	
Identification:	Presumed to Contain Asbestos	
Approx. quantity:	1 no	
Accessibility	Difficult	<i>Assessment Score</i>
Product type:	Asbestos Insulating Board	2
Extent of Damage:	Major damage	3
Surface Treatment:	Unsealed Insulation	3
Asbestos type:	Amosite, Chrysotile	2
Material Assessment Score:		10
Priority Assessment Score:		High
Action:	Manage	
Comments:	No access within live unit

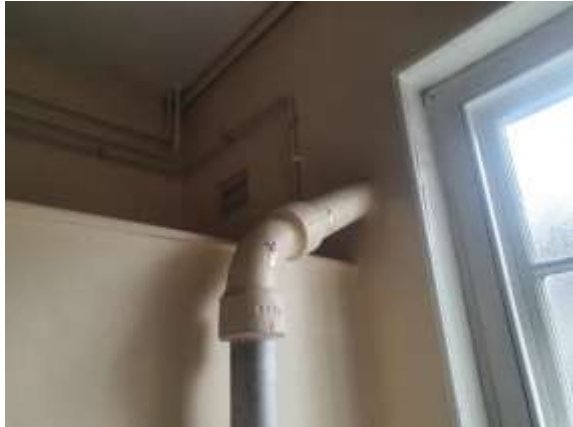
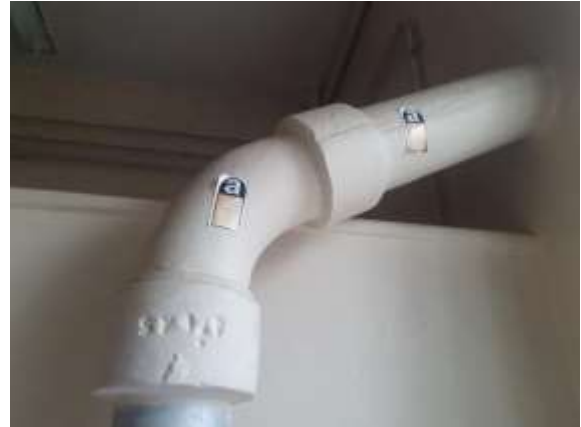
Location: Ground Floor - Ladies WC 010

Material Description:	Flue Pipe - Cement Product	
Identification:	Previously Sampled - Asbestos Detected	
Approx. quantity:	1 LM	
Accessibility	Medium	<i>Assessment Score</i>
Product type:	Cement	1
Extent of Damage:	Slight / minor damage	1
Surface Treatment:	Unsealed Cement	1
Asbestos type:	Chrysotile	1
Material Assessment Score:		4
Priority Assessment Score:		Negligible
Action:	Manage	
Comments:	Previously sampled ref: Armour 30/8/19 - Sample DK/11

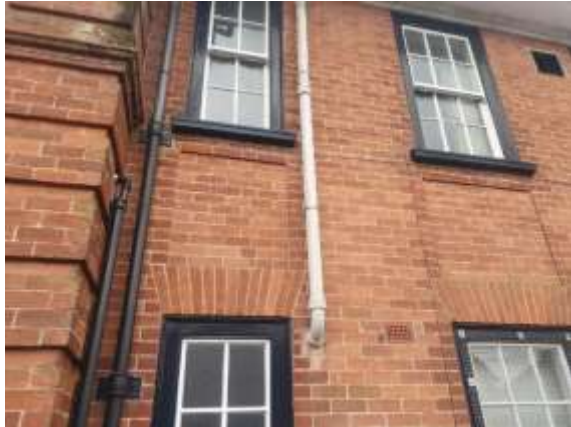
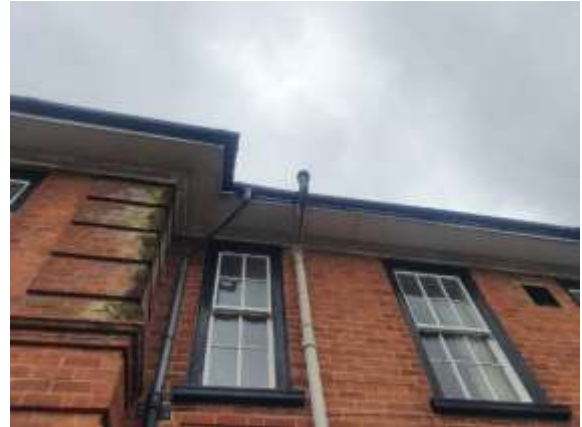
Location: External - Outside Ladies WC 012

Material Description:	Flue Pipe - Cement Product	
Identification:	Previously Sampled - Asbestos Detected	
Approx. quantity:	7 LM	
Accessibility	Difficult	<i>Assessment Score</i>
Product type:	Cement	1
Extent of Damage:	Slight / minor damage	1
Surface Treatment:	Unsealed Cement	1
Asbestos type:	Chrysotile	1
Material Assessment Score:		4
Priority Assessment Score:		Negligible
Action:	Manage	
Comments:	Previously sampled ref: Armour 30/8/19 - Sample DK/11

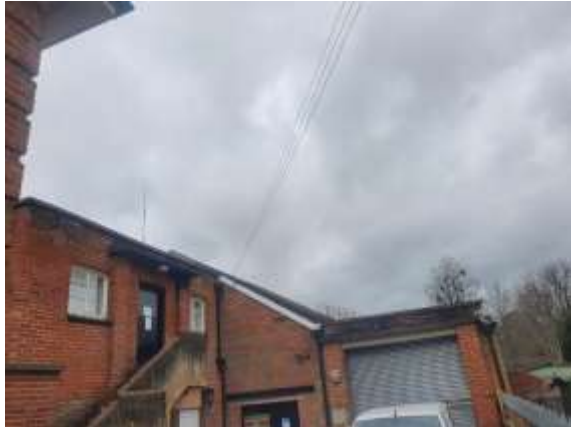
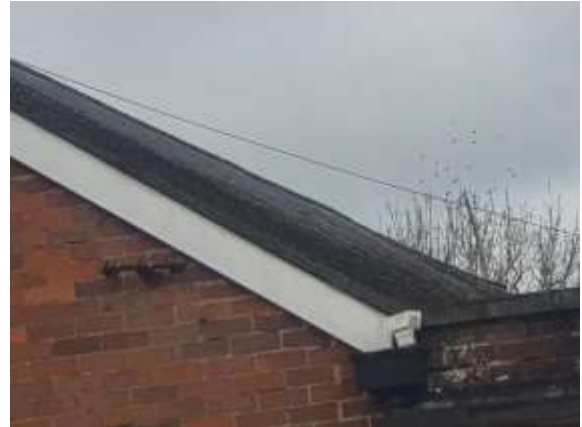
Location: External - Roof to Hall 013

Material Description:	Roof Tiles - Cement Product	
Identification:	Presumed to Contain Asbestos	
Approx. quantity:	270 m ²	
Accessibility	Difficult	<i>Assessment Score</i>
Product type:	Cement	1
Extent of Damage:	Slight / minor damage	1
Surface Treatment:	Unsealed Cement	1
Asbestos type:	Chrysotile	1
Material Assessment Score:		4
Priority Assessment Score:		Negligible
Action:	Manage	
Comments:	No access to sample due to height restrictions

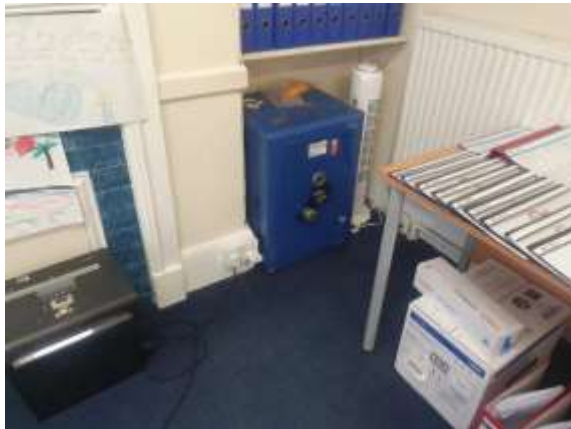
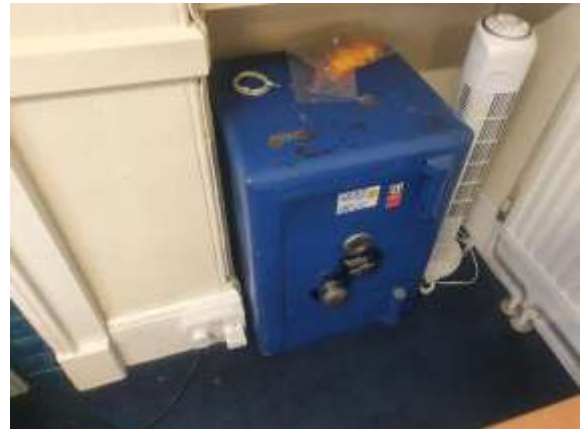
Location: First Floor - Office 014

Material Description:	Components within Safe - Insulating Board	
Identification:	Presumed to Contain Asbestos	
Approx. quantity:	1 no	
Accessibility	Difficult	<i>Assessment Score</i>
Product type:	Asbestos Insulating Board	2
Extent of Damage:	Major damage	3
Surface Treatment:	Unsealed Insulation	3
Asbestos type:	Amosite, Chrysotile	2
Material Assessment Score:		10
Priority Assessment Score:		High
Action:	Remove	
Comments:	No access within safe

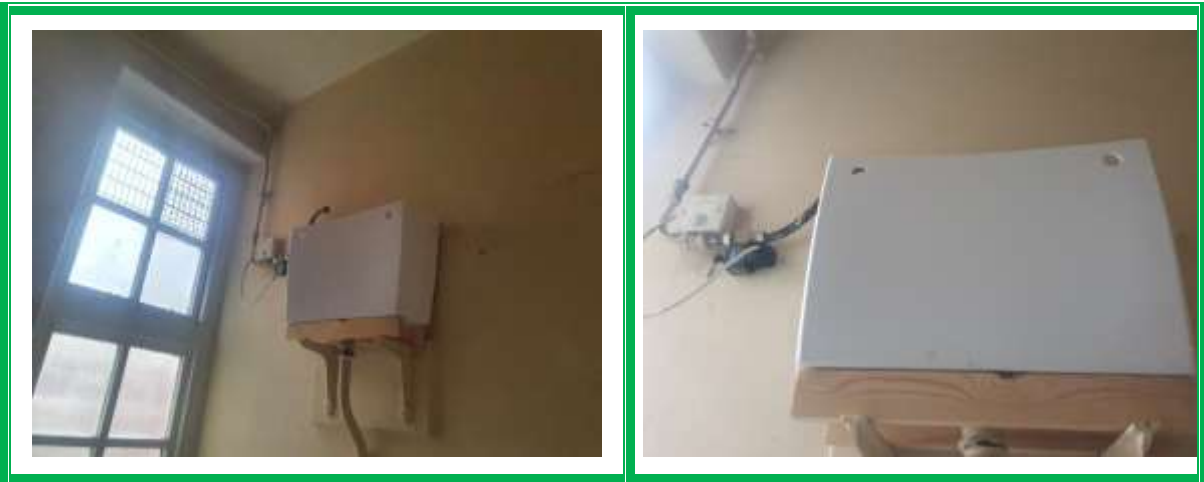
Item No:	11	Sample No:	N/A
Location:	Ground Floor – Men's WC 011

Material Description:	Toilet Cistern - No asbestos suspected	
Identification:	N/A	
Approx. quantity:	N/A	
Accessibility	N/A	<i>Assessment Score</i>
Product type:	N/A	N/A
Extent of Damage:	N/A	N/A
Surface Treatment:	N/A	N/A
Asbestos type:	N/A	N/A
Material Assessment Score:		N/A
Priority Assessment Score:		N/A
Action:	N/A	
Comments:	Toilet Cistern replaced
