**Project Number A-00419 (3700)**

**Re-Inspection  
Asbestos Survey Report**

**Bournemouth Platoon  
Portman Road  
Bournemouth  
BH7 6EU**

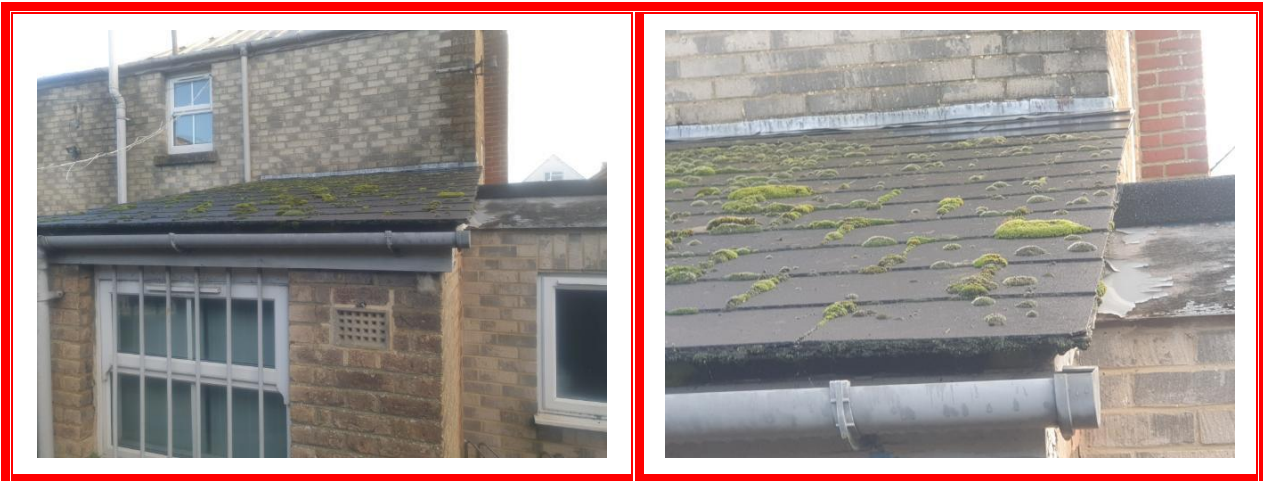
<b>Item No:</b>	<b>1</b>	<b>Sample No:</b>	<b>N/A</b>
<b>Location:</b>	External - Roof 001

<b>Material Description:</b>	Roof Tiles - Cement Product	
<b>Identification:</b>	Previously Sampled - Asbestos Detected	
<b>Approx. quantity:</b>	30 m <sup>2</sup>	
<b>Accessibility</b>	Difficult	Assessment Score
<b>Product type:</b>	Cement	1
<b>Extent of Damage:</b>	Slight / minor damage	1
<b>Surface Treatment:</b>	Unsealed Cement	1
<b>Asbestos type:</b>	Chrysotile	1
<b>Material Assessment Score:</b>		4
<b>Priority Assessment Score:</b>		Negligible
<b>Action:</b>	Manage	
<b>Comments:</b>	Previously sampled ref: Armour 30/9/19 Sample DK/1

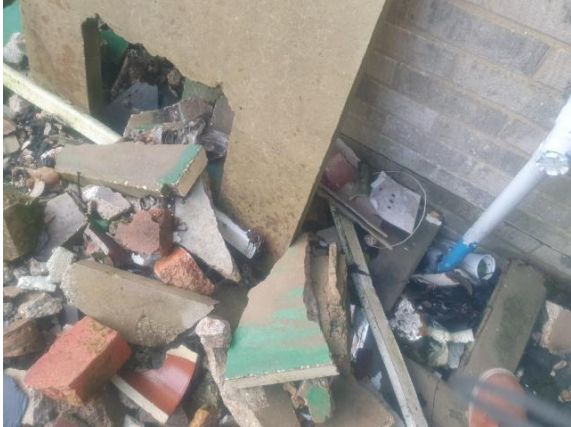
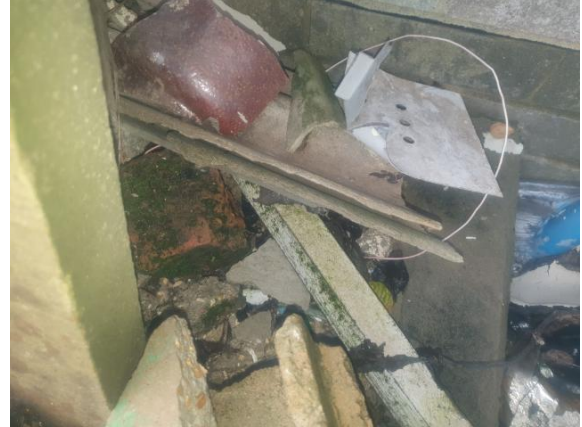
<b>Item No:</b>	<b>2</b>	<b>Sample No:</b>	<b>N/A</b>
<b>Location:</b>	External - Floor 002

<b>Material Description:</b>	Debris - Cement Product	
<b>Identification:</b>	Previously Sampled - Asbestos Detected	
<b>Approx. quantity:</b>	1 m <sup>2</sup>	
<b>Accessibility</b>	Easy	<i>Assessment Score</i>
<b>Product type:</b>	Cement	1
<b>Extent of Damage:</b>	Major damage	3
<b>Surface Treatment:</b>	Unsealed Cement	1
<b>Asbestos type:</b>	Chrysotile	1
<b>Material Assessment Score:</b>		6
<b>Priority Assessment Score:</b>		Low
<b>Action:</b>	Remove	
<b>Comments:</b>	Previously sampled ref: Armour 30/9/19 Sample DK/2

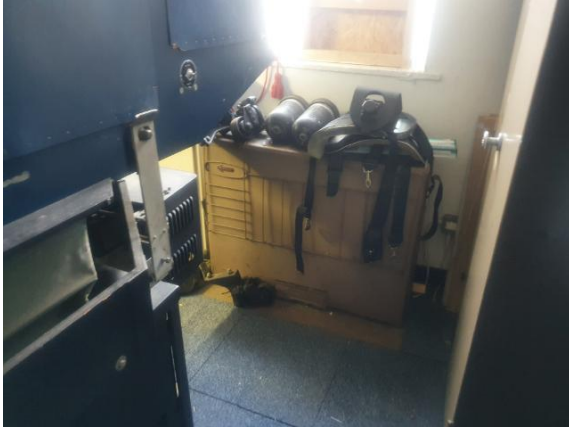
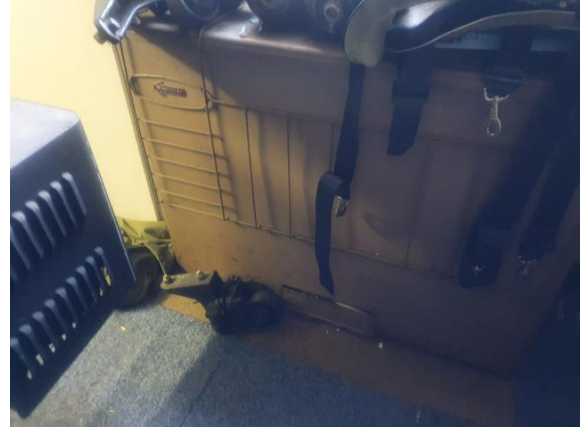
<b>Item No:</b>	<b>3</b>	<b>Sample No:</b>	<b>N/A</b>
<b>Location:</b>	Ground Floor - Link Training Room 003

<b>Material Description:</b>	Heater - No Access Gained	
<b>Identification:</b>	Presumed to Contain Asbestos	
<b>Approx. quantity:</b>	1 no	
<b>Accessibility</b>	Difficult	<i>Assessment Score</i>
<b>Product type:</b>	Asbestos insulating board	2
<b>Extent of Damage:</b>	Major damage	3
<b>Surface Treatment:</b>	Unsealed AIB	2
<b>Asbestos type:</b>	Amosite, Chrysotile	2
<b>Material Assessment Score:</b>		9
<b>Priority Assessment Score:</b>		Medium
<b>Action:</b>	Manage	
<b>Comments:</b>	No access within live heater

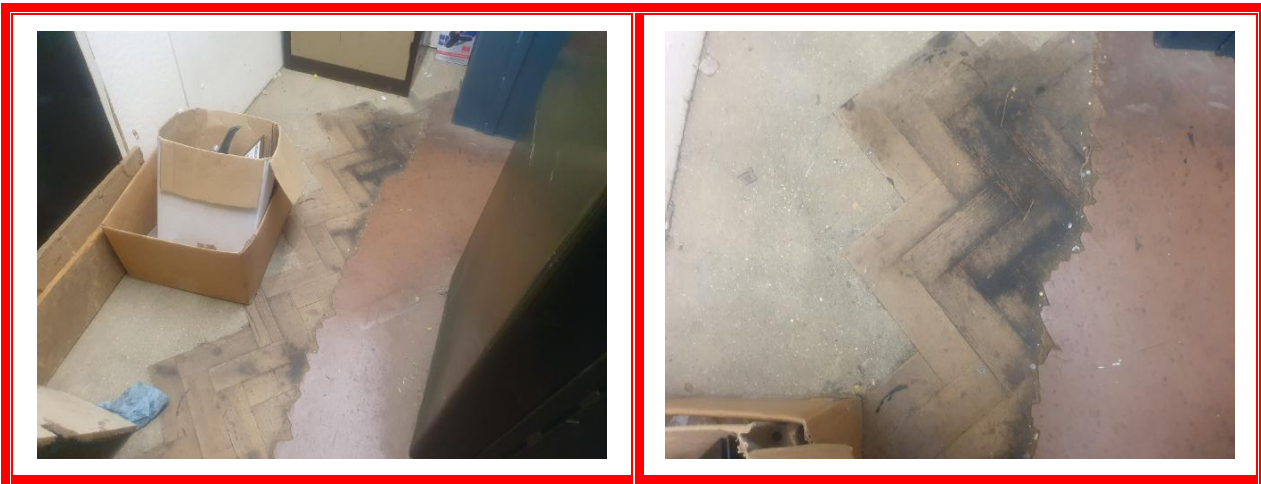
<b>Item No:</b>	<b>4</b>	<b>Sample No:</b>	<b>N/A</b>
<b>Location:</b>	Ground Floor - Drill Hall Stores 004

<b>Material Description:</b>	Adhesive under Parquet Flooring - Bituminous Product	
<b>Identification:</b>	Presumed to Contain Asbestos	
<b>Approx. quantity:</b>	4 m <sup>2</sup>	
<b>Accessibility</b>	Difficult	<i>Assessment Score</i>
<b>Product type:</b>	Bitumen	1
<b>Extent of Damage:</b>	Minor damage	1
<b>Surface Treatment:</b>	Non-Friable	0
<b>Asbestos type:</b>	Chrysotile	1
<b>Material Assessment Score:</b>		3
<b>Priority Assessment Score:</b>		Negligible
<b>Action:</b>	Manage	
<b>Comments:</b>	No access under flooring without causing irreparable damage

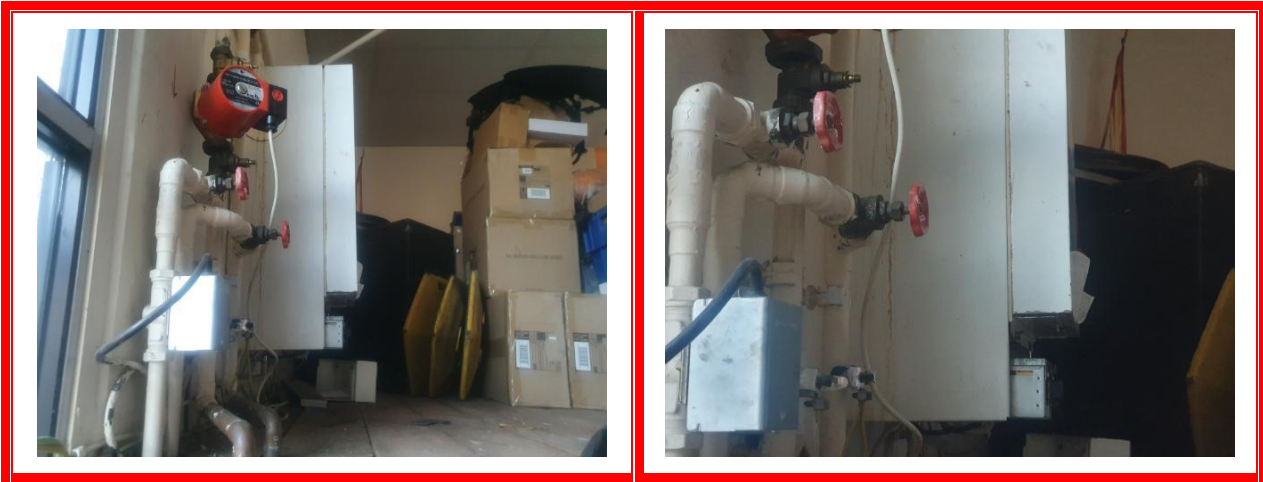
<b>Item No:</b>	<b>5</b>	<b>Sample No:</b>	<b>N/A</b>
<b>Location:</b>	Ground Floor - Mezzanine Above Link Room/Store 005

<b>Material Description:</b>	Glowworm Boiler - No Access Gained	
<b>Identification:</b>	Presumed to Contain Asbestos	
<b>Approx. quantity:</b>	1 no	
<b>Accessibility</b>	Difficult	<i>Assessment Score</i>
<b>Product type:</b>	Asbestos insulating board	2
<b>Extent of Damage:</b>	Major damage	3
<b>Surface Treatment:</b>	Unsealed AIB	2
<b>Asbestos type:</b>	Amosite, Chrysotile	2
<b>Material Assessment Score:</b>		9
<b>Priority Assessment Score:</b>		Medium
<b>Action:</b>	Manage	
<b>Comments:</b>	No access within live boiler

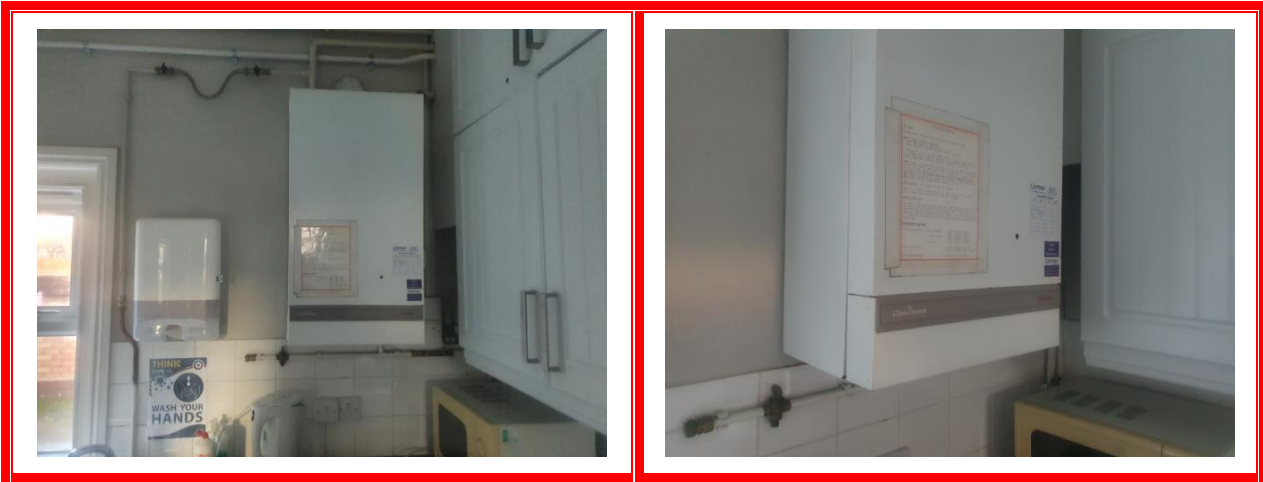
<b>Item No:</b>	<b>6</b>	<b>Sample No:</b>	<b>N/A</b>
<b>Location:</b>	Ground Floor - Cadet Mess 006

<b>Material Description:</b>	Glowworm Boiler - No Access Gained	
<b>Identification:</b>	Presumed to Contain Asbestos	
<b>Approx. quantity:</b>	1 no	
<b>Accessibility</b>	Difficult	<i>Assessment Score</i>
<b>Product type:</b>	Asbestos insulating board	2
<b>Extent of Damage:</b>	Major damage	3
<b>Surface Treatment:</b>	Unsealed AIB	2
<b>Asbestos type:</b>	Amosite, Chrysotile	2
<b>Material Assessment Score:</b>		9
<b>Priority Assessment Score:</b>		Medium
<b>Action:</b>	Manage	
<b>Comments:</b>	No access within live boiler

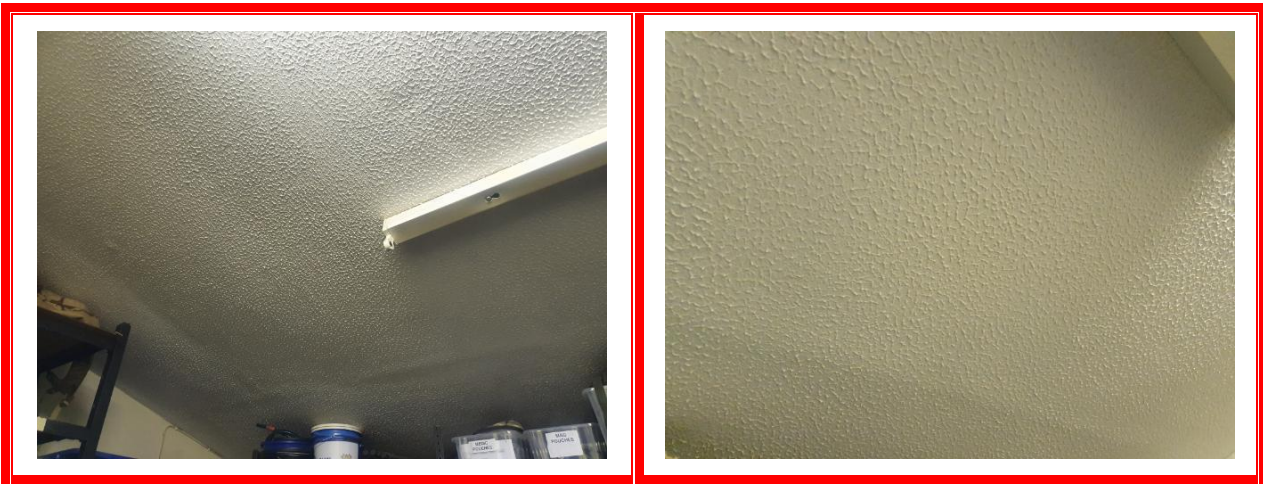
<b>Item No:</b>	<b>7</b>	<b>Sample No:</b>	<b>N/A</b>
<b>Location:</b>	Ground Floor - Store 007

<b>Material Description:</b>	Ceiling - Textured Coating	
<b>Identification:</b>	Previously Sampled - Asbestos Detected	
<b>Approx. quantity:</b>	15 m <sup>2</sup>	
<b>Accessibility</b>	Difficult	<i>Assessment Score</i>
<b>Product type:</b>	Textured Coating	1
<b>Extent of Damage:</b>	Slight / minor damage	1
<b>Surface Treatment:</b>	Non-friable	0
<b>Asbestos type:</b>	Chrysotile	1
<b>Material Assessment Score:</b>		3
<b>Priority Assessment Score:</b>		Negligible
<b>Action:</b>	Manage	
<b>Comments:</b>	Previously sampled ref: Armour 30/9/19 Sample DK/4

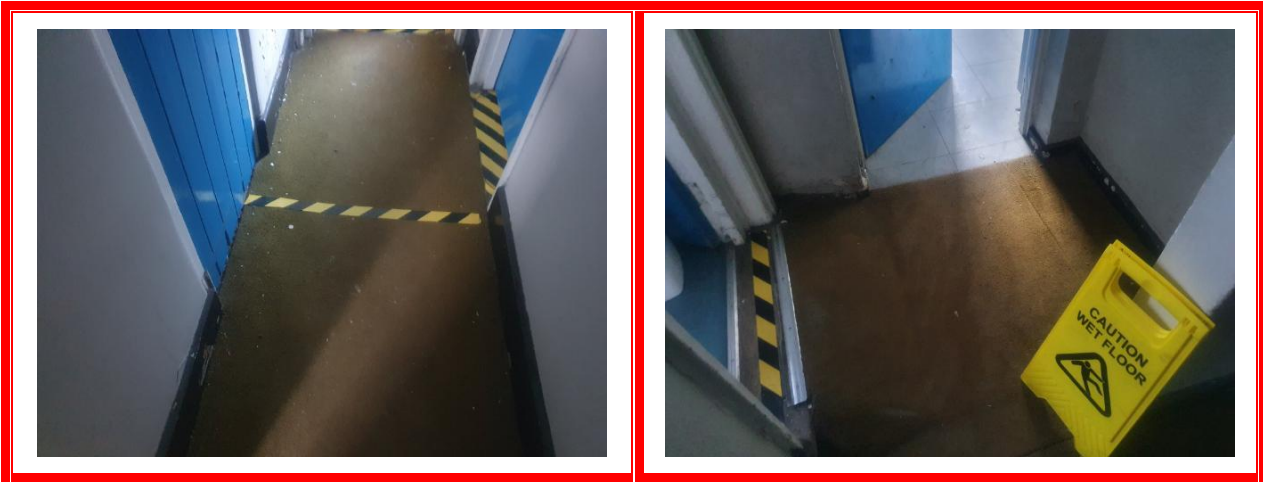
<b>Item No:</b>	<b>8</b>	<b>Sample No:</b>	<b>N/A</b>
<b>Location:</b>	Ground Floor - Circulation and Cupboard 008

<b>Material Description:</b>	Floor Tiles and Adhesive - Vinyl Products	
<b>Identification:</b>	Previously Sampled - Asbestos Detected	
<b>Approx. quantity:</b>	5 m <sup>2</sup>	
<b>Accessibility</b>	Difficult	<i>Assessment Score</i>
<b>Product type:</b>	Vinyl	1
<b>Extent of Damage:</b>	Slight / minor damage	1
<b>Surface Treatment:</b>	Non-friable	0
<b>Asbestos type:</b>	Chrysotile	1
<b>Material Assessment Score:</b>		3
<b>Priority Assessment Score:</b>		Negligible
<b>Action:</b>	Manage	
<b>Comments:</b>	Under carpet. Previously sampled ref: Armour 30/9/19 Sample DK/5

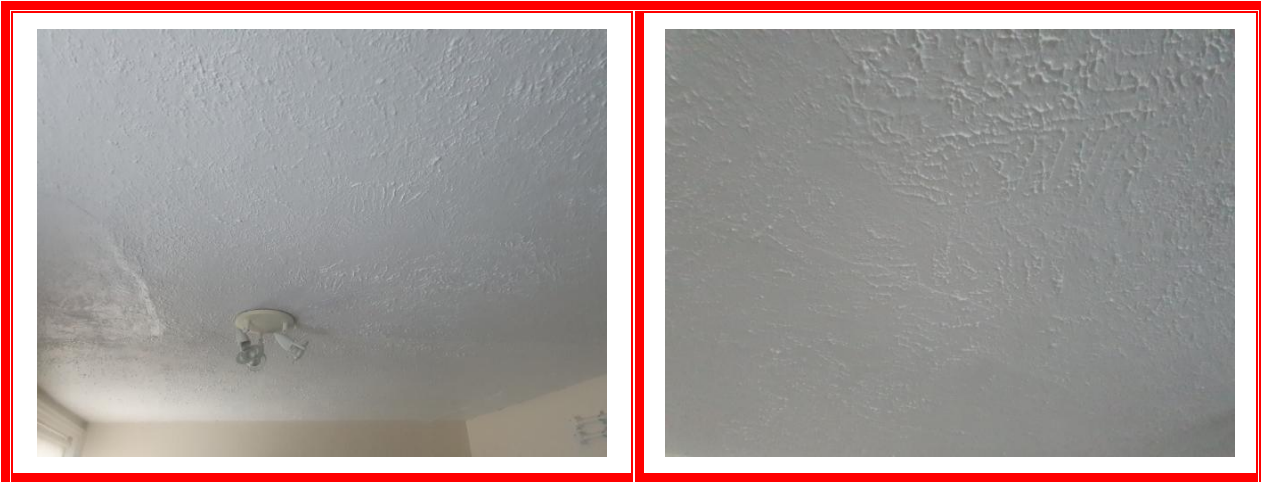
<b>Item No:</b>	<b>10</b>	<b>Sample No:</b>	<b>N/A</b>
<b>Location:</b>	Ground Floor - Officers Mess Room 010

<b>Material Description:</b>	Ceiling - Textured Coating	
<b>Identification:</b>	Previously Sampled - Asbestos Detected	
<b>Approx. quantity:</b>	20 m <sup>2</sup>	
<b>Accessibility</b>	Difficult	<i>Assessment Score</i>
<b>Product type:</b>	Textured Coating	1
<b>Extent of Damage:</b>	Slight / minor damage	1
<b>Surface Treatment:</b>	Non-friable	0
<b>Asbestos type:</b>	Chrysotile	1
<b>Material Assessment Score:</b>		3
<b>Priority Assessment Score:</b>		Negligible
<b>Action:</b>	Manage	
<b>Comments:</b>	Previously sampled ref: Armour 30/9/19 Sample DK/8

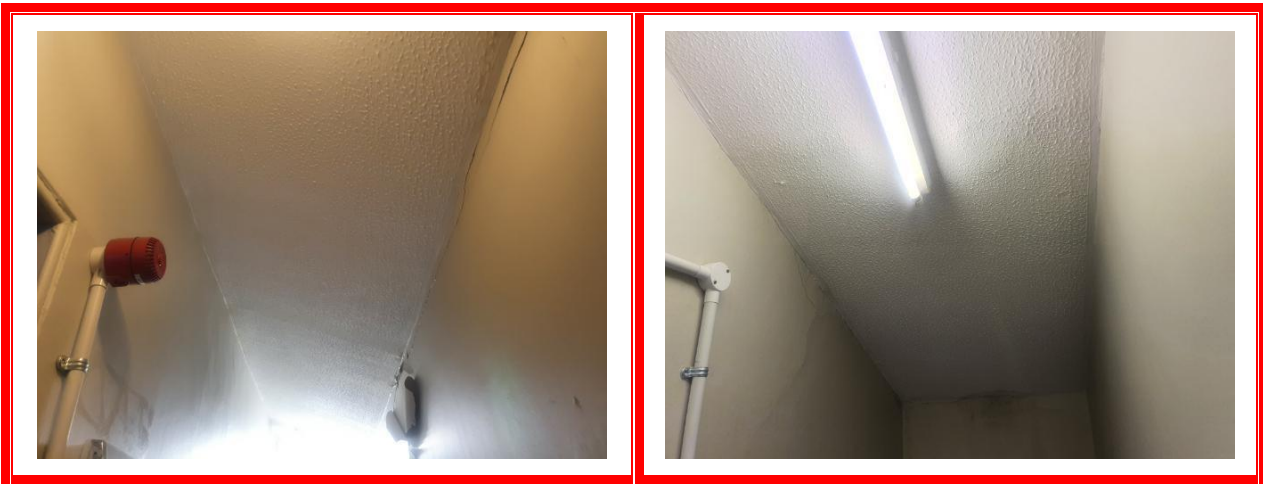
<b>Item No:</b>	<b>12</b>	<b>Sample No:</b>	<b>N/A</b>
<b>Location:</b>	First Floor - Stairwell and Landing 012

<b>Material Description:</b>	Ceiling - Textured Coating	
<b>Identification:</b>	Previously Sampled - Asbestos Detected	
<b>Approx. quantity:</b>	8 m <sup>2</sup>	
<b>Accessibility</b>	Difficult	<i>Assessment Score</i>
<b>Product type:</b>	Textured Coating	1
<b>Extent of Damage:</b>	Slight / minor damage	1
<b>Surface Treatment:</b>	Non-friable	0
<b>Asbestos type:</b>	Chrysotile	1
<b>Material Assessment Score:</b>		3
<b>Priority Assessment Score:</b>		Negligible
<b>Action:</b>	Manage	
<b>Comments:</b>	Previously sampled ref: Armour 30/9/19 Sample DK/9

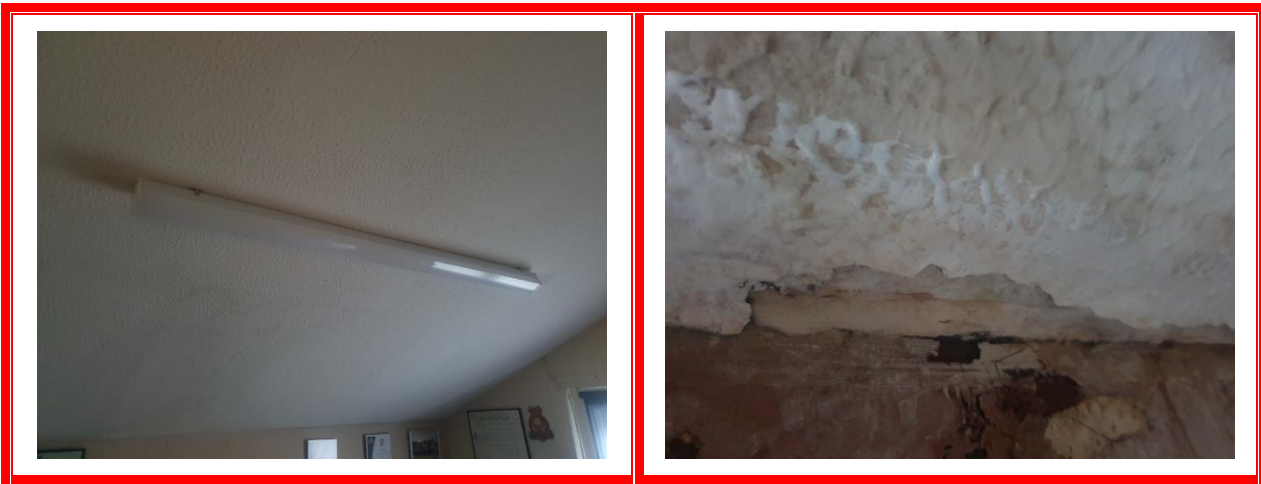
<b>Item No:</b>	<b>13</b>	<b>Sample No:</b>	<b>N/A</b>
<b>Location:</b>	First Floor - Offices x 2 013

<b>Material Description:</b>	Ceilings - Textured Coating	
<b>Identification:</b>	Previously Sampled - Asbestos Detected	
<b>Approx. quantity:</b>	15 m <sup>2</sup>	
<b>Accessibility</b>	Easy	<i>Assessment Score</i>
<b>Product type:</b>	Textured Coating	1
<b>Extent of Damage:</b>	Moderate damage	2
<b>Surface Treatment:</b>	Non-friable	0
<b>Asbestos type:</b>	Chrysotile	1
<b>Material Assessment Score:</b>		4
<b>Priority Assessment Score:</b>		Negligible
<b>Action:</b>	Encapsulate	
<b>Comments:</b>	Previously sampled ref: Armour 30/9/19 Sample DK/9

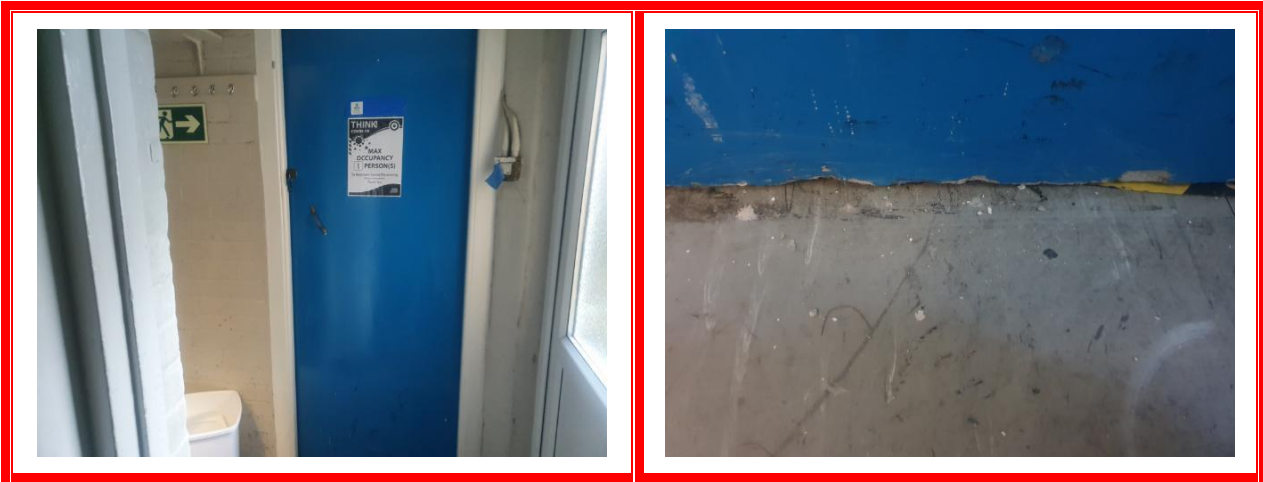
<b>Item No:</b>	<b>14</b>	<b>Sample No:</b>	<b>N/A</b>
<b>Location:</b>	Ground Floor - Circulation and Store 014

<b>Material Description:</b>	Panel on Door - Insulating Board	
<b>Identification:</b>	Previously Sampled - Asbestos Detected	
<b>Approx. quantity:</b>	2 m <sup>2</sup>	
<b>Accessibility</b>	Easy	Assessment Score
<b>Product type:</b>	Asbestos insulating board	2
<b>Extent of Damage:</b>	Moderate damage	2
<b>Surface Treatment:</b>	Unsealed AIB	2
<b>Asbestos type:</b>	Amosite	2
<b>Material Assessment Score:</b>		8
<b>Priority Assessment Score:</b>		Medium
<b>Action:</b>	Encapsulate	
<b>Comments:</b>	Previously sampled ref: Armour 30/9/19 Sample DK/10. Encapsulate and label or remove if in constant use

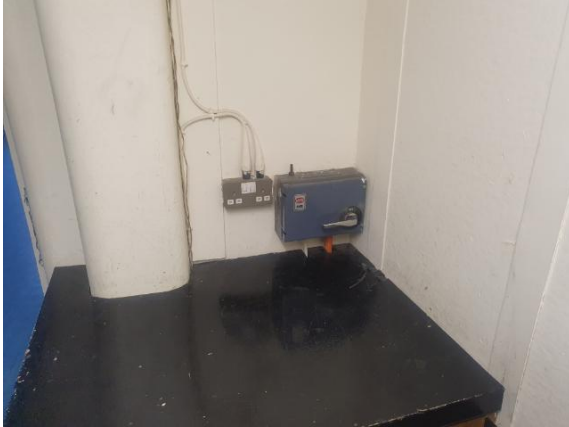
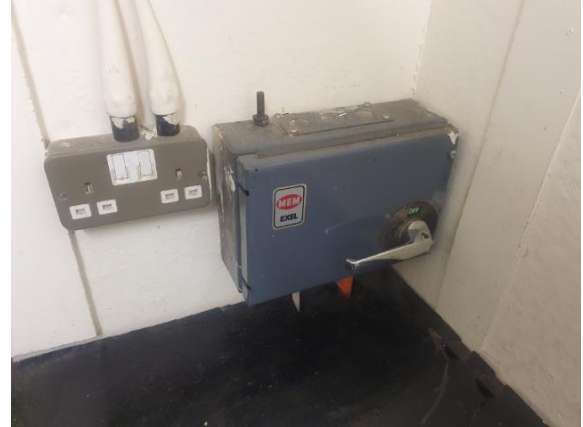
<b>Item No:</b>	<b>15</b>	<b>Sample No:</b>	<b>N/A</b>
<b>Location:</b>	Ground Floor - Drill Hall Store 015

<b>Material Description:</b>	Electrical Panel - No Access Gained	
<b>Identification:</b>	Presumed to Contain Asbestos	
<b>Approx. quantity:</b>	1 no	
<b>Accessibility</b>	Difficult	<i>Assessment Score</i>
<b>Product type:</b>	Flashguards	2
<b>Extent of Damage:</b>	Minor damage	1
<b>Surface Treatment:</b>	Woven	1
<b>Asbestos type:</b>	Chrysotile	1
<b>Material Assessment Score:</b>		5
<b>Priority Assessment Score:</b>		Low
<b>Action:</b>	Manage	
<b>Comments:</b>	No access within live electrics

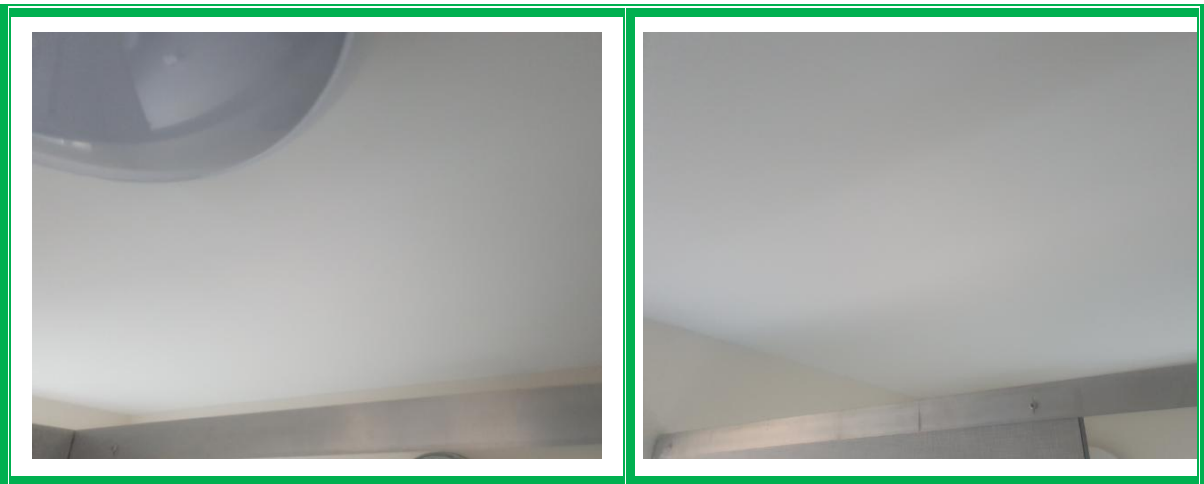
<b>Item No:</b>	9	<b>Sample No:</b>	N/A
<b>Location:</b>	Ground Floor - WC 009

<b>Material Description:</b>	No Suspect Materials Found	
<b>Identification:</b>	N/A	
<b>Approx. quantity:</b>	N/A	
<b>Accessibility</b>	N/A	<i>Assessment Score</i>
<b>Product type:</b>	N/A	N/A
<b>Extent of Damage:</b>	N/A	N/A
<b>Surface Treatment:</b>	N/A	N/A
<b>Asbestos type:</b>	N/A	N/A
<b>Material Assessment Score:</b>		
<b>Priority Assessment Score:</b>		
<b>Action:</b>	N/A	
<b>Comments:</b>	Asbestos ceiling was removed and replaced following a roof leak

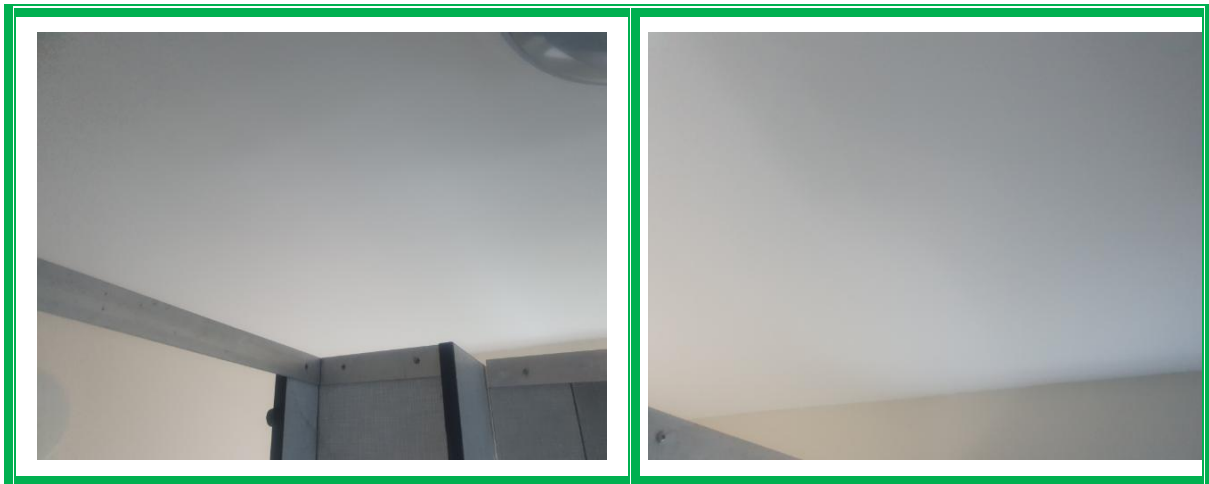
<b>Item No:</b>	<b>11</b>	<b>Sample No:</b>	<b>N/A</b>
<b>Location:</b>	Ground Floor - WC 011

<b>Material Description:</b>	No Suspect Materials Found	
<b>Identification:</b>	N/A	
<b>Approx. quantity:</b>	N/A	
<b>Accessibility</b>	N/A	<i>Assessment Score</i>
<b>Product type:</b>	N/A	N/A
<b>Extent of Damage:</b>	N/A	N/A
<b>Surface Treatment:</b>	N/A	N/A
<b>Asbestos type:</b>	N/A	N/A
<b>Material Assessment Score:</b>		
<b>Priority Assessment Score:</b>		
<b>Action:</b>	N/A	
<b>Comments:</b>	Asbestos ceiling was removed and replaced following a roof leak
