**Project Number 3700**

**Re-Inspection  
Asbestos Survey Report - Revised**

**675 Army Air Corps  
Somerset  
TA1 5LJ**

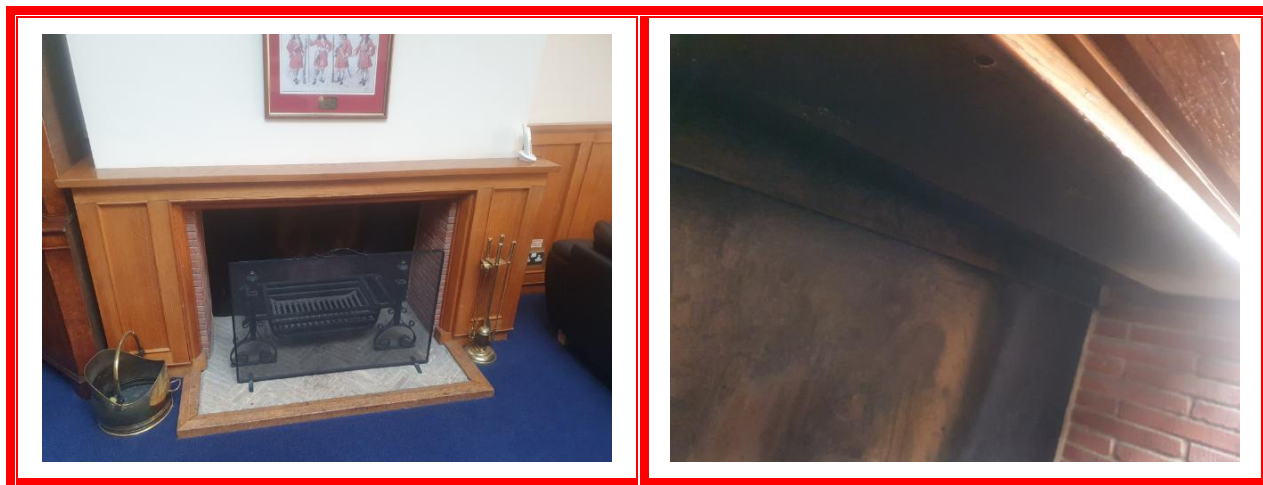
<b>Item No:</b>	<b>1</b>	<b>Sample No:</b>	<b>N/A</b>
<b>Location:</b>	First Floor - Officers Lounge 001

<b>Material Description:</b>	Panel to Top of Fireplace - Cement Product	
<b>Identification:</b>	Previously Sampled - Asbestos Detected	
<b>Approx. quantity:</b>	1 m <sup>2</sup>	
<b>Accessibility</b>	Difficult	Assessment Score
<b>Product type:</b>	Cement	1
<b>Extent of Damage:</b>	Slight / minor damage	1
<b>Surface Treatment:</b>	Unsealed Cement	1
<b>Asbestos type:</b>	Chrysotile	1
<b>Material Assessment Score:</b>		4
<b>Priority Assessment Score:</b>		Negligible
<b>Action:</b>	Encapsulate	
<b>Comments:</b>	Previously sampled ref: Armour 18/6/19 Sample DK/1

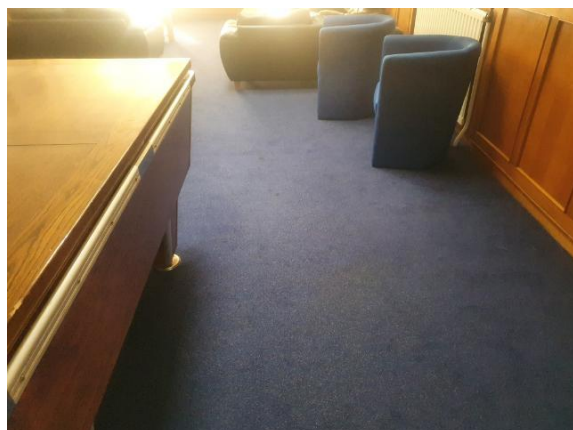
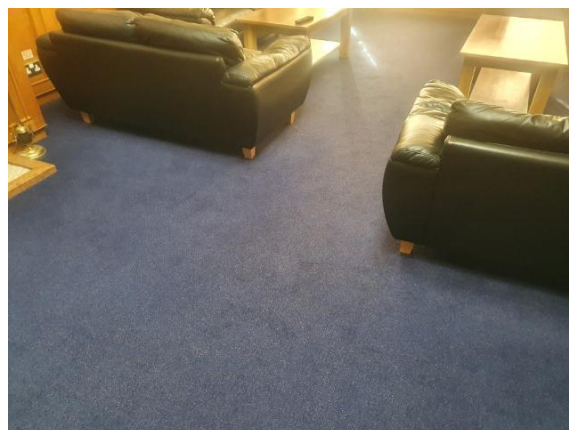
**Location:** First Floor - Officers Lounge 002

<b>Material Description:</b>	Floor Tiles - Vinyl Products	
<b>Identification:</b>	Previously Sampled - Asbestos Detected	
<b>Approx. quantity:</b>	50 m <sup>2</sup>	
<b>Accessibility</b>	Difficult	<i>Assessment Score</i>
<b>Product type:</b>	Vinyl	1
<b>Extent of Damage:</b>	Slight / minor damage	1
<b>Surface Treatment:</b>	Non-friable	0
<b>Asbestos type:</b>	Chrysotile	1
<b>Material Assessment Score:</b>		3
<b>Priority Assessment Score:</b>		Negligible
<b>Action:</b>	Manage	
<b>Comments:</b>	Previously sampled ref: Armour 18/6/19 Sample DK/2. Under carpet

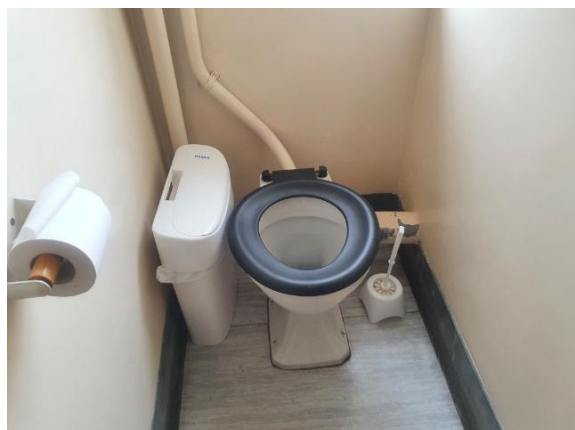
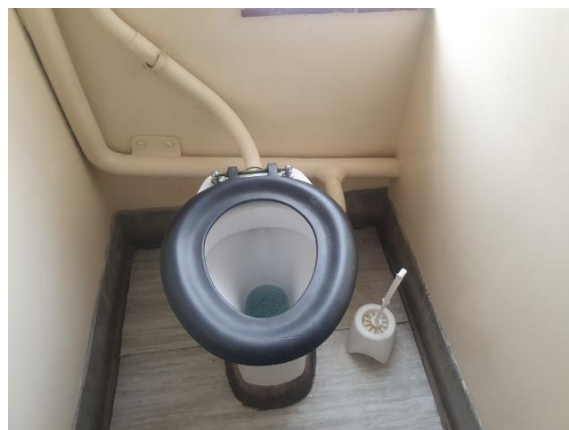
**Location:** First Floor - WC's x 2 003

<b>Material Description:</b>	Toilet Seats - PVC / Reinforced Plastics	
<b>Identification:</b>	Presumed to Contain Asbestos	
<b>Approx. quantity:</b>	2 no	
<b>Accessibility</b>	Easy	<i>Assessment Score</i>
<b>Product type:</b>	Bakelite	1
<b>Extent of Damage:</b>	Major damage	3
<b>Surface Treatment:</b>	Unsealed Insulation	3
<b>Asbestos type:</b>	Chrysotile	1
<b>Material Assessment Score:</b>		8
<b>Priority Assessment Score:</b>		Medium
<b>Action:</b>	Manage	
<b>Comments:</b>	Not possible to sample as may damage integrity of the seats

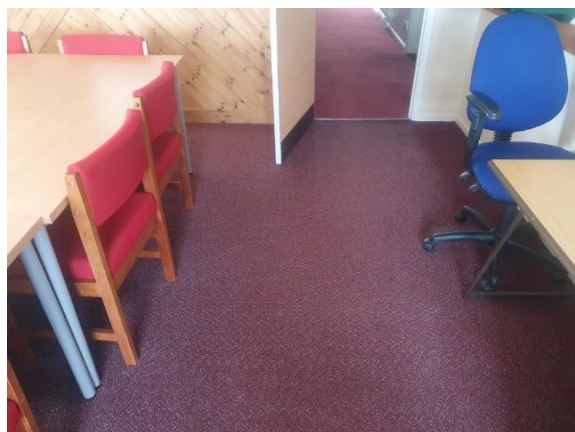
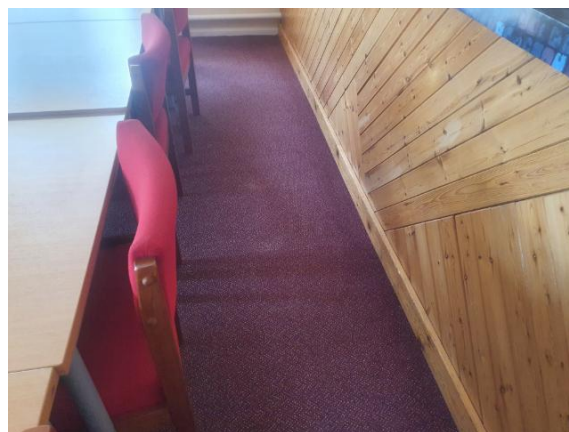
**Location:** First Floor - Conference Room 004

<b>Material Description:</b>	Floor Tiles - Vinyl Products	
<b>Identification:</b>	Previously Sampled - Asbestos Detected	
<b>Approx. quantity:</b>	35 m <sup>2</sup>	
<b>Accessibility</b>	Difficult	<i>Assessment Score</i>
<b>Product type:</b>	Vinyl	1
<b>Extent of Damage:</b>	Slight / minor damage	1
<b>Surface Treatment:</b>	Non-friable	0
<b>Asbestos type:</b>	Chrysotile	1
<b>Material Assessment Score:</b>		3
<b>Priority Assessment Score:</b>		Negligible
<b>Action:</b>	Manage	
<b>Comments:</b>	Previously sampled ref: Armour 18/6/19 Sample DK/4. Under carpet

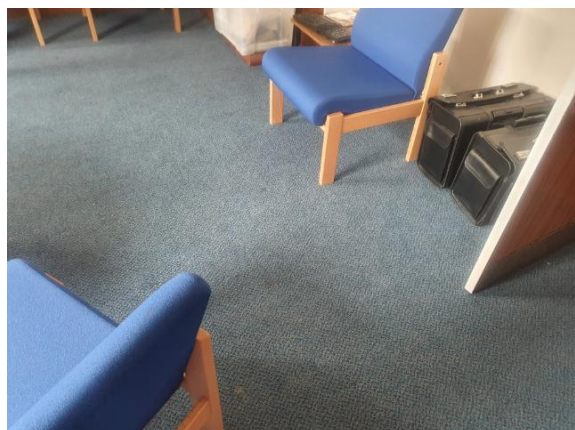
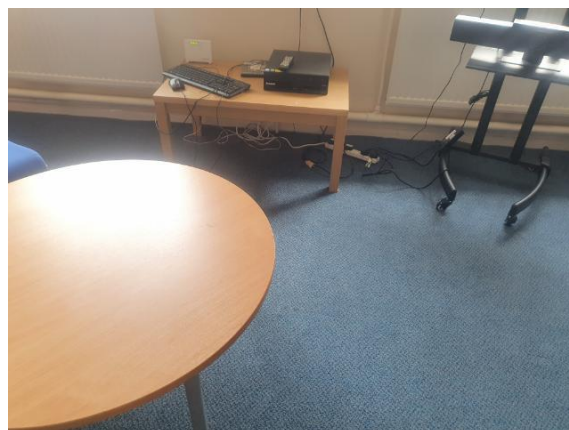
**Location:** First Floor - Harding Room 005

<b>Material Description:</b>	Floor Tiles - Vinyl Products	
<b>Identification:</b>	Previously Sampled - Asbestos Detected	
<b>Approx. quantity:</b>	36 m <sup>2</sup>	
<b>Accessibility</b>	Difficult	<i>Assessment Score</i>
<b>Product type:</b>	Vinyl	1
<b>Extent of Damage:</b>	Slight / minor damage	1
<b>Surface Treatment:</b>	Non-friable	0
<b>Asbestos type:</b>	Chrysotile	1
<b>Material Assessment Score:</b>		3
<b>Priority Assessment Score:</b>		Negligible
<b>Action:</b>	Manage	
<b>Comments:</b>	Previously sampled ref: Armour 18/6/19 Sample DK/6. Under carpet

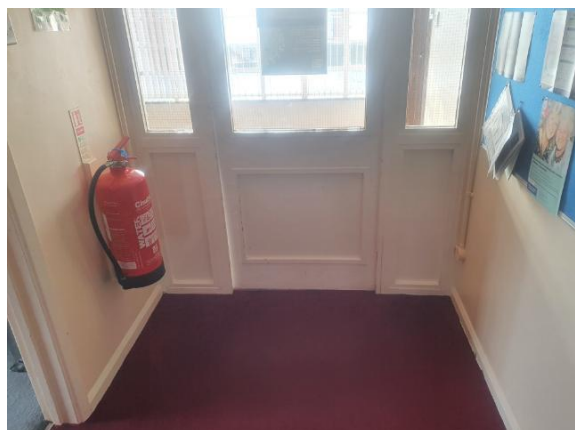
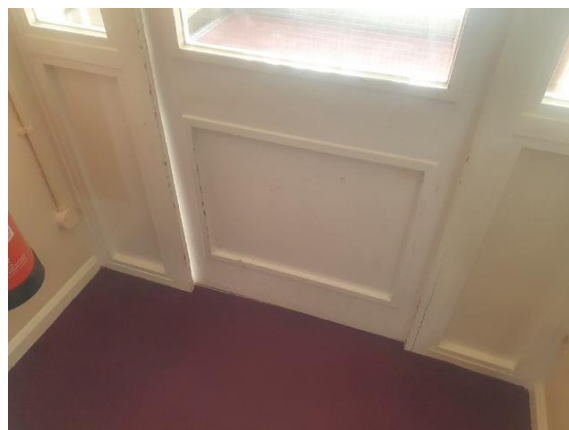
**Location:** First Floor - Corridor 006

<b>Material Description:</b>	Infill Panels to Door - Insulating Board	
<b>Identification:</b>	Previously Sampled - Asbestos Detected	
<b>Approx. quantity:</b>	2 m <sup>2</sup>	
<b>Accessibility</b>	Easy	<i>Assessment Score</i>
<b>Product type:</b>	Asbestos Insulating Board	2
<b>Extent of Damage:</b>	Good	0
<b>Surface Treatment:</b>	Encapsulated AIB	1
<b>Asbestos type:</b>	Amosite	2
<b>Material Assessment Score:</b>		5
<b>Priority Assessment Score:</b>		Low
<b>Action:</b>	Manage	
<b>Comments:</b>	Previously sampled ref: Armour 18/6/19 Sample DK/7. 3no panels

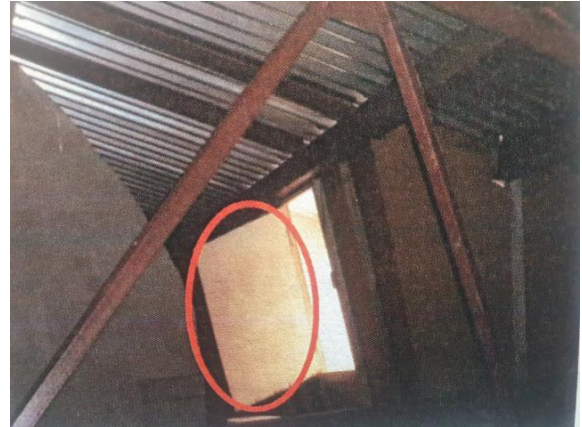
**Location:** First Floor - Loft Space above Corridor 007

<b>Material Description:</b>	Panel to Door - Insulating Board	
<b>Identification:</b>	Previously Sampled - Asbestos Detected	
<b>Approx. quantity:</b>	1 m <sup>2</sup>	
<b>Accessibility</b>	Difficult	<i>Assessment Score</i>
<b>Product type:</b>	Asbestos Insulating Board	2
<b>Extent of Damage:</b>	Slight / minor damage	1
<b>Surface Treatment:</b>	Unsealed AIB	2
<b>Asbestos type:</b>	Amosite	2
<b>Material Assessment Score:</b>		7
<b>Priority Assessment Score:</b>		Medium
<b>Action:</b>	Further Investigation Needed	
<b>Comments:</b>	No safe access to inspect. Panel is visible from the hatch

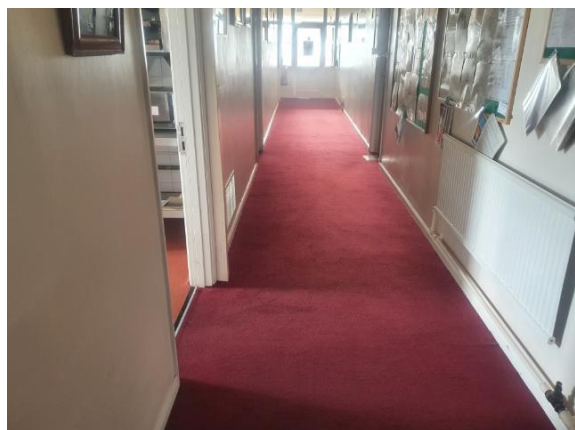
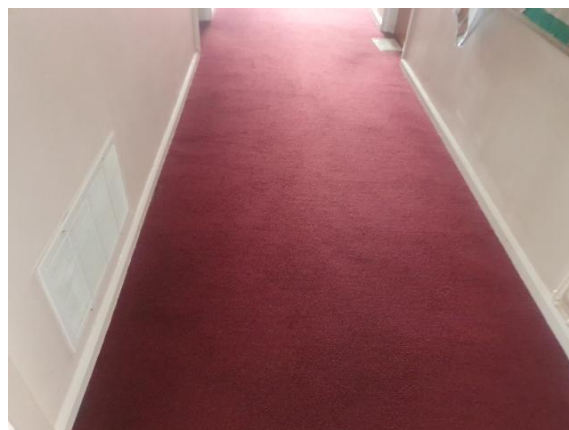
**Location:** First Floor - Corridor 008

<b>Material Description:</b>	Floor Tiles - Vinyl Products	
<b>Identification:</b>	Previously Sampled - Asbestos Detected	
<b>Approx. quantity:</b>	22 m <sup>2</sup>	
<b>Accessibility</b>	Difficult	<i>Assessment Score</i>
<b>Product type:</b>	Vinyl	1
<b>Extent of Damage:</b>	Slight / minor damage	1
<b>Surface Treatment:</b>	Non-friable	0
<b>Asbestos type:</b>	Chrysotile	1
<b>Material Assessment Score:</b>		3
<b>Priority Assessment Score:</b>		Negligible
<b>Action:</b>	Manage	
<b>Comments:</b>	Previously sampled ref: Armour 18/6/19 Sample DK/6. Under carpet

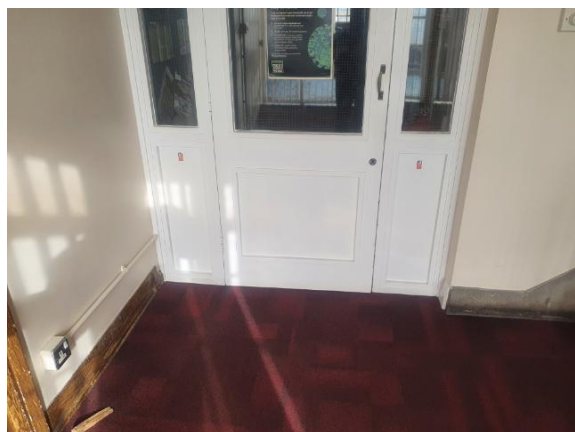
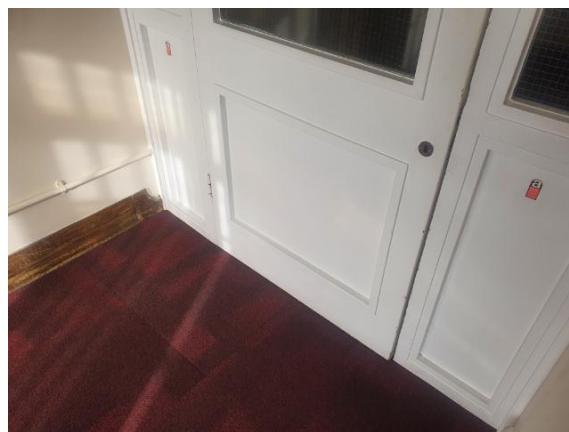
**Location:** First Floor - Landing 009

<b>Material Description:</b>	Infill Panels to Door - Insulating Board	
<b>Identification:</b>	Previously Sampled - Asbestos Detected	
<b>Approx. quantity:</b>	2 m <sup>2</sup>	
<b>Accessibility</b>	Easy	<i>Assessment Score</i>
<b>Product type:</b>	Asbestos Insulating Board	2
<b>Extent of Damage:</b>	Good	0
<b>Surface Treatment:</b>	Encapsulated AIB	1
<b>Asbestos type:</b>	Amosite	2
<b>Material Assessment Score:</b>		5
<b>Priority Assessment Score:</b>		Low
<b>Action:</b>	Manage	
<b>Comments:</b>	Previously sampled ref: Armour 18/6/19 Sample DK/7. 3no panels

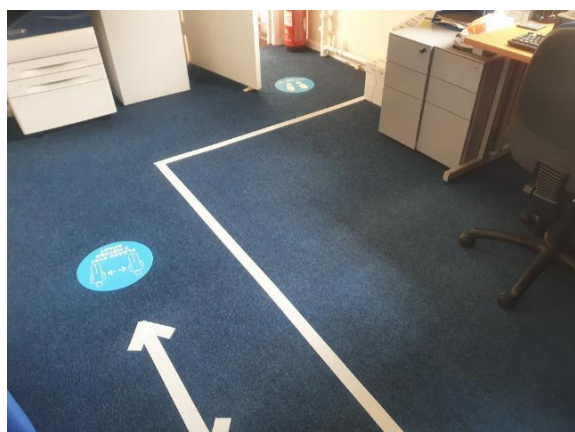
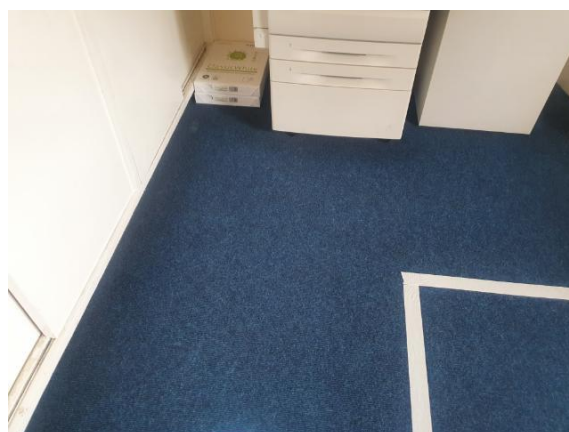
**Location:** First Floor - Office 010

<b>Material Description:</b>	Floor Tiles - Vinyl Products	
<b>Identification:</b>	Previously Sampled - Asbestos Detected	
<b>Approx. quantity:</b>	16 m <sup>2</sup>	
<b>Accessibility</b>	Difficult	<i>Assessment Score</i>
<b>Product type:</b>	Vinyl	1
<b>Extent of Damage:</b>	Slight / minor damage	1
<b>Surface Treatment:</b>	Non-friable	0
<b>Asbestos type:</b>	Chrysotile	1
<b>Material Assessment Score:</b>		3
<b>Priority Assessment Score:</b>		Negligible
<b>Action:</b>	Manage	
<b>Comments:</b>	Previously sampled ref: Armour 18/6/19 Sample DK/6. Under carpet

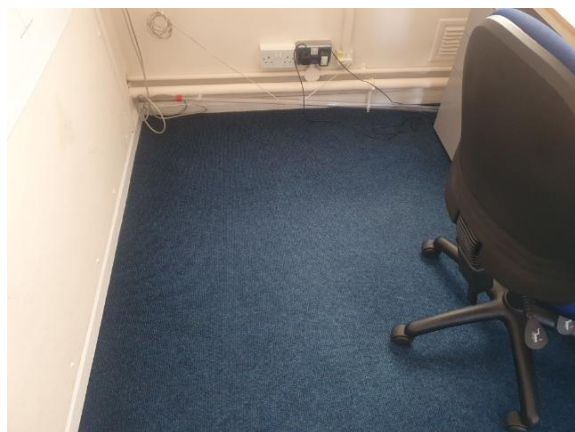
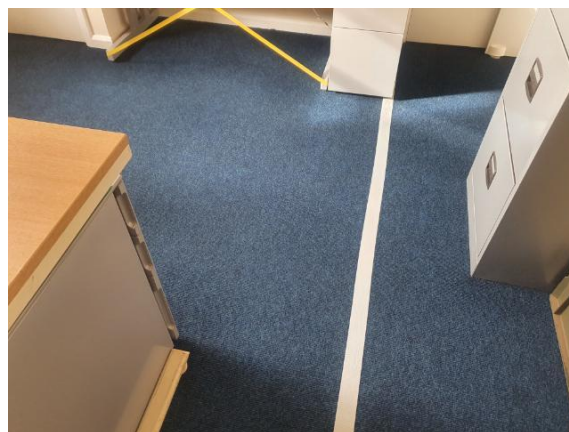
**Location:** First Floor - CEO Office 011

<b>Material Description:</b>	Floor Tiles - Vinyl Products	
<b>Identification:</b>	Previously Sampled - Asbestos Detected	
<b>Approx. quantity:</b>	16 m <sup>2</sup>	
<b>Accessibility</b>	Difficult	<i>Assessment Score</i>
<b>Product type:</b>	Vinyl	1
<b>Extent of Damage:</b>	Slight / minor damage	1
<b>Surface Treatment:</b>	Non-friable	0
<b>Asbestos type:</b>	Chrysotile	1
<b>Material Assessment Score:</b>		3
<b>Priority Assessment Score:</b>		Negligible
<b>Action:</b>	Manage	
<b>Comments:</b>	Previously sampled ref: Armour 18/6/19 Sample DK/6. Under carpet. No access within boxing within room

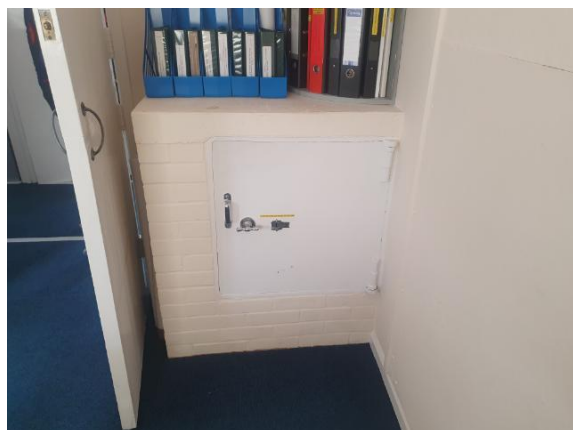
**Location:** First Floor - CEO Office 012

<b>Material Description:</b>	Safe - Insulating Board	
<b>Identification:</b>	Presumed to Contain Asbestos	
<b>Approx. quantity:</b>	1 no	
<b>Accessibility</b>	Difficult	<i>Assessment Score</i>
<b>Product type:</b>	Asbestos Insulating Board	2
<b>Extent of Damage:</b>	Major damage	3
<b>Surface Treatment:</b>	Unsealed Insulation	3
<b>Asbestos type:</b>	Amosite, Chrysotile	2
<b>Material Assessment Score:</b>		10
<b>Priority Assessment Score:</b>		High
<b>Action:</b>	Manage	
<b>Comments:</b>	No access within safe casings without damaging safe

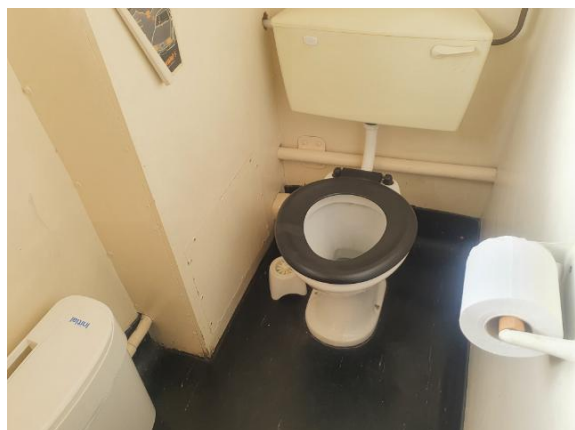
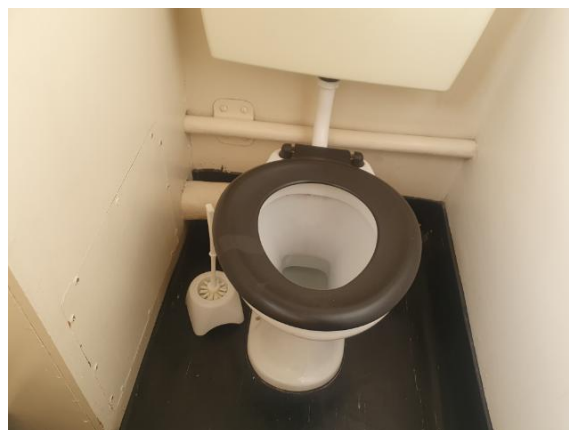
**Location:** First Floor - WC 013

<b>Material Description:</b>	Toilet Seat - PVC / Reinforced Plastics	
<b>Identification:</b>	Presumed to Contain Asbestos	
<b>Approx. quantity:</b>	1 no	
<b>Accessibility</b>	Easy	<i>Assessment Score</i>
<b>Product type:</b>	Bakelite	1
<b>Extent of Damage:</b>	Major damage	3
<b>Surface Treatment:</b>	Unsealed Insulation	3
<b>Asbestos type:</b>	Chrysotile	1
<b>Material Assessment Score:</b>		8
<b>Priority Assessment Score:</b>		Medium
<b>Action:</b>	Manage	
<b>Comments:</b>	Not possible to sample as may damage integrity of the seat

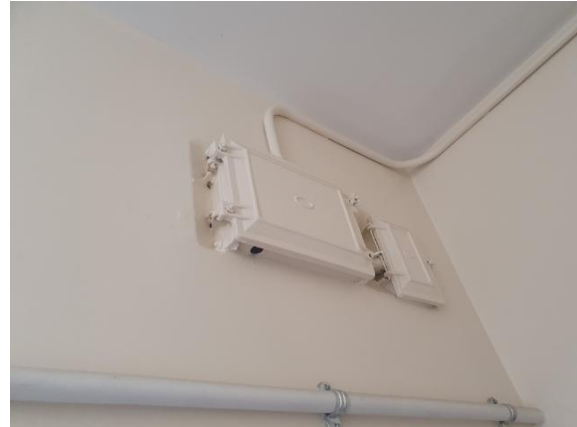
**Location:** First Floor - Landing/Corridor 014

<b>Material Description:</b>	Components within Electrical Boxes - Woven Product	
<b>Identification:</b>	Presumed to Contain Asbestos	
<b>Approx. quantity:</b>	2 no	
<b>Accessibility</b>	Difficult	<i>Assessment Score</i>
<b>Product type:</b>	Rope	2
<b>Extent of Damage:</b>	Major damage	3
<b>Surface Treatment:</b>	Unsealed Insulation	3
<b>Asbestos type:</b>	Chrysotile	1
<b>Material Assessment Score:</b>		9
<b>Priority Assessment Score:</b>		N/A
<b>Action:</b>	Manage	
<b>Comments:</b>	No access within live boxes

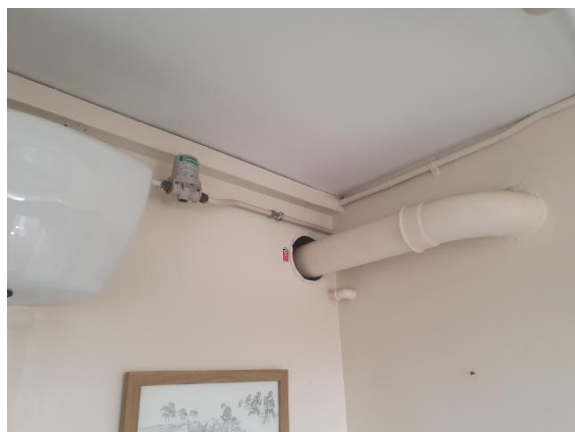
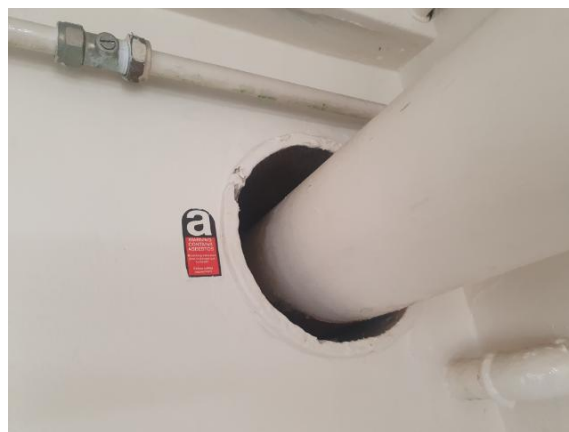
**Location:** Ground Floor - WC 016

<b>Material Description:</b>	Pipework Sleeve within Wall - Cement Product	
<b>Identification:</b>	Previously Sampled - Asbestos Detected	
<b>Approx. quantity:</b>	<1 LM	
<b>Accessibility</b>	Difficult	<i>Assessment Score</i>
<b>Product type:</b>	Cement	1
<b>Extent of Damage:</b>	Slight / minor damage	1
<b>Surface Treatment:</b>	Unsealed Cement	1
<b>Asbestos type:</b>	Chrysotile	1
<b>Material Assessment Score:</b>		4
<b>Priority Assessment Score:</b>		Negligible
<b>Action:</b>	Encapsulate	
<b>Comments:</b>	Previously sampled ref: Armour 18/6/19 Sample DK/9

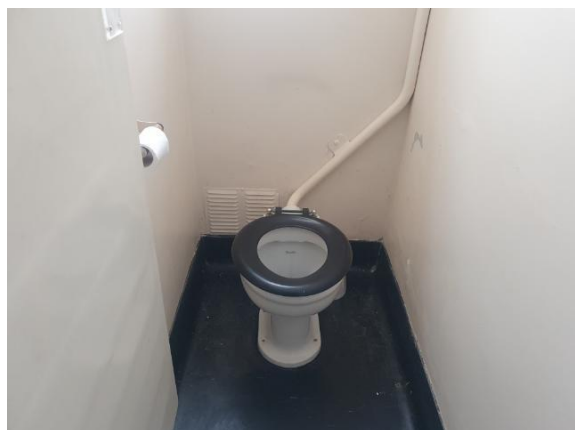
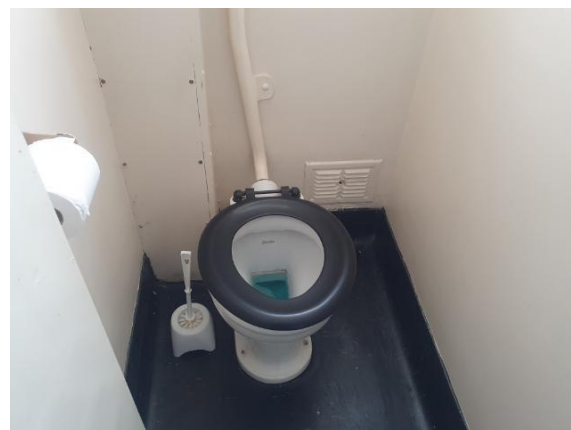
**Location:** Ground Floor - Changing Room 017

<b>Material Description:</b>	Toilet Seat - PVC / Reinforced Plastics	
<b>Identification:</b>	Presumed to Contain Asbestos	
<b>Approx. quantity:</b>	2 no	
<b>Accessibility</b>	Easy	<i>Assessment Score</i>
<b>Product type:</b>	Bakelite	1
<b>Extent of Damage:</b>	Major damage	3
<b>Surface Treatment:</b>	Unsealed Insulation	3
<b>Asbestos type:</b>	Chrysotile	1
<b>Material Assessment Score:</b>		8
<b>Priority Assessment Score:</b>		Medium
<b>Action:</b>	Manage	
<b>Comments:</b>	Not possible to sample as may damage integrity of the seats

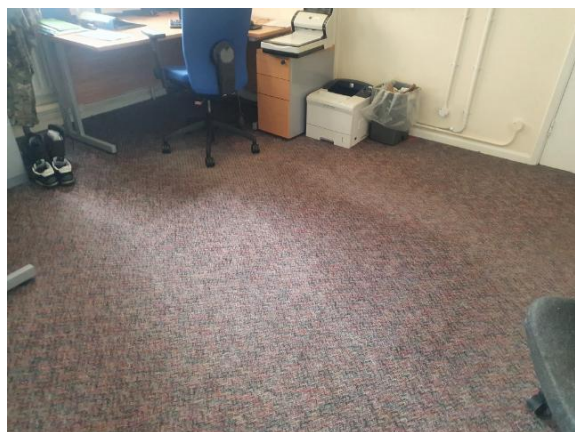
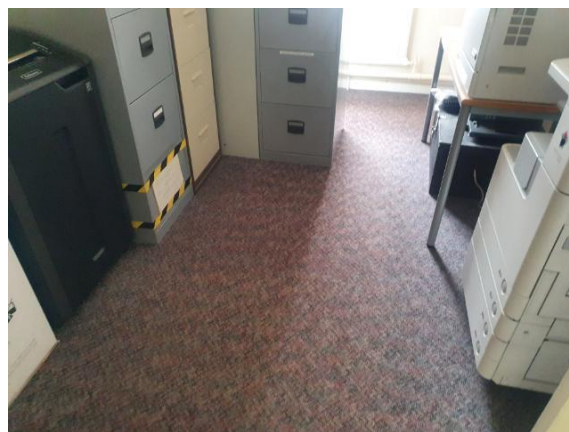
**Location:** Ground Floor - Offices x 2 018

<b>Material Description:</b>	Floor Tiles - Vinyl Products	
<b>Identification:</b>	Previously Sampled - Asbestos Detected	
<b>Approx. quantity:</b>	28 m <sup>2</sup>	
<b>Accessibility</b>	Difficult	<i>Assessment Score</i>
<b>Product type:</b>	Vinyl	1
<b>Extent of Damage:</b>	Moderate damage	2
<b>Surface Treatment:</b>	Non-friable	0
<b>Asbestos type:</b>	Chrysotile	1
<b>Material Assessment Score:</b>		4
<b>Priority Assessment Score:</b>		Negligible
<b>Action:</b>	Manage	
<b>Comments:</b>	Previously sampled ref: Armour 18/6/19 Sample DK/10. Under carpet

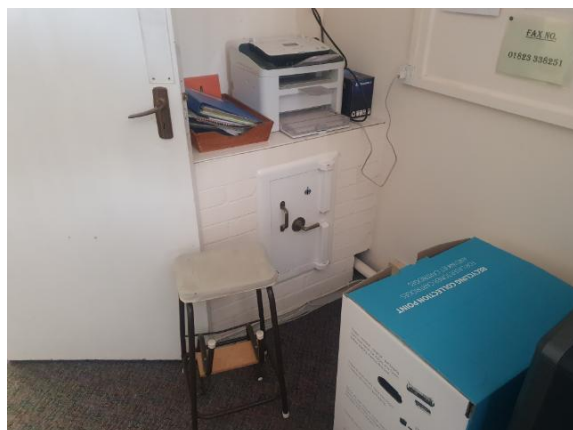
**Location:** Ground Floor - Office 019

<b>Material Description:</b>	Safe - Insulating Board	
<b>Identification:</b>	Presumed to Contain Asbestos	
<b>Approx. quantity:</b>	1 no	
<b>Accessibility</b>	Difficult	Assessment Score
<b>Product type:</b>	Asbestos Insulating Board	2
<b>Extent of Damage:</b>	Major damage	3
<b>Surface Treatment:</b>	Unsealed Insulation	3
<b>Asbestos type:</b>	Amosite, Chrysotile	2
<b>Material Assessment Score:</b>		10
<b>Priority Assessment Score:</b>		High
<b>Action:</b>	Manage	
<b>Comments:</b>	No access within safe casings without damaging safe

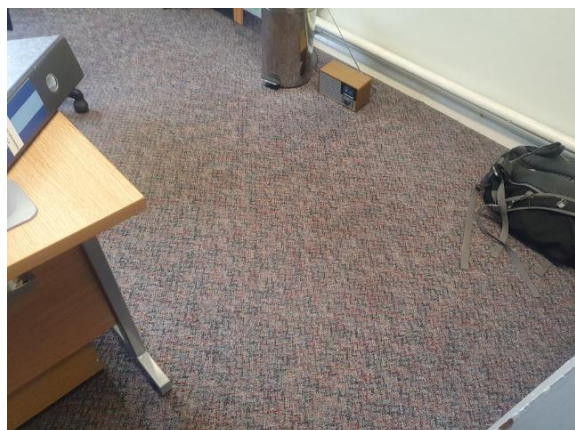
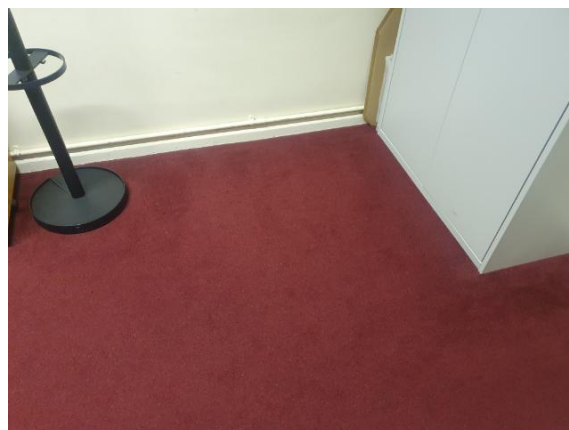
**Location:** Ground Floor - Offices x 2 020

<b>Material Description:</b>	Floor Tiles - Vinyl Products	
<b>Identification:</b>	Previously Sampled - Asbestos Detected	
<b>Approx. quantity:</b>	22 m <sup>2</sup>	
<b>Accessibility</b>	Difficult	<i>Assessment Score</i>
<b>Product type:</b>	Vinyl	1
<b>Extent of Damage:</b>	Slight / minor damage	1
<b>Surface Treatment:</b>	Non-friable	0
<b>Asbestos type:</b>	Chrysotile	1
<b>Material Assessment Score:</b>		3
<b>Priority Assessment Score:</b>		Negligible
<b>Action:</b>	Manage	
<b>Comments:</b>	Previously sampled ref: Armour 18/6/19 Sample DK/10. Under carpet

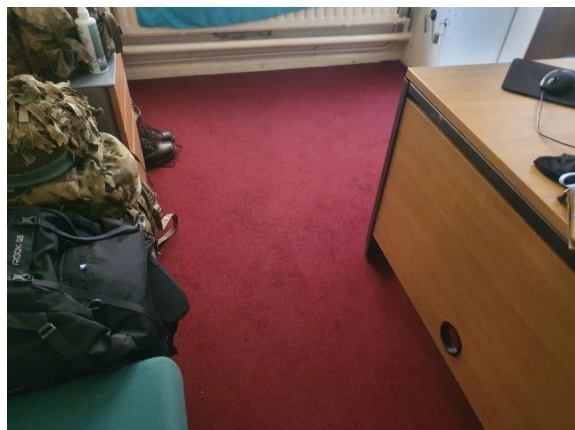
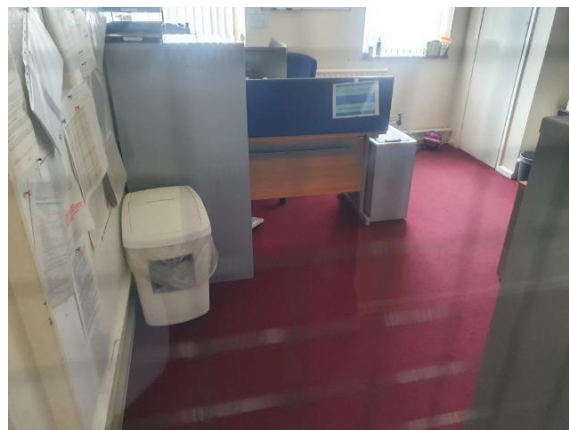
**Location:** Ground Floor - Admin Office and Staff Instructors Office  
021

<b>Material Description:</b>	Floor Tiles - Vinyl Products	
<b>Identification:</b>	Previously Sampled - Asbestos Detected	
<b>Approx. quantity:</b>	30 m <sup>2</sup>	
<b>Accessibility</b>	Difficult	<i>Assessment Score</i>
<b>Product type:</b>	Vinyl	1
<b>Extent of Damage:</b>	Slight / minor damage	1
<b>Surface Treatment:</b>	Non-friable	0
<b>Asbestos type:</b>	Chrysotile	1
<b>Material Assessment Score:</b>		3
<b>Priority Assessment Score:</b>		Negligible
<b>Action:</b>	Manage	
<b>Comments:</b>	Previously sampled ref: Armour 18/6/19 Sample DK/10. Under carpet

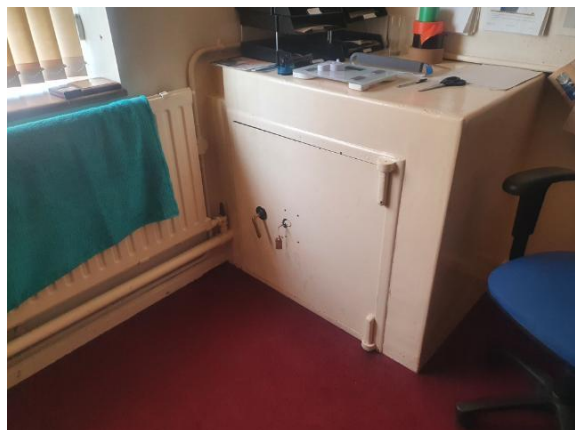
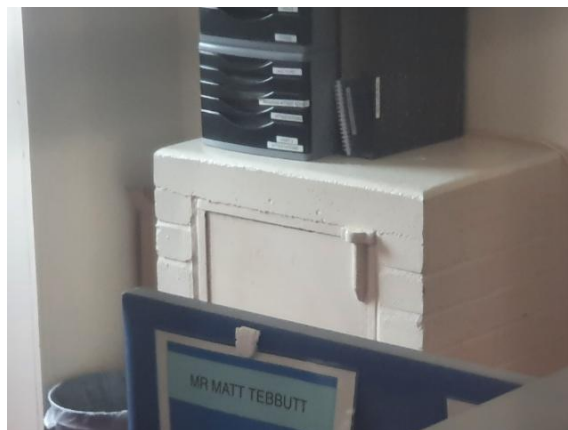
**Location:** Ground Floor - Admin Office and Staff Instructors Office  
022

<b>Material Description:</b>	Safes - Insulating Board	
<b>Identification:</b>	Presumed to Contain Asbestos	
<b>Approx. quantity:</b>	2 no	
<b>Accessibility</b>	Difficult	Assessment Score
<b>Product type:</b>	Asbestos Insulating Board	2
<b>Extent of Damage:</b>	Major damage	3
<b>Surface Treatment:</b>	Unsealed Insulation	3
<b>Asbestos type:</b>	Amosite, Chrysotile	2
<b>Material Assessment Score:</b>		10
<b>Priority Assessment Score:</b>		High
<b>Action:</b>	Manage	
<b>Comments:</b>	No access within safe casings without damaging safes

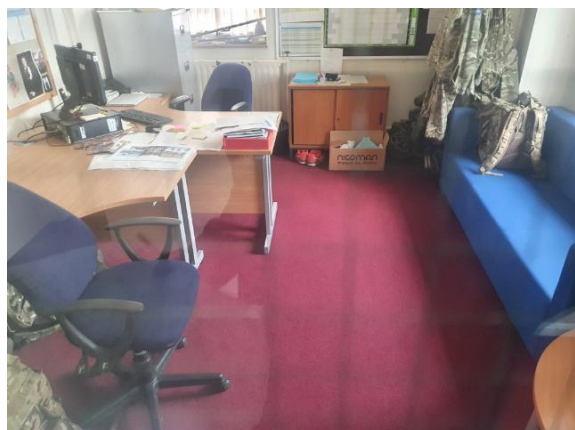
**Location:** Ground Floor - Offices x 3 023

<b>Material Description:</b>	Floor Tiles - Vinyl Products	
<b>Identification:</b>	Previously Sampled - Asbestos Detected	
<b>Approx. quantity:</b>	40 m <sup>2</sup>	
<b>Accessibility</b>	Difficult	<i>Assessment Score</i>
<b>Product type:</b>	Vinyl	1
<b>Extent of Damage:</b>	Slight / minor damage	1
<b>Surface Treatment:</b>	Non-friable	0
<b>Asbestos type:</b>	Chrysotile	1
<b>Material Assessment Score:</b>		3
<b>Priority Assessment Score:</b>		Negligible
<b>Action:</b>	Manage	
<b>Comments:</b>	Previously sampled ref: Armour 18/6/19 Sample DK/10. Under carpet

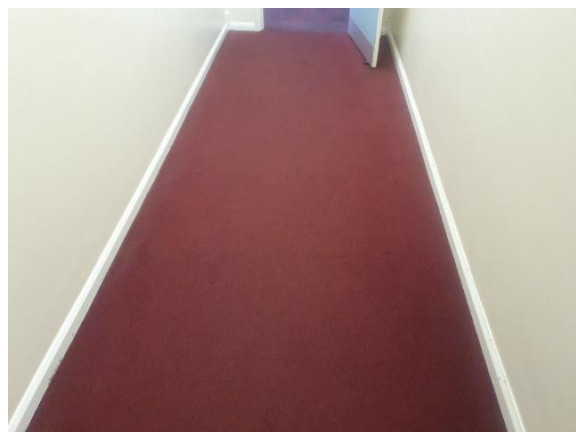
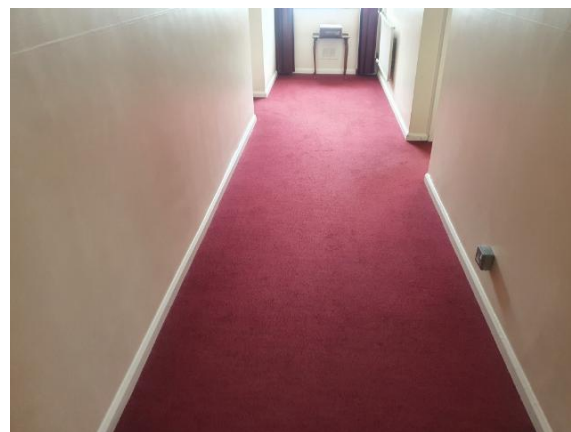
**Location:** Ground Floor - Corridor 024

<b>Material Description:</b>	Floor Tiles - Vinyl Products	
<b>Identification:</b>	Previously Sampled - Asbestos Detected	
<b>Approx. quantity:</b>	30 m <sup>2</sup>	
<b>Accessibility</b>	Difficult	<i>Assessment Score</i>
<b>Product type:</b>	Vinyl	1
<b>Extent of Damage:</b>	Slight / minor damage	1
<b>Surface Treatment:</b>	Non-friable	0
<b>Asbestos type:</b>	Chrysotile	1
<b>Material Assessment Score:</b>		3
<b>Priority Assessment Score:</b>		Negligible
<b>Action:</b>	Manage	
<b>Comments:</b>	Previously sampled ref: Armour 18/6/19 Sample DK/10. Under carpet

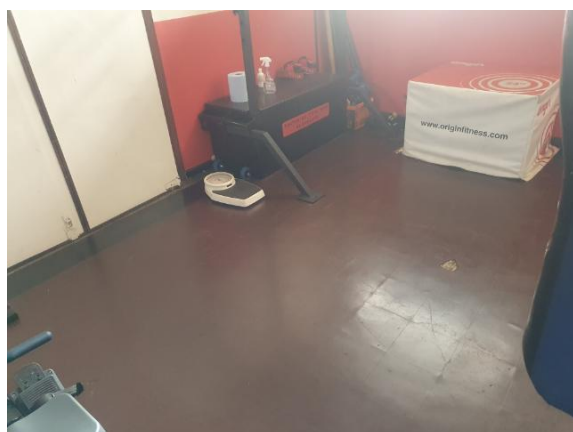
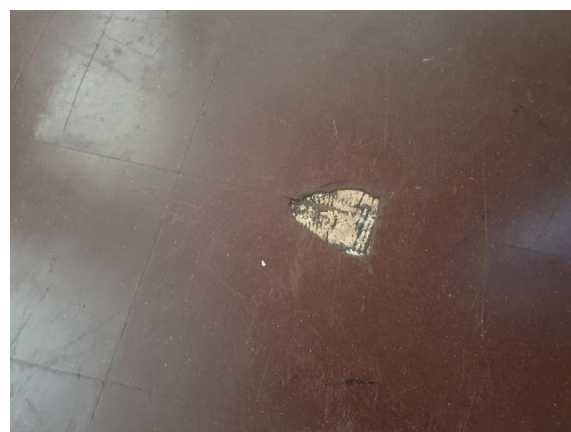
**Location:** Ground Floor - Main Hall and Gym 025

<b>Material Description:</b>	Floor Tiles and Adhesive - Vinyl Products	
<b>Identification:</b>	Previously Sampled - Asbestos Detected	
<b>Approx. quantity:</b>	50 m <sup>2</sup>	
<b>Accessibility</b>	Easy	<i>Assessment Score</i>
<b>Product type:</b>	Vinyl	1
<b>Extent of Damage:</b>	Moderate damage	2
<b>Surface Treatment:</b>	Non-friable	0
<b>Asbestos type:</b>	Chrysotile	1
<b>Material Assessment Score:</b>		4
<b>Priority Assessment Score:</b>		Negligible
<b>Action:</b>	Manage	
<b>Comments:</b>	Previously sampled ref: Armour 18/6/19 Sample DK/11

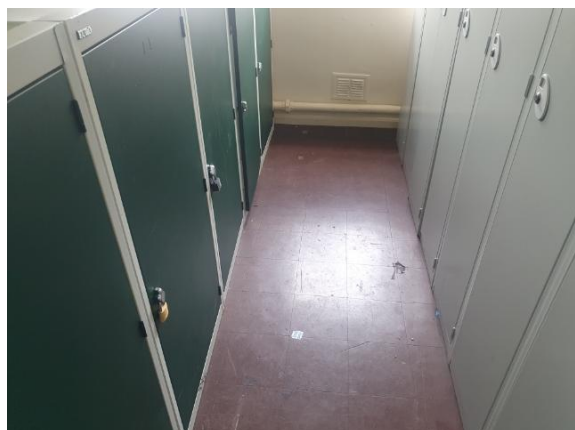
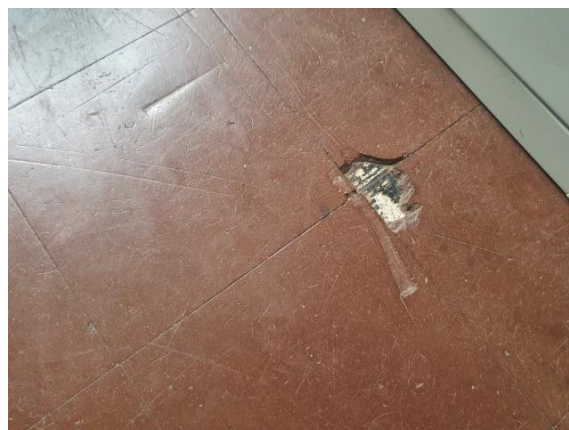
**Location:** Ground Floor - Cadet Locker Room 026

<b>Material Description:</b>	Floor Tiles and Adhesive - Vinyl Products	
<b>Identification:</b>	Previously Sampled - Asbestos Detected	
<b>Approx. quantity:</b>	18 m <sup>2</sup>	
<b>Accessibility</b>	Easy	<i>Assessment Score</i>
<b>Product type:</b>	Vinyl	1
<b>Extent of Damage:</b>	Moderate damage	2
<b>Surface Treatment:</b>	Non-friable	0
<b>Asbestos type:</b>	Chrysotile	1
<b>Material Assessment Score:</b>		4
<b>Priority Assessment Score:</b>		Negligible
<b>Action:</b>	Manage	
<b>Comments:</b>	Previously sampled ref: Armour 18/6/19 Sample DK/11

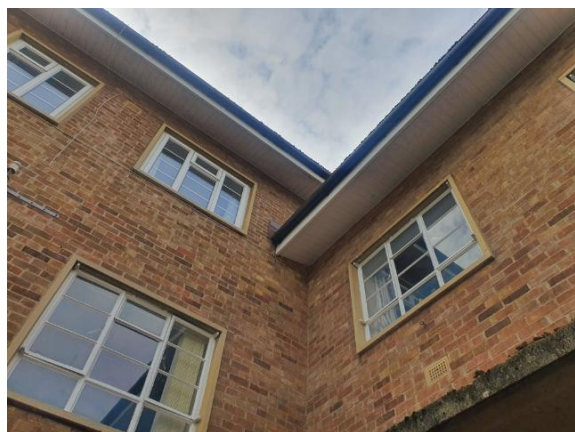
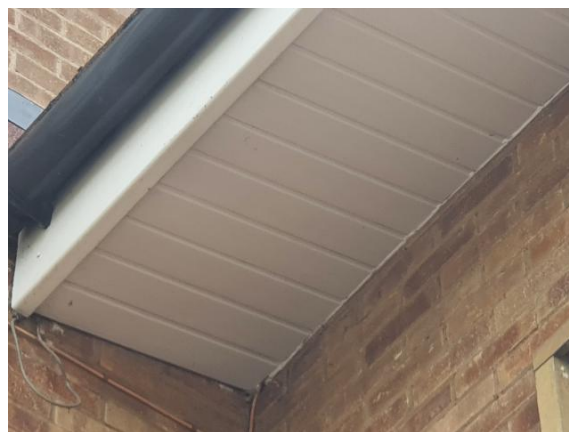
**Location:** External - Main Building 027

<b>Material Description:</b>	Soffits above Plastic - Insulating Board	
<b>Identification:</b>	Presumed to Contain Asbestos	
<b>Approx. quantity:</b>	110 LM	
<b>Accessibility</b>	Difficult	<i>Assessment Score</i>
<b>Product type:</b>	Asbestos Insulating Board	2
<b>Extent of Damage:</b>	Major damage	3
<b>Surface Treatment:</b>	Unsealed Insulation	3
<b>Asbestos type:</b>	Amosite	2
<b>Material Assessment Score:</b>		10
<b>Priority Assessment Score:</b>		High
<b>Action:</b>	Manage	
<b>Comments:</b>	No access above plastic soffits

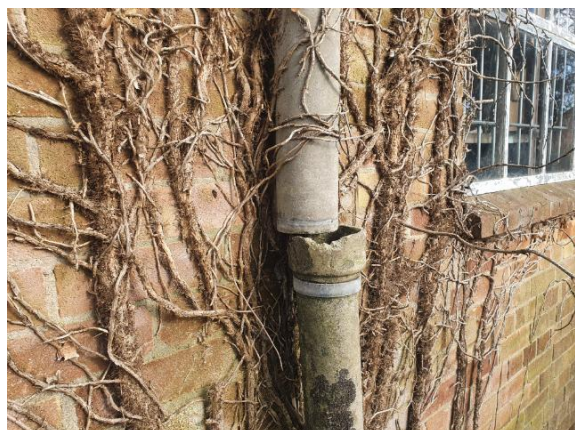
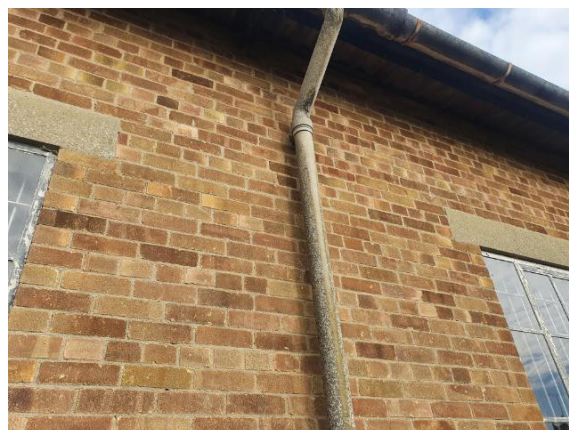
**Location:** External - Garages 028

<b>Material Description:</b>	Downpipes - Cement Product	
<b>Identification:</b>	Previously Sampled - Asbestos Detected	
<b>Approx. quantity:</b>	18 LM	
<b>Accessibility</b>	Medium	<i>Assessment Score</i>
<b>Product type:</b>	Cement	1
<b>Extent of Damage:</b>	Moderate damage	2
<b>Surface Treatment:</b>	Unsealed Cement	1
<b>Asbestos type:</b>	Chrysotile	1
<b>Material Assessment Score:</b>		5
<b>Priority Assessment Score:</b>		Low
<b>Action:</b>	Manage	
<b>Comments:</b>	Previously sampled ref: Armour 18/6/19 Sample DK/12. 3no pipes

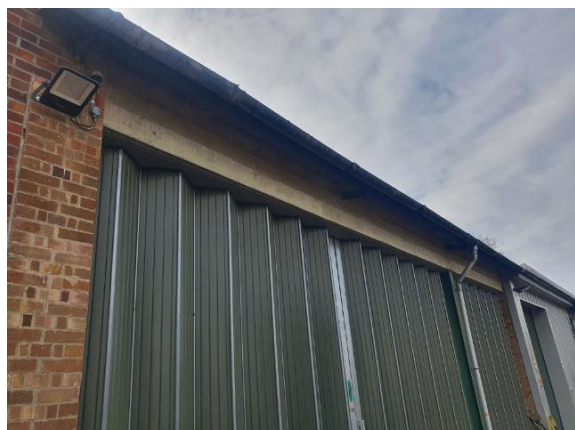
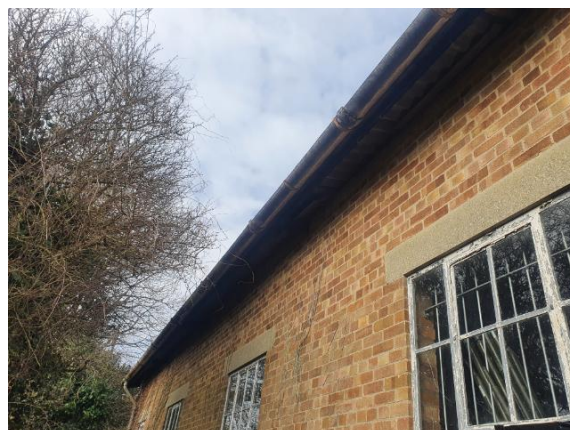
**Location:** External - Garages 029

<b>Material Description:</b>	Guttering - Cement Product	
<b>Identification:</b>	Previously Sampled - Asbestos Detected	
<b>Approx. quantity:</b>	60 LM	
<b>Accessibility</b>	Difficult	<i>Assessment Score</i>
<b>Product type:</b>	Cement	1
<b>Extent of Damage:</b>	Slight / minor damage	1
<b>Surface Treatment:</b>	Unsealed Cement	1
<b>Asbestos type:</b>	Chrysotile	1
<b>Material Assessment Score:</b>		4
<b>Priority Assessment Score:</b>		Negligible
<b>Action:</b>	Manage	
<b>Comments:</b>	Previously sampled ref: Armour 18/6/19 Sample DK/12

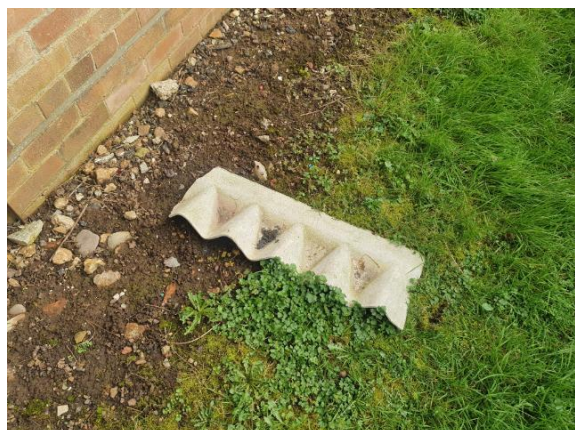
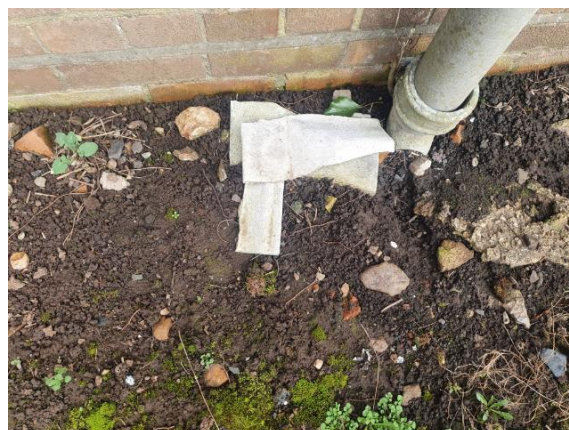
**Location:** External - Garages 030

<b>Material Description:</b>	Profiled Sheet Debris - Cement Product	
<b>Identification:</b>	Previously Sampled - Asbestos Detected	
<b>Approx. quantity:</b>	1 m <sup>2</sup>	
<b>Accessibility</b>	Easy	<i>Assessment Score</i>
<b>Product type:</b>	Cement	1
<b>Extent of Damage:</b>	Major damage	3
<b>Surface Treatment:</b>	Unsealed Cement	1
<b>Asbestos type:</b>	Chrysotile	1
<b>Material Assessment Score:</b>		6
<b>Priority Assessment Score:</b>		Low
<b>Action:</b>	Remove	
<b>Comments:</b>	Previously sampled ref: Armour 18/6/19 Sample DK/19

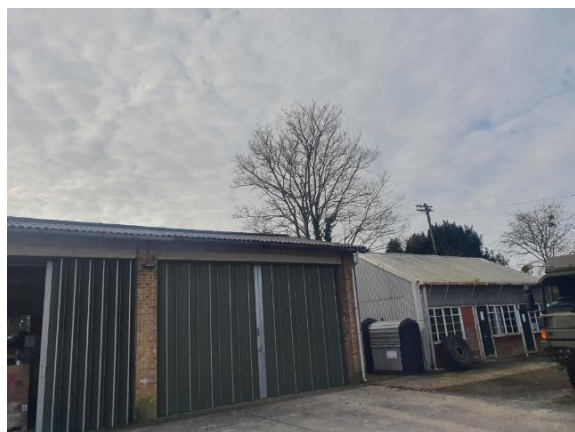
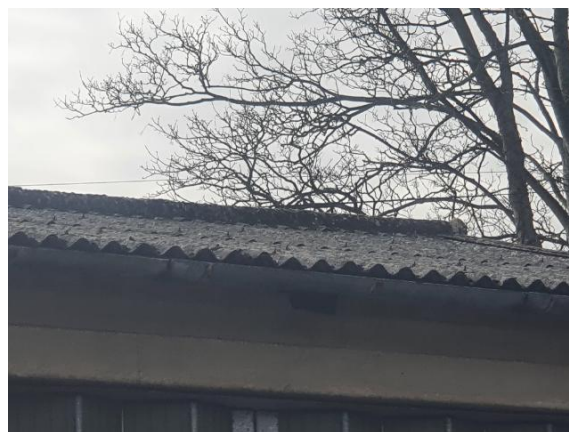
**Location:** External - Garages 031

<b>Material Description:</b>	Profiled Roof - Cement Product	
<b>Identification:</b>	Previously Sampled - Asbestos Detected	
<b>Approx. quantity:</b>	200 m <sup>2</sup>	
<b>Accessibility</b>	Difficult	<i>Assessment Score</i>
<b>Product type:</b>	Cement	1
<b>Extent of Damage:</b>	Slight / minor damage	1
<b>Surface Treatment:</b>	Unsealed Cement	1
<b>Asbestos type:</b>	Chrysotile	1
<b>Material Assessment Score:</b>		4
<b>Priority Assessment Score:</b>		Negligible
<b>Action:</b>	Manage	
<b>Comments:</b>	Previously sampled ref: Armour 18/6/19 Sample DK/19

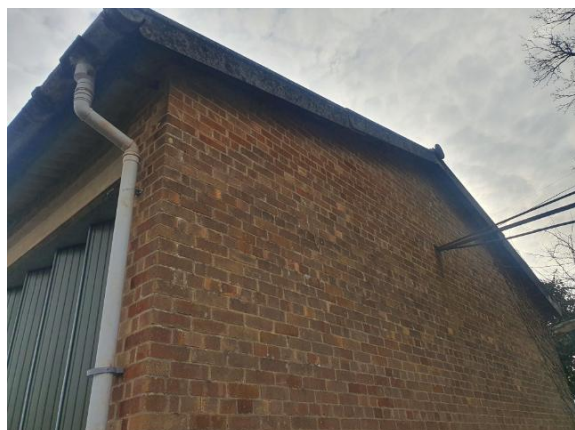
**Location:** External - Garages 032

<b>Material Description:</b>	Roof Edging - Cement Product	
<b>Identification:</b>	Previously Sampled - Asbestos Detected	
<b>Approx. quantity:</b>	8 LM	
<b>Accessibility</b>	Difficult	<i>Assessment Score</i>
<b>Product type:</b>	Cement	1
<b>Extent of Damage:</b>	Slight / minor damage	1
<b>Surface Treatment:</b>	Unsealed Cement	1
<b>Asbestos type:</b>	Chrysotile	1
<b>Material Assessment Score:</b>		4
<b>Priority Assessment Score:</b>		Negligible
<b>Action:</b>	Manage	
<b>Comments:</b>	No access to sample due to height restrictions

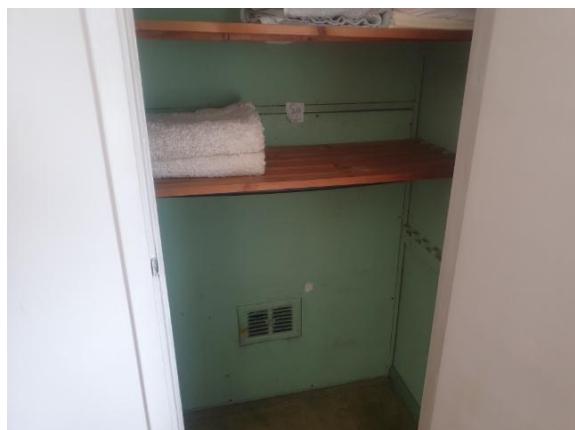
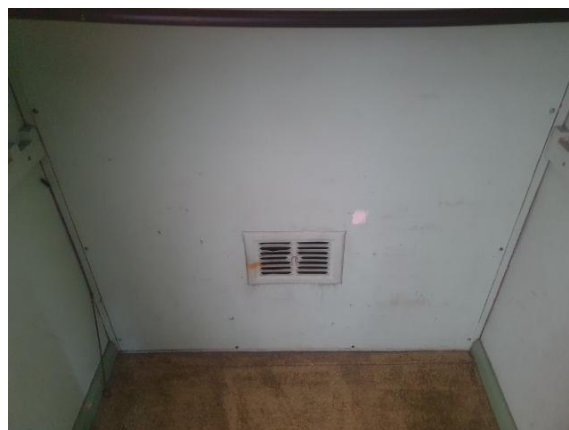
**Location:** Second Floor - Bedroom 2 Cupboard 033

<b>Material Description:</b>	Wall Panel - Cement Product	
<b>Identification:</b>	Previously Sampled - Asbestos Detected	
<b>Approx. quantity:</b>	3 m <sup>2</sup>	
<b>Accessibility</b>	Easy	<i>Assessment Score</i>
<b>Product type:</b>	Cement	1
<b>Extent of Damage:</b>	Slight / minor damage	1
<b>Surface Treatment:</b>	Unsealed Cement	1
<b>Asbestos type:</b>	Chrysotile	1
<b>Material Assessment Score:</b>		4
<b>Priority Assessment Score:</b>		Negligible
<b>Action:</b>	Manage	
<b>Comments:</b>	Previously sampled ref: Armour 18/6/19 Sample DK/13. Entire back wall of cupboard

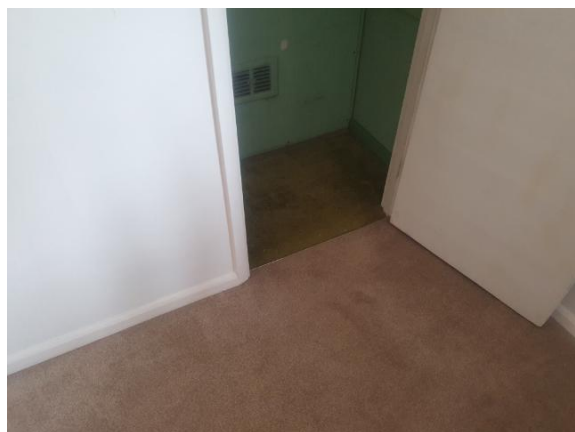
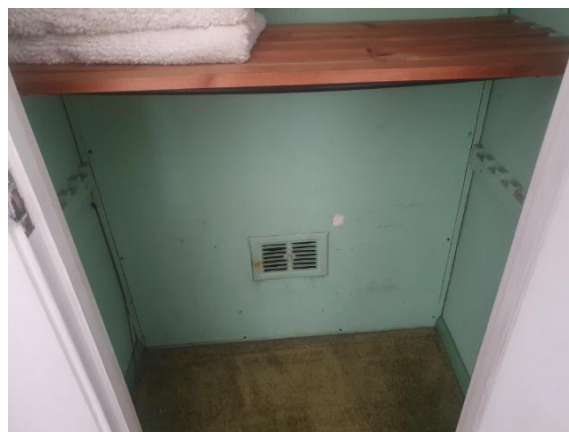
**Location:** Second Floor - Bedroom 2 and Cupboard 034

<b>Material Description:</b>	Floor Tiles and Adhesive - Vinyl Products	
<b>Identification:</b>	Previously Sampled - Asbestos Detected	
<b>Approx. quantity:</b>	8 m <sup>2</sup>	
<b>Accessibility</b>	Difficult	Assessment Score
<b>Product type:</b>	Vinyl	1
<b>Extent of Damage:</b>	Slight / minor damage	1
<b>Surface Treatment:</b>	Non-friable	0
<b>Asbestos type:</b>	Chrysotile	1
<b>Material Assessment Score:</b>		3
<b>Priority Assessment Score:</b>		Negligible
<b>Action:</b>	Manage	
<b>Comments:</b>	Previously sampled ref: Armour 18/6/19 Sample DK/14. Under carpet

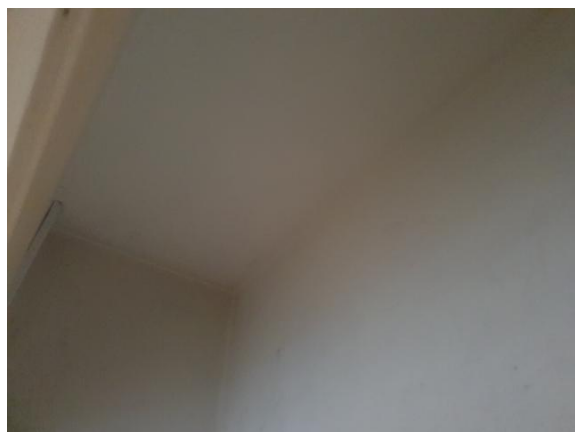
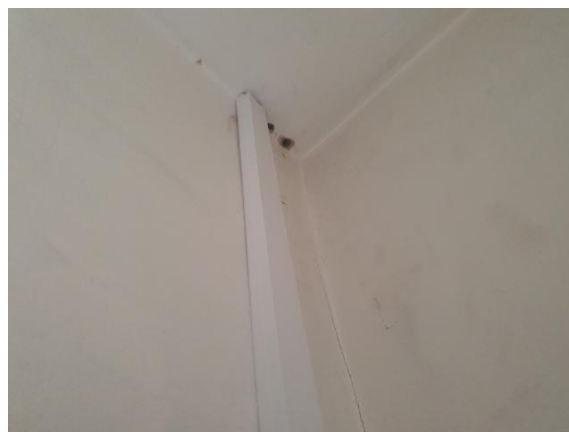
**Location:** Second Floor - Bedroom 1 Cupboard 035

<b>Material Description:</b>	Ceiling to Cupboard - Insulating Board	
<b>Identification:</b>	Previously Sampled - Asbestos Detected	
<b>Approx. quantity:</b>	2 m <sup>2</sup>	
<b>Accessibility</b>	Medium	<i>Assessment Score</i>
<b>Product type:</b>	Asbestos Insulating Board	2
<b>Extent of Damage:</b>	Moderate damage	2
<b>Surface Treatment:</b>	Unsealed AIB	2
<b>Asbestos type:</b>	Amosite	2
<b>Material Assessment Score:</b>		8
<b>Priority Assessment Score:</b>		Medium
<b>Action:</b>	Encapsulate	
<b>Comments:</b>	Previously sampled ref: GU/TA/001/17. 4no holes in panel require encapsulation. Do not remove wires

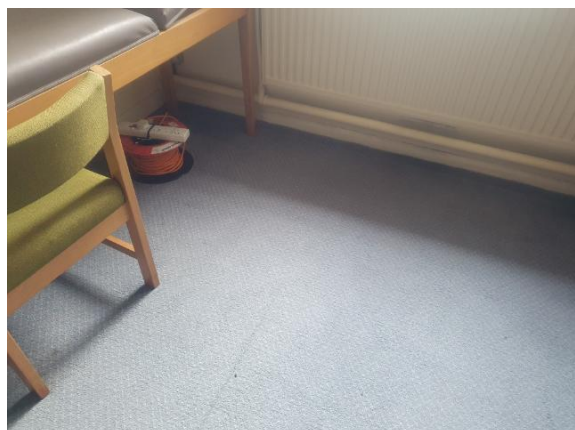
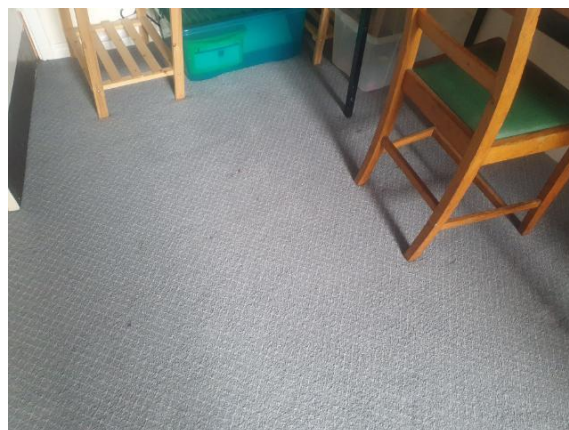
**Location:** First Floor - Medical Room 036

<b>Material Description:</b>	Floor Tiles and Adhesive - Vinyl Products	
<b>Identification:</b>	Previously Sampled - Asbestos Detected	
<b>Approx. quantity:</b>	15 m <sup>2</sup>	
<b>Accessibility</b>	Difficult	<i>Assessment Score</i>
<b>Product type:</b>	Vinyl	1
<b>Extent of Damage:</b>	Slight / minor damage	1
<b>Surface Treatment:</b>	Non-friable	0
<b>Asbestos type:</b>	Chrysotile	1
<b>Material Assessment Score:</b>		3
<b>Priority Assessment Score:</b>		Negligible
<b>Action:</b>	Manage	
<b>Comments:</b>	Previously sampled ref: Armour 18/6/19 Sample DK/6. Under carpet

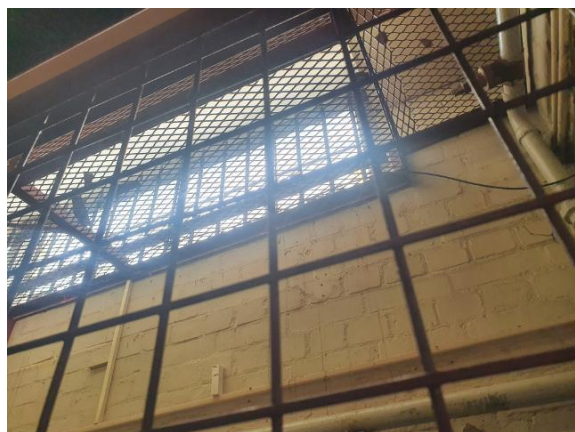
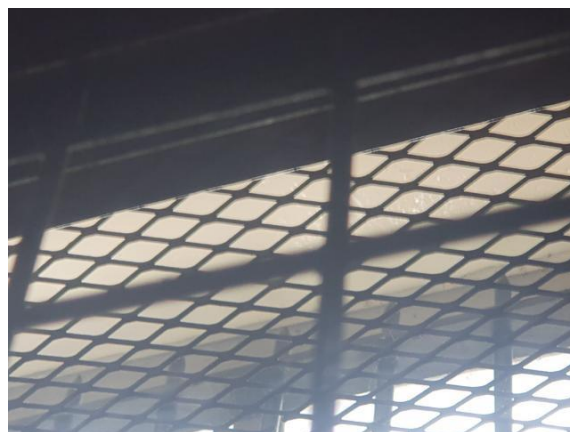
**Location:** Ground Floor - Armoury 039

<b>Material Description:</b>	Panels above Cage - Insulating Board	
<b>Identification:</b>	Presumed to Contain Asbestos	
<b>Approx. quantity:</b>	6 LM	
<b>Accessibility</b>	Difficult	<i>Assessment Score</i>
<b>Product type:</b>	Asbestos Insulating Board	2
<b>Extent of Damage:</b>	Major damage	3
<b>Surface Treatment:</b>	Unsealed Insulation	3
<b>Asbestos type:</b>	Amosite	2
<b>Material Assessment Score:</b>		10
<b>Priority Assessment Score:</b>		High
<b>Action:</b>	Manage	
<b>Comments:</b>	No access above cage to sample. Panels located above cage next to windows
