**Project Number 3700**

**Re-Inspection  
Asbestos Survey Report - Revised**

**675 Army Air Corps  
Somerset  
TA1 5LJ**

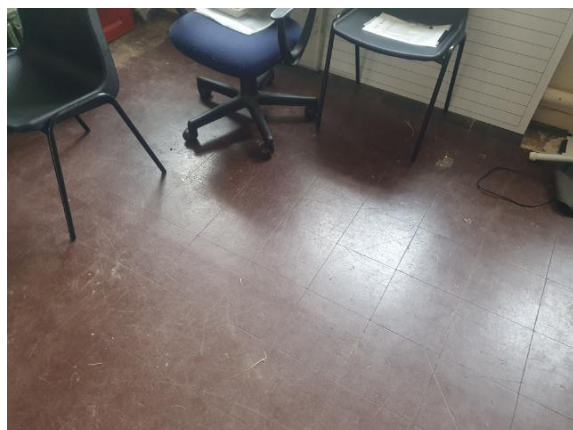
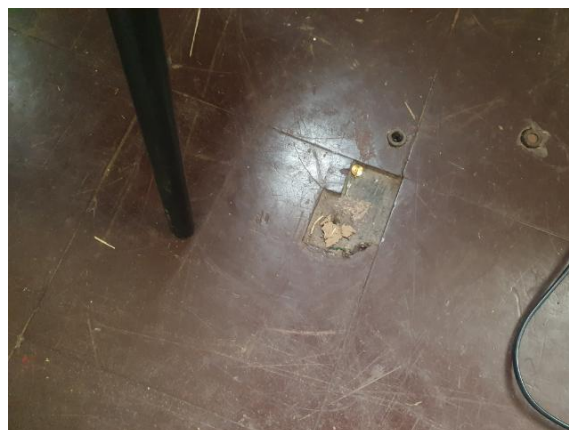
<b>Material Description:</b>	Floor Tiles and Adhesive - Vinyl Products	
<b>Identification:</b>	Previously Sampled - Asbestos Detected	
<b>Approx. quantity:</b>	20 m <sup>2</sup>	
<b>Accessibility</b>	Easy	<i>Assessment Score</i>
<b>Product type:</b>	Vinyl	1
<b>Extent of Damage:</b>	Moderate damage	2
<b>Surface Treatment:</b>	Non-friable	0
<b>Asbestos type:</b>	Chrysotile	1
<b>Material Assessment Score:</b>		4
<b>Priority Assessment Score:</b>		Negligible
<b>Action:</b>	Manage	
<b>Comments:</b>	Previously sampled ref: Armour 18/6/19 Sample DK/11

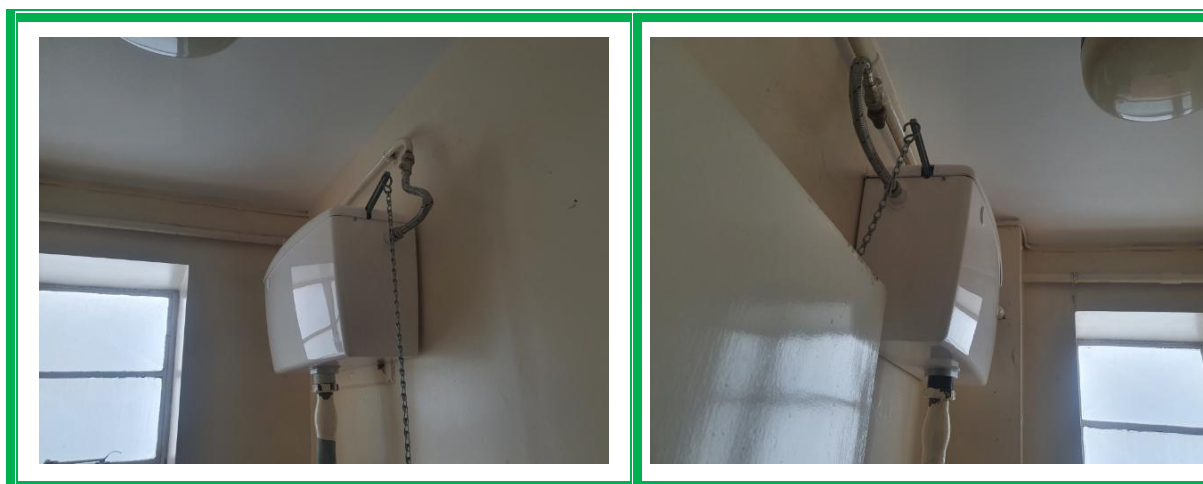
<b>Material Description:</b>	No Suspect Materials Found	
<b>Identification:</b>	N/A	
<b>Approx. quantity:</b>	N/A	
<b>Accessibility</b>	N/A	<i>Assessment Score</i>
<b>Product type:</b>	N/A	N/A
<b>Extent of Damage:</b>	N/A	N/A
<b>Surface Treatment:</b>	N/A	N/A
<b>Asbestos type:</b>	N/A	N/A
<b>Material Assessment Score:</b>		N/A
<b>Priority Assessment Score:</b>		N/A
<b>Action:</b>	N/A	
<b>Comments:</b>	All cisterns replaced

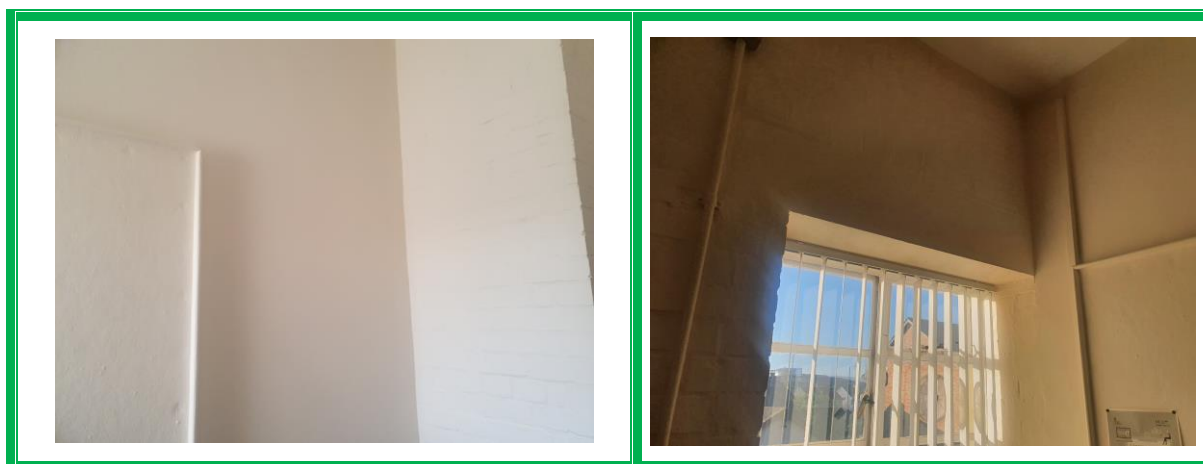
<b>Material Description:</b>	No Suspect Materials Found	
<b>Identification:</b>	N/A	
<b>Approx. quantity:</b>	N/A	
<b>Accessibility</b>	N/A	<i>Assessment Score</i>
<b>Product type:</b>	N/A	N/A
<b>Extent of Damage:</b>	N/A	N/A
<b>Surface Treatment:</b>	N/A	N/A
<b>Asbestos type:</b>	N/A	N/A
<b>Material Assessment Score:</b>		N/A
<b>Priority Assessment Score:</b>		N/A
<b>Action:</b>	N/A	
<b>Comments:</b>	Previously a no access area now accessed. Solid walls, concrete ceiling, concrete under carpet.

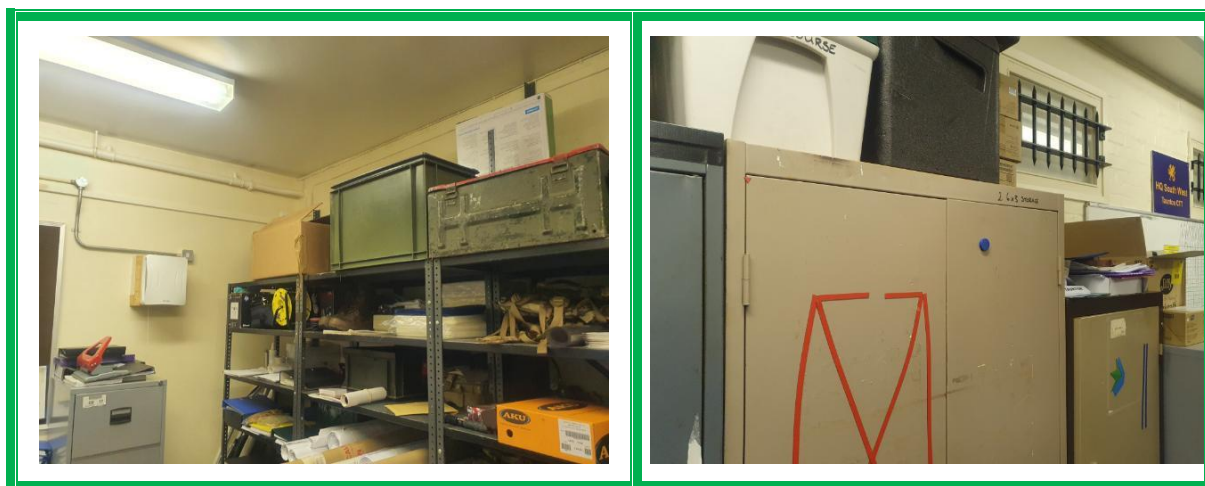
<b>Material Description:</b>	No Suspect Materials Found	
<b>Identification:</b>	N/A	
<b>Approx. quantity:</b>	N/A	
<b>Accessibility</b>	N/A	<i>Assessment Score</i>
<b>Product type:</b>	N/A	N/A
<b>Extent of Damage:</b>	N/A	N/A
<b>Surface Treatment:</b>	N/A	N/A
<b>Asbestos type:</b>	N/A	N/A
<b>Material Assessment Score:</b>		N/A
<b>Priority Assessment Score:</b>		N/A
<b>Action:</b>	N/A	
<b>Comments:</b>	Non asbestos lino under carpet
