**Project Number A-00370 (3700)**

**Re-Inspection  
Asbestos Survey Report - Revised**

**Marlborough Platoon  
Wiltshire  
SN8 2AJ**

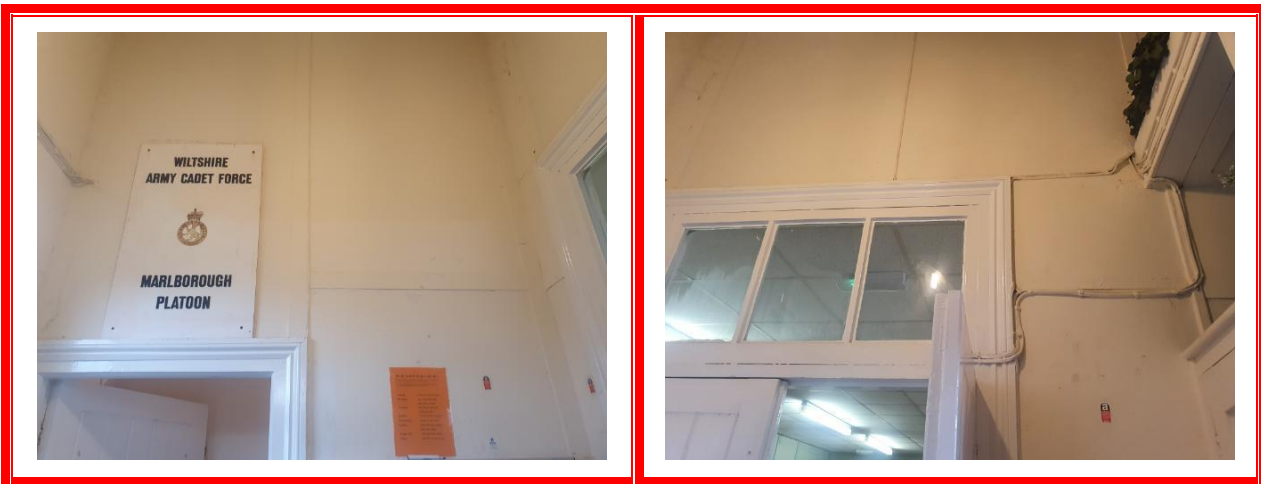
<b>Item No:</b>	<b>1</b>	<b>Sample No:</b>	<b>N/A</b>
<b>Location:</b>	Ground Floor - Lobby 001

<b>Material Description:</b>	Wall Panels - Cement Product	
<b>Identification:</b>	Previously Sampled - Asbestos Detected	
<b>Approx. quantity:</b>	48 m <sup>2</sup>	
<b>Accessibility</b>	Easy	Assessment Score
<b>Product type:</b>	Cement	1
<b>Extent of Damage:</b>	Slight / minor damage	1
<b>Surface Treatment:</b>	Sealed Cement	0
<b>Asbestos type:</b>	Chrysotile	1
<b>Material Assessment Score:</b>		3
<b>Priority Assessment Score:</b>		Negligible
<b>Action:</b>	Manage	
<b>Comments:</b>	Located to all walls including walls and ceiling in cupboard. Previously sampled ref: 7/10/19 - DK/1

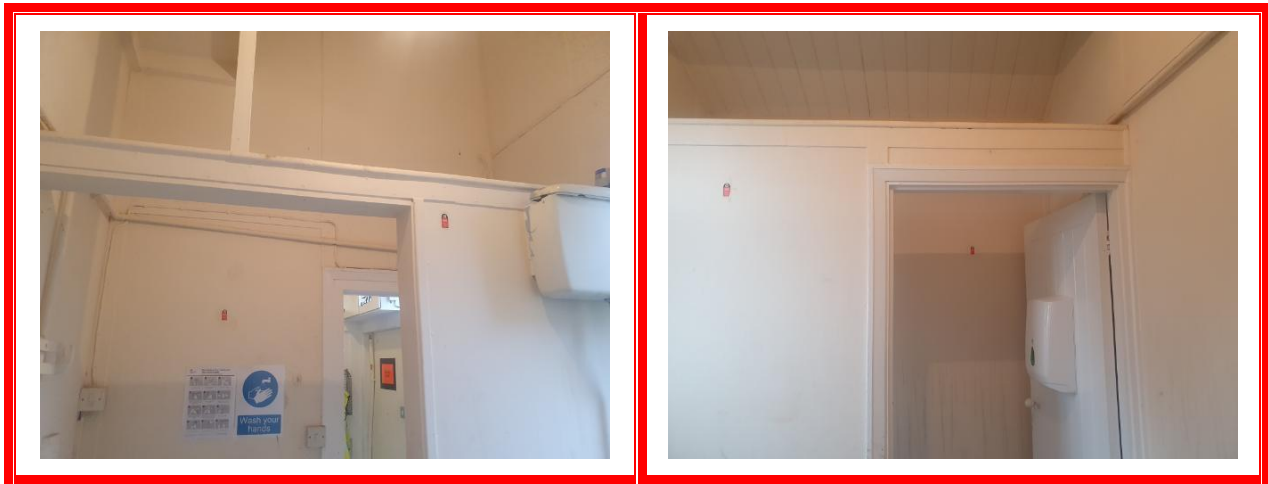
<b>Item No:</b>	<b>2</b>	<b>Sample No:</b>	<b>N/A</b>
<b>Location:</b>	Ground Floor - WC 002

<b>Material Description:</b>	Wall Panels - Cement Product	
<b>Identification:</b>	Previously Sampled - Asbestos Detected	
<b>Approx. quantity:</b>	50 m <sup>2</sup>	
<b>Accessibility</b>	Easy	<i>Assessment Score</i>
<b>Product type:</b>	Cement	1
<b>Extent of Damage:</b>	Slight / minor damage	1
<b>Surface Treatment:</b>	Sealed Cement	0
<b>Asbestos type:</b>	Chrysotile	1
<b>Material Assessment Score:</b>		3
<b>Priority Assessment Score:</b>		Negligible
<b>Action:</b>	Manage	
<b>Comments:</b>	Located to all walls including partition walls. Previously sampled ref: 7/10/19 - DK/1

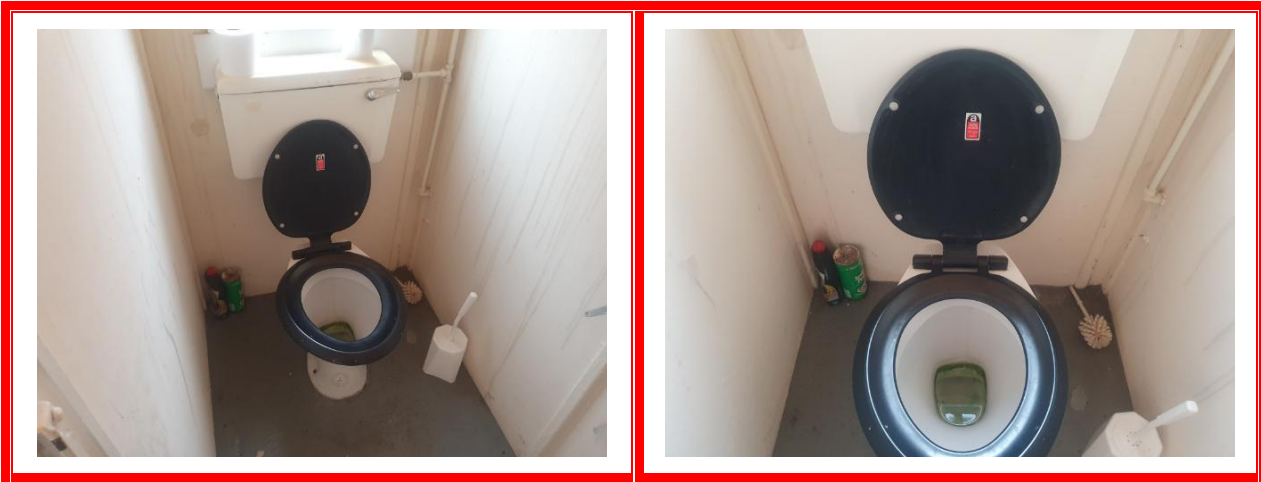
<b>Item No:</b>	<b>3</b>	<b>Sample No:</b>	<b>N/A</b>
<b>Location:</b>	Ground Floor - WC 003

<b>Material Description:</b>	Toilet Seat - PVC / Reinforced Plastics	
<b>Identification:</b>	Presumed to Contain Asbestos	
<b>Approx. quantity:</b>	1 no	
<b>Accessibility</b>	Easy	<i>Assessment Score</i>
<b>Product type:</b>	Reinforced Plastic	1
<b>Extent of Damage:</b>	Minor damage	1
<b>Surface Treatment:</b>	Reinforced Plastic	0
<b>Asbestos type:</b>	Chrysotile	1
<b>Material Assessment Score:</b>		3
<b>Priority Assessment Score:</b>		Negligible
<b>Action:</b>	Manage	
<b>Comments:</b>	Not possible to sample as may damage integrity of seat

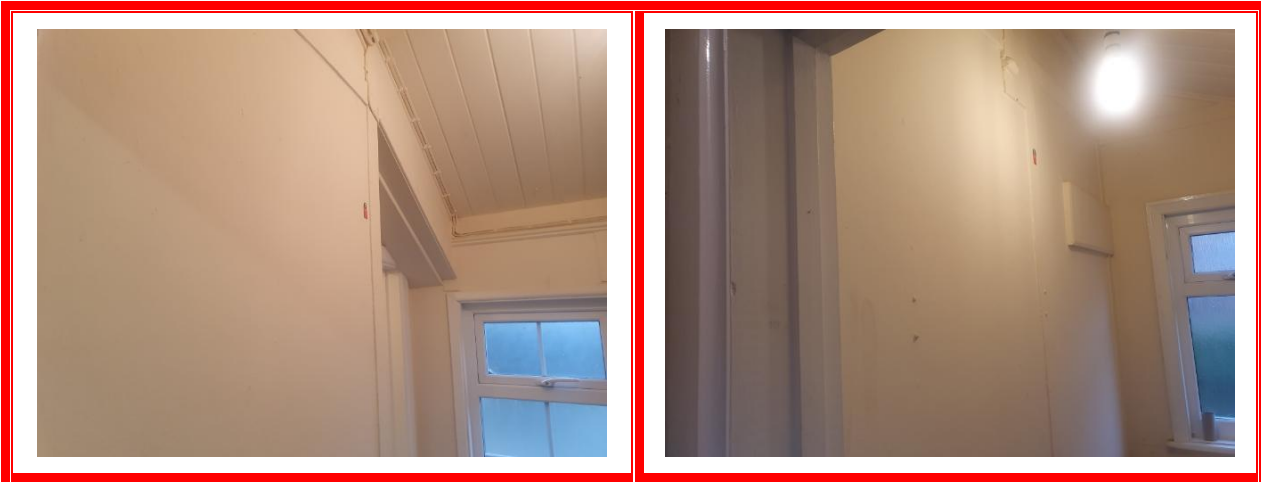
<b>Item No:</b>	<b>4</b>	<b>Sample No:</b>	<b>N/A</b>
<b>Location:</b>	Ground Floor - WC 004

<b>Material Description:</b>	Wall Panels - Cement Product	
<b>Identification:</b>	Previously Sampled - Asbestos Detected	
<b>Approx. quantity:</b>	19 m <sup>2</sup>	
<b>Accessibility</b>	Easy	<i>Assessment Score</i>
<b>Product type:</b>	Cement	1
<b>Extent of Damage:</b>	Slight / minor damage	1
<b>Surface Treatment:</b>	Sealed Cement	0
<b>Asbestos type:</b>	Chrysotile	1
<b>Material Assessment Score:</b>		3
<b>Priority Assessment Score:</b>		Negligible
<b>Action:</b>	Manage	
<b>Comments:</b>	Located to all walls except for right hand wall as you enter room. Previously sampled ref: 7/10/19 - DK/1

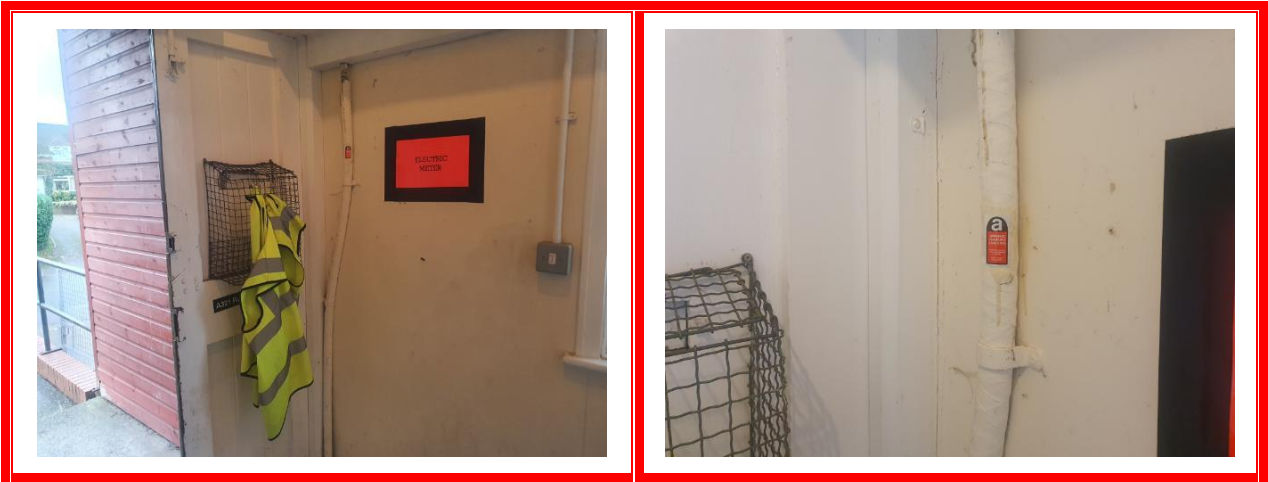
<b>Item No:</b>	<b>6</b>	<b>Sample No:</b>	<b>N/A</b>
<b>Location:</b>	Ground Floor - Lobby 006

<b>Material Description:</b>	Wrap to Mains Cable - Bituminous Product	
<b>Identification:</b>	Presumed to Contain Asbestos	
<b>Approx. quantity:</b>	3 LM	
<b>Accessibility</b>	Easy	<i>Assessment Score</i>
<b>Product type:</b>	Bitumen	1
<b>Extent of Damage:</b>	Minor damage	1
<b>Surface Treatment:</b>	Bitumen	0
<b>Asbestos type:</b>	Chrysotile	1
<b>Material Assessment Score:</b>		3
<b>Priority Assessment Score:</b>		Negligible
<b>Action:</b>	Manage	
<b>Comments:</b>	No access to sample as live

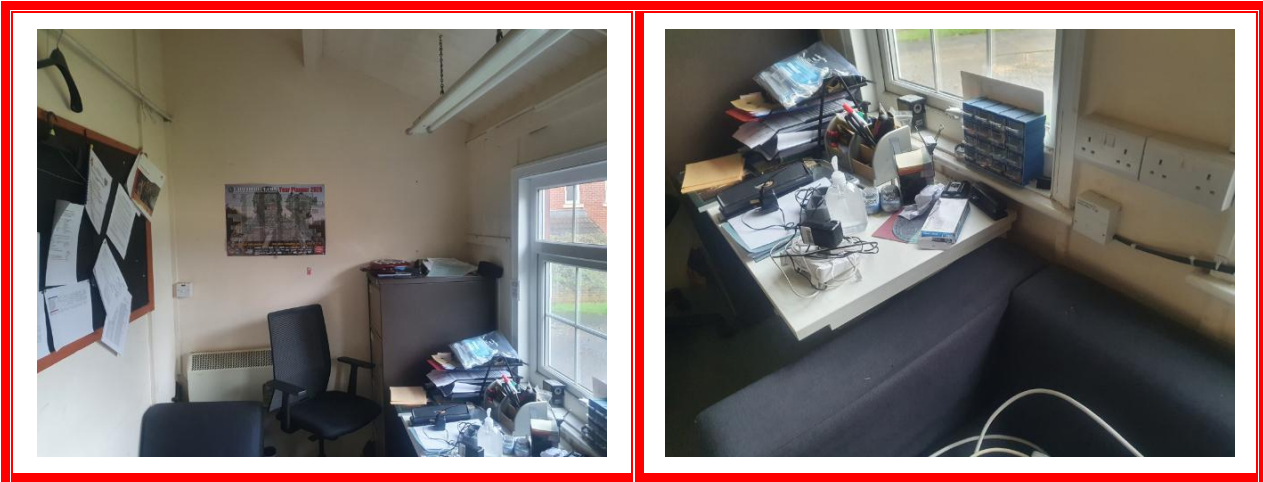
<b>Item No:</b>	<b>7</b>	<b>Sample No:</b>	<b>N/A</b>
<b>Location:</b>	Ground Floor - Office 007

<b>Material Description:</b>	Wall Panels - Cement Product	
<b>Identification:</b>	Previously Sampled - Asbestos Detected	
<b>Approx. quantity:</b>	2 m <sup>2</sup>	
<b>Accessibility</b>	Easy	<i>Assessment Score</i>
<b>Product type:</b>	Cement	1
<b>Extent of Damage:</b>	Slight / minor damage	1
<b>Surface Treatment:</b>	Sealed Cement	0
<b>Asbestos type:</b>	Chrysotile	1
<b>Material Assessment Score:</b>		3
<b>Priority Assessment Score:</b>		Negligible
<b>Action:</b>	Manage	
<b>Comments:</b>	2M2 of cement panels. All other walls are timber. Previously sampled ref: 7/10/19 - DK/1

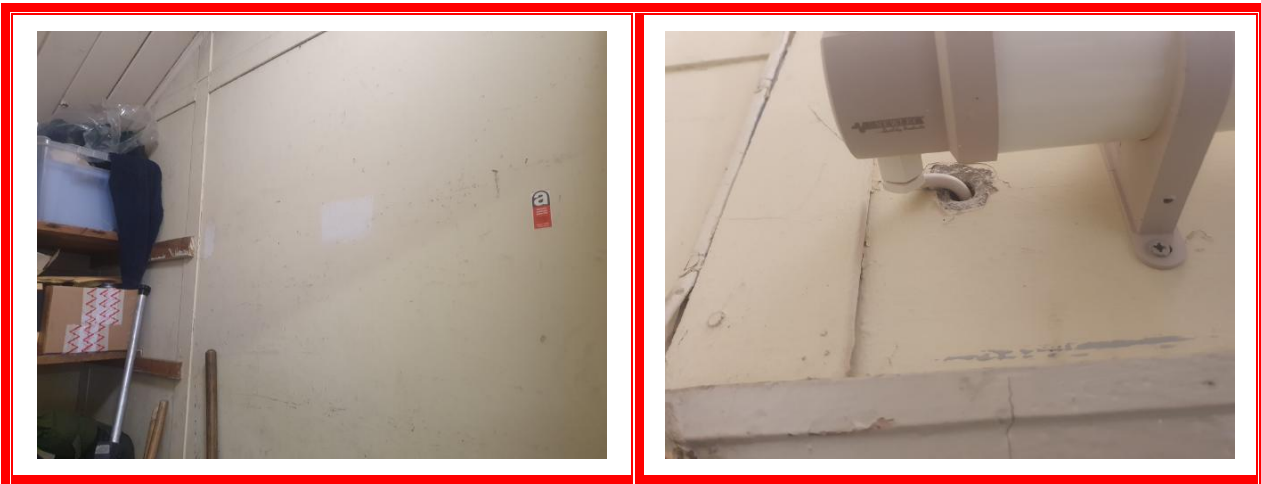
<b>Item No:</b>	<b>8</b>	<b>Sample No:</b>	<b>N/A</b>
<b>Location:</b>	Ground Floor - Store 008

<b>Material Description:</b>	Wall Panels - Cement Product	
<b>Identification:</b>	Previously Sampled - Asbestos Detected	
<b>Approx. quantity:</b>	10 m <sup>2</sup>	
<b>Accessibility</b>	Easy	<i>Assessment Score</i>
<b>Product type:</b>	Cement	1
<b>Extent of Damage:</b>	Moderate damage	2
<b>Surface Treatment:</b>	Sealed Cement	0
<b>Asbestos type:</b>	Chrysotile	1
<b>Material Assessment Score:</b>		4
<b>Priority Assessment Score:</b>		Negligible
<b>Action:</b>	Encapsulate	
<b>Comments:</b>	To all walls. 3 holes in panels. Previously sampled ref: 7/10/19 - DK/2

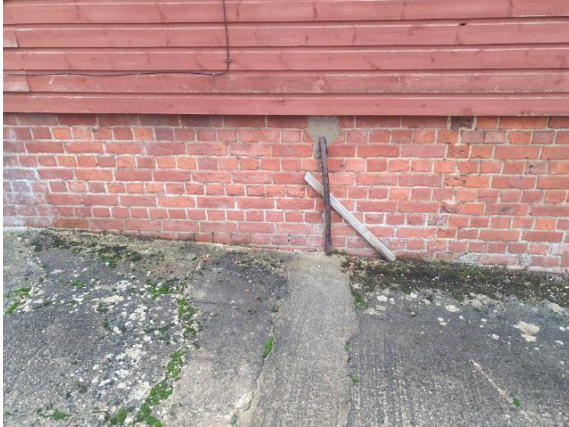
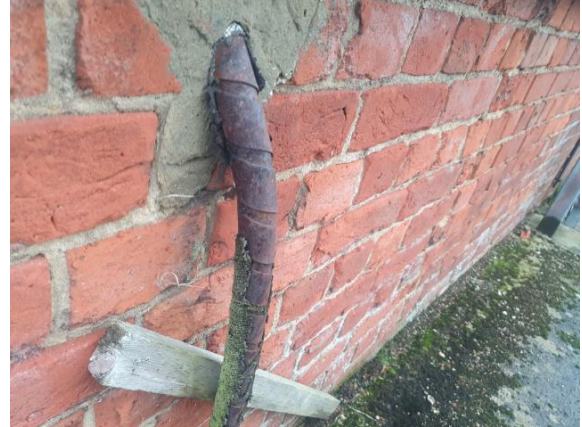
<b>Item No:</b>	<b>9</b>	<b>Sample No:</b>	<b>N/A</b>
<b>Location:</b>	External – Main Hut 009

<b>Material Description:</b>	Wrap to Mains Cable - Bituminous Product	
<b>Identification:</b>	Presumed to Contain Asbestos	
<b>Approx. quantity:</b>	1 LM	
<b>Accessibility</b>	Easy	<i>Assessment Score</i>
<b>Product type:</b>	Bitumen	1
<b>Extent of Damage:</b>	Moderate damage	2
<b>Surface Treatment:</b>	Bitumen	0
<b>Asbestos type:</b>	Chrysotile	1
<b>Material Assessment Score:</b>		4
<b>Priority Assessment Score:</b>		Negligible
<b>Action:</b>	Manage	
<b>Comments:</b>	Not possible to sample as live

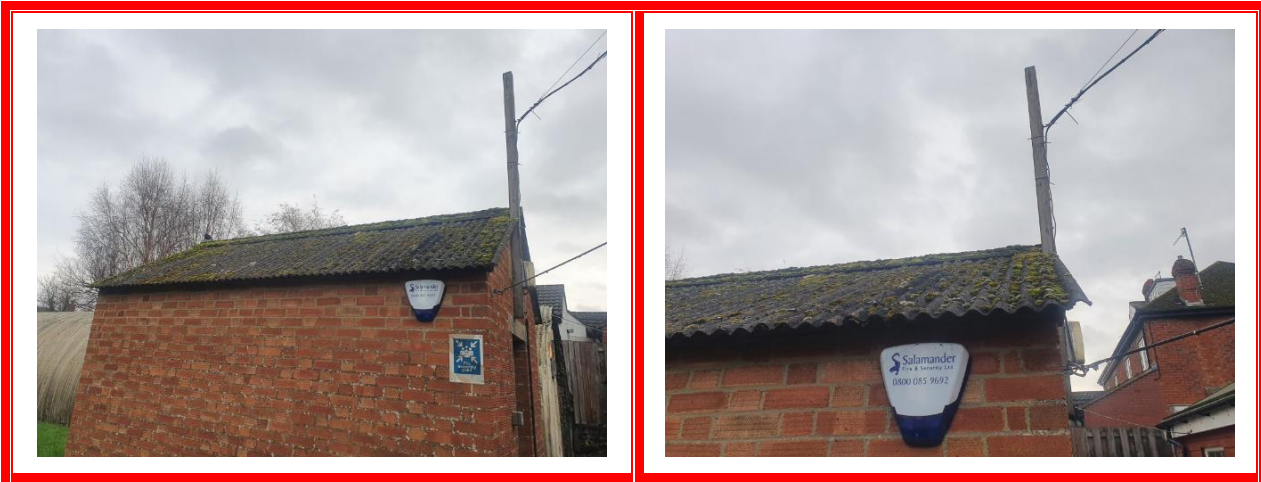
<b>Item No:</b>	<b>10</b>	<b>Sample No:</b>	<b>N/A</b>
<b>Location:</b>	External - Armoury 010

<b>Material Description:</b>	Profiled Roof - Cement Product	
<b>Identification:</b>	Previously Sampled - Asbestos Detected	
<b>Approx. quantity:</b>	15 m <sup>2</sup>	
<b>Accessibility</b>	Difficult	<i>Assessment Score</i>
<b>Product type:</b>	Cement	1
<b>Extent of Damage:</b>	Slight / minor damage	1
<b>Surface Treatment:</b>	Unsealed Cement	1
<b>Asbestos type:</b>	Chrysotile	1
<b>Material Assessment Score:</b>		4
<b>Priority Assessment Score:</b>		Negligible
<b>Action:</b>	Manage	
<b>Comments:</b>	Previously sampled ref: 7/10/19 - DK/3

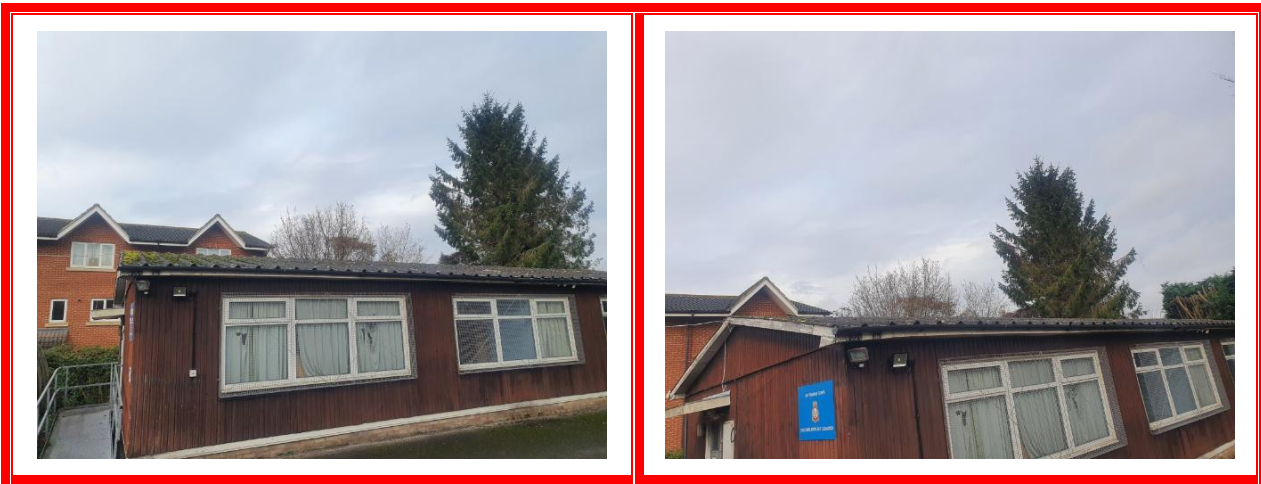
<b>Item No:</b>	<b>13</b>	<b>Sample No:</b>	<b>N/A</b>
<b>Location:</b>	External - Air Cadet Hut 013

<b>Material Description:</b>	Profiled Roof - Cement Product	
<b>Identification:</b>	Previously Sampled - Asbestos Detected	
<b>Approx. quantity:</b>	100 m <sup>2</sup>	
<b>Accessibility</b>	Difficult	<i>Assessment Score</i>
<b>Product type:</b>	Cement	1
<b>Extent of Damage:</b>	Slight / minor damage	1
<b>Surface Treatment:</b>	Unsealed Cement	1
<b>Asbestos type:</b>	Chrysotile	1
<b>Material Assessment Score:</b>		4
<b>Priority Assessment Score:</b>		Negligible
<b>Action:</b>	Manage	
<b>Comments:</b>	Previously sampled ref: 7/10/19 - DK/4

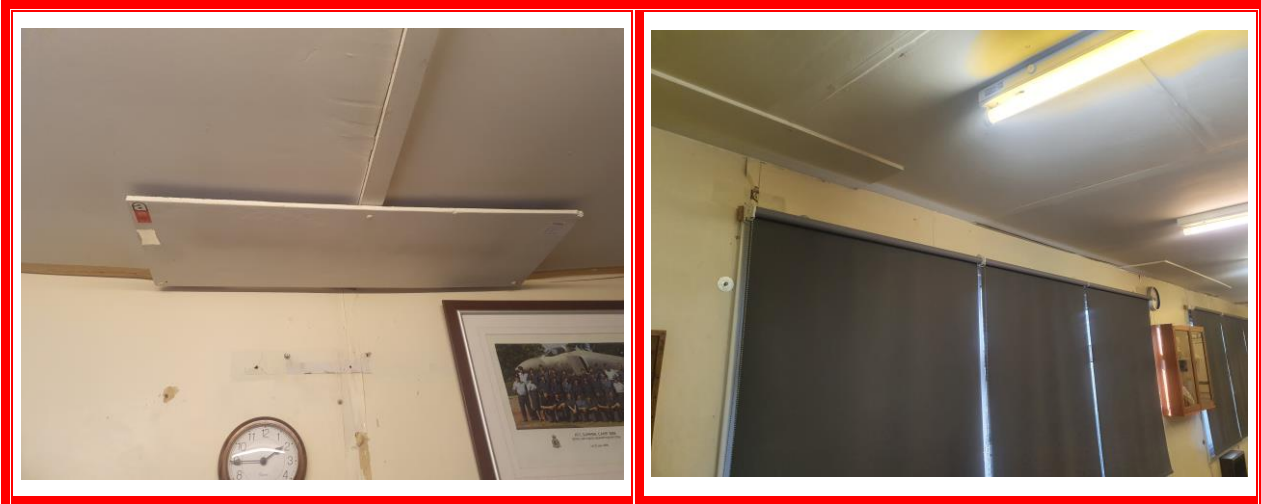
<b>Item No:</b>	<b>14</b>	<b>Sample No:</b>	<b>DK/01</b>
<b>Location:</b>	Air Cadet Hut – Offices x 2, Classrooms x 3 & Drill Hall 014

<b>Material Description:</b>	Panels on Ceiling – Insulation Board	
<b>Identification:</b>	Sampled – Asbestos Detected	
<b>Approx. quantity:</b>	10no Panels (5M2)	
<b>Accessibility</b>	Difficult	<i>Assessment Score</i>
<b>Product type:</b>	Insulation Board	2
<b>Extent of Damage:</b>	Minor damage	1
<b>Surface Treatment:</b>	Sealed AIB	1
<b>Asbestos type:</b>	Amosite	2
<b>Material Assessment Score:</b>		6
<b>Priority Assessment Score:</b>		Low
<b>Action:</b>	Manage	
<b>Comments:</b>	Located to ceiling in each room

Sample No.	Sample Ref.	Location	Asbestos Detected	Asbestos Type
DK/01	BS644781	Air Cadet Hut Office - Panels on Ceilings	Yes	Chrysotile Amosite
DK/02	BS644782	WC's x2 - Cisterns & Toilet Seats	Yes	Amosite

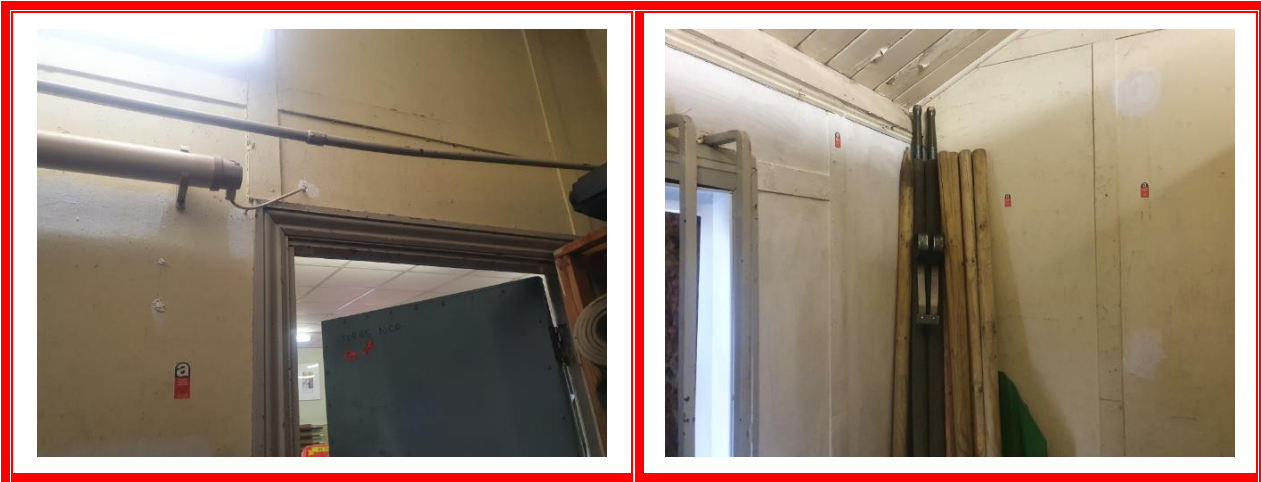
<b>Item No:</b>	<b>15</b>	<b>Sample No:</b>	<b>N/A</b>
<b>Location:</b>	Ground Floor - Store 015

<b>Material Description:</b>	Wall Panels - Cement Product	
<b>Identification:</b>	Previously Sampled - Asbestos Detected	
<b>Approx. quantity:</b>	40 m <sup>2</sup>	
<b>Accessibility</b>	Easy	<i>Assessment Score</i>
<b>Product type:</b>	Cement	1
<b>Extent of Damage:</b>	Slight / minor damage	1
<b>Surface Treatment:</b>	Sealed Cement	0
<b>Asbestos type:</b>	Chrysotile	1
<b>Material Assessment Score:</b>		3
<b>Priority Assessment Score:</b>		Negligible
<b>Action:</b>	Manage	
<b>Comments:</b>	To all walls. Previous damage encapsulated. Previously sampled ref: 7/10/19 - DK/2

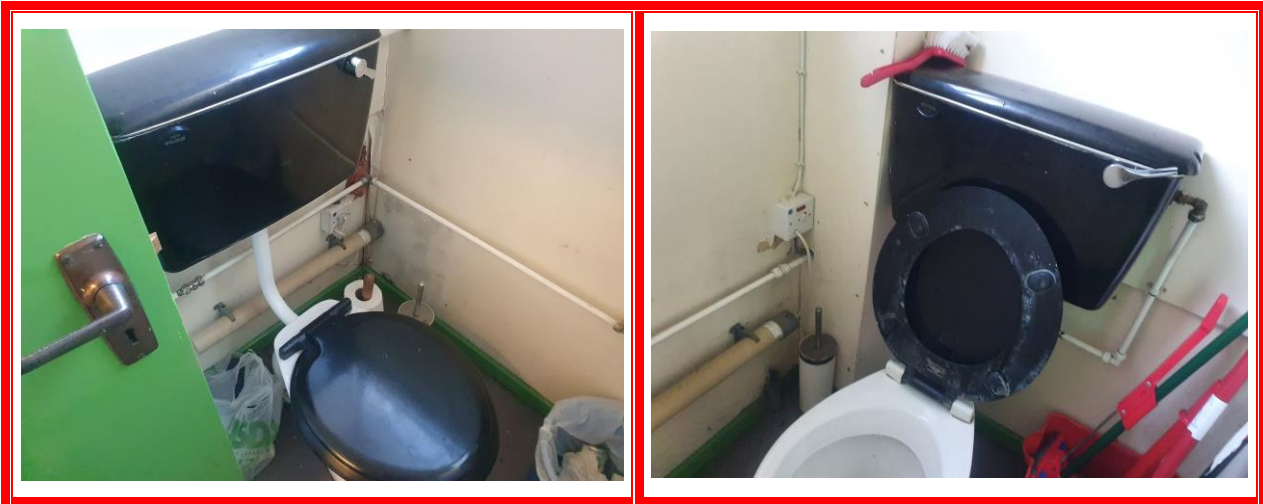
<b>Item No:</b>	<b>16</b>	<b>Sample No:</b>	<b>DK/02</b>
<b>Location:</b>	Air Cadet Hut – WC's x 2

<b>Material Description:</b>	Toilet Cisterns & Seats – Reinforced Plastic	
<b>Identification:</b>	Sampled – Asbestos Detected	
<b>Approx. quantity:</b>	2 no	
<b>Accessibility</b>	Easy	<i>Assessment Score</i>
<b>Product type:</b>	Reinforced Plastic	1
<b>Extent of Damage:</b>	Slight / minor damage	1
<b>Surface Treatment:</b>	Non-Friable	0
<b>Asbestos type:</b>	Amosite	2
<b>Material Assessment Score:</b>		4
<b>Priority Assessment Score:</b>		Negligible
<b>Action:</b>	Manage	
<b>Comments:</b>	N/A

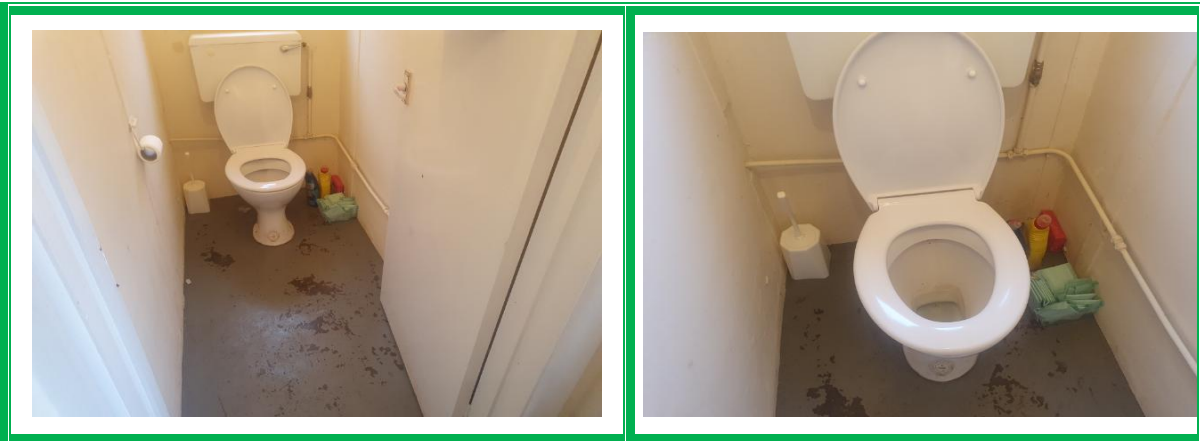
<b>Item No:</b>	<b>5</b>	<b>Sample No:</b>	<b>N/A</b>
<b>Location:</b>	Ground Floor - WC 005

<b>Material Description:</b>	Toilet Seat	
<b>Identification:</b>	N/A	
<b>Approx. quantity:</b>	N/A	
<b>Accessibility</b>	N/A	<i>Assessment Score</i>
<b>Product type:</b>	N/A	N/A
<b>Extent of Damage:</b>	N/A	N/A
<b>Surface Treatment:</b>	N/A	N/A
<b>Asbestos type:</b>	N/A	N/A
<b>Material Assessment Score:</b>		
<b>Priority Assessment Score:</b>		
<b>Action:</b>	N/A	
<b>Comments:</b>	Toilet seat replaced with plastic. Item 5 on previous survey ref 7/10/19

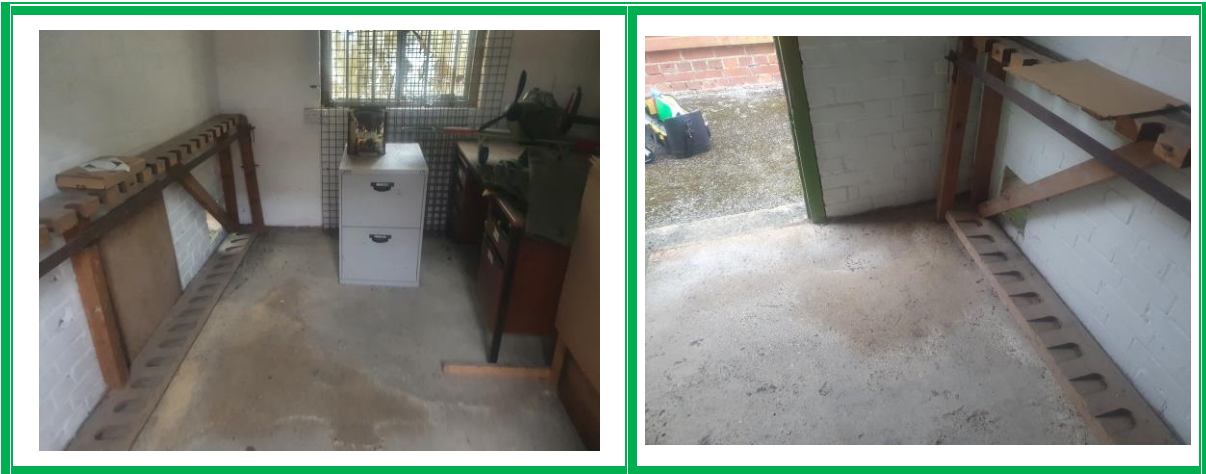
<b>Item No:</b>	<b>11</b>	<b>Sample No:</b>	<b>N/A</b>
<b>Location:</b>	Armoury

<b>Material Description:</b>	No Asbestos Suspected	
<b>Identification:</b>	N/A	
<b>Approx. quantity:</b>	N/A	
<b>Accessibility</b>	N/A	<i>Assessment Score</i>
<b>Product type:</b>	N/A	N/A
<b>Extent of Damage:</b>	N/A	N/A
<b>Surface Treatment:</b>	N/A	N/A
<b>Asbestos type:</b>	N/A	N/A
<b>Material Assessment Score:</b>		
<b>Priority Assessment Score:</b>		
<b>Action:</b>	N/A	
<b>Comments:</b>	Previously a no access area, now accessed. No asbestos suspected.

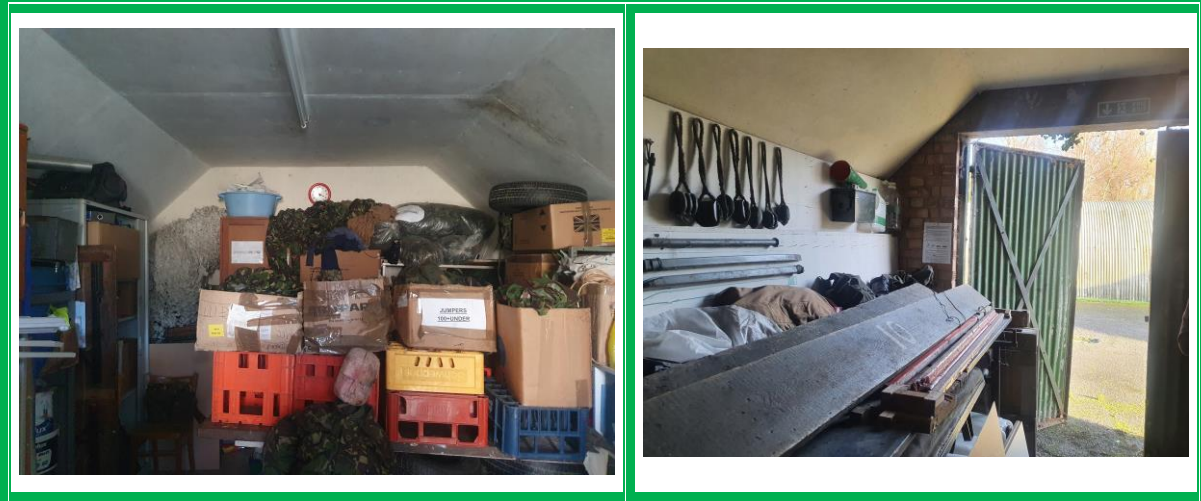
<b>Item No:</b>	<b>12</b>	<b>Sample No:</b>	<b>N/A</b>
<b>Location:</b>	Air Cadet - Store

<b>Material Description:</b>	Visual Inspection – No Asbestos Found	
<b>Identification:</b>	N/A	
<b>Approx. quantity:</b>	N/A	
<b>Accessibility</b>	N/A	<i>Assessment Score</i>
<b>Product type:</b>	N/A	N/A
<b>Extent of Damage:</b>	N/A	N/A
<b>Surface Treatment:</b>	N/A	N/A
<b>Asbestos type:</b>	N/A	N/A
<b>Material Assessment Score:</b>		
<b>Priority Assessment Score:</b>		
<b>Action:</b>	N/A	
<b>Comments:</b>	Previously un-accessed room. Now accessed and no asbestos found. Limited access into room due to stored items.

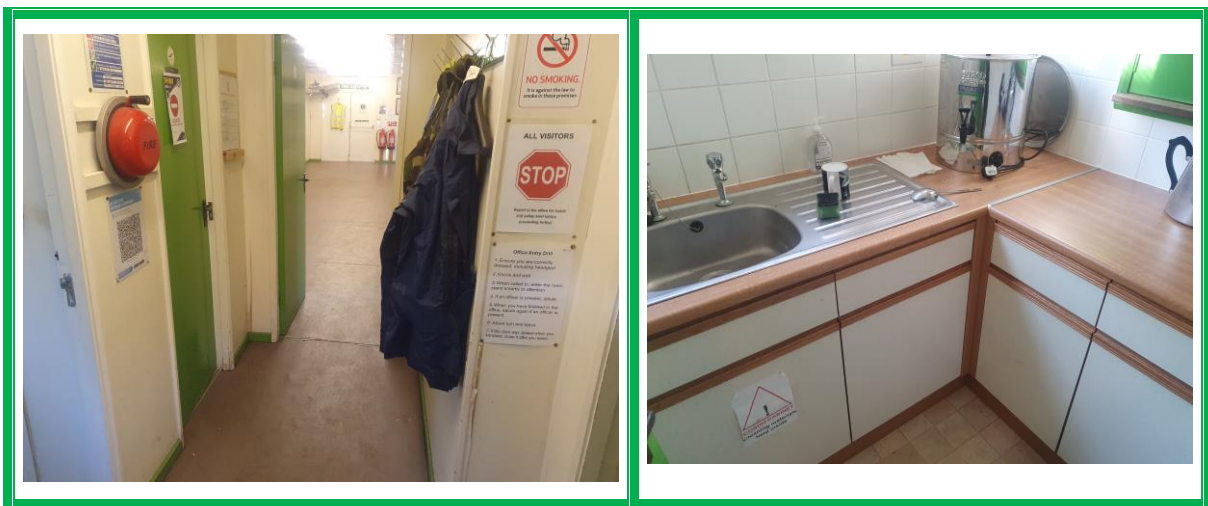
<b>Item No:</b>	<b>17</b>	<b>Sample No:</b>	<b>N/A</b>
<b>Location:</b>	Air Cadet Hut – Lobby, Cupboard & Kitchen

<b>Material Description:</b>	Visual Inspection – No Asbestos Found	
<b>Identification:</b>	N/A	
<b>Approx. quantity:</b>	N/A	
<b>Accessibility</b>	N/A	<i>Assessment Score</i>
<b>Product type:</b>	N/A	N/A
<b>Extent of Damage:</b>	N/A	N/A
<b>Surface Treatment:</b>	N/A	N/A
<b>Asbestos type:</b>	N/A	N/A
<b>Material Assessment Score:</b>		
<b>Priority Assessment Score:</b>		
<b>Action:</b>	N/A	
<b>Comments:</b>	Previously un-accessed rooms. Now accessed and no asbestos found. Modern sink pad in kitchen.
