Project Number 2481

**Management
Asbestos Survey Report**

**2385 Melksham, 33 Lancaster Road, Wiltshire,
SN12 6SS**

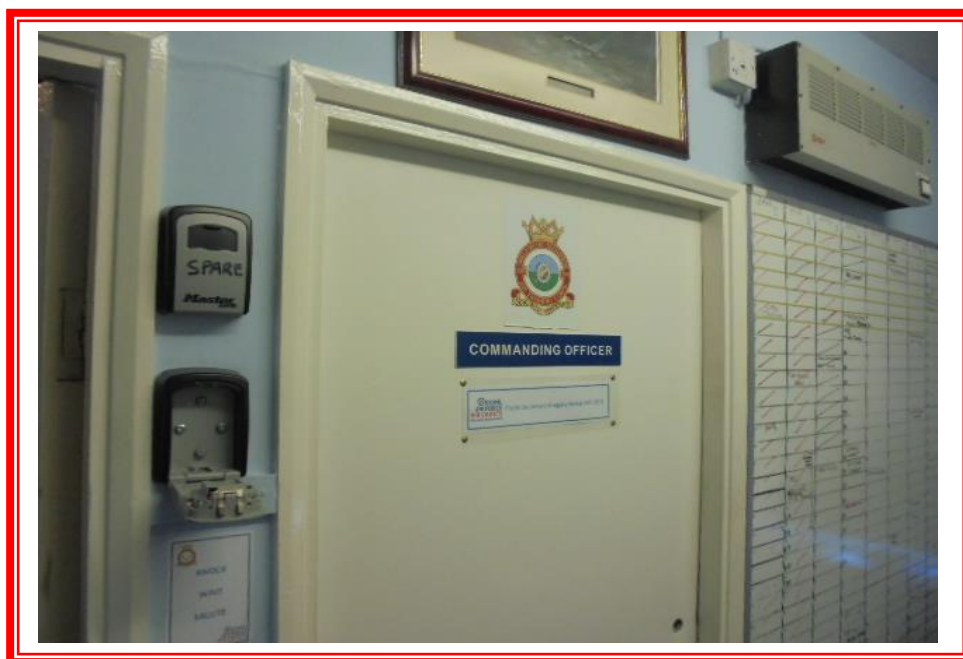
Item No: 6

Item 6 – Building 1 - OC Office – No Access within locked room as no key was available

Material Description:	No access within locked room	
Identification:	Presumed to Contain Asbestos	
Approx. quantity:	1 x Room	
Accessibility	Low	<i>Assessment Score</i>
Product type:	No Access	3
Extent of Damage:	No Access	3
Surface Treatment:	No Access	3
Asbestos type:	No Access	3
Material Assessment Score:		12
Priority Assessment Score:		High
Action:	Further Investigation Required	
Comments:	No key was available on site as instructed by site contact

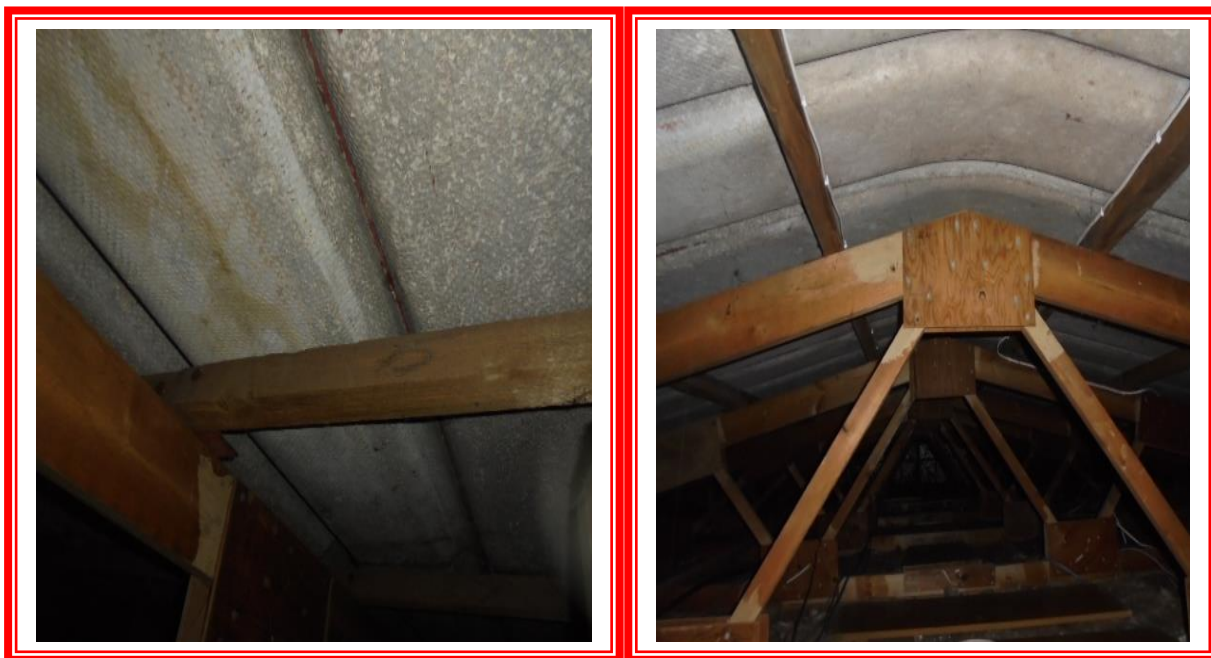
**Item No: 7****Sample No: DK/3****Location: Building 1 – Loft Space**

Material Description:	Profiled Cement Roof	
Identification:	Sampled – Asbestos Detected	
Approx. quantity:	120M2	
Accessibility	Low	<i>Assessment Score</i>
Product type:	Cement	1
Extent of Damage:	Minor	1
Surface Treatment:	Unsealed	1
Asbestos type:	Chrysotile	1
Material Assessment Score:		4
Priority Assessment Score:		Negligible
Action:	Manage	
Comments:	Profiled asbestos cement roof has been over-clad with profiled metal

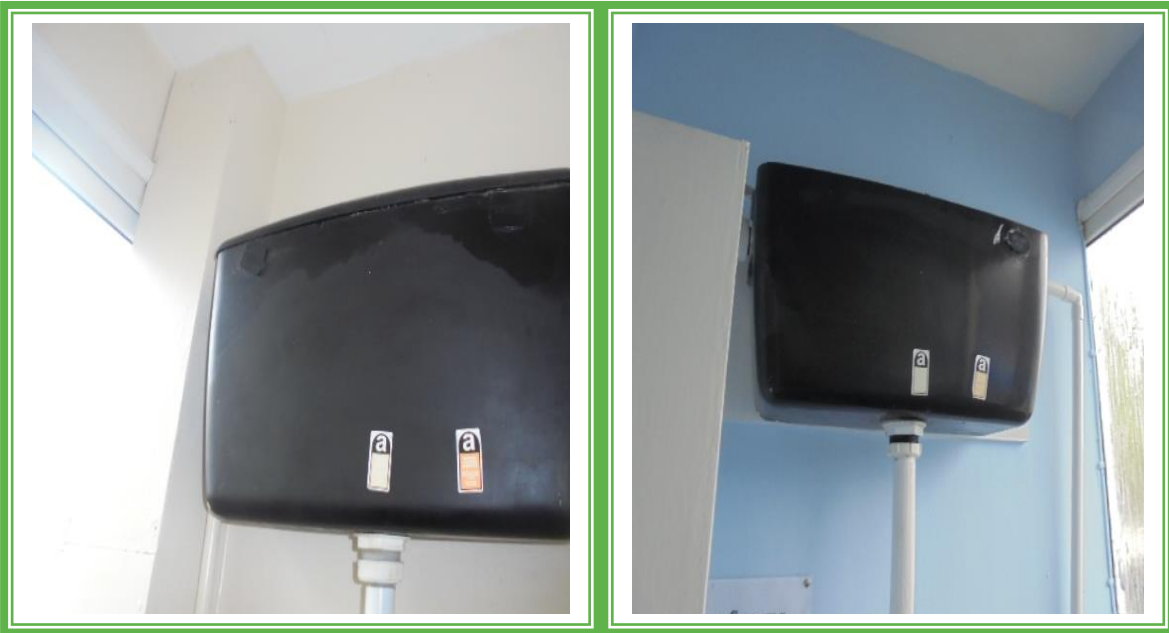
Item No: 1

Material Description:	Toilet Cisterns	
Identification:	Sampled – No Asbestos Detected	
Approx. quantity:	2 x Cisterns	
Accessibility	N/A	<i>Assessment Score</i>
Product type:		N/A
Extent of Damage:		N/A
Surface Treatment:		N/A
Asbestos type:		N/A
Material Assessment Score:		N/A
Priority Assessment Score:		N/A
Action:	N/A	
Comments:	Plastic toilet seats

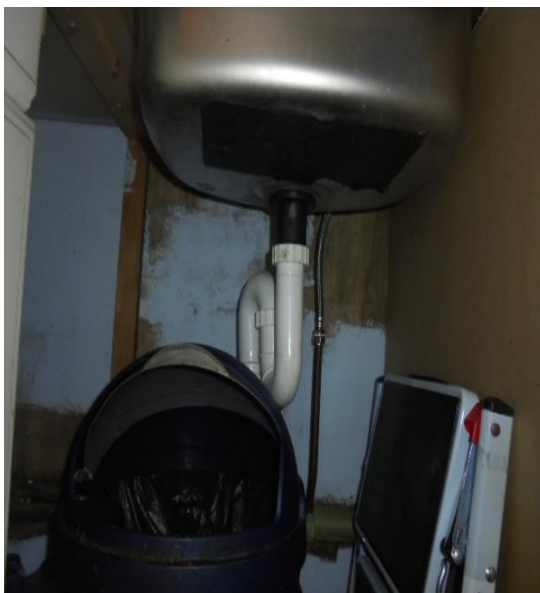
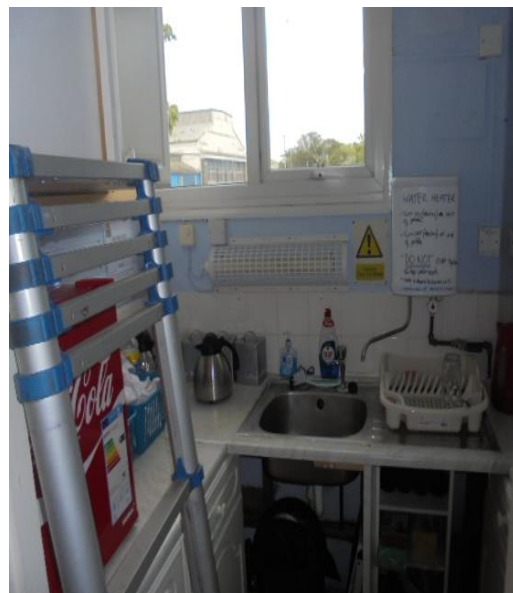
**Item No: 2****Sample No: DK/2****Location: Building 1 – Kitchen**

Material Description:	Sink Pad	
Identification:	Sampled – No Asbestos Detected	
Approx. quantity:	1 x Sink	
Accessibility	N/A	<i>Assessment Score</i>
Product type:		N/A
Extent of Damage:		N/A
Surface Treatment:		N/A
Asbestos type:		N/A
Material Assessment Score:		N/A
Priority Assessment Score:		N/A
Action:	N/A	
Comments:	N/A

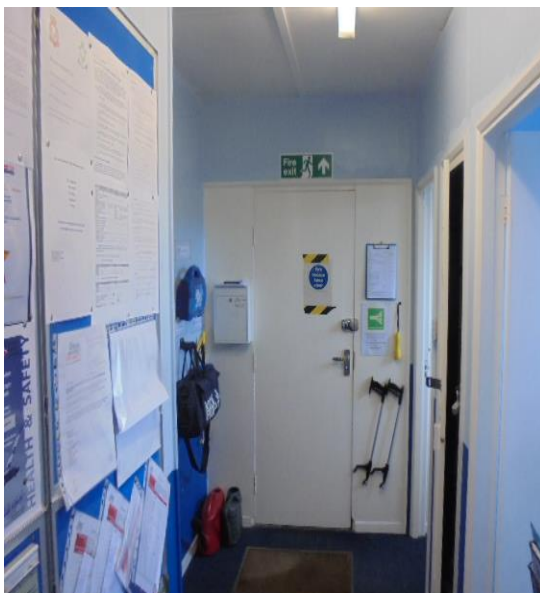
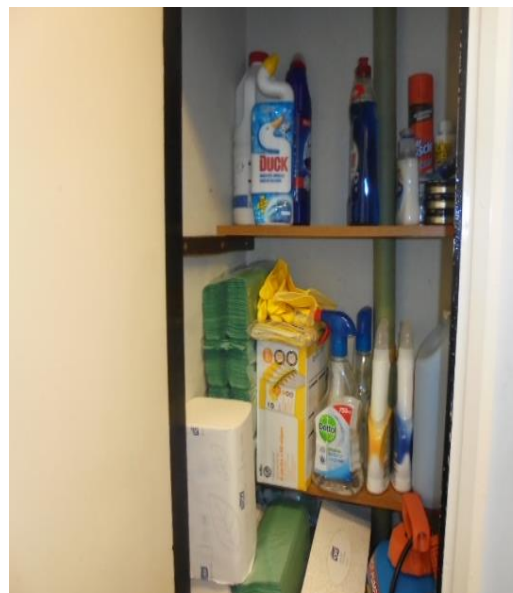
Item No: 3

Material Description:	Visual Inspection – No Suspect Materials Found	
Identification:	N/A	
Approx. quantity:	N/A	
Accessibility	N/A	<i>Assessment Score</i>
Product type:		N/A
Extent of Damage:		N/A
Surface Treatment:		N/A
Asbestos type:		N/A
Material Assessment Score:		N/A
Priority Assessment Score:		N/A
Action:	N/A	
Comments:	N/A

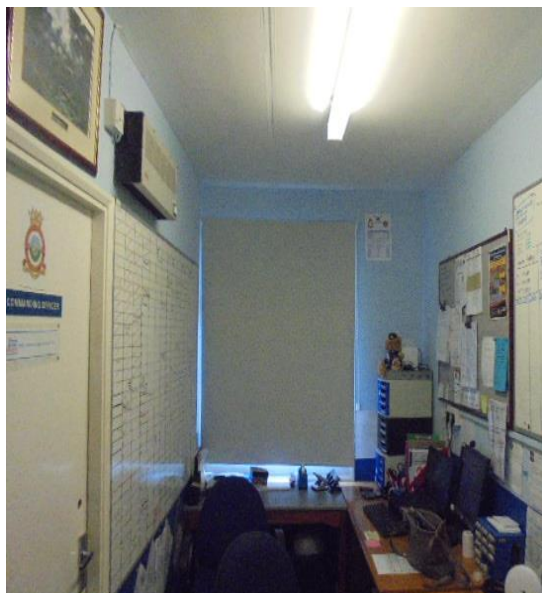
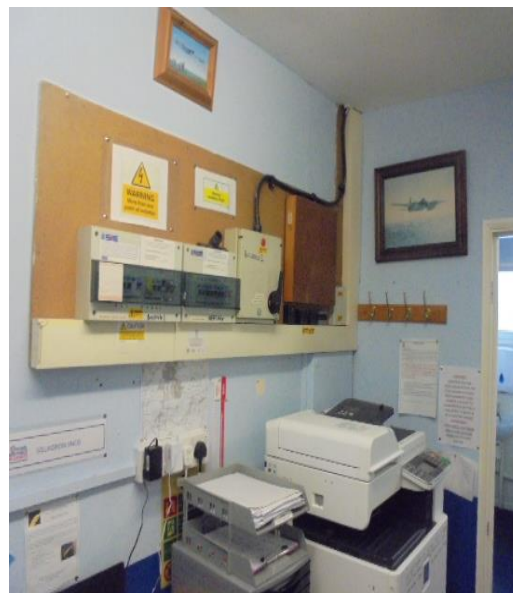
**Item No: 4****Sample No: N/A****Location: Building 1 – Office**

Material Description:	Visual Inspection – No Suspect Materials Found	
Identification:	N/A	
Approx. quantity:	N/A	
Accessibility	N/A	<i>Assessment Score</i>
Product type:		N/A
Extent of Damage:		N/A
Surface Treatment:		N/A
Asbestos type:		N/A
Material Assessment Score:		N/A
Priority Assessment Score:		N/A
Action:	N/A	
Comments:	N/A

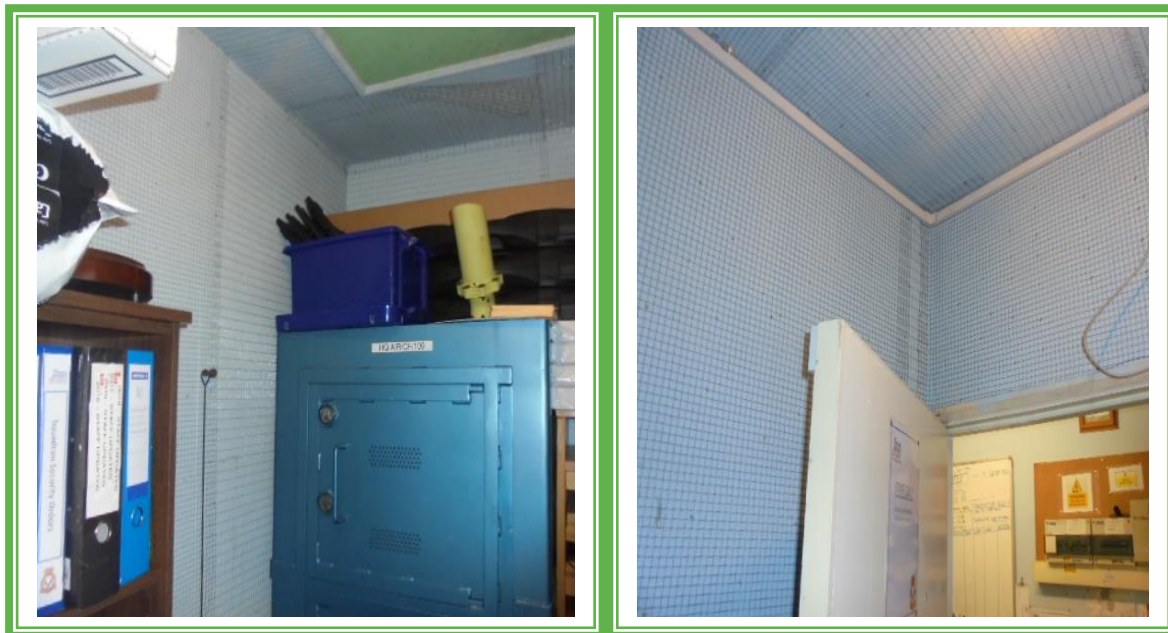
Item No: 5

Material Description:	Visual Inspection – No Suspect Materials Found	
Identification:	N/A	
Approx. quantity:	N/A	
Accessibility	N/A	<i>Assessment Score</i>
Product type:		N/A
Extent of Damage:		N/A
Surface Treatment:		N/A
Asbestos type:		N/A
Material Assessment Score:		N/A
Priority Assessment Score:		N/A
Action:	N/A	
Comments:	N/A

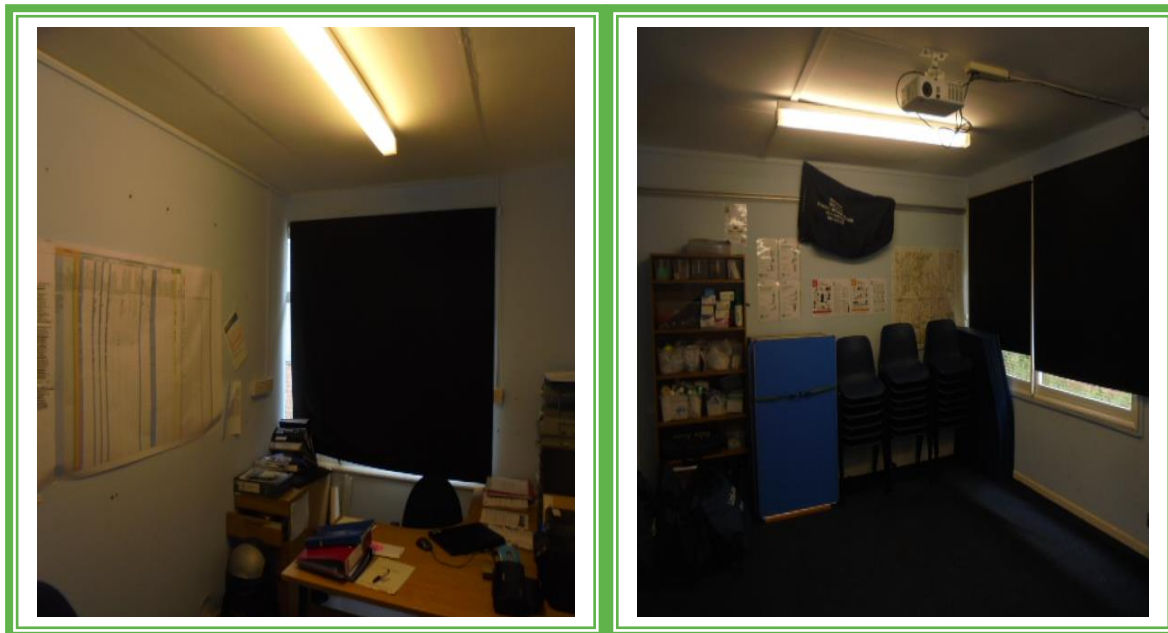
Item No: 8

Material Description:	Visual Inspection – No Suspect Materials Found	
Identification:	N/A	
Approx. quantity:	N/A	
Accessibility	N/A	<i>Assessment Score</i>
Product type:		N/A
Extent of Damage:		N/A
Surface Treatment:		N/A
Asbestos type:		N/A
Material Assessment Score:		N/A
Priority Assessment Score:		N/A
Action:	N/A	
Comments:	N/A

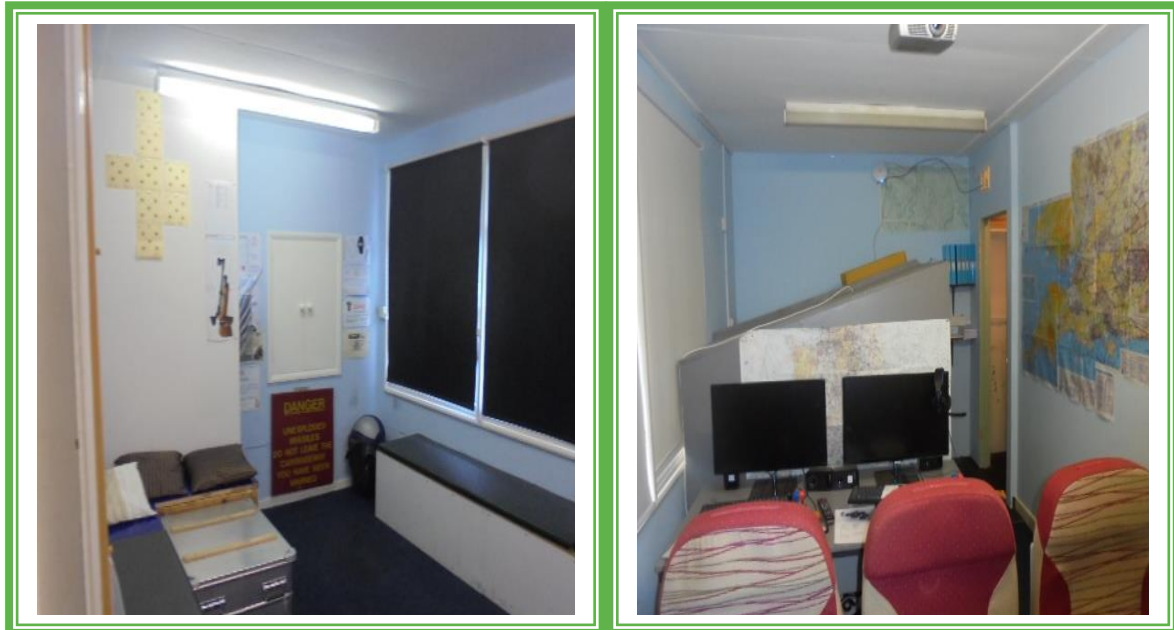
Item No: 9

Material Description:	Visual Inspection – No Suspect Materials Found	
Identification:	N/A	
Approx. quantity:	N/A	
Accessibility	N/A	<i>Assessment Score</i>
Product type:		N/A
Extent of Damage:		N/A
Surface Treatment:		N/A
Asbestos type:		N/A
Material Assessment Score:		N/A
Priority Assessment Score:		N/A
Action:	N/A	
Comments:	N/A

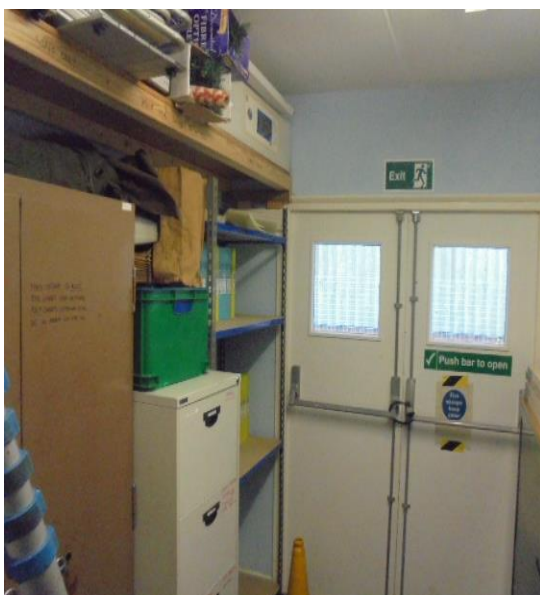
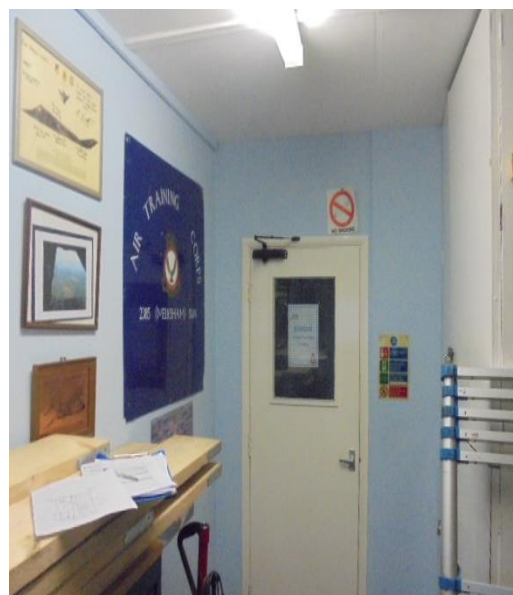
Item No: 10

Material Description:	Visual Inspection – No Suspect Materials Found	
Identification:	N/A	
Approx. quantity:	N/A	
Accessibility	N/A	<i>Assessment Score</i>
Product type:		N/A
Extent of Damage:		N/A
Surface Treatment:		N/A
Asbestos type:		N/A
Material Assessment Score:		N/A
Priority Assessment Score:		N/A
Action:	N/A	
Comments:	N/A

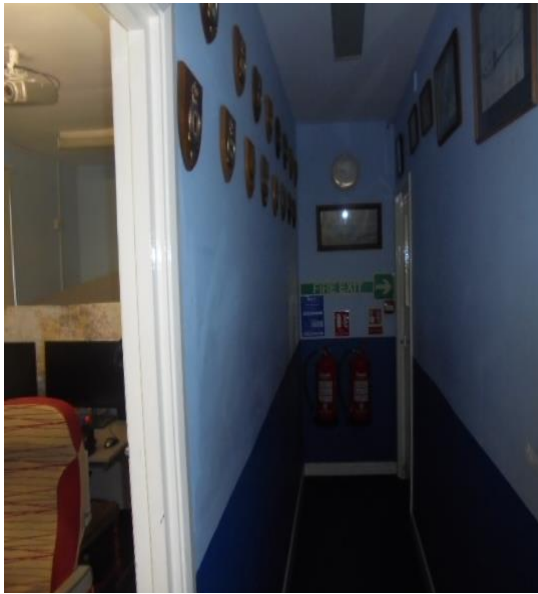
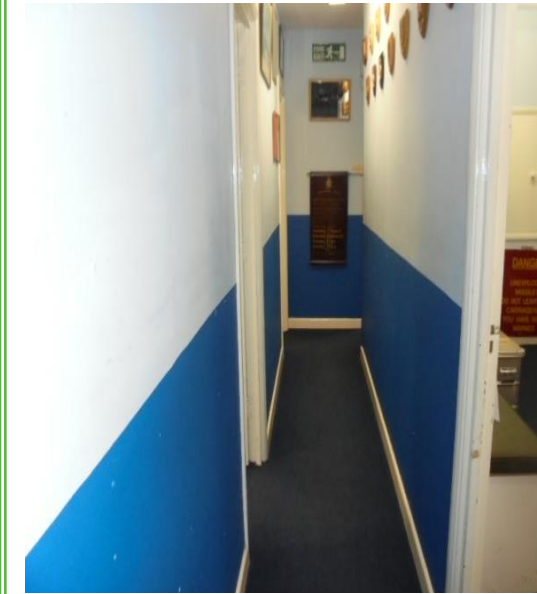
**Item No: 11****Sample No: N/A****Location: Building 1 – Corridor**

Material Description:	Visual Inspection – No Suspect Materials Found	
Identification:	N/A	
Approx. quantity:	N/A	
Accessibility	N/A	<i>Assessment Score</i>
Product type:		N/A
Extent of Damage:		N/A
Surface Treatment:		N/A
Asbestos type:		N/A
Material Assessment Score:		N/A
Priority Assessment Score:		N/A
Action:	N/A	
Comments:	N/A

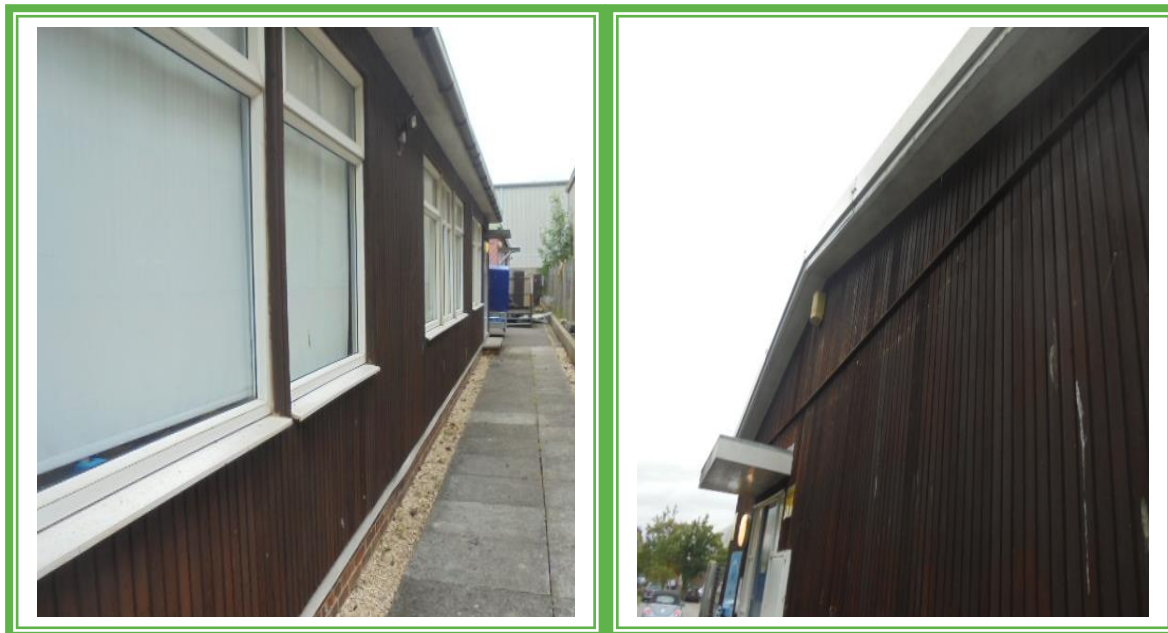
Item No: 12

Material Description:	Visual Inspection – No Suspect Materials Found	
Identification:	N/A	
Approx. quantity:	N/A	
Accessibility	N/A	<i>Assessment Score</i>
Product type:		N/A
Extent of Damage:		N/A
Surface Treatment:		N/A
Asbestos type:		N/A
Material Assessment Score:		N/A
Priority Assessment Score:		N/A
Action:	N/A	
Comments:	N/A

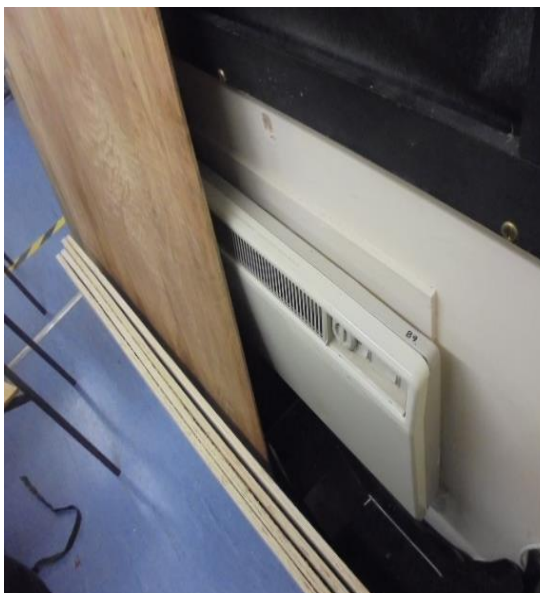
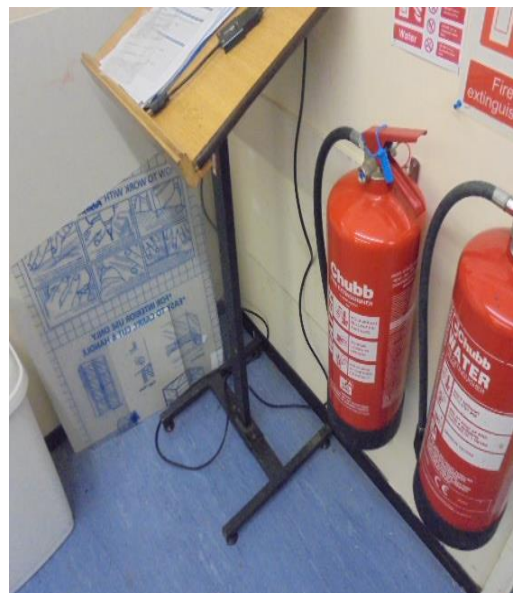
Item No: 13

Material Description:	Panel Behind Heater & Redundant Heater Wall Panels	
Identification:	Sampled – No Asbestos Detected	
Approx. quantity:	2 x Panels	
Accessibility	N/A	<i>Assessment Score</i>
Product type:		N/A
Extent of Damage:		N/A
Surface Treatment:		N/A
Asbestos type:		N/A
Material Assessment Score:		N/A
Priority Assessment Score:		N/A
Action:	N/A	
Comments:	N/A

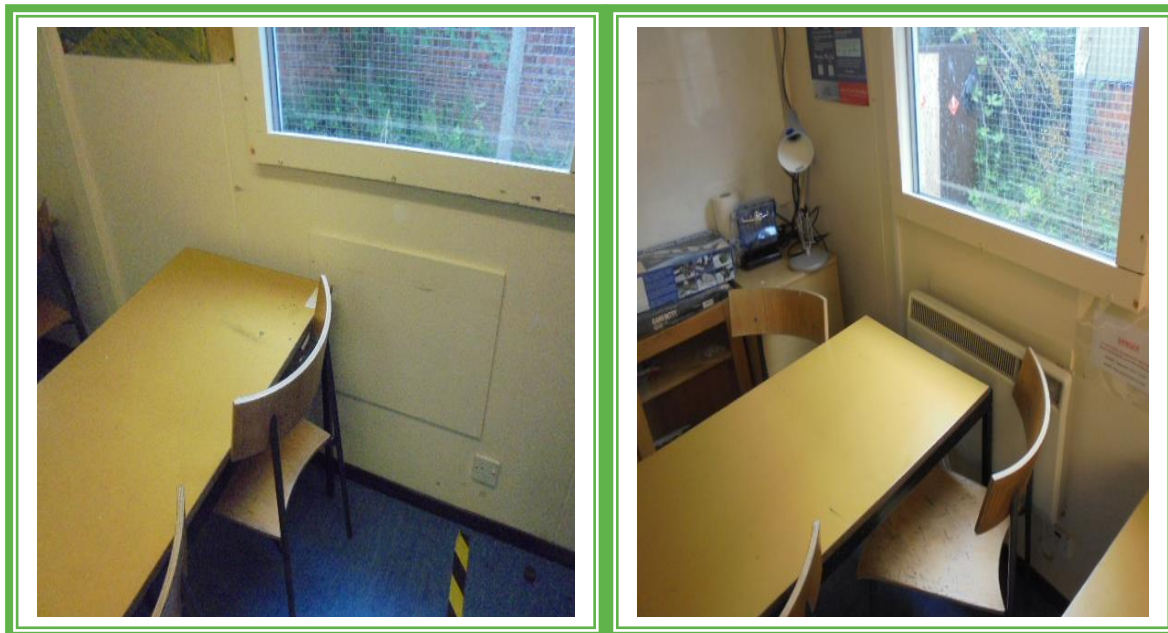
Item No: 14

Material Description:	Panel Behind Heater & Redundant Heater Wall Panel	
Identification:	As Sample DK/4 – No Asbestos Detected	
Approx. quantity:	2 x Panels	
Accessibility	N/A	<i>Assessment Score</i>
Product type:		N/A
Extent of Damage:		N/A
Surface Treatment:		N/A
Asbestos type:		N/A
Material Assessment Score:		N/A
Priority Assessment Score:		N/A
Action:	N/A	
Comments:	N/A

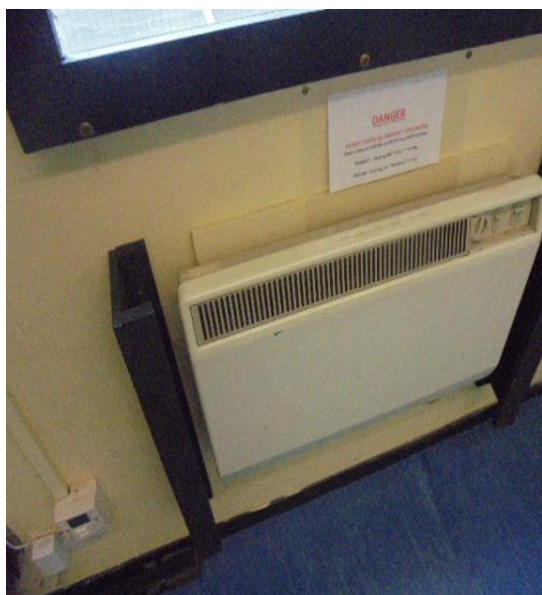
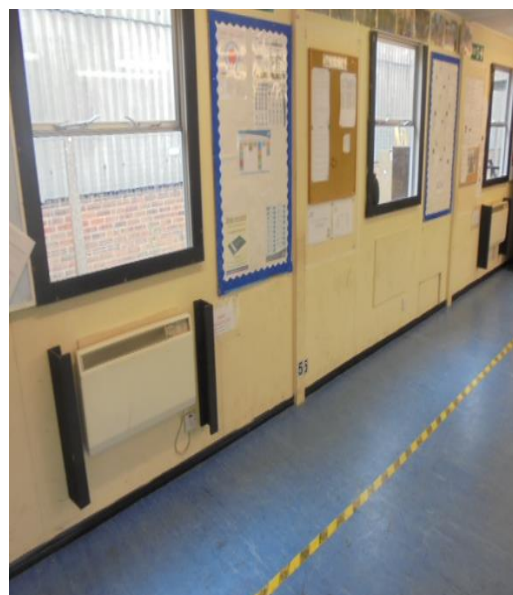
**Item No: 15****Sample No: DK/5****Location: Building 2 – Parade Hall**

Material Description:	Panel Behind Heater & Redundant Heater Wall Panels	
Identification:	Sampled – No Asbestos Detected	
Approx. quantity:	6 x Panels	
Accessibility	N/A	<i>Assessment Score</i>
Product type:		N/A
Extent of Damage:		N/A
Surface Treatment:		N/A
Asbestos type:		N/A
Material Assessment Score:		N/A
Priority Assessment Score:		N/A
Action:	N/A	
Comments:	N/A

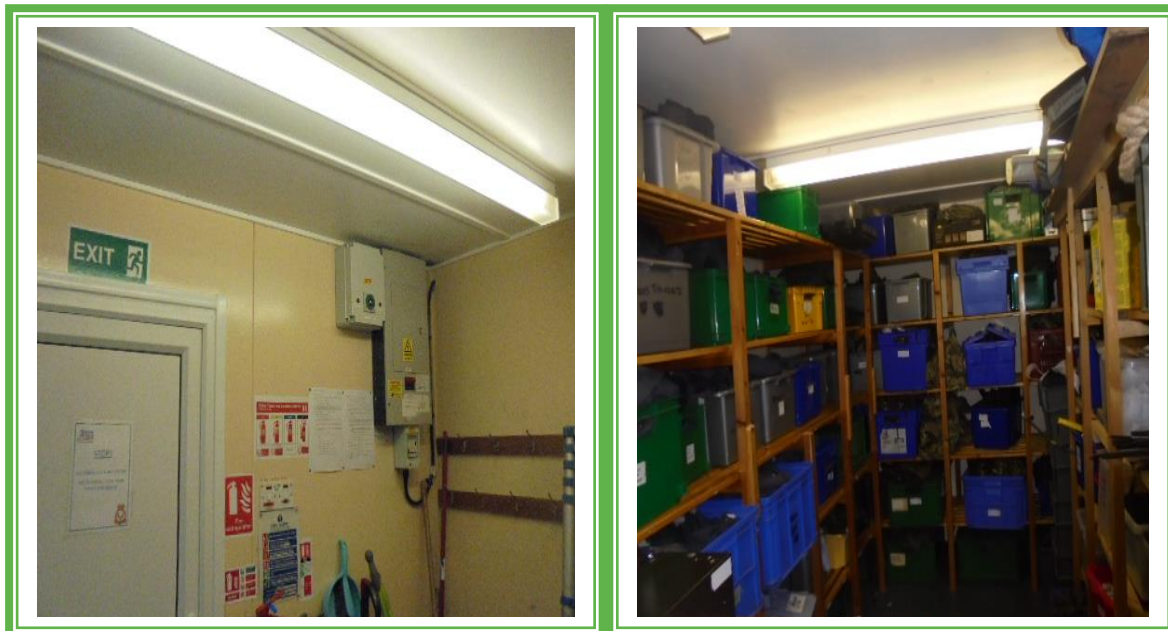
Item No: 16

Material Description:	Visual Inspection – No Suspect Materials Found	
Identification:	N/A	
Approx. quantity:	N/A	
Accessibility	N/A	<i>Assessment Score</i>
Product type:		N/A
Extent of Damage:		N/A
Surface Treatment:		N/A
Asbestos type:		N/A
Material Assessment Score:		N/A
Priority Assessment Score:		N/A
Action:	N/A	
Comments:	N/A

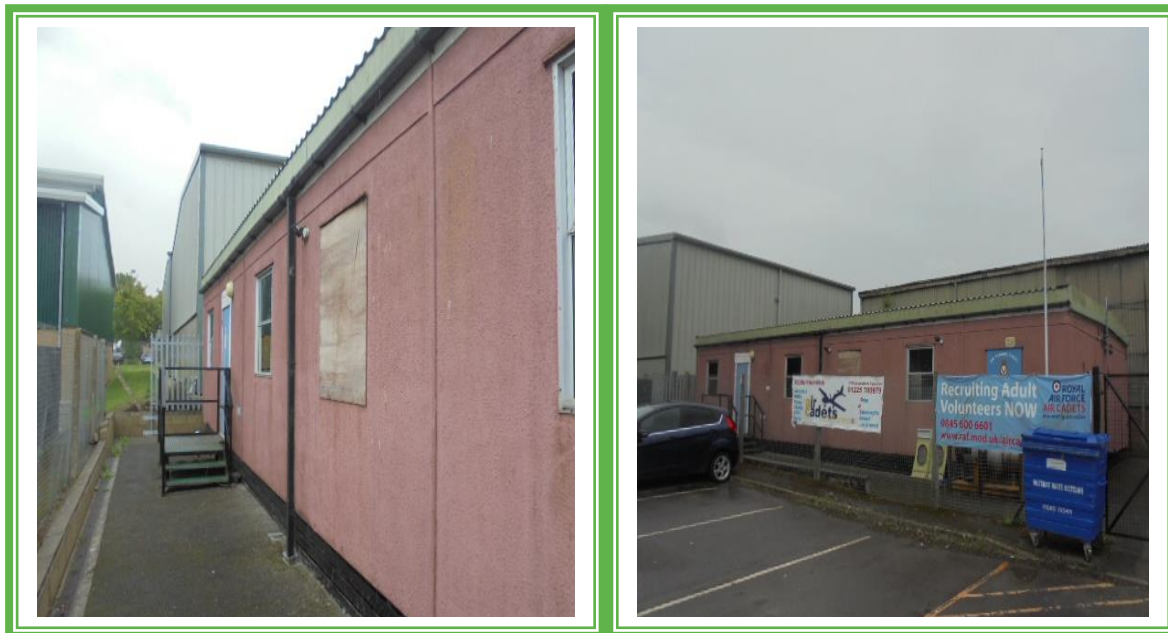
**Item No: 17****Sample No: N/A****Location: Building 2 – External**

Material Description:	Visual Inspection – No Suspect Materials Found	
Identification:	N/A	
Approx. quantity:	N/A	
Accessibility	N/A	<i>Assessment Score</i>
Product type:		N/A
Extent of Damage:		N/A
Surface Treatment:		N/A
Asbestos type:		N/A
Material Assessment Score:		N/A
Priority Assessment Score:		N/A
Action:	N/A	
Comments:	No access below metal roof or above plasterboard ceilings
